Construction Completion Report
**Groundwater Interim Action
Phase 1**
Former Frank Wear Dry Cleaner Site
Yakima, Washington

March 2, 2015
Job No. 17800-23/Task 8

Prepared by
Hart Crowser, Inc.

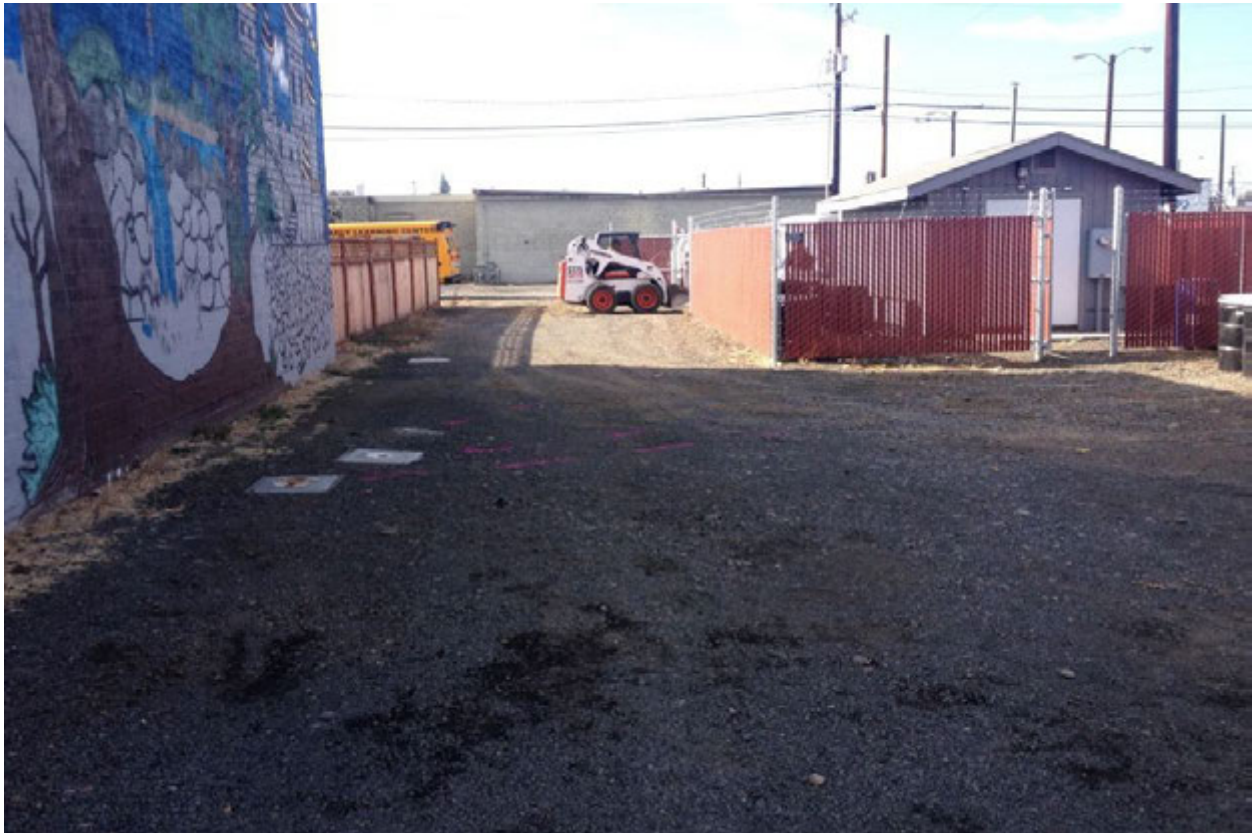
Photograph 1 – Former Frank Wear Cleaners site conditions prior to beginning construction. Children’s daycare building on the left, SVE system on the right. Photograph taken facing west.

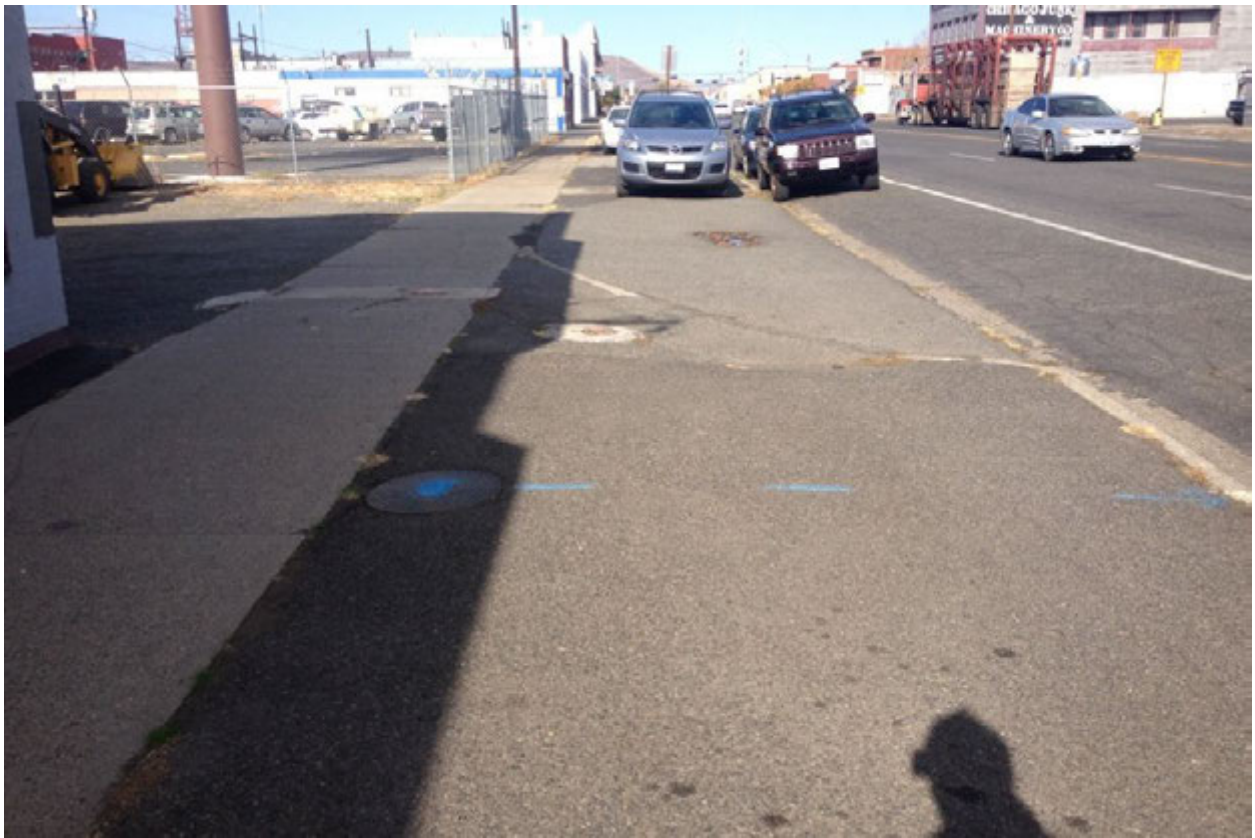
Photograph 2 – South 3rd Avenue sidewalk conditions prior to construction. Children’s daycare water service line marked in blue in foreground. Photograph taken facing north.

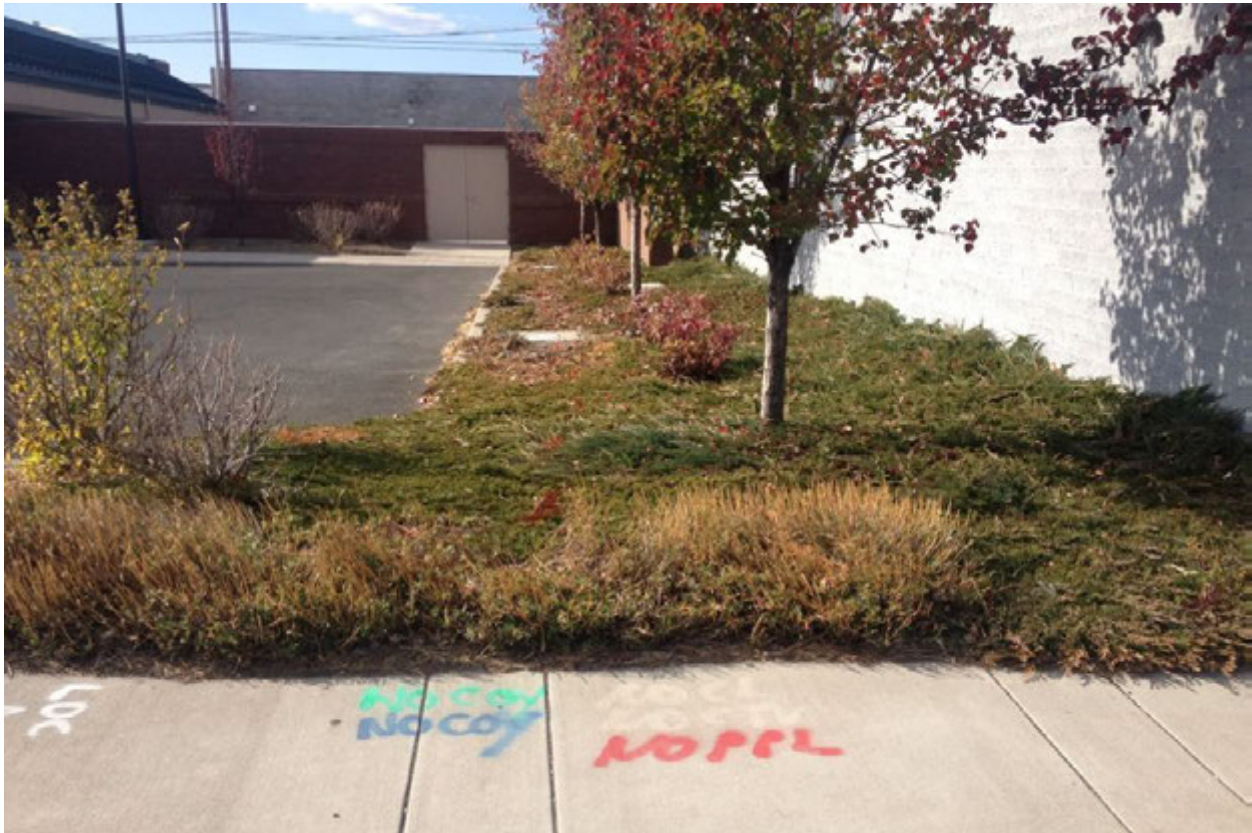
Photograph 3 – Landscaped area on the north side of CWCMH facility property prior to construction. Children’s daycare building to the right. Photograph taken facing west.

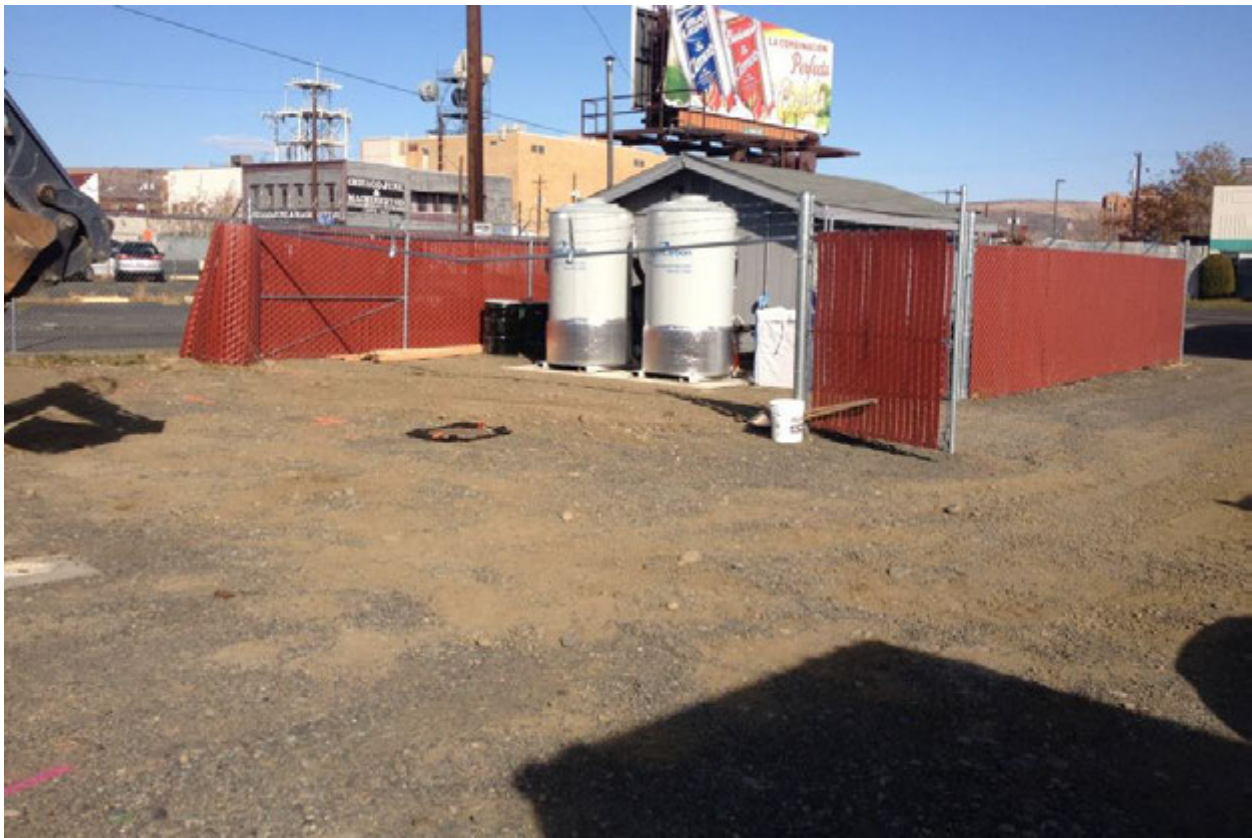
Photograph 4 – SVE System enclosure opened up during site preparation activities. GTS to be installed to west of SVE system and existing fence extended. Photograph taken facing northeast.

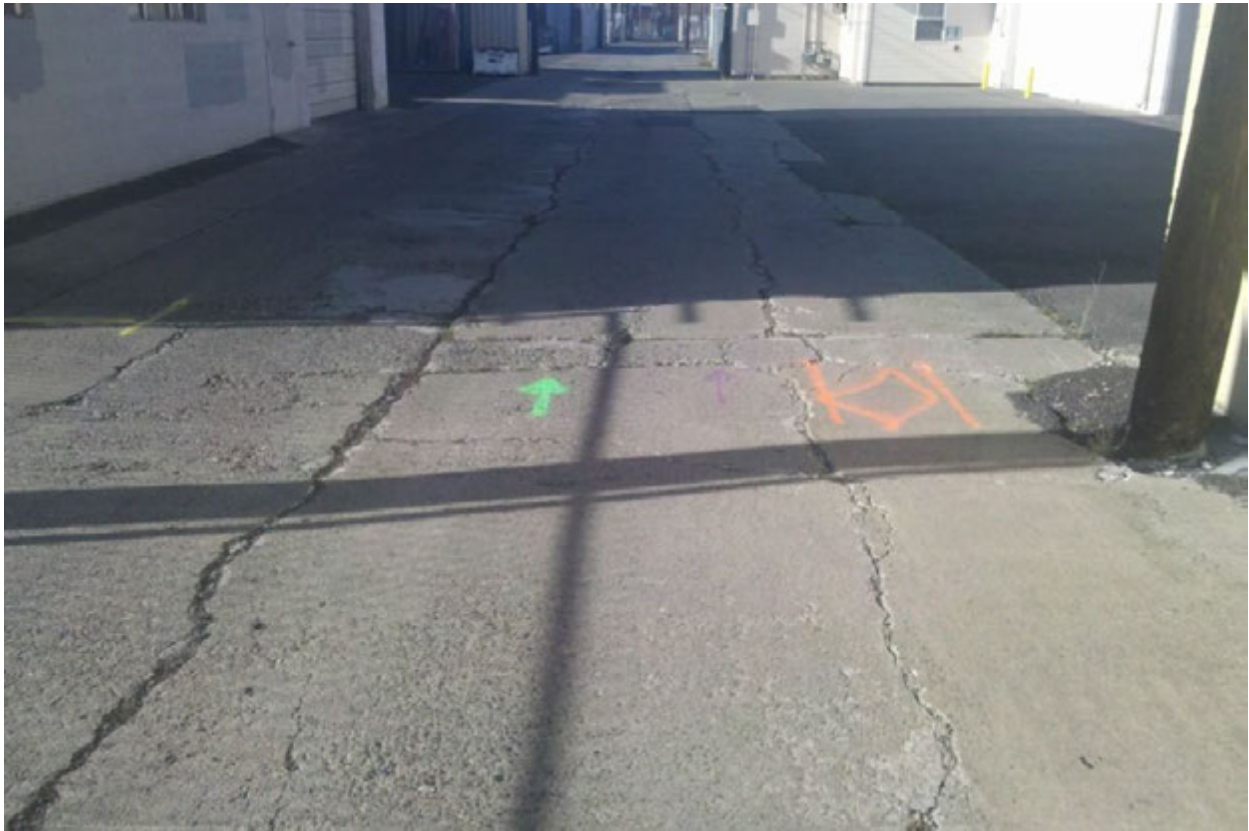
Photograph 5 – Alleyway along the west side of the Site showing multiple underground utilities including from left to right; natural gas, sewer, irrigation, and communication lines. Photograph taken facing south.

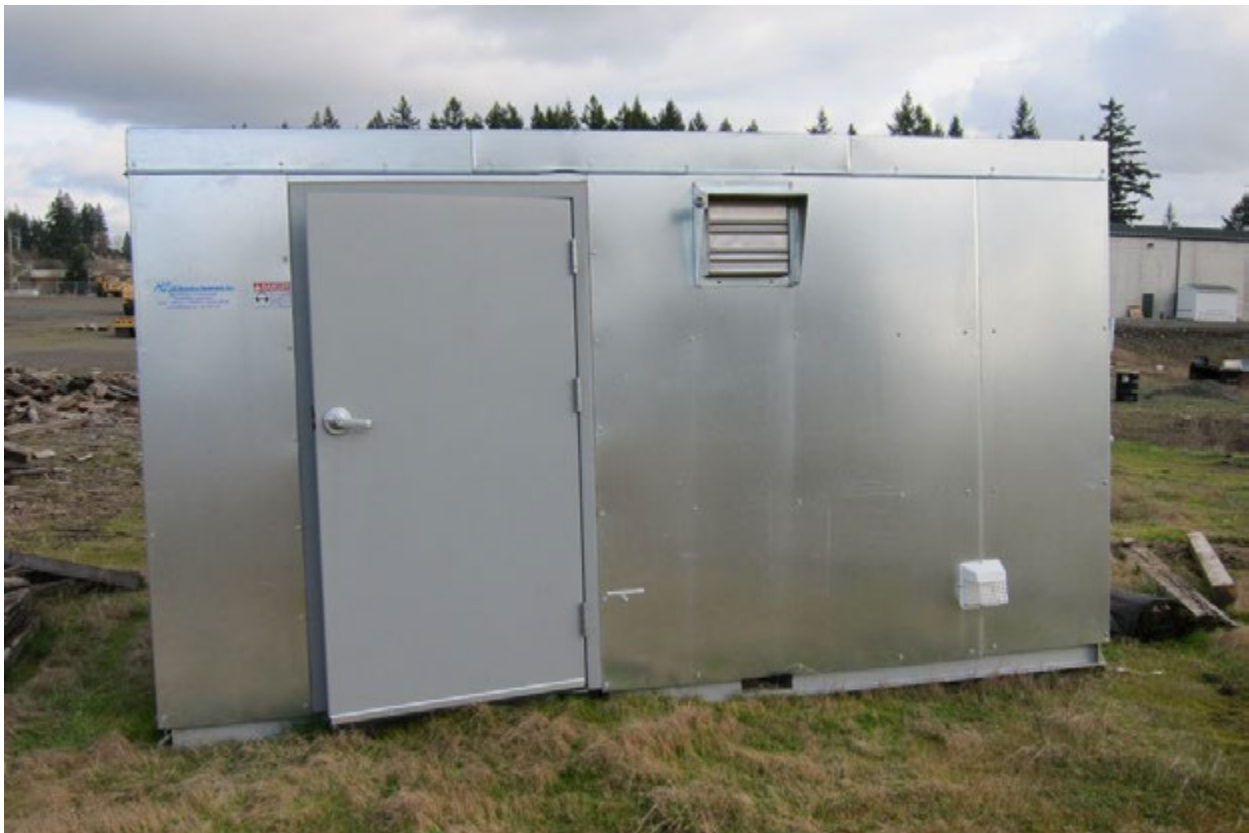
Photograph 6 – GTS prior to delivery. Photograph shows the external construction of the building including I-beam skid foundation.

The GTS building was picked up by ERRG staff from a storage yard in Sherwood, Oregon, and transported to the Site on the weekend of November 2 and 3, 2013. The GTS building was removed from the travel trailer and stored within the fenced private parking lot north of the Frank Wear property on November 4, 2013, using a large forklift. The GTS building was placed on the concrete pad using the large forklift on November 8, 2013.

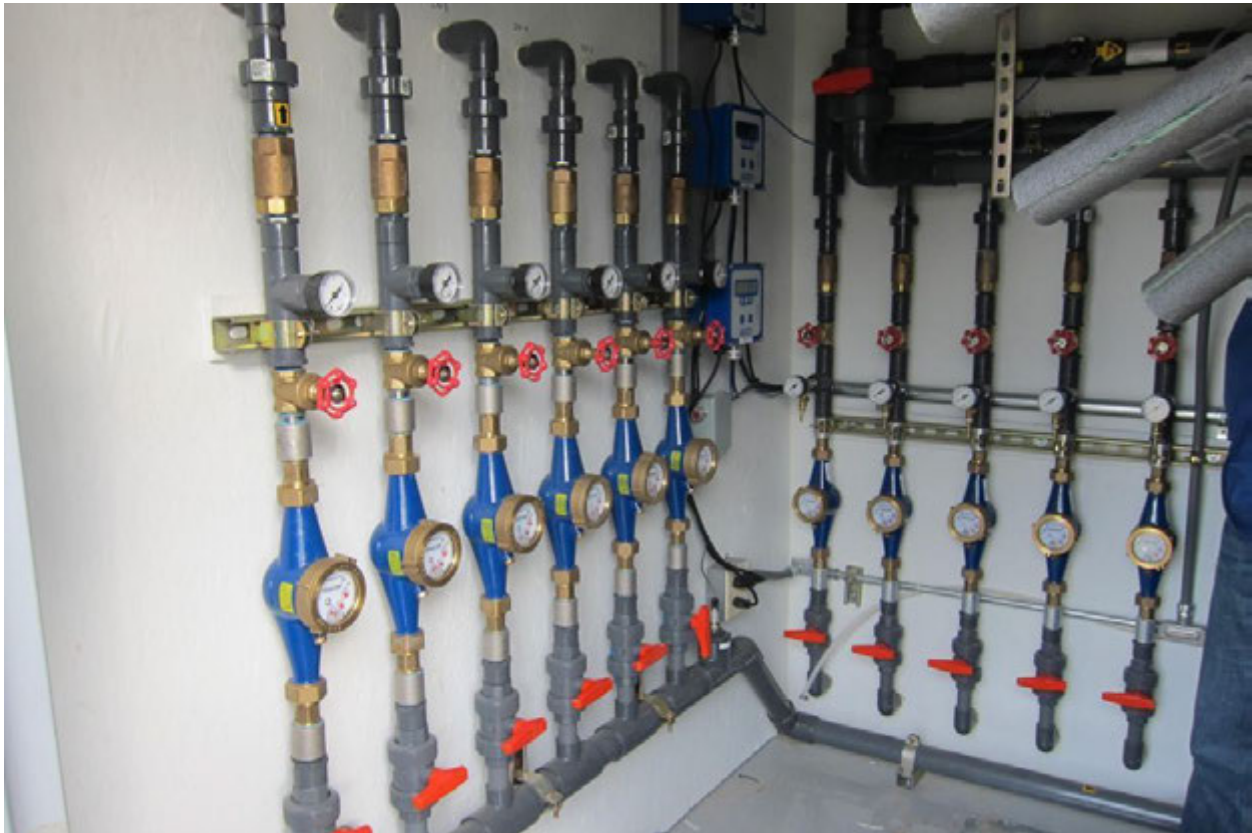
Photograph 7 – Inside of the GTS, photograph shows the injection well manifold on the left and a portion of the extraction well manifold on the right.

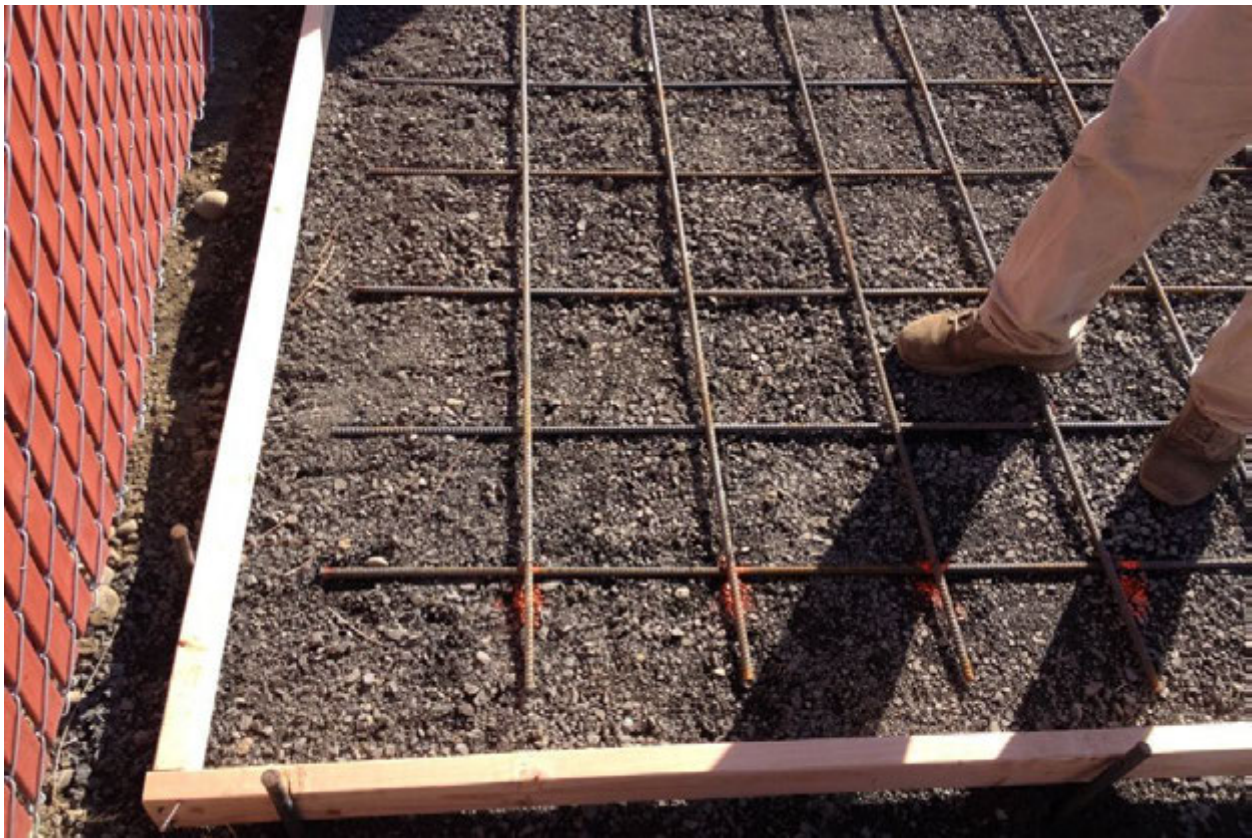
Photograph 8 – GTS concrete foundation form work and reinforced rebar grid. Rebar is spaced 12 inches apart.

The concrete foundation was poured on October 29, 2014. While the concrete truck was pouring concrete, ERRG staff manually lifted the reinforcing rebar grid approximately 2 inches off the ground to the center of the slab. The concrete pad was smoothed and leveled while it cured using the top of the form for reference. Once almost dry, the pad was textured using a broom to prevent the GTS building from slipping once installed.

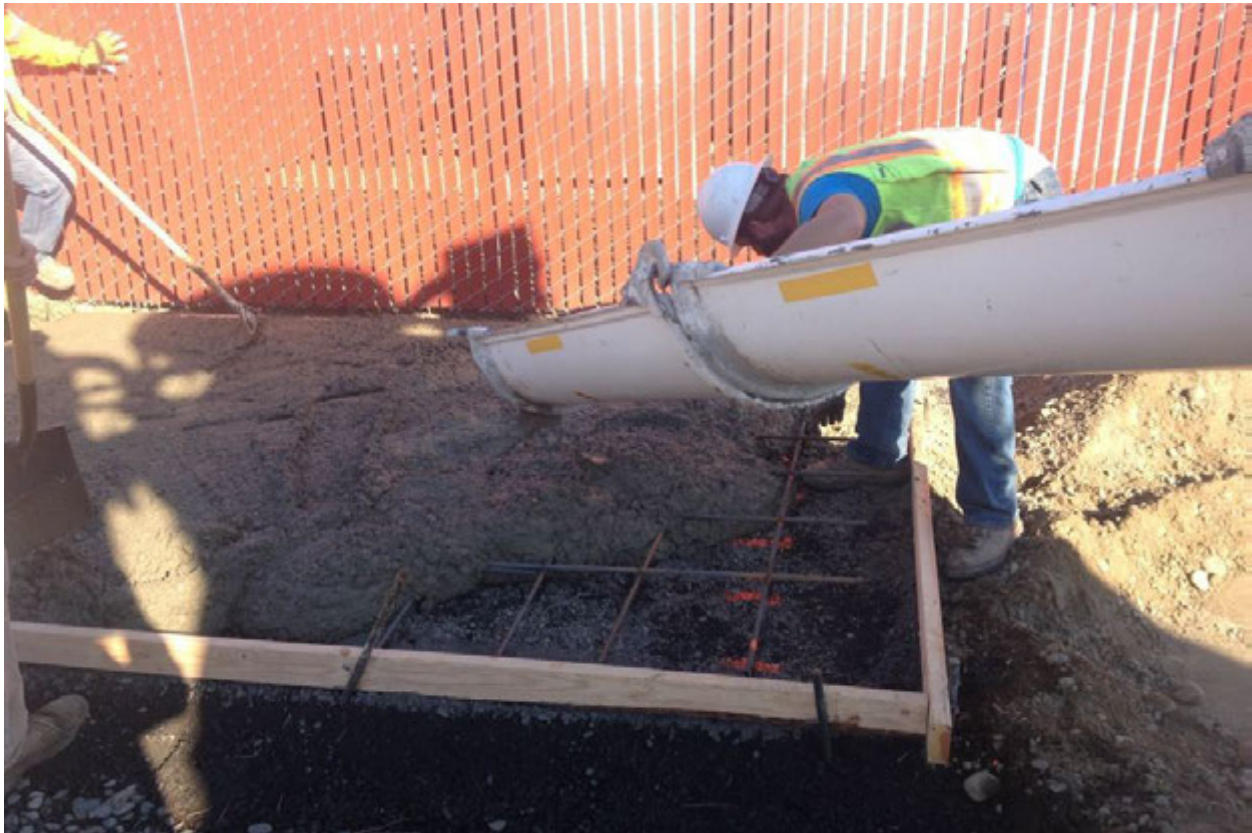
Photograph 9 – ERRG staff working concrete mixture and positioning rebar grid while pouring concrete foundation. Treatment compound fence shown in the background. Photograph taken facing east.

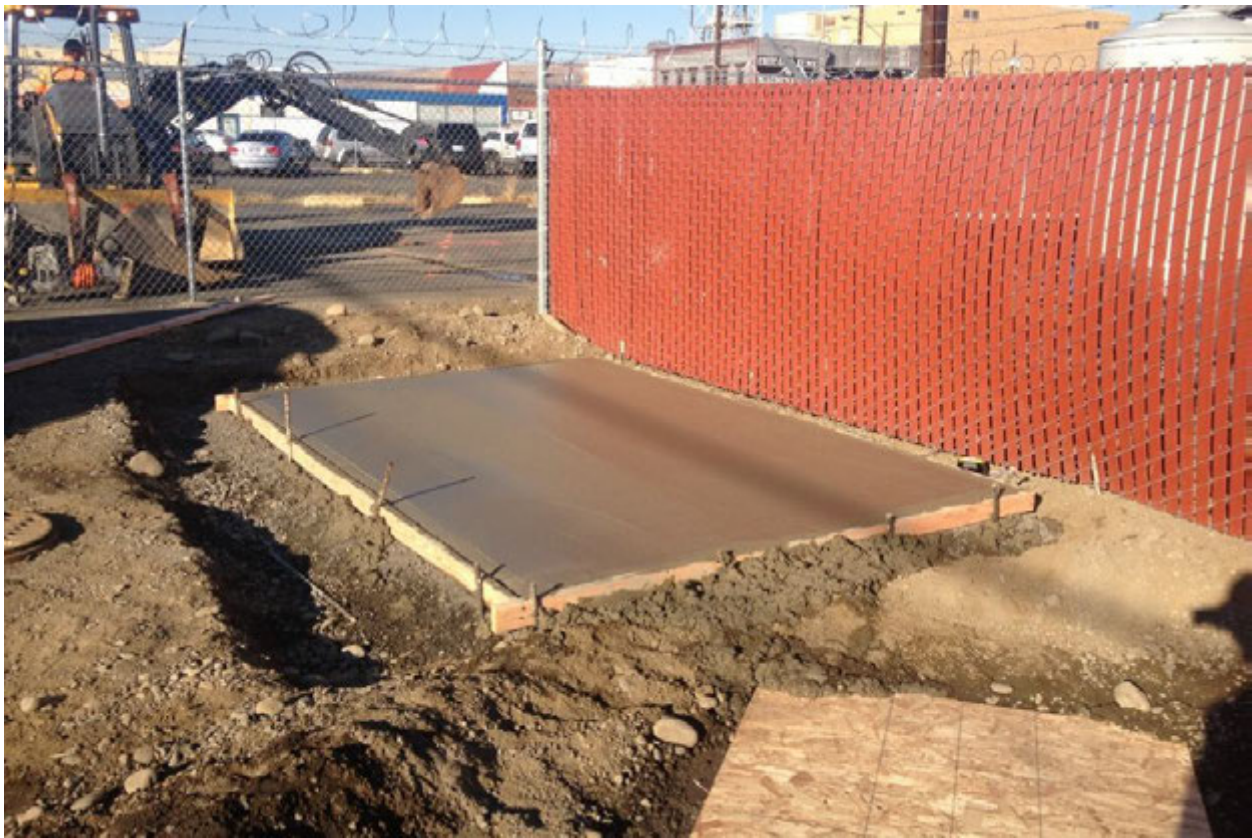
Photograph 10 – Concrete slab poured. Private asphalt parking lot shown in the background with SVE system fence to the right. Photograph taken facing northeast.

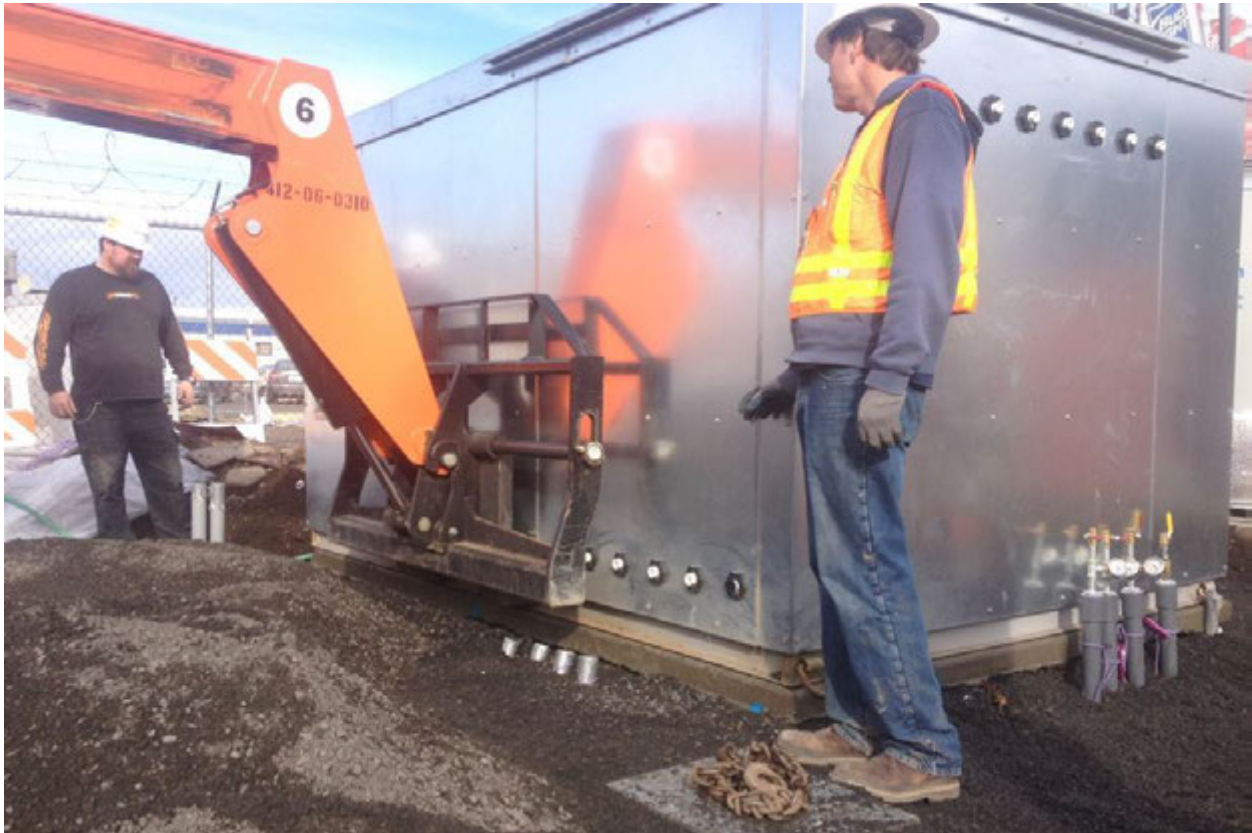
Photograph 11 – Installation of the GTS building on the concrete slab. Note four groundwater extraction pipes surfacing near the center of the building, four groundwater injection pipes surfacing near the right of the building, and an electrical pull box shown in the foreground. Photograph taken facing northeast.

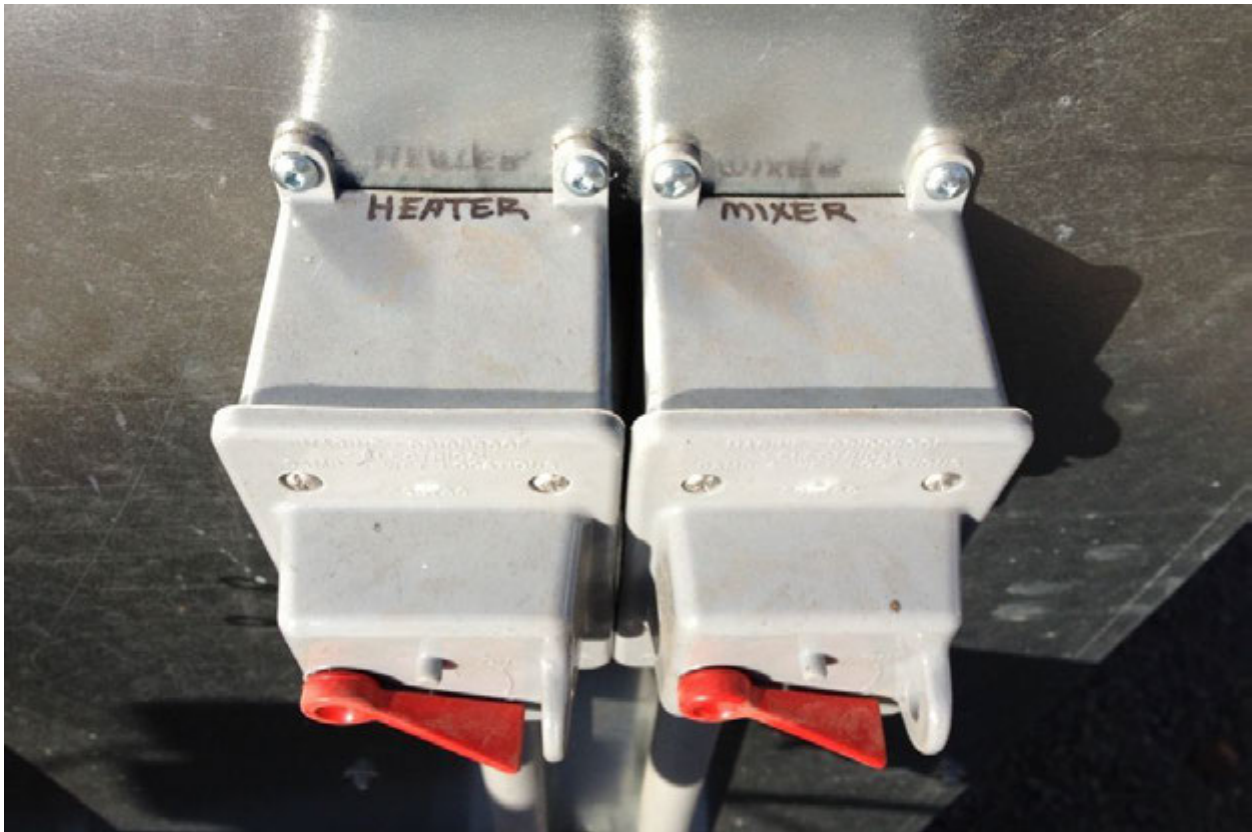
Photograph 12 – External switches installed on the GTS building to control batch tank mixer and heater.

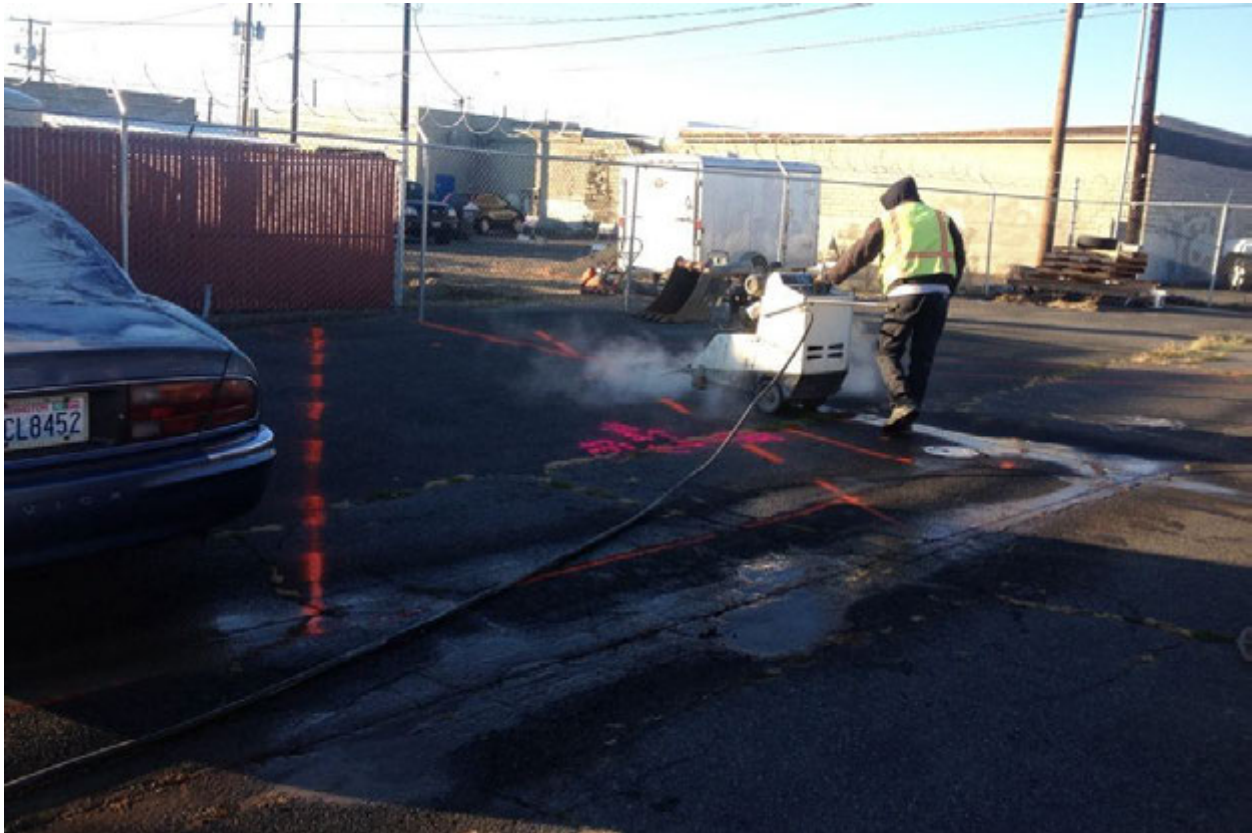
Photograph 13 – Concrete cutting on the private parking lot north of the Site. Injection well INJ-2 can be seen behind the employee. Photograph taken facing southwest.

Trenching began on October 29, 2013, in the private parking lot north of the Frank Wear property where injection wells INJ-1 through INJ-4 are located. ERRG contracted a concrete cutting firm to cut the asphalt within the trench alignment for the injection wells. While the concrete cutting firm was on the Site, they also cut the concrete on the South 3rd Avenue sidewalk where extraction well trenches were to be located. The injection wells and trenches are oriented in a line in the east-west direction upgradient of the Frank Wear property bringing the conveyance pipe toward the north end of the GTS building. The trench passed under the parking lot fence onto the Frank Wear property where it wrapped around and connected to the south side of the GTS building.

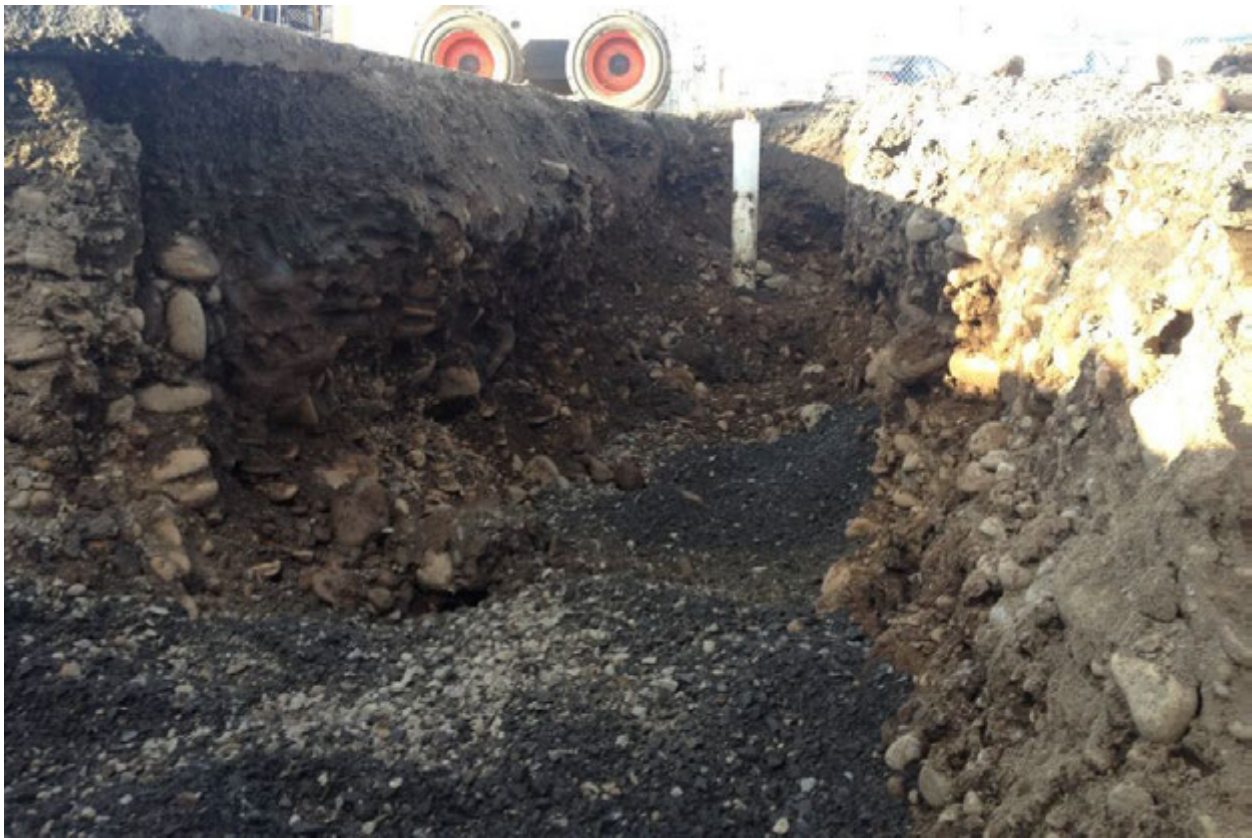
Photograph 14 – Trenching to INJ-1 (well casing visible) showing typical cave-in issues encountered within trenches. In this photograph the pipe bedding material was loosely placed when cave-in occurred. Photograph taken from within INJ-1 trench facing west.

Trenches were generally wider than the minimum width provided on the plan drawings to provide stable working conditions against cave-ins. Trenches were completed up to 5 feet deep, as necessary. No groundwater was encountered in any of the trenches.

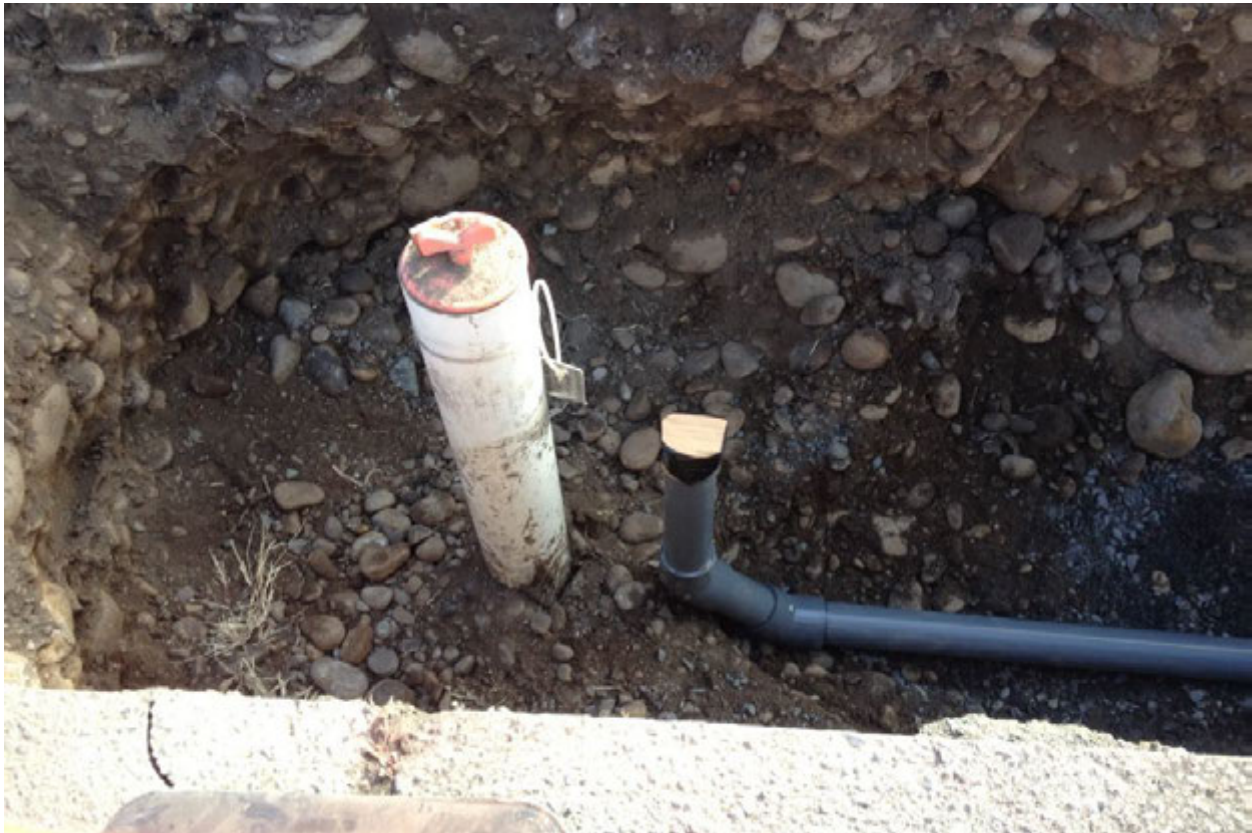
Photograph 15 – Typical well casing (white) with conveyance pipe (gray).

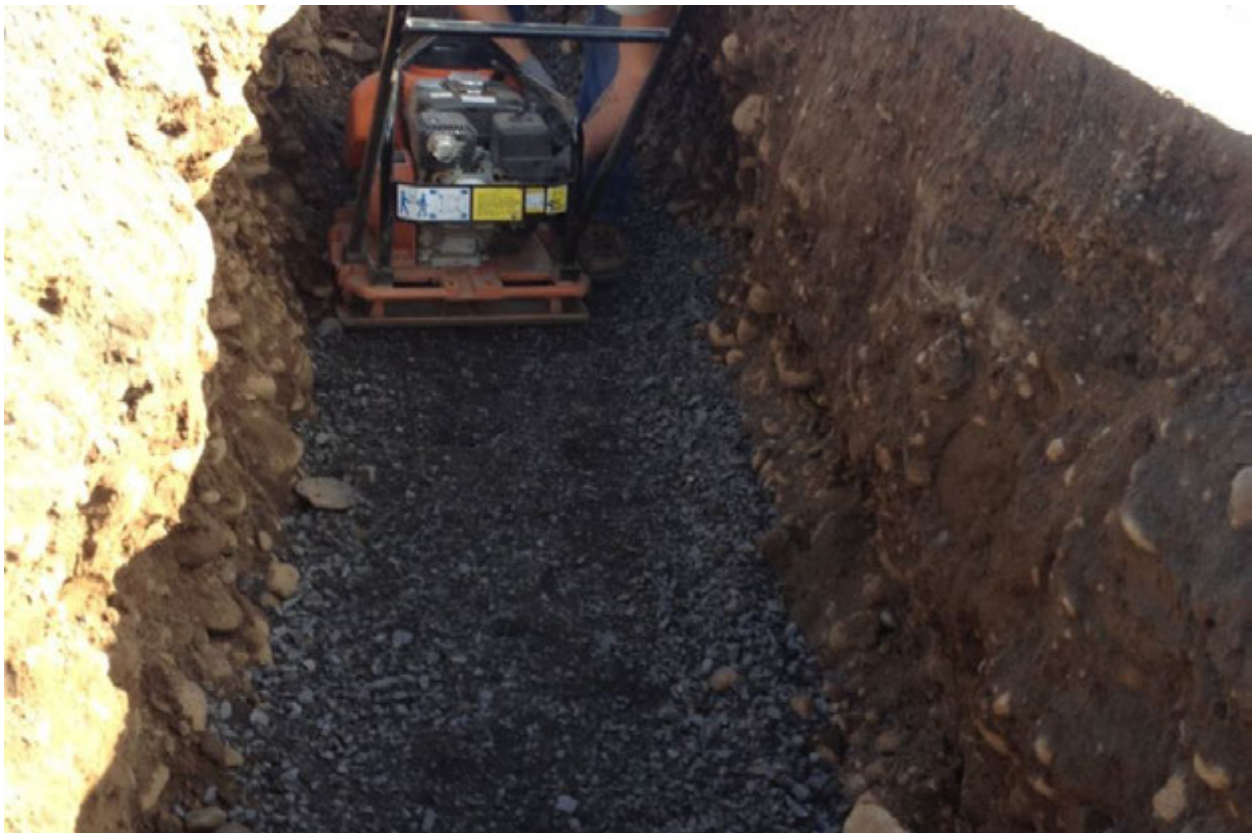
Photograph 16 – Typical trench with pipe bedding material placed and beginning compaction.

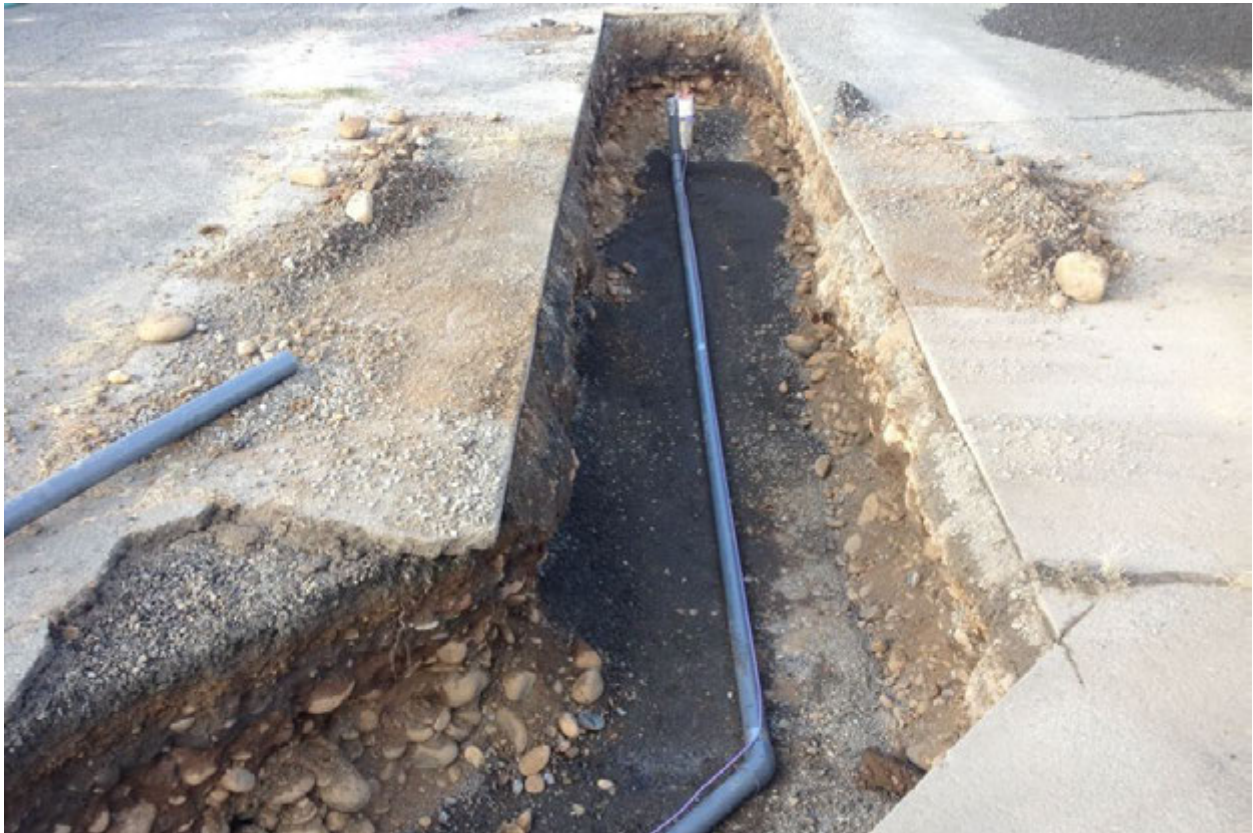
Photograph 17 – INJ-1 trench with conveyance pipe installed over compacted bedding material with tracer wire attached. Photograph taken facing west.

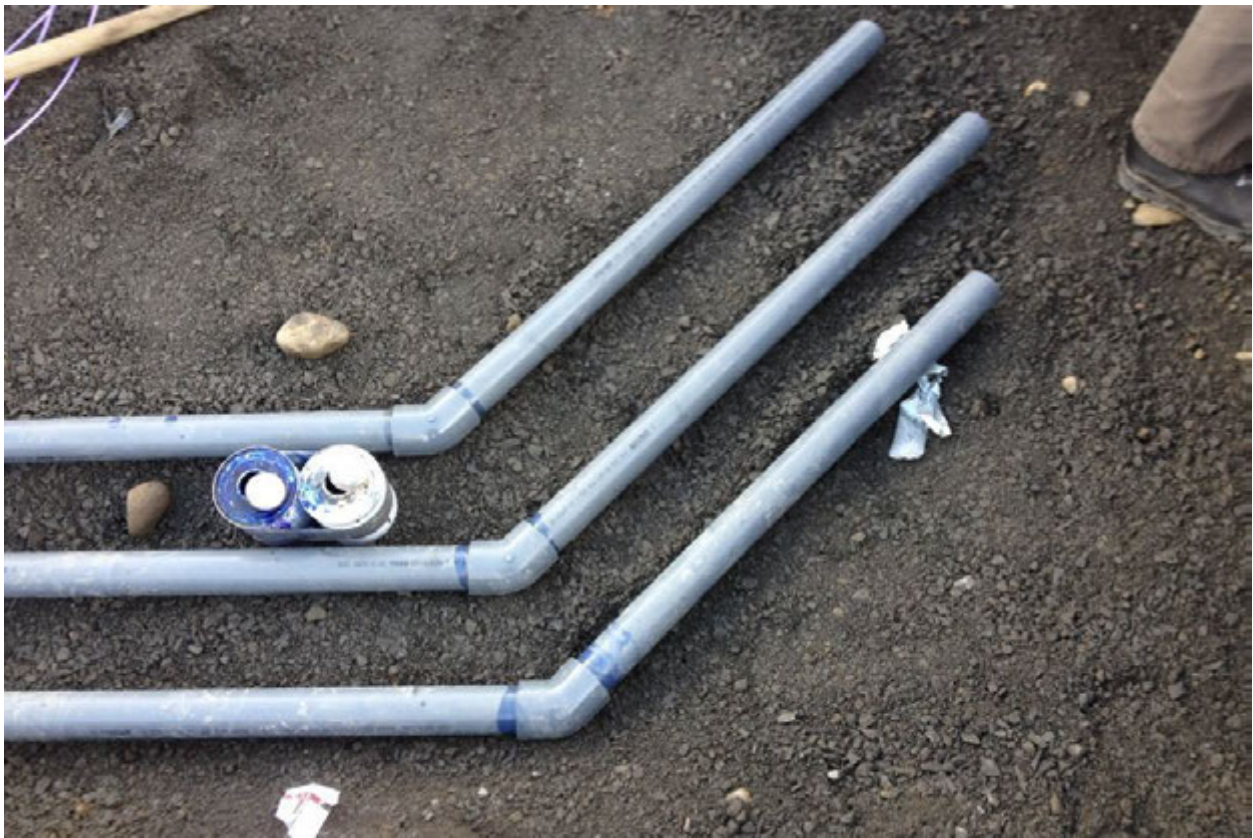
Photograph 18 – Typical spacing of multiple conveyance pipes sharing a trench.

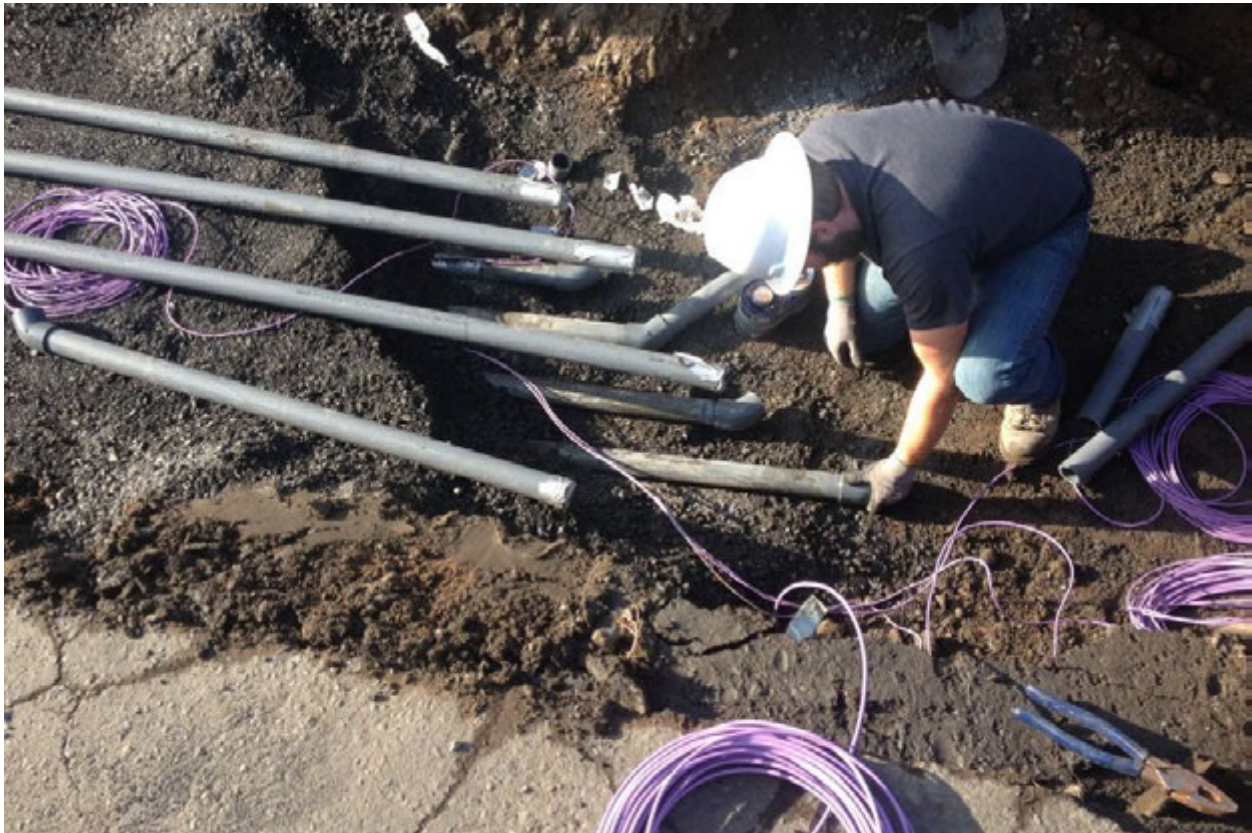
Photograph 19 – This photograph shows a second row of conveyance pipes placed over a lower row of installed pipe. Contractor is installing fittings on lower row in photograph. Purple coils of utility tracer wire can also be seen.

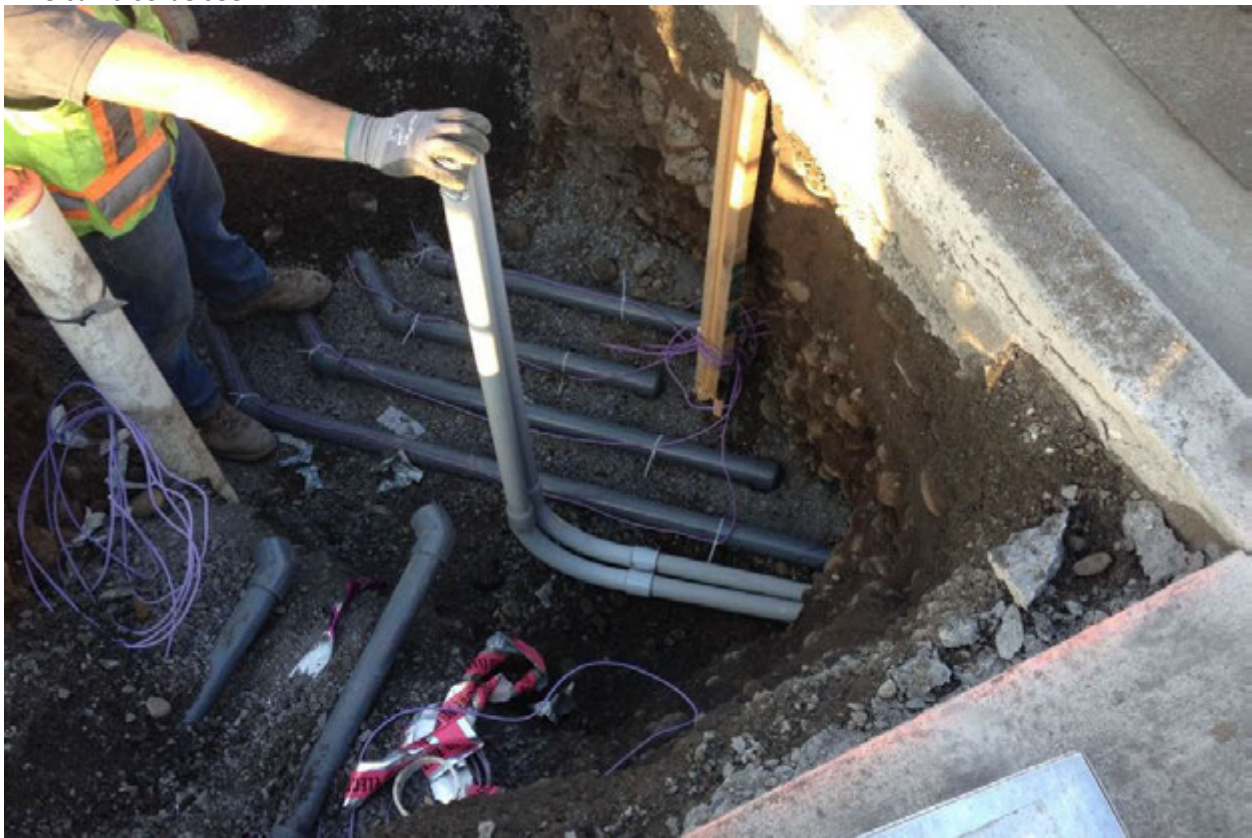
Photograph 20 – Photograph shows intersection of conveyance pipe and electrical conduit (employee is holding) at EXT-4 (white vertical pipe with orange cap). Four lower pipes on the right are capped in the photograph for future installation. Two pipes on the left are conveyance pipe for EXT- and EXT-3. South 3rd Ave. is on the right.
