Construction Completion Report
**Groundwater Interim Action
Phase 1**
Former Frank Wear Dry Cleaner Site
Yakima, Washington

March 2, 2015
Job No. 17800-23/Task 8

Prepared by
Hart Crowser, Inc.

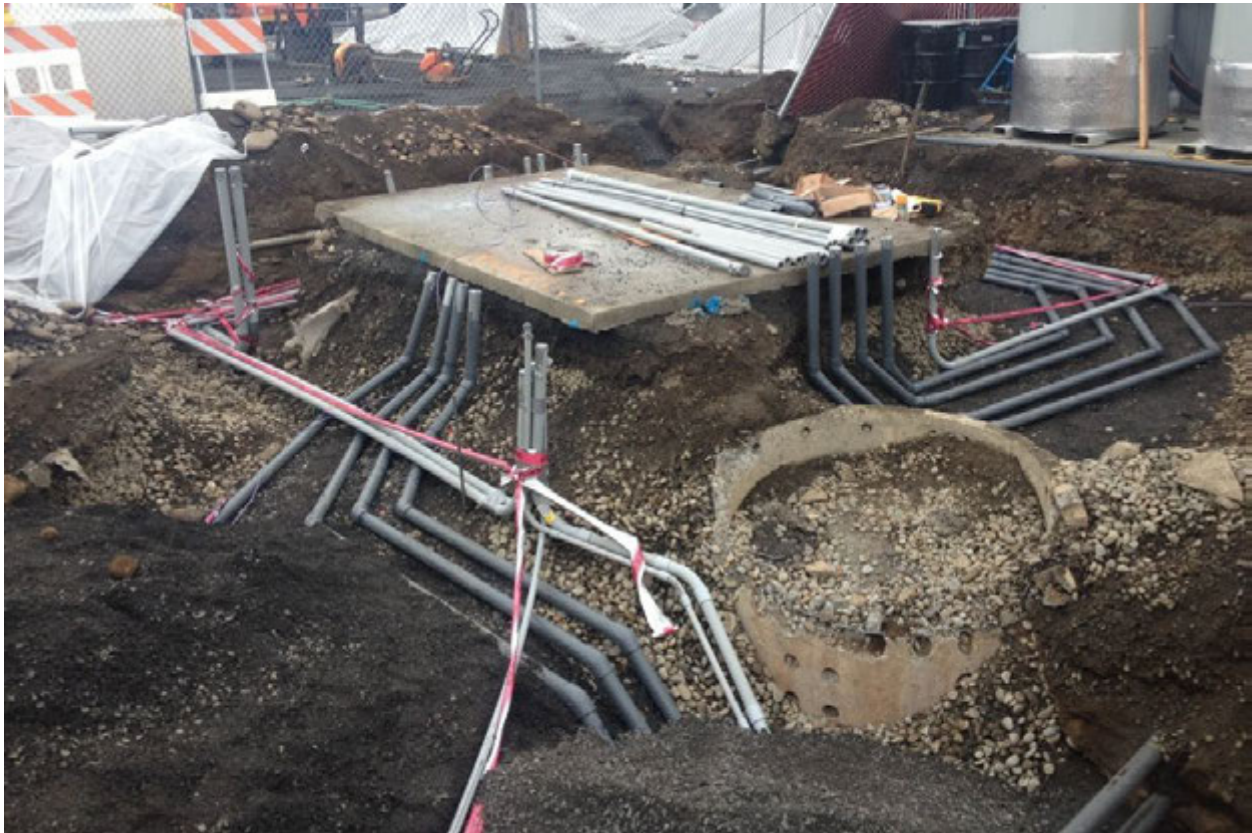
Photograph 21 – Photograph shows GTS building foundation slab with excavation on all sides for pipe installation. Extraction well pipes are in the foreground on the left. Extraction well conduit crosses over the conveyance pipe and wraps around the slab. Injection well pipe wraps around the slab on the right with electrical conduit for batch tank accessories currently sitting on the pipe. The abandoned dry well is visible in the foreground. Photograph taken facing northeast.

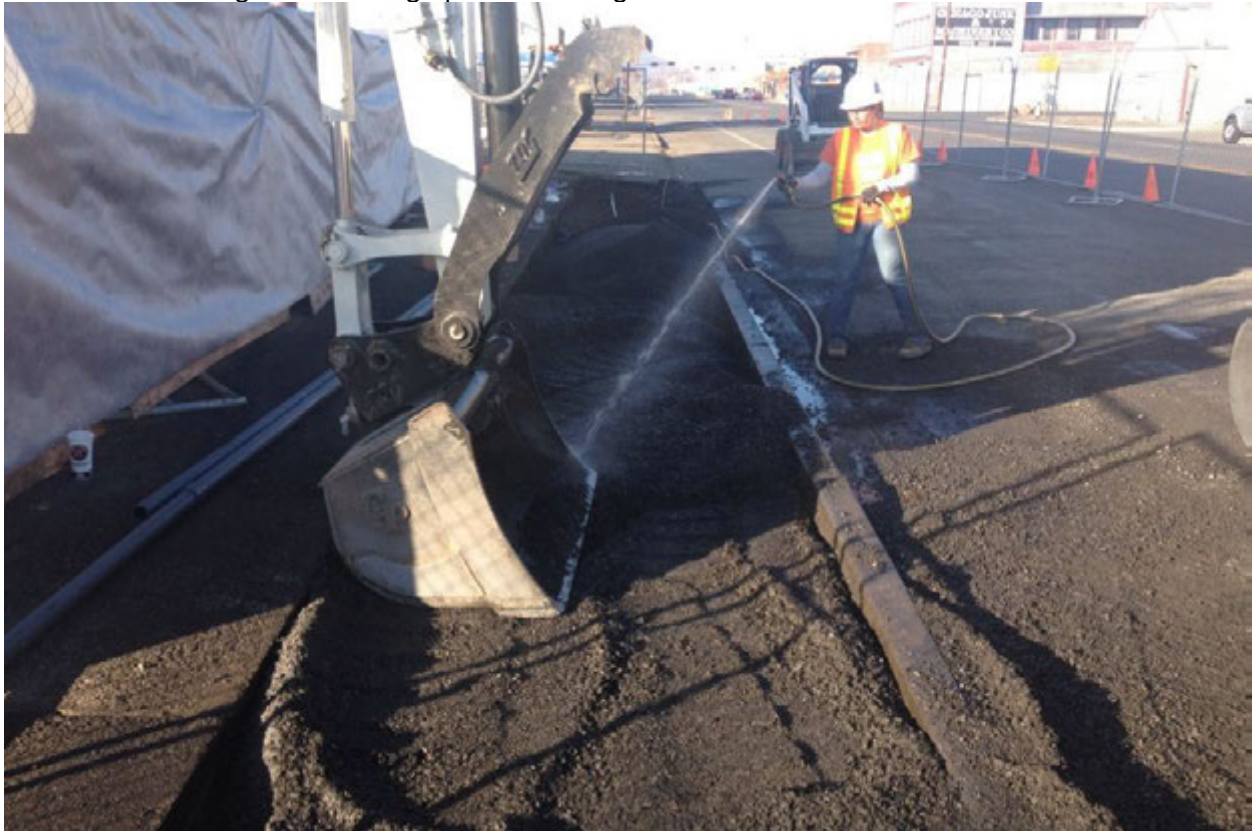
Photograph 22 – Wetting trench backfill while placing along S 3rd Ave. Photograph taken facing north.

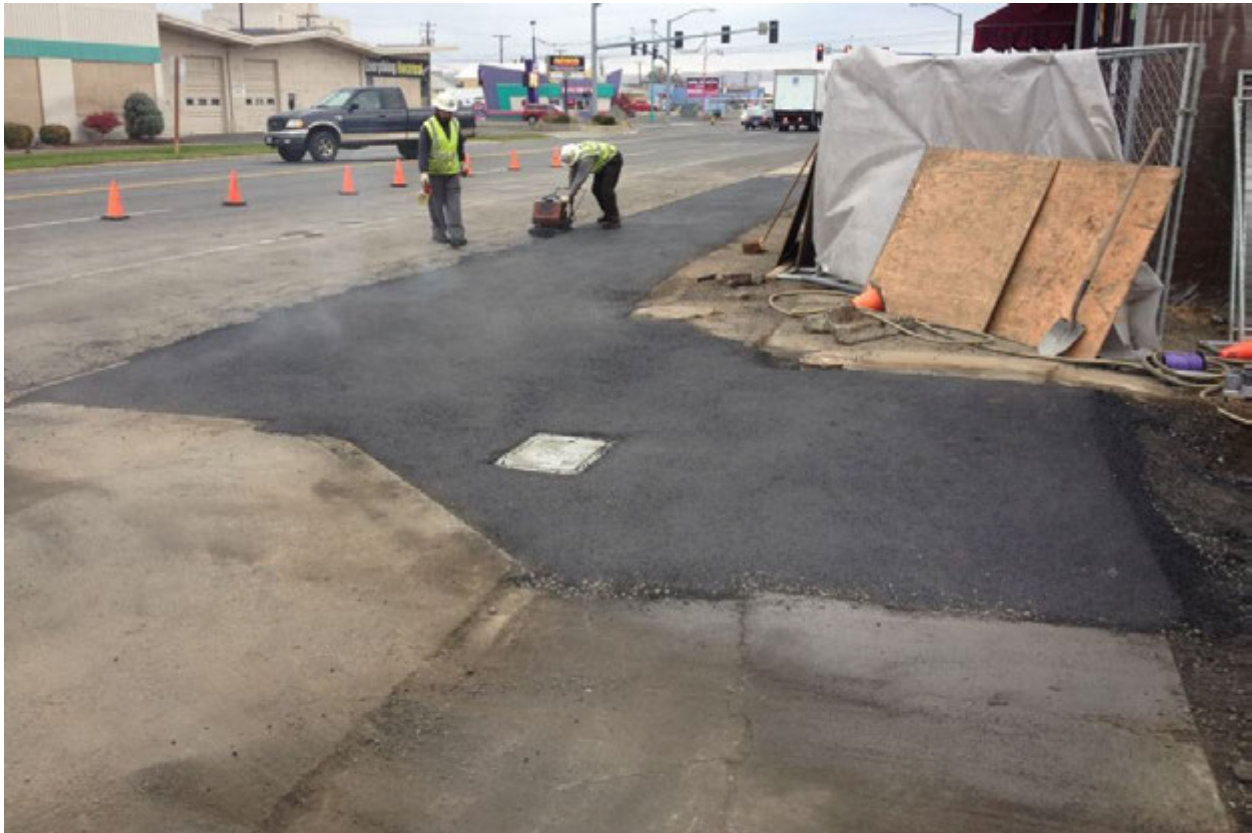
Photograph 23 – Extraction well trench surface completed using hot asphalt. S 3rd Ave is on the left, the Site and children’s daycare are on the right. Photograph taken facing south.

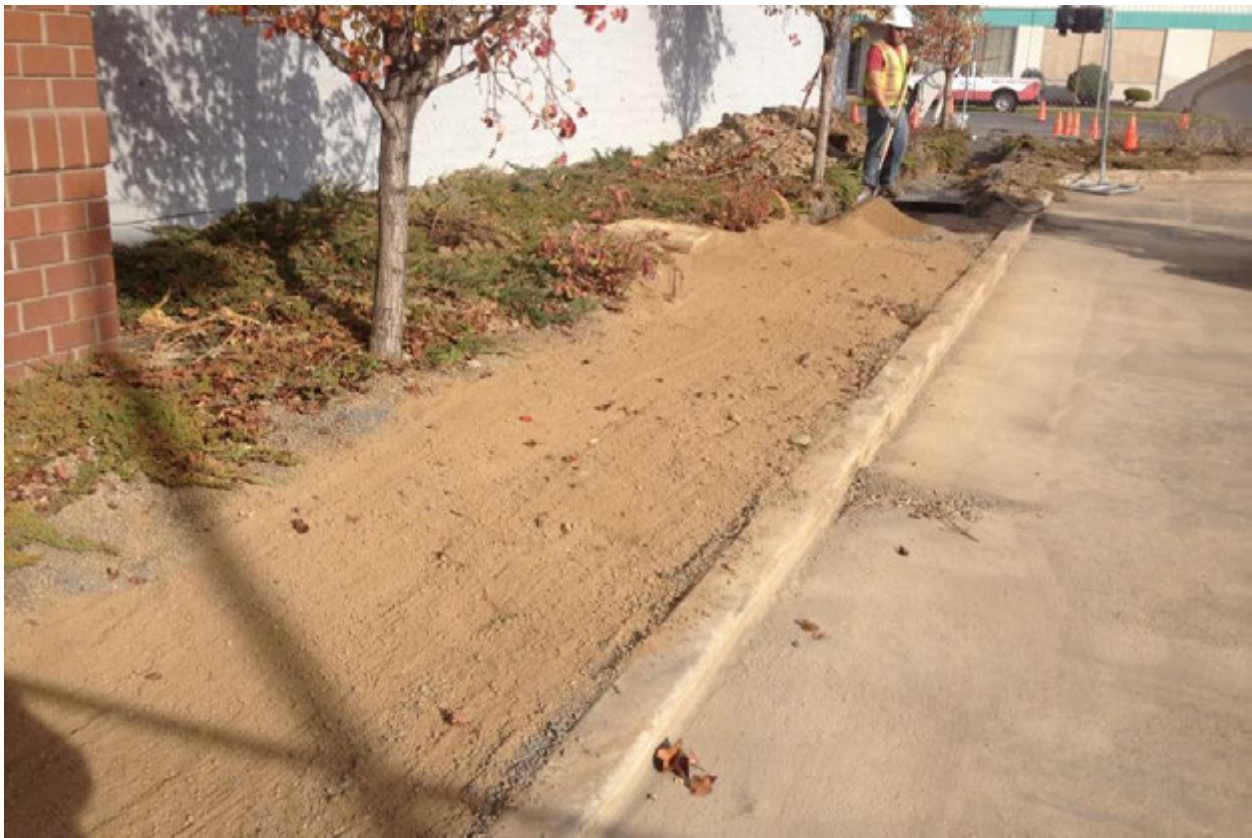
Photograph 24 – Extraction well EXT-2 and EXT-3 trench surface material within landscaped area of CWCMH facility property. Photograph taken facing east.

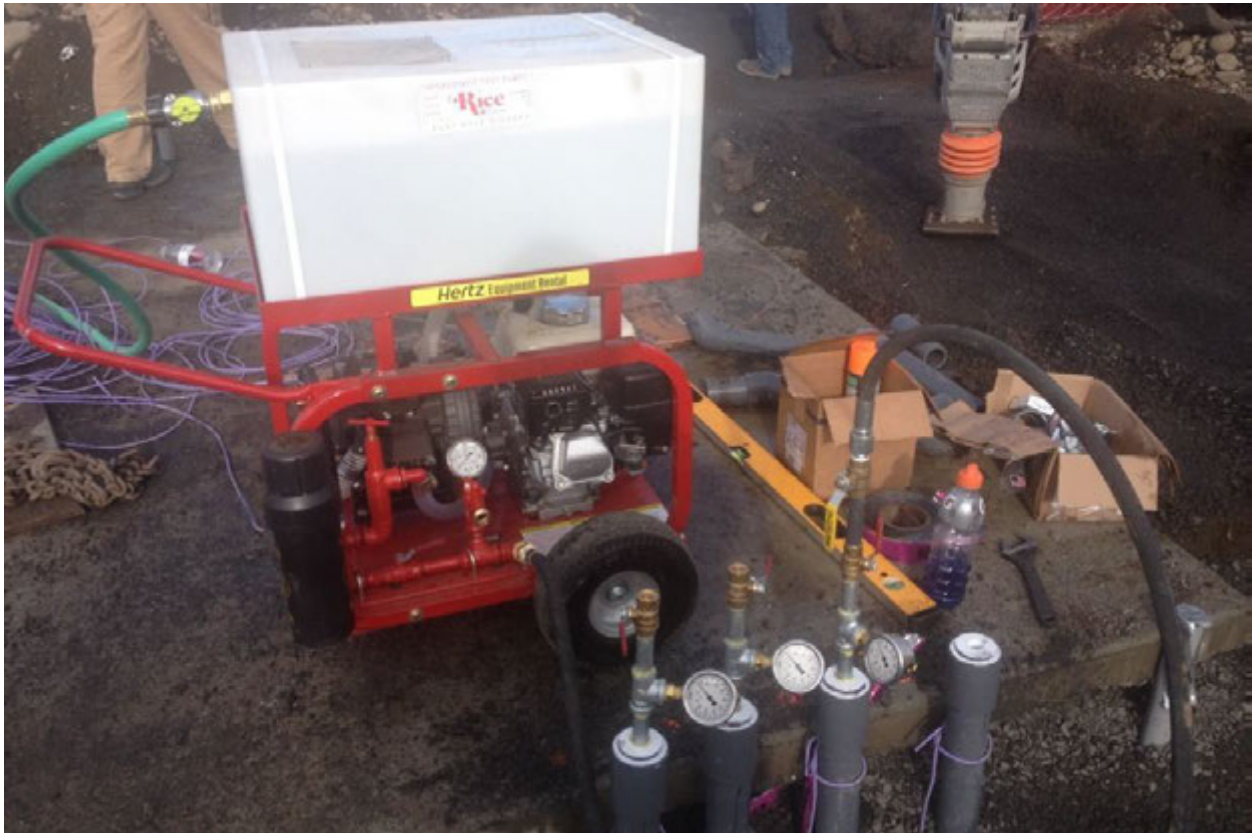
Photograph 25 – Hydrostatic pressure tester sitting on GTS foundation slab connected to injection well piping. Photograph taken facing north-northeast.

Procedure. ERRG rented a hydrostatic test pump designed for this purpose (manufactured by Rice Hydro Inc.). The hydrostatic pump was set up at the GTS building near the conveyance pipes. The pump reservoir was filled using potable water from the fire hydrant along South 4th Avenue. The entire length of underground conveyance pipes were tested from the GTS building to the wellheads. The exposed end the conveyance pipes at the GTS was fitted with a glued PVC slip coupling, then reduced to hold a 3/4-inch galvanized tee fitting with a pressure gauge. A ball valve was fitted to the opposite end of the tee where the hydrostatic pump hose was secured. At each wellhead, the conveyance pipe was fitted with a glued PVC slip coupling and reduced to hold a 1-inch ball valve. The ball valve was open to the atmosphere.

- The conveyance pipe was slowly filled with water from the hydrostatic test pump with the ball valve at the wellhead open to purge air from the lines.
- Once water was flowing steadily, the ball valve at the wellhead was shut and the pressure allowed to build within the pipe as recorded on the gauge at the GTS building.
- When pressure built up to 150 psi, the ball valve at the GTS was closed.
- The gauge installed in the tee fitting was monitored for pressure loss.
- If no immediate pressure was lost (e.g., leaking valve), the hydrostatic pump hose was removed from the top of the tee (not disturbing the test in progress) and fitted onto the next conveyance pipe.
- The conveyance pipe remained undisturbed for 30 minutes and the pressure was recorded.

Results. Test failures were typically encountered during the initial pressure tests and were due to leaking valves and fittings. Once an adequate valve setup was determined, the results generally met the specified requirements and were repeatable.

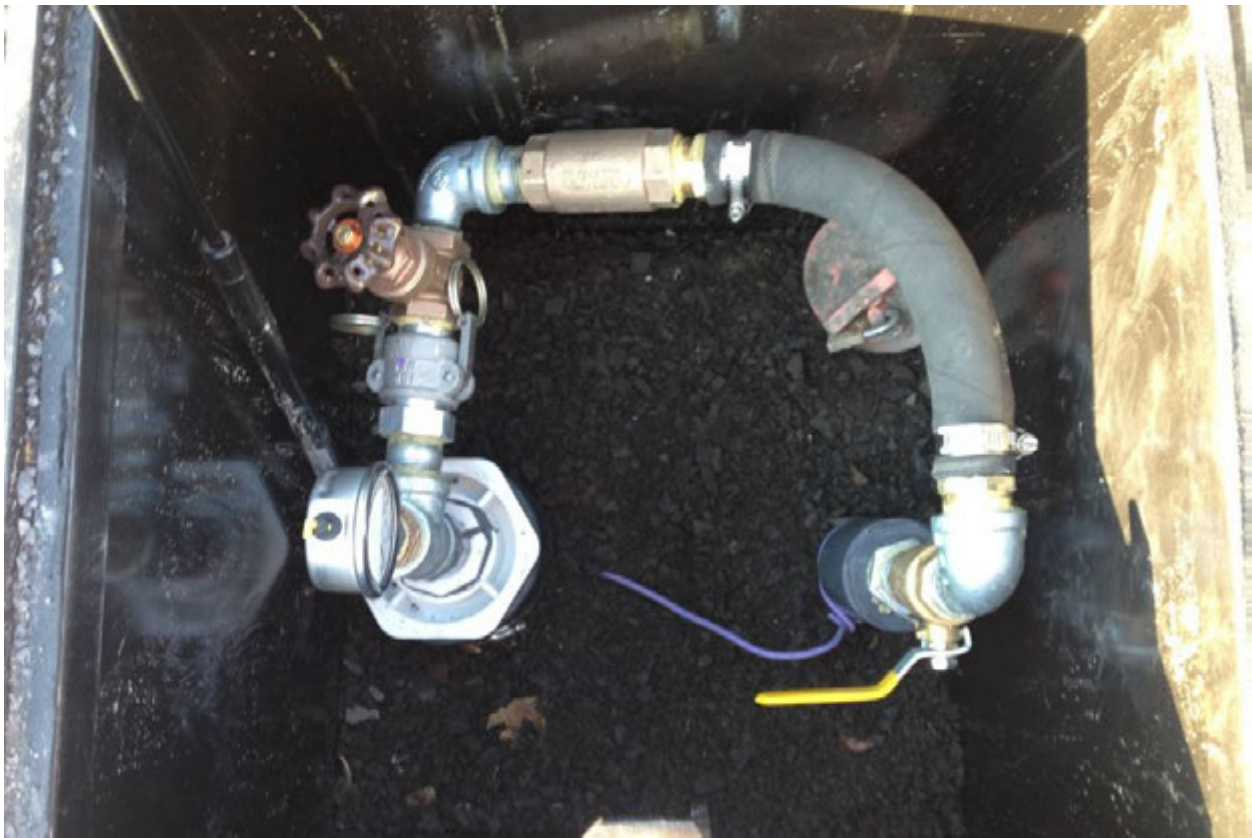
Photograph 26 – Typical injection well vault showing wellhead connections.

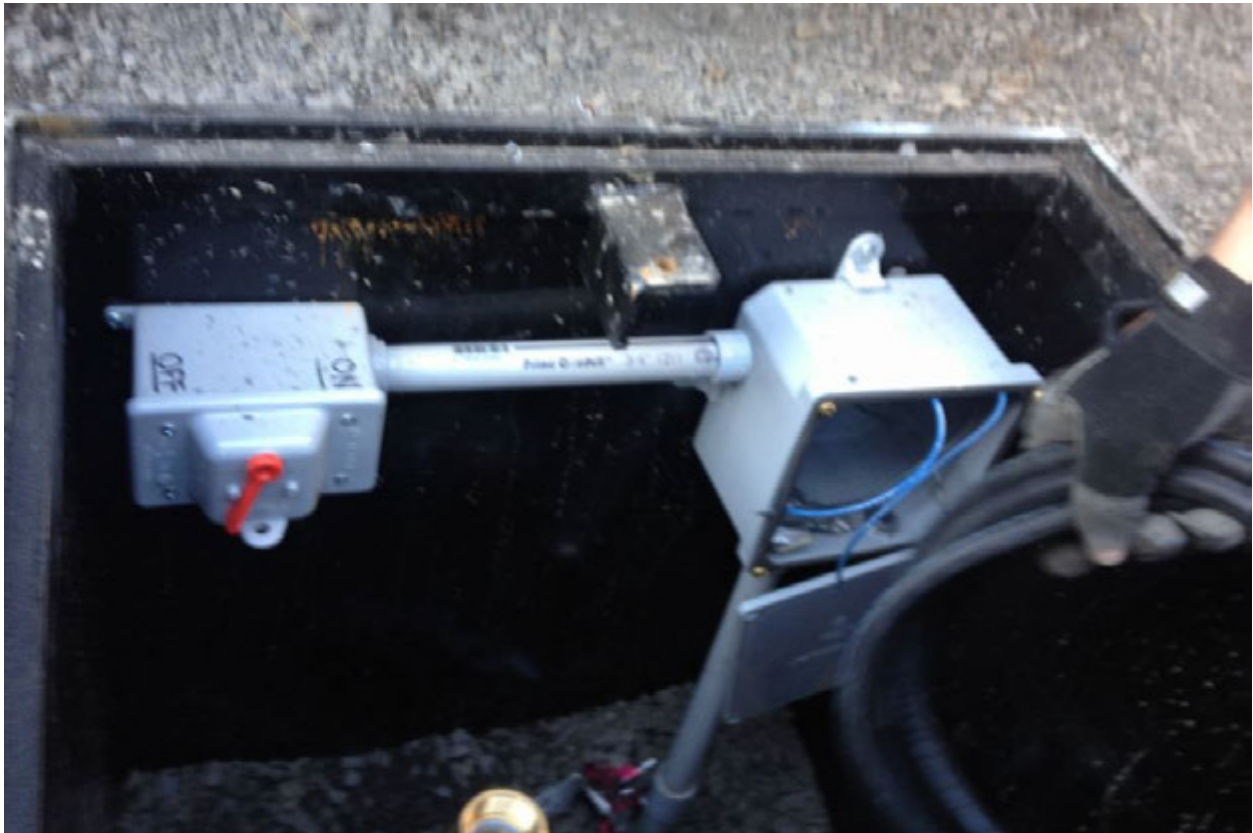
Photograph 27 – Typical electrical boxes installed in extraction well vaults. Manual pump on/off switch provided on the left with electrical connection/pull box on the right.

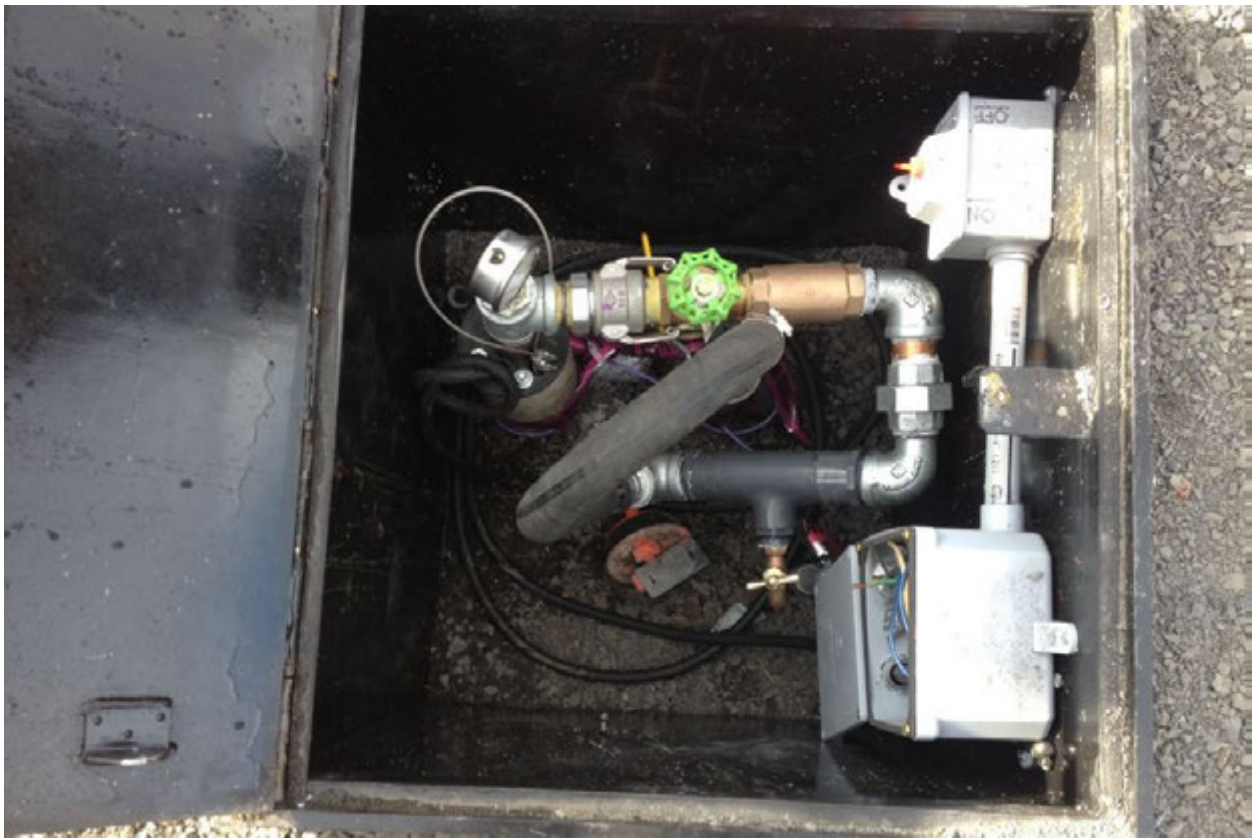
Photograph 28 – Typical extraction well vault showing wellhead connections and electrical components.

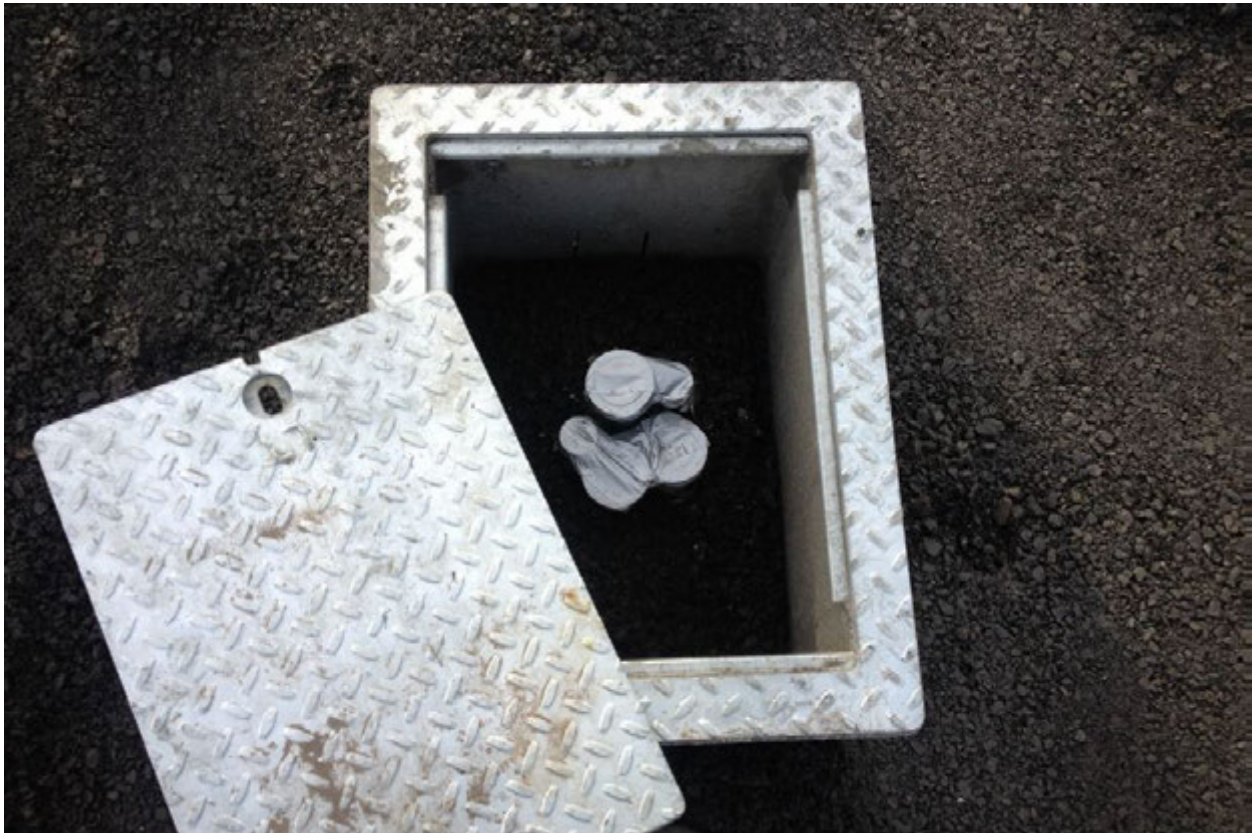
Photograph 29 – Typical electrical pull box vault.

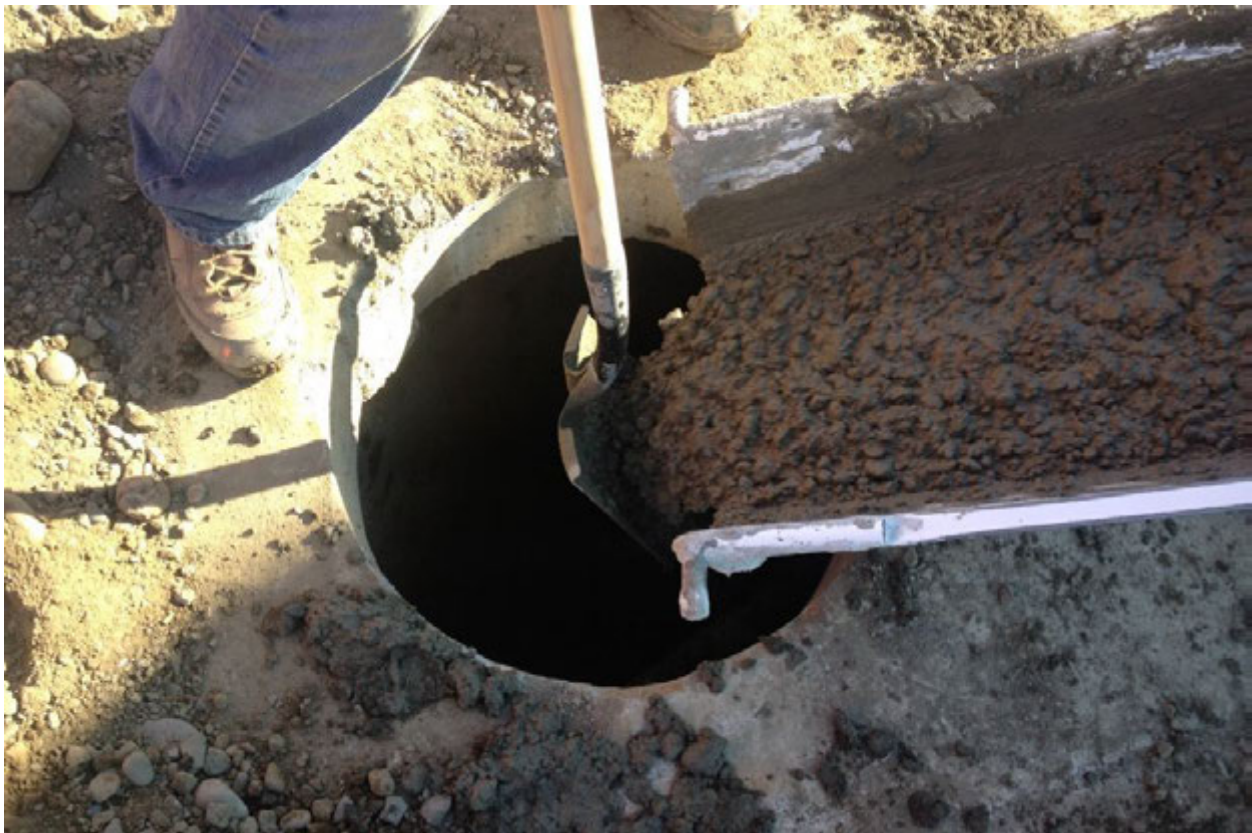
Photograph 30 – Photograph shows decommissioning of drywell on the Site by filling with leftover concrete after pouring GTS building foundation slab.

- **Dry well decommissioning.** The drywell located on the Frank Wear property was not addressed in the Contract Specifications. The drywell was abandoned in-place as described in Section 4.5.

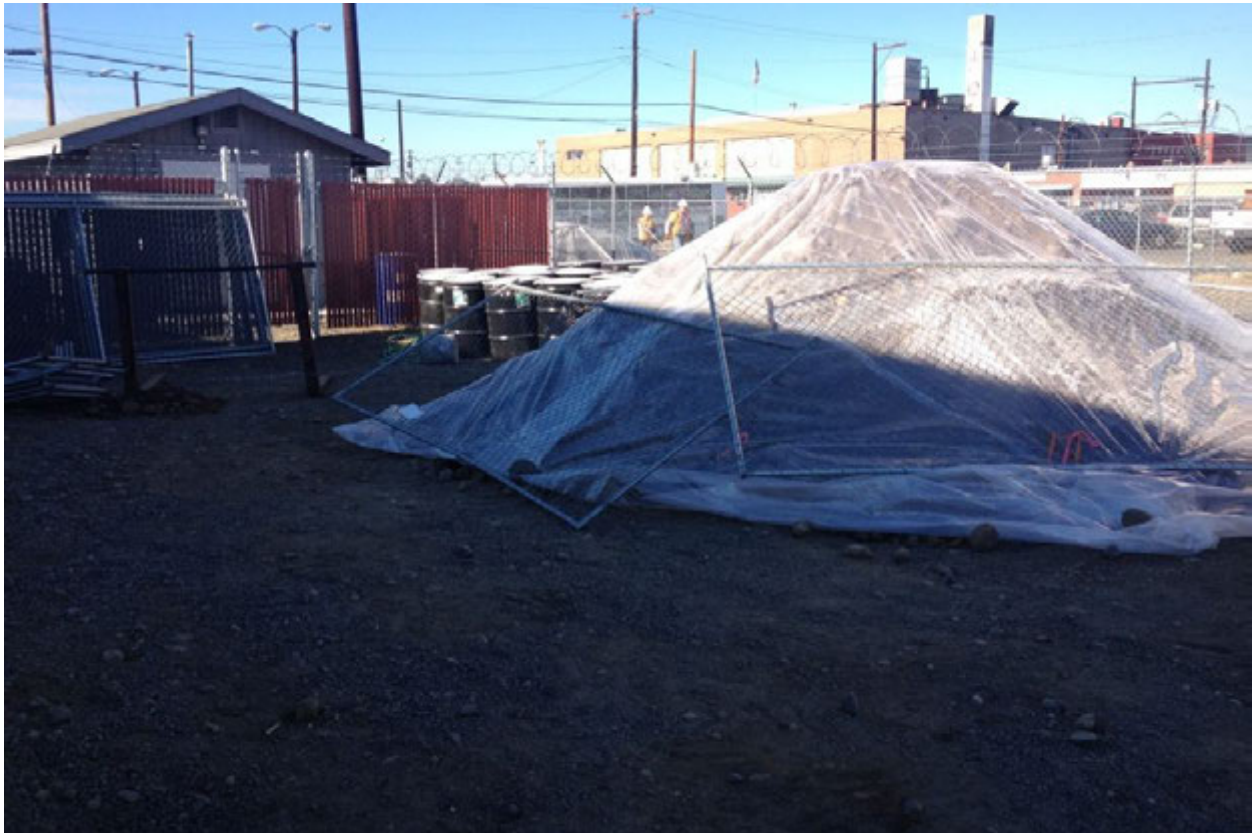
Photograph 31 – Excavated soil pile on the Site pending analysis for disposal. Photograph taken facing northwest.

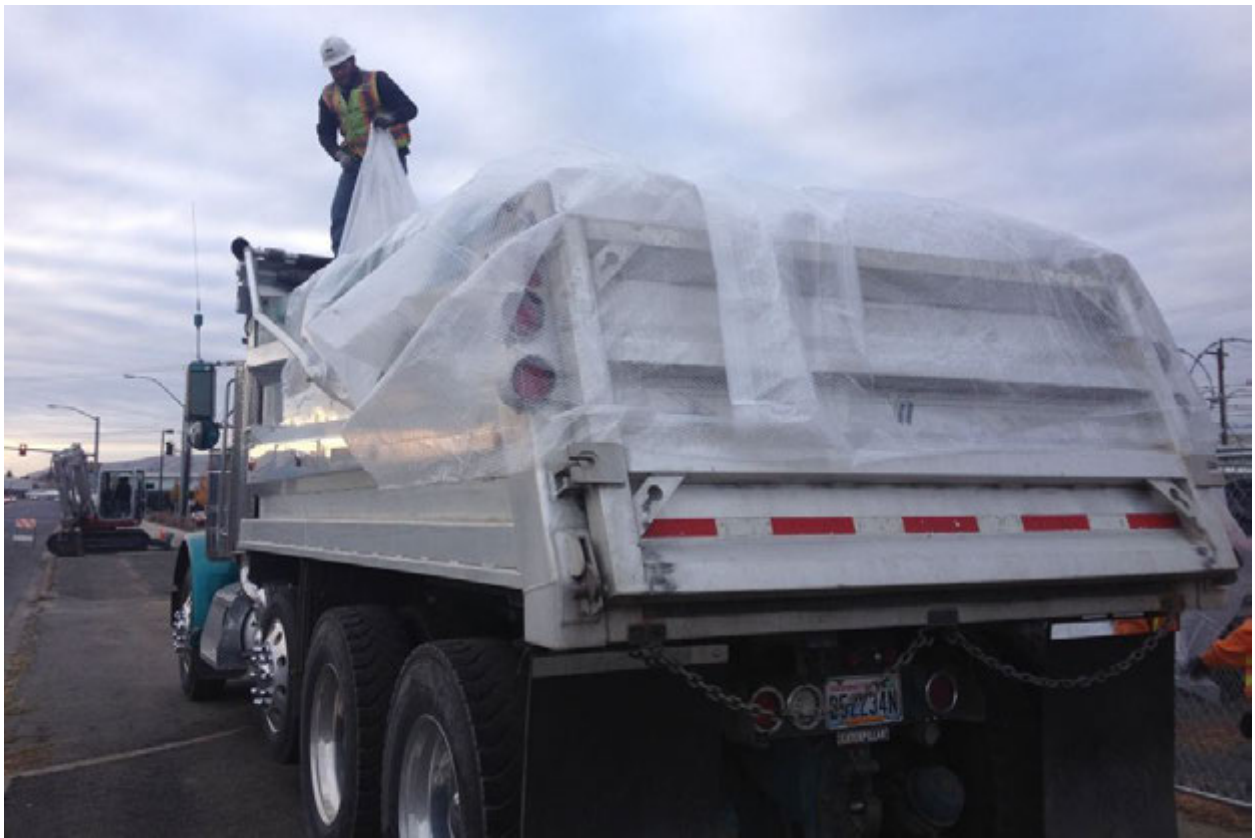
Photograph 32 – Truck bed liner being lined with plastic for impacted soil disposal. Photograph taken facing south.
