# FOCUSED SITE ASSESSMENT WORK PLAN

SOUTH 154TH STREET TRANSIT-ORIENTED DEVELOPMENT  
PROPERTY

PREPARED FOR  
**CITY OF SEATAC**  
APRIL 30, 2014  
PROJECT NO. 0879.01.02

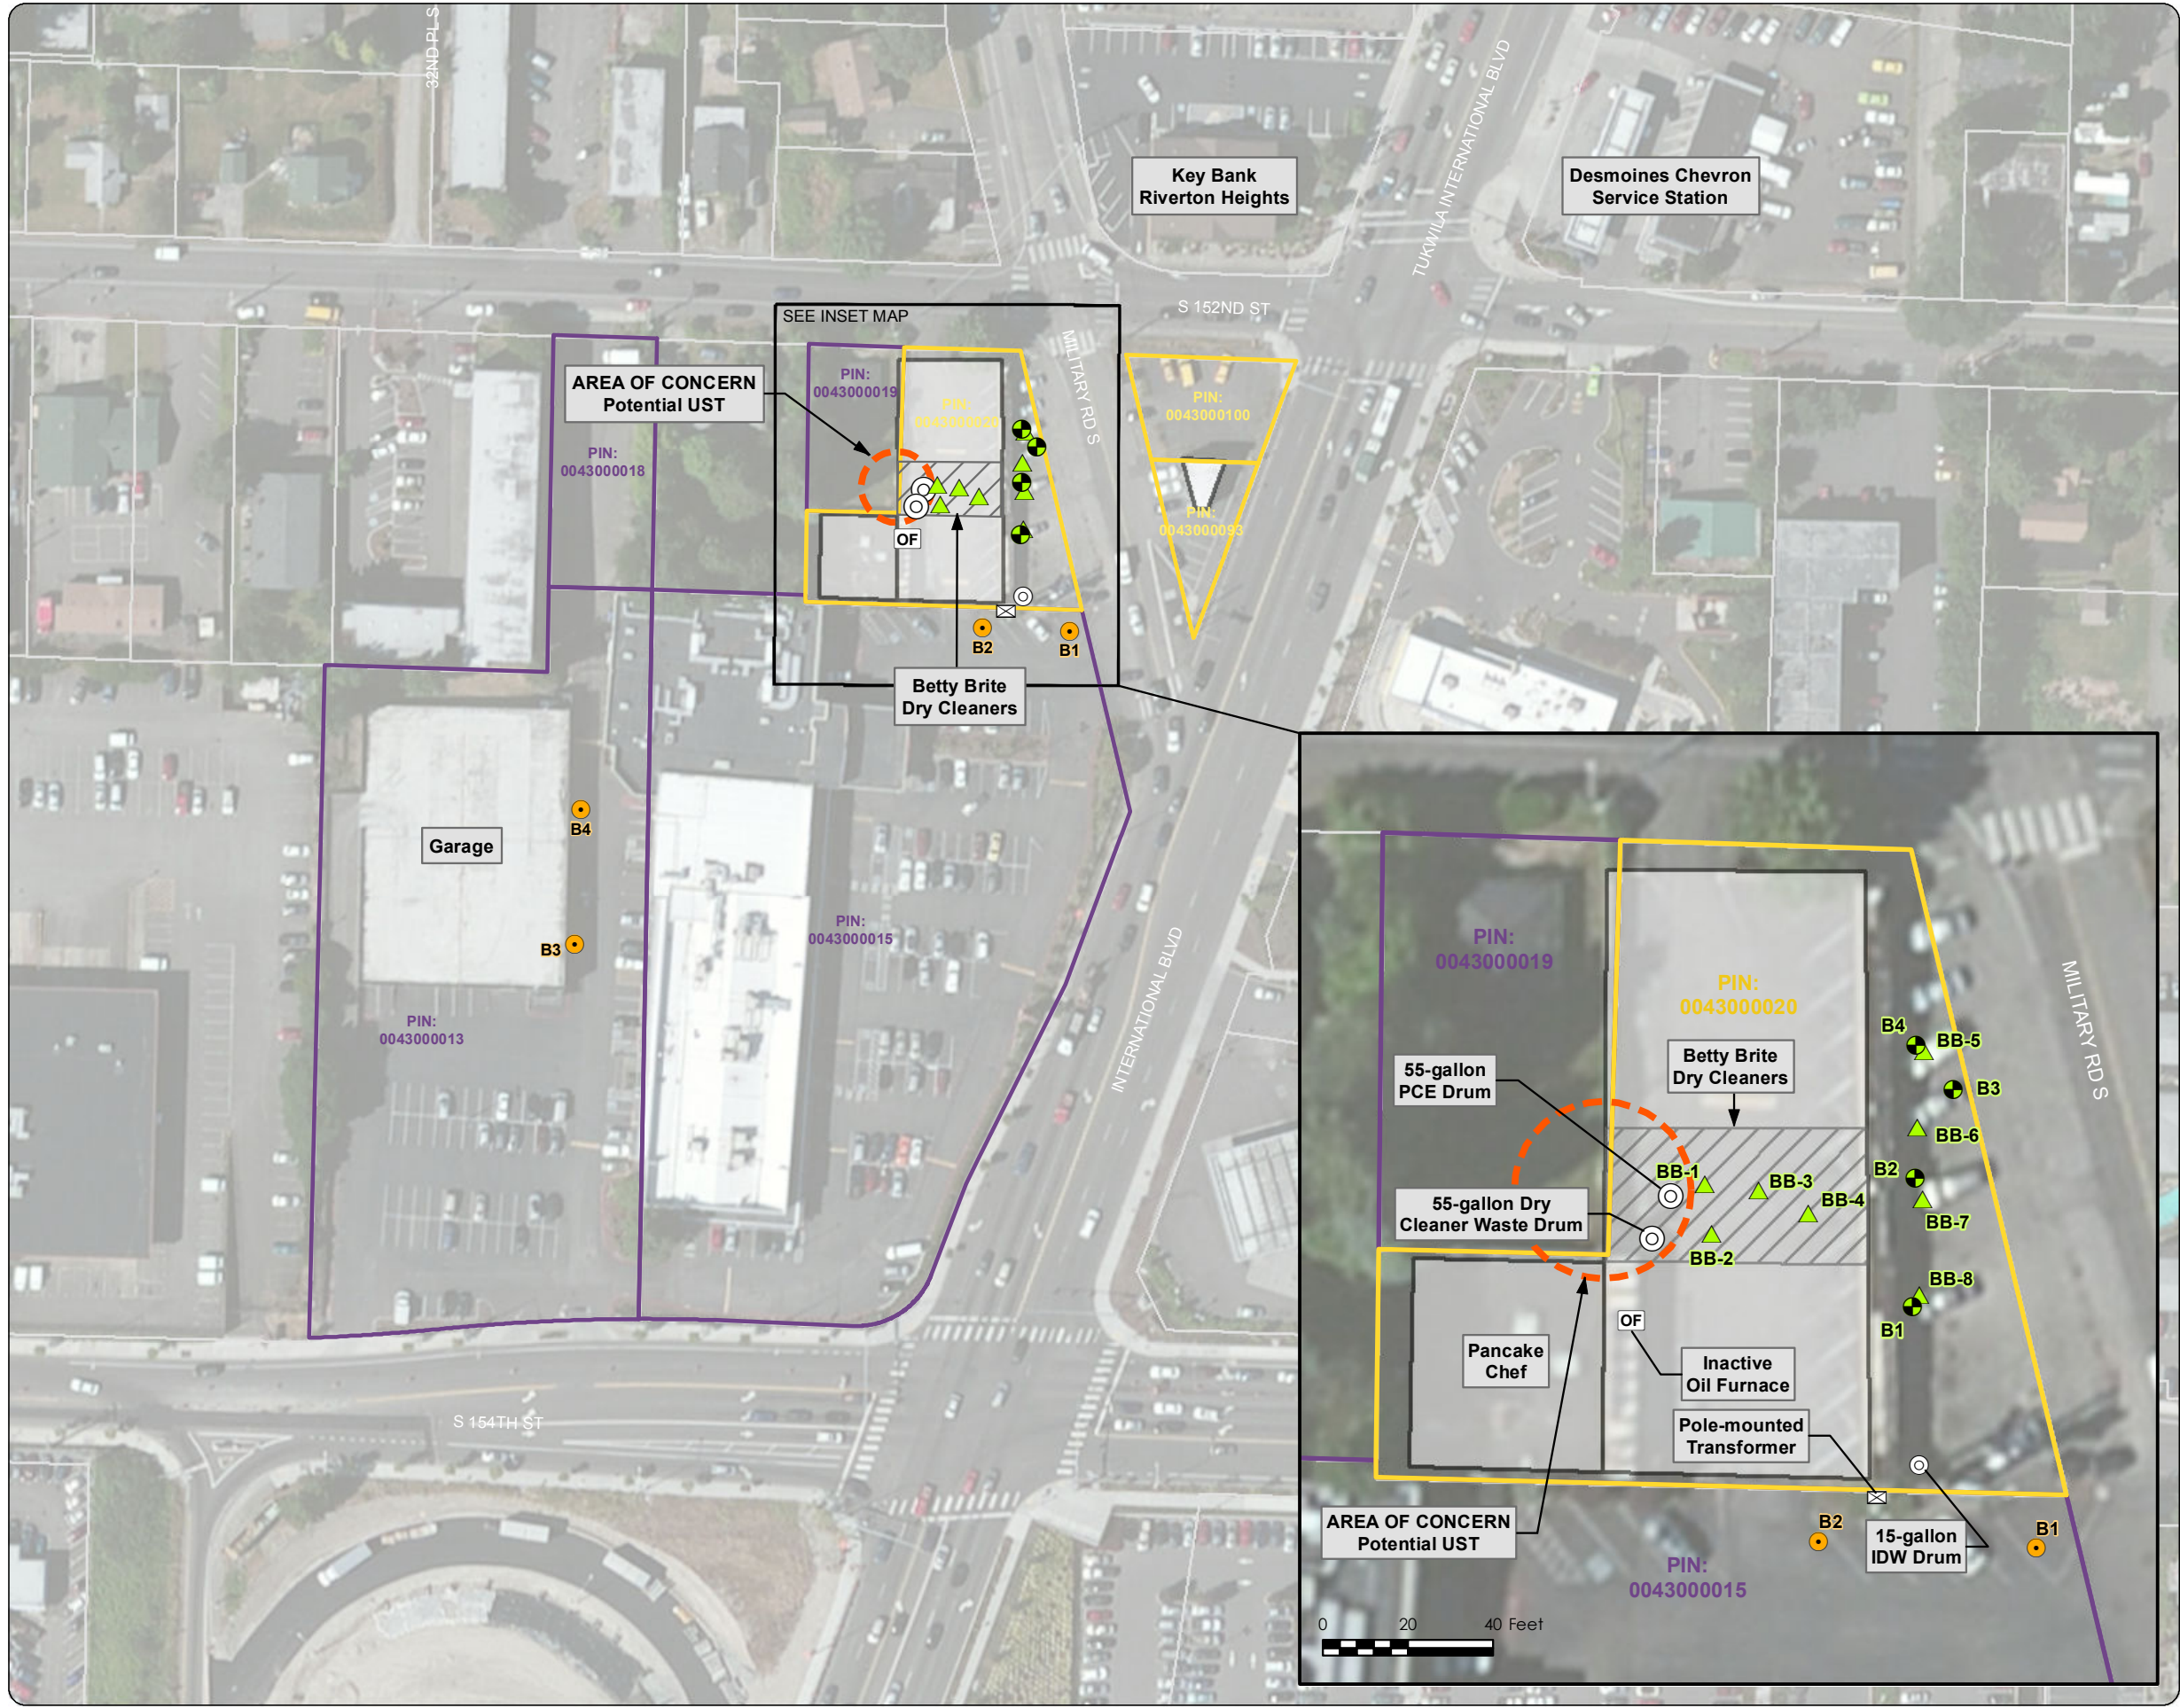
**Figure 2**  
**Historical Site Features**  
S. 154th Street TOD  
Seatac, Washington

Source: Aerial photograph obtained from Esri ArcGIS Online; roads and parcels obtained from King County GIS (2011).

- Former oil burner—archival information indicates that the Betty Brite Dry Cleaners building used an oil burner as the heating source. Heating oil is a potential source of impact. The likelihood exists that an abandoned historical UST may be on parcel 0043000020.
