Re: Remedial Action Report, Former Arco Service Station #0855
4603 Ocean Beach Highway, Longview, Washington

REMEDIAL ACTION REPORT
FORMER ARCO SERVICE STATION #0855
LONGVIEW, WASHINGTON

Prepared for
Wakefield Family LLC
July 21, 2008

Prepared by
SLR International Corp
22122 20th Avenue SE
Bothell, Washington 98021

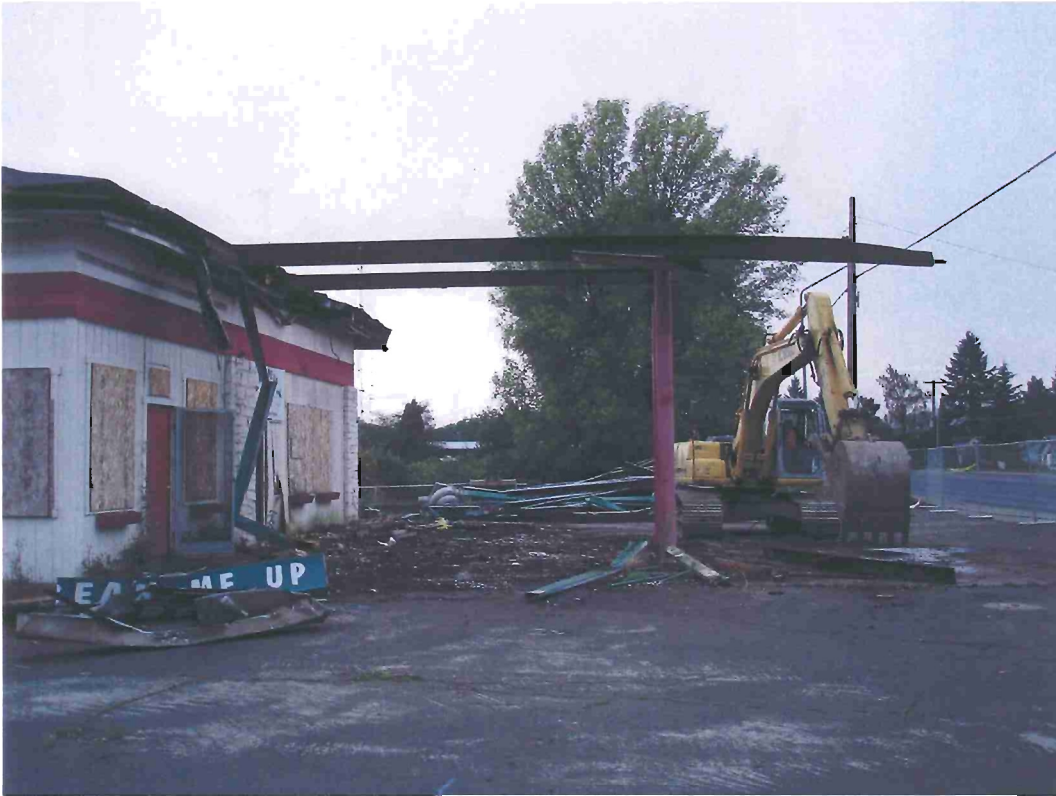
Demolition of former dispenser island and canopy.

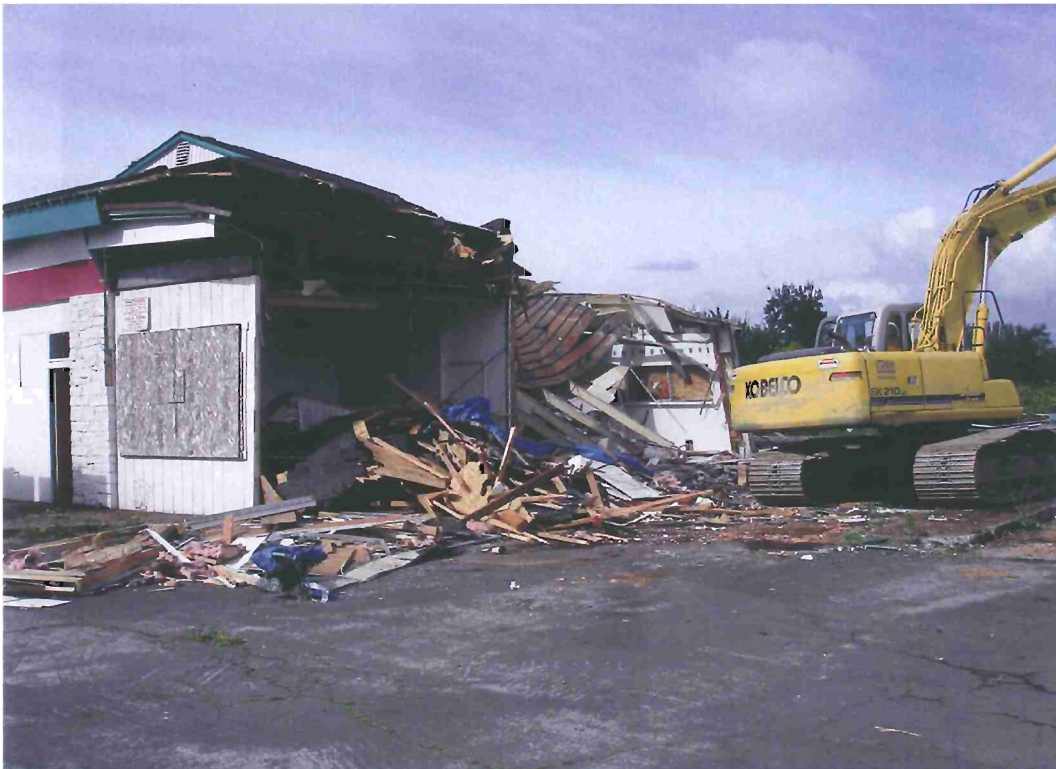
Demolition of northeast side of former service station building.

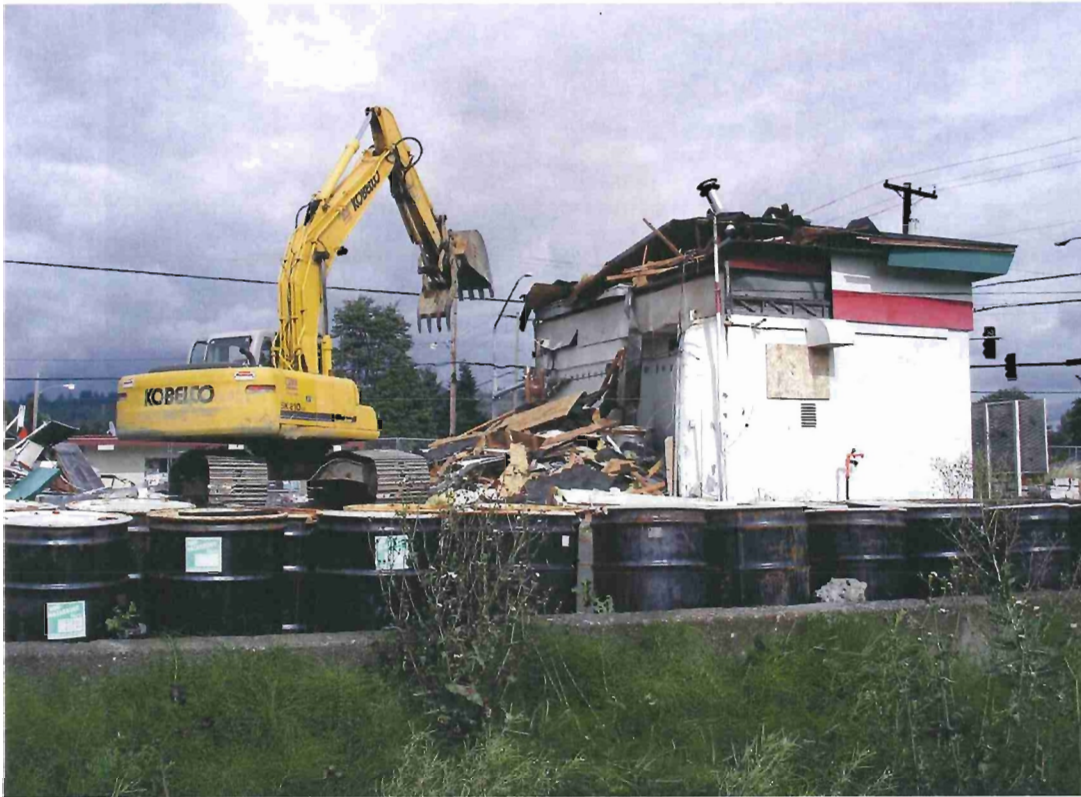
Demolition of northwestern part of former service station building.

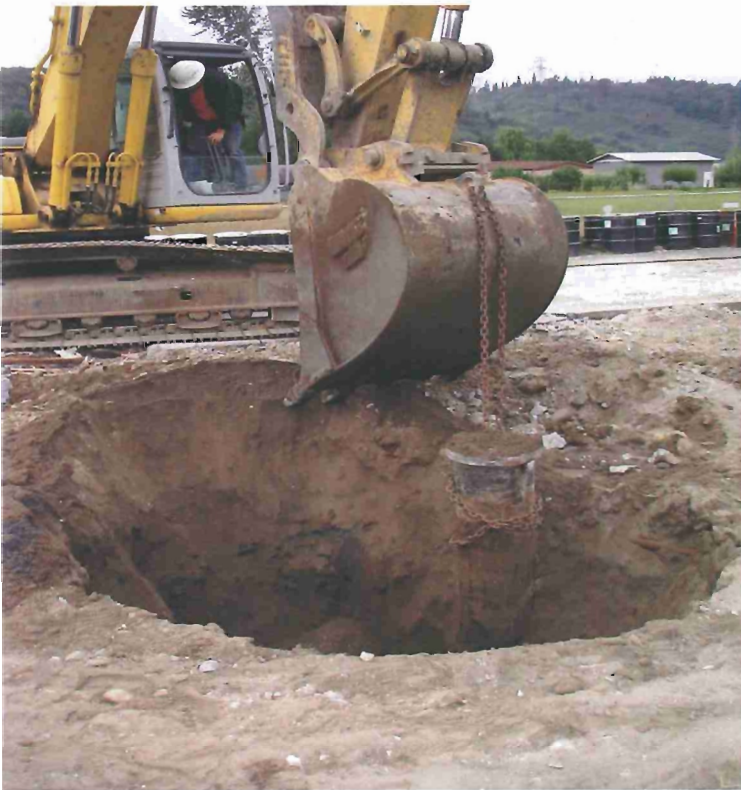
Removal of former hydraulic hoist.

During the demolition of the former station building, a hydraulic hoist and an oil sump were discovered in the central and western parts of the building. The approximate locations of the hoist and sump are shown on Figure 5. A total of approximately 20 gallons of oil, rinse water, and sludge were pumped from the hoist and hauled to the Marine Vacuum Service facility in Seattle, Washington, for disposal. Wyser excavated the hoist and the sump, removed a minor amount of oil-stained soil from the sump, and

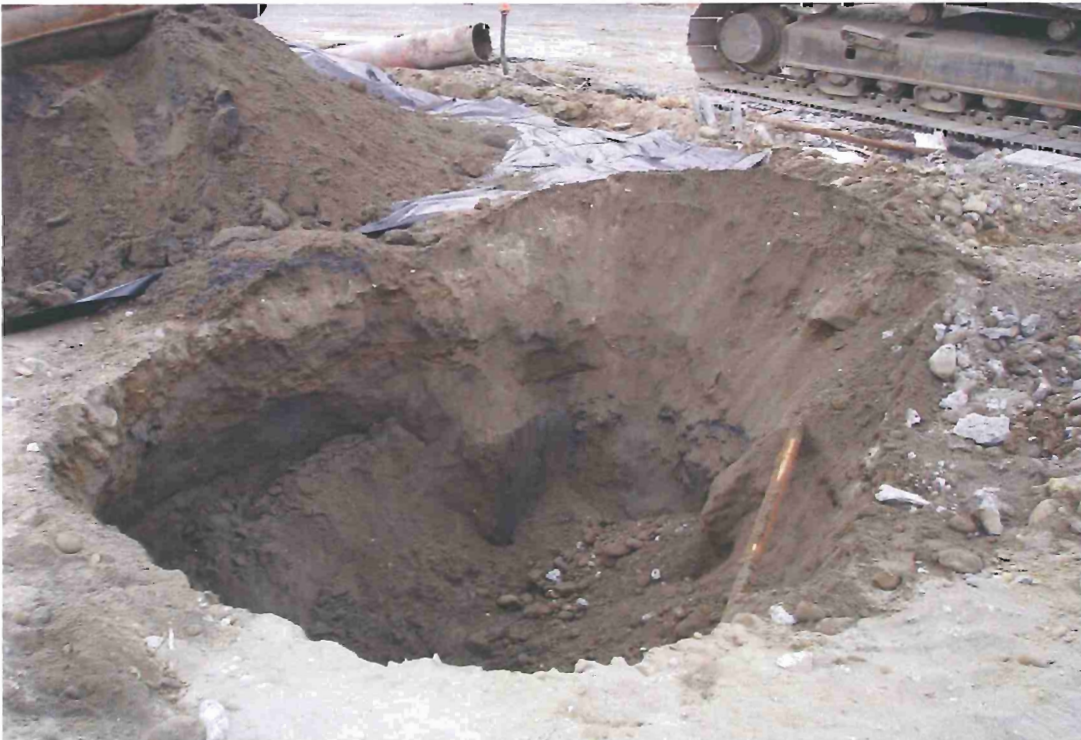
North to south view of former hoist excavation.

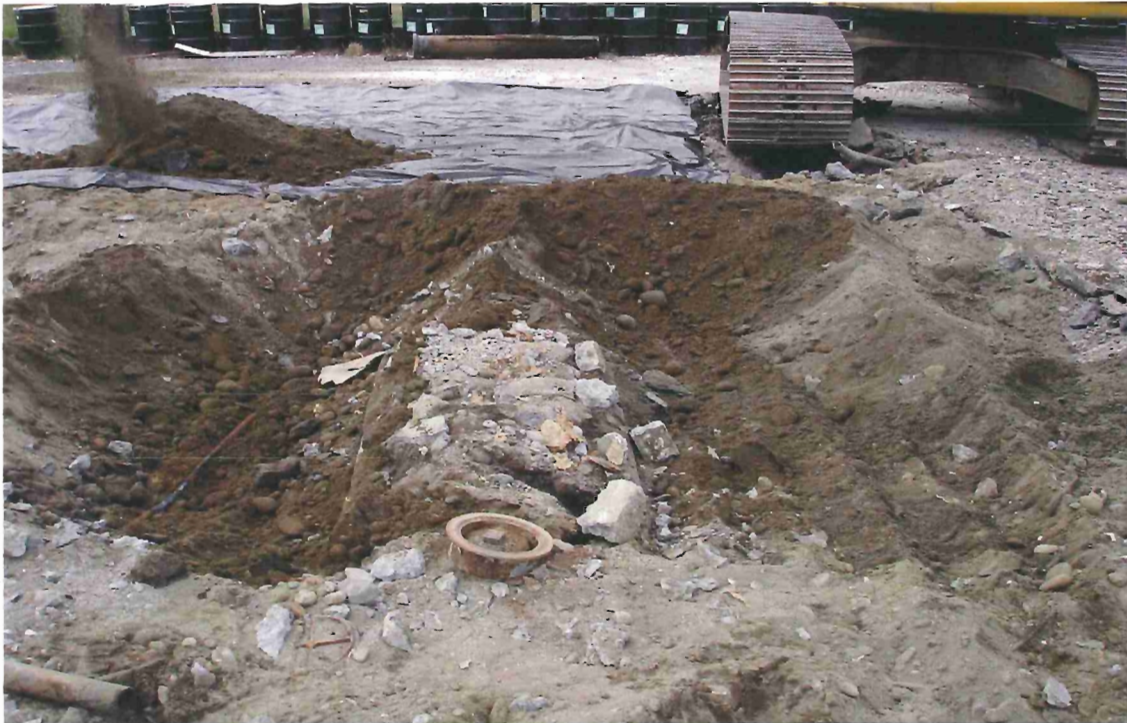
Northwest to southeast view of former oil sump.

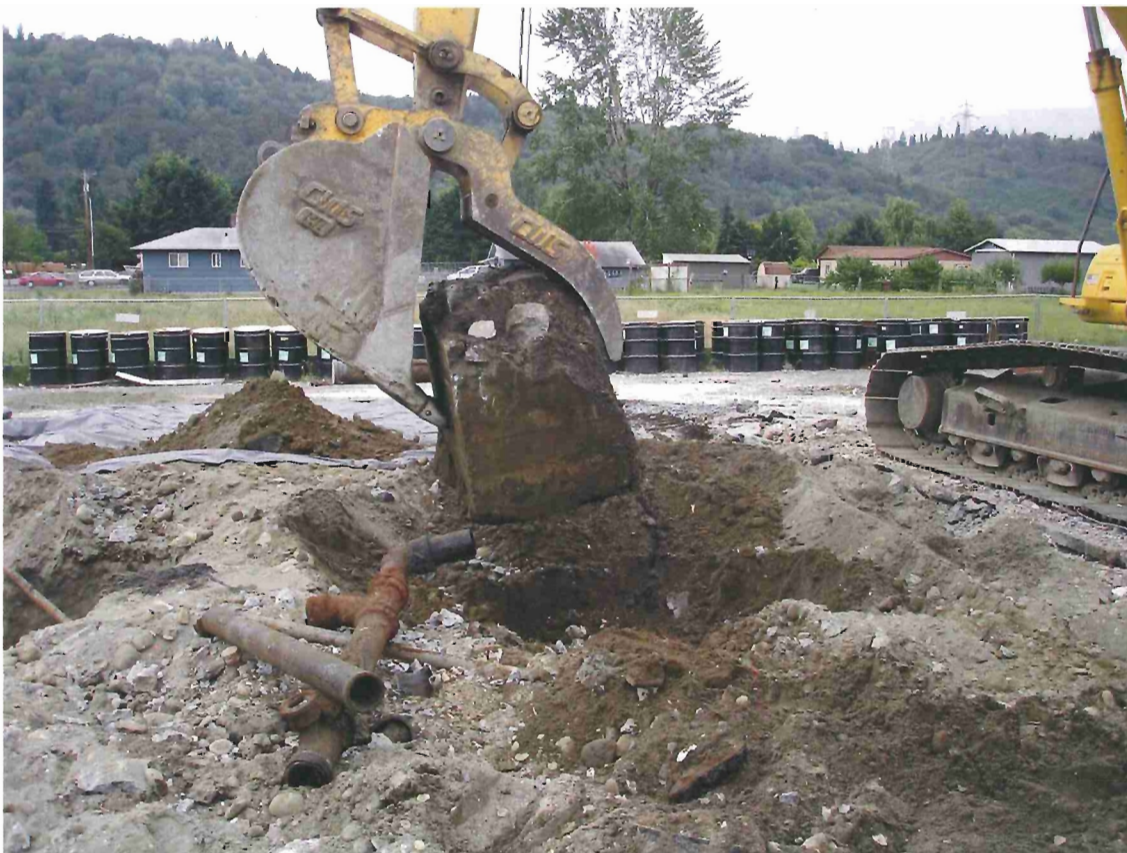
Removal of former oil sump.

hauled the hoist and sump to Metro Metals for recycling. The oil-stained soil was stockpiled on site and hauled off-site with the excavated soil that was removed during the subsequent soil excavation activities described in Section 3.2. The hoist excavation covered an area of approximately 25 square feet, and extended to a depth of approximately 8 feet bgs. The sump excavation was approximately 10 square feet in area and extended to a depth of approximately 3 feet bgs. SLR collected soil samples from the bottom of the hoist excavation and the sump excavation (designated Hoist-Ex-Flr-8' and Sump-Ex-Flr-3', respectively), and submitted the samples to Friedman & Bruya, Inc. (F&B) in Seattle, Washington, for analysis. The samples were analyzed for DRO and HO by Ecology Method NWTPH-Dx (after silica gel cleanup), and for polycyclic aromatic hydrocarbons (PAHs) by EPA Method 8270C SIM. The samples did not contain DRO or HO concentrations above the MRLs. The samples contained toxicity-adjusted total carcinogenic PAH (cPAH) concentrations (up to 0.019 mg/kg) and naphthalene concentrations (up to 0.012 mg/kg) that were below the MRLs or the MTCA Method A cleanup levels (0.1 and 5 mg/kg, respectively). The sample analytical results are presented in Table 1 and a copy of the laboratory report is presented in Appendix B. The approximate sample locations are shown on Figure 6.

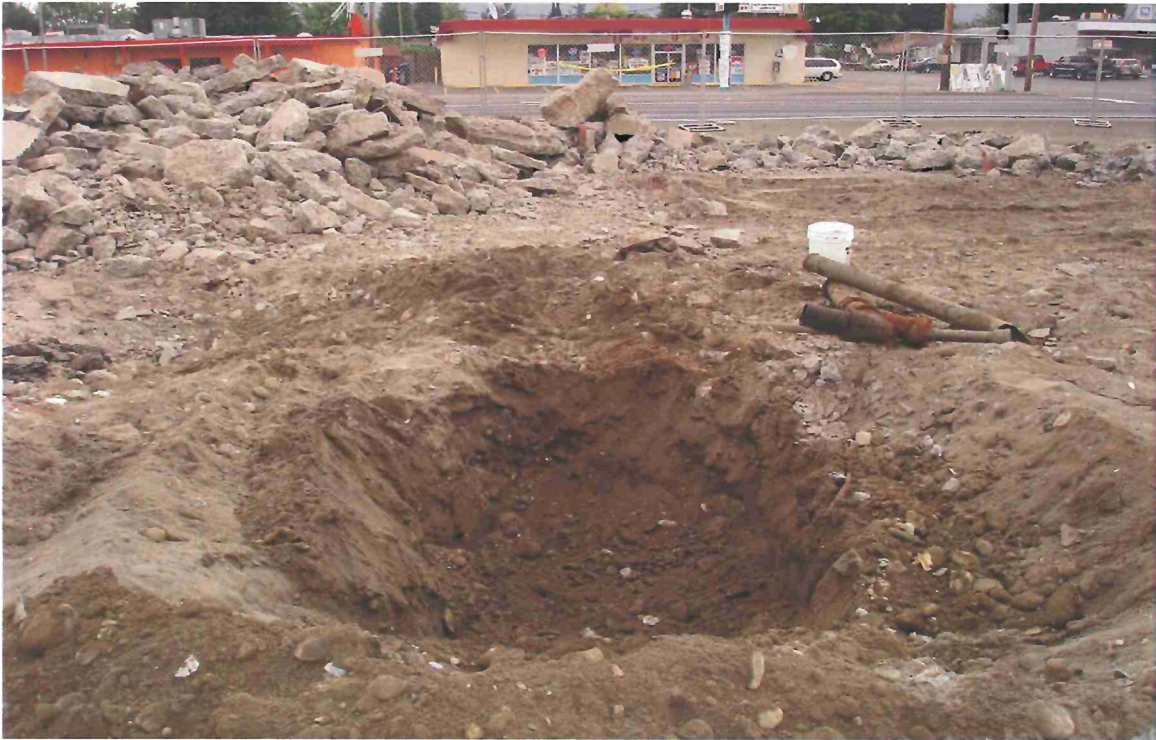
Southwest to northeast view of former oil sump excavation.

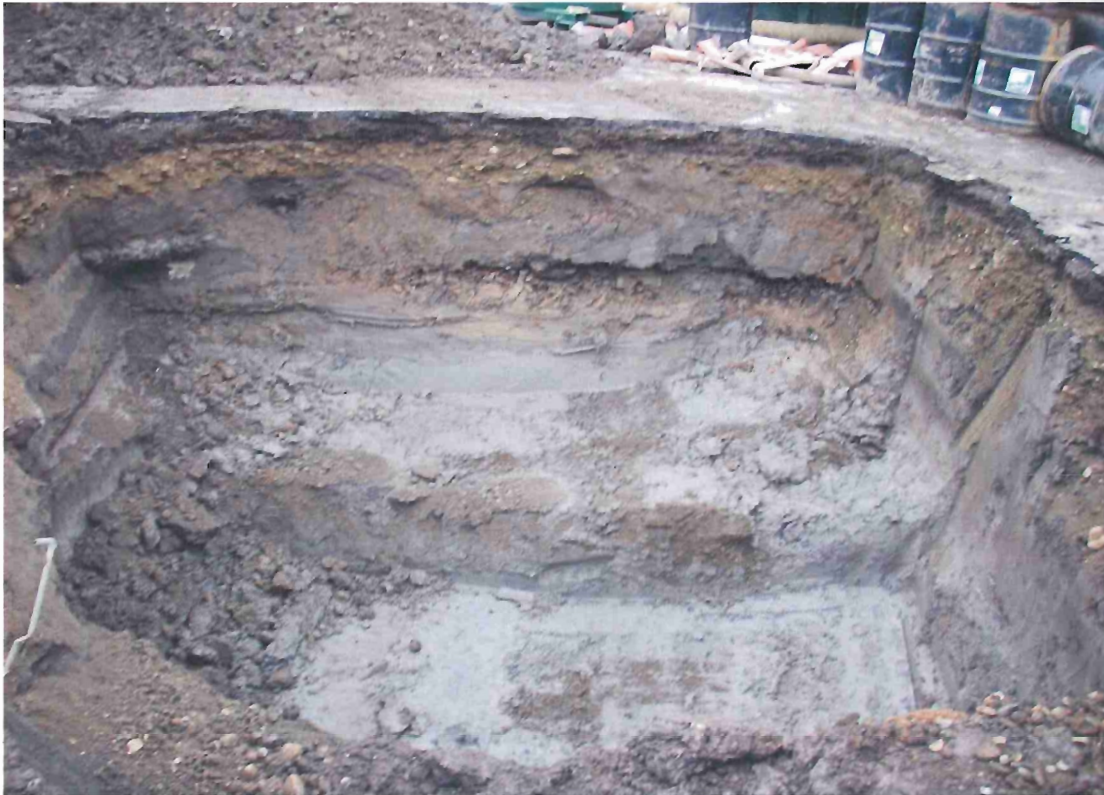
Northwest to southeast view of excavation at former heating oil and used oil UST area.

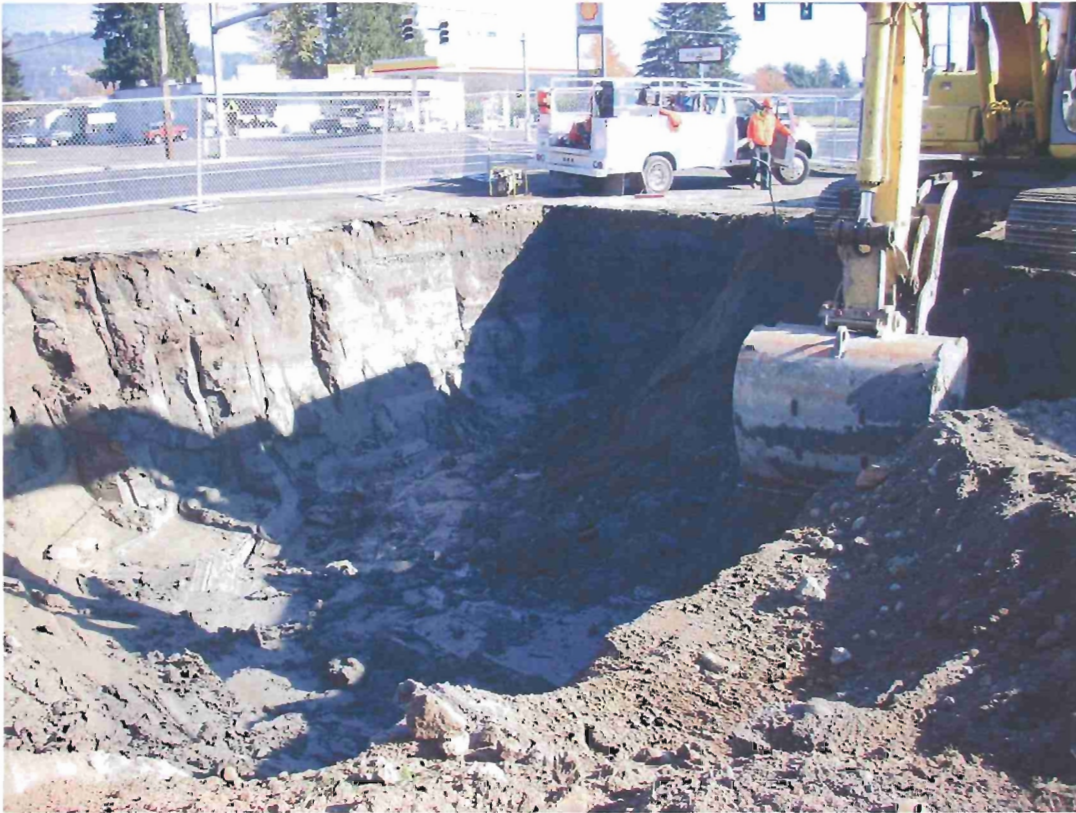
West to east view of excavation at the former dispenser island area.

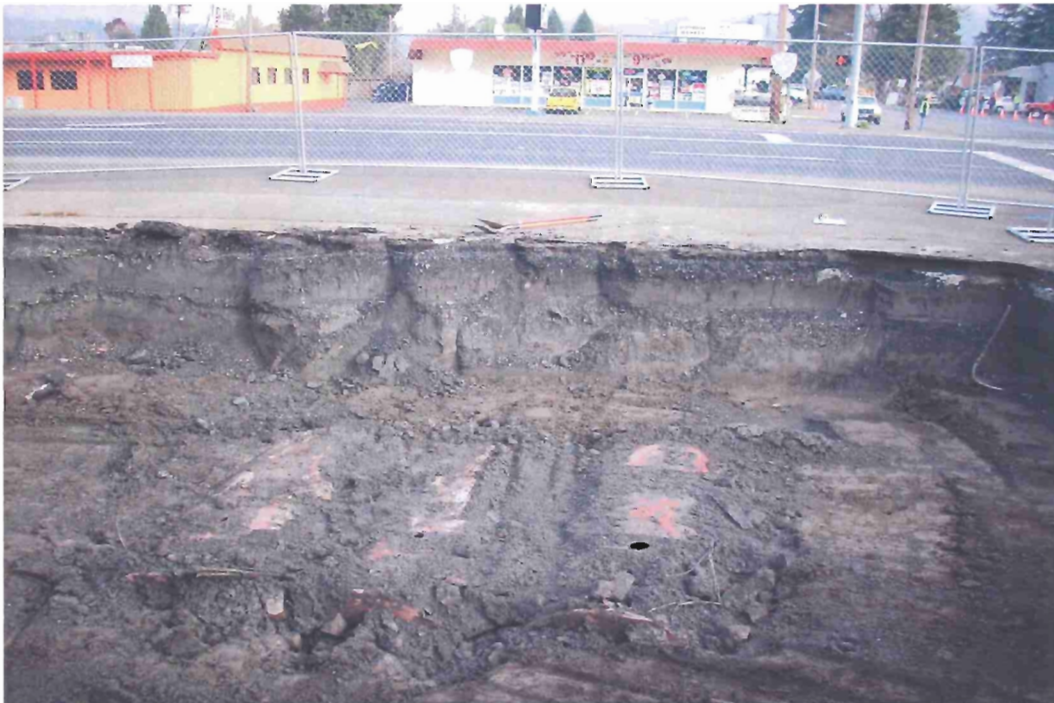
Southwest to northeast view of the three USTs that were discovered in the eastern part of the excavation near the former dispenser island area.

While excavating to the east of the former dispenser island, Wyser encountered three 550-gallon USTs. The approximate locations of the tanks are shown on Figure 5. The steel tanks were in poor condition, and each tank contained up to approximately 300 gallons of product that smelled like gasoline. The product from each tank was removed and the tanks were excavated. A total of approximately 1,080 gallons of product, rinse water, and sludge were hauled to the Marine Vacuum Service facility in Seattle, Washington, for disposal. The tanks were transported to the Metro Metals facility for recycling.

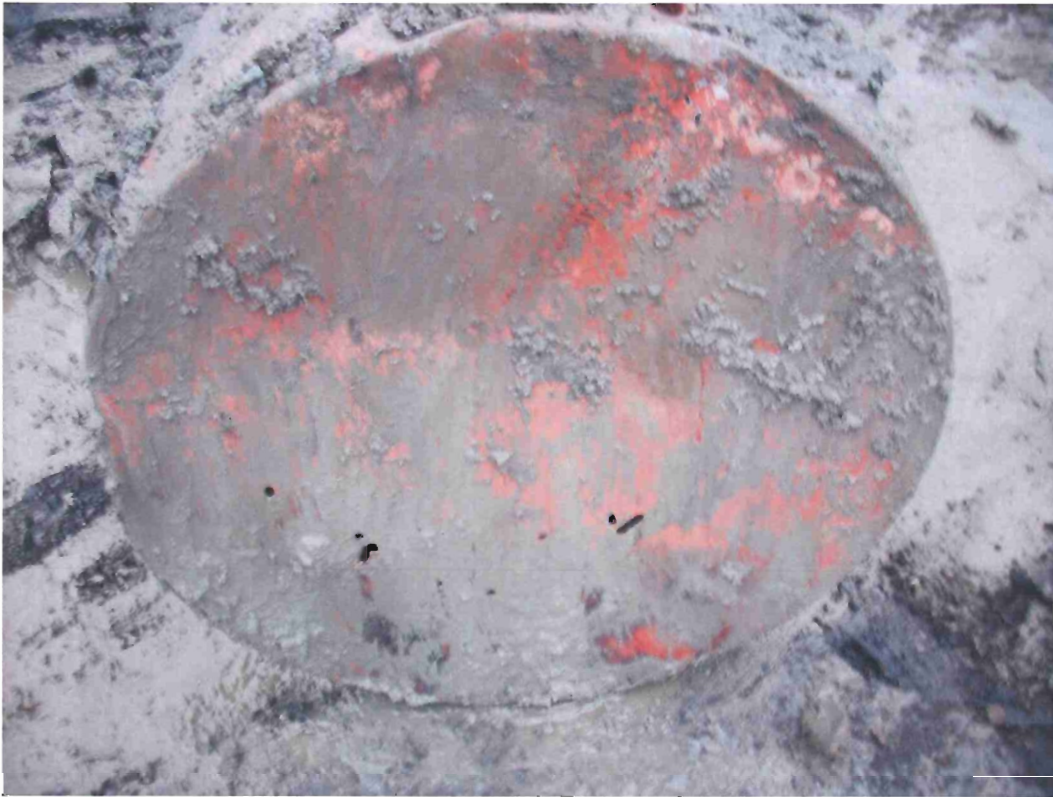
Holes in end of northwesternmost UST (designated Tank 1).

While excavating to the east of the former dispenser island, three 550-gallon USTs were encountered. The steel tanks were in poor condition, and each tank contained approximately 300 gallons of product that smelled like gasoline. The product from each tank was removed and the tanks were excavated. A total of approximately 1,080 gallons of product, rinse water, and sludge were hauled to the Marine Vacuum Service facility in Seattle, Washington, for disposal. The tanks were transported to the Metro Metals facility for recycling. After removal of the tanks, SLR collected a soil sample from

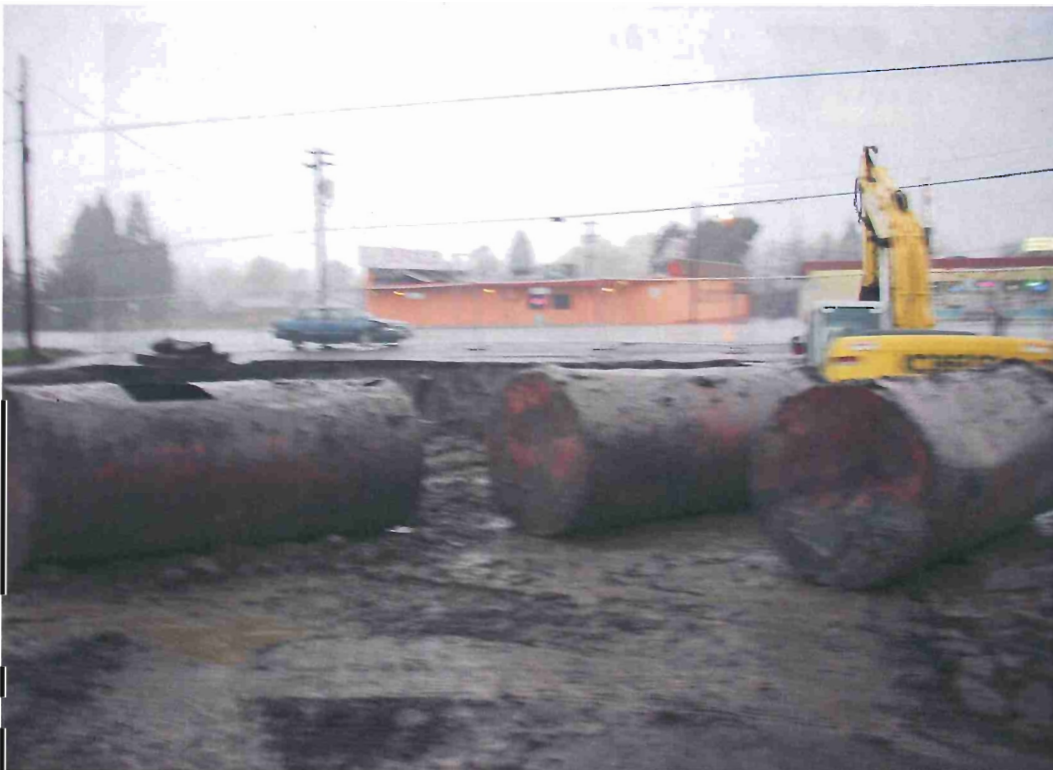
The three USTs after removal.

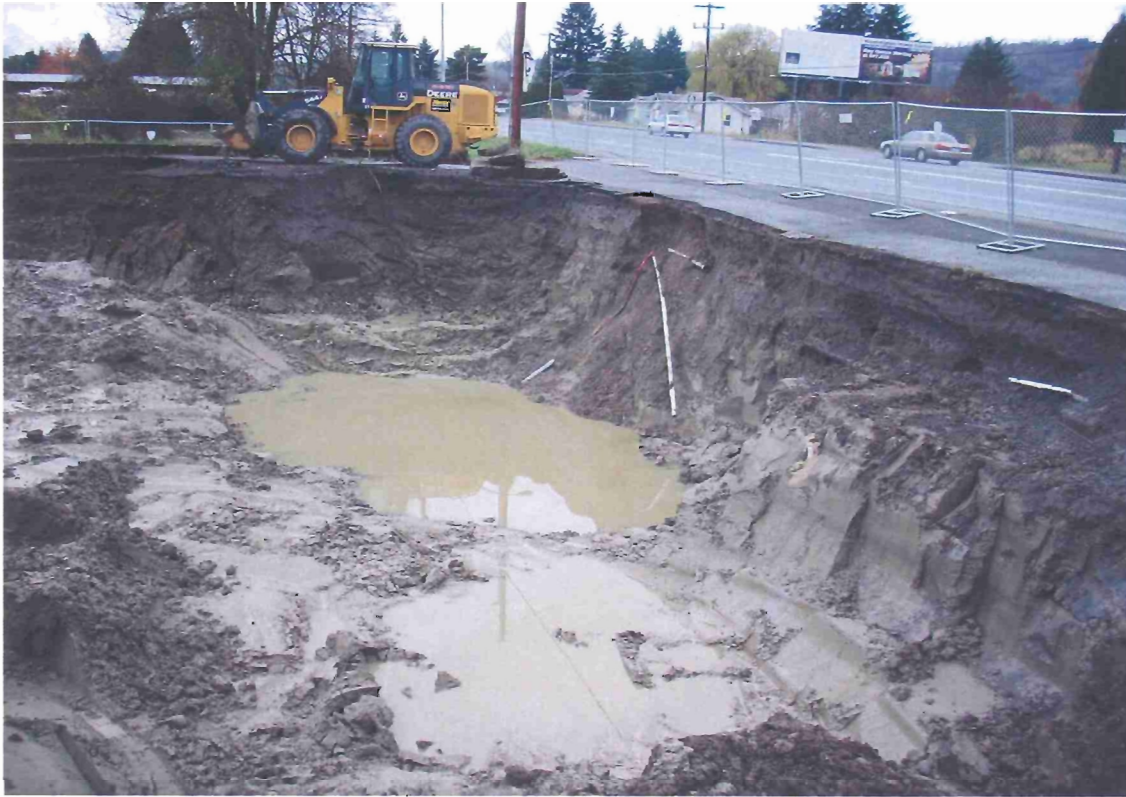
Southwest to northeast view of the final northern and northeastern extents of excavation near the former dispenser island area.

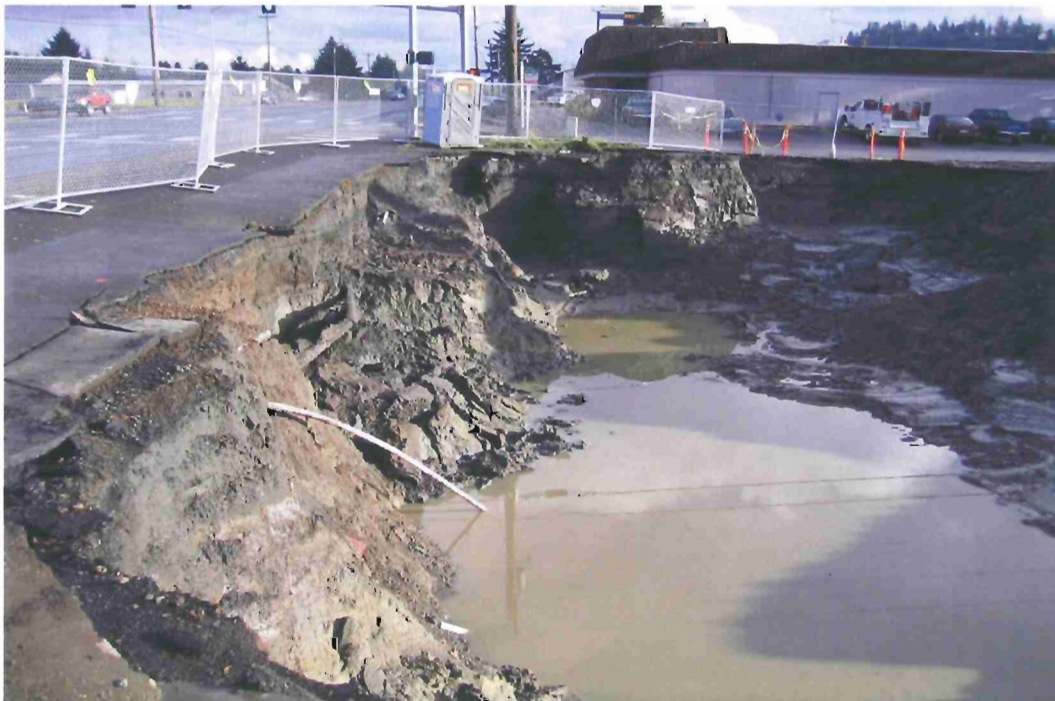
Northwest to southeast view of the final northeastern and eastern extents of the excavation near the former dispenser island area.

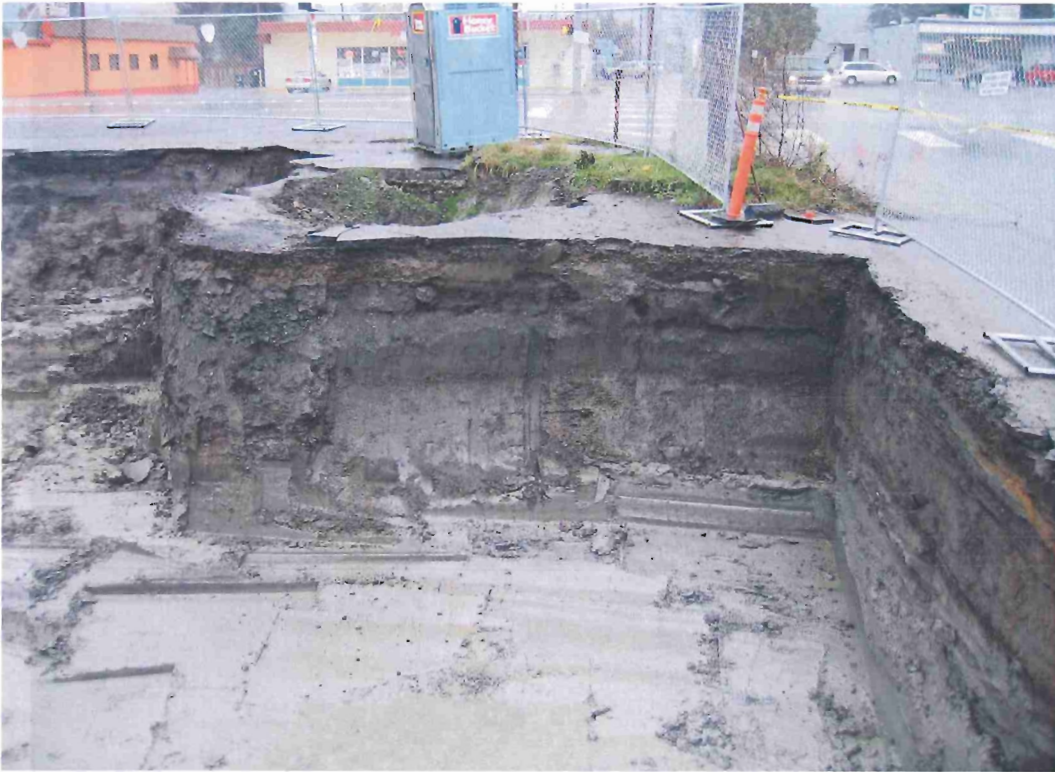
Southwest to northeast view of final eastern extent of the excavation near the former dispenser island area.

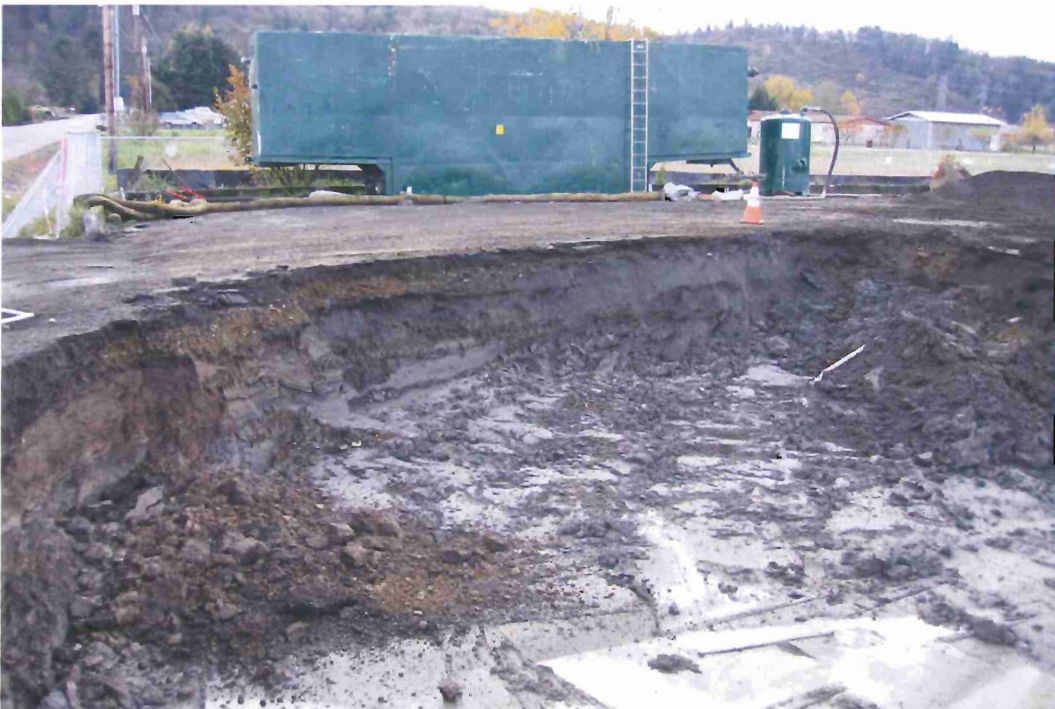
East to west view of the final southern extent of the excavation near the former dispenser island area. The groundwater treatment system is in the background.

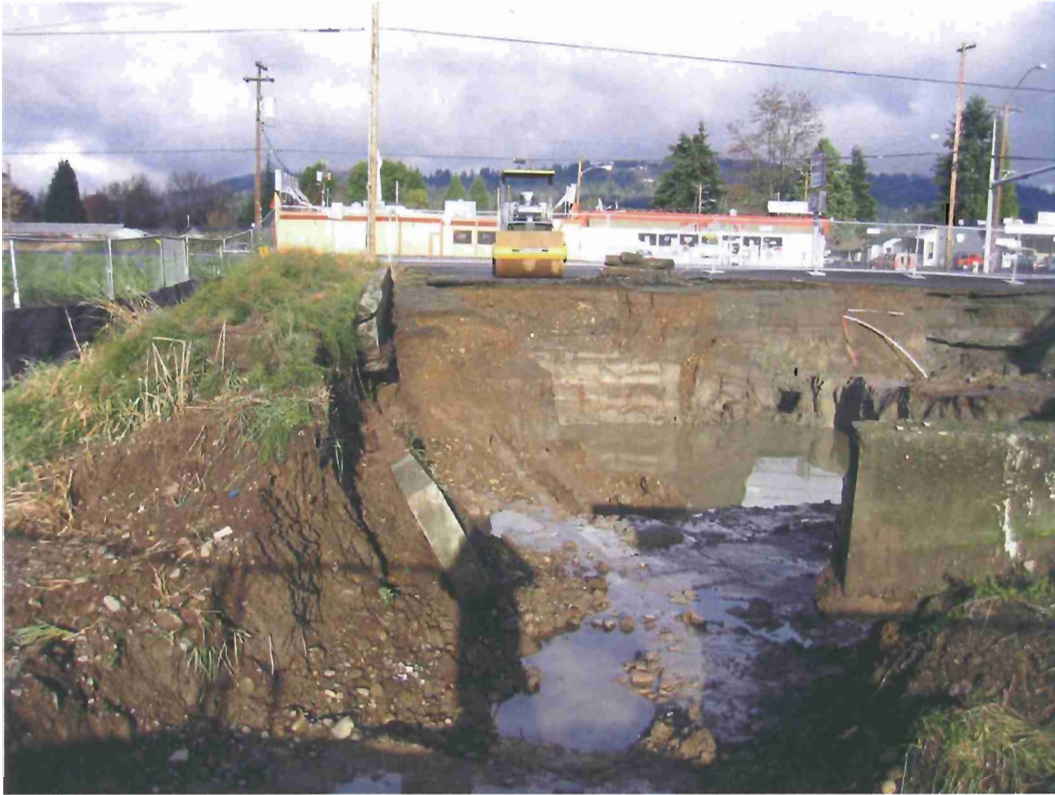
Southwest to northeast view of final western and northern areas of excavation near the former gasoline UST area.

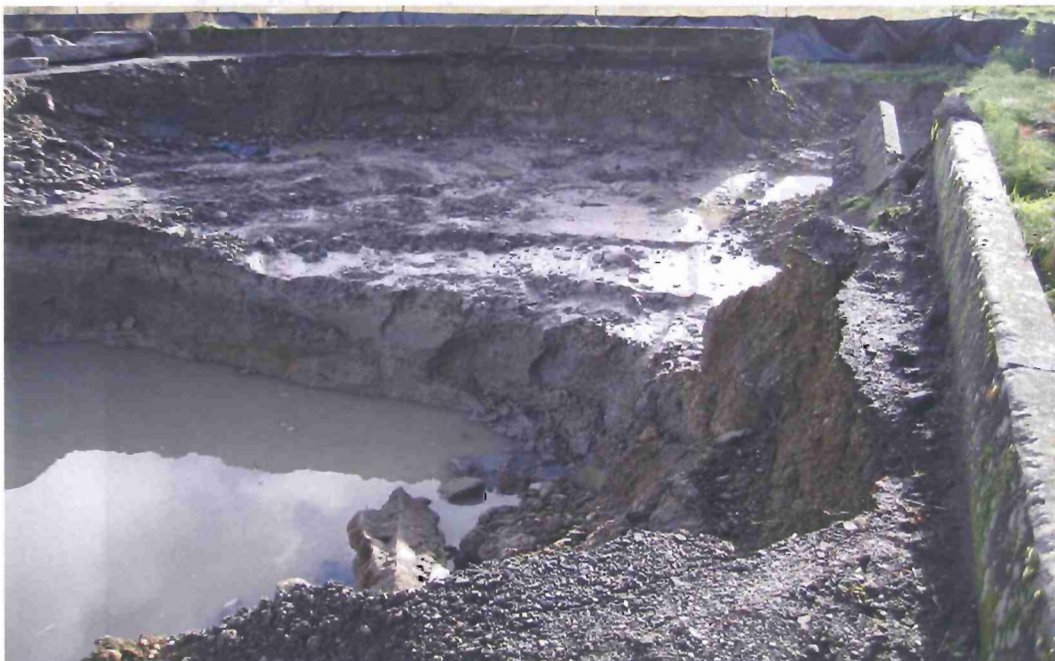
Northeast to southwest view of the final western area of excavation near the former gasoline UST area.

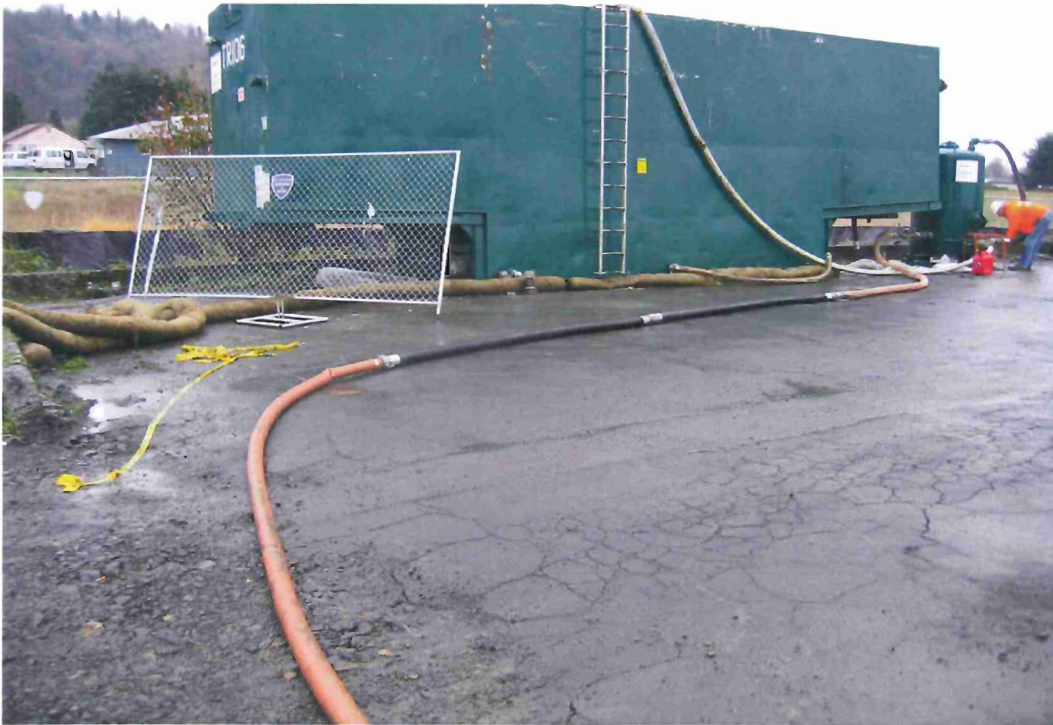
The groundwater treatment system, which consisted of a 21,000-gallon storage tank and a canister filled with 3,000 pounds of activated carbon.

The groundwater treatment system initially consisted of two 21,000-gallon tanks in series followed by a canister filled with approximately 3,000 pounds of activated carbon. During the excavation activities, only a limited volume of groundwater collected in the excavation. Free product was not observed on the water that collected in the excavation. Due to the relatively low volume of water and the lack of free product, the second of the two tanks was removed during the second week of the excavation.

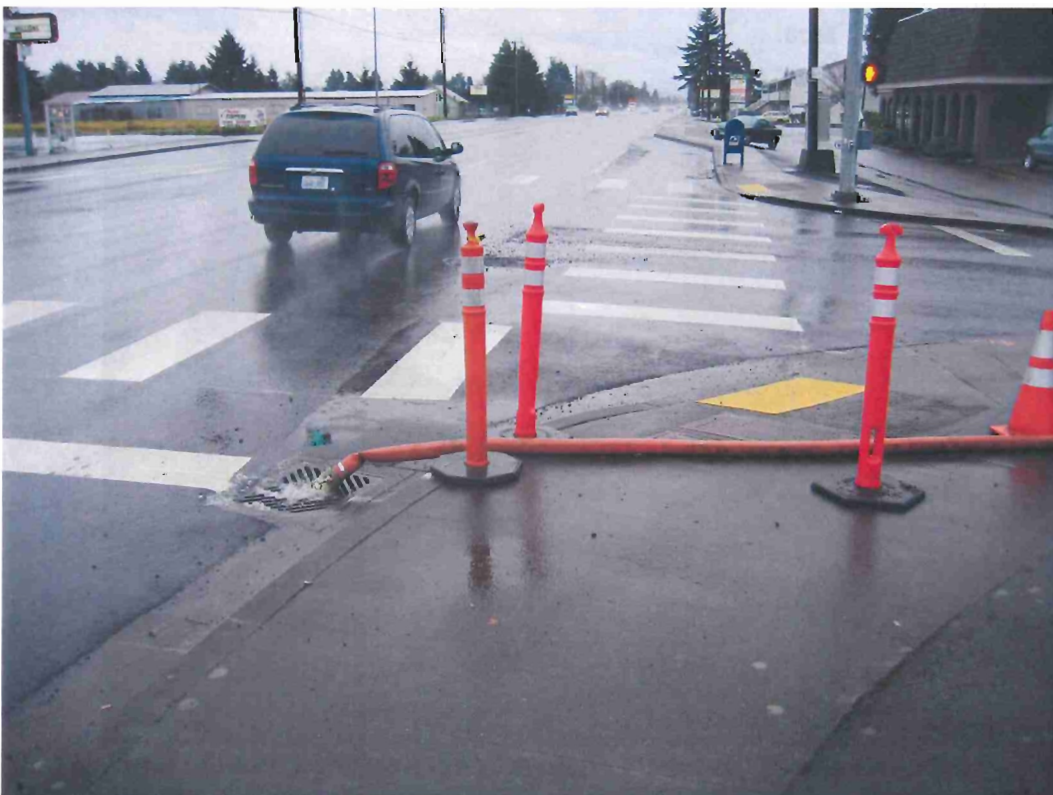
Discharge of treated water to storm sewer system.

To remediate the petroleum hydrocarbon-impacted groundwater that entered the open soil excavation near the former dispenser island (the area of greatest petroleum hydrocarbon concentrations in the shallow groundwater), a suction pump was placed below the water level in the excavation and the water was pumped into a groundwater treatment system. The treated water was discharged to the City of Longview stormwater system under the conditions of a short-term discharge authorization that was issued by Ecology.

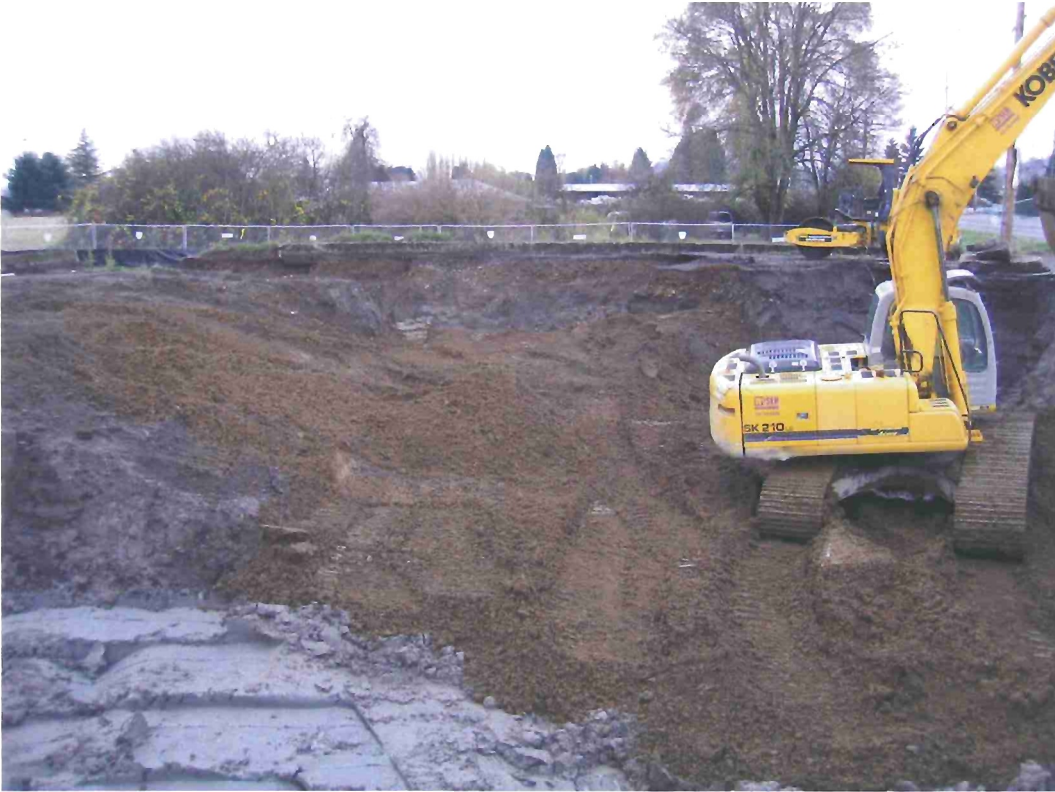
Backfilling the excavation near the former dispenser island area.

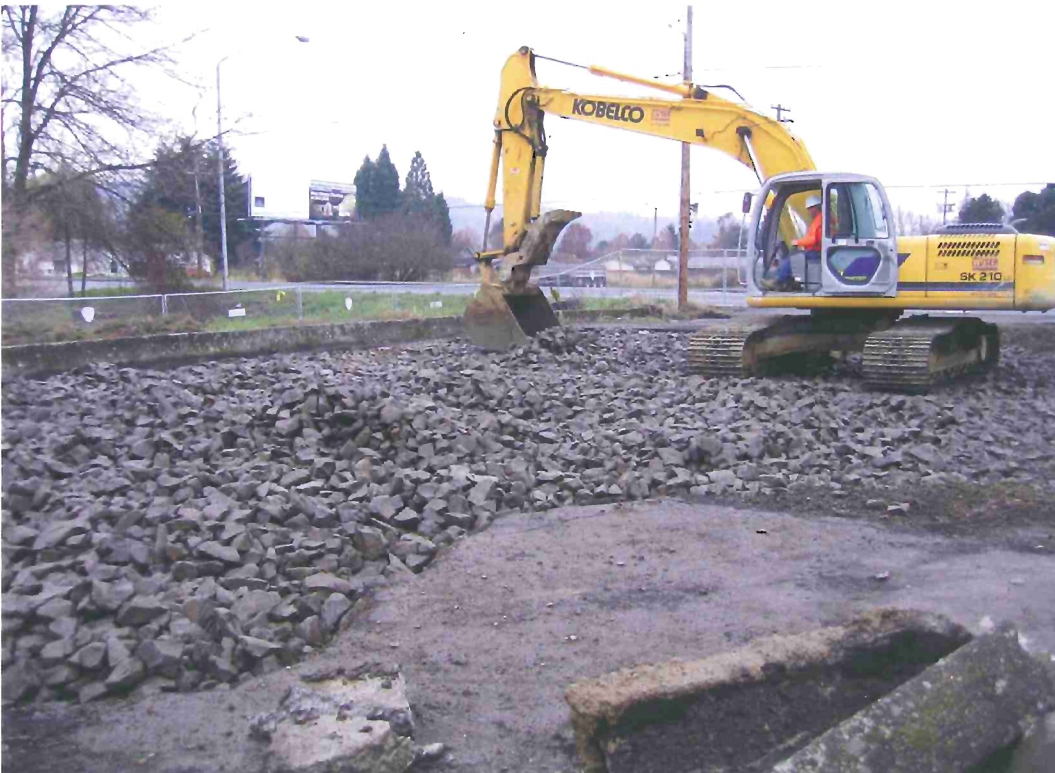
Backfilling near the ground surface with crushed rock.

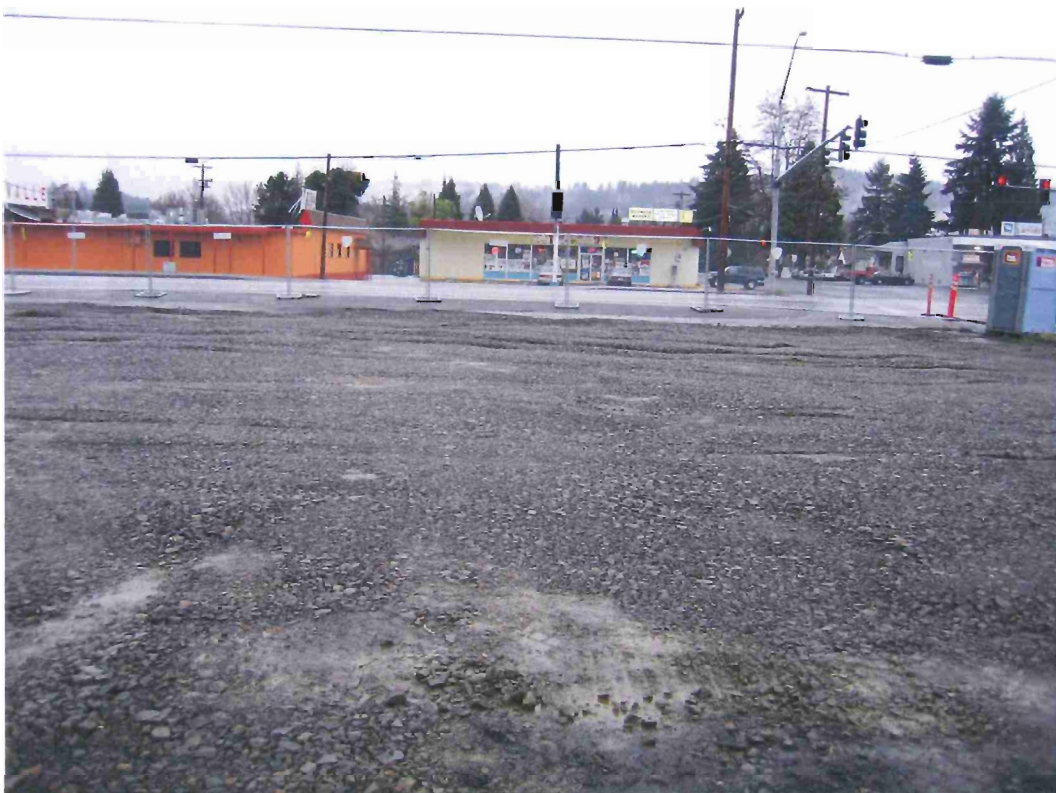
Southwest to northeast view of backfilled excavation.

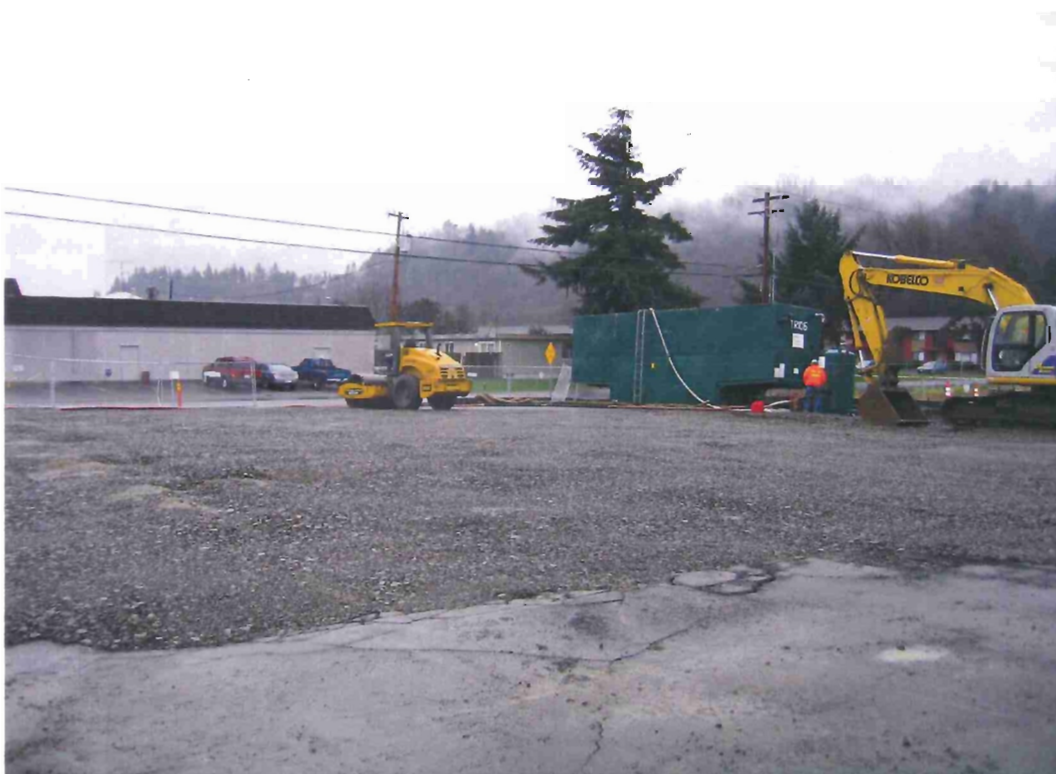
North to south view of backfilled excavation.
