**YAKIMA RAILROAD AREA REMEDIAL INVESTIGATION  
SITE HISTORY/SOIL VAPOR ASSESSMENT  
SOUTHGATE LAUNDRY  
YAKIMA, WASHINGTON**

Maxim Technologies, Inc.  
402 East Yakima Avenue, Suite 750  
P.O. Box 2887  
Yakima, Washington 98907

July 1996

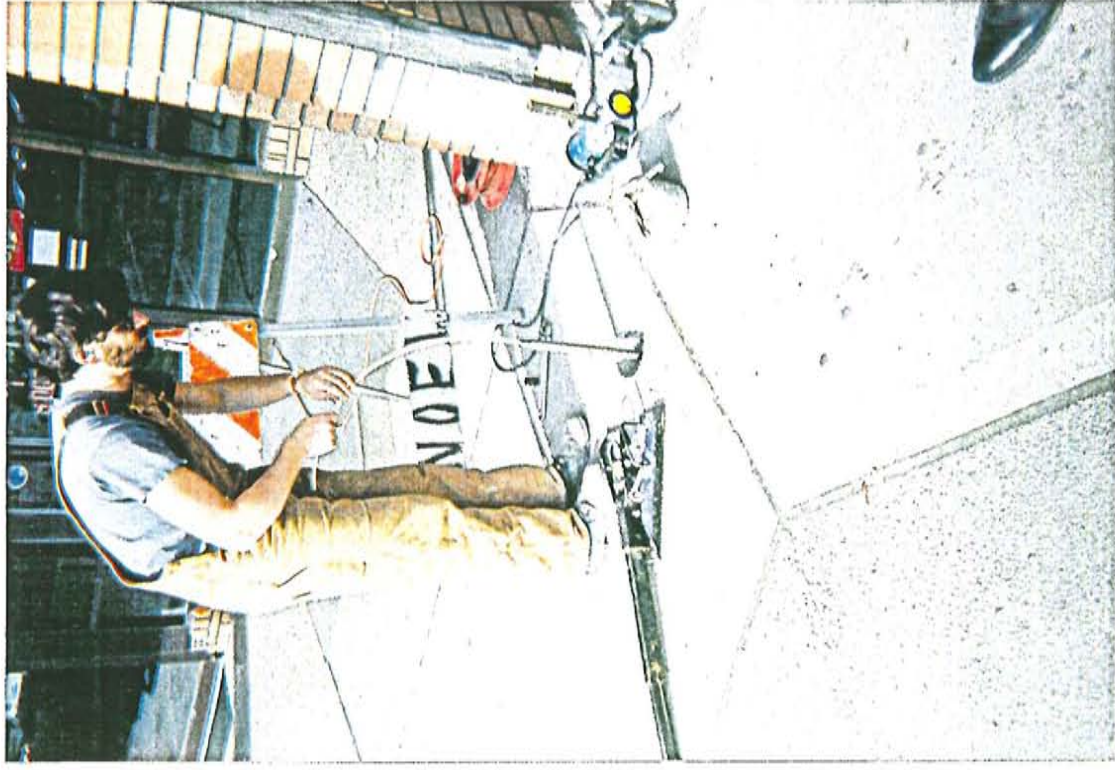
Soil Vapor Collection at Borehole No. 1
