Pilot Study Results and Feasibility Study Addendum

**Whitney's Chevrolet, Inc.
123 Pioneer Avenue
Montesano, Washington 98563**

May 22, 2014

Project Number: 51201.13

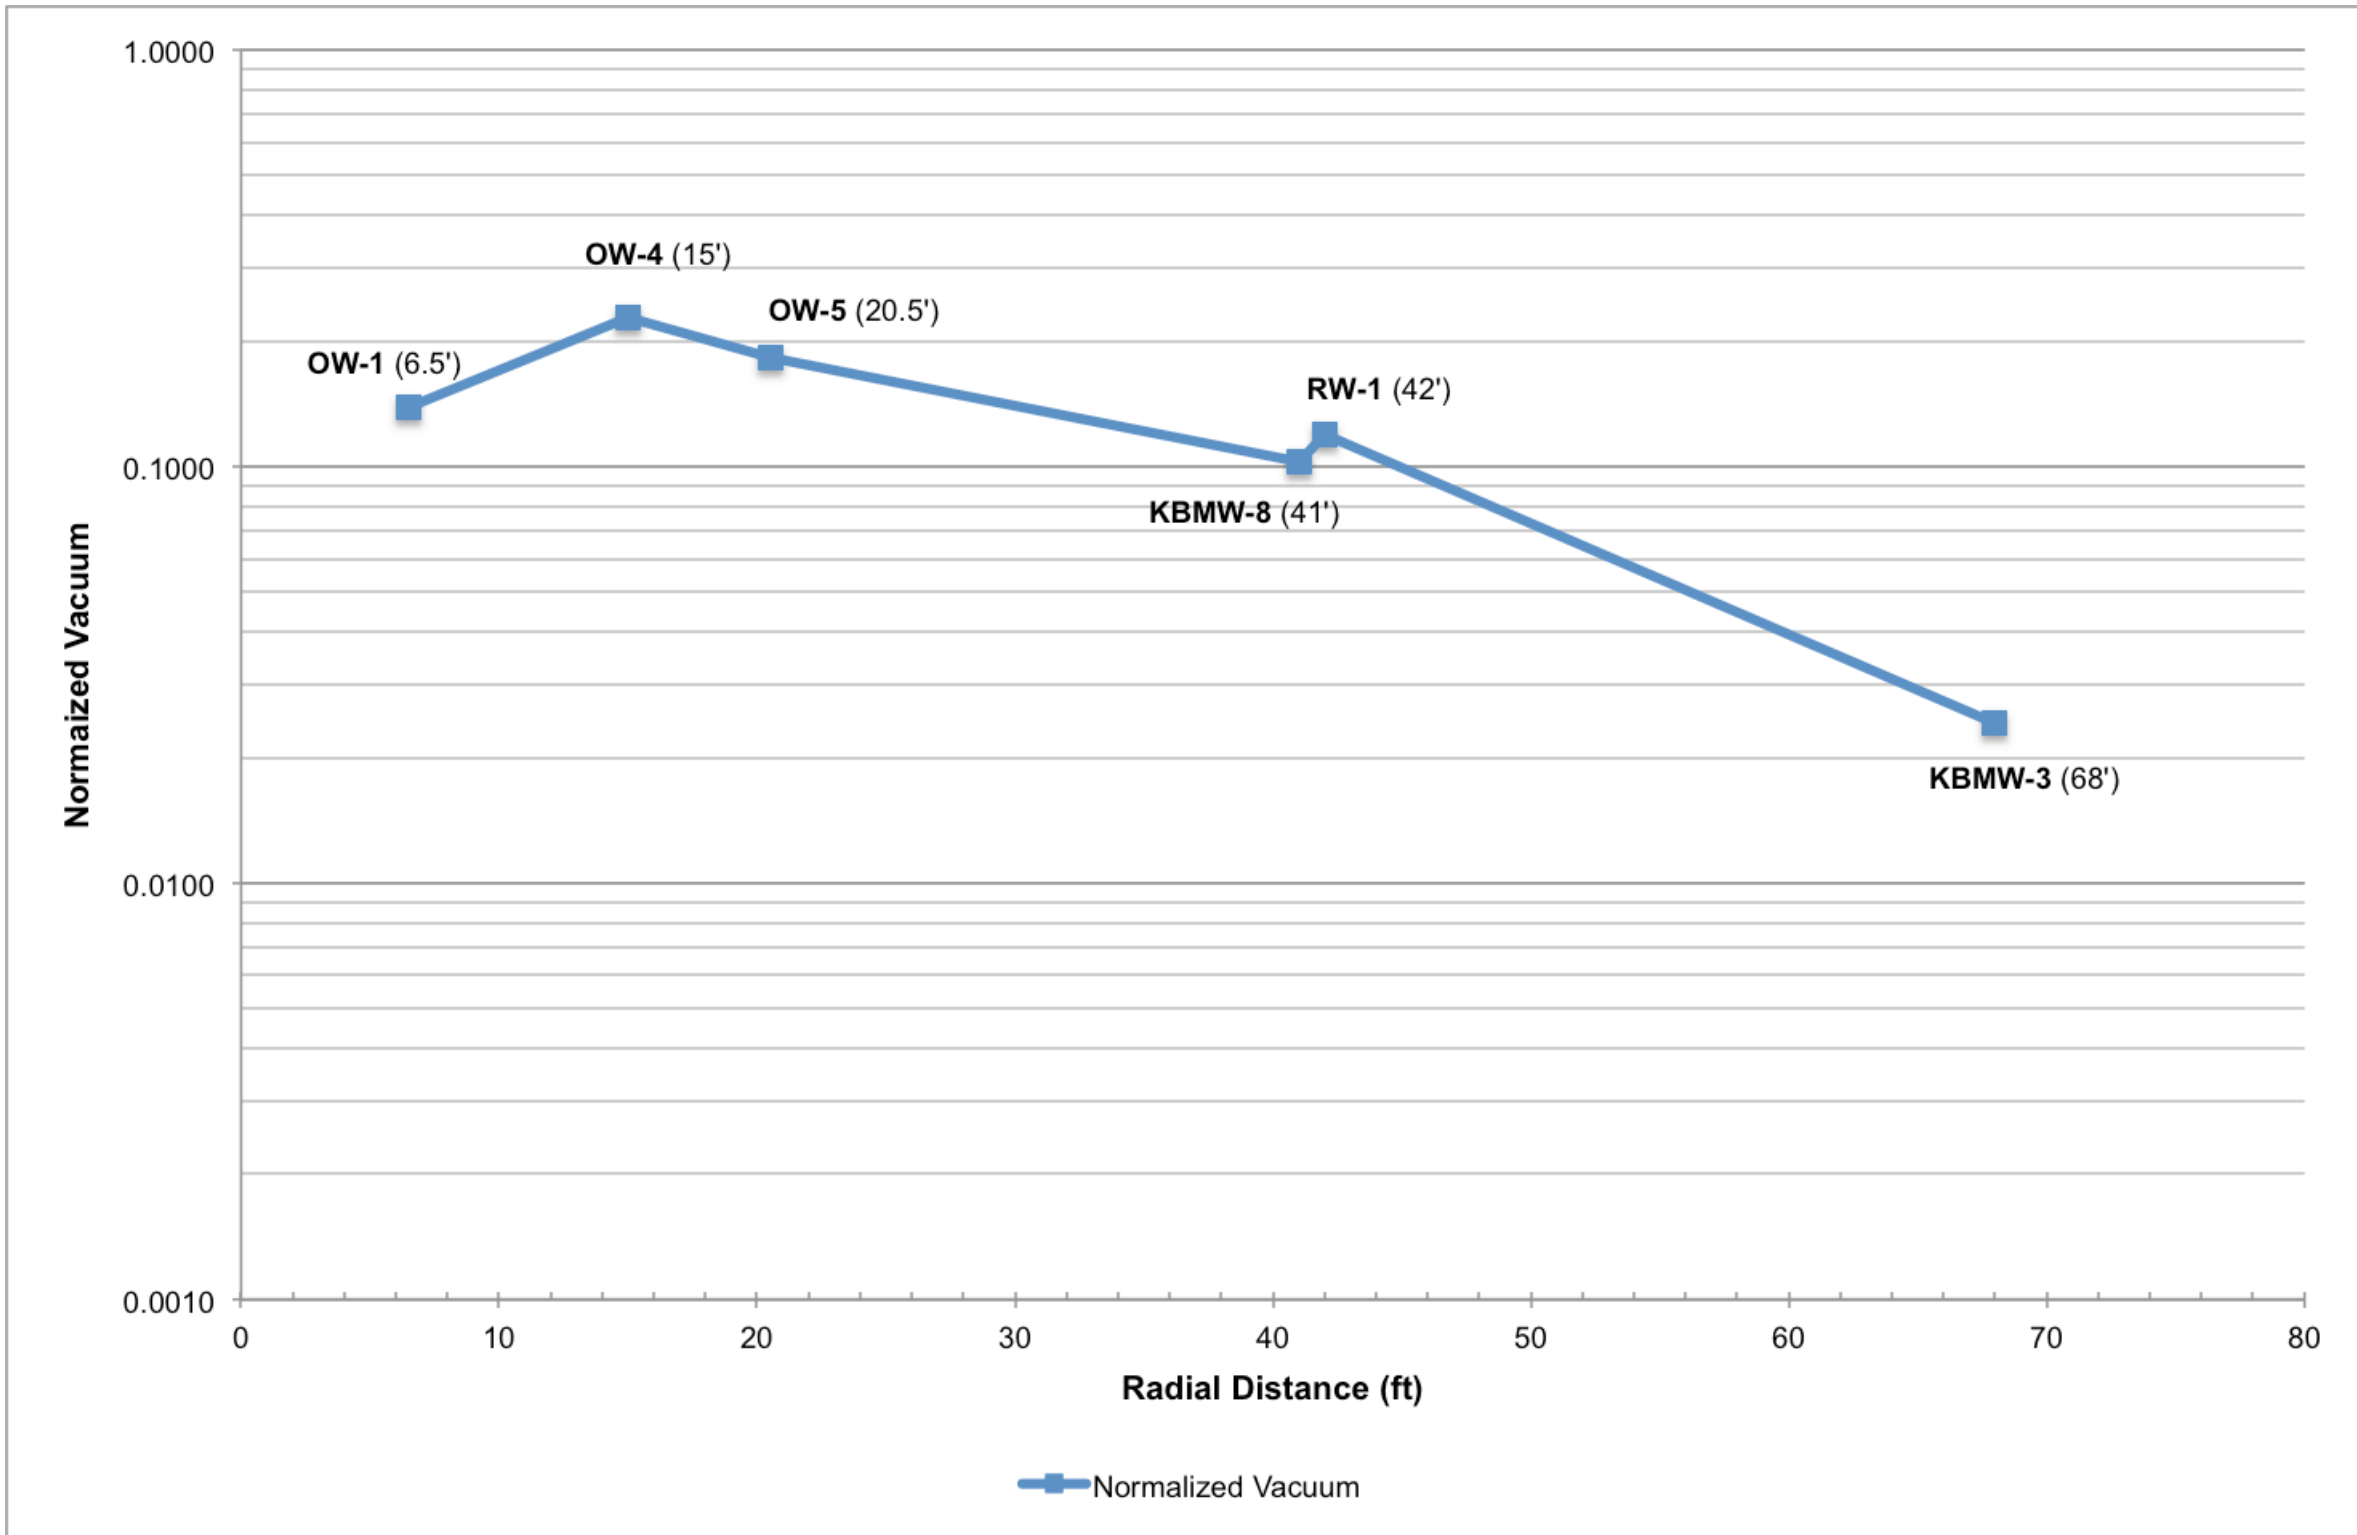
FIGURE 4
 NORMALIZED VACUUM VS RADIAL DISTANCE
 SVE-1 TEST VACUUM AT 10 INCHES W.C.
 SOIL VAPOR EXTRACTION TEST
 OCTOBER 3, 2013

An effective ROI is determined by evaluating the radial distance from the test well where the ratio of observed vacuum to applied vacuum (i.e., normalized vacuum) equals 0.01. All of the normalized vacuums in the observation wells exceeded this minimum value.

As shown on the graphs, the results are generally linear for the observation wells located 15 to 68 feet from the test well. The response at the closest observation well (OW-1, at 6.5 feet from the test well) was less than the responses observed at the two next closest wells (OW-4 and OW-5 at 15 and 20.5 feet, respectively). This is the only observation well installed using DPT methods and the lower response is likely due to "smearing" of the boring sidewalls during installation. This effect appears to have limited the ability of the well to respond to vacuum effects.

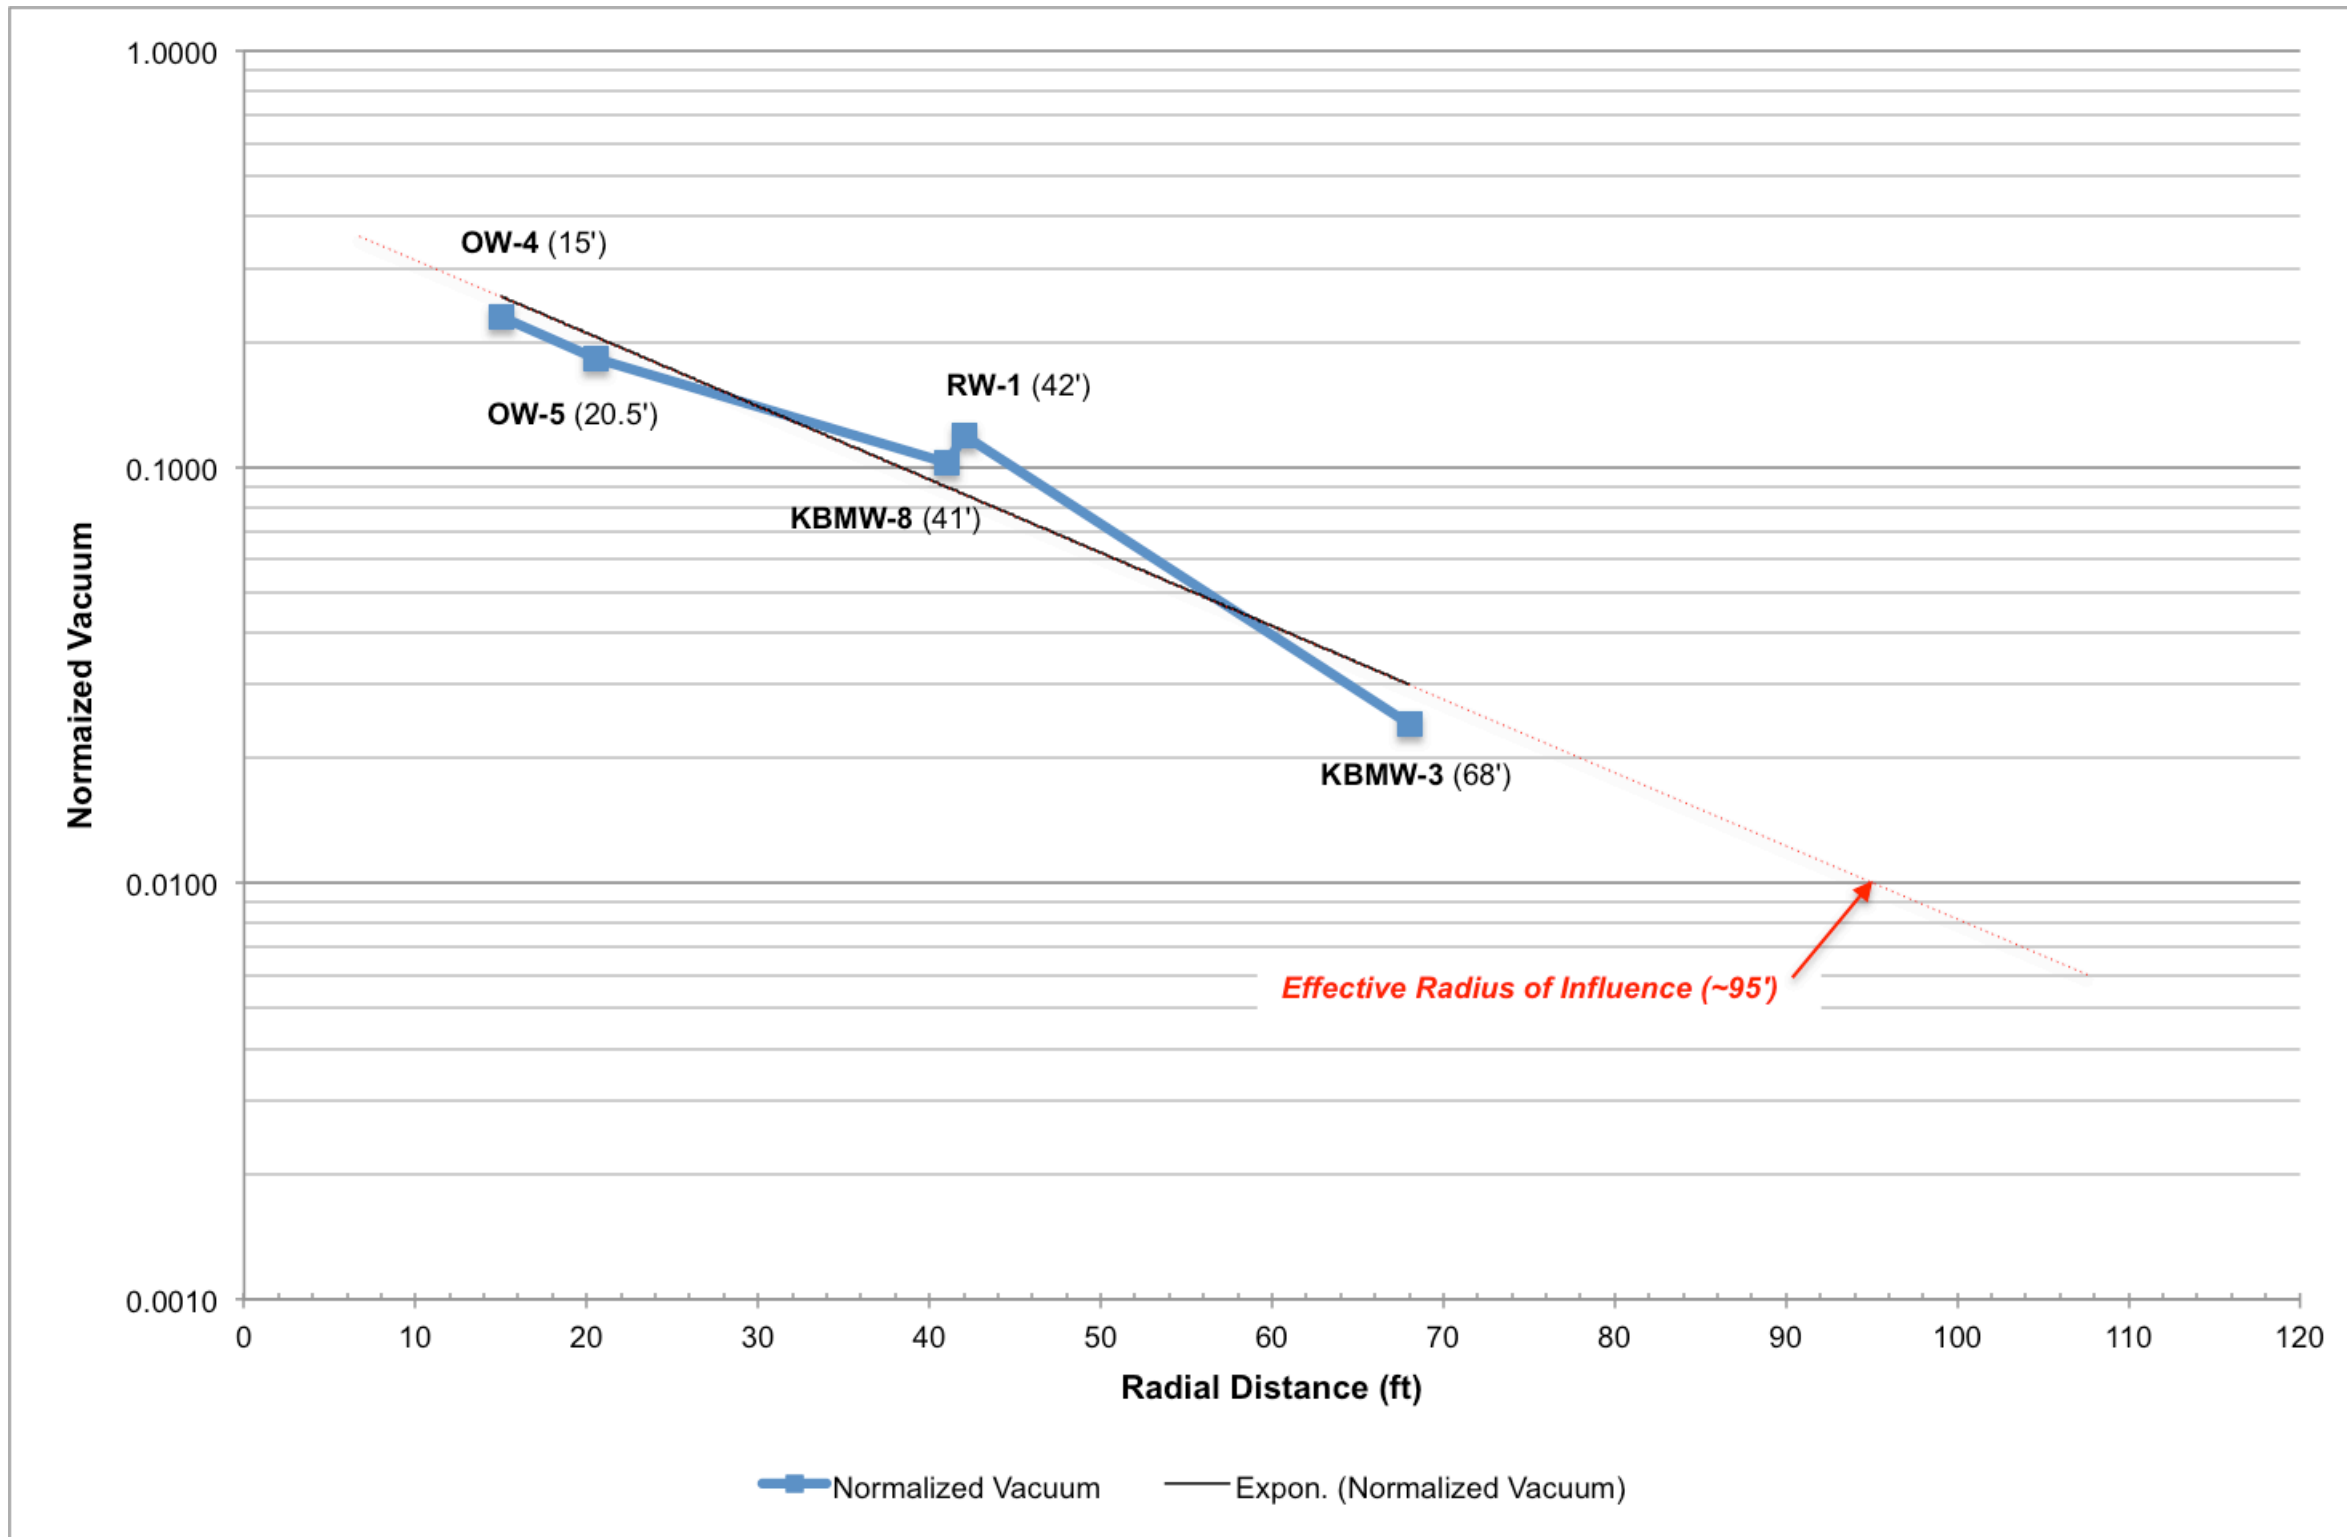
FIGURE 6
 RADIUS OF INFLUENCE EVALUATION
 SVE-1 TEST VACUUM AT 10 INCHES W.C.
 SOIL VAPOR EXTRACTION TEST
 OCTOBER 3, 2013

These distances are greater than the 30-foot ROI that was assumed for the Site in the FS, indicating that Site conditions are very conducive to SVE.

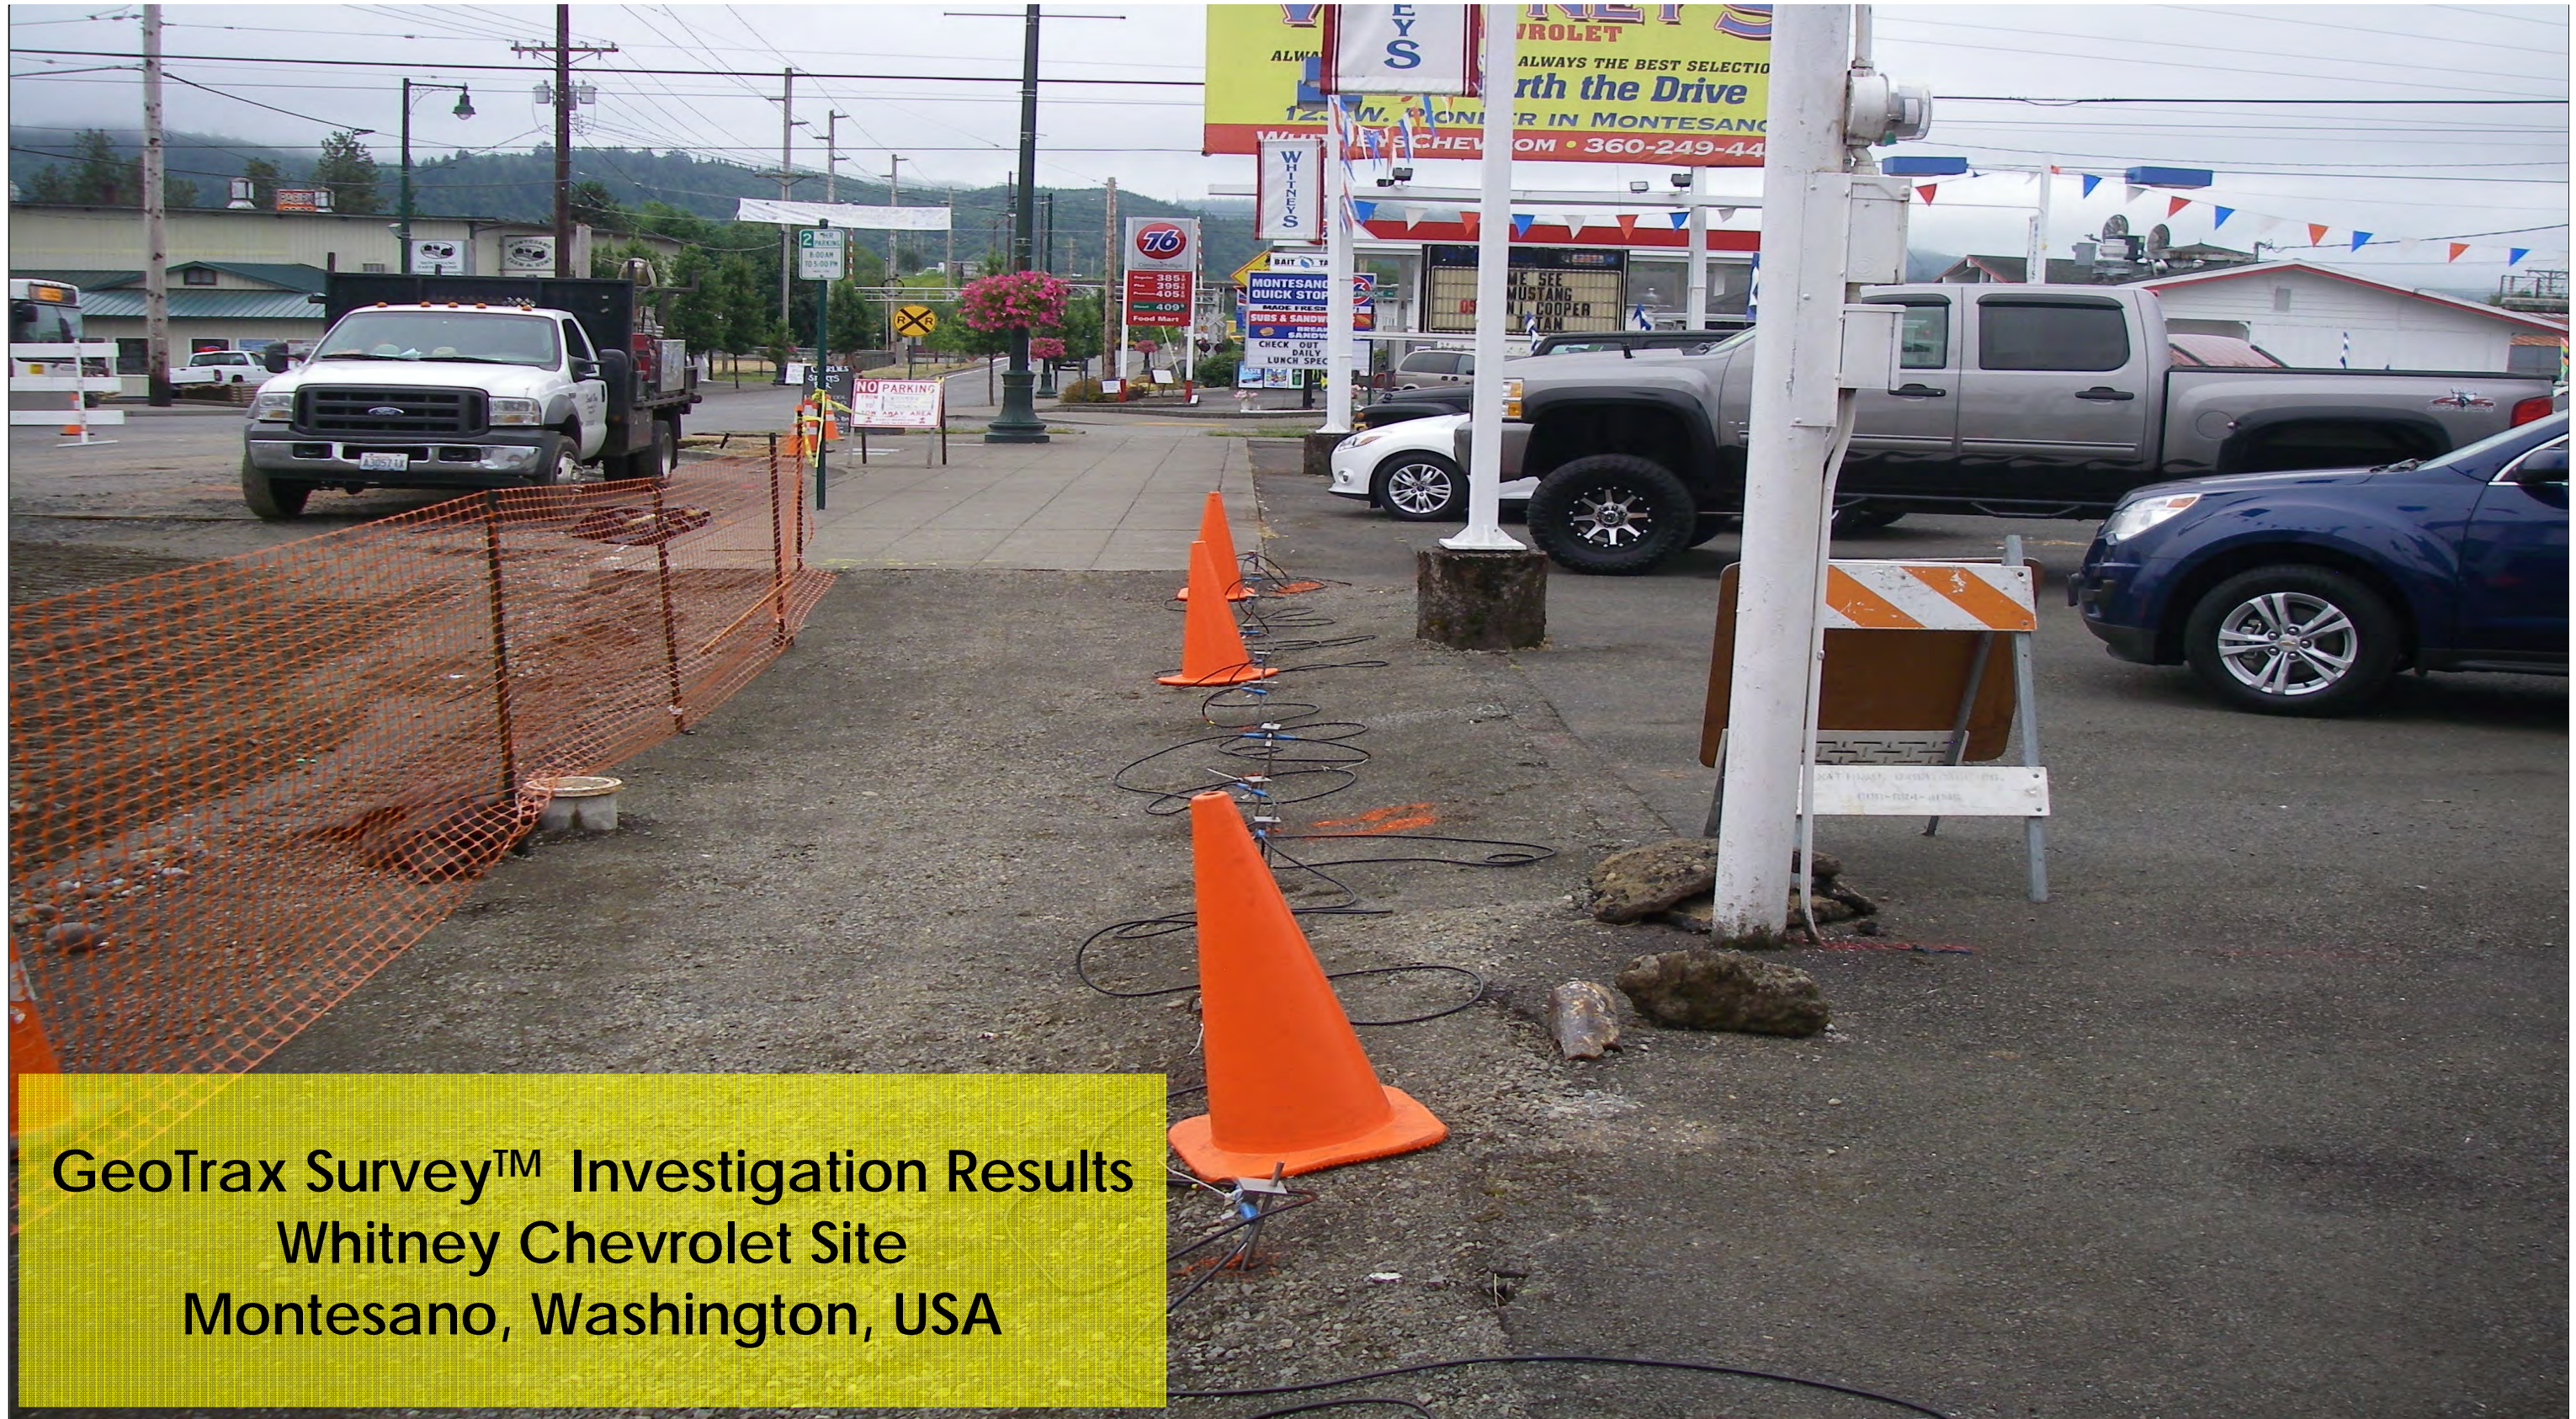
**GeoTrax Survey™ Investigation Results
Whitney Chevrolet Site
Montesano, Washington, USA**

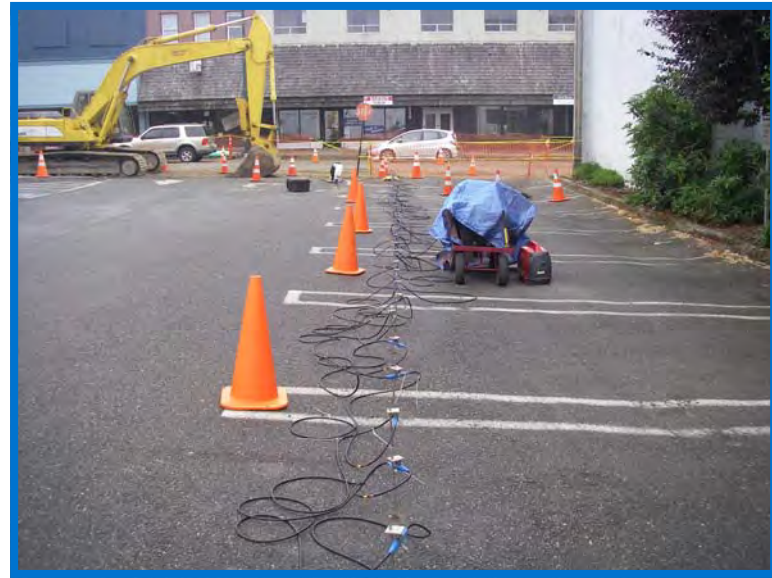
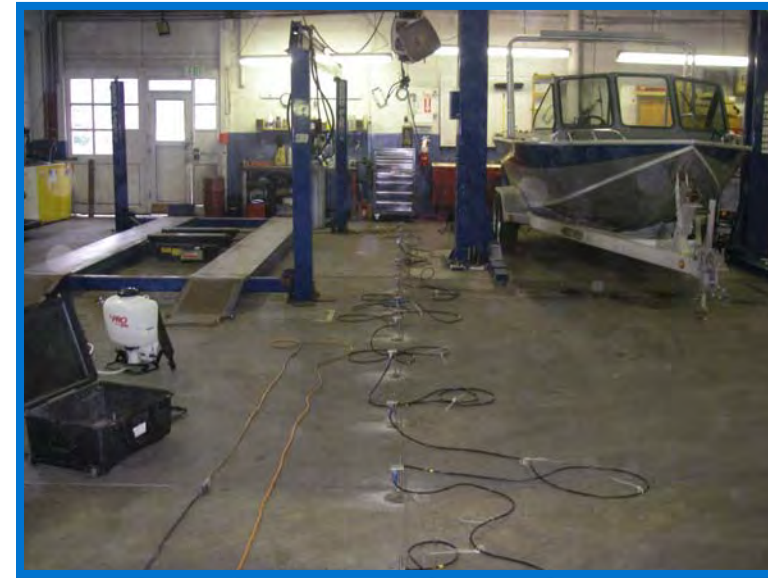
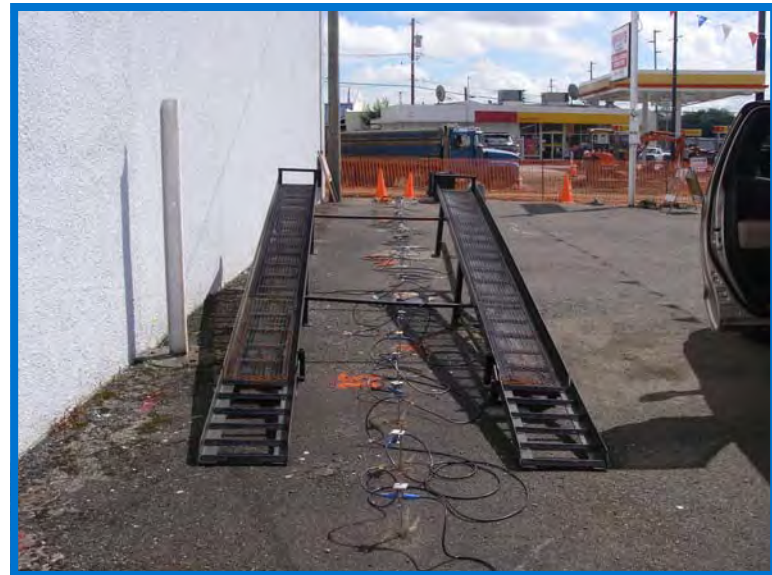
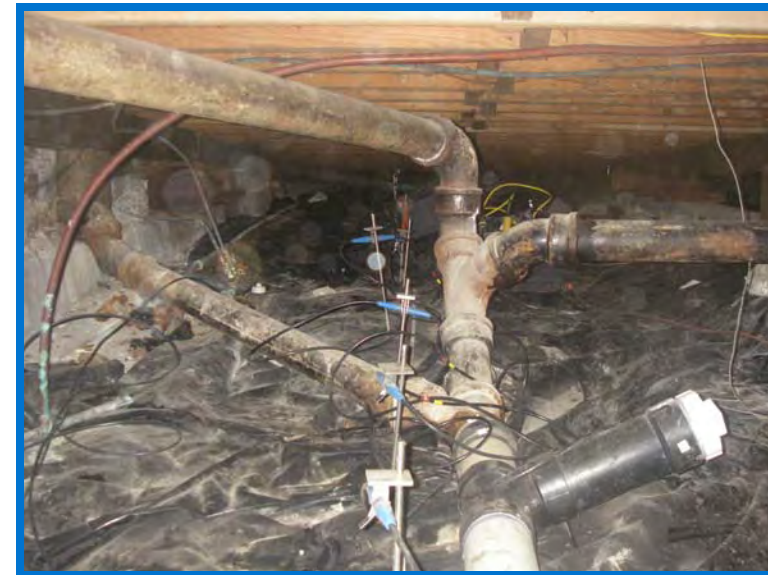
Representative Site Photos*

<p>1.888.GEO.TRAX www.aestusllc.com</p>	7 Red Oak Road Wilmington, DE 19806	Scale: NTS unless specified	<p>Photos of GeoTrax Survey™ Locations Whitney Chevrolet Site Montesano, Washington, USA INTERIM REPORT</p>	<p>FIGURE</p> <p style="font-size: 2em; font-weight: bold;">8</p>
	2605 Dotsero Court Loveland, CO 80538	Drawn By: MAS		
	6005 West 19th Avenue Stillwater, OK 74074	Approved By: SWM		
		Date: 10-16-13		
		Project No.: 12-147-09	<p>Prepared for</p>

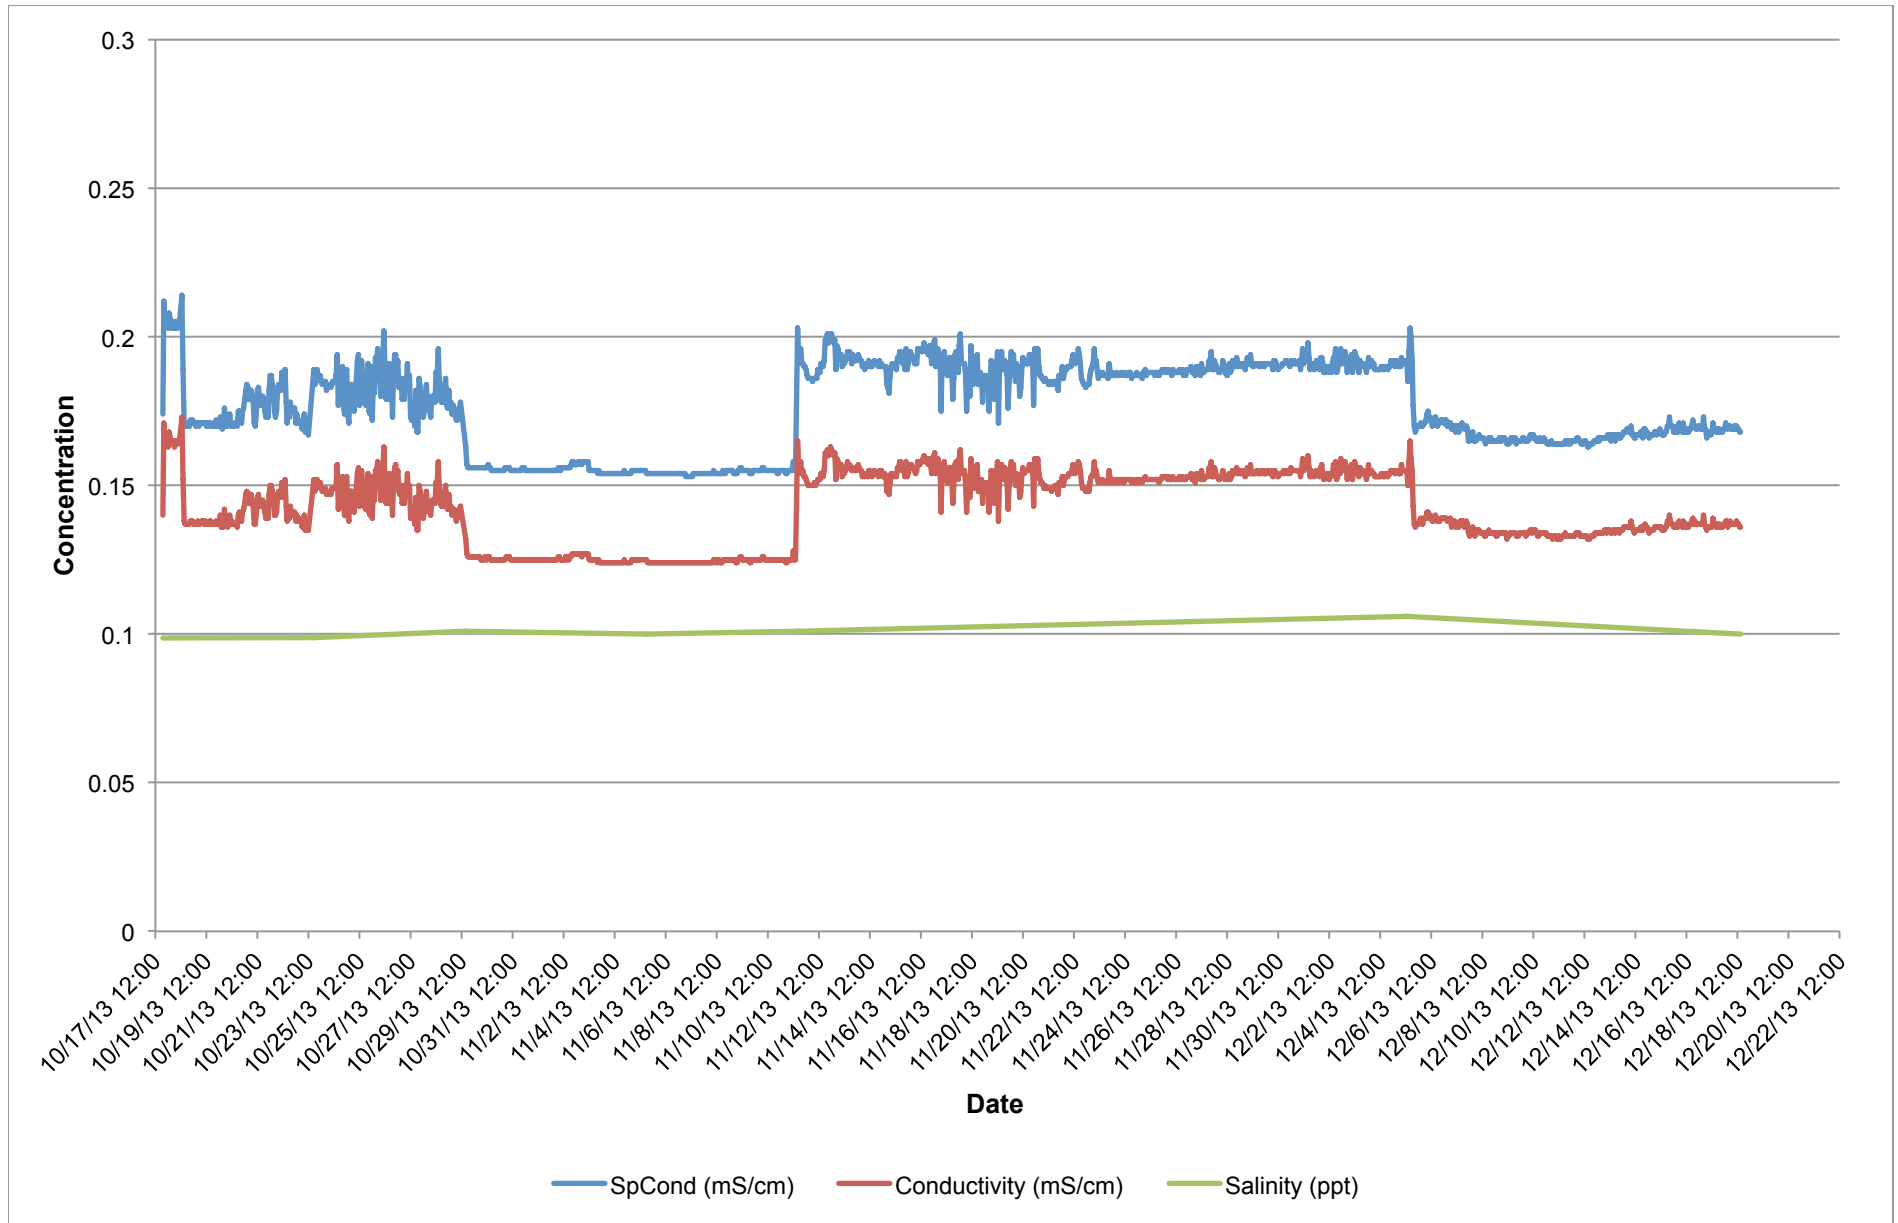
Attachment I
Conductivity and Salinity Data - Observation Well OW-1 (Adjusted)
Saline Tracer Test - October through December 2013
Whitney's Chevrolet
123 W. Pioneer Avenue
Montesano, Washington

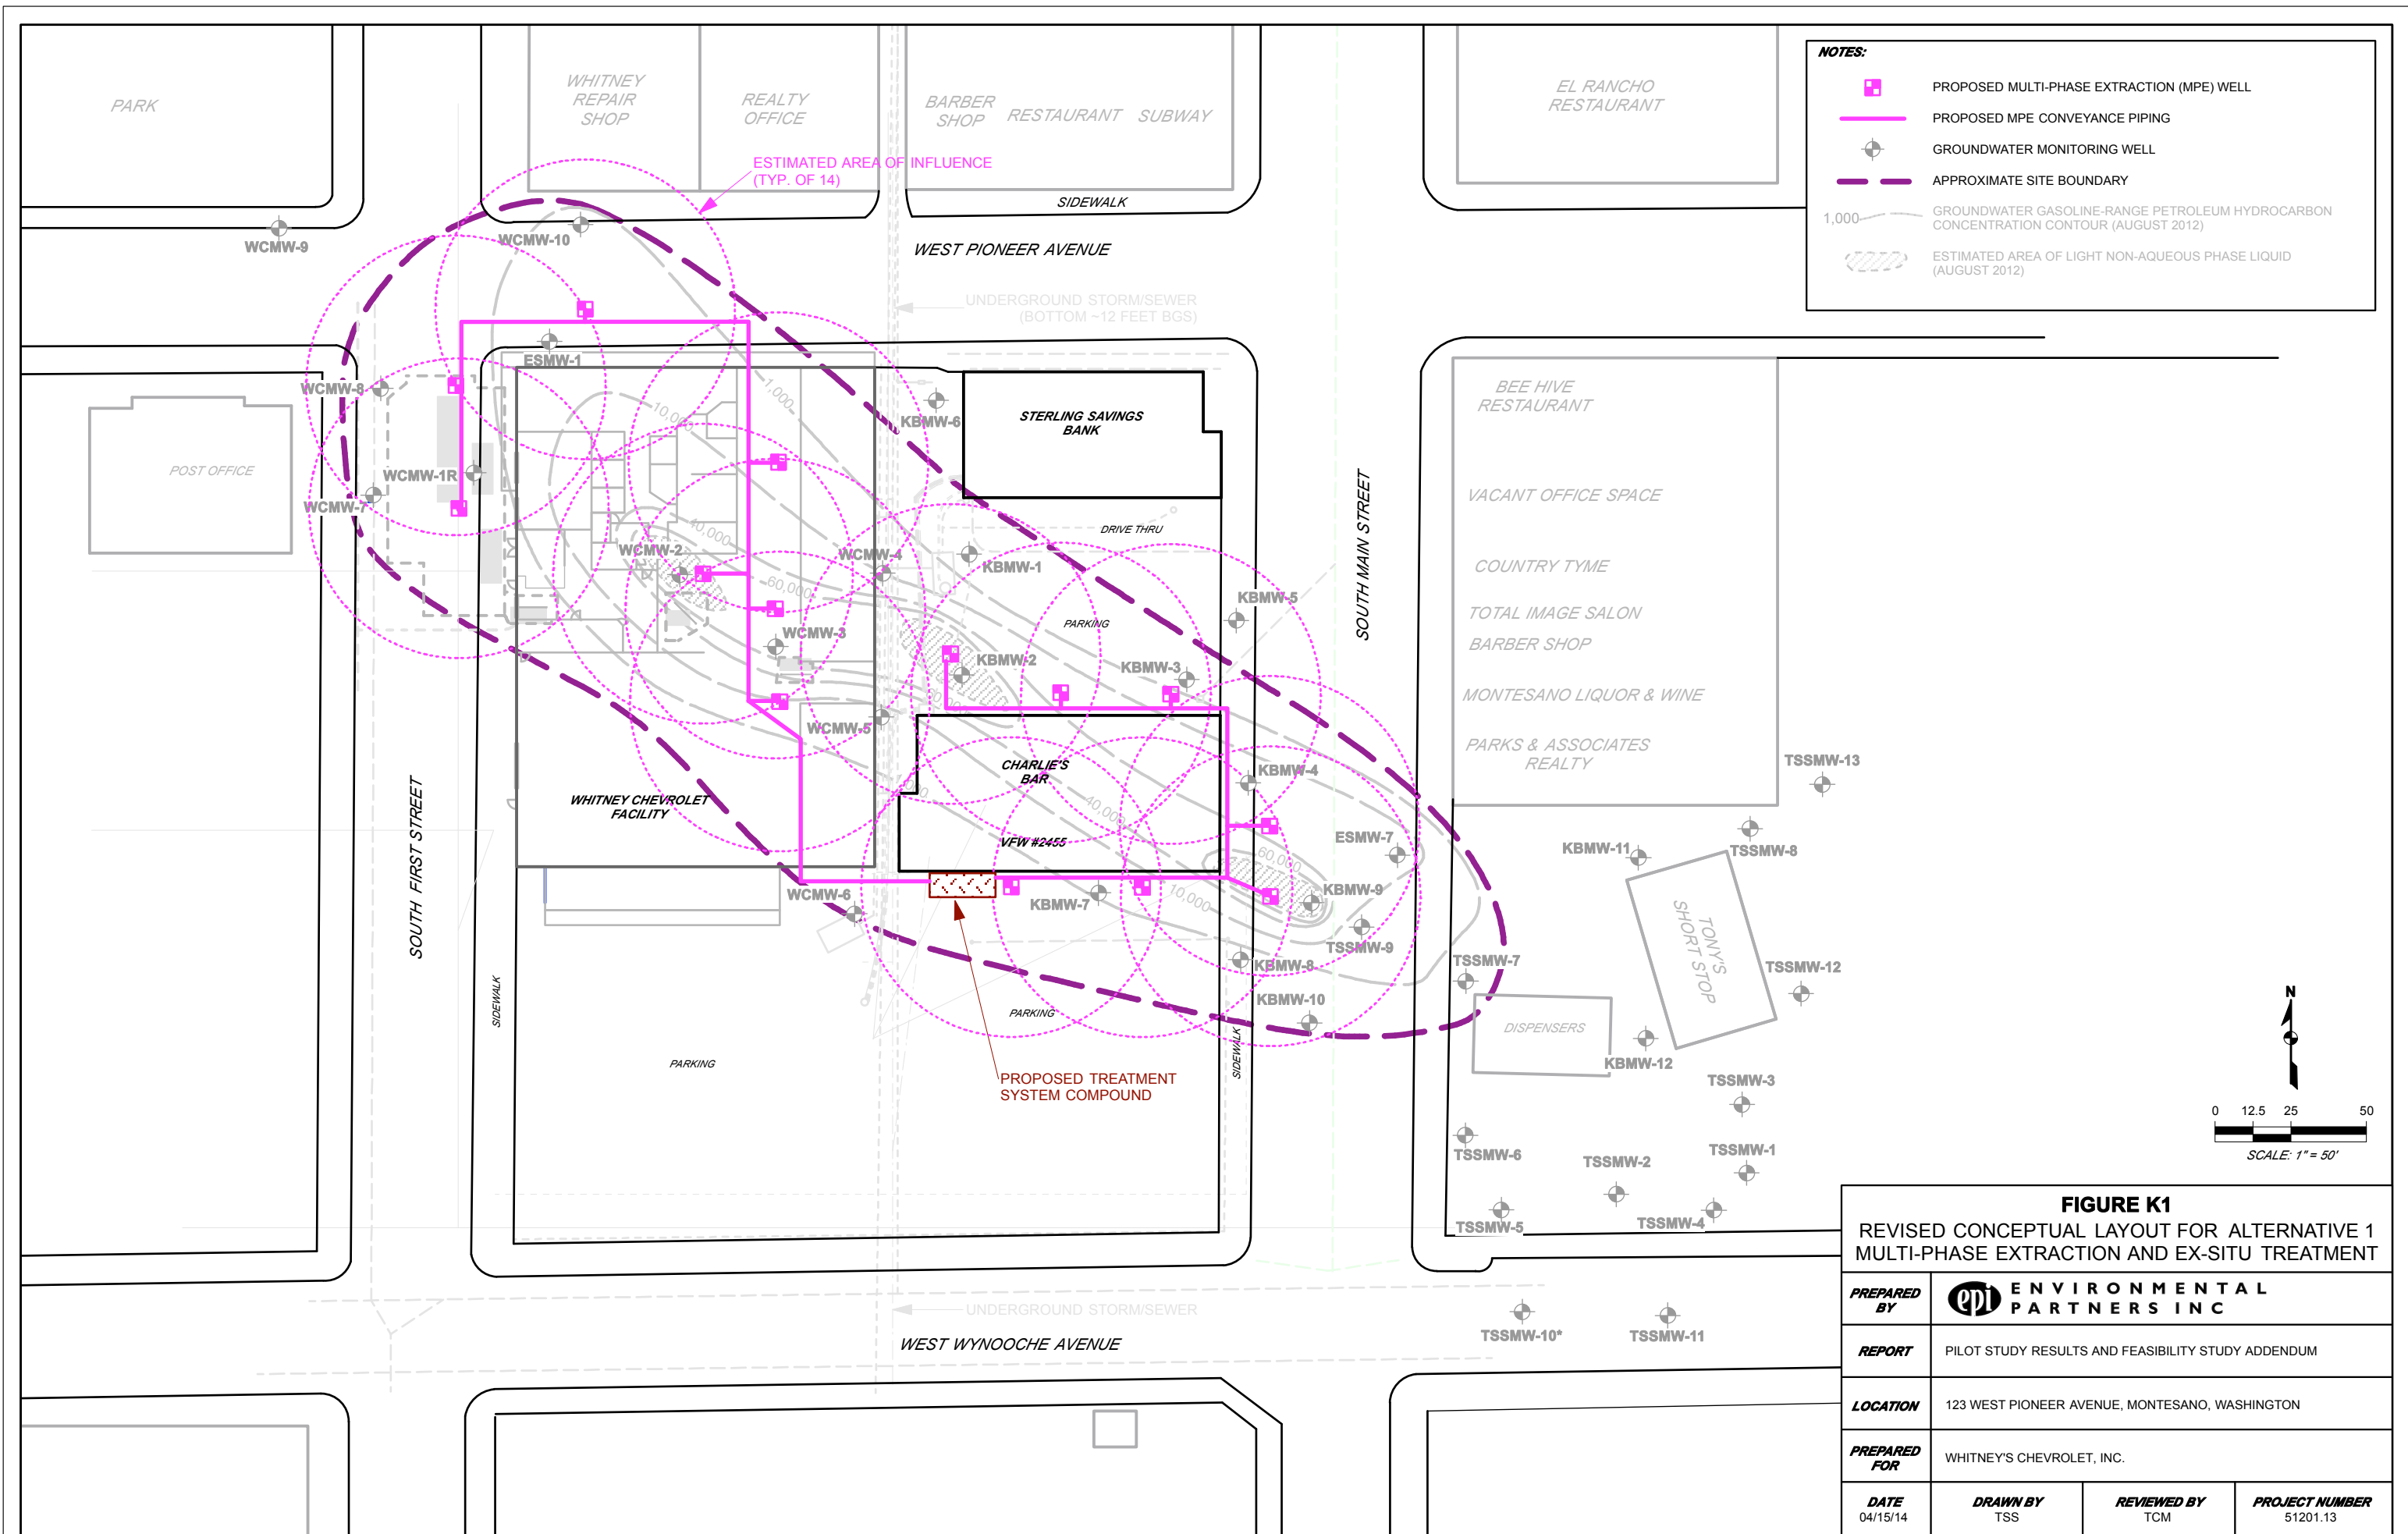
- NOTES:**
- PROPOSED MULTI-PHASE EXTRACTION (MPE) WELL
 - PROPOSED MPE CONVEYANCE PIPING
 - GROUNDWATER MONITORING WELL
 - - - APPROXIMATE SITE BOUNDARY
 - 1,000 GROUNDWATER GASOLINE-RANGE PETROLEUM HYDROCARBON CONCENTRATION CONTOUR (AUGUST 2012)
 - ESTIMATED AREA OF LIGHT NON-AQUEOUS PHASE LIQUID (AUGUST 2012)
