# INITIAL INVESTIGATION FIELD REPORT

ERTS Number: **644362**  
Parcel #(s): **7090000880 + 7 09 0000 881**  
COUNTY: **Pierce**

Site Name (e.g., Co. name over door): Hibbard Residential Property	Site Address (including City and Zip+4): 3617 South Madison St Tacoma, WA 98409-2215	Site Phone: None
Site Contact and Title: Mike Slade, Public Works/Construction Manager	Site Contact Address (including City and Zip+4): City of Tacoma 747 Market Street, Rm 836, Tacoma, WA 98402	Site Contact Phone: 253-591-2004
Site Owner: Bradley J. Hibbard	Site Owner Address (including City and Zip+4): c/o Bradley D. Hibbard 1108 North E Street, Tacoma, WA 98403-2918	Site Owner Phone: 253-572-3697
Site Owner Contact:	Site Owner Contact Address (including City and Zip+4):	Owner Contact Phone:
Alternate Site Name(s):	Comments:	
Previous Site Owner(s):	Comments:

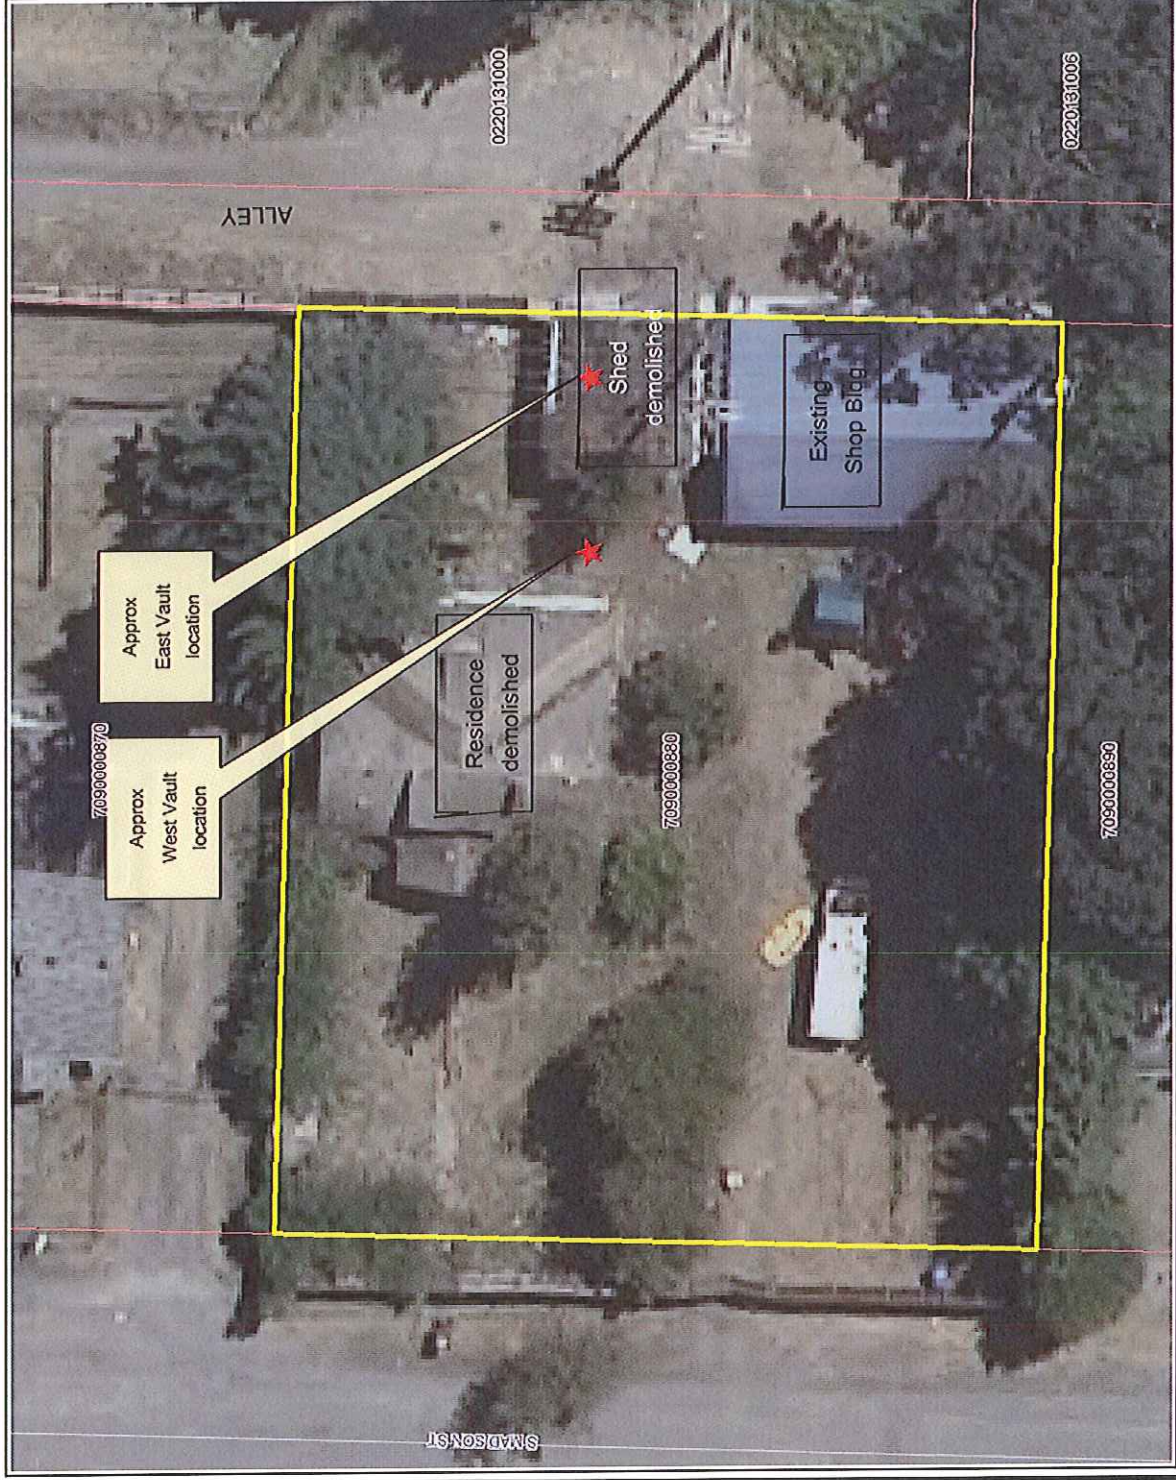
ERTS# 644362 3617 S. Madison St, Tacoma APN: 7090000880

Hibbard Residential Property (House & Shed demolished)

Contaminated soil discovered under concrete floor of shed
