**CLOSURE REPORT
BRIGGS NURSERY INC.
DEBRIS DISPOSAL AREA
OLYMPIA, WASHINGTON**

ENTRIX, INC.
2701 First Avenue, Suite 300
Seattle, Washington 98121

February 5, 2003

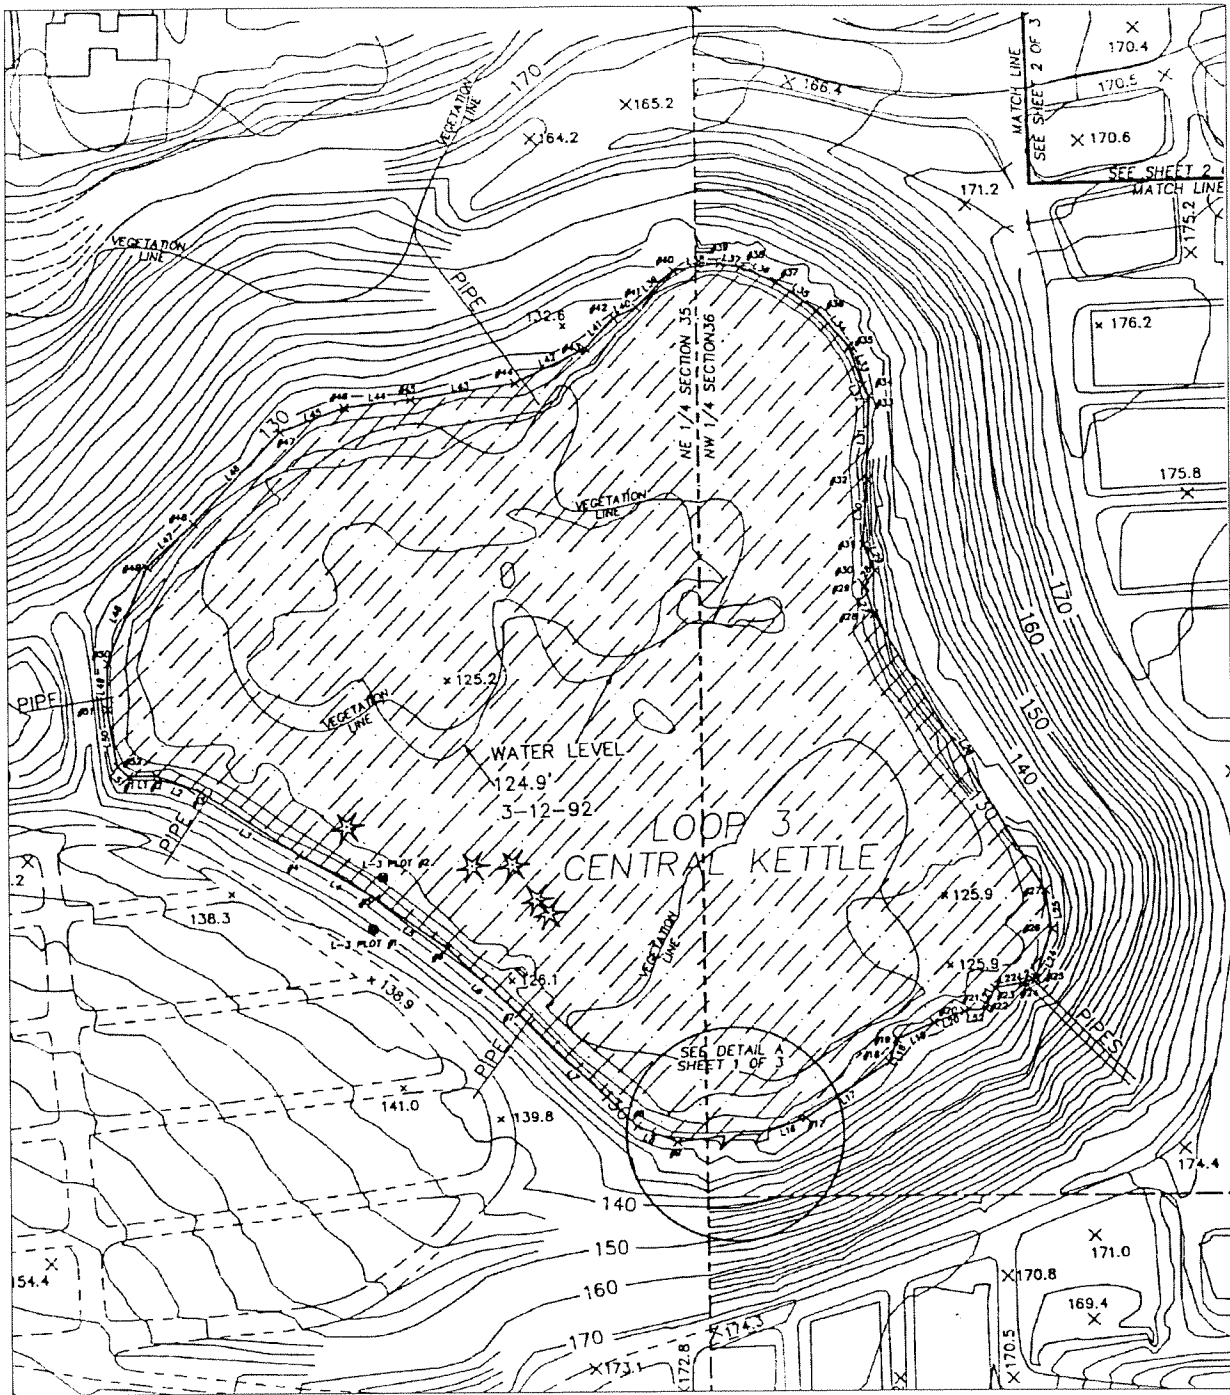
Figure 4: Debris Disposal Area
Exploration Locations

The results of the 2001 soil removal action indicated that the lateral and vertical extent of pesticide-affected soil in the northwest corner of the excavation area was undefined. Therefore, in April 2002, four exploratory borings, NW-1, NW-2, NW-3, and NW-4 were advanced to approximately 25 feet bgs to further evaluate the presence of pesticide-affected soil (Figure 4). The boring logs are provided in Appendix E.

Seven additional borings, P-1 through P-7, were advanced on the east-side perimeter of the Central Kettle to assess the lateral and vertical extent of solid waste and pesticide affected soil (Figure 4). Solid wastes were observed in borings P-1 through P-7 at depths ranging from seven to 25 feet bgs. The boring locations extended along a 120-foot length of the kettle perimeter. The logs are also provided in Appendix E.

Stockpile 6 was comprised of soils excavated from the northwest corner of the excavating, which occurred between October 10, 2001 to October 19, 2001 (Figure 4). Analytical results from soils excavated between October 10 and October 15 show concentrations of chlorinated pesticides below MTCA cleanup levels (Table 3). However, two samples from soils excavated between October 17 and October 19 show concentrations of aldrin (0.93 mg/kg), DDD (0.89 mg/kg), and DDT (6.6 mg/kg) in soil above MTCA Method A and B cleanup levels (Table 3). Because of inclement fall weather, the excavation was prepared for closure through the winter months and Stockpile 6 was covered with plastic sheeting and secured.

The materials found in borings and test pits on the east side of the Central Kettle were evaluated and the approximate lateral and vertical extent of waste that required excavation was identified (Figure 4).

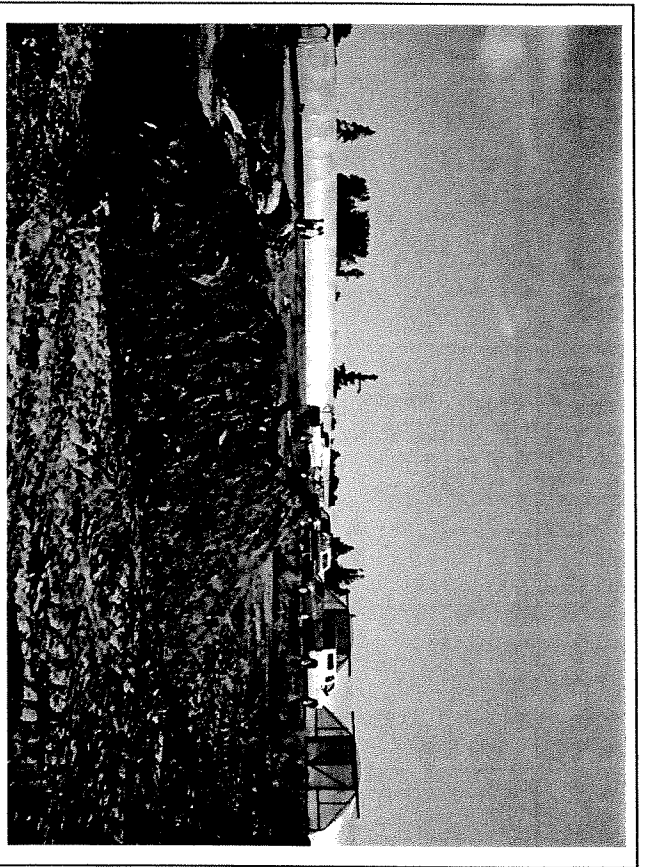
9/23/01: Excavation begins in the eastern corner; small debris piles visible

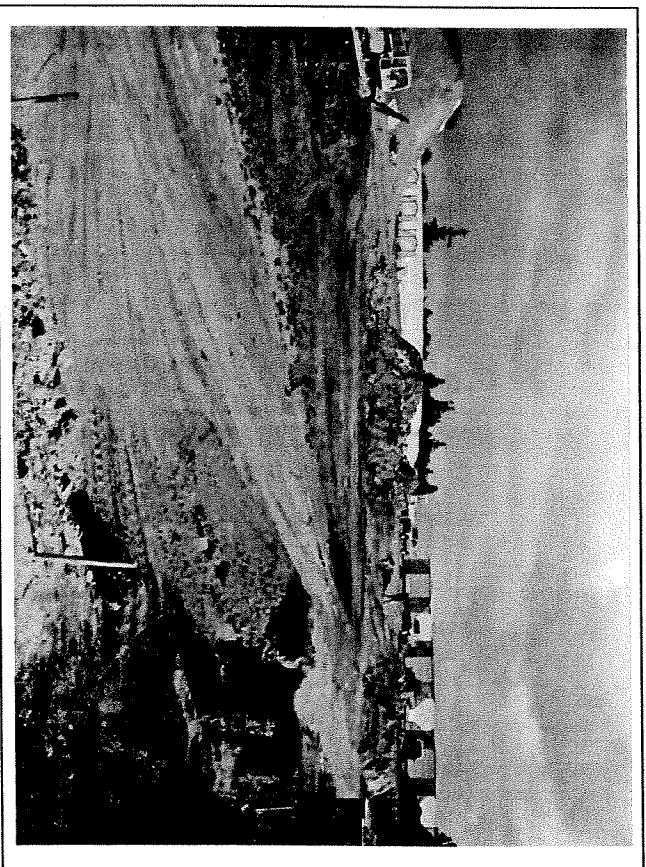
10/13/01: Looking east toward parking area; debris piles visible

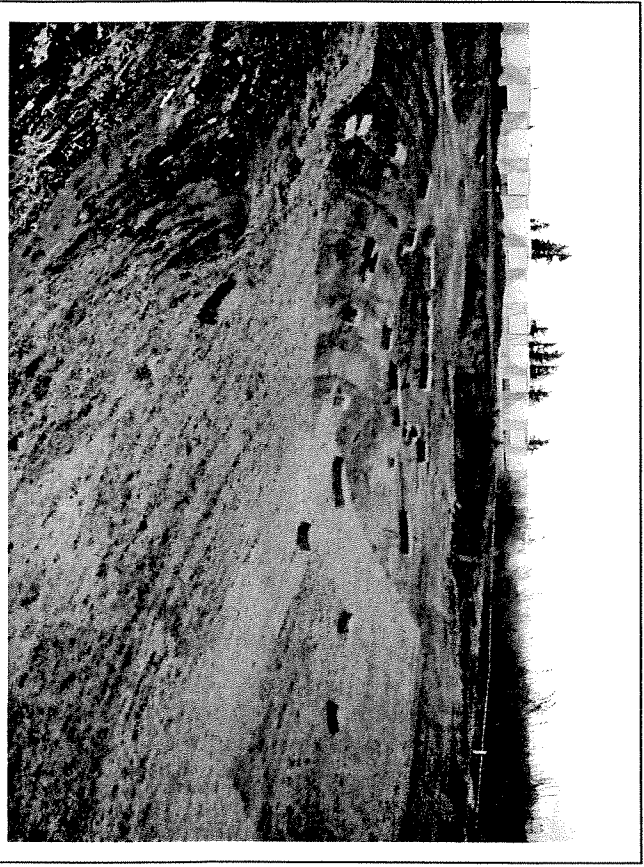
10/25/01: Eastern portion of excavation pit after seed/straw application

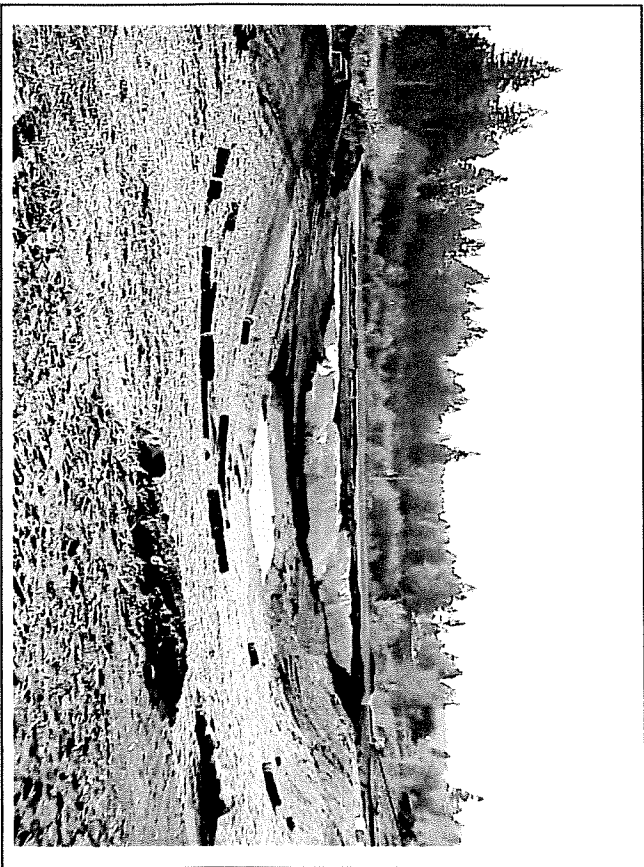
11/10/01: Pit from SE corner, shows NW section covered with plastic for winter

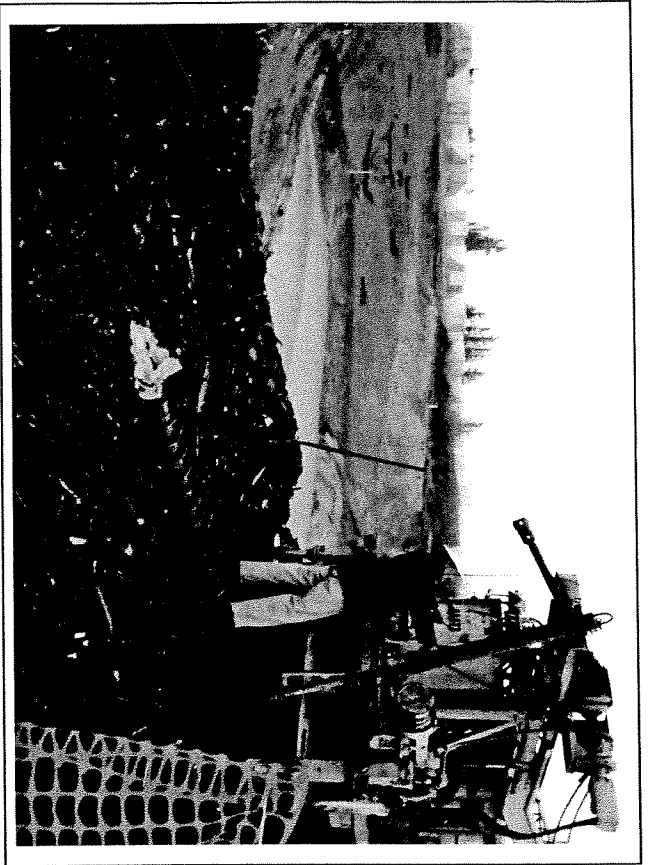
4/9/02: Exploratory borings along the NW corner of the excavation pit

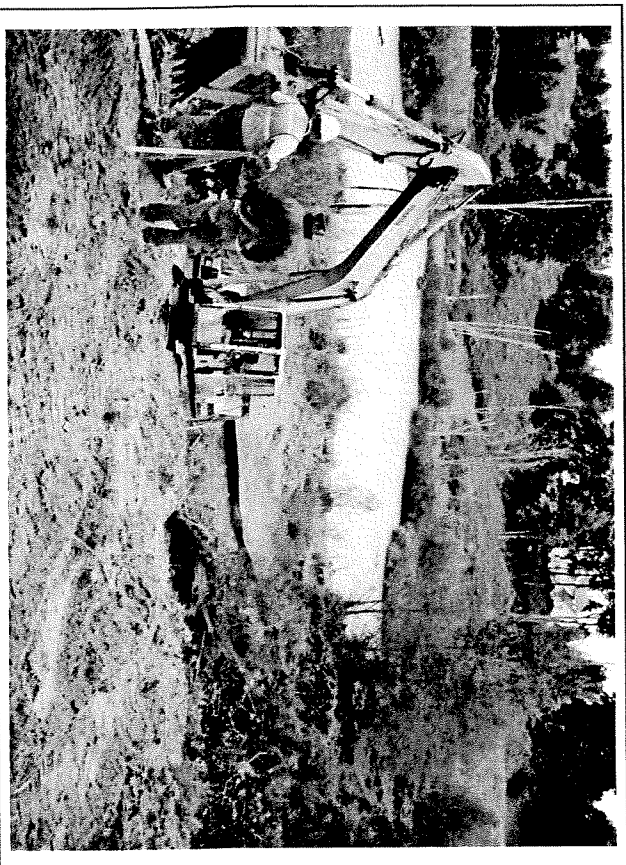
8/16/02: Digging test pit on hillside; Central Kettle visible

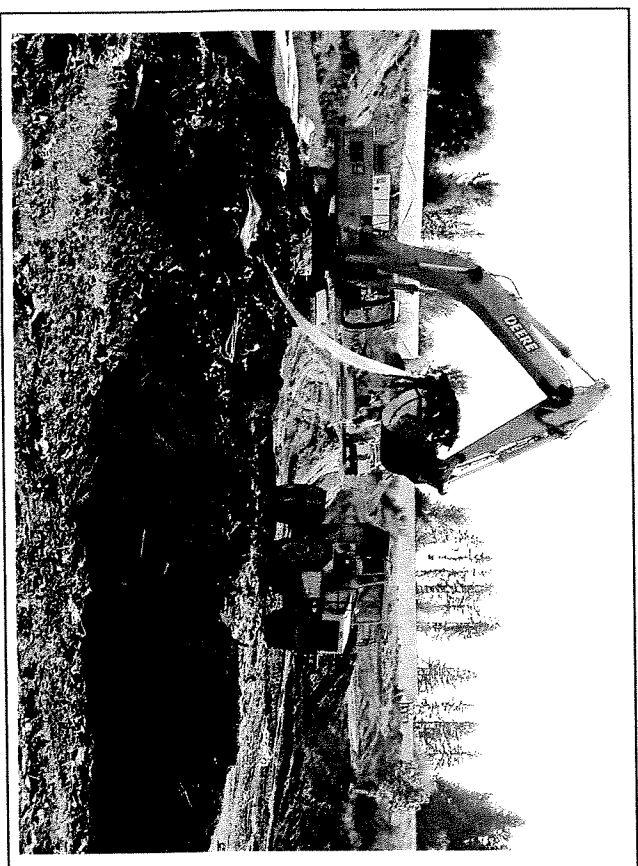
9/24/02: Excavation in process near southwest corner; loading debris (plastic)

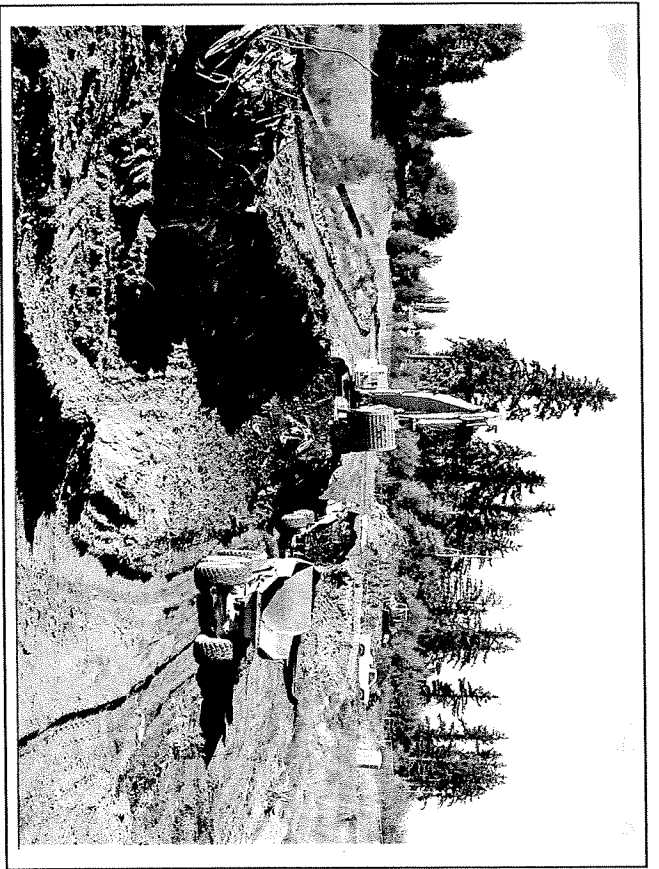
9/25/02: Excavation in process; looking north toward Waste Debris Area

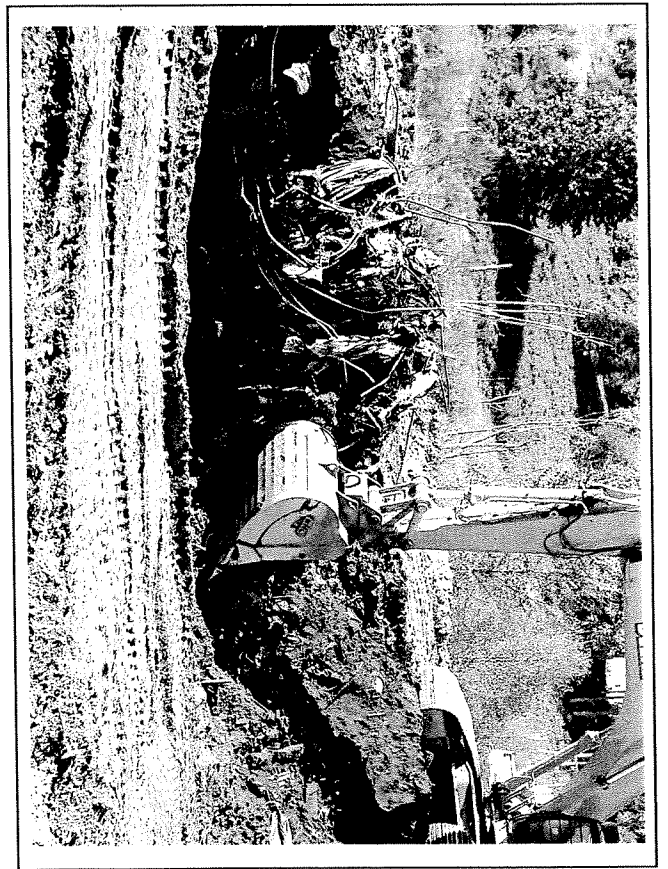
9/25/02: Thick debris along N-S access road, near TP-2

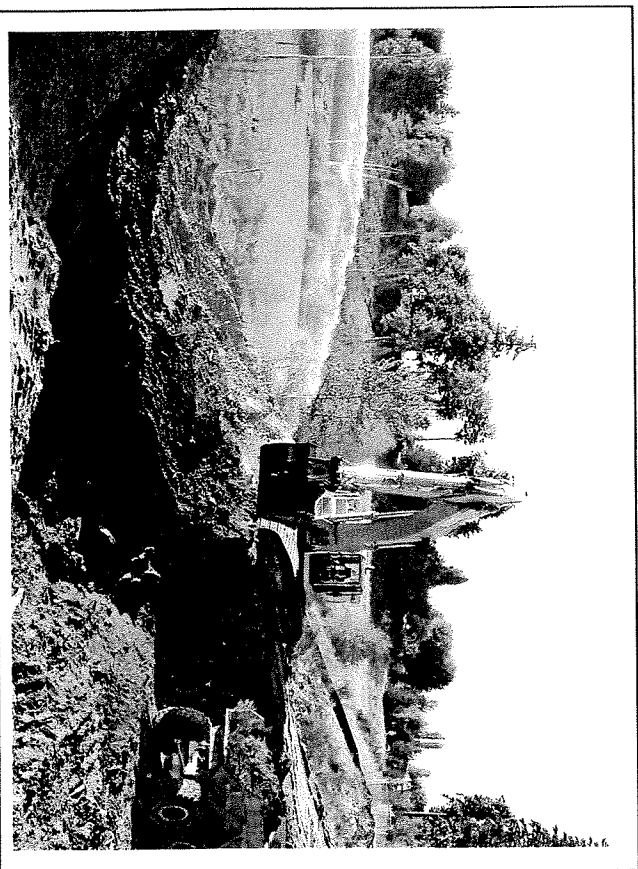
9/26/02: Dust control during excavation of hillside, near TP-2 area

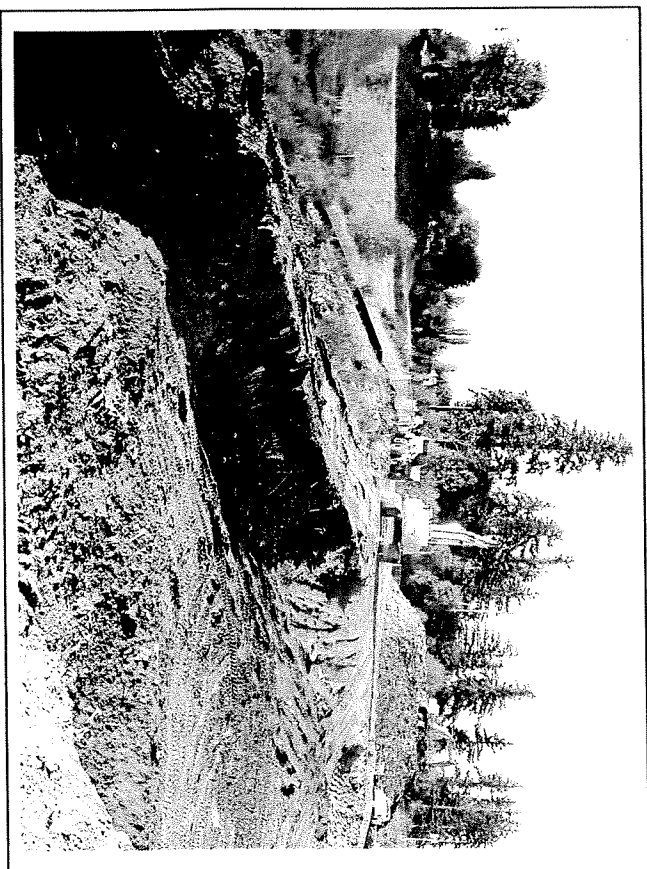
9/26/02: Line of excavation, looking north toward Waste Debris Area

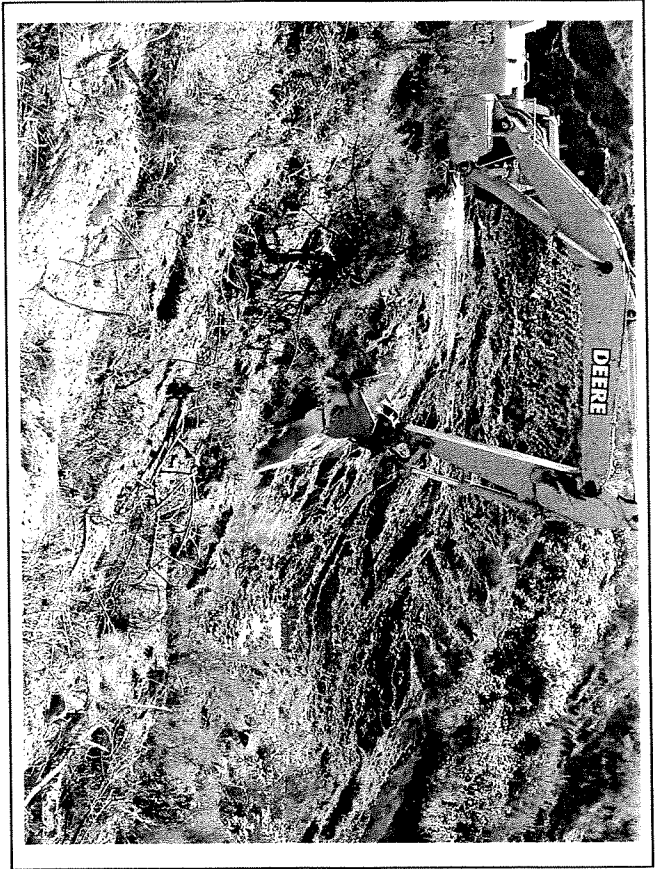
9/27/02: Clearing overburden material from hillside during excavation process

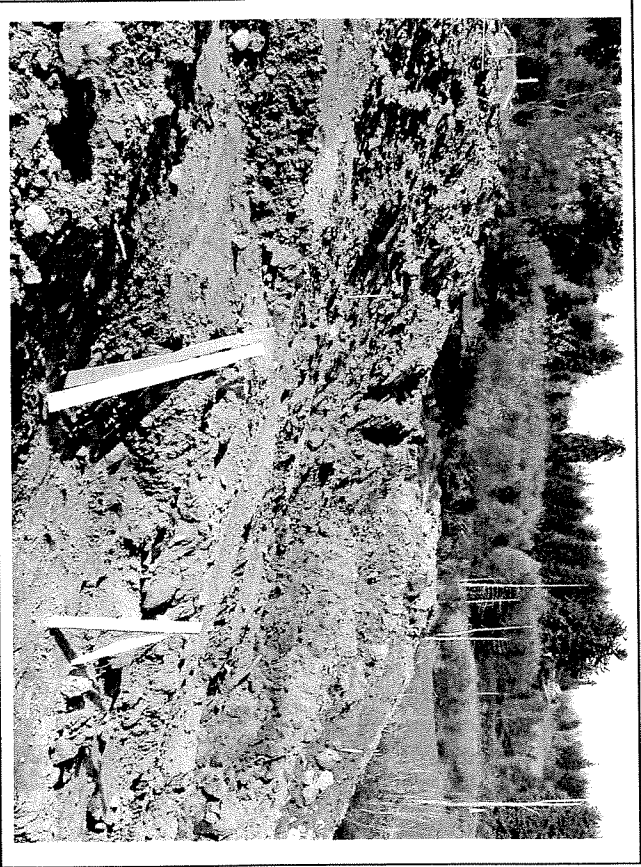
10/2/02: Grid sampling visible along southern portion of excavation area

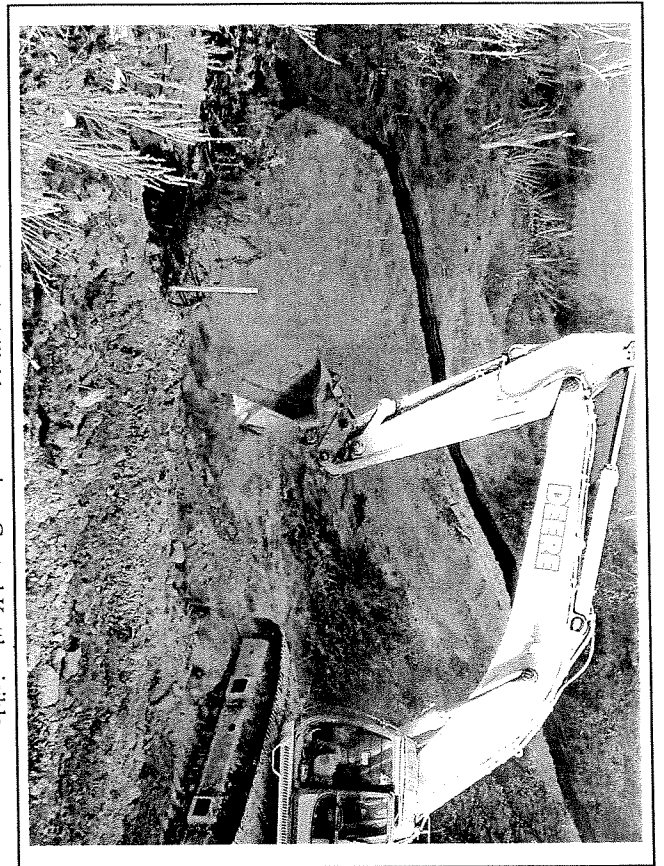
9/30/02: Extent of main hillside excavation; Central Kettle visible

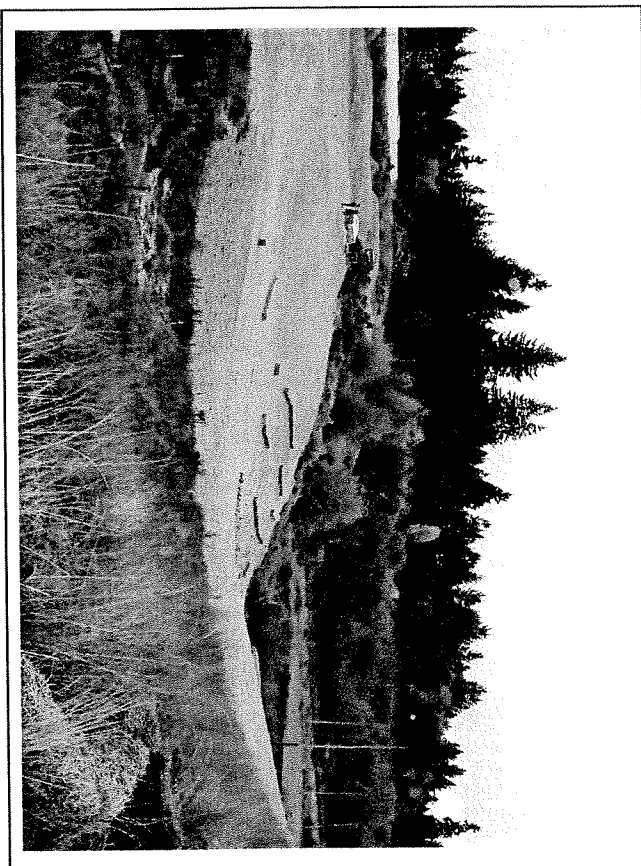
10/24/02: Excavation pit after hydro-seed and straw application; Central Kettle visible
