**REPORT  
OF  
PHASE II ENVIRONMENTAL SITE ASSESSMENT**

**PHASE II ENVIRONMENTAL SITE ASSESSMENT:  
SUBSURFACE INVESTIGATION FOR REGULATED SUBSTANCES  
Yakima Goodwill Industries Site  
222 South 3rd Street  
Yakima, Washington**

**City of Yakima  
424 East Yakima Avenue  
Suite 100  
Yakima, Washington 98901**

**Huntingdon Engineering and Environmental  
P.O. Box 2601  
Tri-Cities, Washington  
(509) 547-1671**

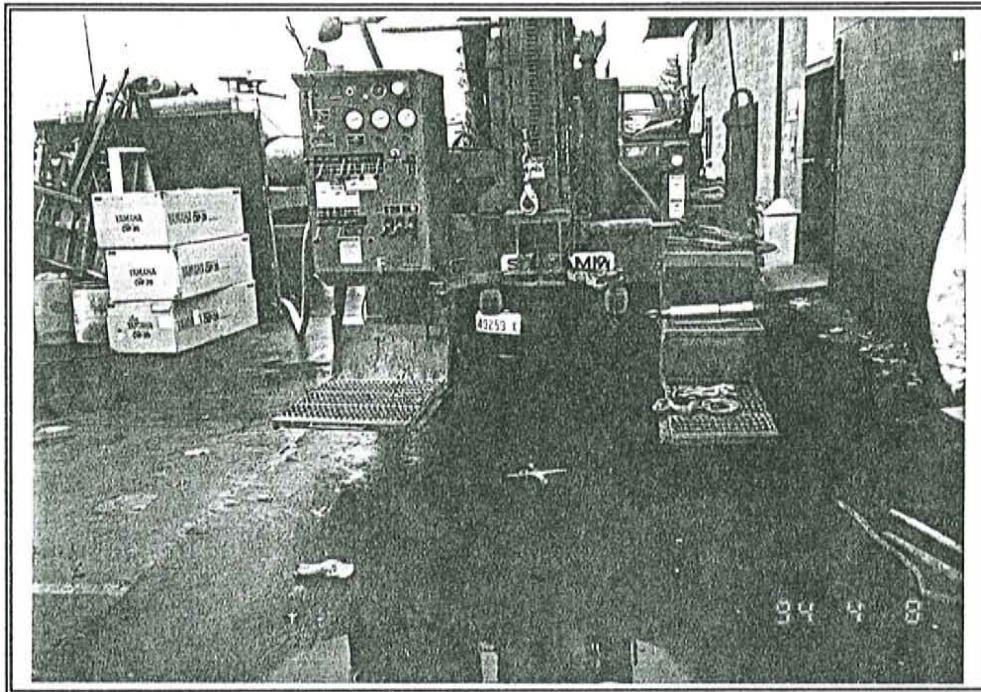
VIEW: Drill rig setting up over B-1/MW-1 in receiving area north of the store.

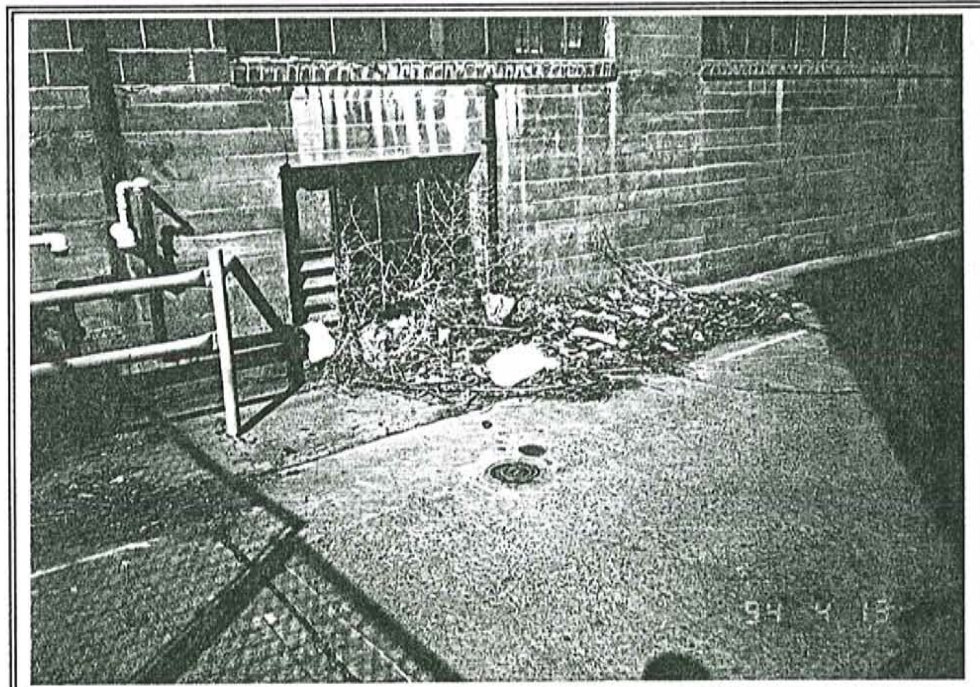
VIEW: Monitoring well LW-4.
