**PHASE III ENVIRONMENTAL REMEDIATION
YAKIMA GOODWILL INDUSTRIES SITE
222 SOUTH THIRD STREET
YAKIMA, WASHINGTON**

**PART 2 OF 2
MAPS, TABLES, APPENDICES**

**Prepared by:
Rachel Tauman, Project Scientist & Manager
HUNTINGDON ENGINEERING AND ENVIRONMENTAL, INC.
Consulting Engineers & Scientists
2214 North 4th Avenue
Pasco, Washington
(509) 547-1671
February, 1995**

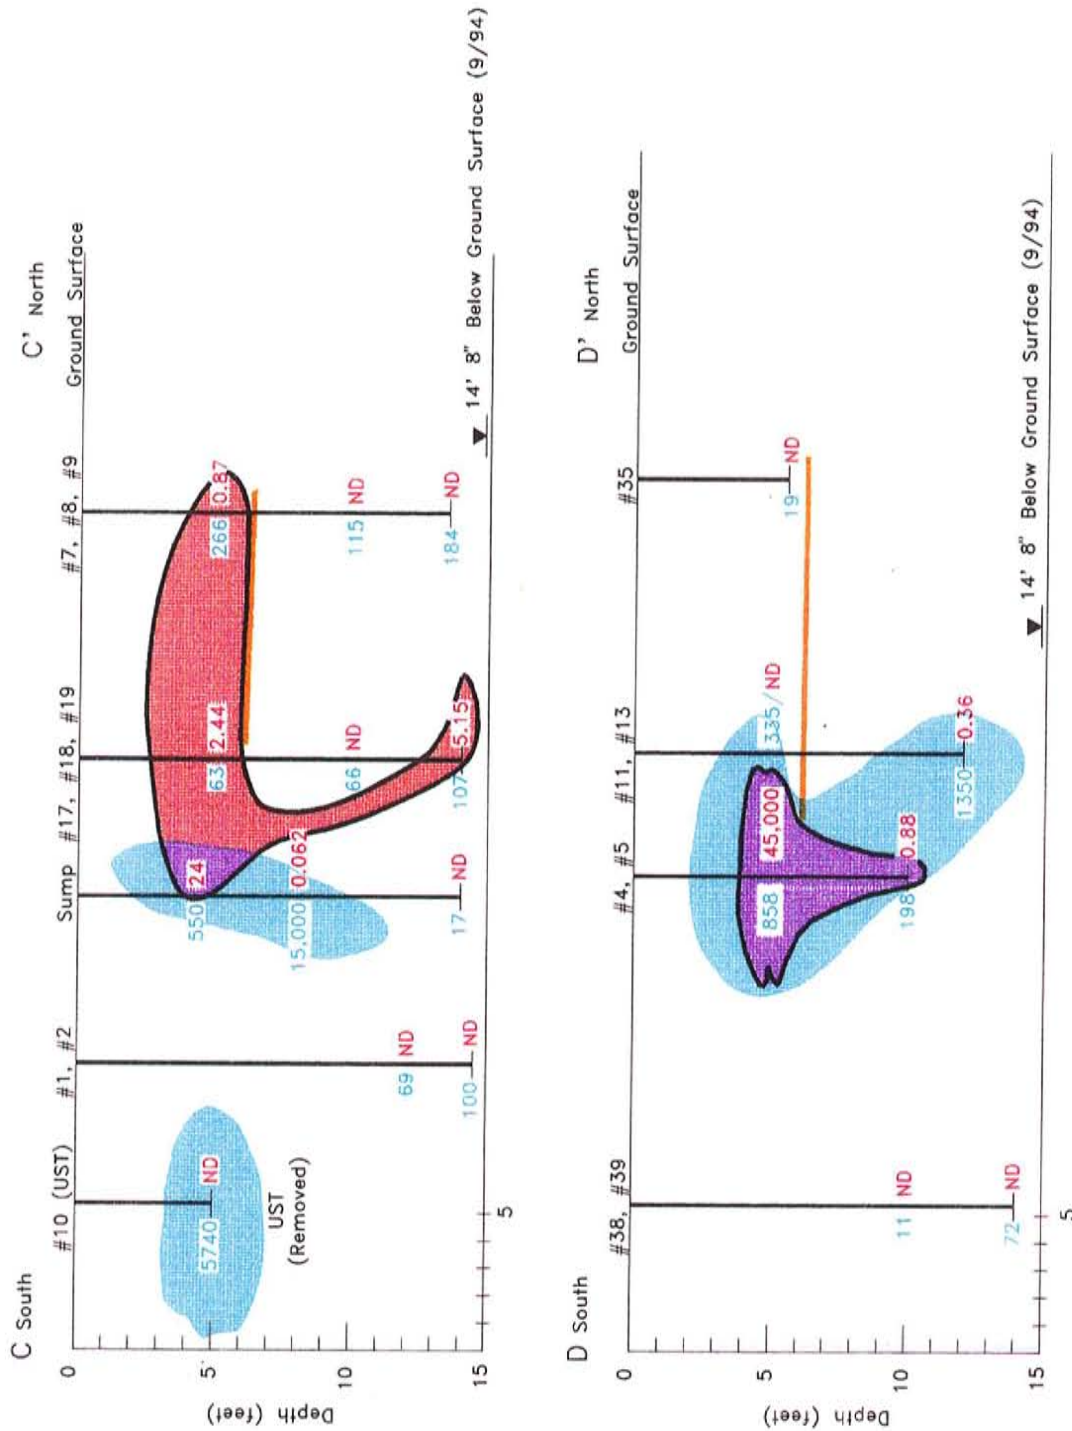
Cross Sections C-C' and D-D'
Yakima Goodwill Industries
222 South 3rd Street
Yakima, Washington
FIGURE 6

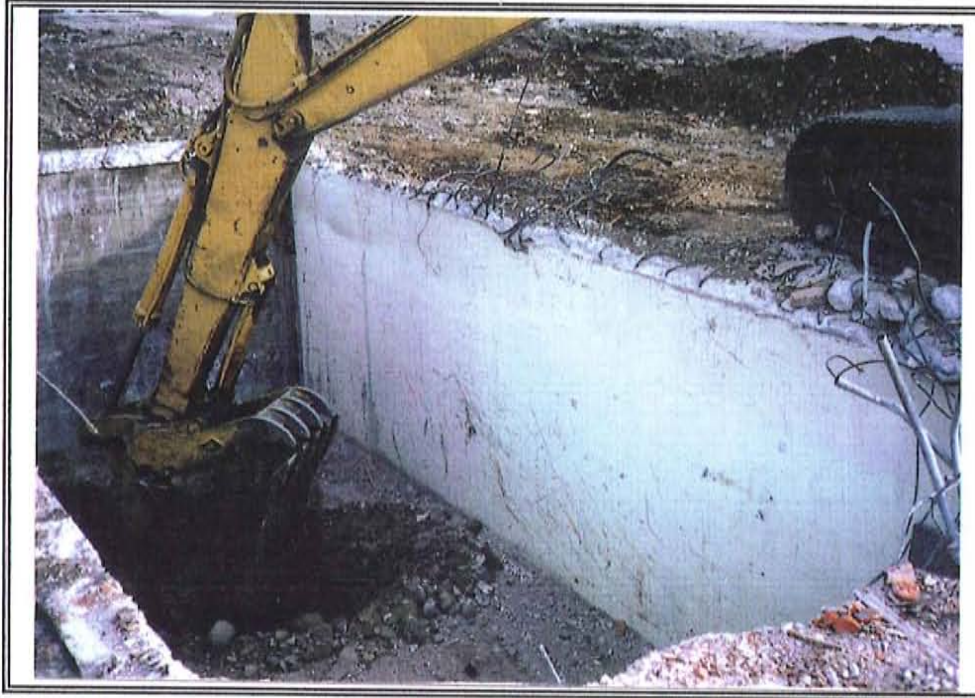
VIEW: Excavated beneath the basement.

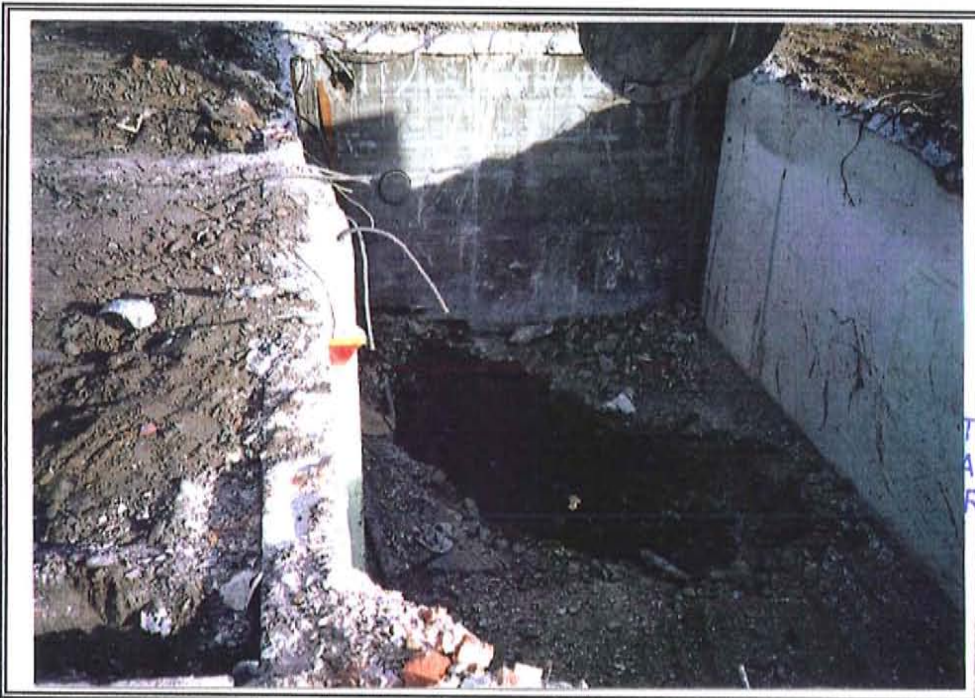
VIEW: Excavated basement and corehole in the wall.

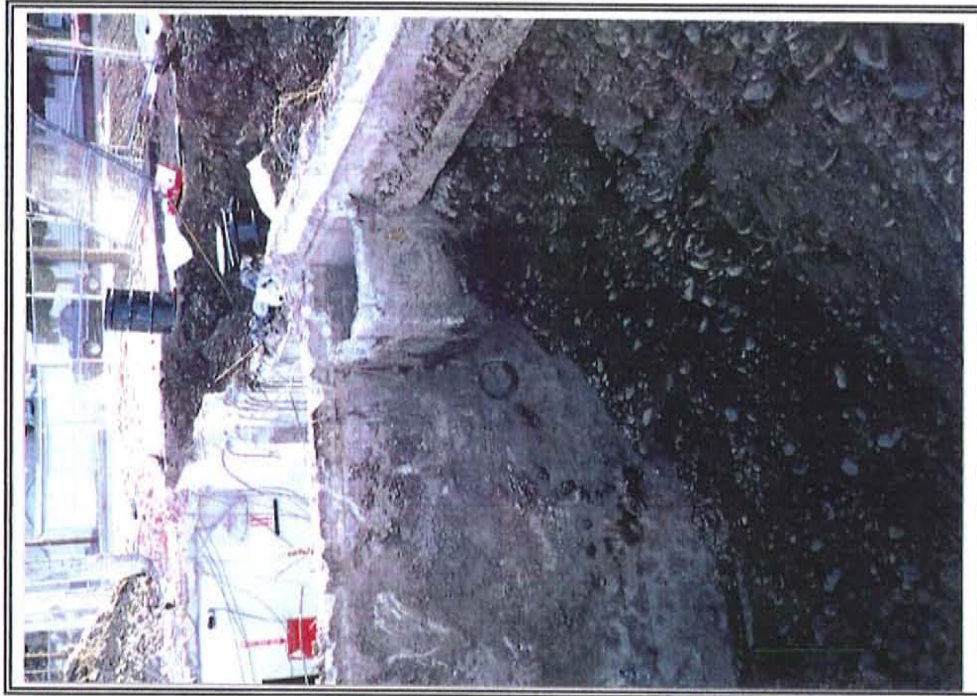
PHOTOGRAPHER: Rachel Tauman
DATE: 10-12-94
VIEW: Excavation beneath the sump
 and old basement.

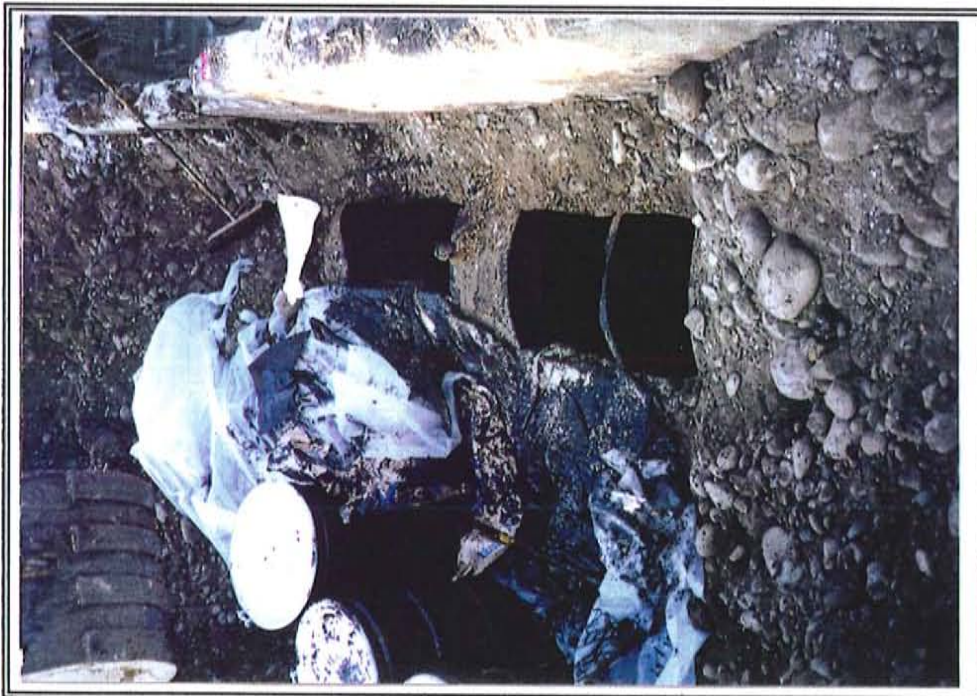
PHOTOGRAPHER: Rachel Tauman
DATE: 10-12-94
VIEW: UST in the alley south of the
 sump.

The UST was carefully uncovered and remaining product was removed. Approximately 250 gallons of liquid and sludge was removed from the tank. After inerting the tank with dry ice, the tank is cut opened and cleaned in-place. Once removed from the excavation, the tank is inspected for signs of leakage. The tank was examined for visible cracks, seam failures, severe rusting, and staining. Staining was observed on the tank and appeared to be present around the fill spout.

An environmental professional from Huntingdon arrived at the site to observe UST removal activities and to perform a UST site assessment on October 13, 1994. The tank had been uncovered and had been cleaned in-place. After being removed from the ground, the tank was inspected for signs of leakage. The tank appeared to be in good condition with no signs of rusting and/or pitting. Physical information pertaining to the tank is presented in Table 1.

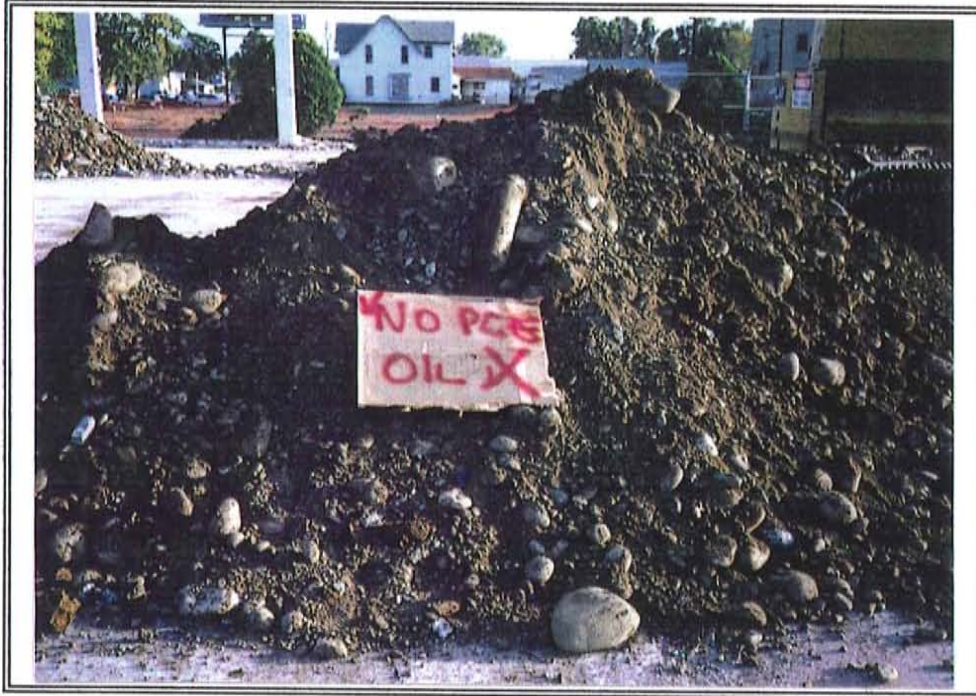
VIEW: Stockpile of excavated TPH contaminated soil (No PCE).

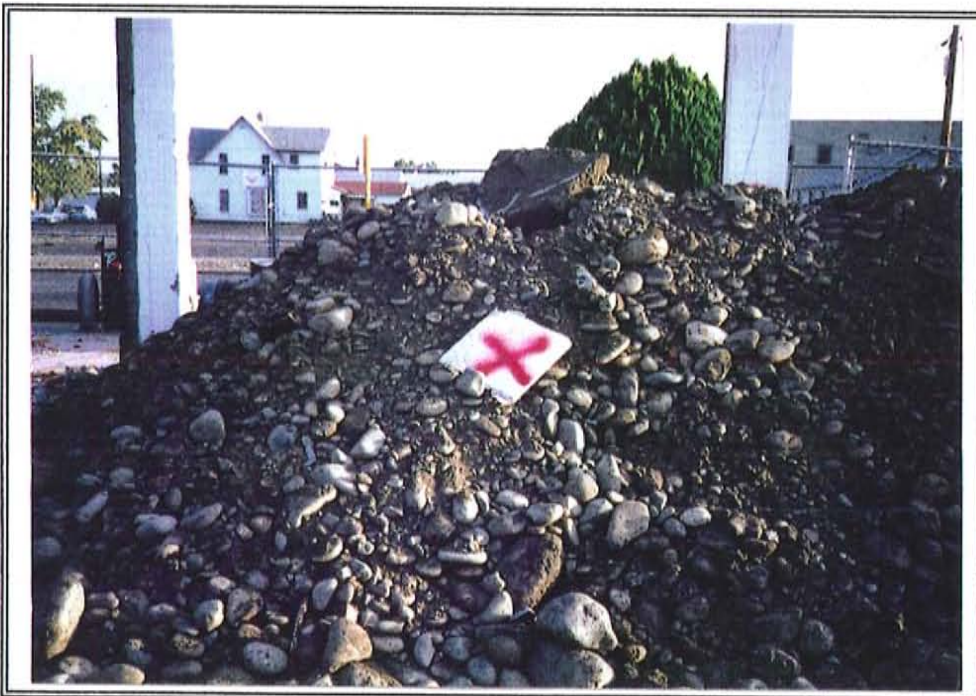
VIEW: Stockpile of PCE contaminated soil.

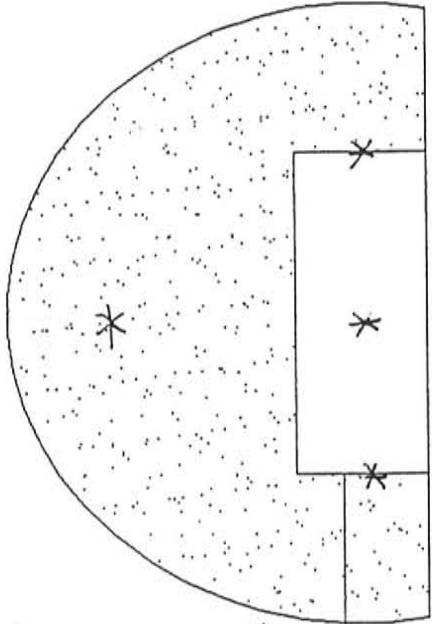
EXCAVATION
BOUNDARY ↗

BASEMENT

Overexcavation activities were initiated, due to the presence of stained and odorous soil. The excavation was extended to the north, south and west and to a depth of 8 feet below ground surface. Evidence of staining or odorous soil was not apparent after the overexcavation activities were complete. The final dimensions of the excavation are depicted in the Detailed Site Plan (Appendix 1, Figure 2).

Representative soil samples were obtained from the boundaries of the tank excavation after overexcavation was completed and from stockpiled soil. The sample exhibiting the worst staining and odor was analyzed for total petroleum hydrocarbon identification and found to be in the range of heavy oils. All samples were analyzed by Transglobal Environmental Geosciences Northwest, Inc. Analytical results are summarized in Table 2 while the laboratory reports are contained in Appendix 2. Sample locations are shown on Figure 2 (Appendix 1).
