Custom Plywood Mill Site Anacortes Interim Action Cleanup Plan

Open House and Public Meeting

February 24, 2011

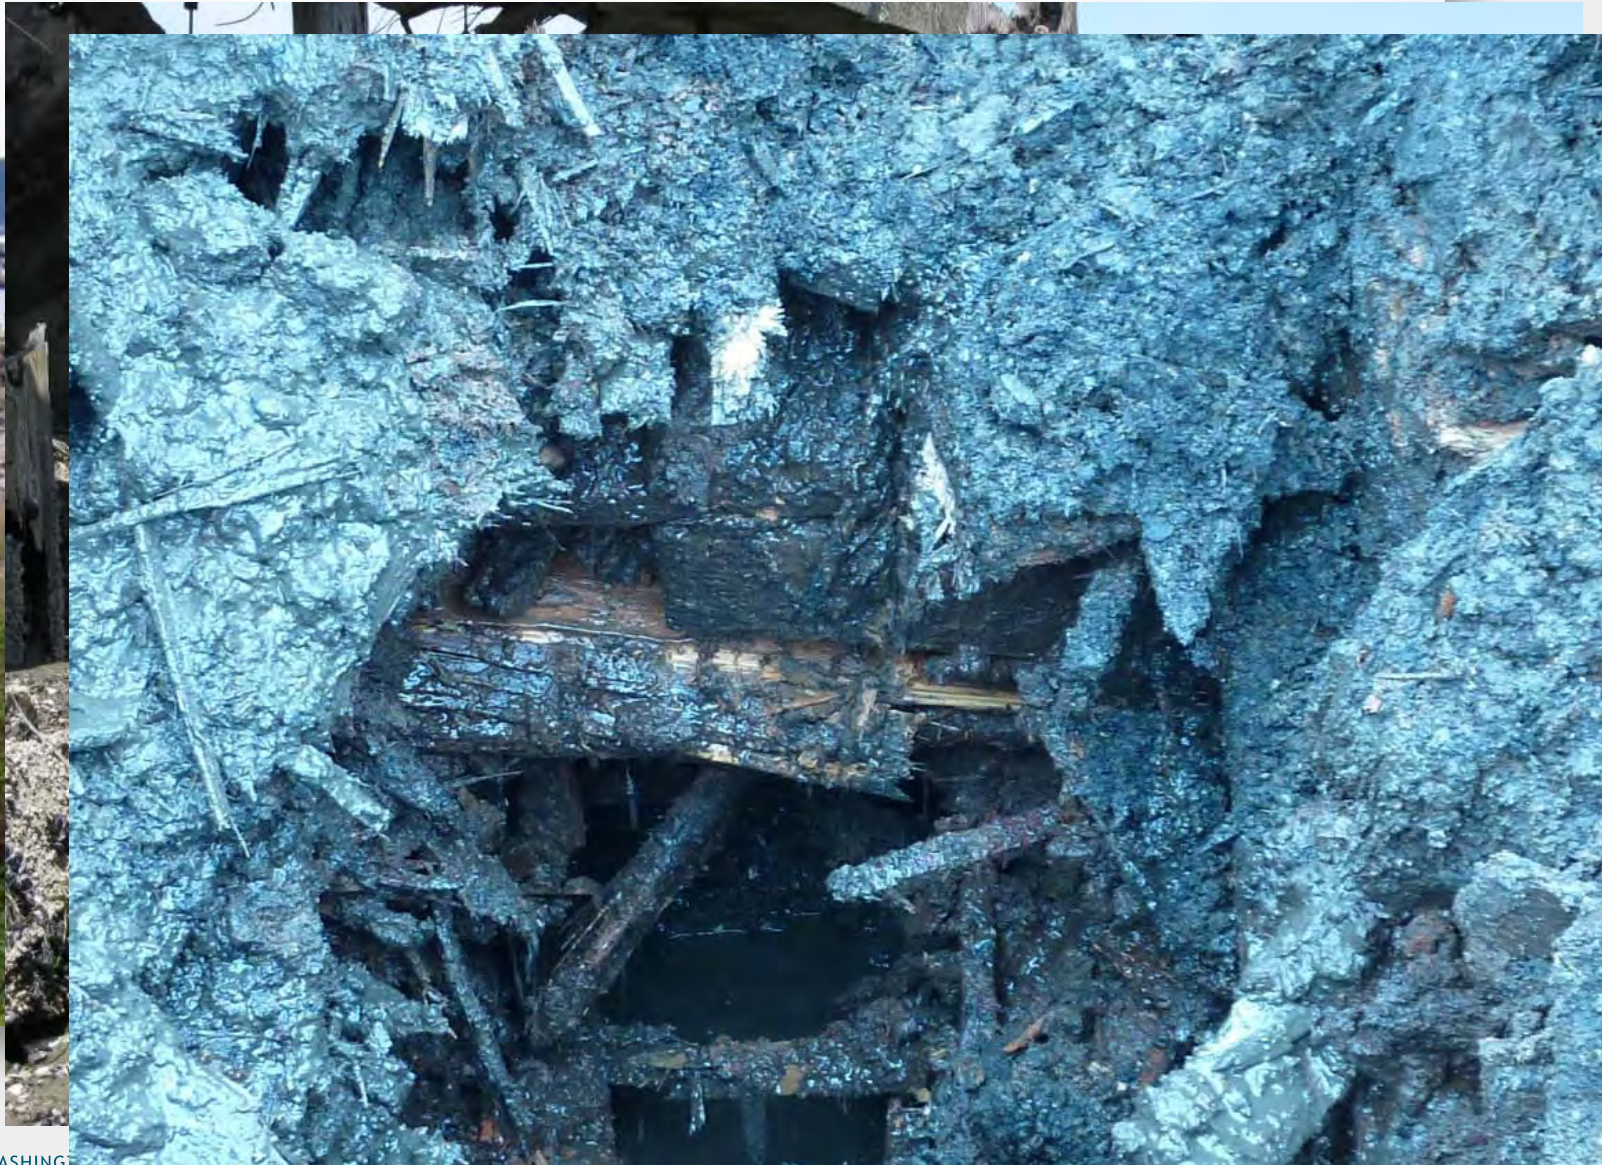
Custom Plywood Site – Current View

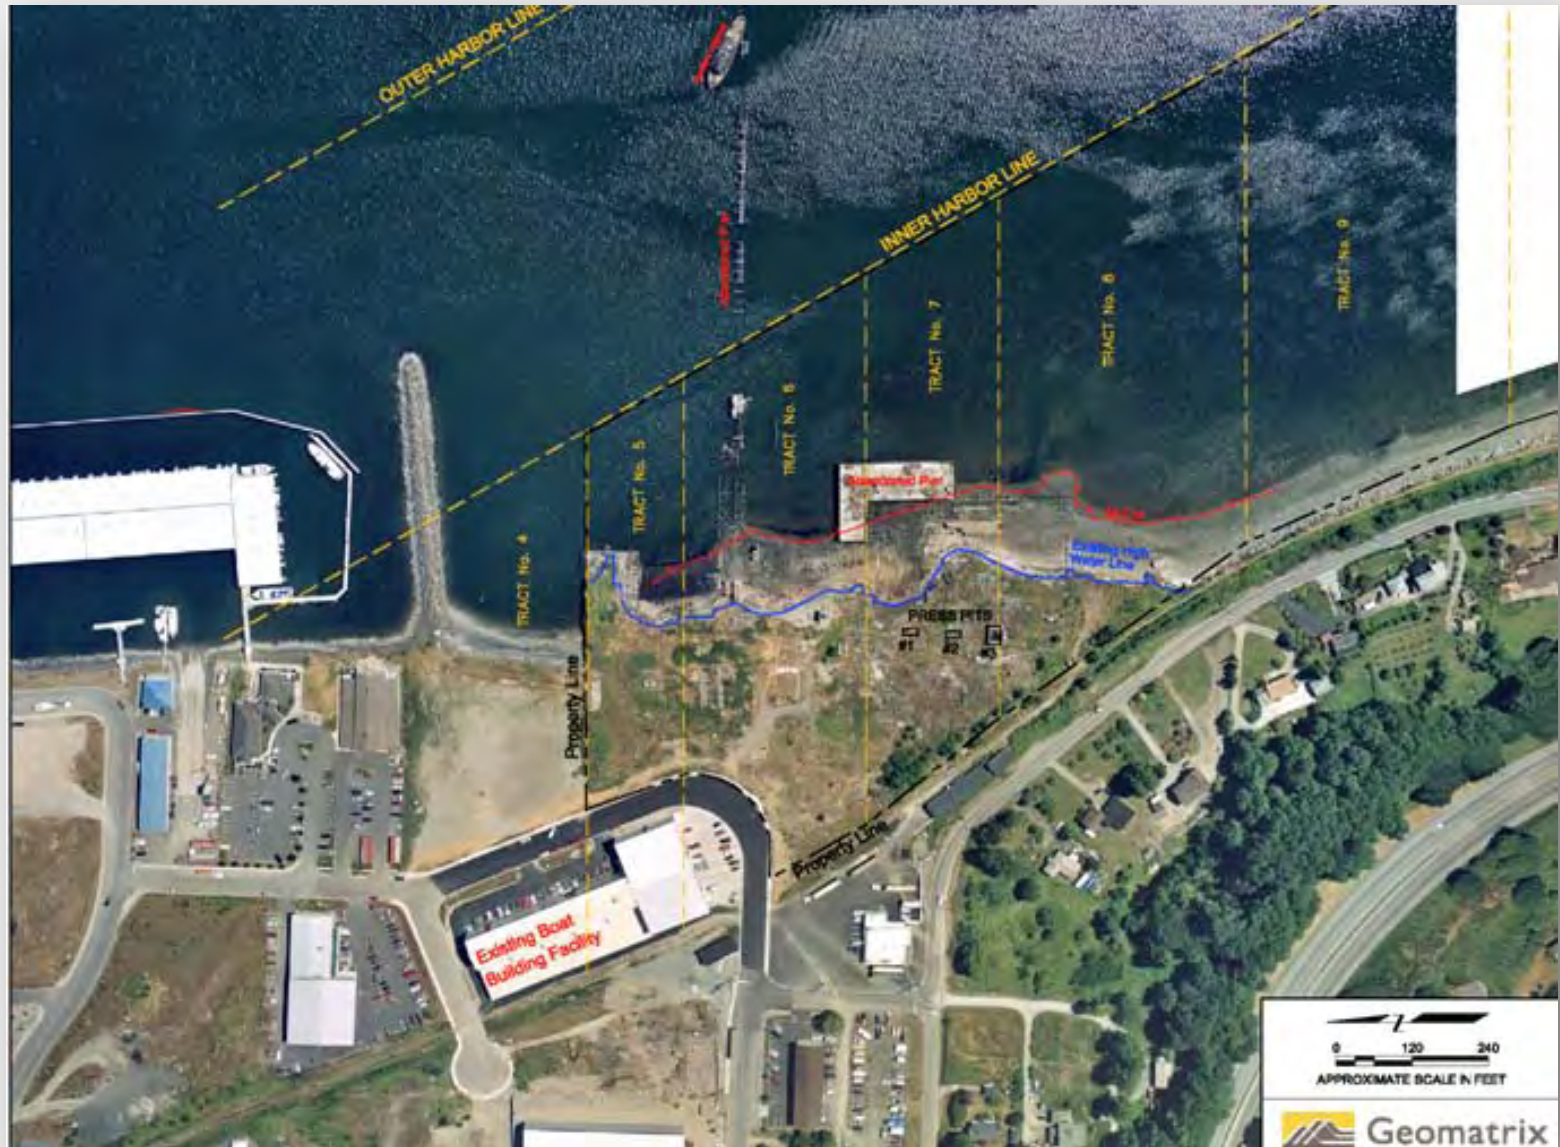
12

Custom Plywood Aerial Photo: Site Lay-out

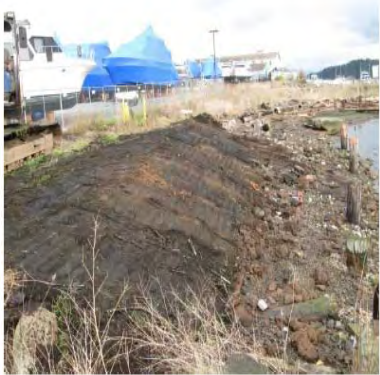
Photograph 3 Final grade before geotextile is laid down.

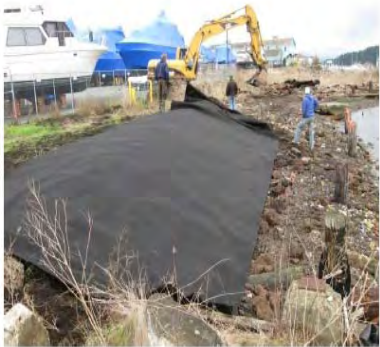
Photograph 4 Rolling out geotextile.

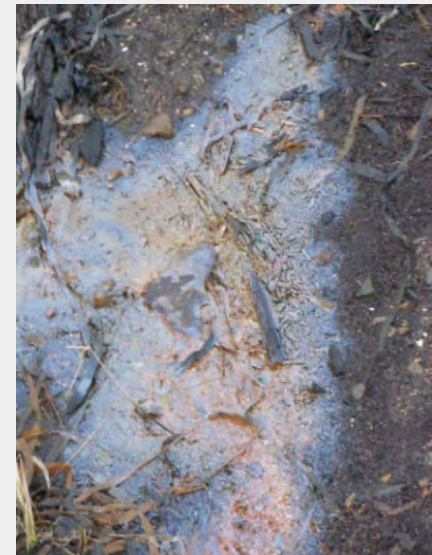
- On-going shoreline erosion leading to contaminant pathway into bay
- Significant environmental damage during January 2010 storm surge
- Urgent need to prevent further environmental damage through erosion and transport of contaminated materials to the Bay

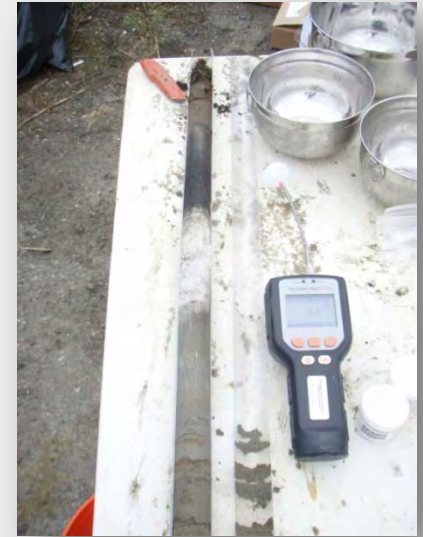
Aerial Extent of Impacted Soil

- Indicator Hazardous Substances
 - Soil:
 - ✓ Metals (As, Cd, Cu, Pb, Ni, Zn, Hg, etc.)
 - ✓ sVOCs: cPAHs, PCBs
 - ✓ TPH-Dx & lube oil range
 - Groundwater/Surface water (seep):
 - ✓ Metals (As, Cu, Ni, Zn, etc.)
 - ✓ sVOCs: cPAHs
 - ✓ TPH-Dx & lube oil range
- Magnitude of soil Impacted (estimated):
 - Area: 3.2 acre
 - Volume: 25,000 ~ 40,000 cy

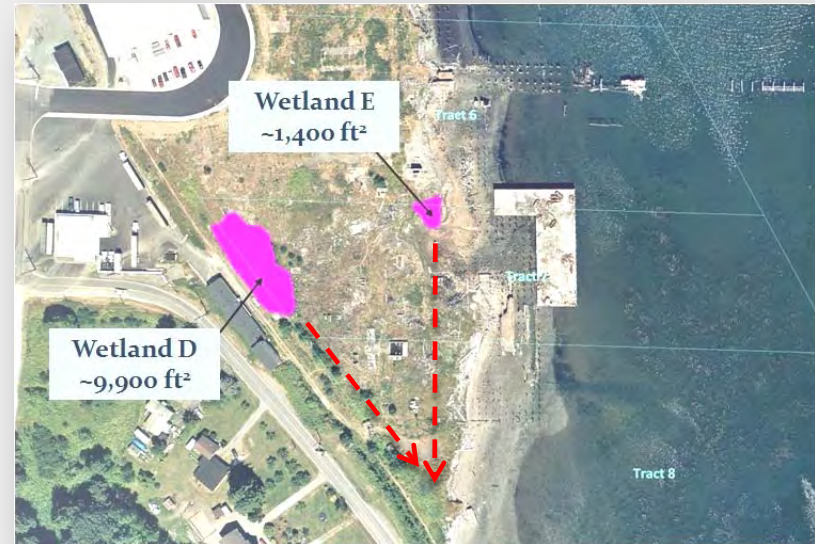
Wetland Mitigation Plan - Plan view

- Restore one consolidated on-site 12,000 sf Estuarine-type wetland
- Upland buffer (50 ~ 75 feet) in width – native vegetation
- Temporary berm along the opening at OHW line during upland construction
- Installation of stormwater swale
- Post-construction stormwater & confirmational monitoring & maintenance required

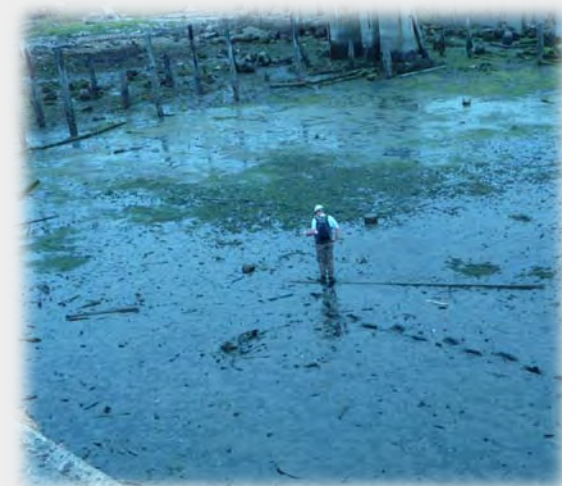
Bioassay failures

- **Indicator Hazardous Substances:**
 - **Bioassay Failure**
 - **Wood waste/debris @ nearshore area (deleterious impact)**
 - **Dioxins/Furans**
- **Sediment Area Impacted by Dioxin:**
 - **Approx. 440 Acre @> Fidalgo Bay Background Level (1.4 ppt)**
 - ✓ **22 Acre - greater than 10 ppt**
 - ✓ **3.2 Acre – greater than 25 ppt**
- **Sediment volume impacted by Dioxin:**
 - **19,000 cy: 10 ~ 24 ppt**
 - **1,400 cy: >25 ppt –**
- **Total wood waste volume: 50,000 cy**

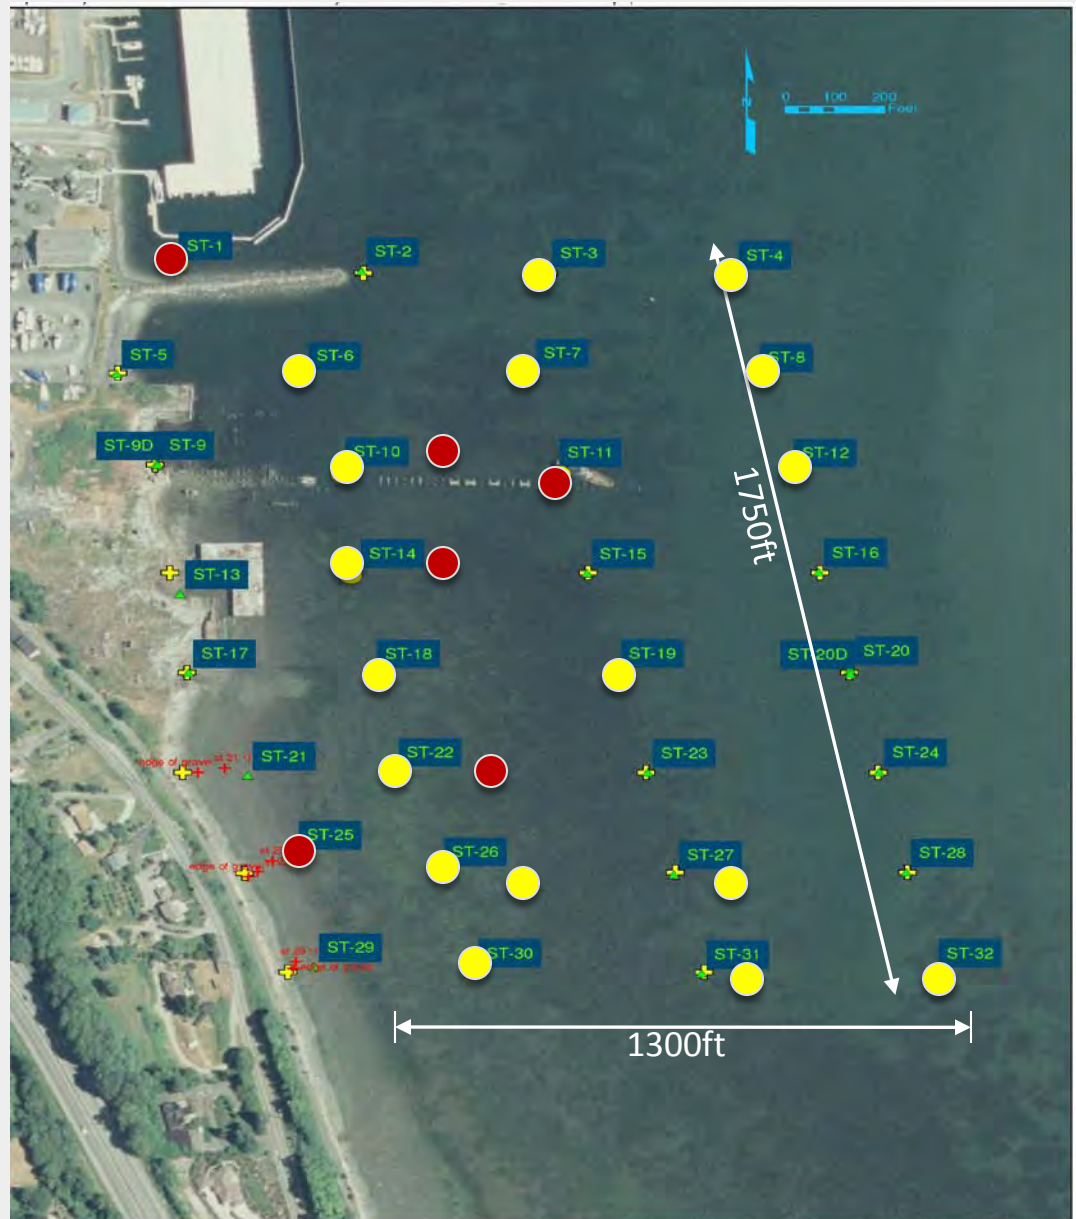
By: RHE	Date: 10/21/2008	Project No. 10554.001
AMEC Geomatrix		Figure 16

- + Proposed Sampling Locations
- + Attempted (failed) grabs
- ▲ Actual Sampling Locations
- CSL Failures

Note: Samples were collected by pneumatically operated grab sampler, except ST-5, ST-9, ST-9D, ST-13, and ST-17 were collected by hand.

**PROPOSED AND ACTUAL SEDIMENT
SAMPLE LOCATIONS**
Former Custom Plywood Mill
Anacortes, Washington

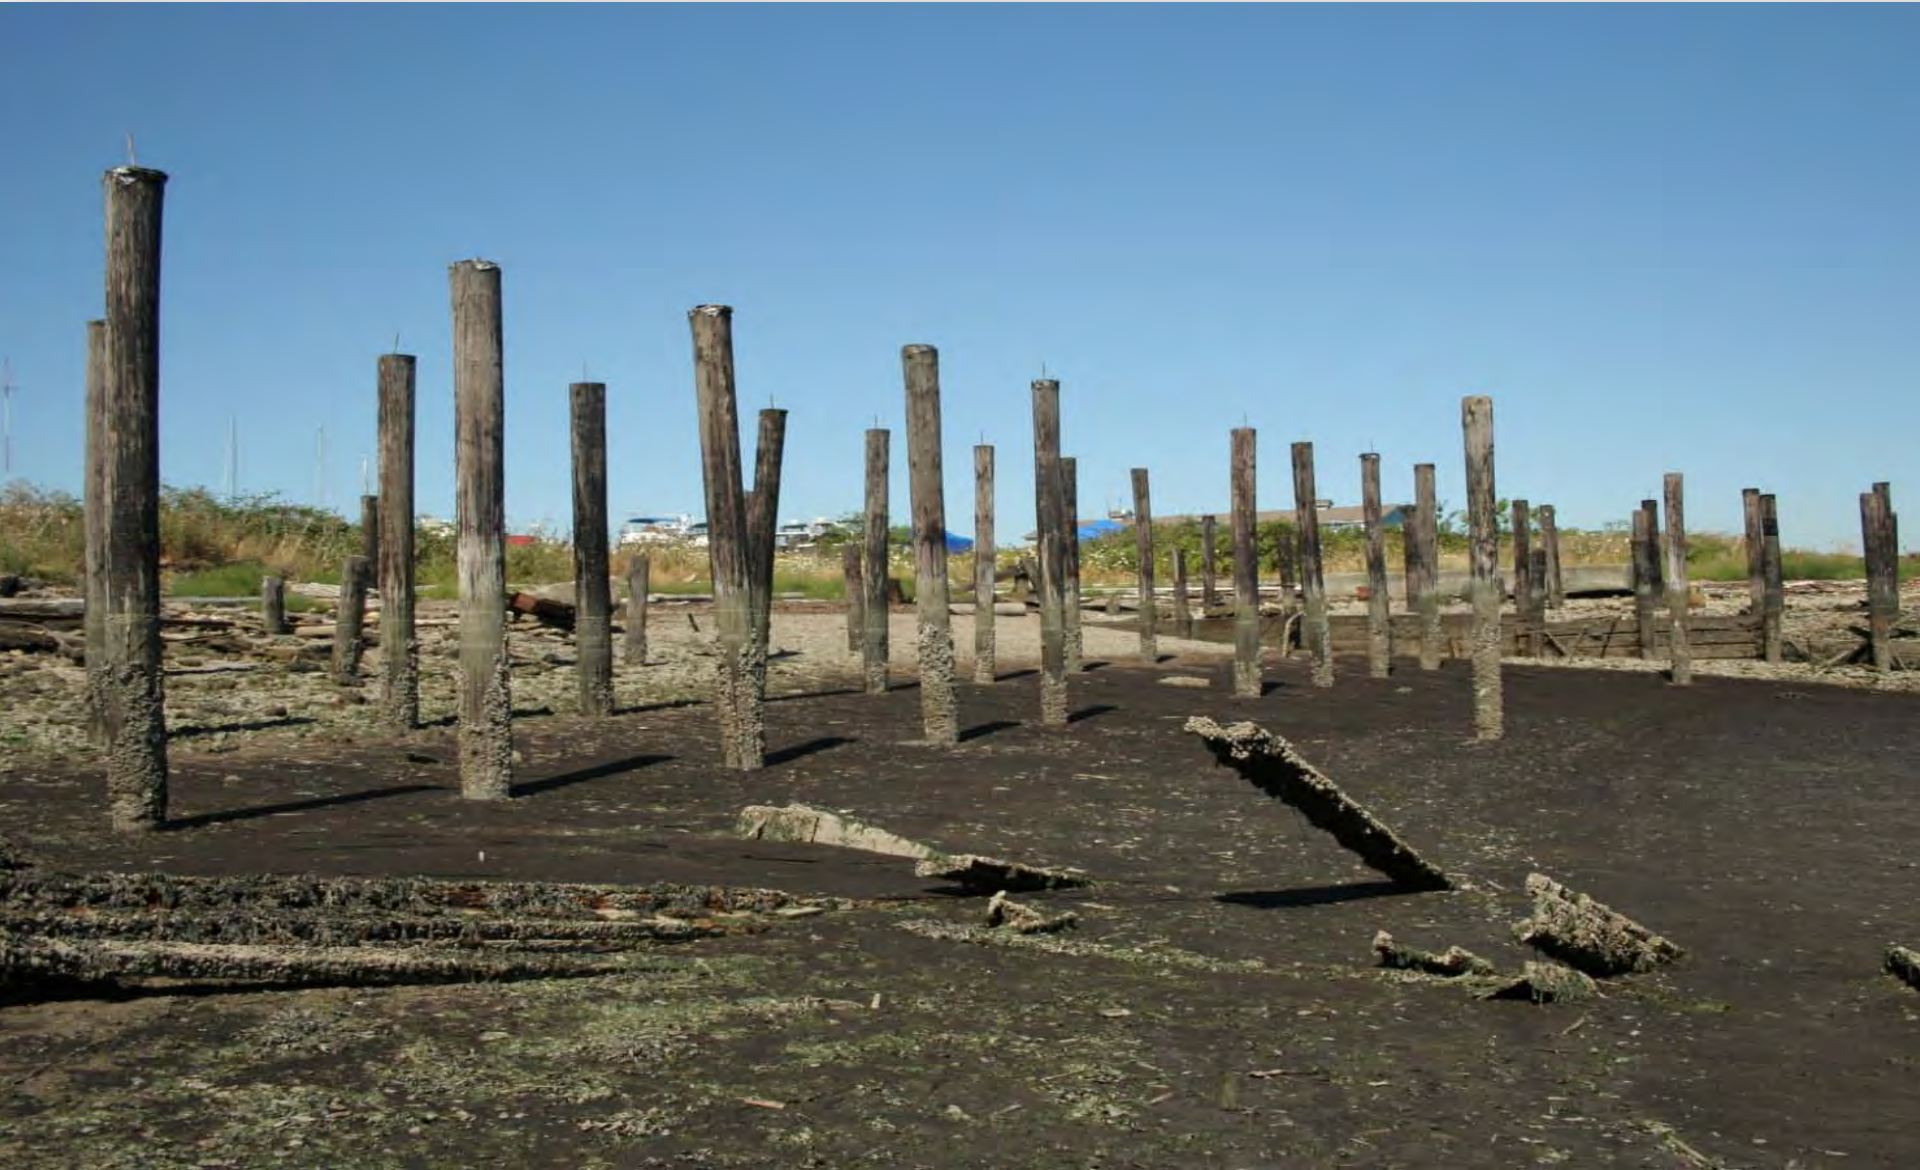
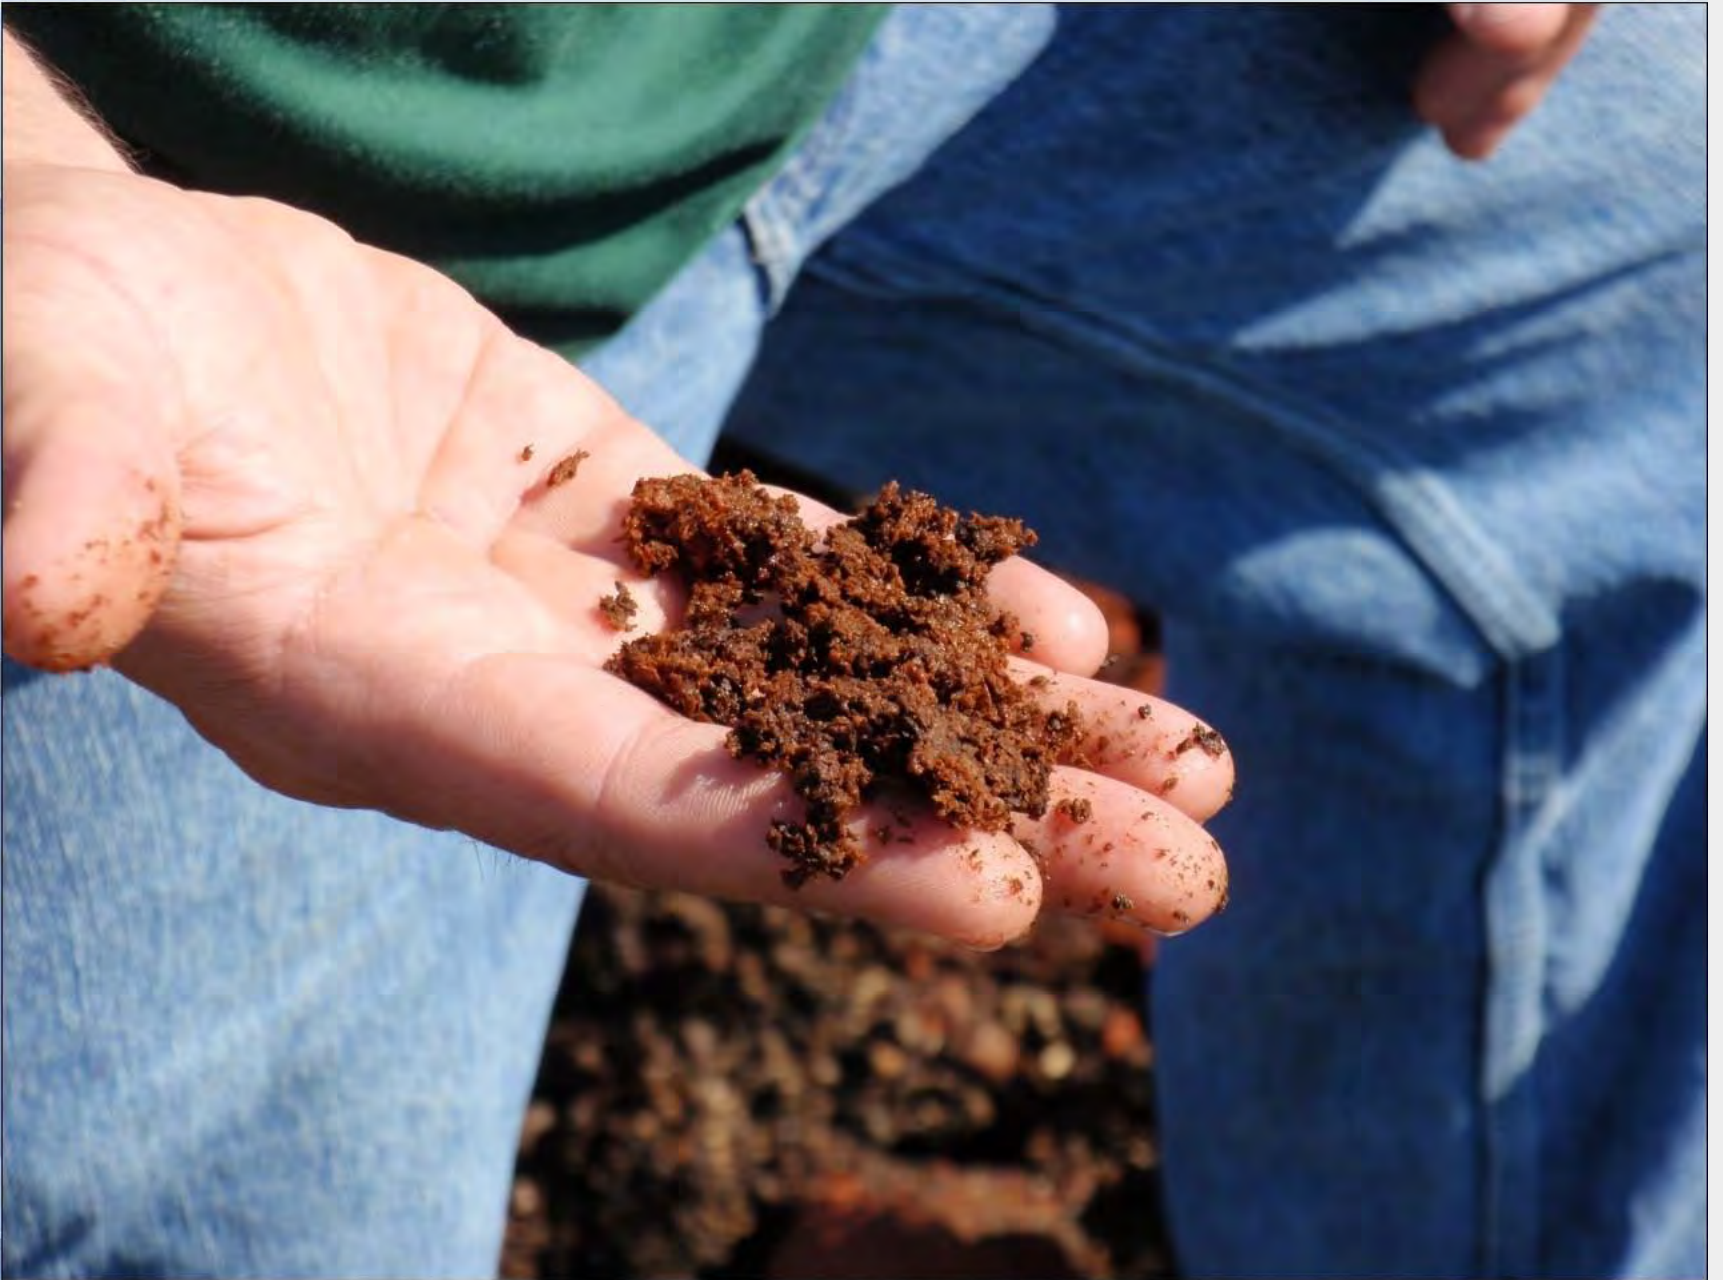
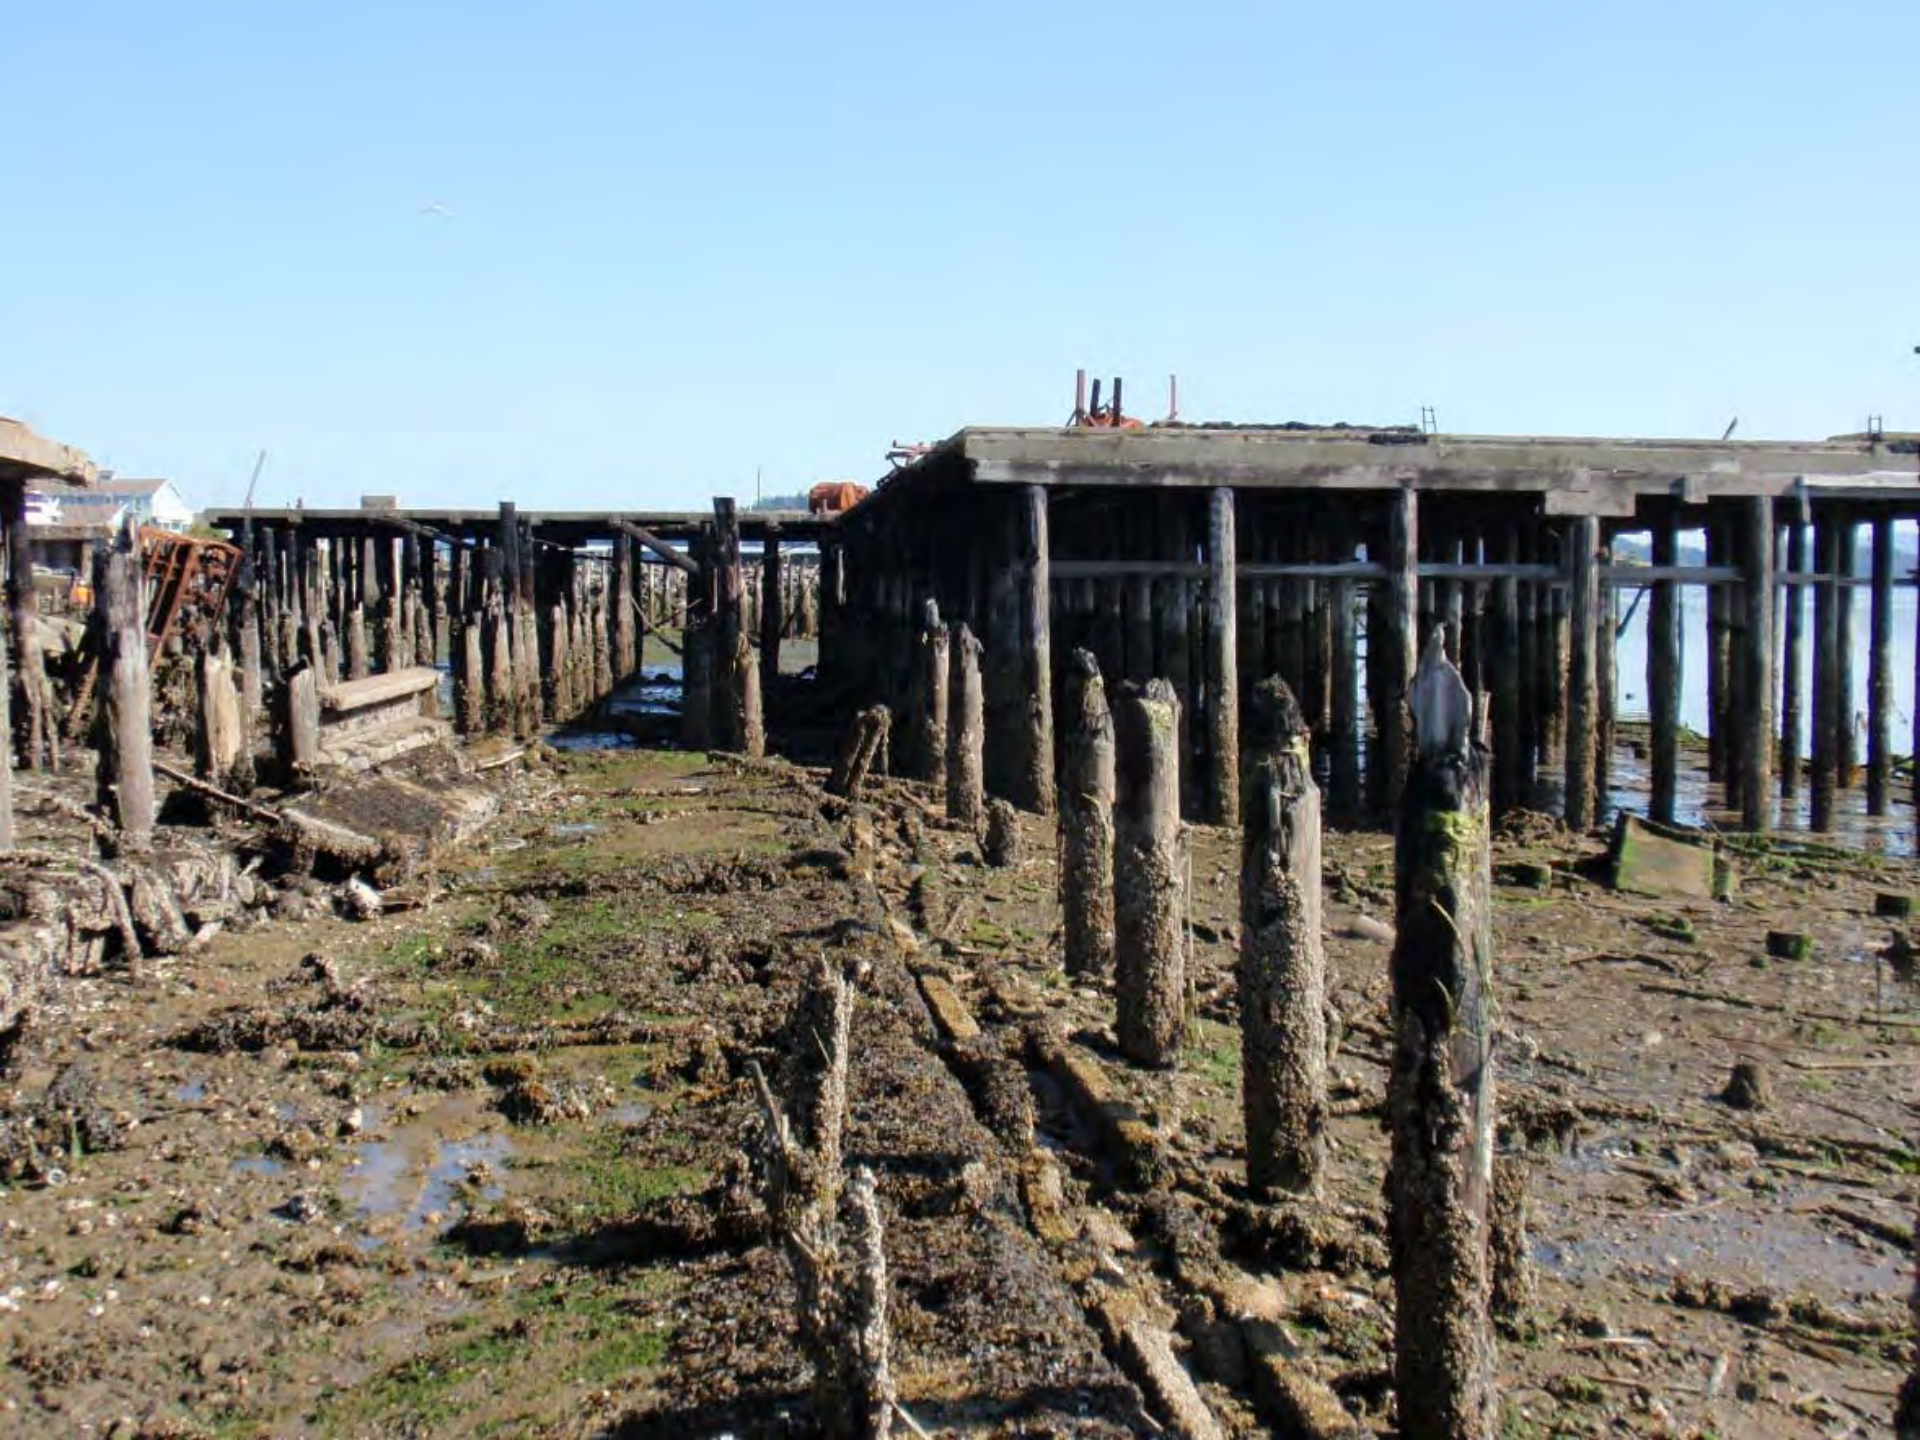
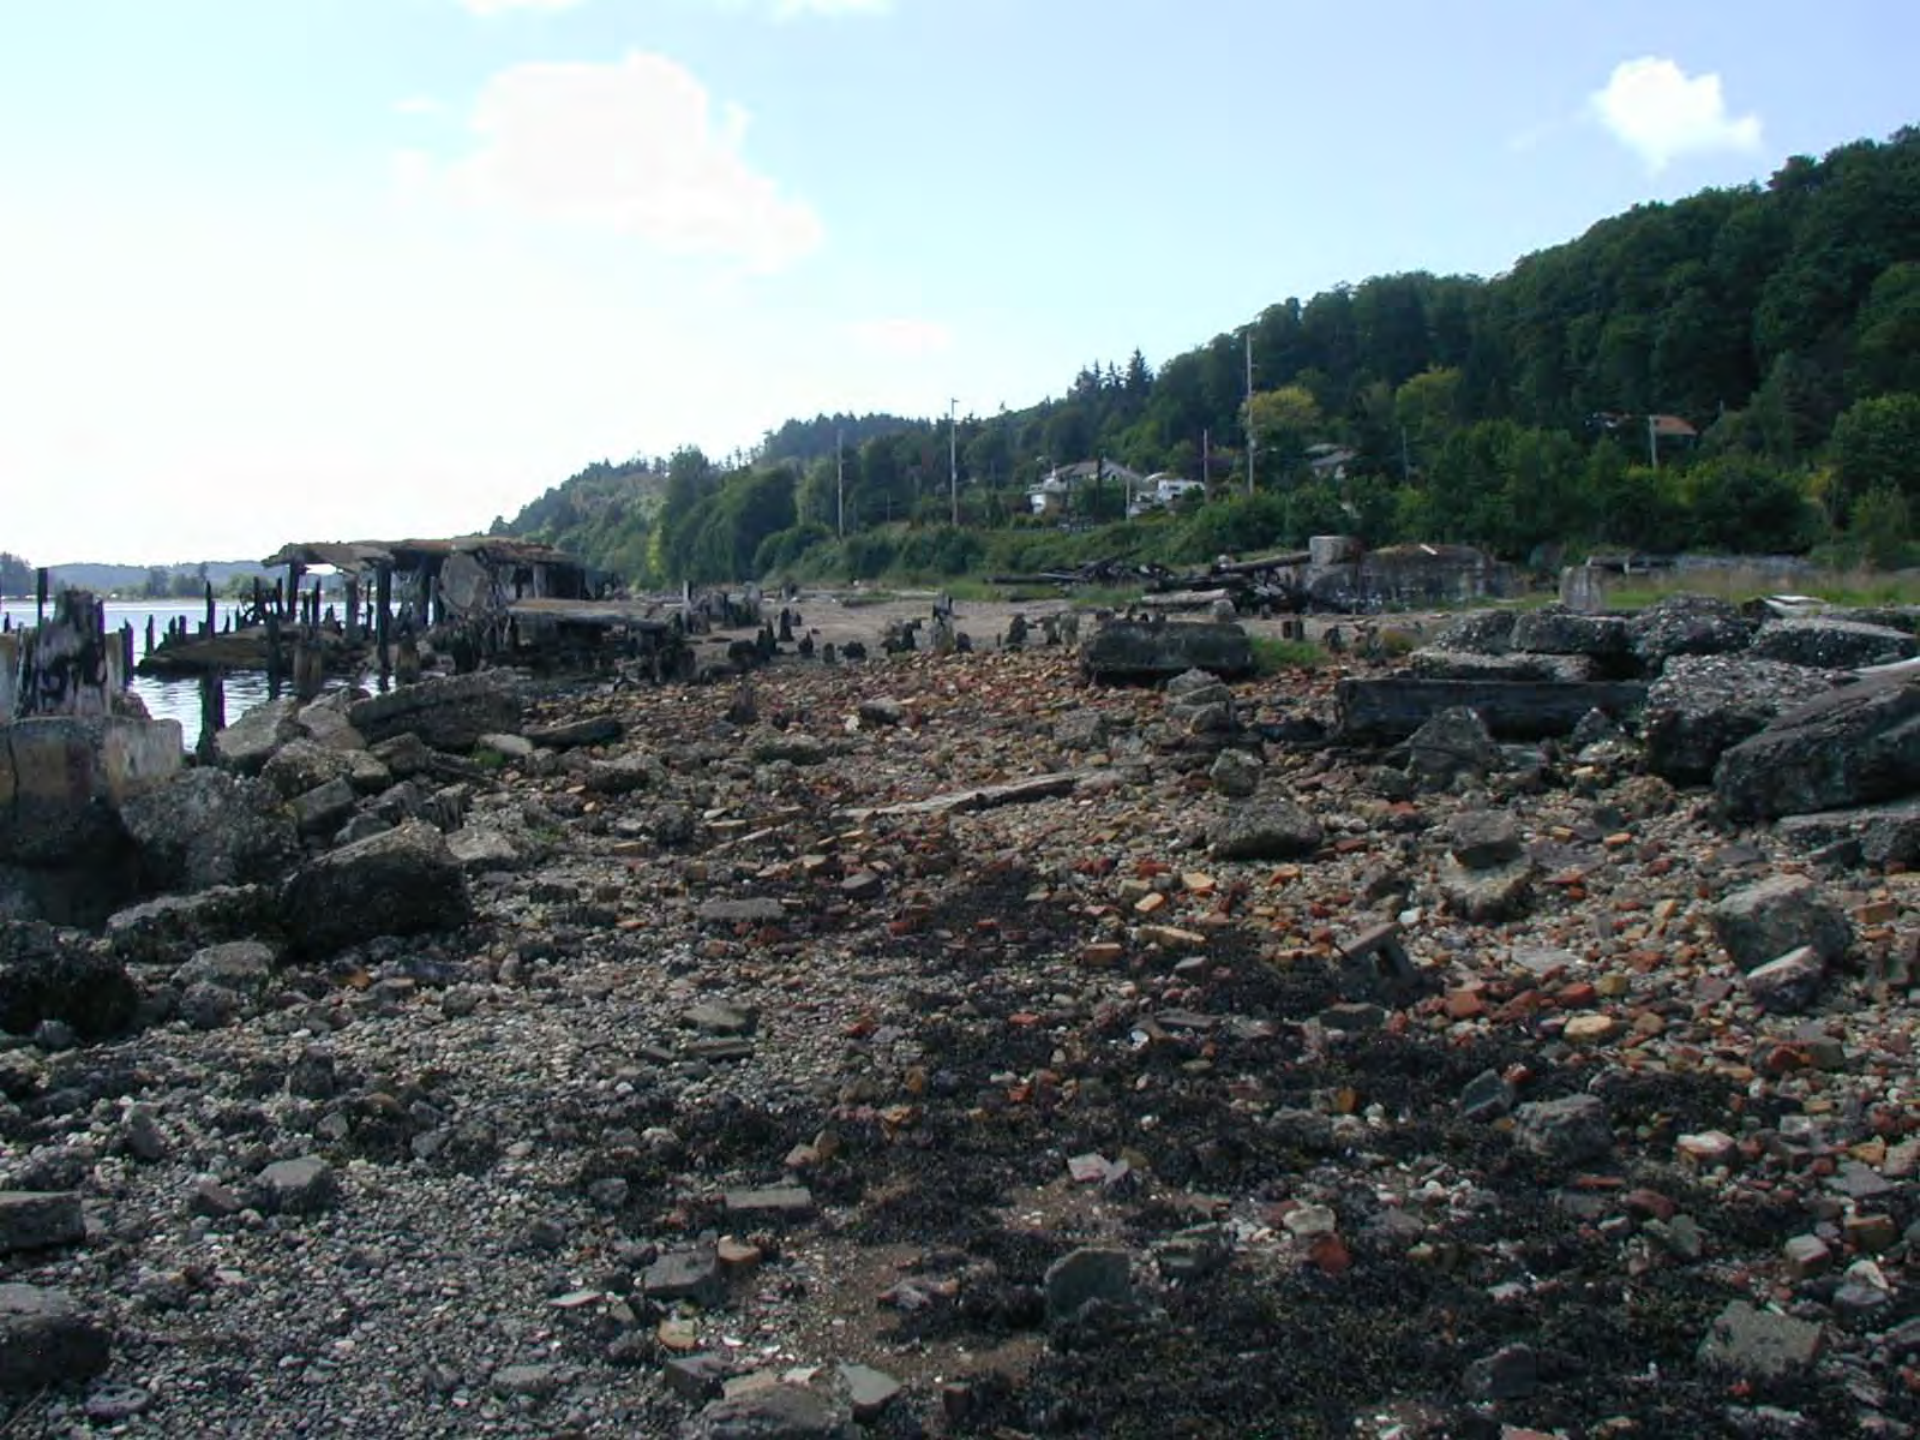
Wood debris, Pilings and construction debris

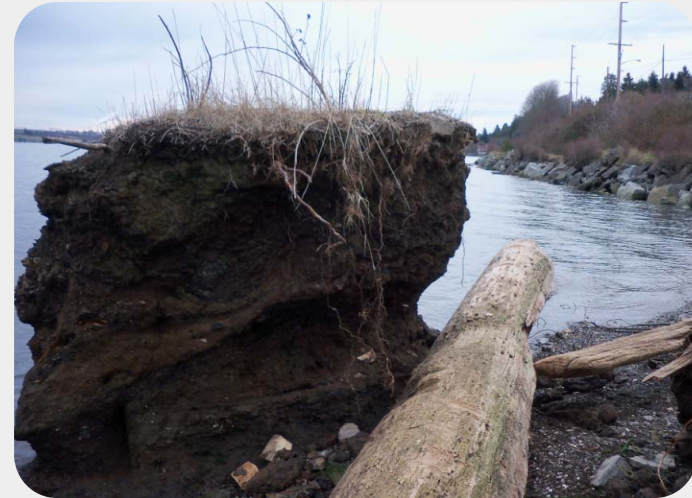
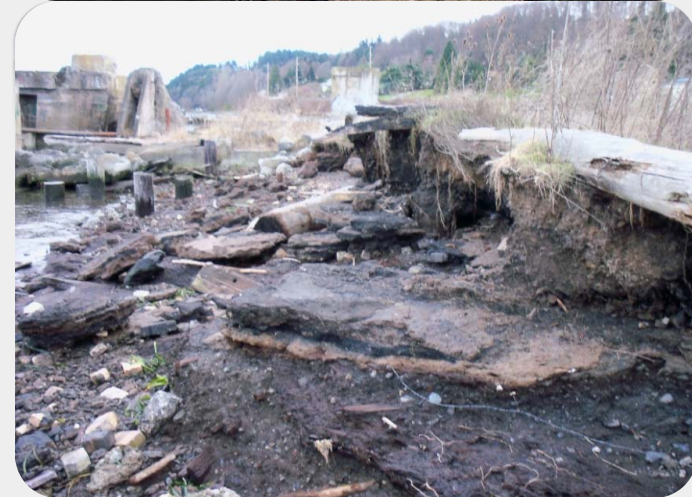
Proposed Spit/Breakwater–Extension Structure

- Prevent shoreline erosion that could expose residual contaminants to aquatic environment
- Minimize use of rock armoring
- Preservation of mitigated estuarine wetland
- Habitat enhancement for forage fish spawning & juvenile salmonid foraging

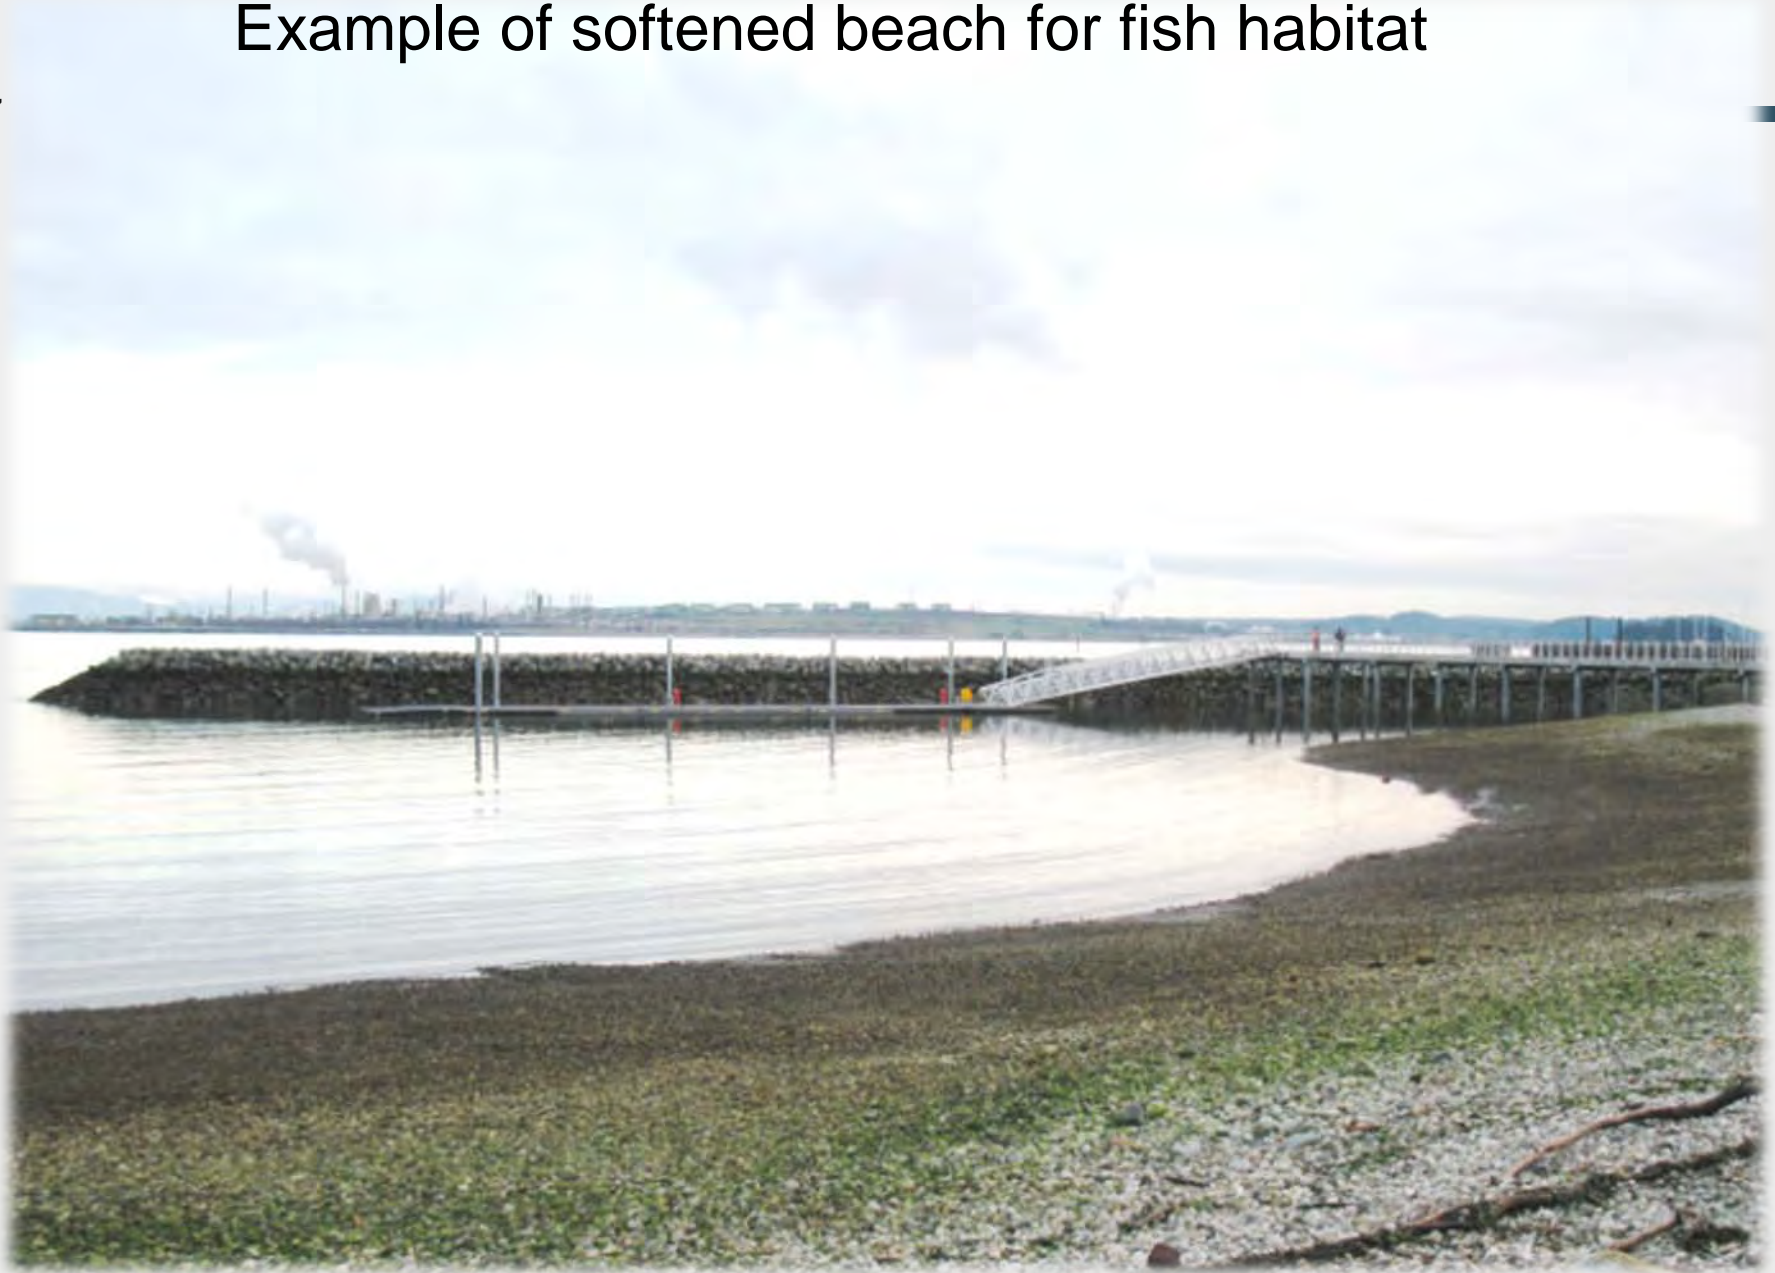
Example of softened beach for fish habitat
