FINAL CLEANUP REPORT

Fred Meyer Stores Property (aka Bethel Texaco, Facility Site ID #2614)

Port Orchard, Washington

Cleanup ID #5165, Agreed Order No. DE 9040

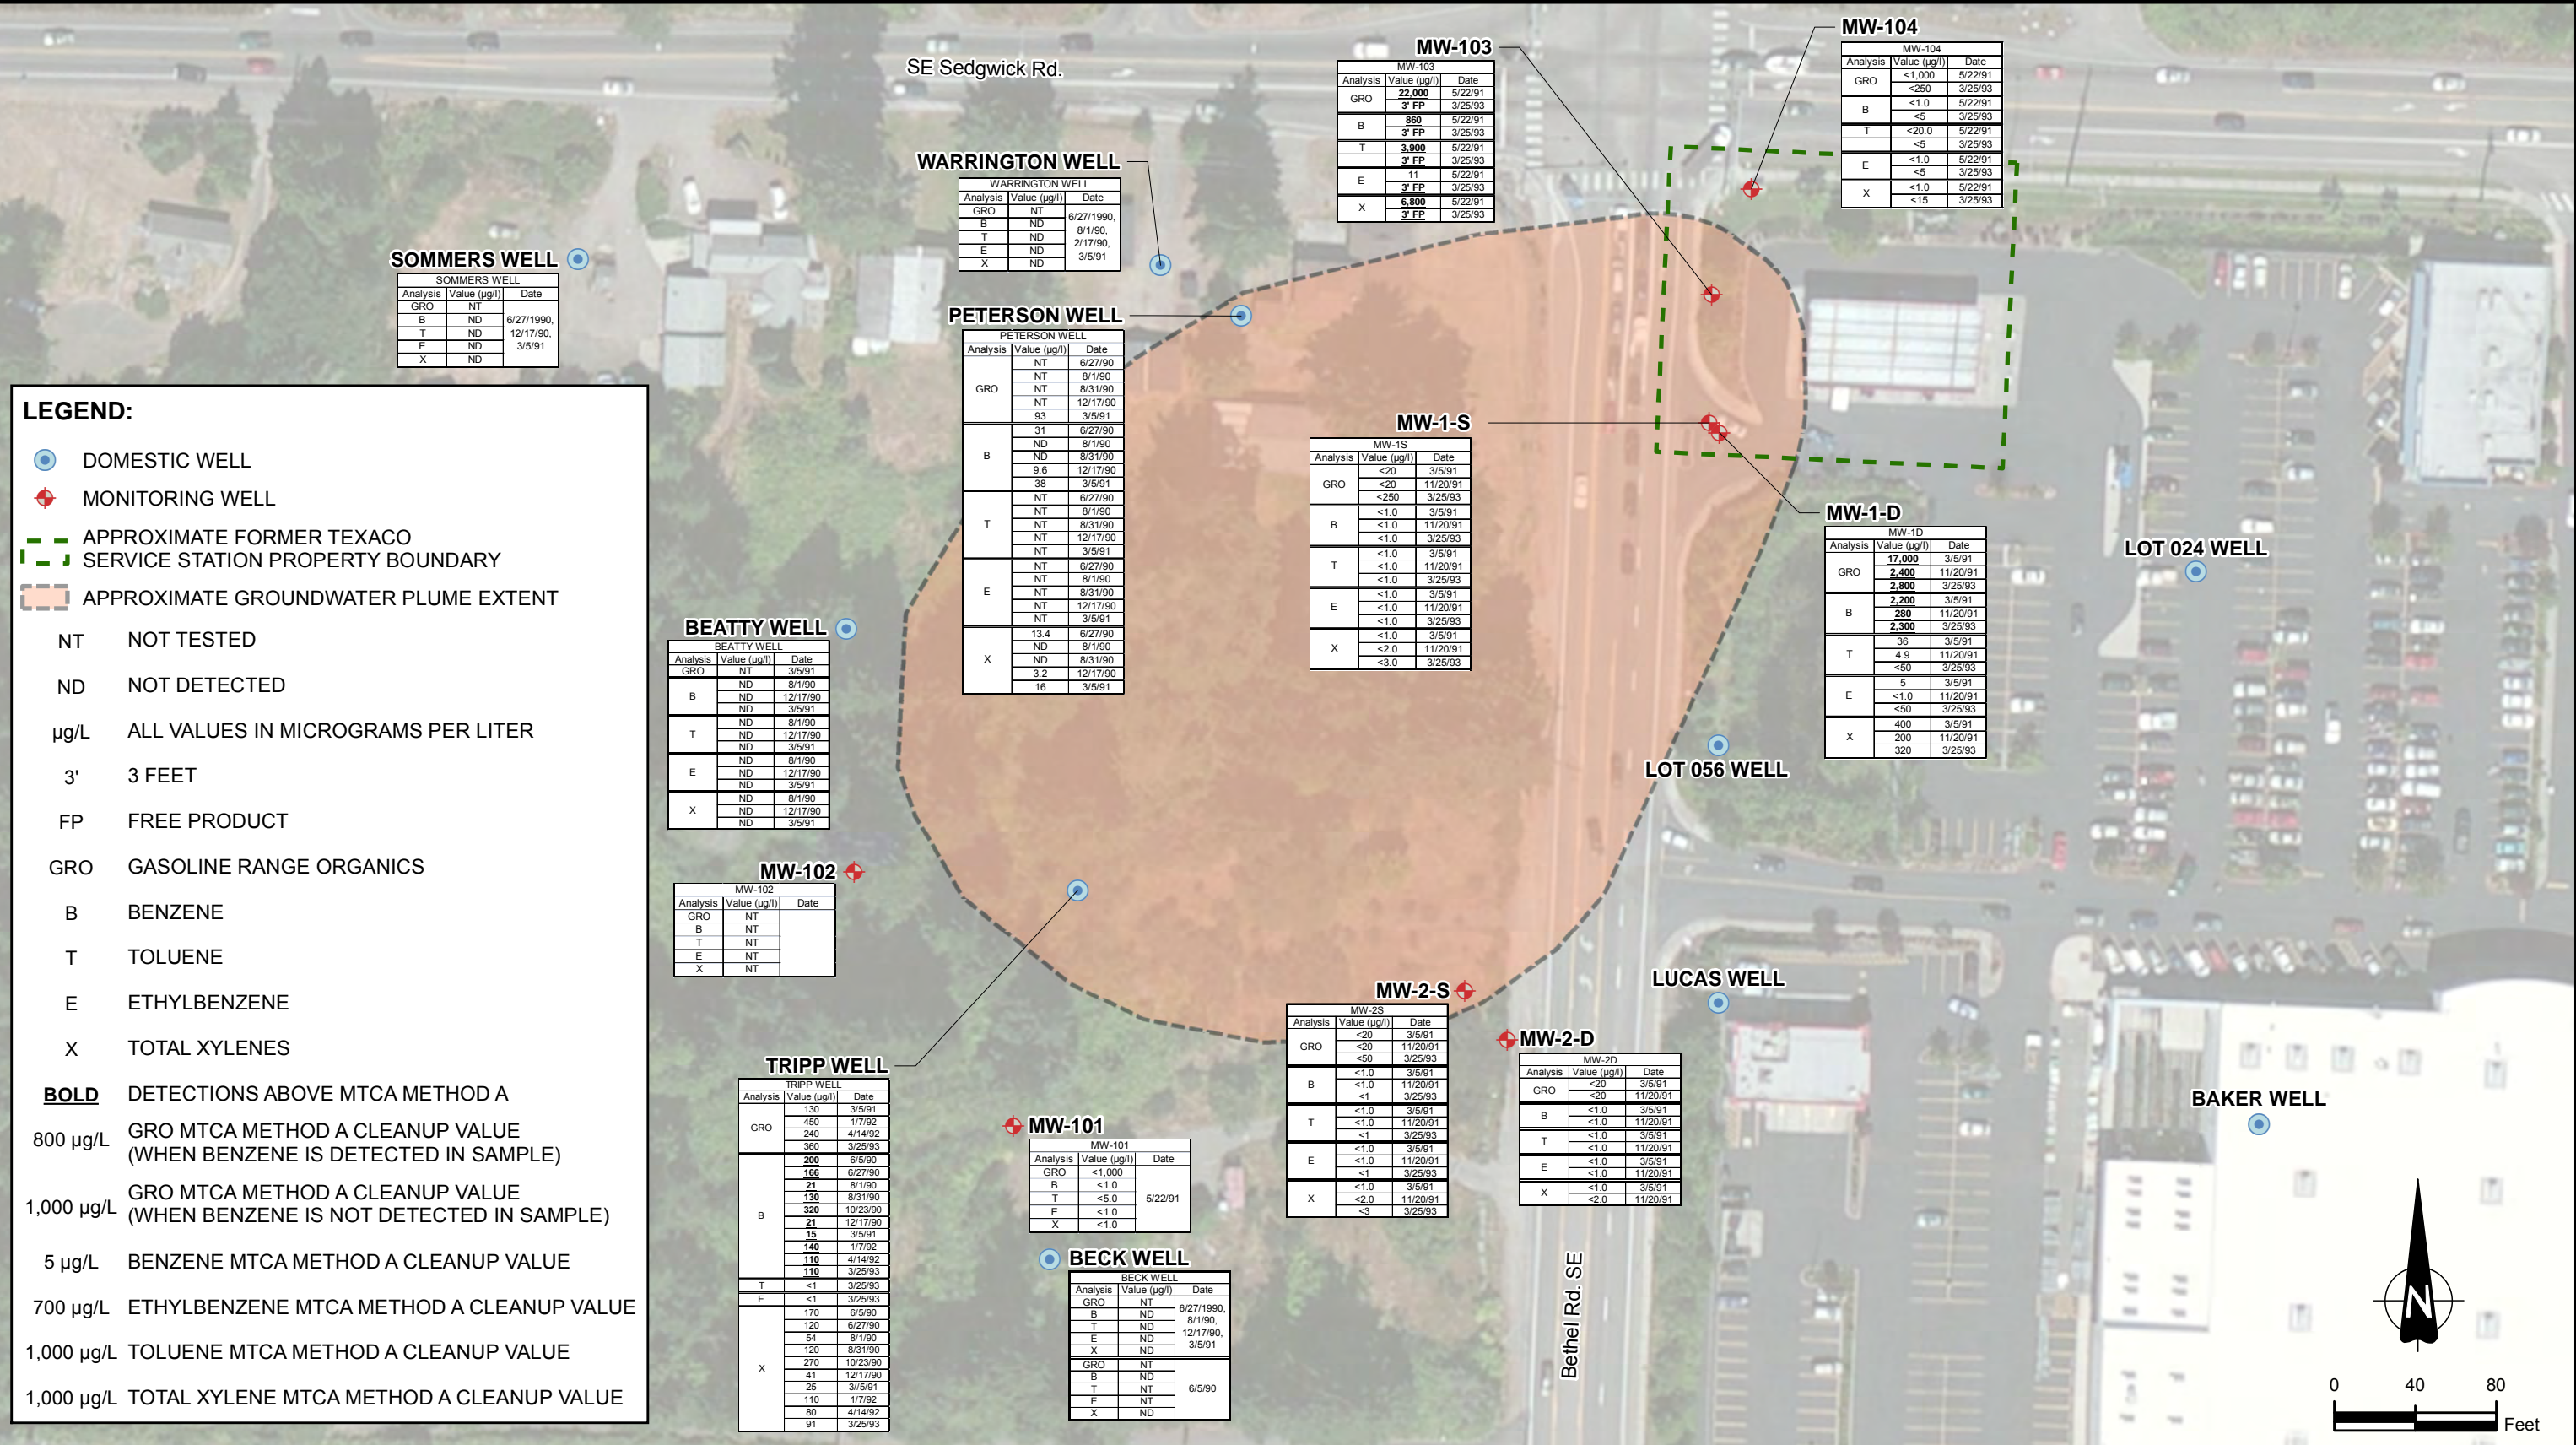
DATE	APRIL 2015
SCALE	1" = 60'
PROJECT NO.	9-61M-10282-0
FIGURE	4

- DOMESTIC WELL
- ⊕ MONITORING WELL
- APPROXIMATE FORMER TEXACO SERVICE STATION PROPERTY BOUNDARY
- APPROXIMATE GROUNDWATER PLUME EXTENT
