**ENVIRONMENTAL SITE ASSESSMENT:
PHASE II SOIL AND GROUNDWATER INVESTIGATION**

**VIEW RIDGE PLAZA
220 OLYMPIC BOULEVARD
SNOHOMISH COUNTY PARCEL 00606200004102
EVERETT, WASHINGTON**

February 28, 2014

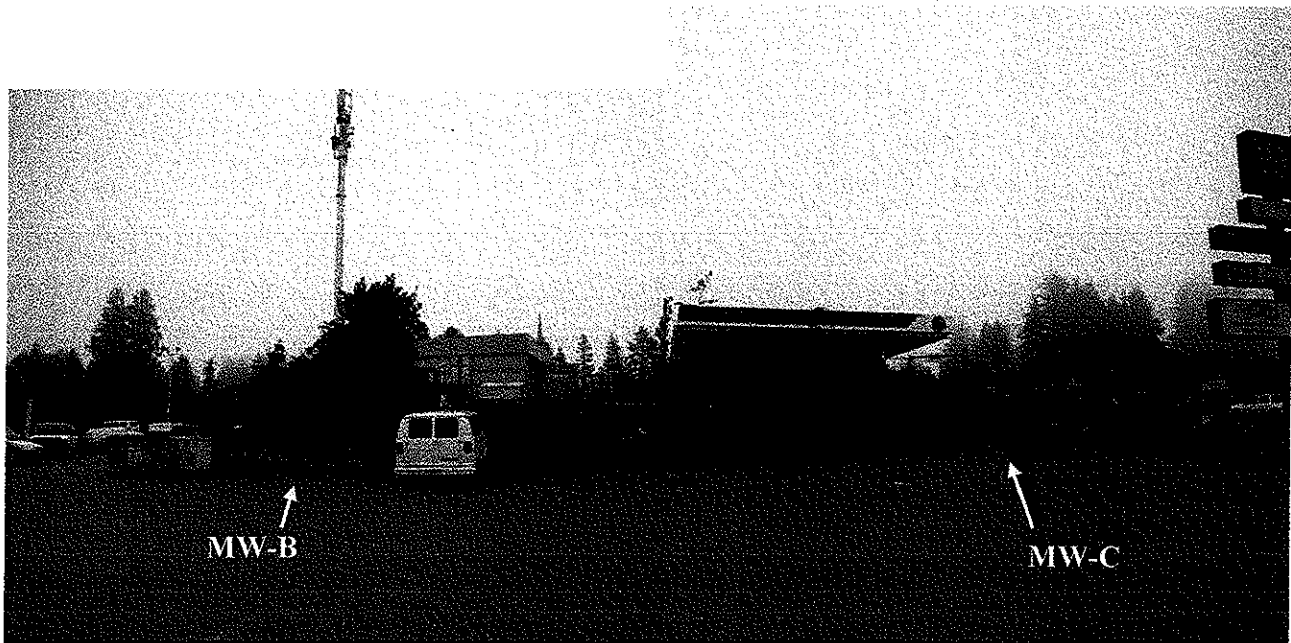
Figure 8. View of the southeastern portion of the site, looking west toward the 76 gasoline station. Monitoring wells MW-B and MW-C are identified in the photo.

MW-B: West of northwest corner of 76 Station, west of underground tanks
(47°57'25.96"N, 122°13'56.74"W)

MW-C: West of southwestern portion of 76 Station, west of fuel pump islands
(47°57'25.27"N, 122°13'56.76"W)

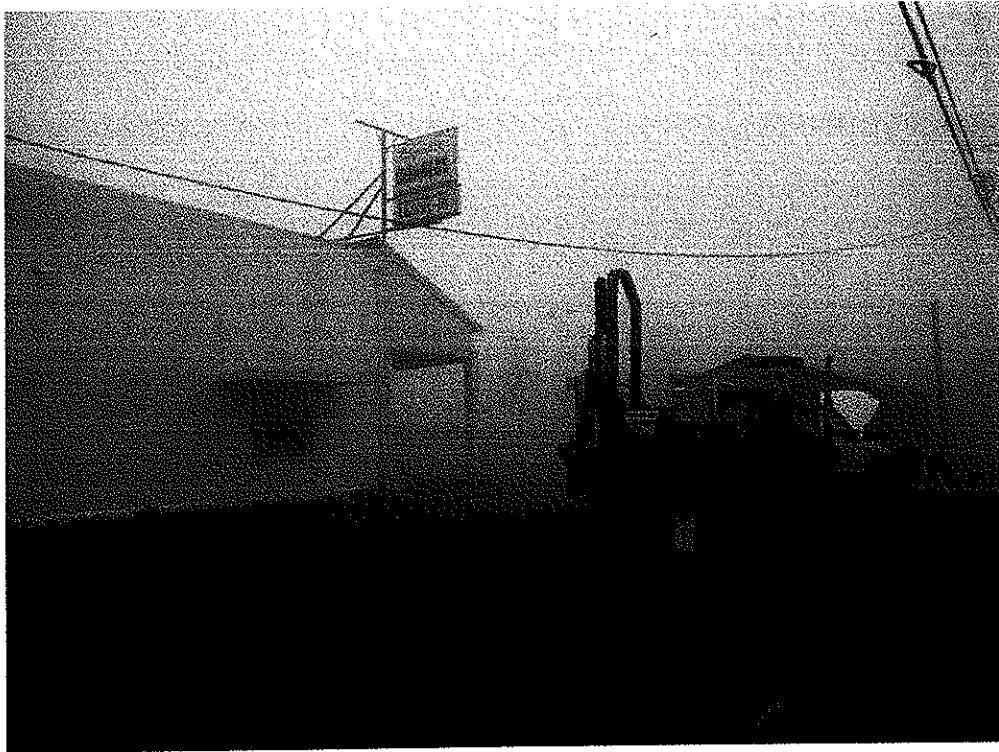
Figure 9. Location of Boring 1.

Boring 1 was located to the west of the southwestern corner of the retail mall building, in a potentially down gradient position from the dry cleaning activities. Boring 1 was completed to a depth of 15 feet. A sample was collected from 4 feet depth (Sample B1-4) and 7 feet depth (Sample B1-7). Sample B1-4 was chosen for analysis due to an unknown organic-type odor in the soil. The soil consisted of grey-brown damp silt with minor sand and some wood. Sample B1-7 was collected at the top of a dense clay layer and consisted of grey, moist to wet well sorted sand. No odor was detected in soils around Sample B1-7. Groundwater was encountered at approximately 7 feet.

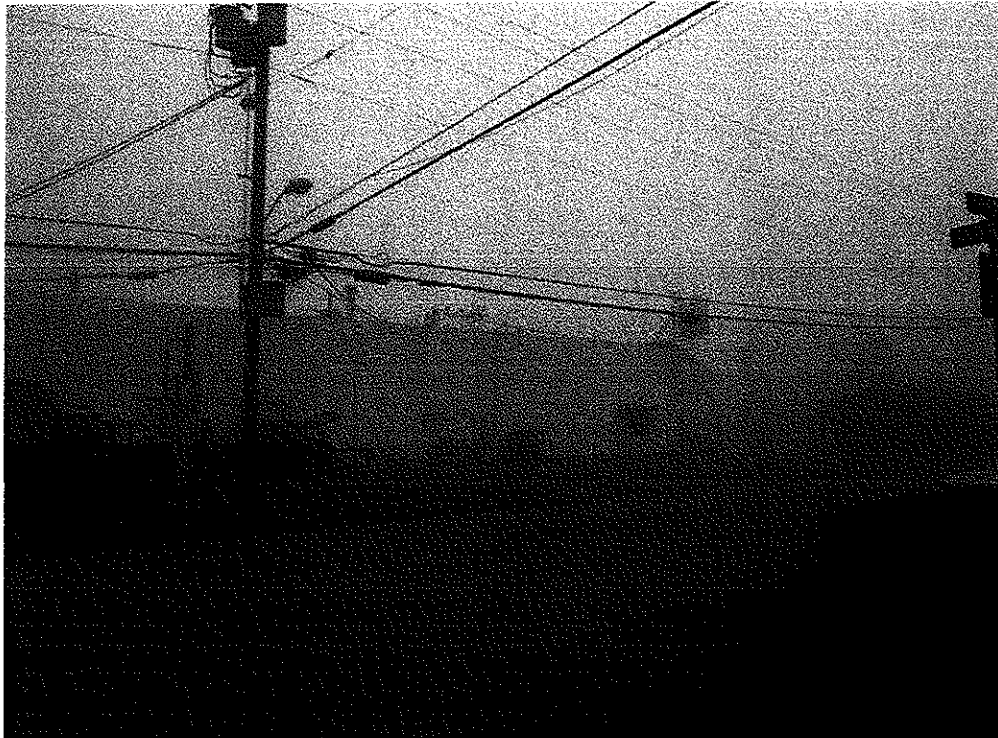
Figure 12. Location of Boring 3, looking eastward. Boring 3 is the northernmost boring location.

Boring 3 was located along the northwest of the dry cleaning operations. Boring 3 was completed to 20 feet depth, where drill rig hit refusal. Soil samples were collected from 5' (Sample B3-5) and 13' depth (Sample B3-13). Sample B3-5 consisted of dark grey moist silty sand with a slight organic odor. Sample B3-13 consisted of damp tan-grey silt located just beneath a 4" layer of wet grey sand. No obvious indicators of contamination were observed during field tests. No groundwater was encountered.
