**Ecology Review Draft  
Interim Action Completion Report  
Rod Mill Area Closed Landfill  
Former Kaiser Aluminum Property  
3400 Taylor Way  
Tacoma, Washington**

March 24, 2014

**Port of Tacoma  
Tacoma, Washington**

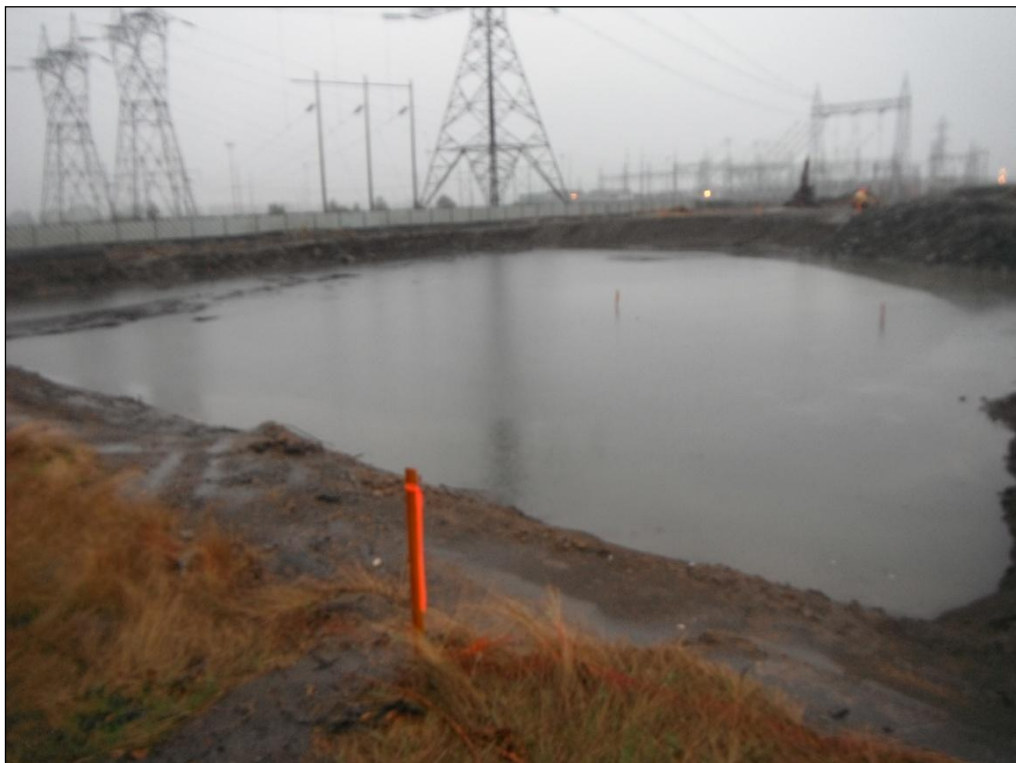
6. Looking southwest across the completed Closed Landfill excavation after a rise in groundwater level.

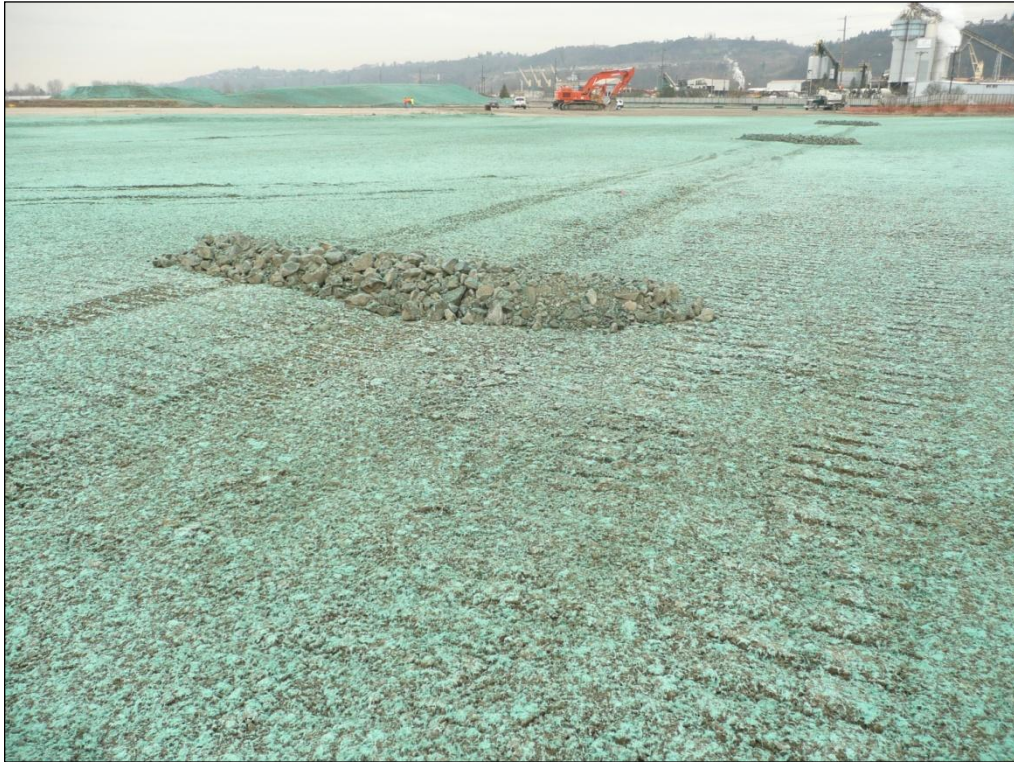
9. Looking northwest at the quarry spall check dams placed across the central drainage swale after completion of excavation backfilling.

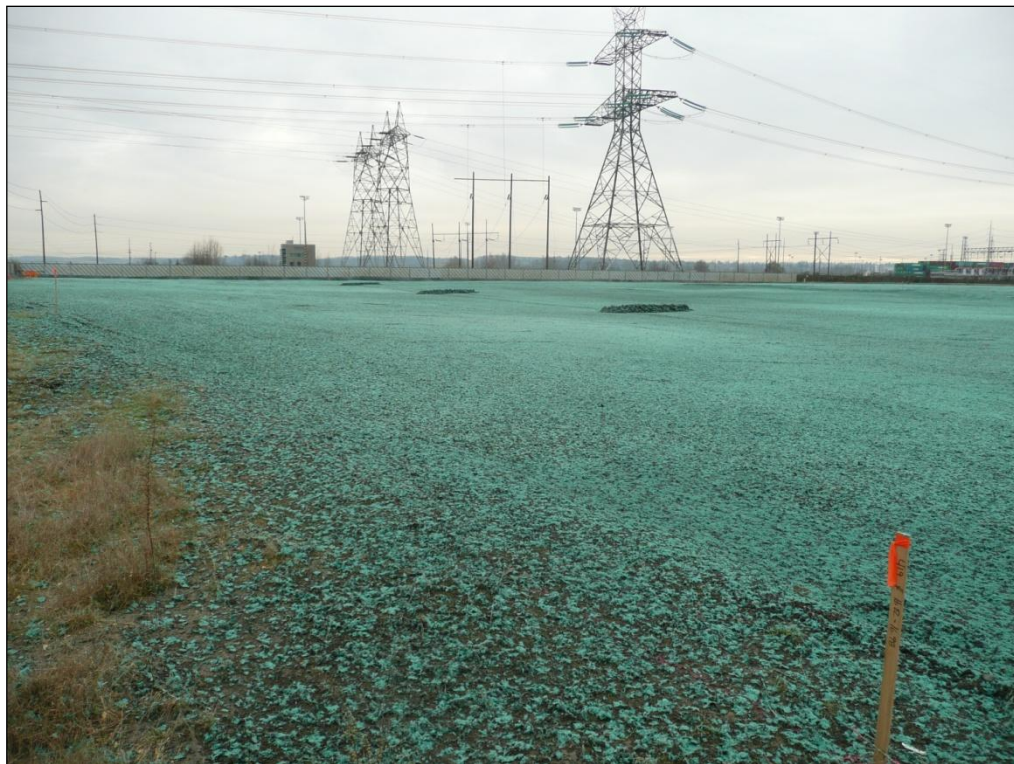
10. Looking southwest across the Closed Landfill area after completion of excavation backfilling and hydroseeding.
