**Decommissioning and Concrete Pad Sampling  
Former Spent Potlining Facility  
Kaiser Aluminum & Chemical Corp.  
Tacoma, Washington**

April 30, 2003

**Kaiser Aluminum & Chemical Corporation  
2111 E. Hawthorne Rd.  
Mead, WA 99021**

**LANDAU  
ASSOCIATES**

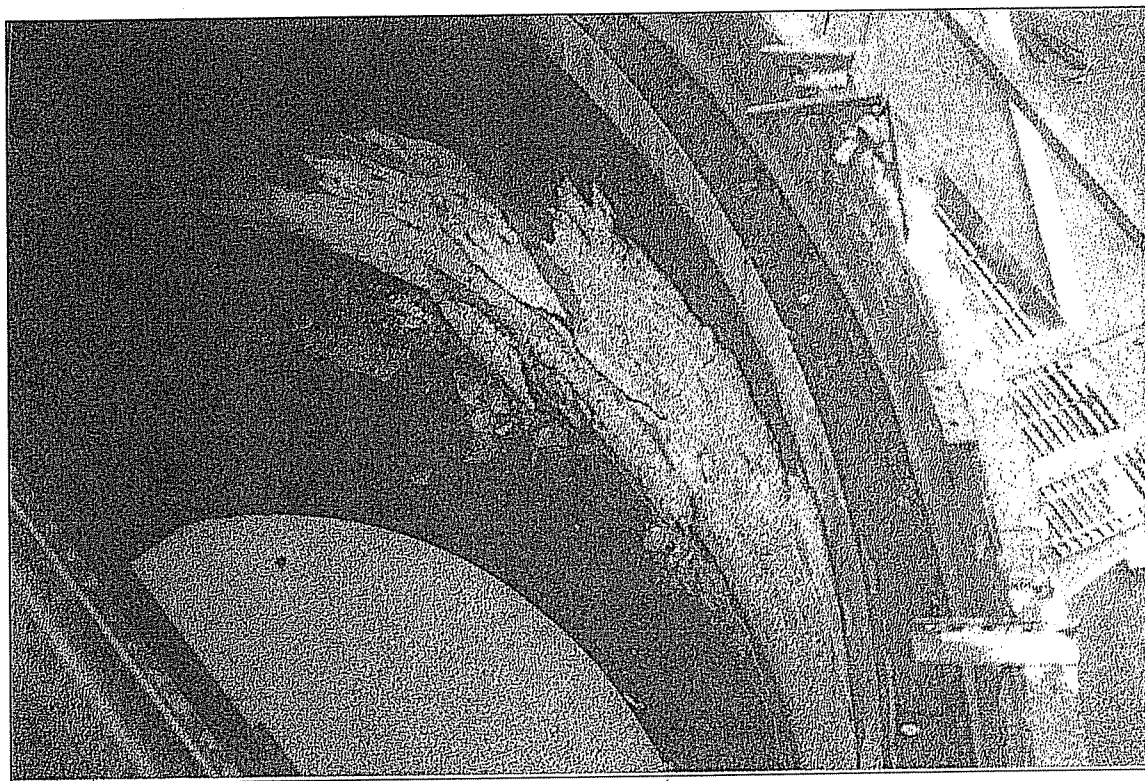
2. Interior condition of the treatment tank prior to closure activities.

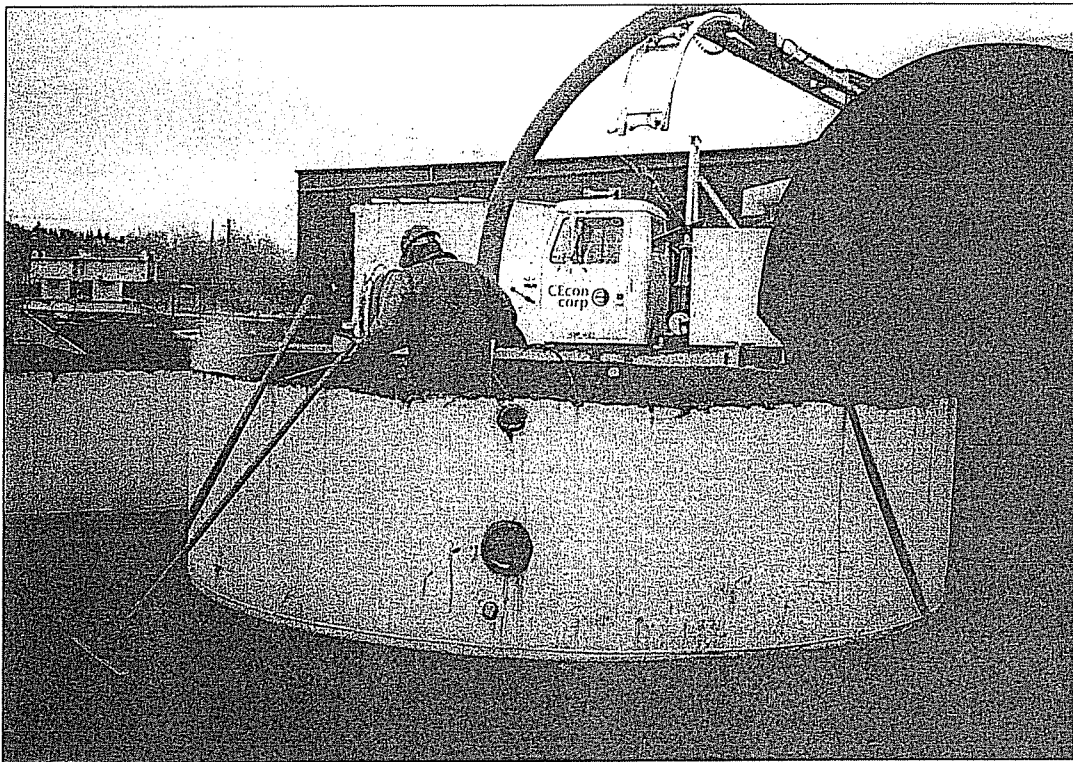
9. Leachate removal in bottom of surge tanks.
