**PORT OF TACOMA - KAISER FACILITY**

**BUILDING #65 RCRA  
DECONTAMINATION REPORT**

**September 26, 2007**

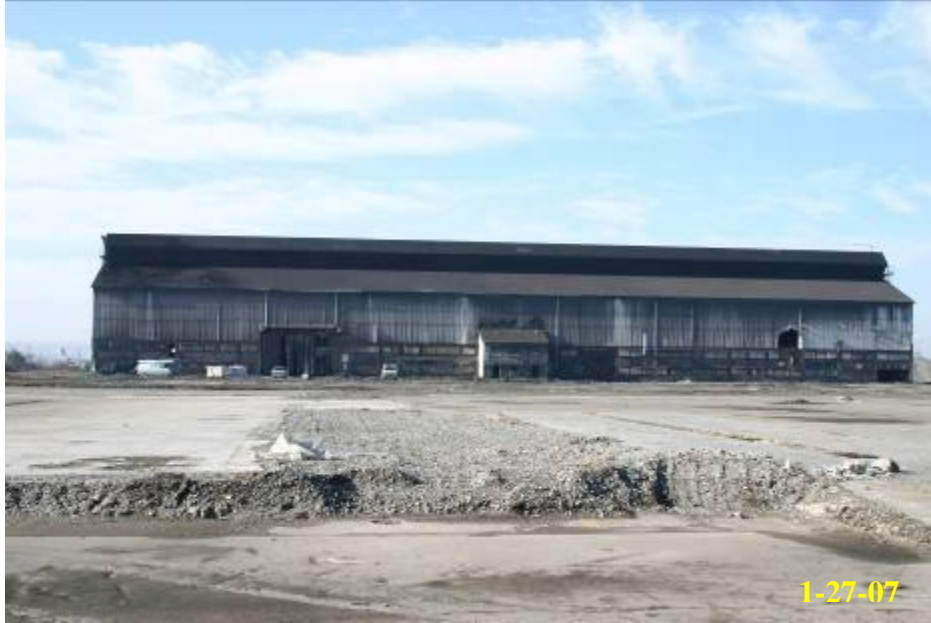
**6.0 - East side of Building 65 prior to demolition; also shows encapsulant sprayed roof**

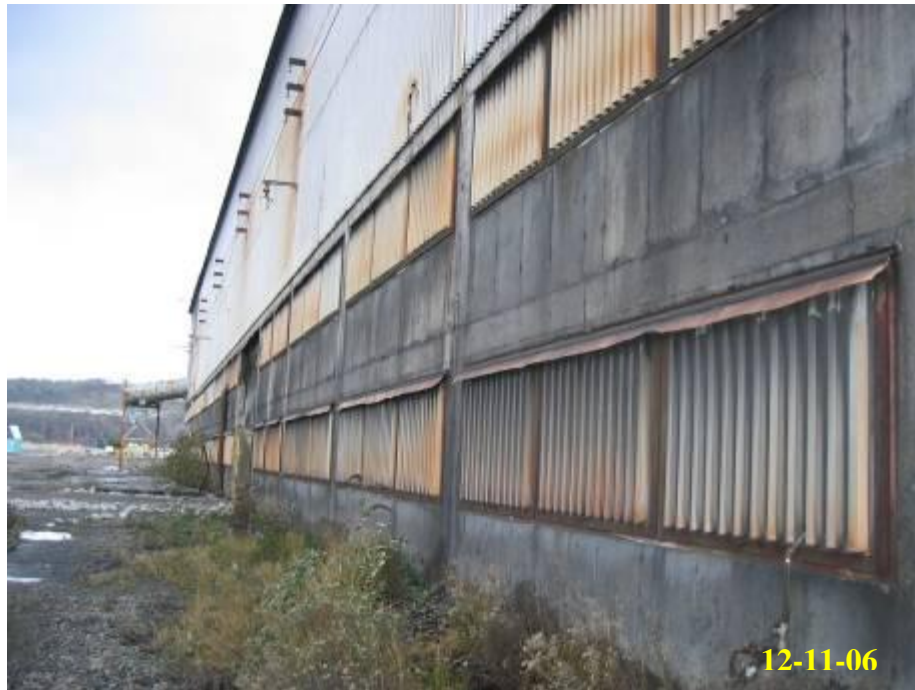
**6.1 - West exterior of building prior to construction of wash water containment**

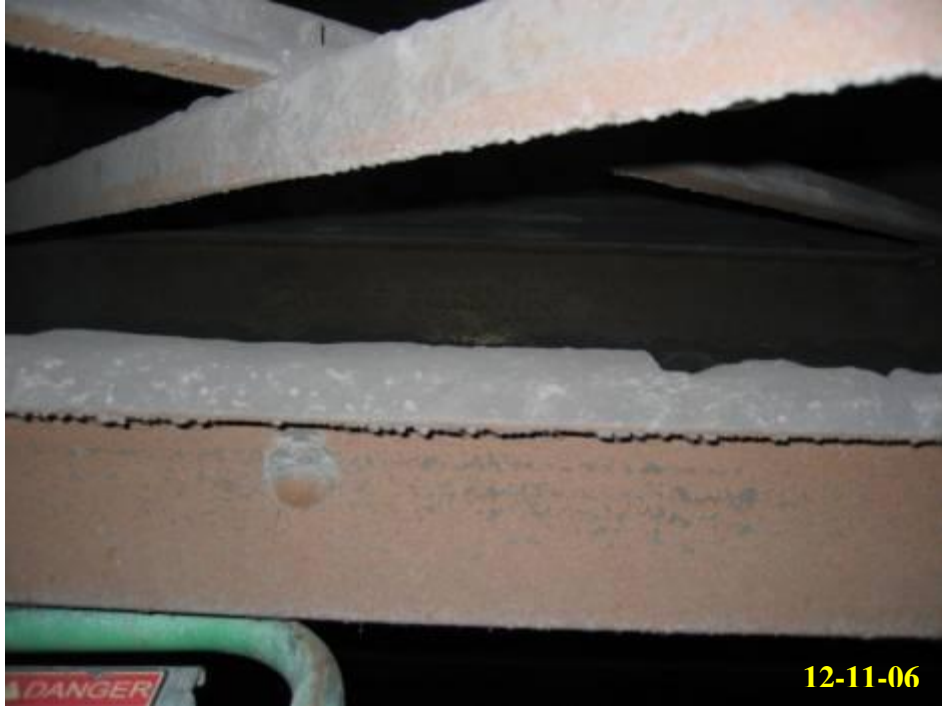
**6.3 - Trusses prior to cleaning**

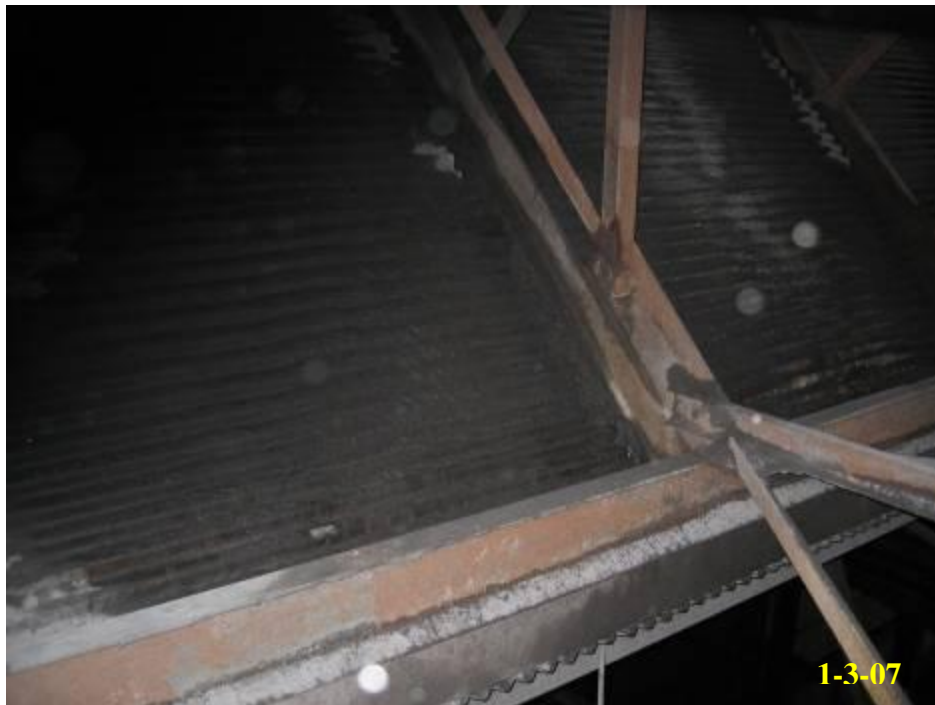
**6.4 - Vent to roof joint prior to cleaning**

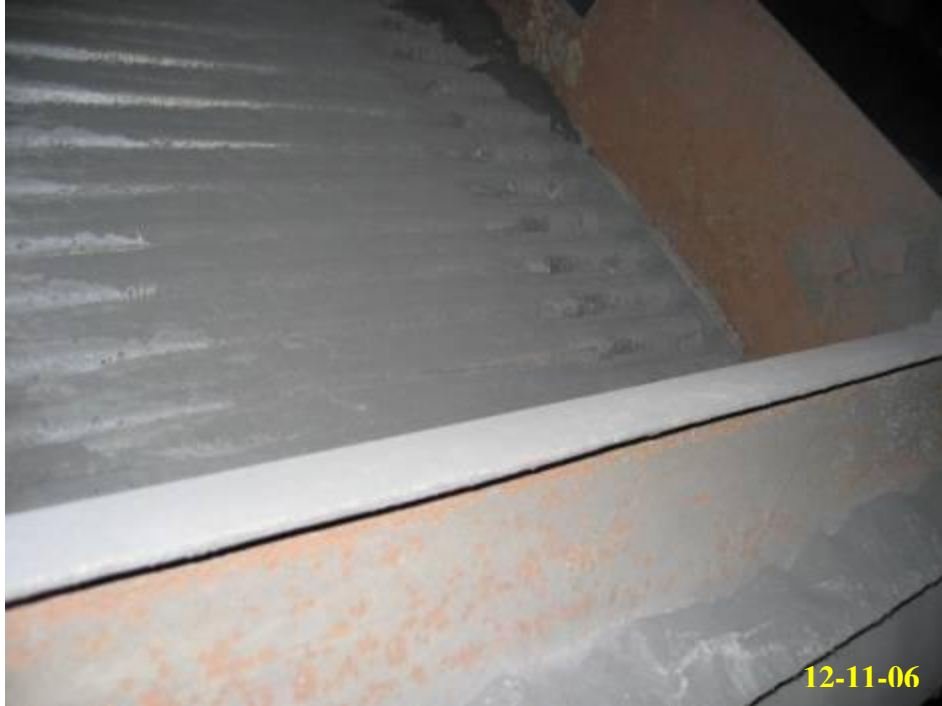
**6.5 - Roof to vent structure prior to cleaning**

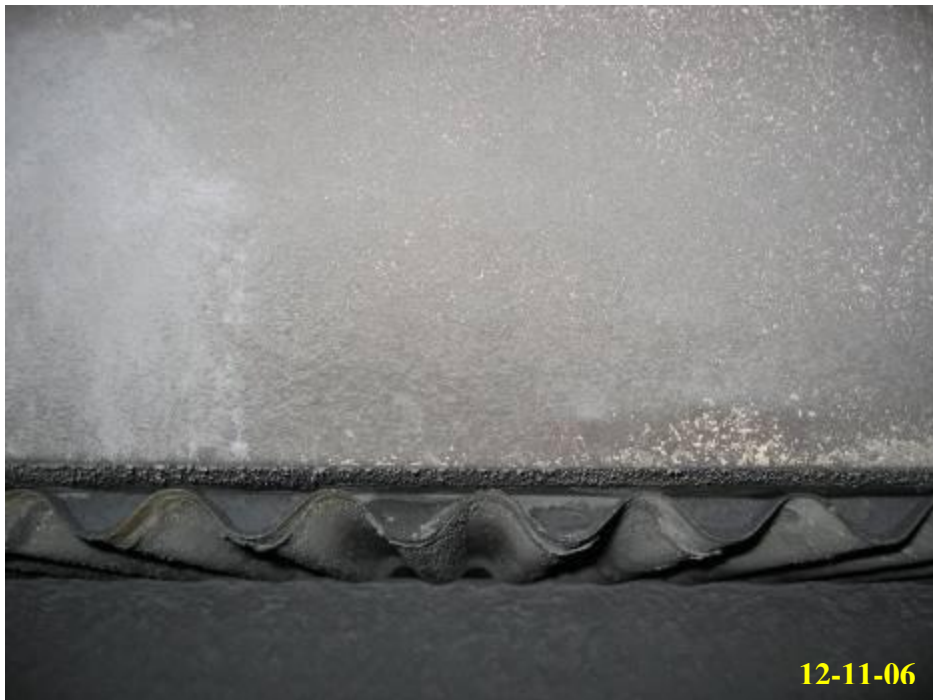
**6.6 - Roof vent joint prior to cleaning**

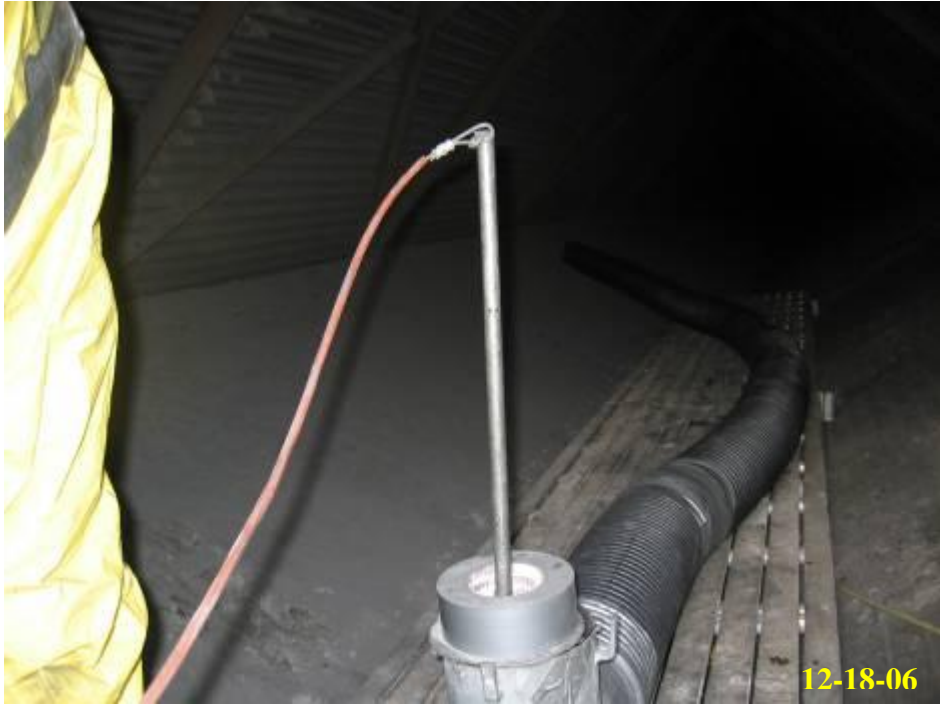
**6.7 - Roof vent interior prior to cleaning**

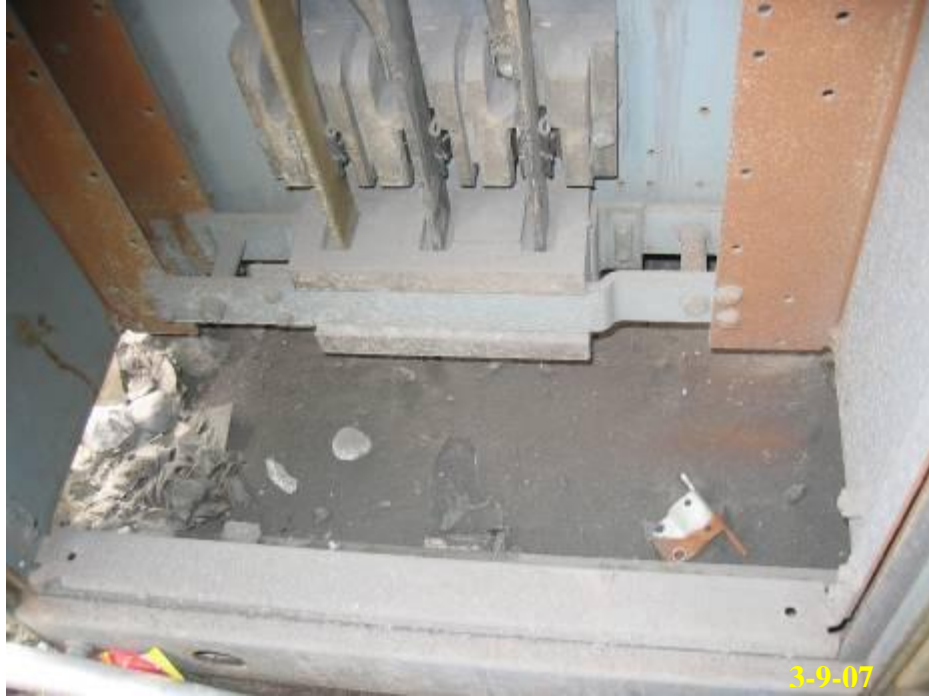
**6.9 - Inside of main MCC breaker panel prior to cleaning**

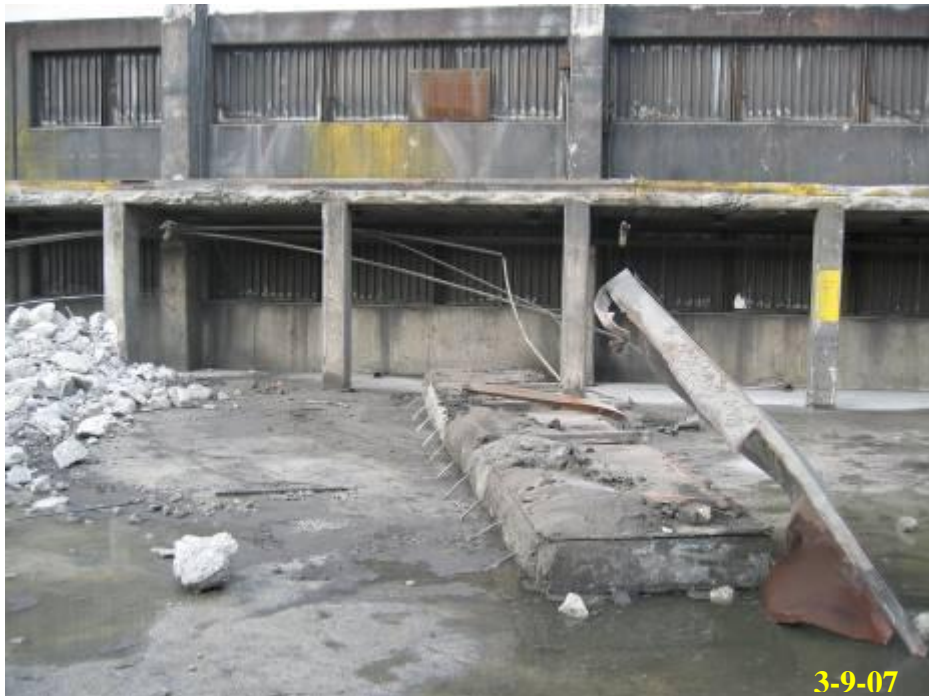
**6.10 - Interior building divider prior to cleaning**

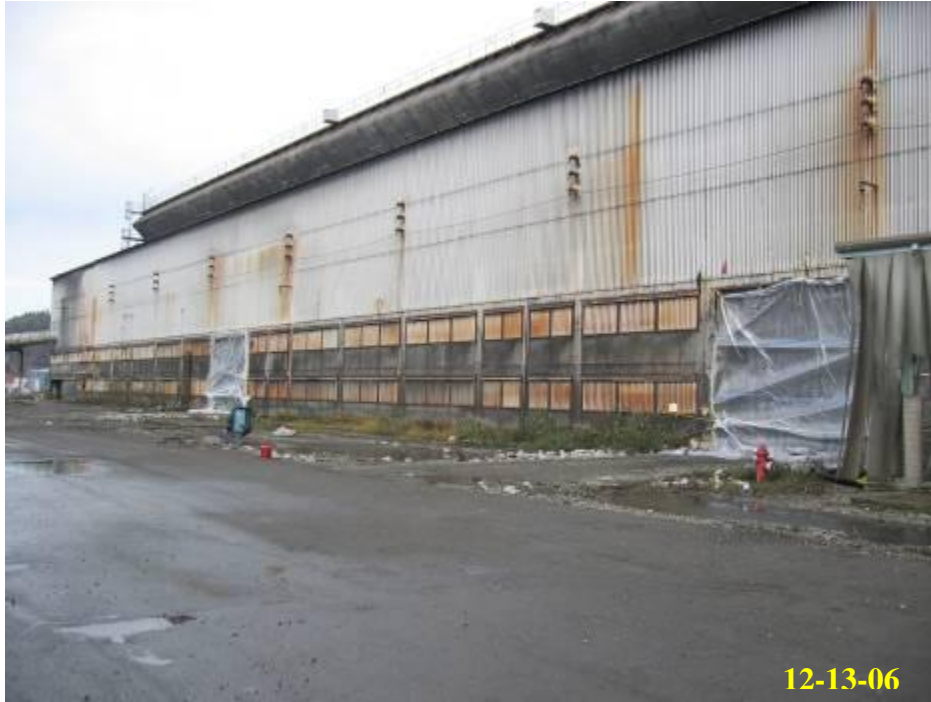
**6.11 - Doorway sealing during building cleaning**

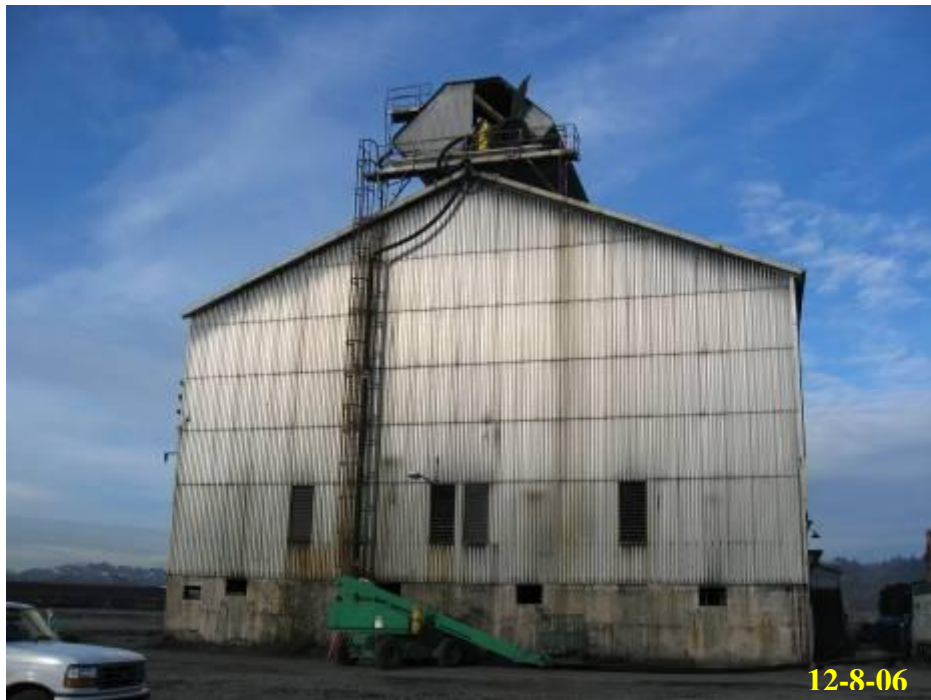
**6.12 - Vacuuming of roof vent interior at south end of building**

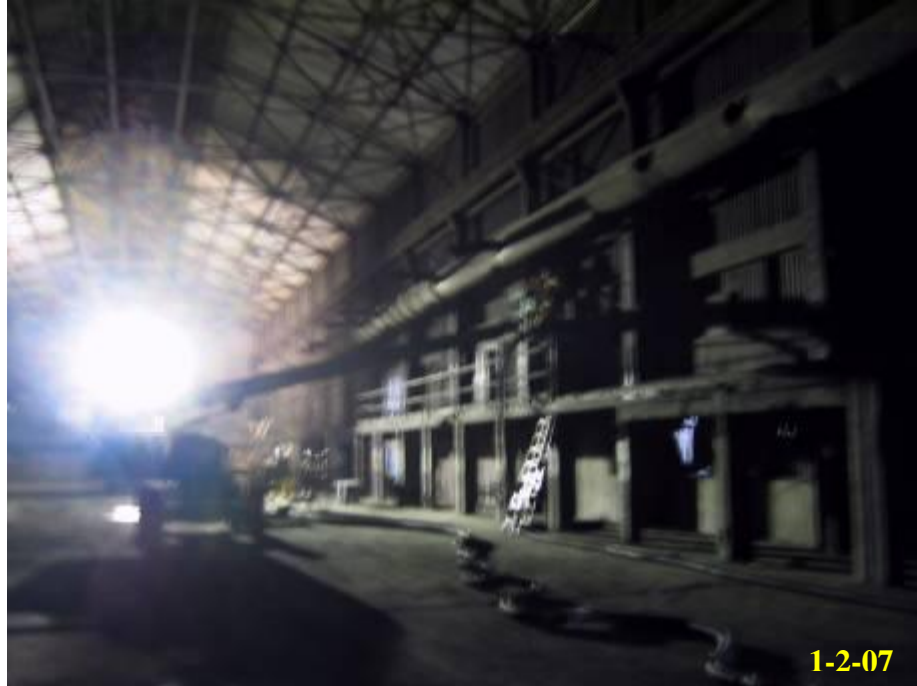
**6.13 - Vacuuming of building structural**

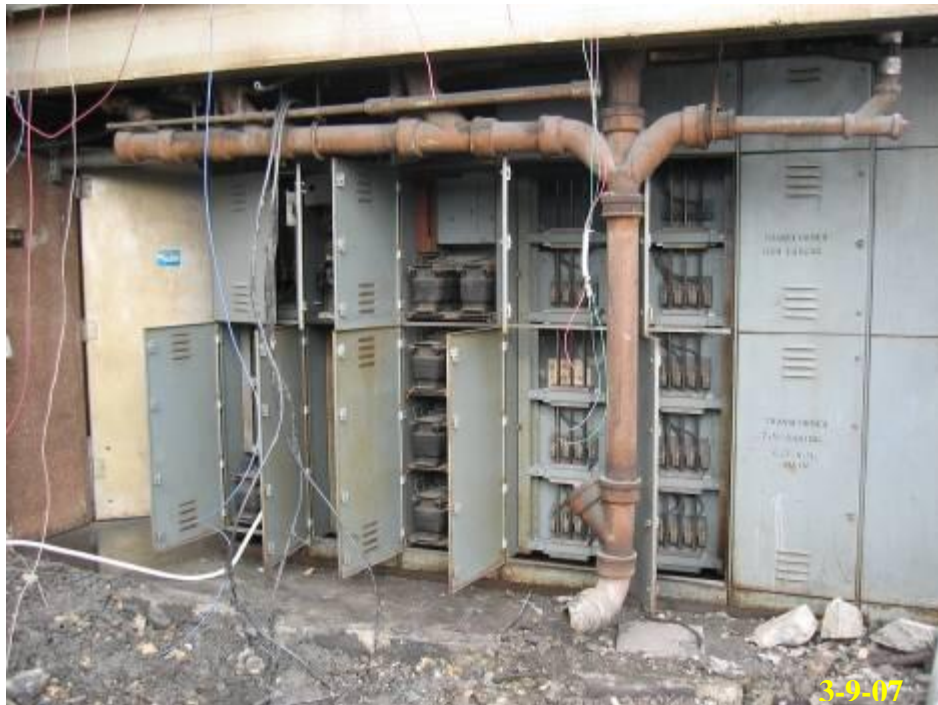
**6.14 - Main breaker panels during cleanup**

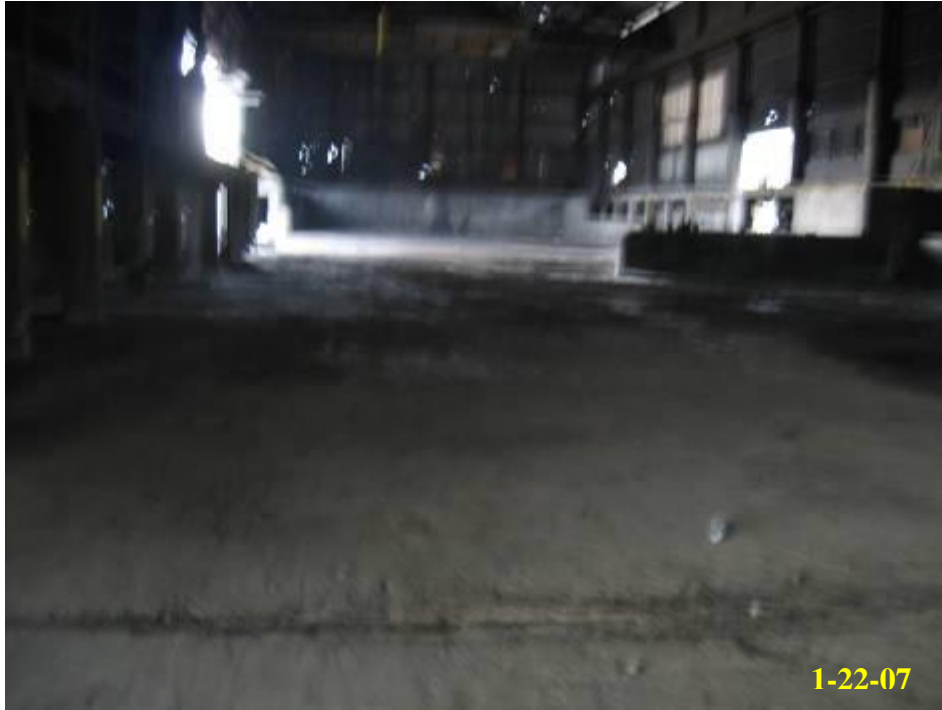
6.15 - Floor during cleaning

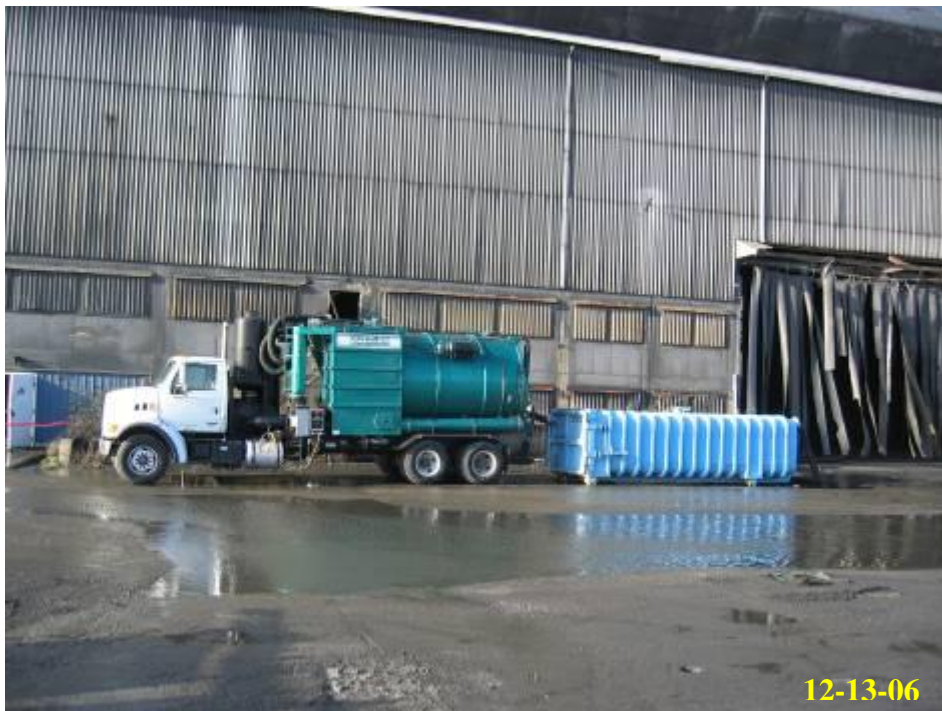
6.16 - Vacuum truck and dust enclosure type roll-off box during vacuuming

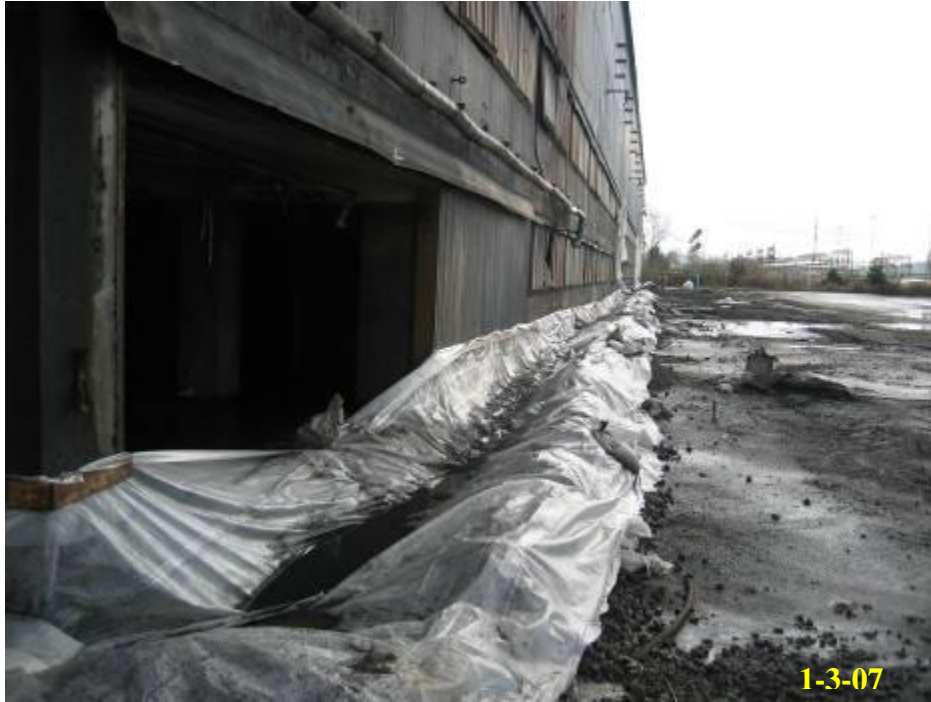
**6.17 – Wash water containment berm constructed around building**

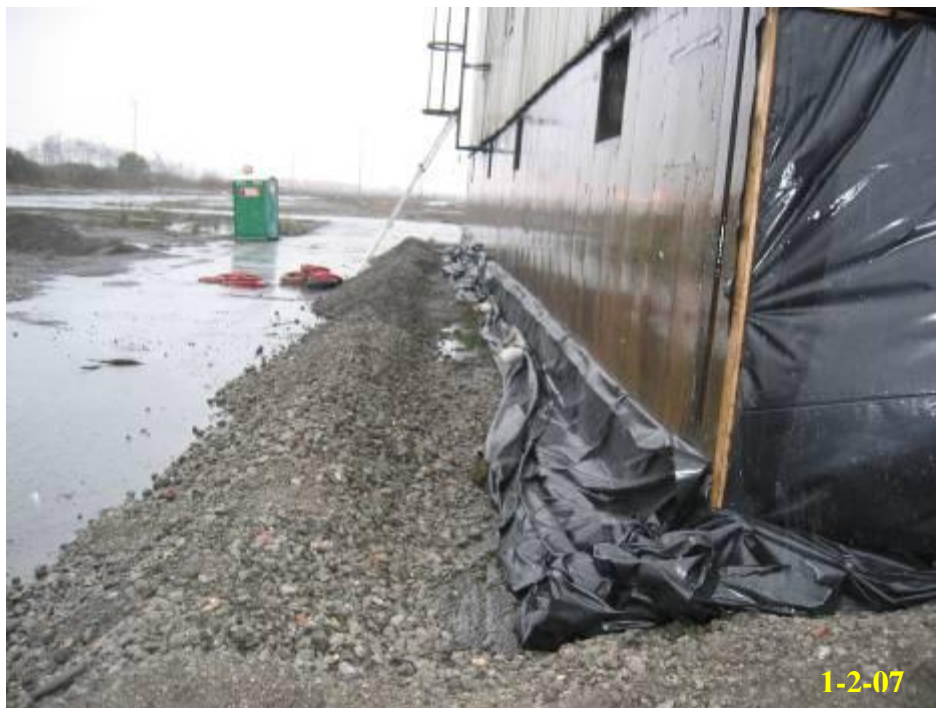
**6.18 – Wash water containment berm showing attachment of Visqueen to building wall**

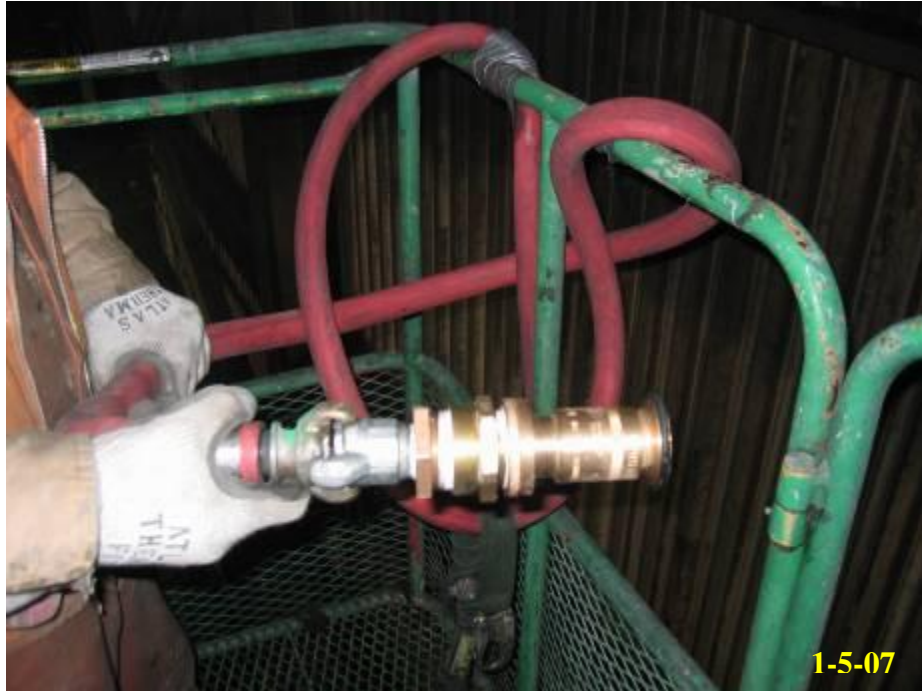
**6.19 - Typical wash nozzle used for building washing**

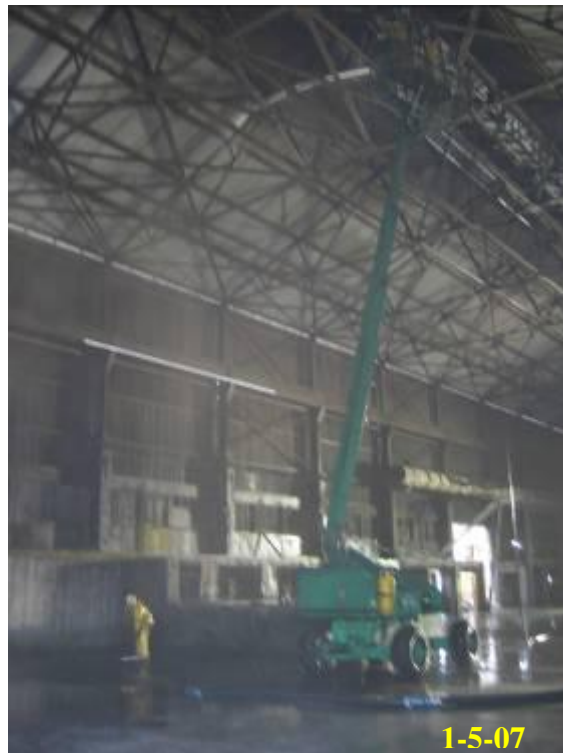
**6.20 - Washing of building structure from manlift; Vacuuming of wash water from floor**

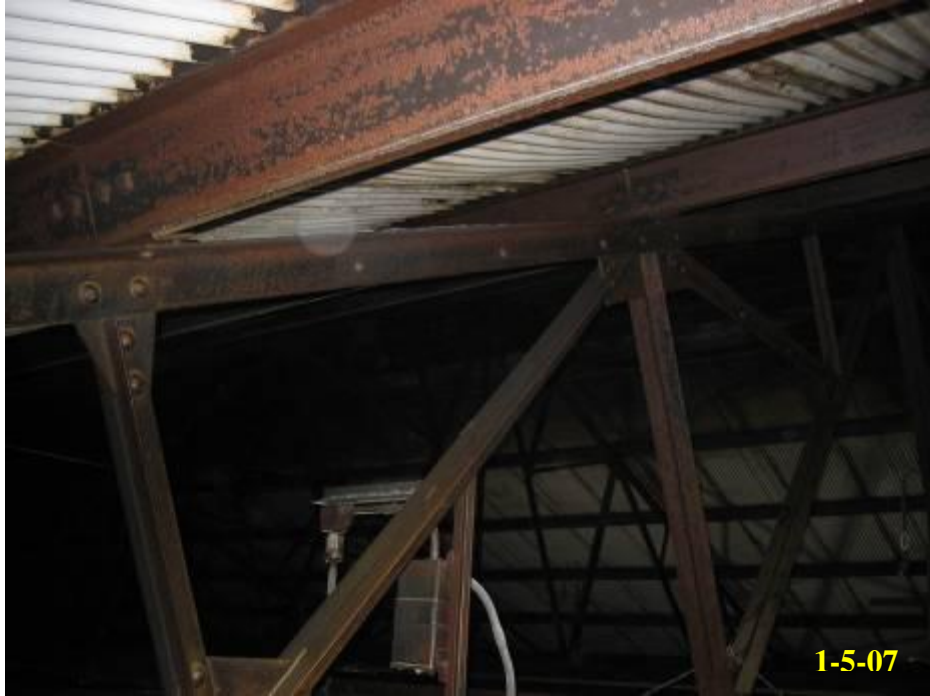
**6.21 - Roof trusses during washing**

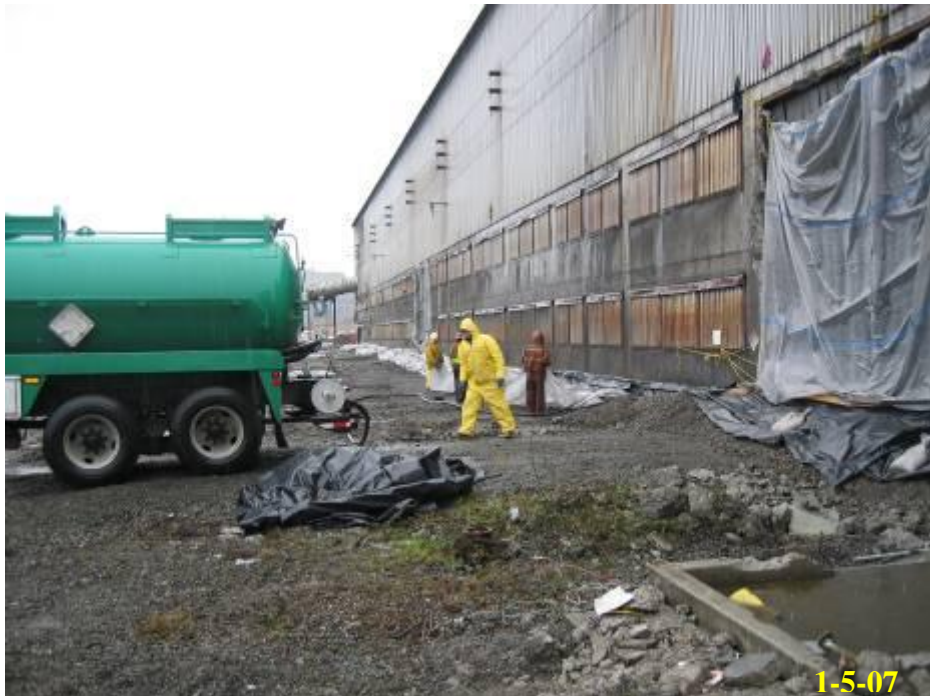
**6.22 - Typical vacuuming of wash water from containment during washing**

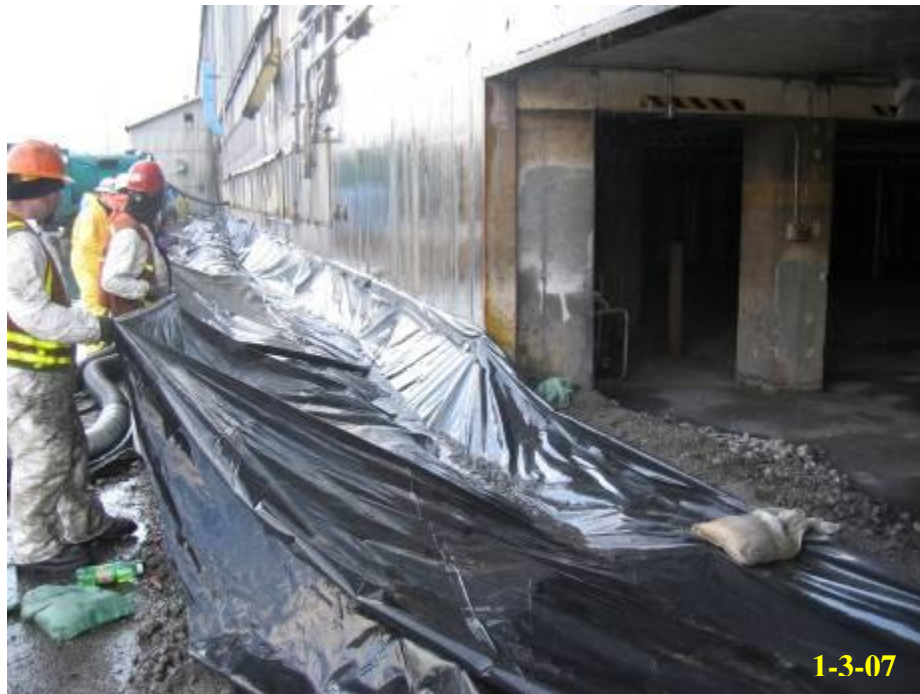
**6.23 – Wash water containment management during washing of wall interior**

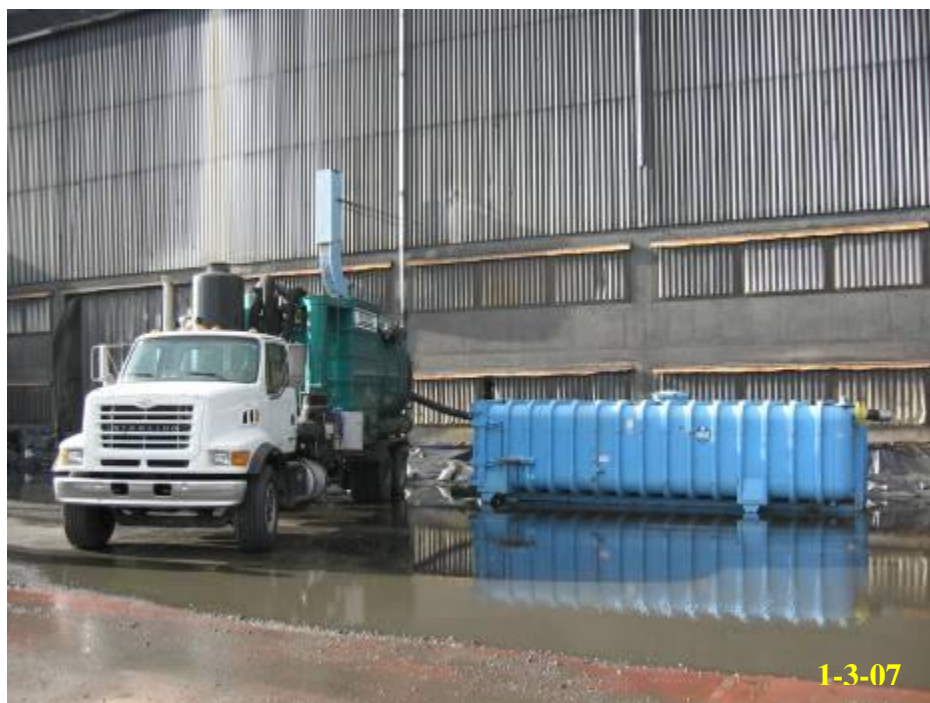
**6.24 - Vacuum truck staging during building washing**

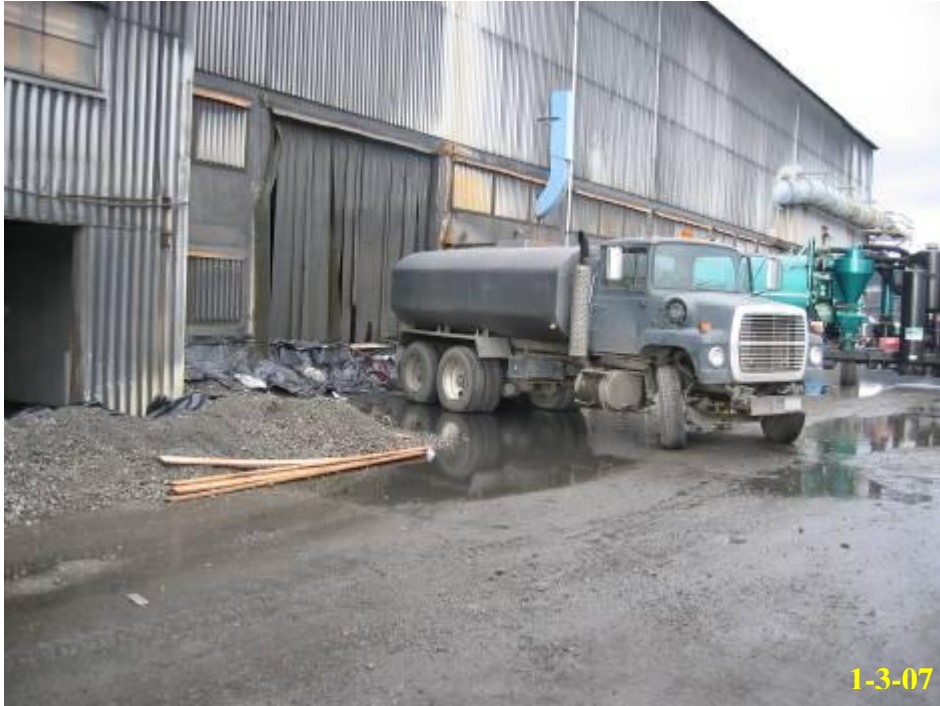
**6.25 – Wash water tanker/pumper Truck**

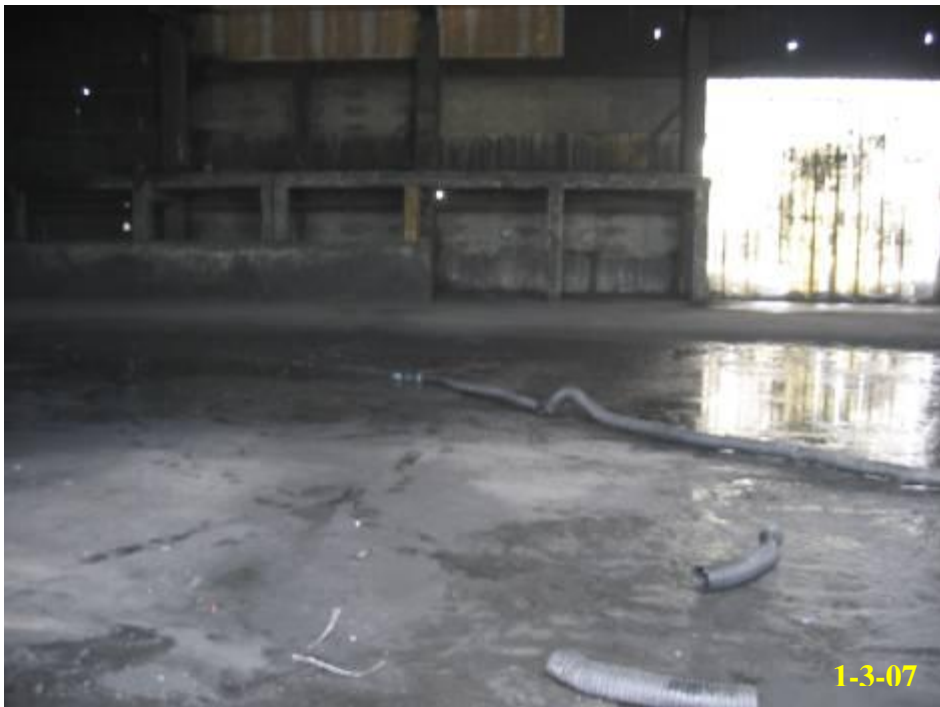
**6.26 - Typical wash water vacuuming from floor during building washing**

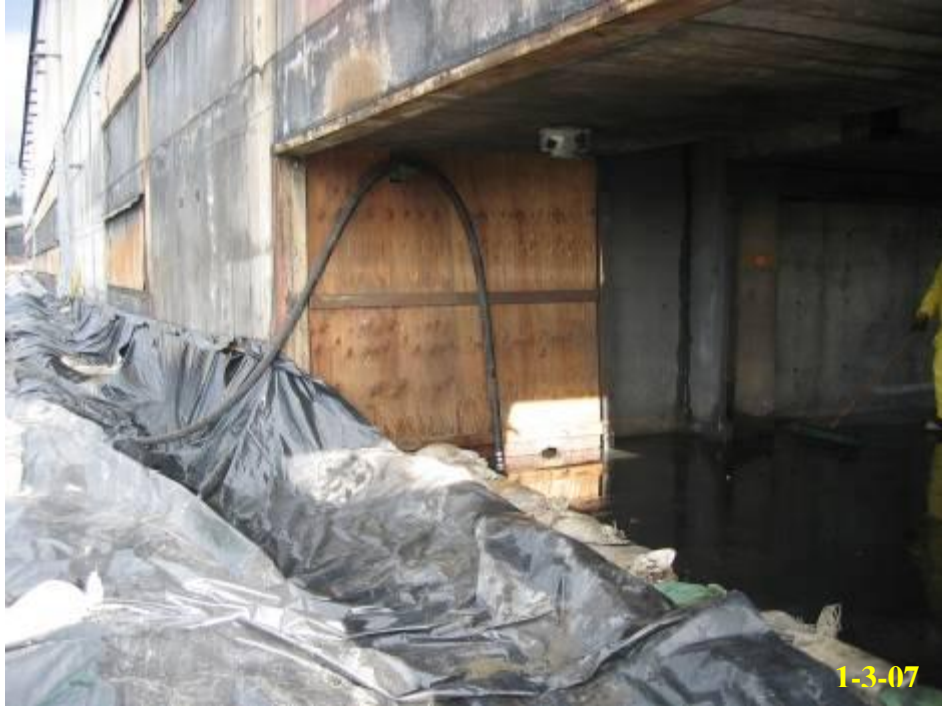
6.27 – Wash water vacuuming/containment (typical)

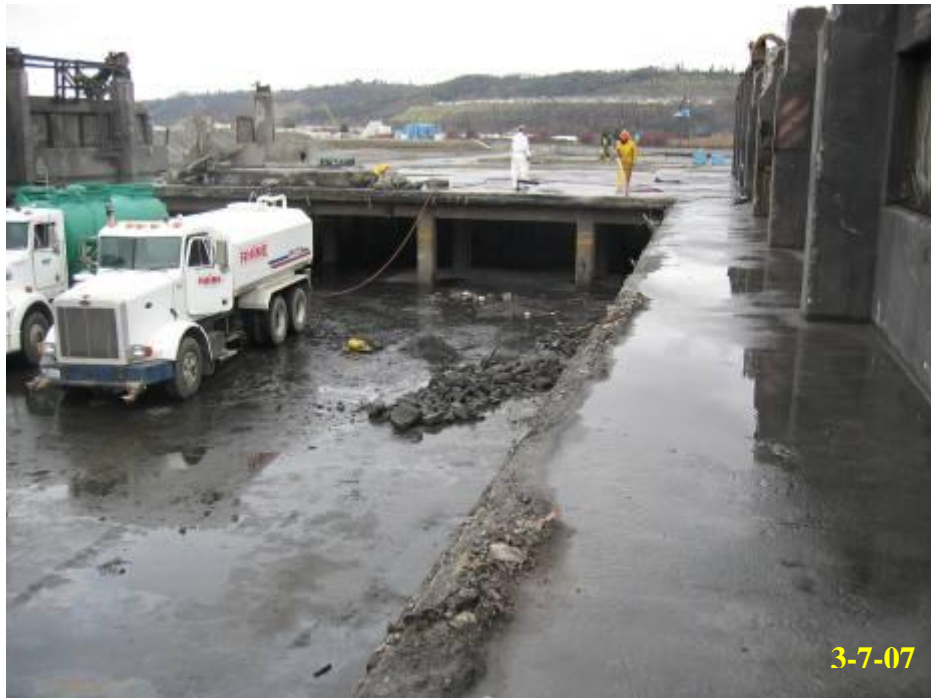
6.28 - Washing of north mezzanine floor

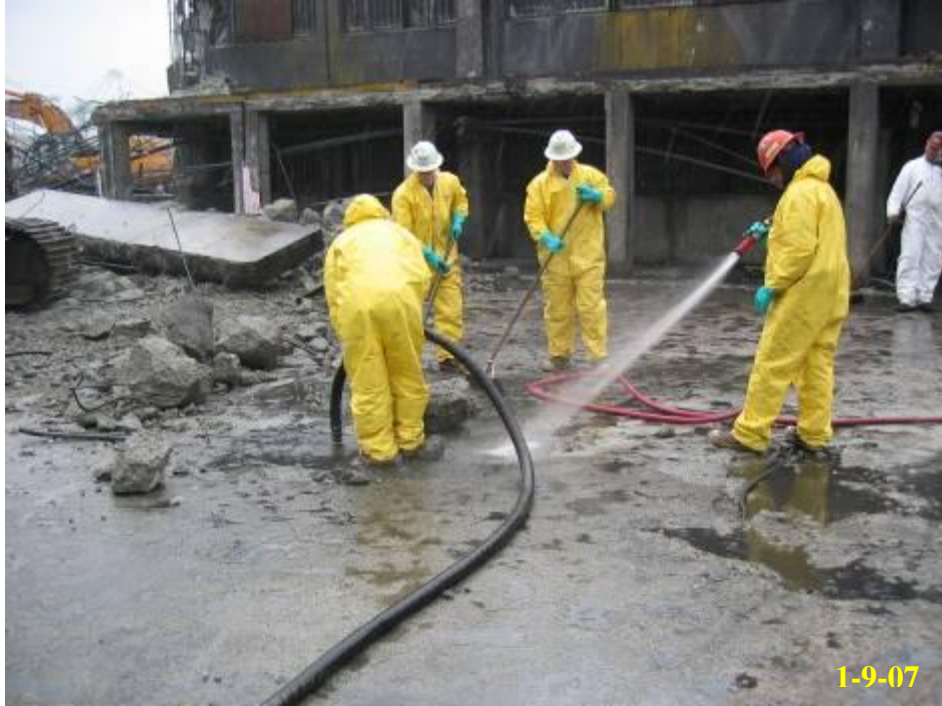
**6.29 - Final washing of building floor after demolition of main metal portion of the building**

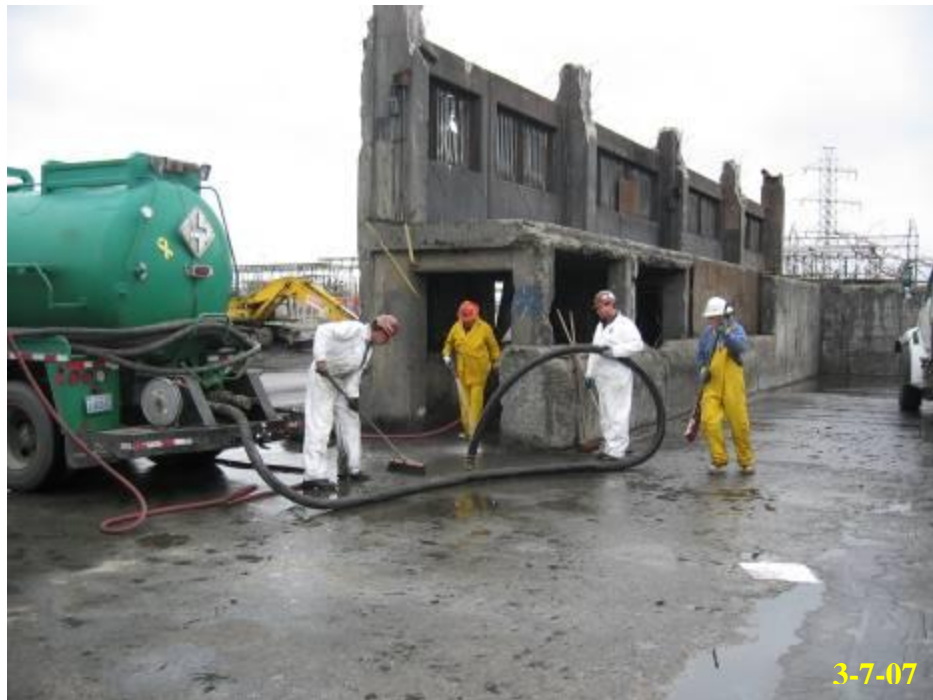
**6.30 - Washing/cleanup vacuuming of floor under east mezzanine**

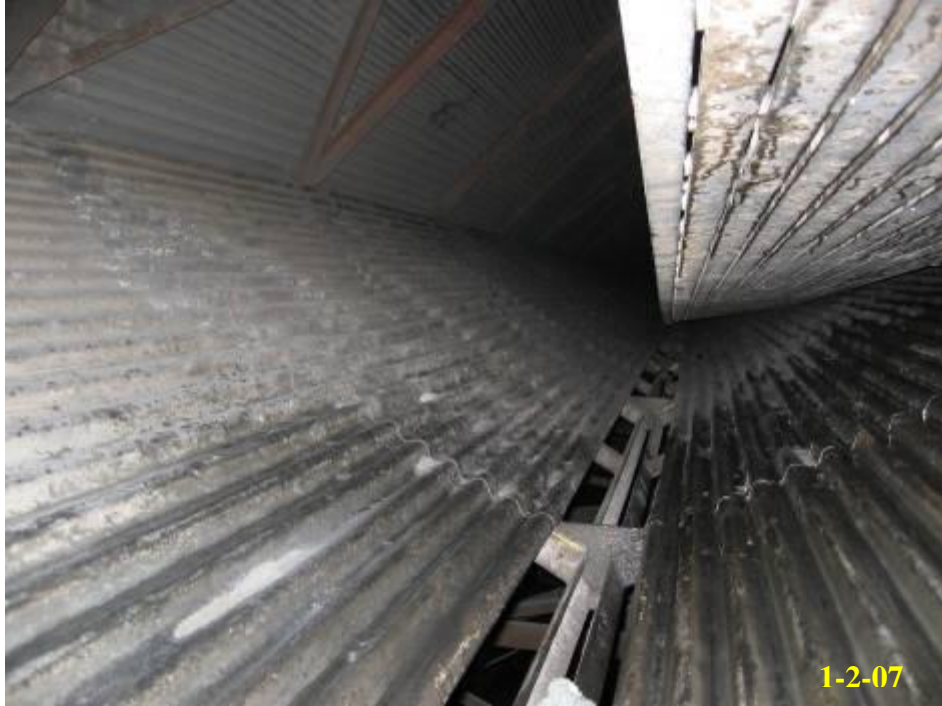
**6.31 - Roof vent interior after final cleaning**

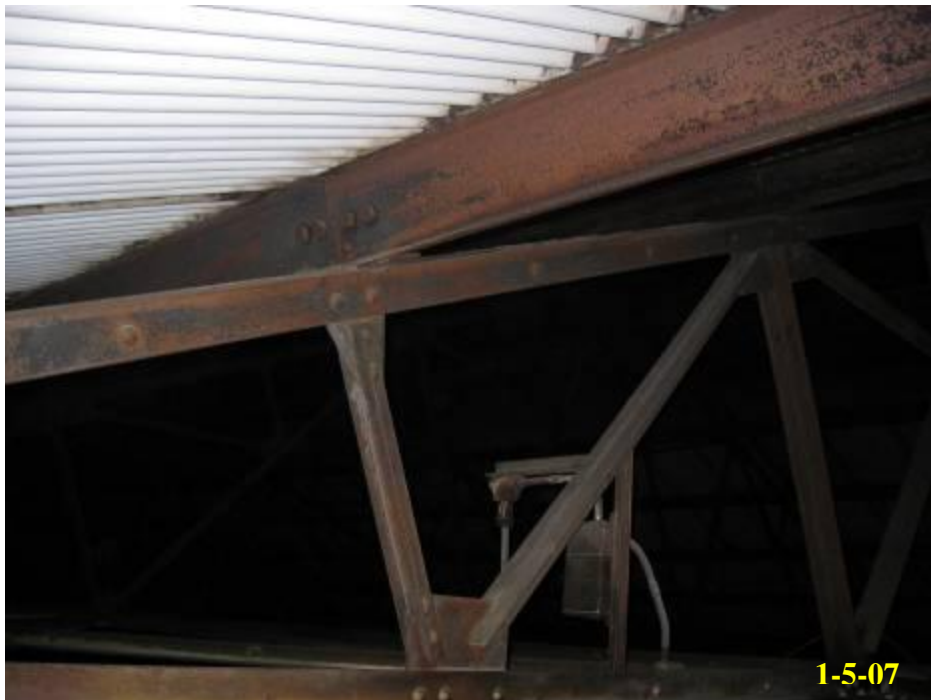
**6.32 - Building trusses after final cleaning**

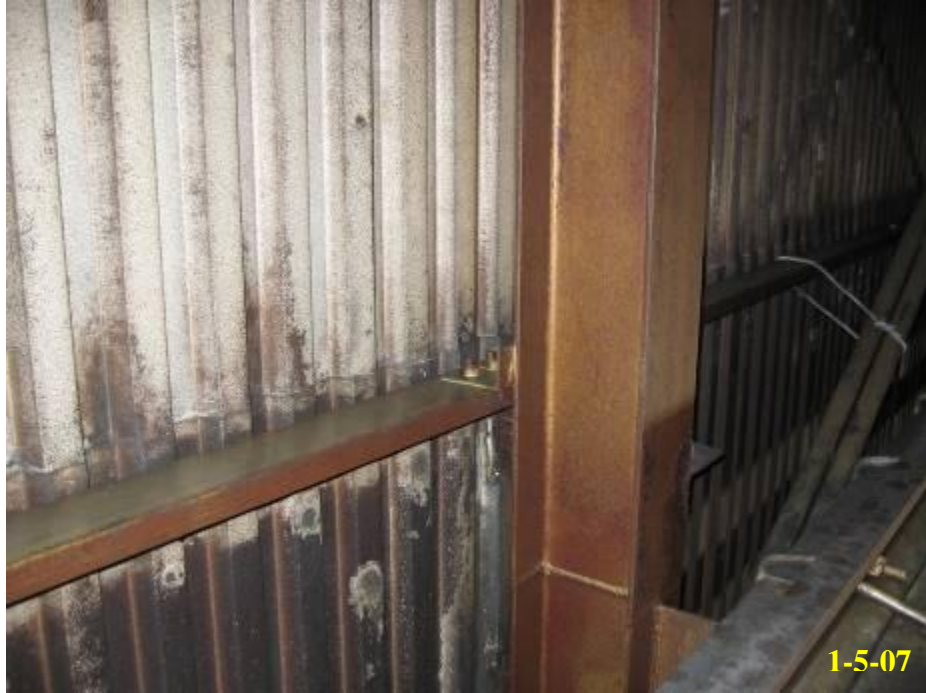
**6.33 - Building wall structural after final cleaning**

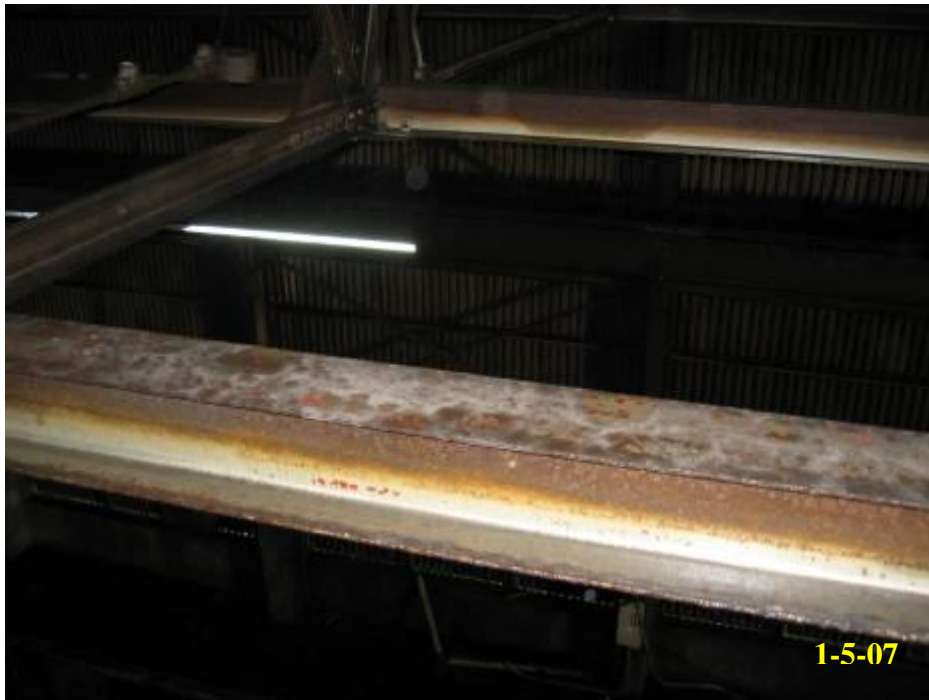
**6.34 - Typical roof structural after cleaning**

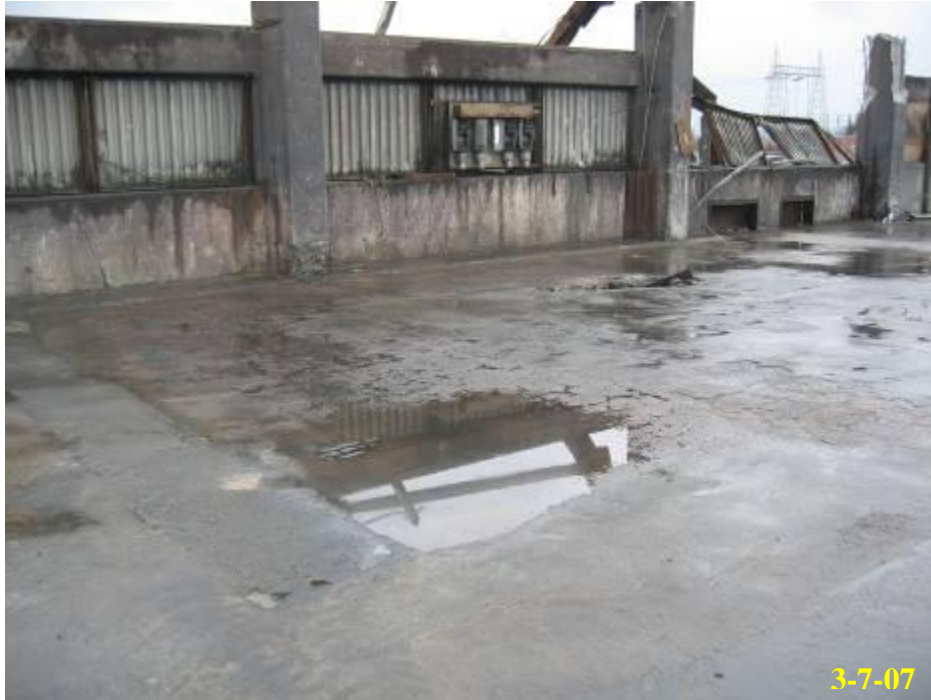
**6.35 - North mezzanine floor after final cleanup**

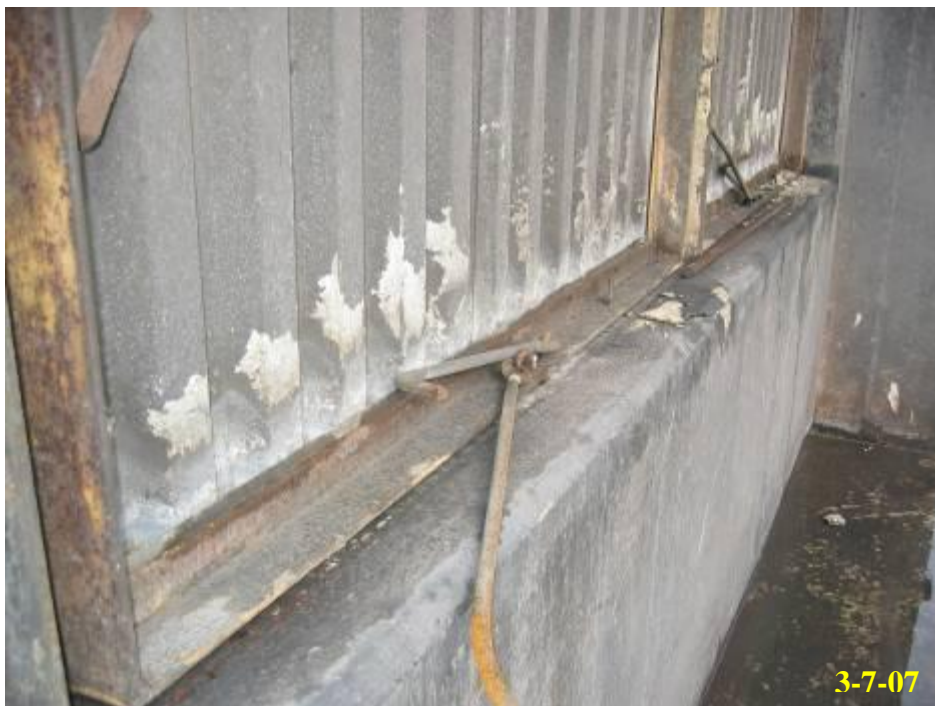
**6.36 - Wall louver area after final cleaning**
