**PORT OF TACOMA - KAISER FACILITY**

**BUILDING #65 RCRA  
DECONTAMINATION REPORT**

**September 26, 2007**

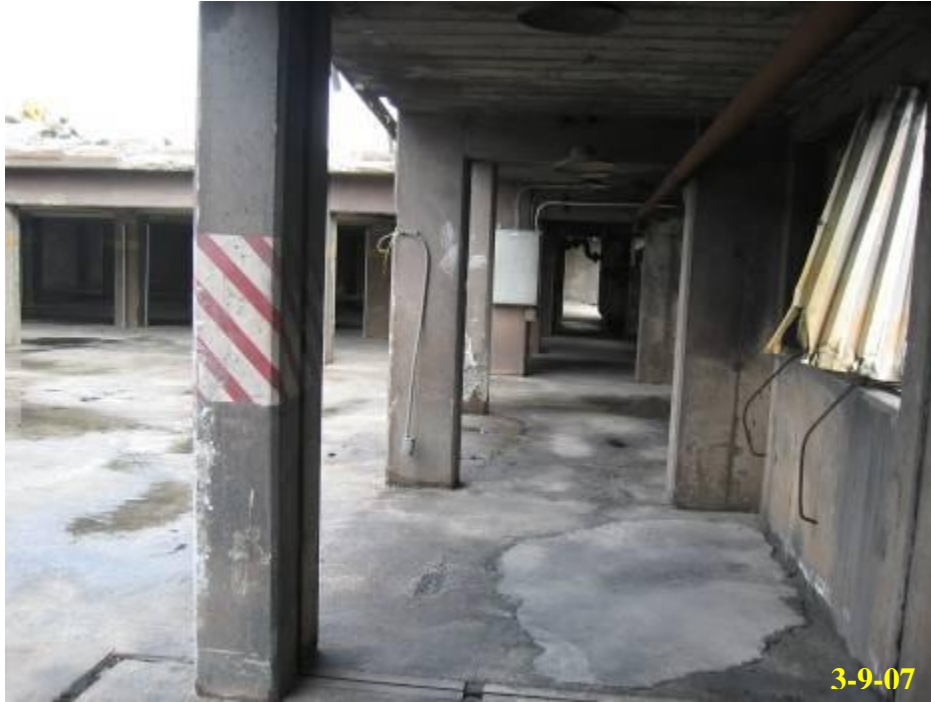
**6.37 - Floor under NW mezzanine after final cleanup**

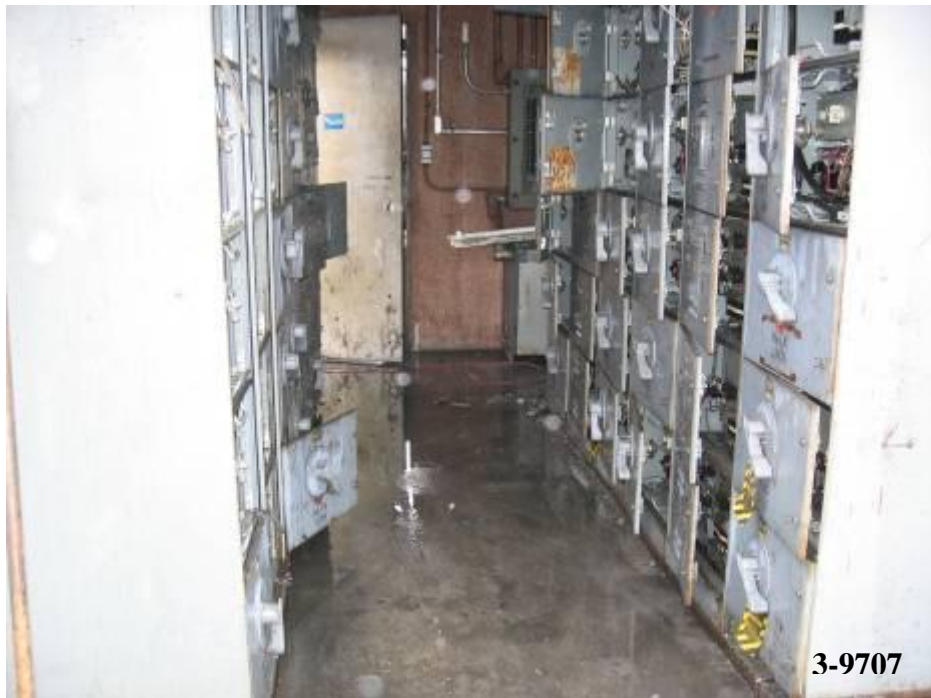
**6.38 - Motor Control Center after final cleaning**

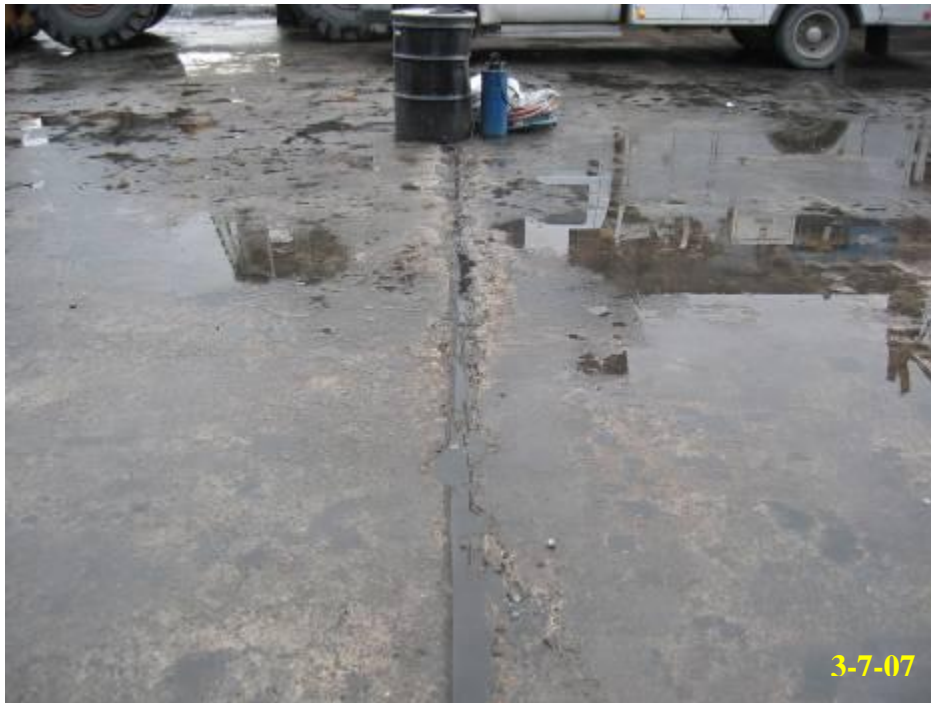
**6.39 - Floor of main building after final cleaning**

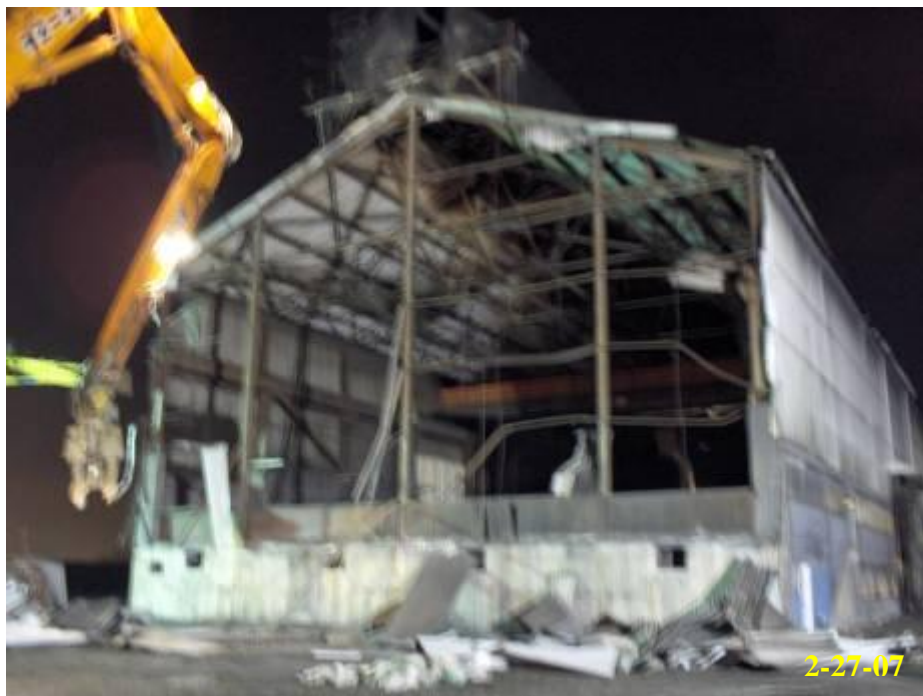
**6.40 - Start of building demolition at south end**

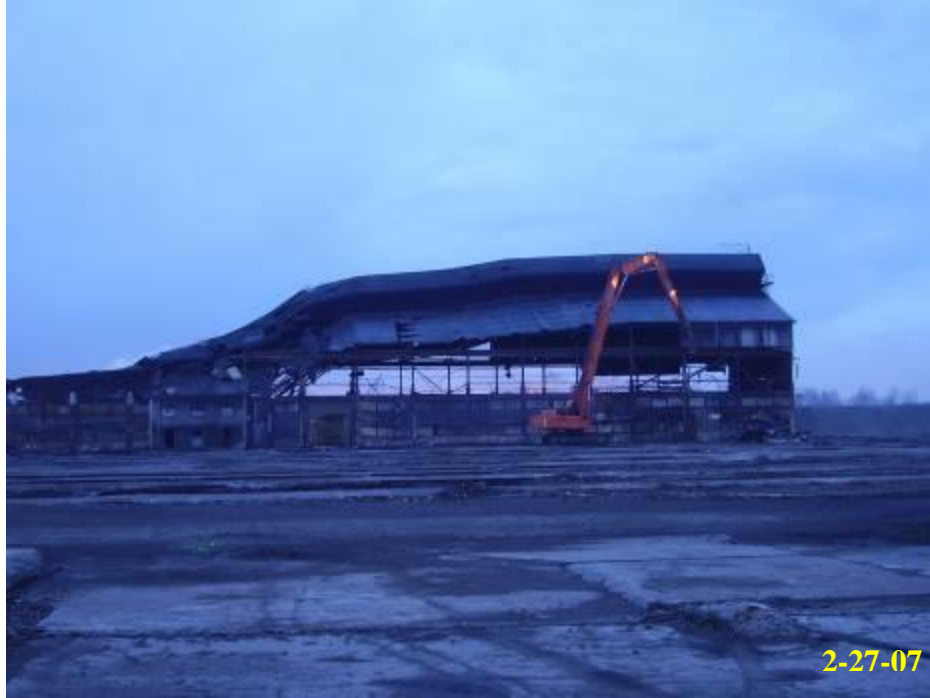
**6.41 - Demolition of building siding/columns**

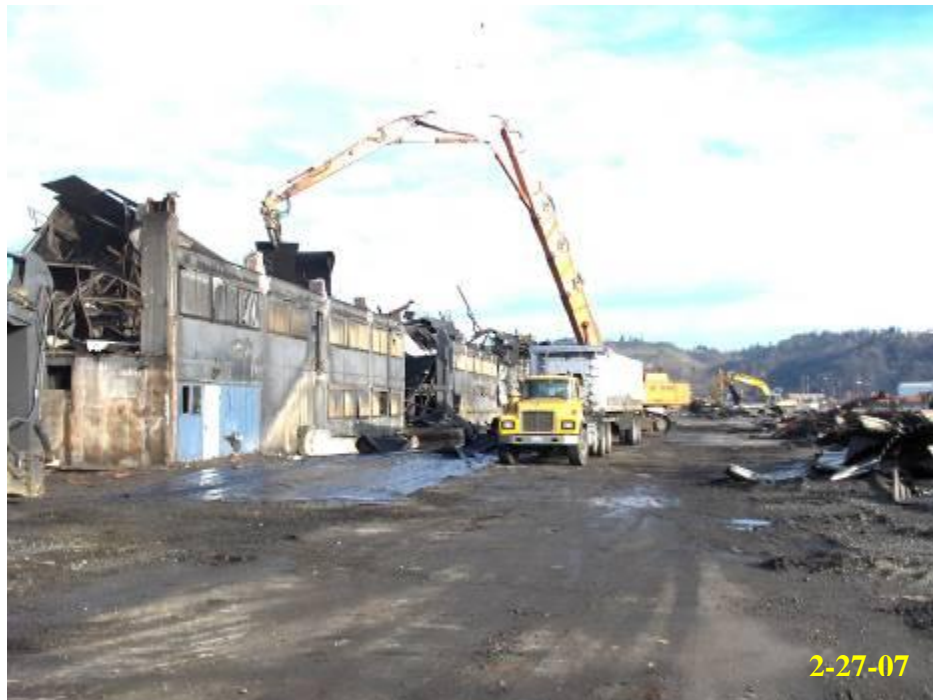
**6.42 - Metal processing and loading of roof panels for disposal**

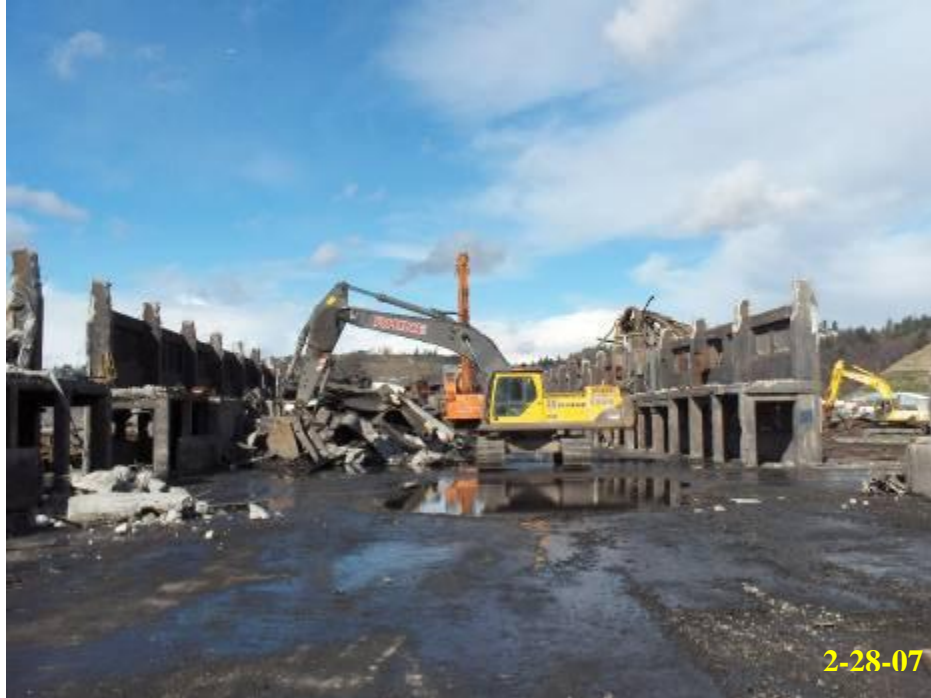
**6.43 - Metal processing during building demolition**

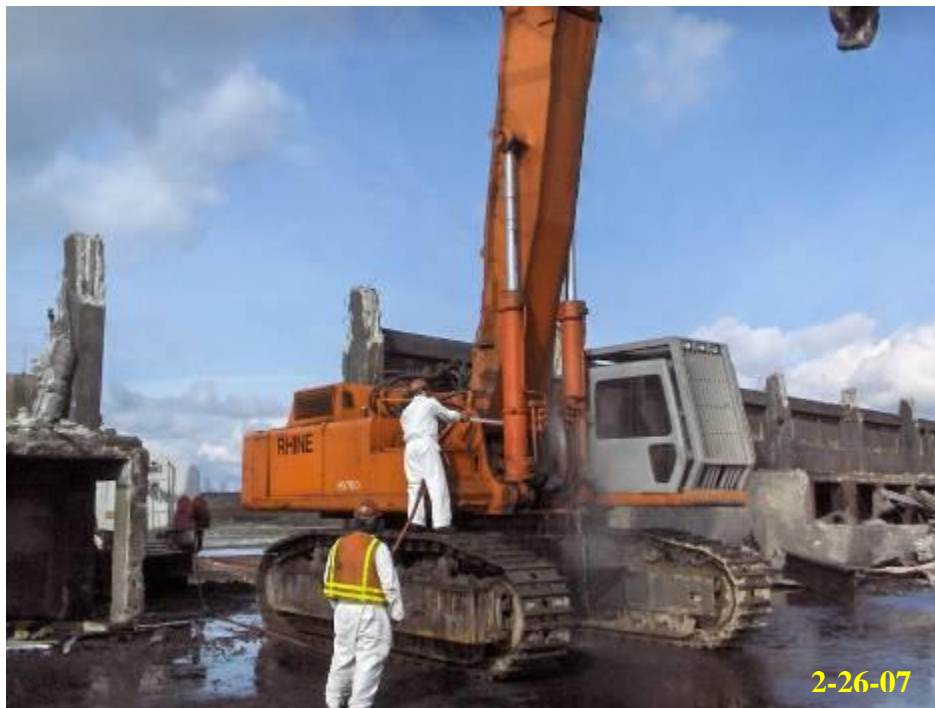
**6.44 - Decontamination of equipment (typical)**

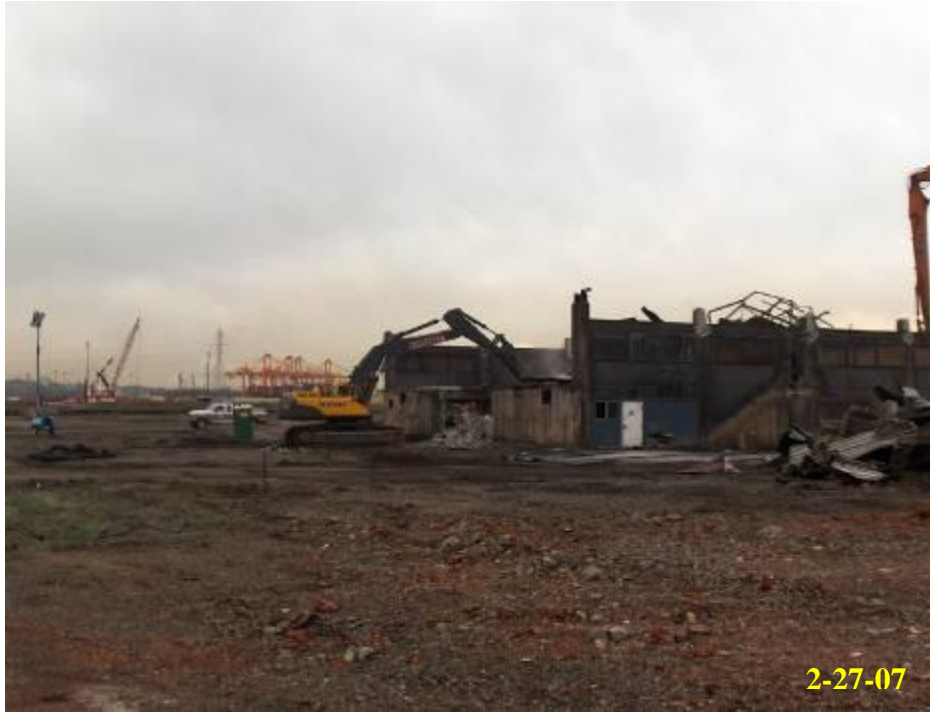
**6.45 - Beginning of concrete wall demolition at south end**

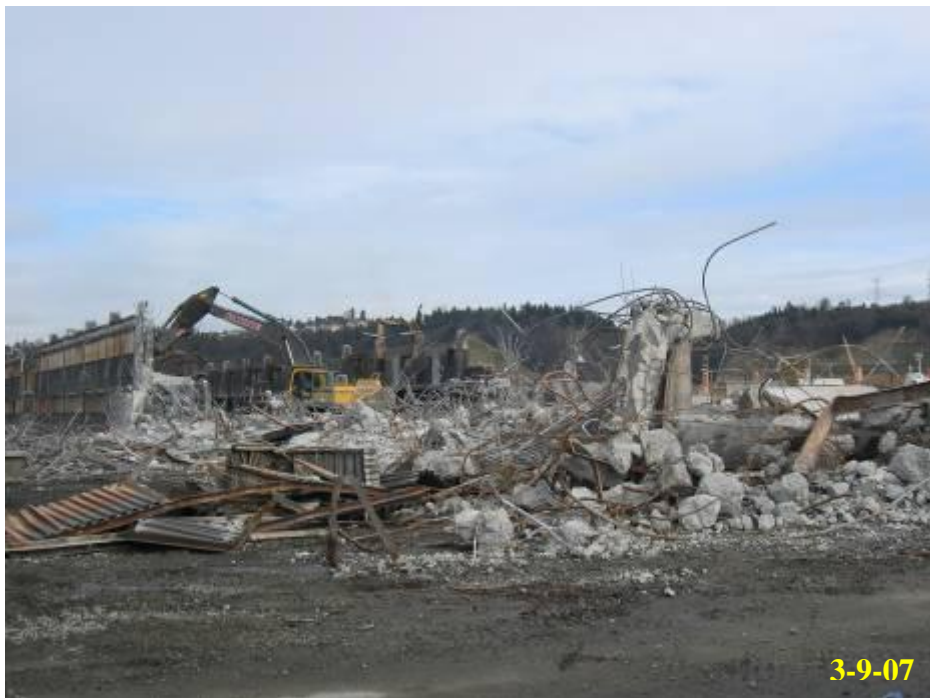
**6.46 - Demolition of west concrete walls**

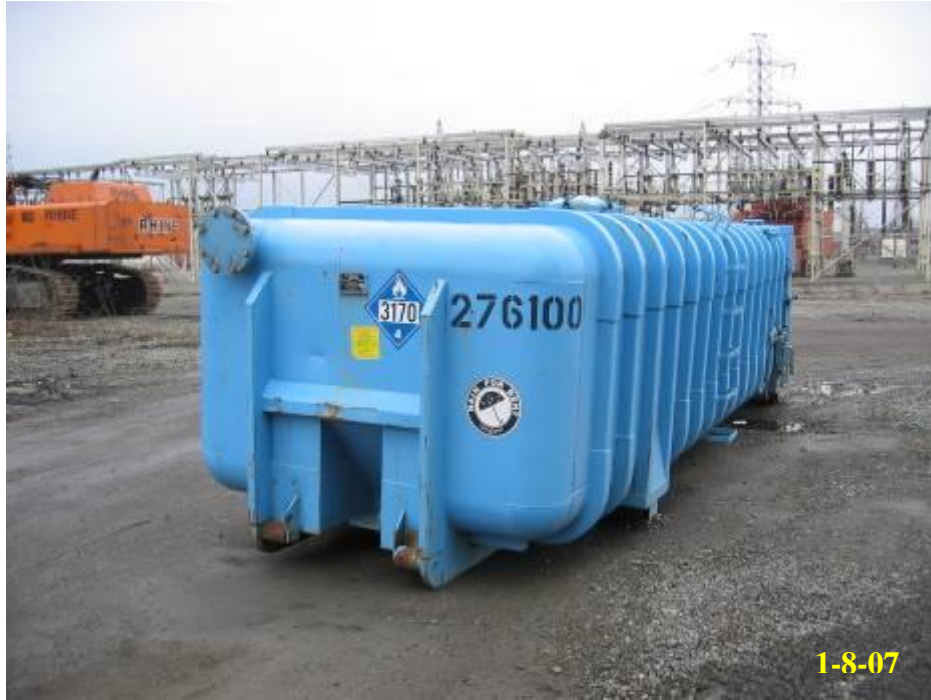
**6.47 - Storage and shipping roll-off for dust**

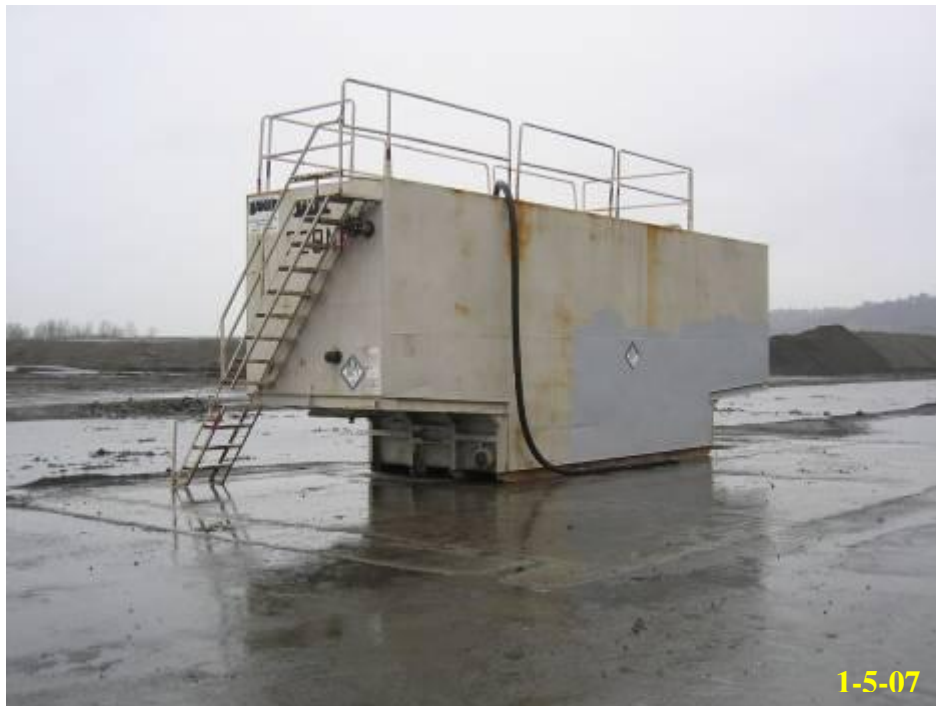
**6.48 - First rented tank used for waste wash water storage**
