**PHASE I ENVIRONMENTAL SITE
ASSESSMENT**

Bayliner Marine

17825 59th Avenue NE

DRAFT
PHASE I ENVIRONMENTAL
SITE ASSESSMENT REPORT
Bayliner Marine
17825 59th Avenue NE
Arlington, Snohomish County, WA 98223

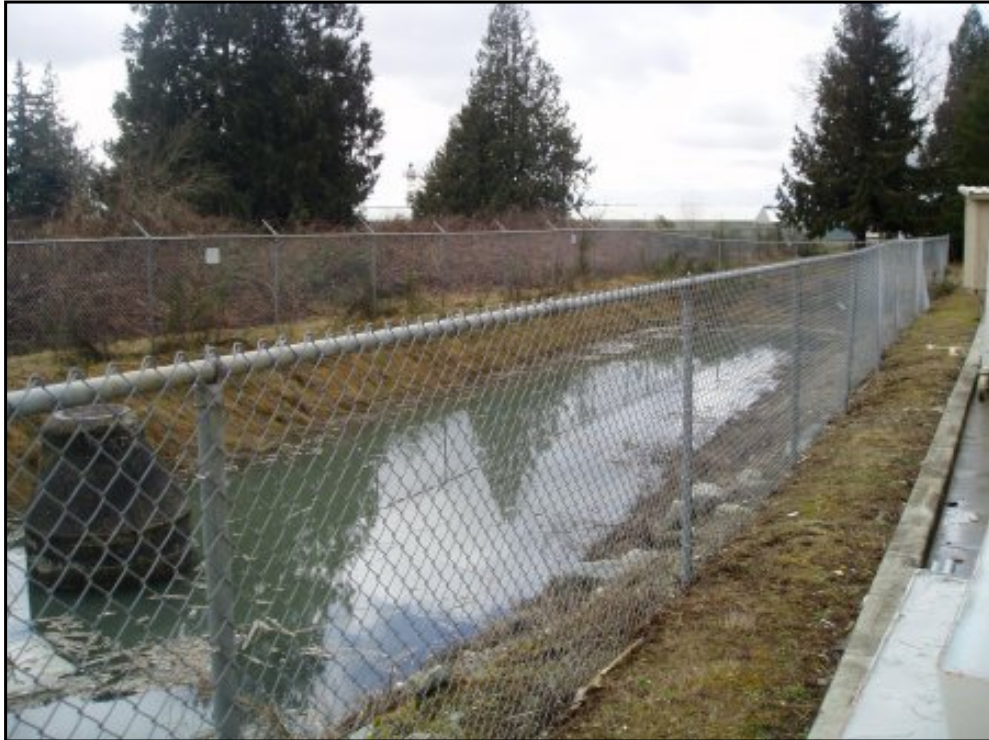
Three stormwater retention ponds were observed along the south side of the subject property. No other pits, ponds, or lagoons were observed.

View of retention pond one located southwest of Building 16.

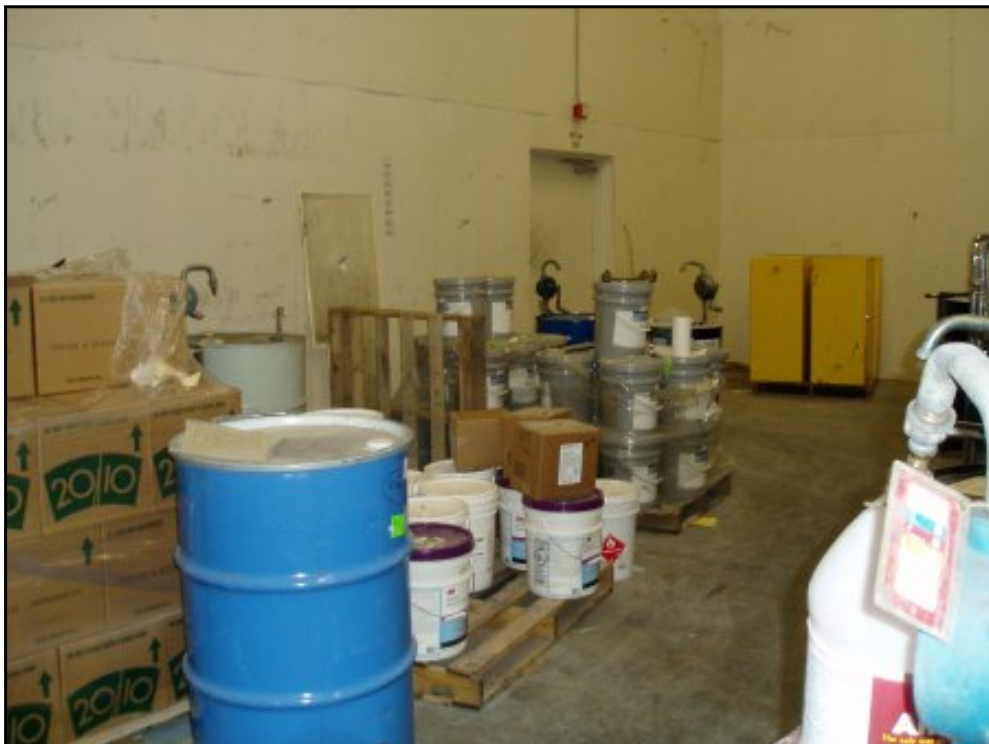
All hazardous materials remaining at the subject property had been consolidated in Building 16. Mr. Nieshe stated that the hazardous materials will be removed by May 2008. The following materials were observed at the time of Stantec's site reconnaissance:

Several containers of one-gallon or less of urethane, latex paint, primers, acetone, epoxies, and lacquer thinner were also observed in Building 16, stored on wood pallets and within secondary containment.

No floor drains or significant staining was observed on the concrete floor in the vicinity of the hazardous materials storage area.

View of hazardous materials stored in Building 16.

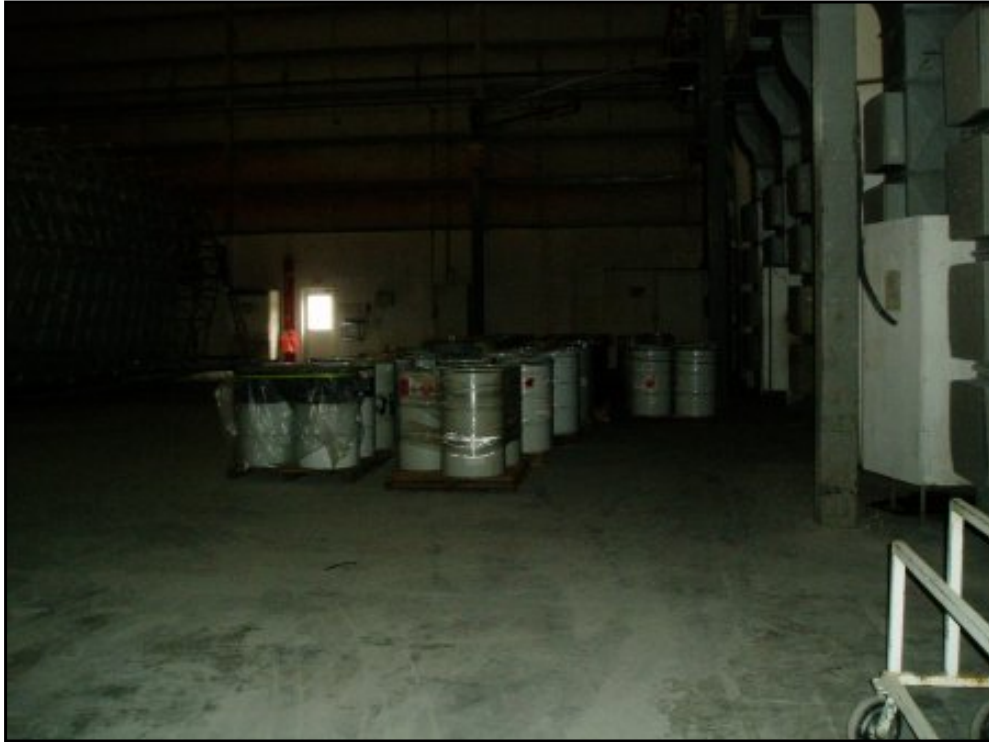
View of hazardous materials stored in Building 16.

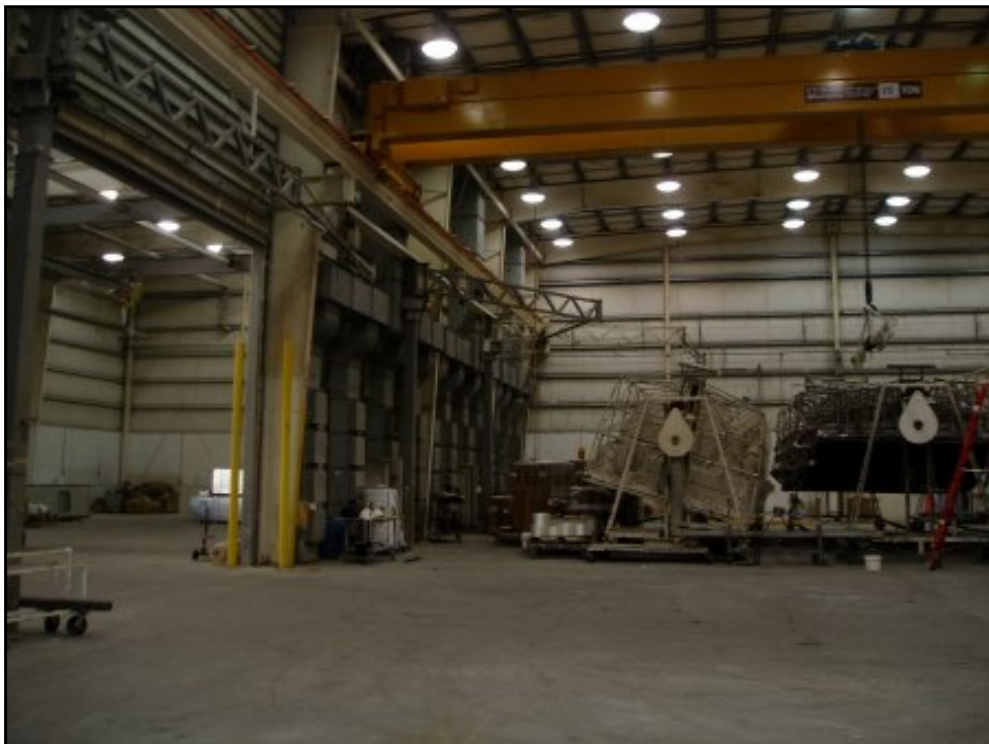
Building 16 - Lamination Building. Building 16 is a single-story building constructed of a steel frame with metal siding on a concrete slab-on-grade foundation. No floor drains were observed in the building. The concrete floors were observed to be in good condition with no significant staining. The building was formerly used for detailing boats. A 20-ton capacity overhead crane was observed as well as a former grinding booth. At the time of the site reconnaissance the building was being used for boat storage, and for temporary storage of all remaining hazardous materials from the entire subject property. All of the different hazardous materials were stored in their original containers, ranging from one-pint cans to 55-gallon drums. All containers were labeled and on pallets or within wooden over-sized containers. No staining was observed in the vicinity of the hazardous materials storage area. According to Mr. Nieshe, all the remaining hazardous materials will be removed from the subject property.

View of remaining items in Building 16.

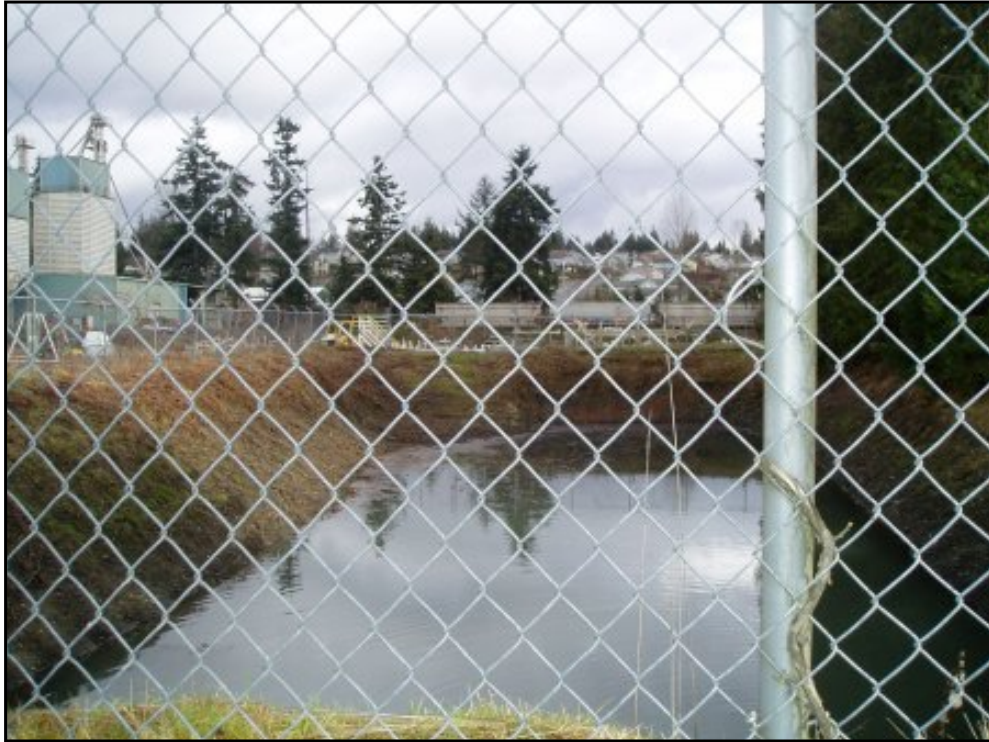
View of retention pond three located near the southeast corner of the subject property.

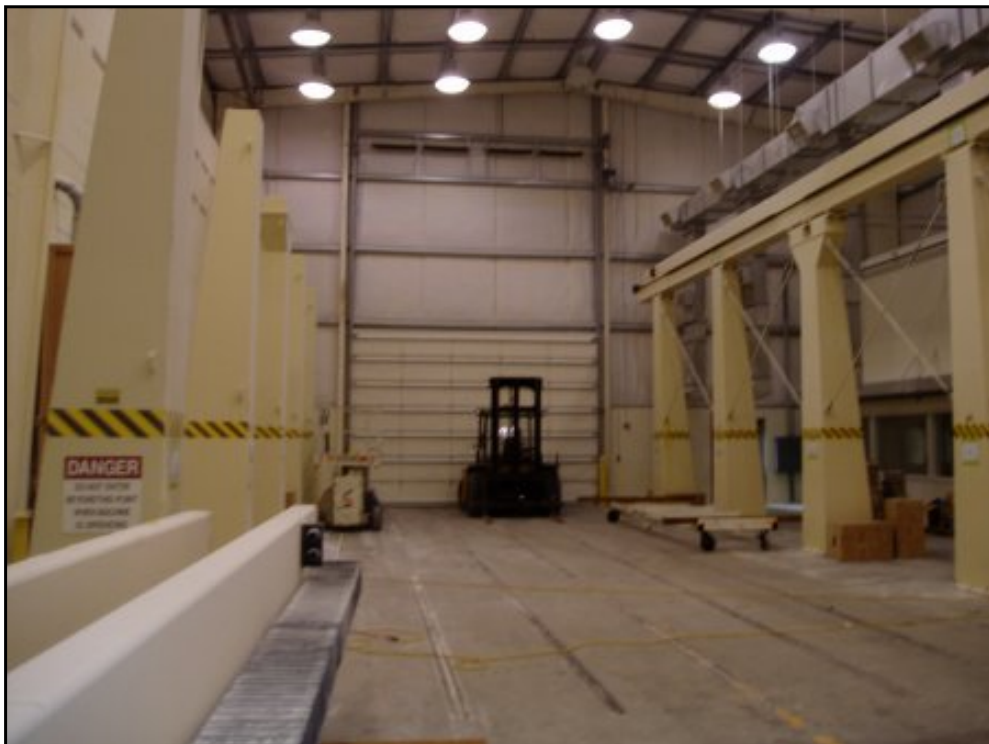
Building 12A - Foam Milling Room. Building 12A is a single-story building constructed of a steel frame with metal siding on a concrete slab-on-grade foundation. No floor drains were observed in the building. The concrete floors were observed to be in good condition with no significant staining. The building was formerly occupied by a large router used to cut foam products. At the time of the site reconnaissance the building was empty.

View of Building 12A, the former foam cutting building.

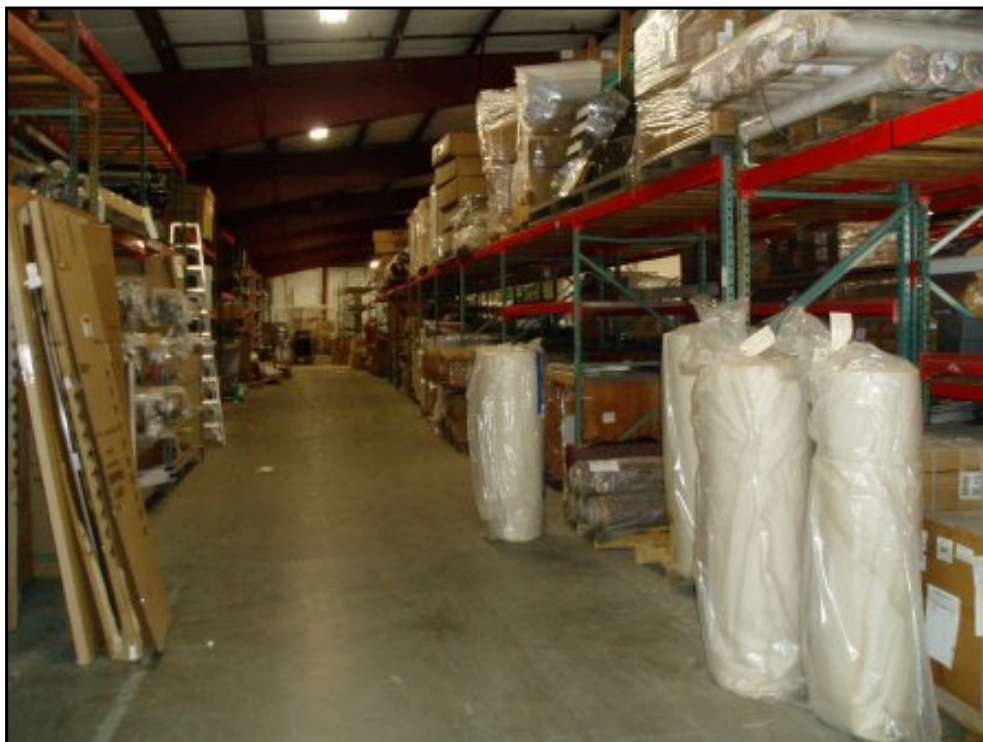
Building 7 - Warehouse of Boat and Yacht Parts. Building 7 is a single-story building constructed of a steel frame with metal siding on a concrete slab-on-grade foundation. No floor drains were observed in the building. The concrete floors were observed to be in good condition with no significant staining. The building was used to warehouse dry goods, like foam, fabric, rugs, fiberglass, and a variety of parts.

View of products warehoused in Building 7.

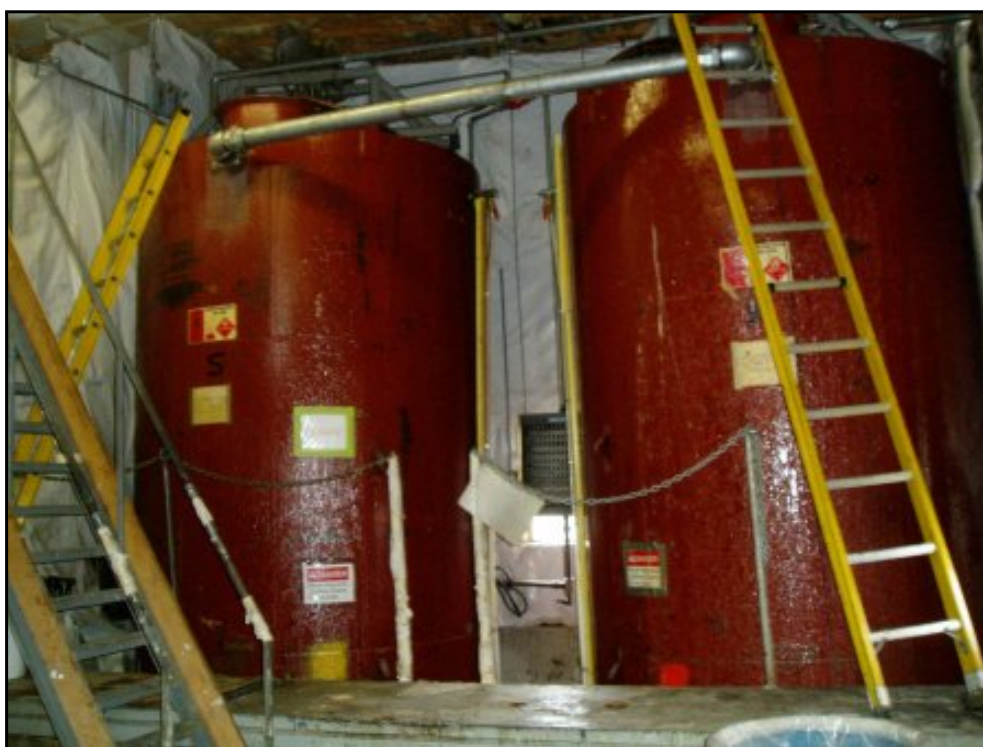
Tank ID	Tank Location	Tank Construction	Walls	Product
Resin #1	Resin Room	Fiberglass	Single walled	Resin
Volume (Gals.)	Installation Year	Active?	Secondary Containment	Surface Underlying Tank
10,000	Unknown	No	Yes	Concrete
Overall Condition of Tank	Visible Rust on Tank?	Visible Dents or Holes?	Visible Staining	Piping Location
Good	No	No	No	Above ground

View of two 10,000-gallon resin tanks observed north of Building 2.

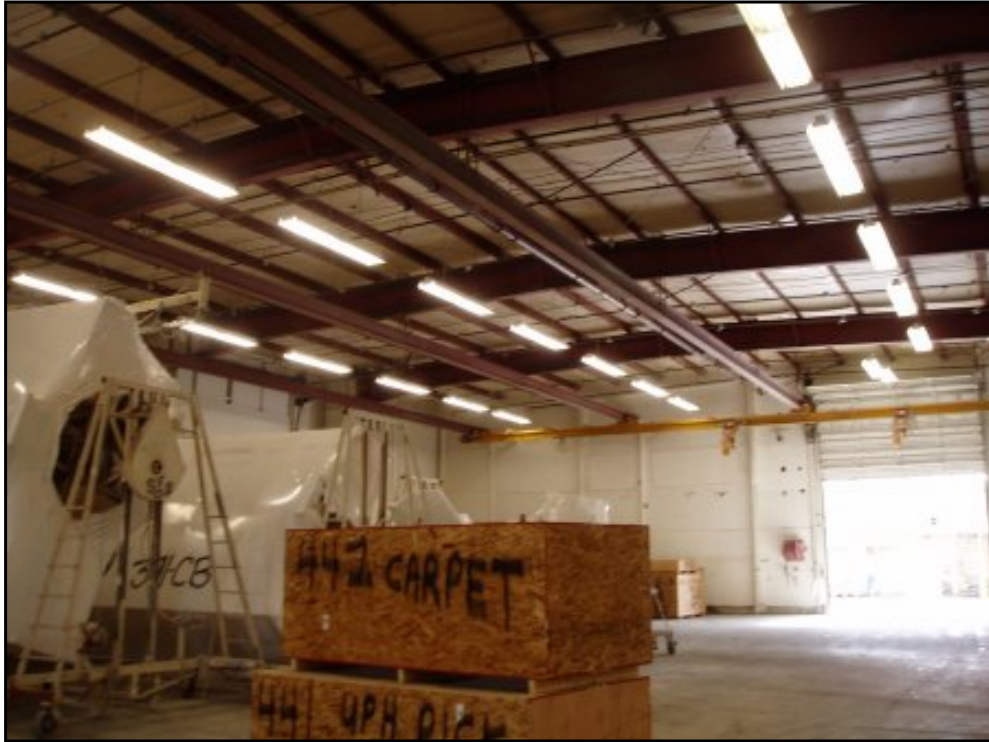
Building 3 - Production Lamination. Building 3 is a single-story building constructed of a steel frame with metal siding on a concrete slab-on-grade foundation. One trench drain was observed on the west side of the building. Mr. Nieshe stated the drain discharges to the stormwater retention ponds on the subject property. No staining or oily residue was observed in or around the trench drain. No other floor drains were observed in the building. The concrete floors were observed to be in good condition with no significant staining. The building was formerly used for production lamination. A former grinding booth was observed in the building. At the time of the site reconnaissance the building was being used for mold storage.

View of boat and mold storage in Building 3.

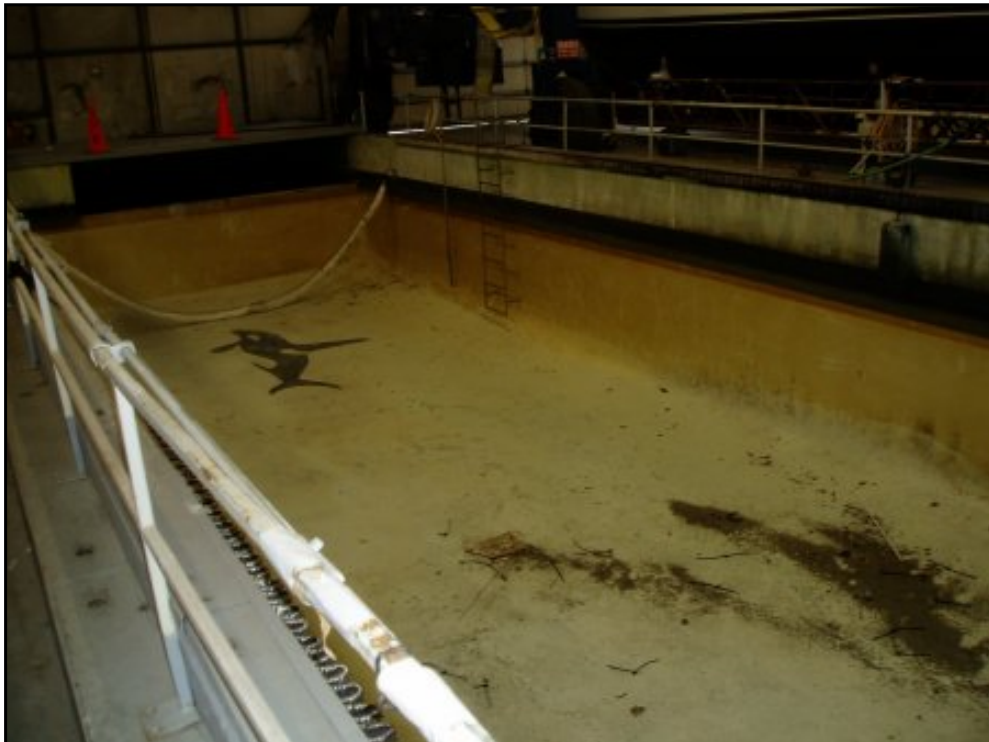
Building 4 - Yacht Assembly. Building 4 is a single-story building constructed of a steel frame with metal siding on a concrete slab-on-grade foundation. One trench drain was observed

near the testing pool. The trench drain reportedly discharges to the on-site stormwater retention ponds. No staining or oily residue was observed in or around the trench drain. No other floor drains were observed in the building. The concrete floors were observed to be in good condition with no significant staining. The building was formerly used for yacht assembly and had concrete utility trenches to each assembly station. A wire shop, counter top fabrication shop, lunch room and offices were also observed. At the time of the site reconnaissance the building was being used for boat storage.

View of the testing pool in Building 4.

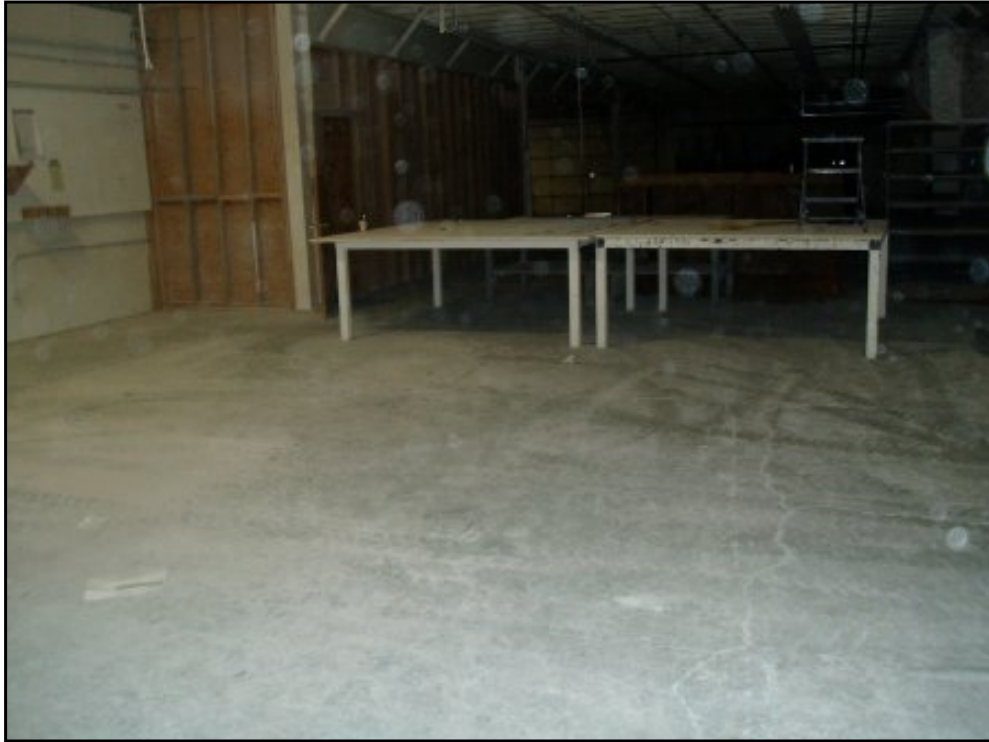
View of the former counter fabrication area in Building 4.

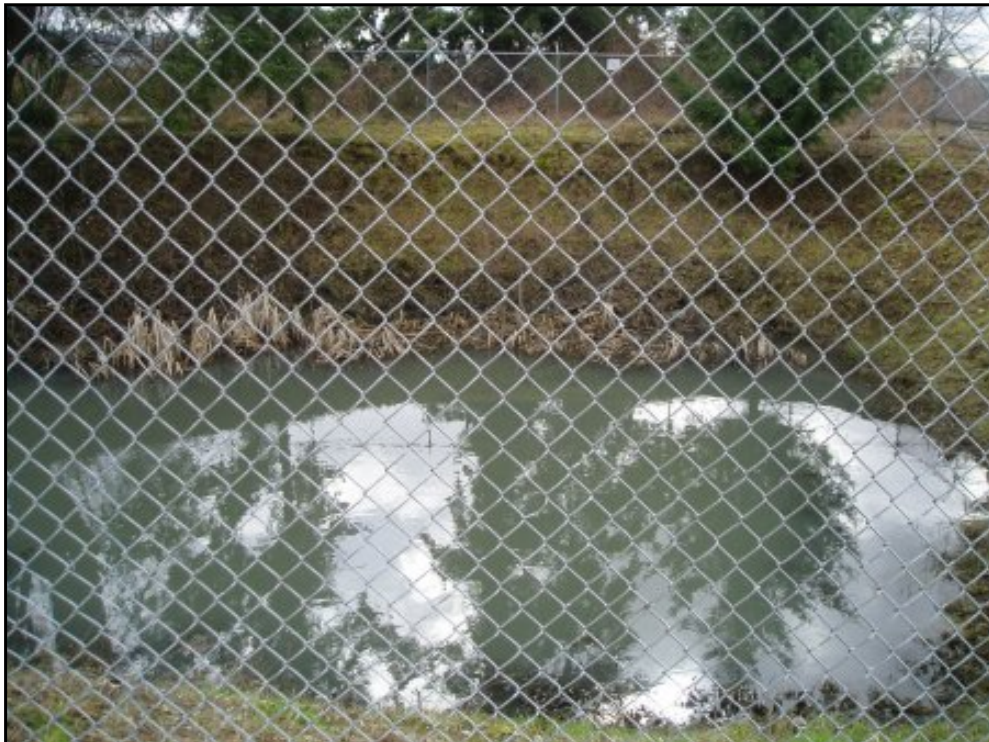
View of retention pond 2 located east of Building 11.

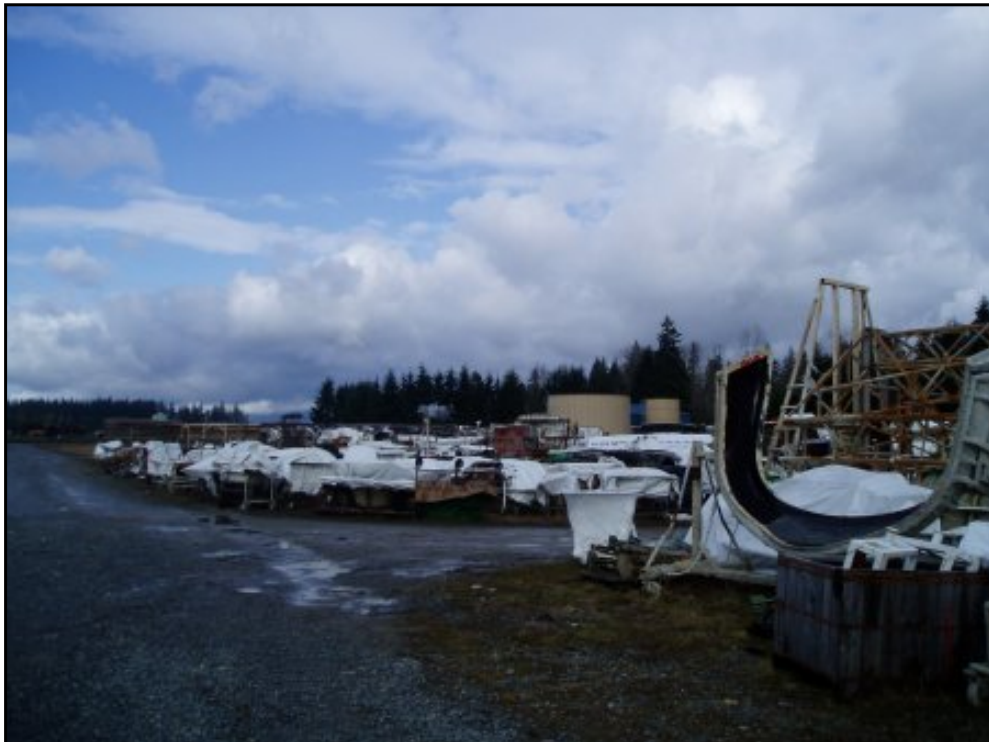
View of boat and mold storage located on the east side of the subject property.

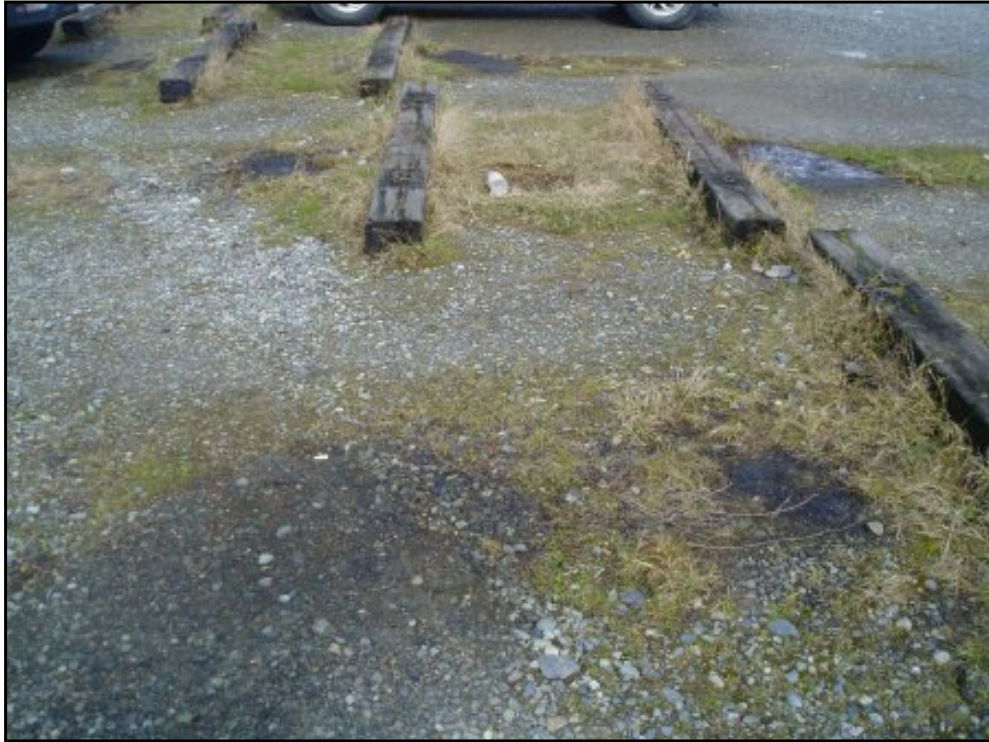
None observed, with the exception that *de minimis* oily staining was observed in the gravel parking areas. The staining appeared consistent with small leaks or drips from parked automobiles.

View of typical oily stained gravel observed in the employee parking lot on the east side of the subject property.

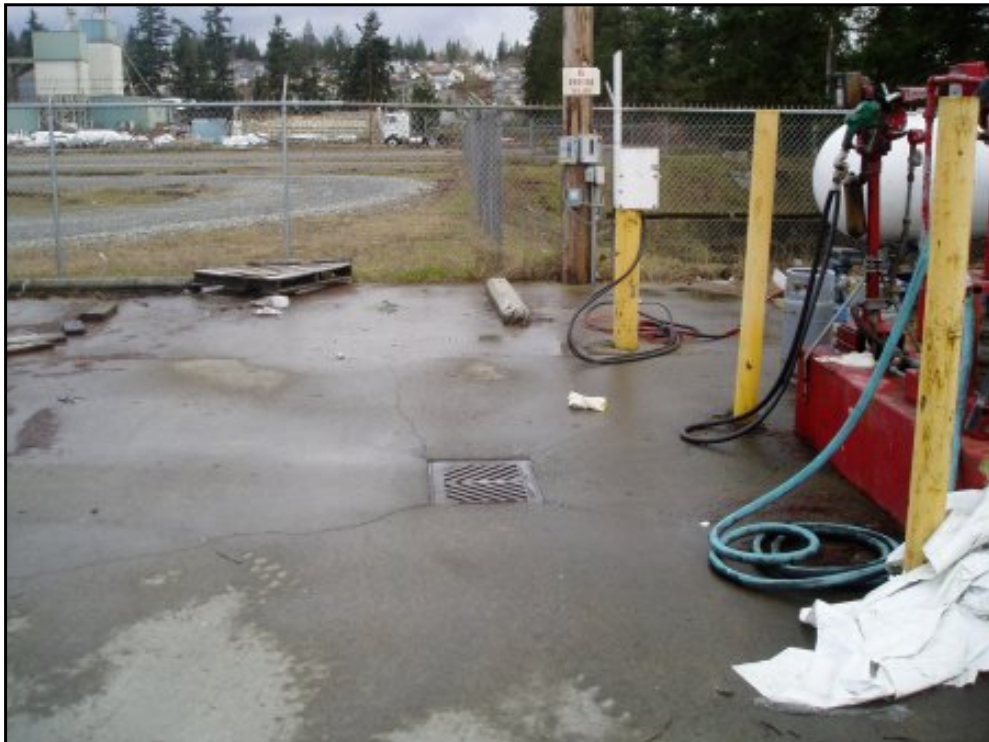
Multiple stormwater drains were observed at the subject property. The stormwater drains discharge to a series of retention ponds located on the south side of the subject property.

View of a stormwater drain and the diesel and gasoline dispenser island located northeast of Building 14.

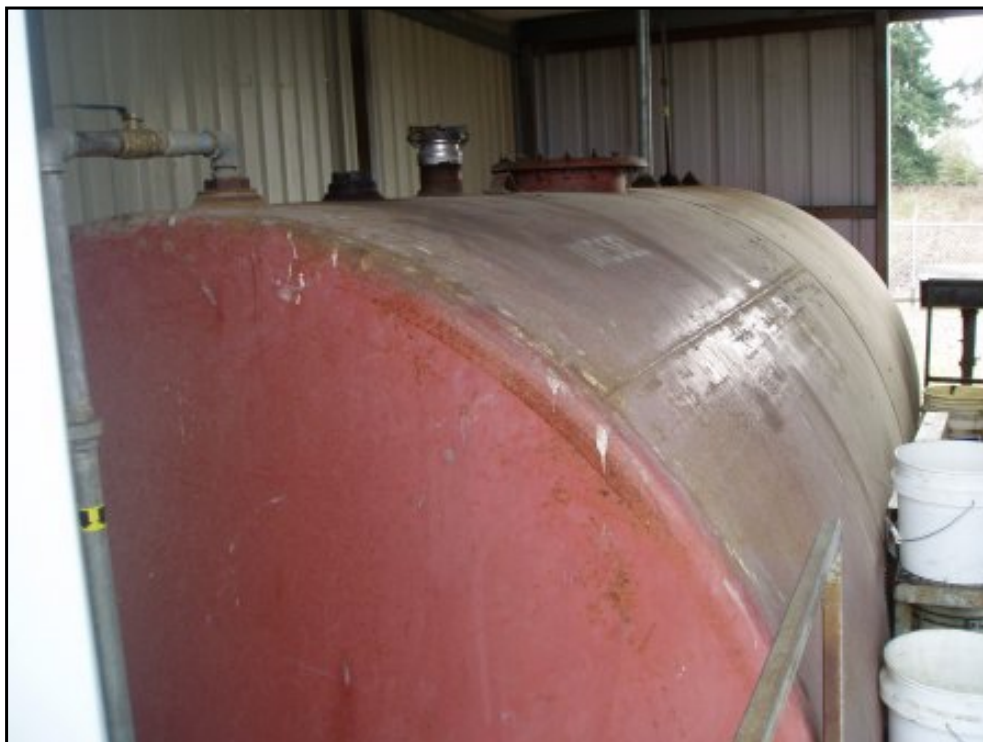
View of the 10,000-gallon diesel AST located northeast of Building 14.

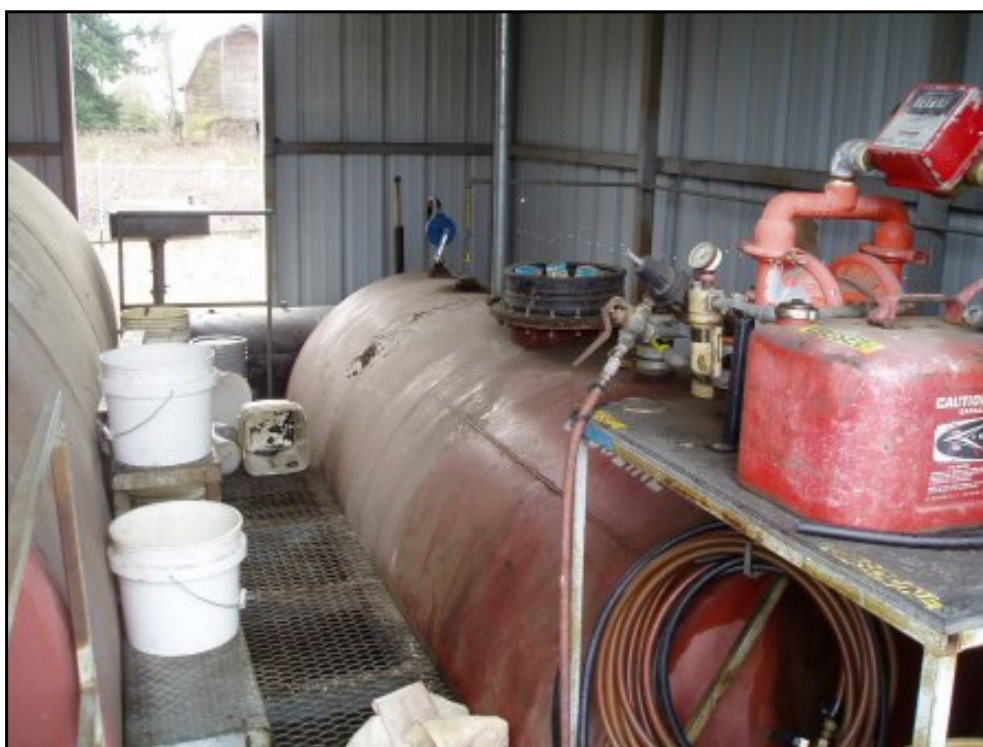
View of the 5,000-gallon gasoline AST located northeast of Building 14.

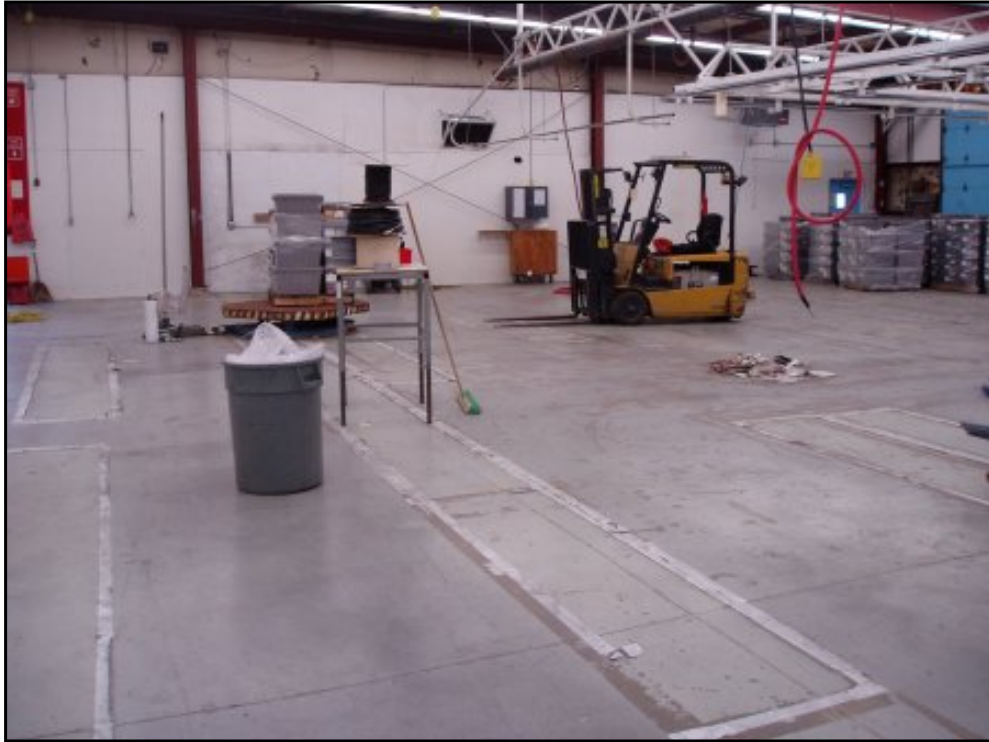
Building 14 - Windshield and Wire Shop. Building 14 is a single-story building constructed of a steel frame with metal siding on a concrete slab-on-grade foundation. No floor drains were observed in the building. The concrete floors were observed to be in good condition with no

significant staining. The building was formerly used to assemble windshields and wiring. At the time of the site reconnaissance all machinery had been removed from the building and the building was being cleaned up.

View of the former windshield and wire shop in Building 14.

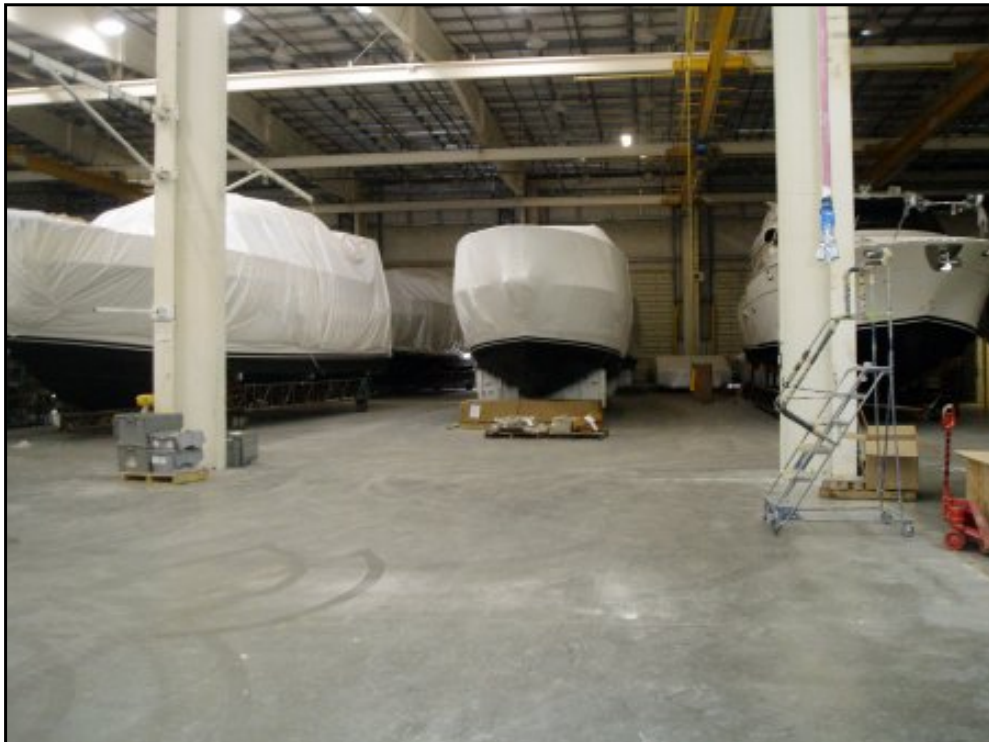
Building 17 - Assembly of Larger Yachts. Building 17 is a single-story building constructed of a steel frame with metal siding on a concrete slab-on-grade foundation. No floor drains were observed in the building. The concrete floors were observed to be in good condition with no significant staining. The building was formerly used for assembly of large yachts. At the time of the site reconnaissance the building was used for yacht storage.

View of boat storage in Building 17.
