## **CLEANUP ACTION SUMMARY REPORT**

**ED'S TRANSMISSIONS  
10226 STATE AVENUE  
MARYSVILLE, WASHINGTON**

**Submitted by:  
Farallon Consulting, L.L.C.  
975 5<sup>th</sup> Avenue Northwest  
Issaquah, Washington 98027  
Farallon PN: 1160-001**

October 2, 2014

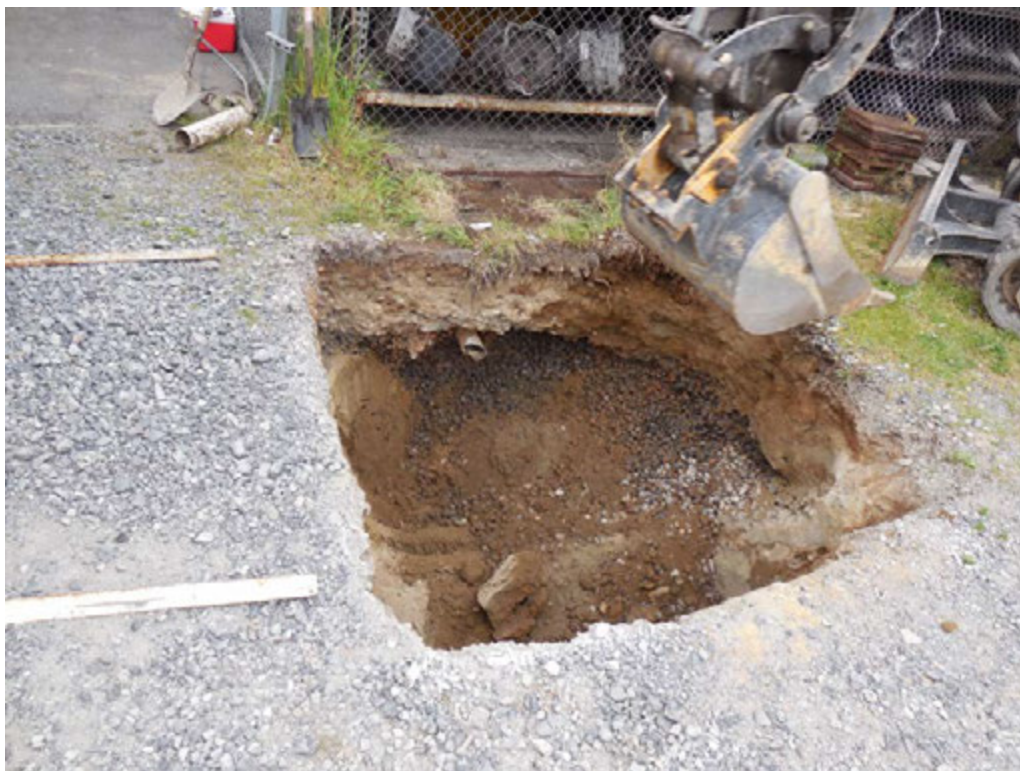
**Photograph 1:** Perforated drainpipe extending west from Site building.

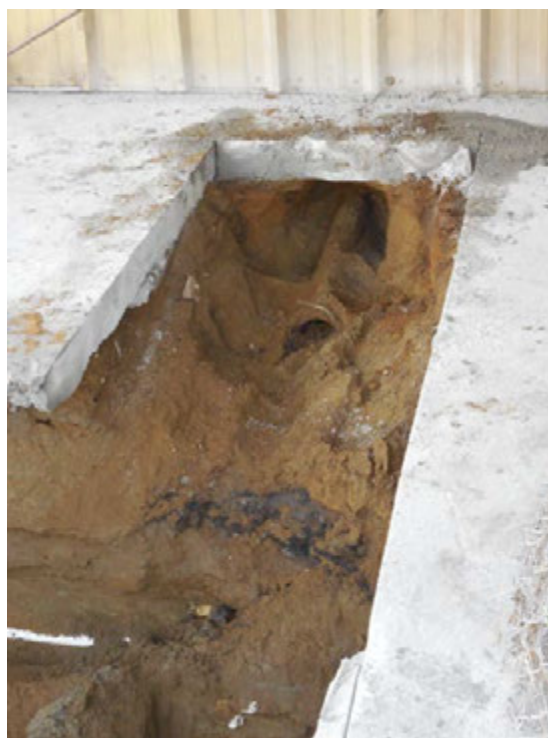
The excavation exposed drain pipe DP3 at approximately 2 feet bgs, surrounded by sand and drain rock (Figure 3). Drain pipe DP3 was connected to an unknown 3-inch-diameter metal drain pipe beneath the Property building. The suspected source for the 3-inch metal drain pipe could not be identified. A black substance with a faint petroleum odor was observed in drain pipe DP3 and on the surrounding drain rock.

**Photograph 2:** Metal drainpipe extending west from unknown location inside the Site building that was connected to the perforated drainpipe.

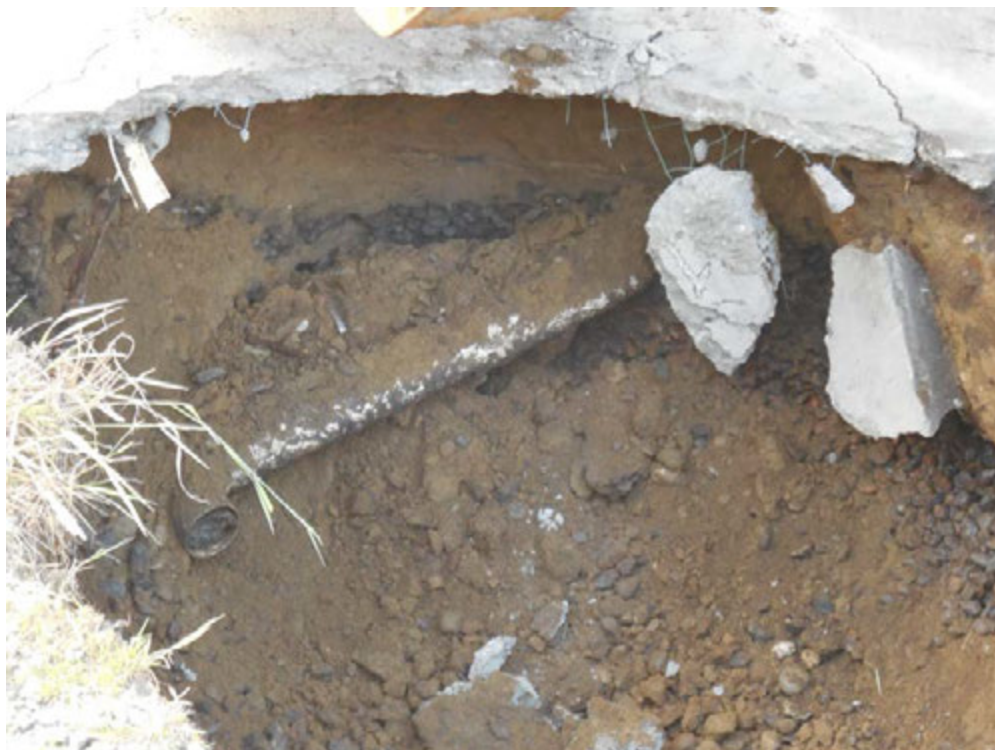
**Photograph 3:** Perforated drainpipe.

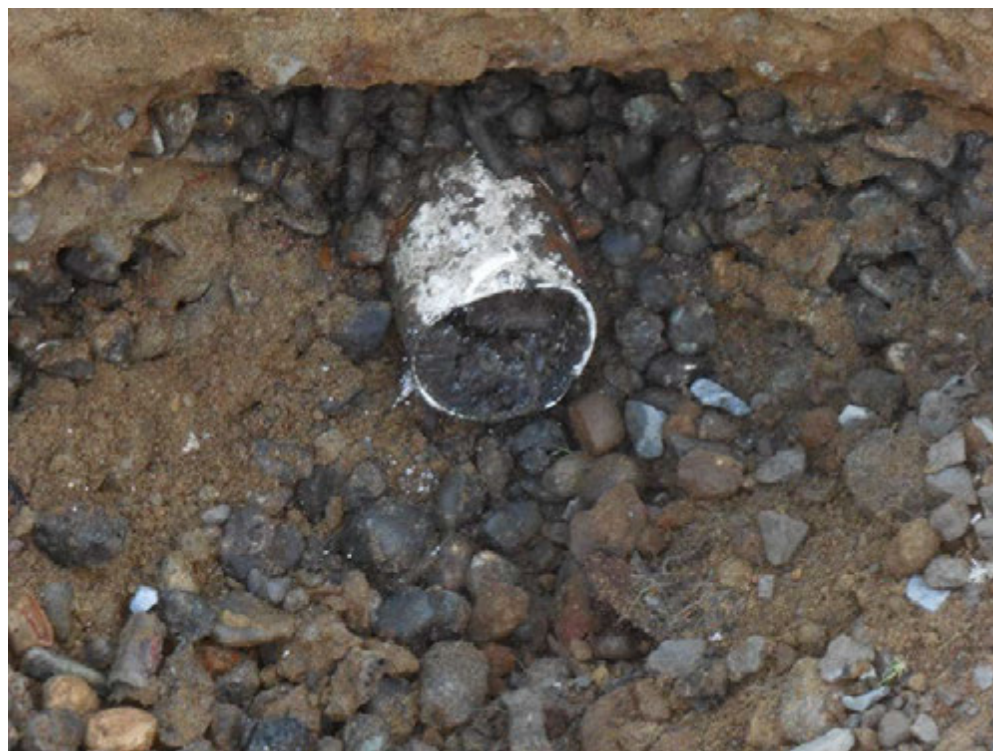
**Photograph 4:** Black substance inside perforated drainpipe.

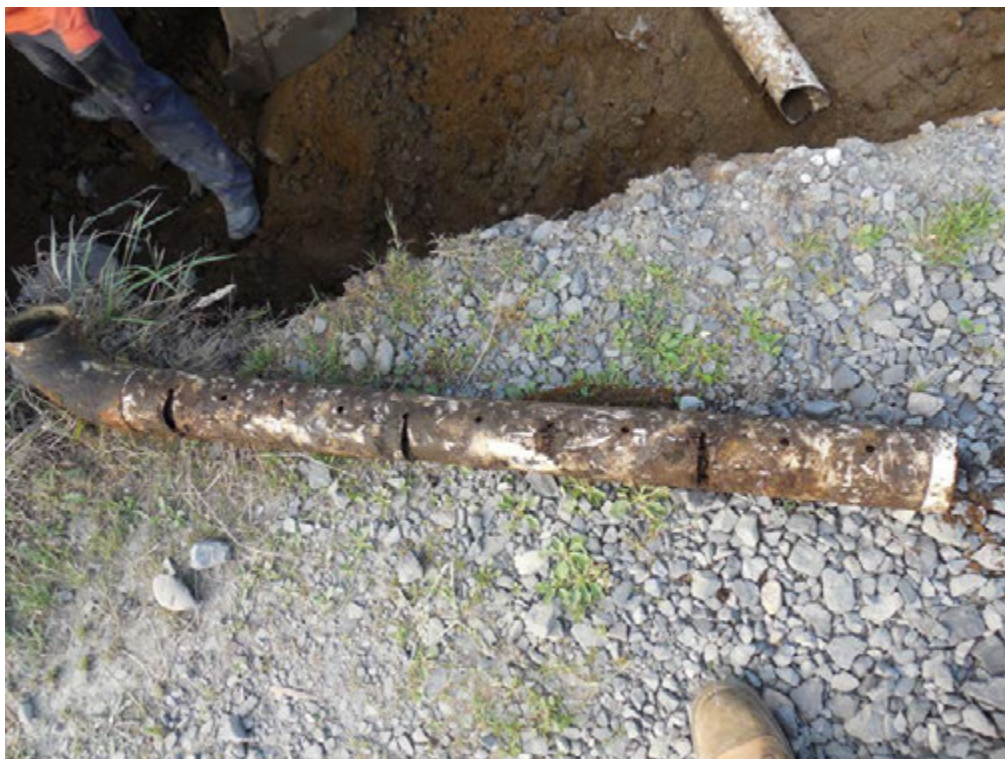
**Photograph 5:** Removed section of perforated drainpipe.

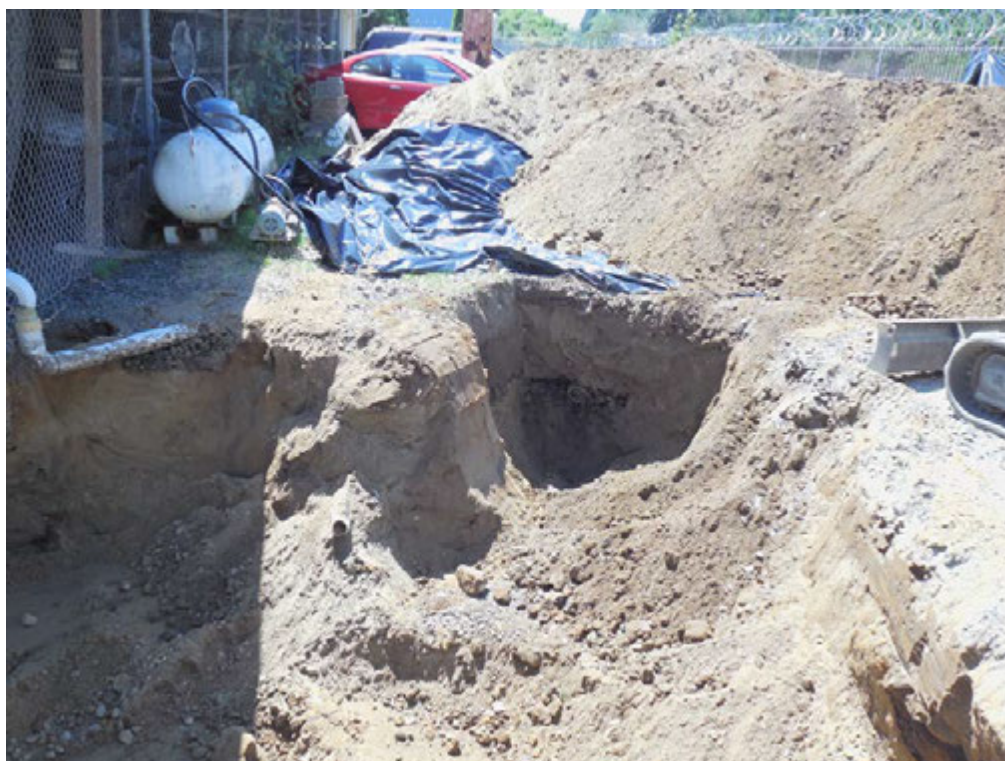
**Photograph 6:** Septic drainpipe and perforated drainpipe extending south.
