April 4, 2014
Project No. TV130367E

Subject: Remedial Investigation and Feasibility Study
Clear Lake Industrial Park Property
12785 State Route 9 and 12827 South Front Street
12713 Sawyer Court
Clear Lake, Washington

Associated Earth Sciences, Inc. (AESI) is pleased to provide this letter-report presenting the results of our remedial investigation and feasibility study at the above-referenced site. The subject property includes five contiguous tax parcels (Skagit County Tax Parcel Numbers P74820, P74823, P74826, P74833, and P23293) totaling approximately 6.2 acres. The site is developed with eight commercial/light industrial buildings constructed between 1938 and 1976. AESI understands that you have been appointed the Receiver of, and intend to sell, the subject property. The location of the subject property is shown on Figure 1, "Vicinity Map," and the site and east-adjointing property layout is depicted on Figure 2, "Site Plan."

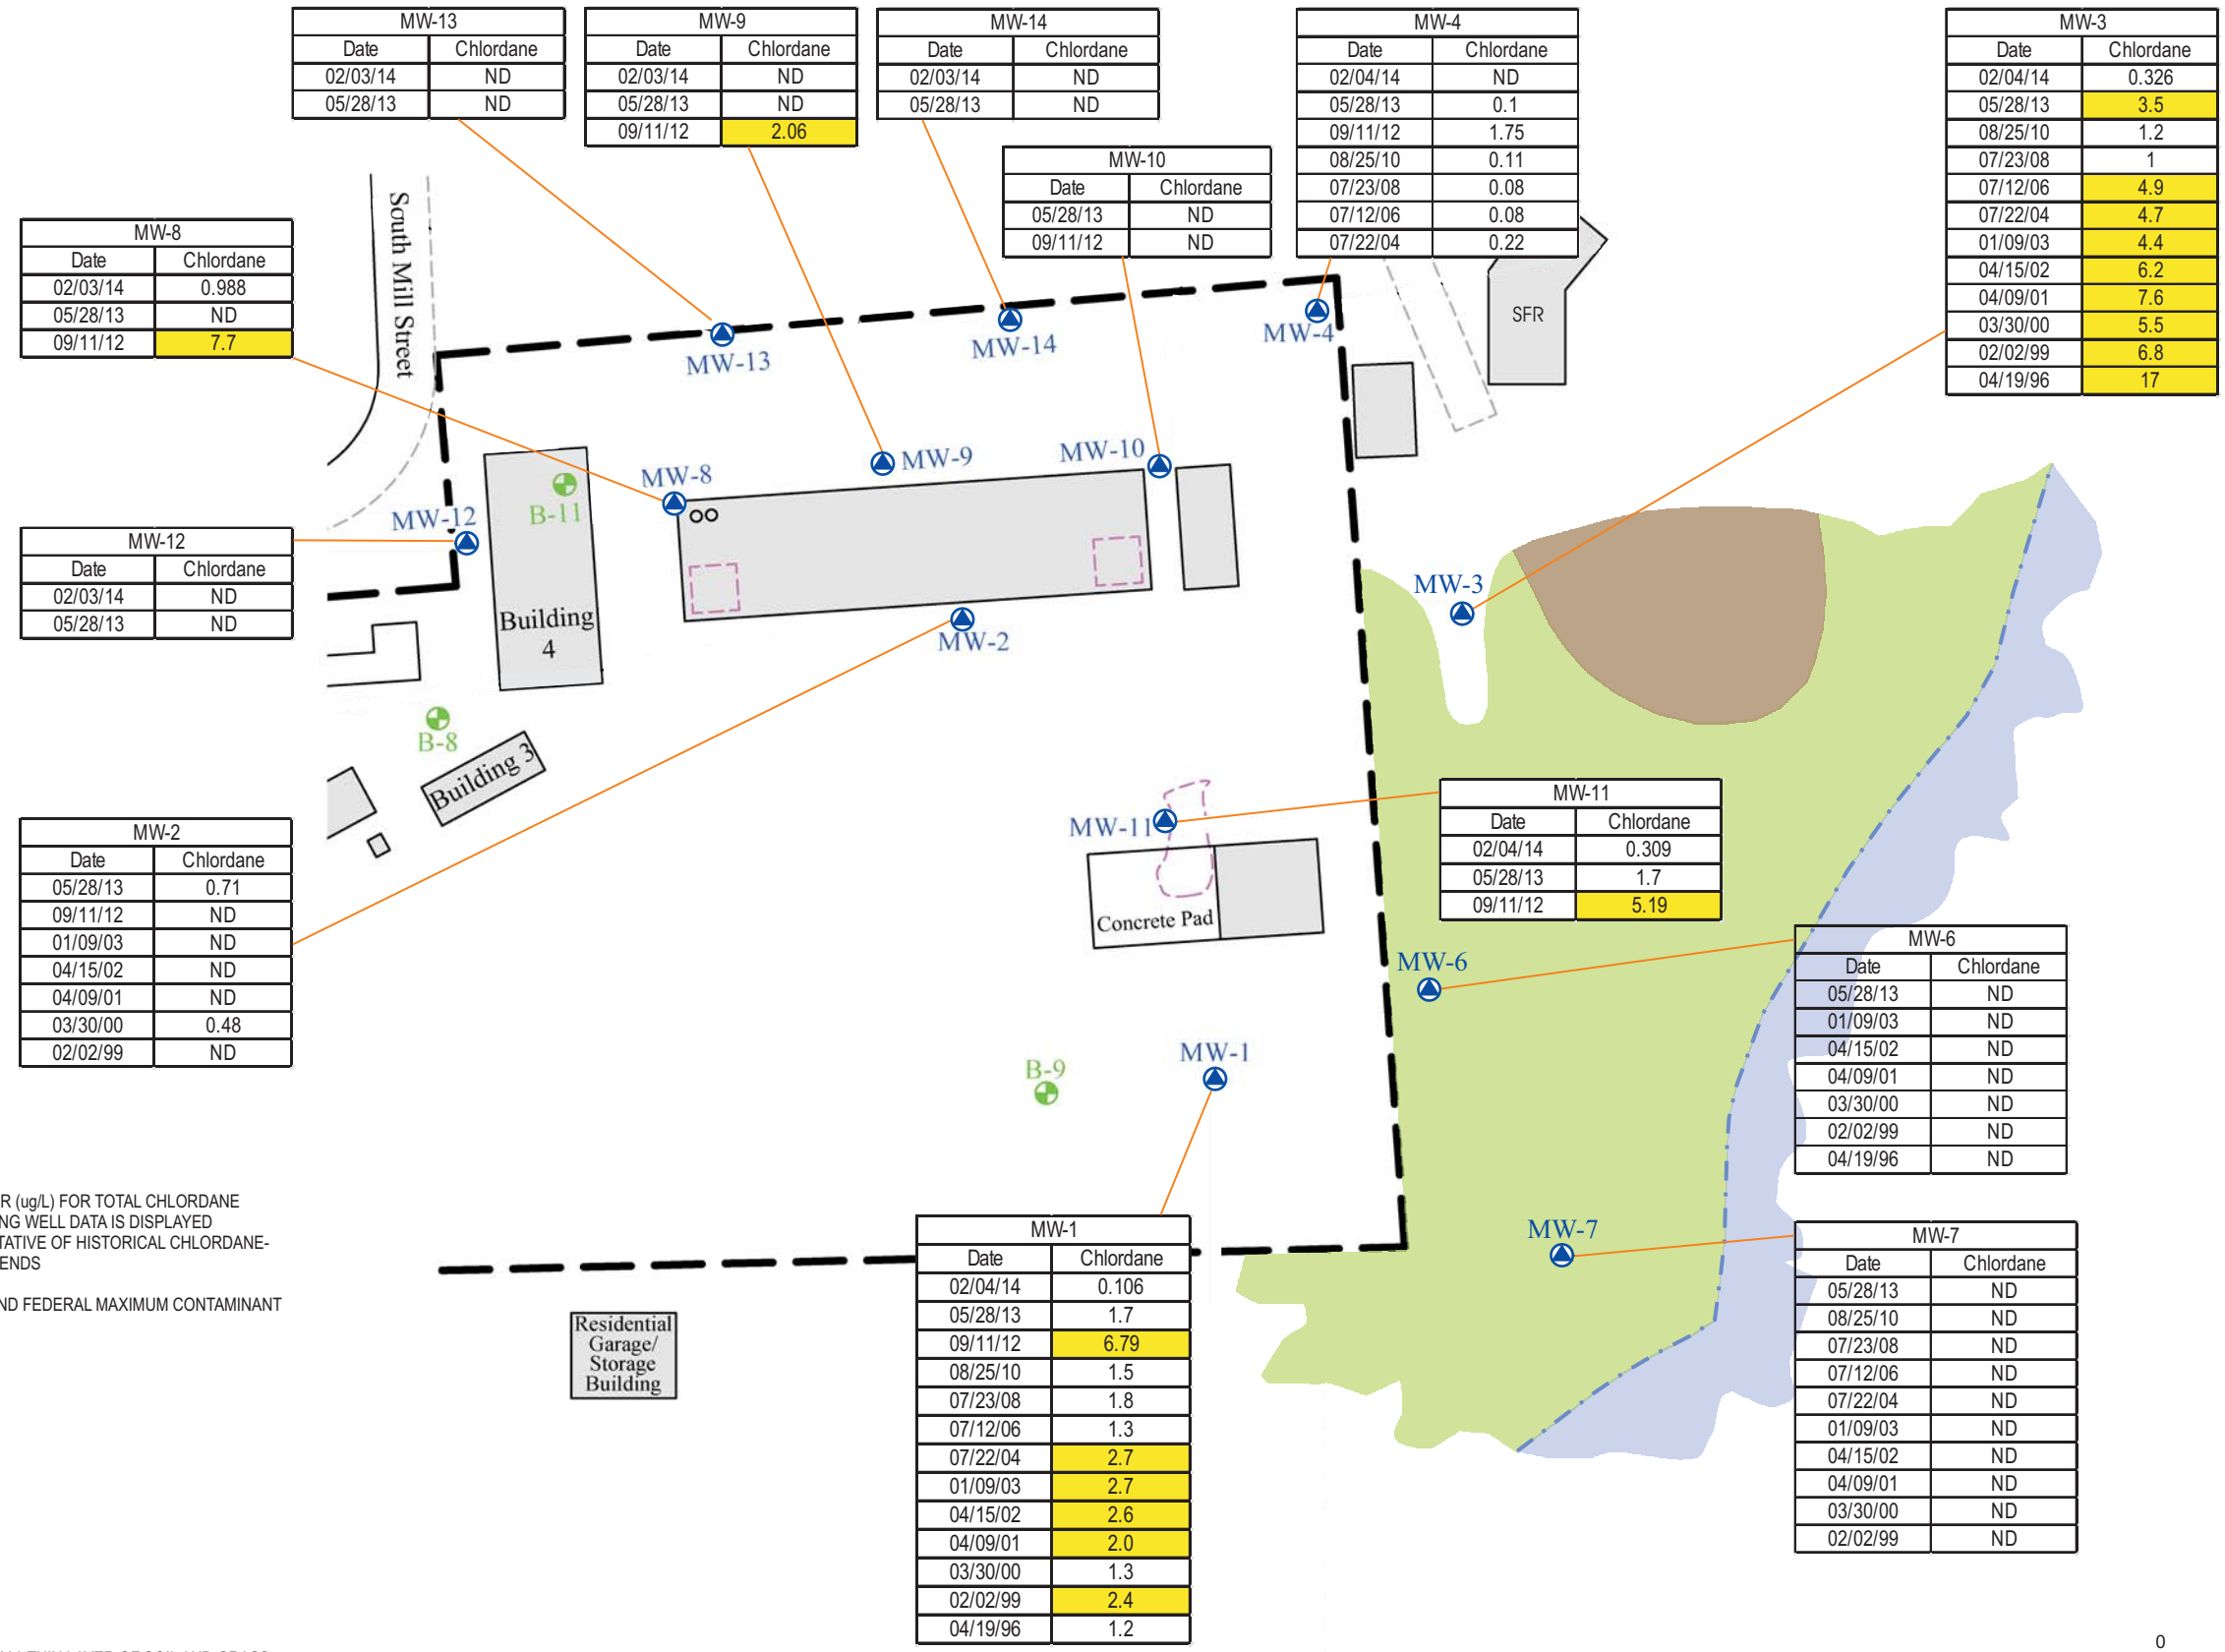
- LEGEND:**
- SITE BOUNDARY
 - SFR SINGLE-FAMILY RESIDENCE
 - CHLORDANE REMEDIAL EXCAVATION
 - GROUND WATER ANALYTICAL DATA IN MICROGRAMS PER LITER (ug/L) FOR TOTAL CHLORDANE
NOT ALL HISTORICAL GROUND WATER MONITORING WELL DATA IS DISPLAYED
DATA DISPLAYED IS INTENDED TO BE REPRESENTATIVE OF HISTORICAL CHLORDANE-IMPACTED GROUND WATER CONCENTRATION TRENDS
 - CHLORDANE CONCENTRATION ABOVE WASHINGTON STATE AND FEDERAL MAXIMUM CONTAMINANT LEVEL (2ug/L) - HIGHLIGHTED IN YELLOW
 - ND NOT DETECTED
 - MONITORING WELL LOCATION BY OTHERS
 - TEST PROBE LOCATION BY OTHERS 9/7/12
 - TEST PROBE LOCATION BY AESI FEBRUARY-MARCH 2014
 - DEEP BORING LOCATION BY AESI FEBRUARY-MARCH 2014
 - SHORELINE
 - HEAVY VEGETATION
 - AREA FILLED WITH LARGE PIECES OF CONCRETE COVERED BY A THIN LAYER OF SOIL AND GRASS

The ground water results from the ground water grab sampling are summarized in Table 1, "Laboratory Analysis Results for Soil Samples;" the ground water grab sample results from the Remedial Investigation are summarized in Table 2, "Laboratory Analysis Results for Ground Water Grab Samples;" and the ground water results from the monitoring event are summarized in Table 3, "Laboratory Analytical Results for Ground Water Monitoring Wells," all of which are attached to this letter-report. The laboratory analytical report is included in Appendix A. A historical summary of laboratory analytical results from the monitoring well sampling events performed to-date is provided on Figure 4.

Ground water data collected at this site, dating back to 1996, show a clear downward trend of chlordane concentrations (see Figure 4). For example, in April 1996, the chlordane concentration in well MW-3 was 17 $\mu\text{g/L}$. Chlordane concentrations have steadily decreased over time to the level detected in February 2014, which was 0.326 $\mu\text{g/L}$. No active remediation of the ground water has occurred, indicating that the concentrations are decreasing due to natural degradation.
