February 10, 2014  
G-Logics File 01-0739-F

**Subject: Operation and Monitoring Summary Memo 4<sup>th</sup> Quarter 2013  
Former Drycleaner Location  
10610 NE 8th Street  
Bellevue, WA**

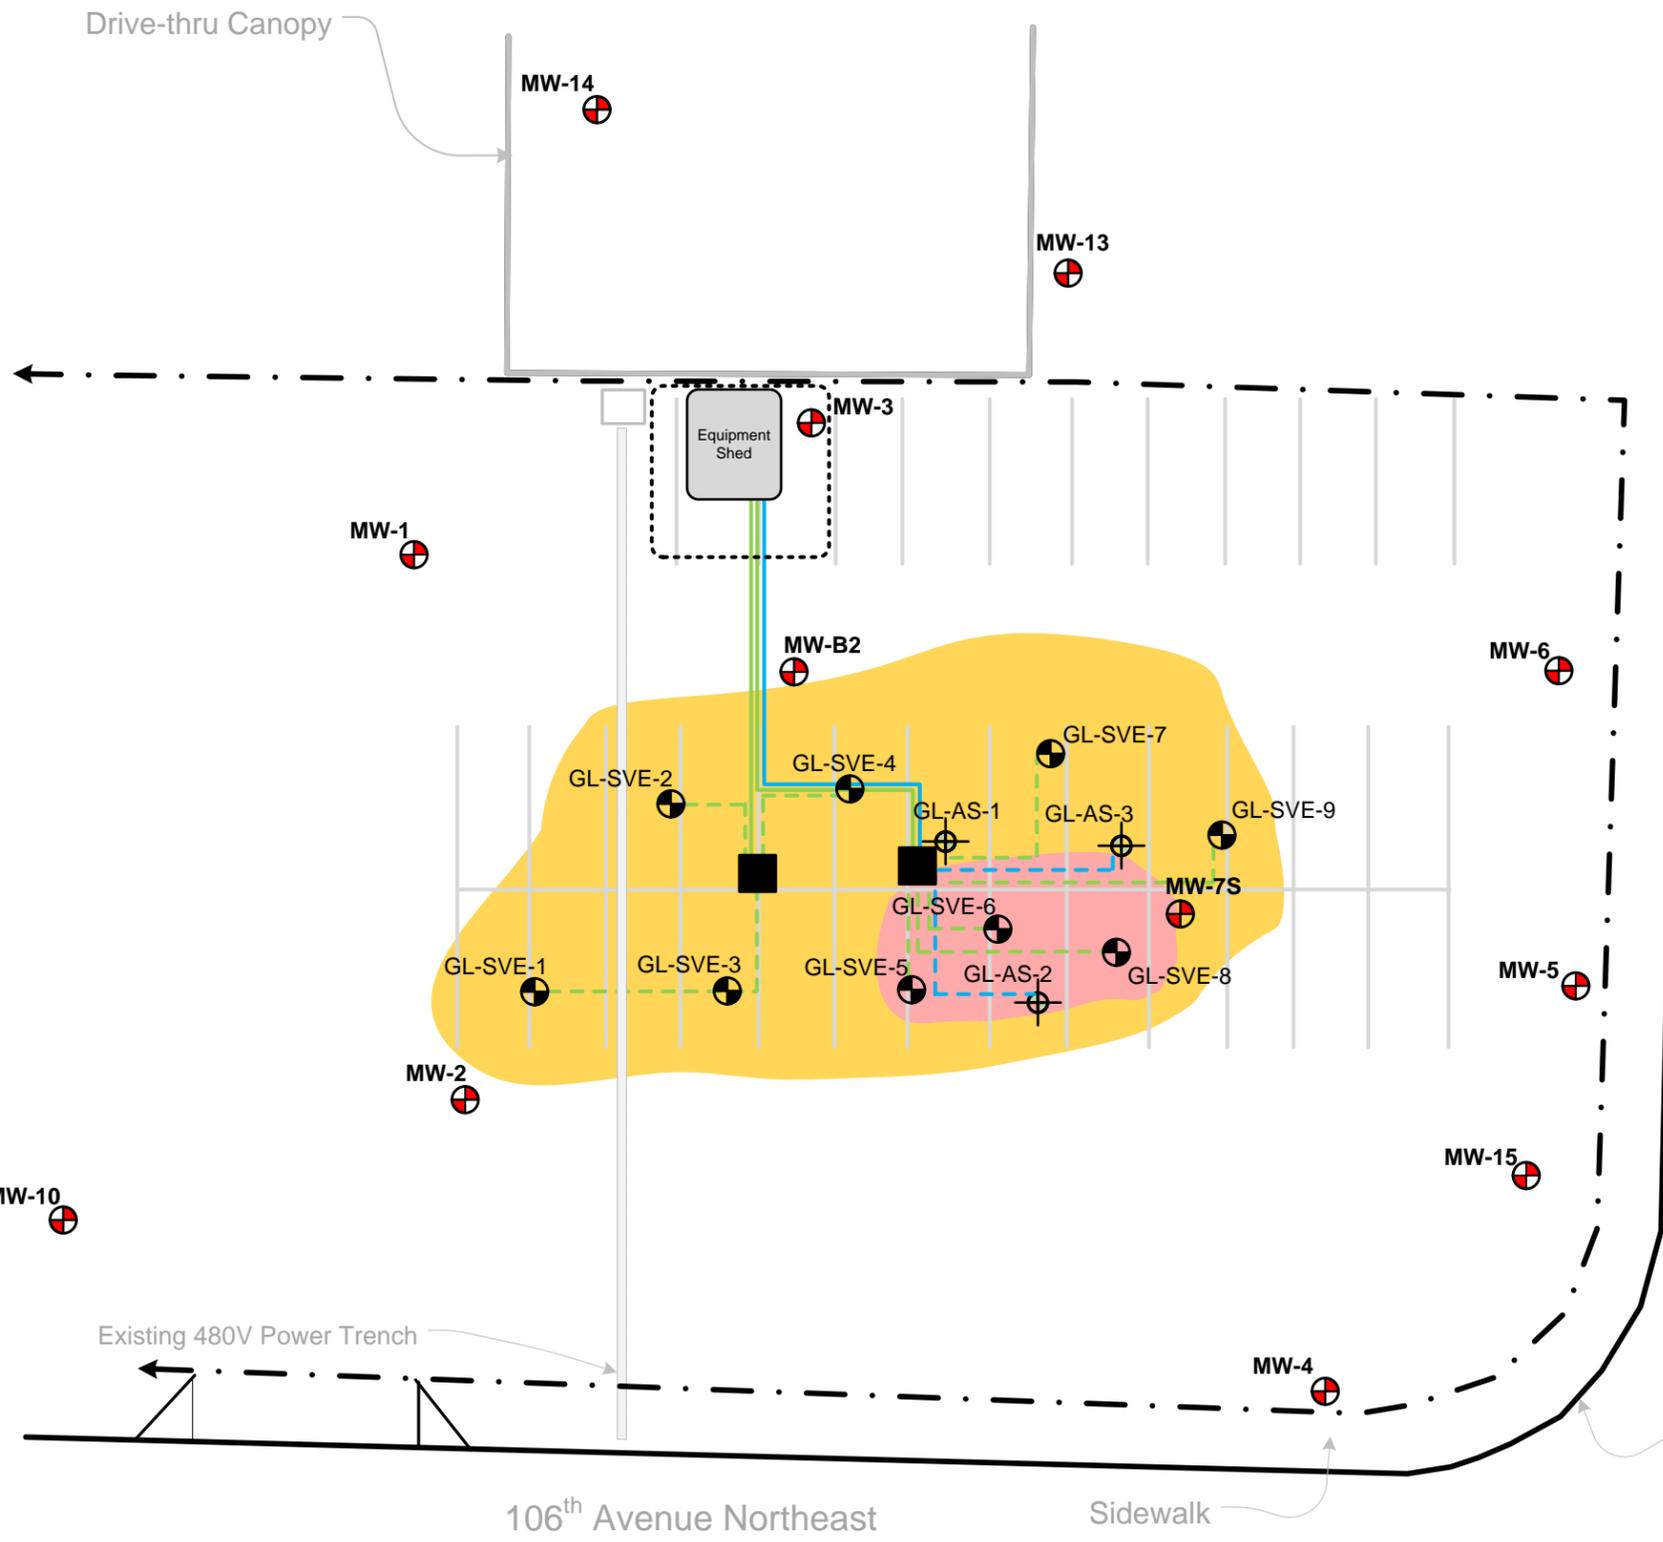
Figure  
 3

On December 23, 2013, vapor samples were collected (using Tedlar bags) from the exhaust-stack and all nine SVE Wells. The vapor samples were analyzed by EPA Method 8260. Analytical results demonstrate that vapor-contaminants continue to be removed from the soil and groundwater on the property (see Table 1). The most significant concentrations of contaminant removal were observed in SVE Wells 4, 5, 6, and 7. These wells are located in the area that was mapped as having elevated concentrations of Tetrachloroethene (PCE) in the soil (Figure 3).

**AS/SVE System Layout with PCE Mapping**  
 Former Thinker Toy Property  
 NE. 8<sup>th</sup> St.  
 Bellevue, Washington
