DRAFT
Remedial Investigation Report Addendum
USG Interiors Highway 99 Site
Milton, Washington

January 14, 2013

CDM Project No. 19921.77628

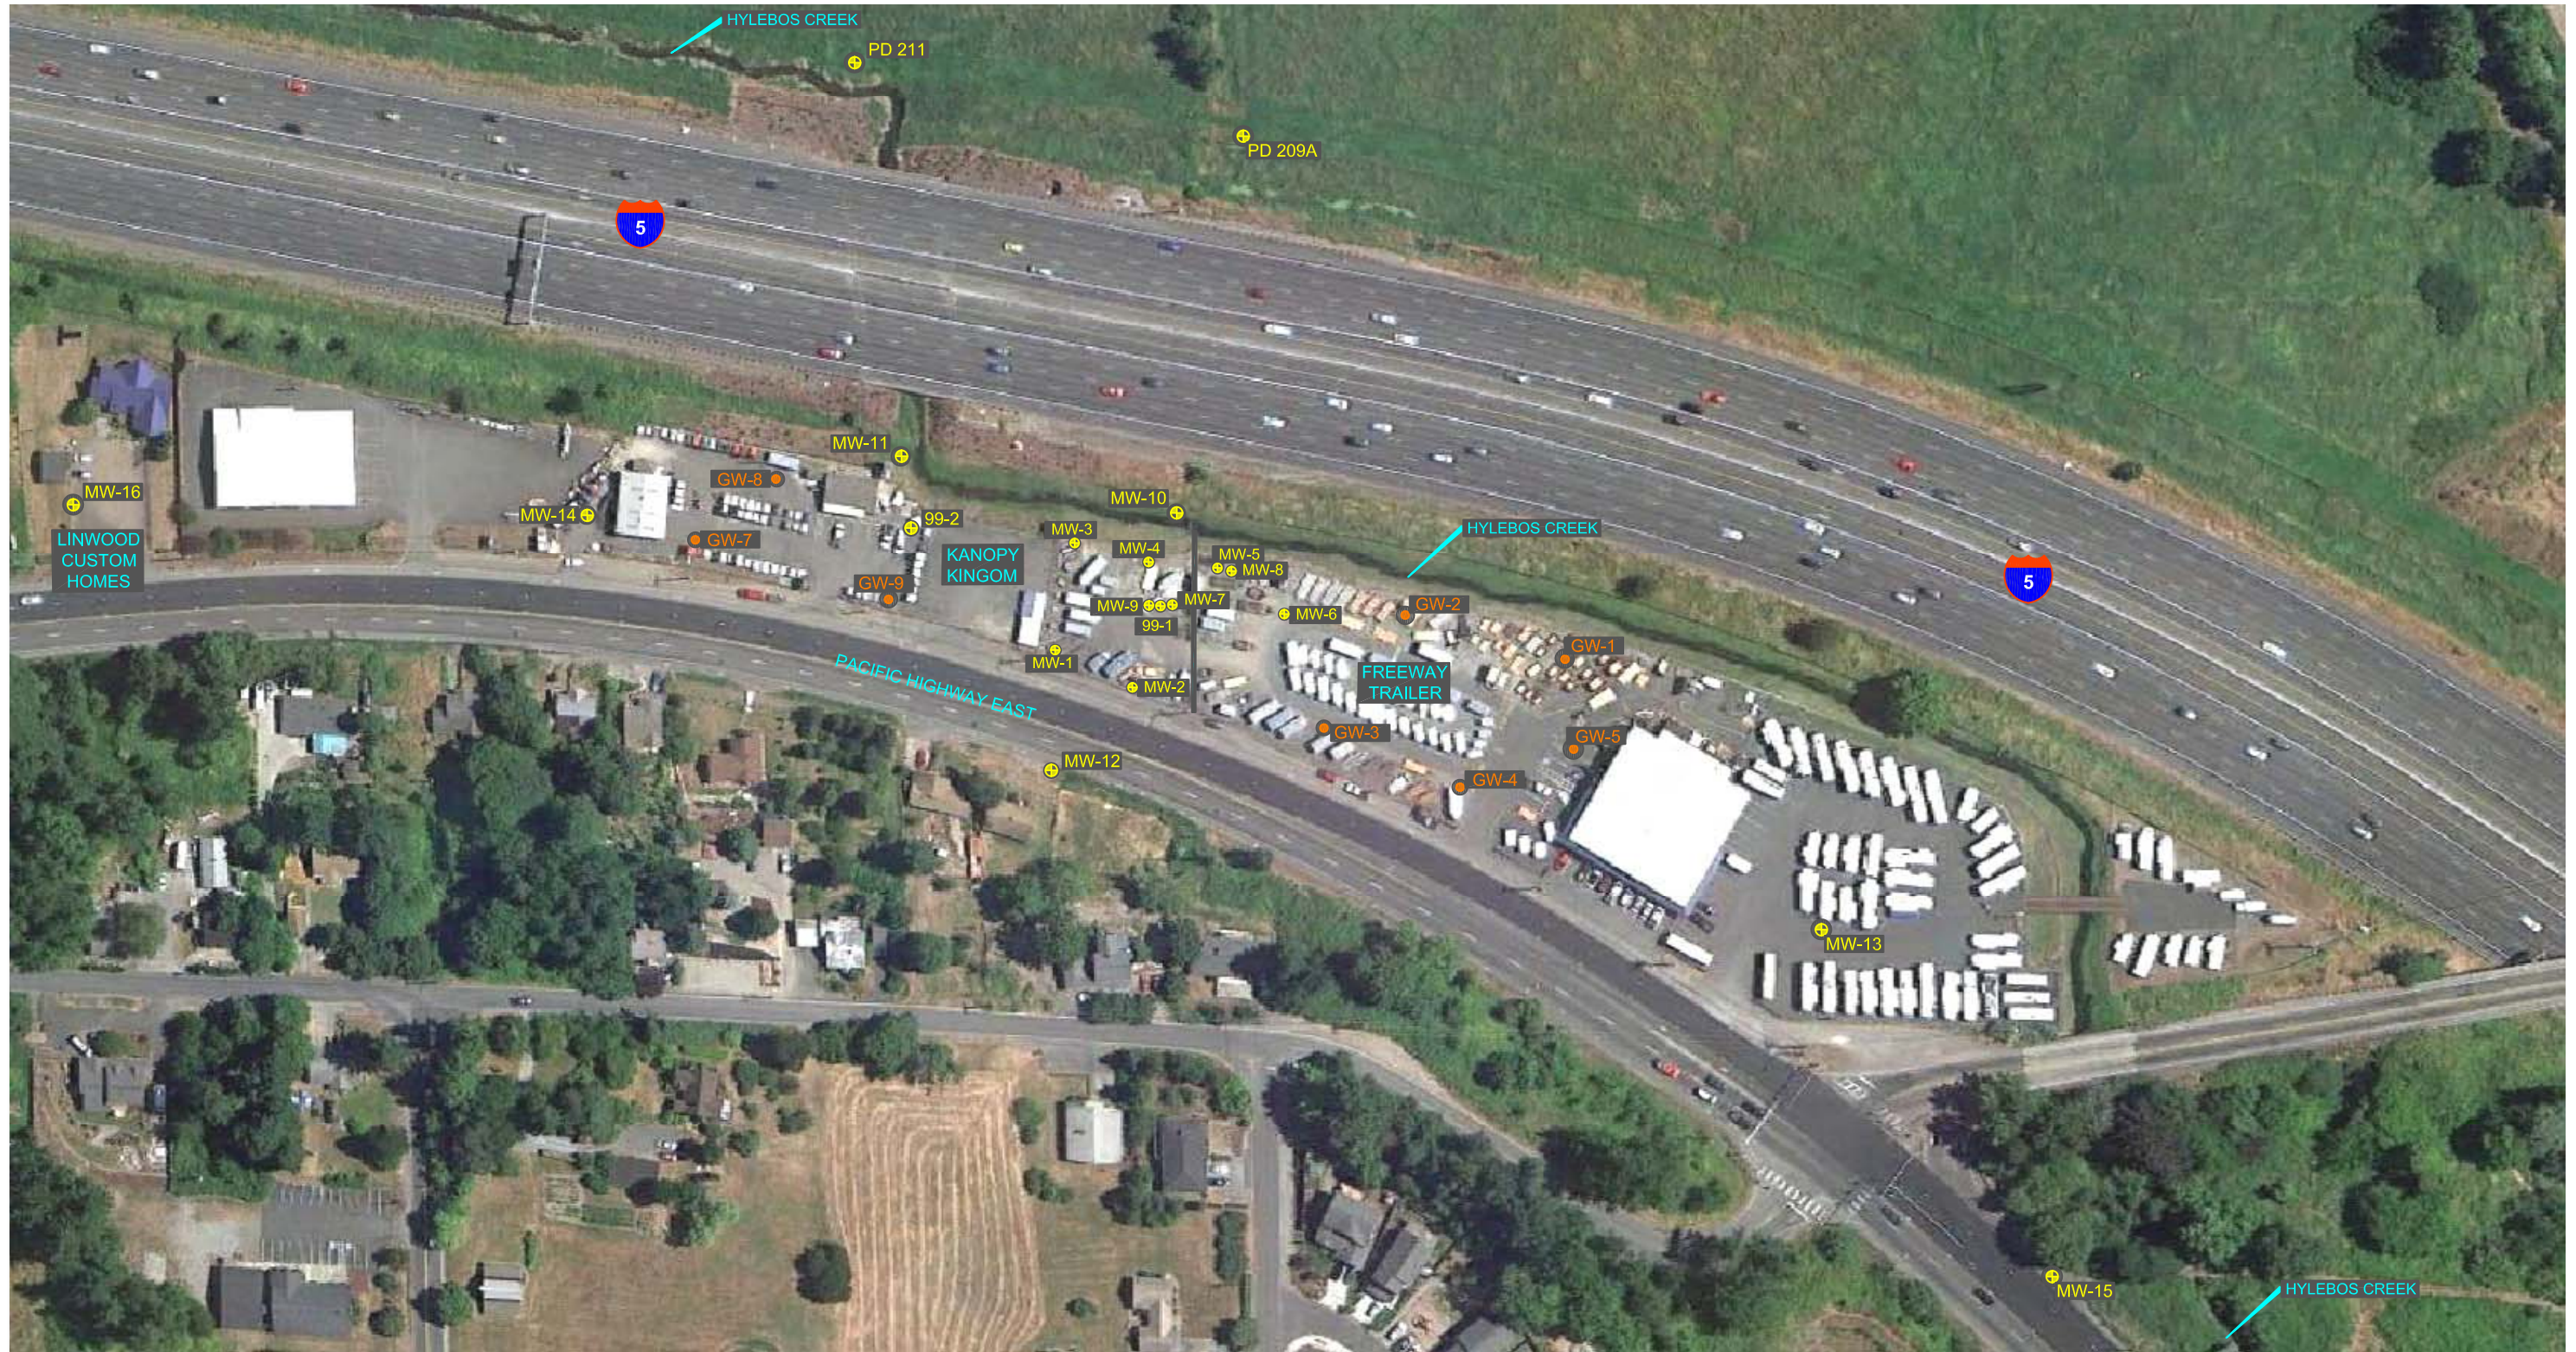
Figure No. 2A
 Site Plan

The USG Highway 99 site is located between Pacific Highway East and Interstate 5 in Milton, Washington. **Figure 2A** shows the entire groundwater investigation area for the RI. For clarity, the extent of the exploration points shown on **Figure 2A** is referred to as the "site" throughout this report. The majority of RI fieldwork occurred in the core investigation area shown on **Figure 2B**, which is used to illustrate the RI results.

Freeway Trailer and Kanopy Kingdom currently operate at the site; their business locations are shown on **Figure 2B**. Chain link fence separates each business and the western property line along Pacific Highway East.

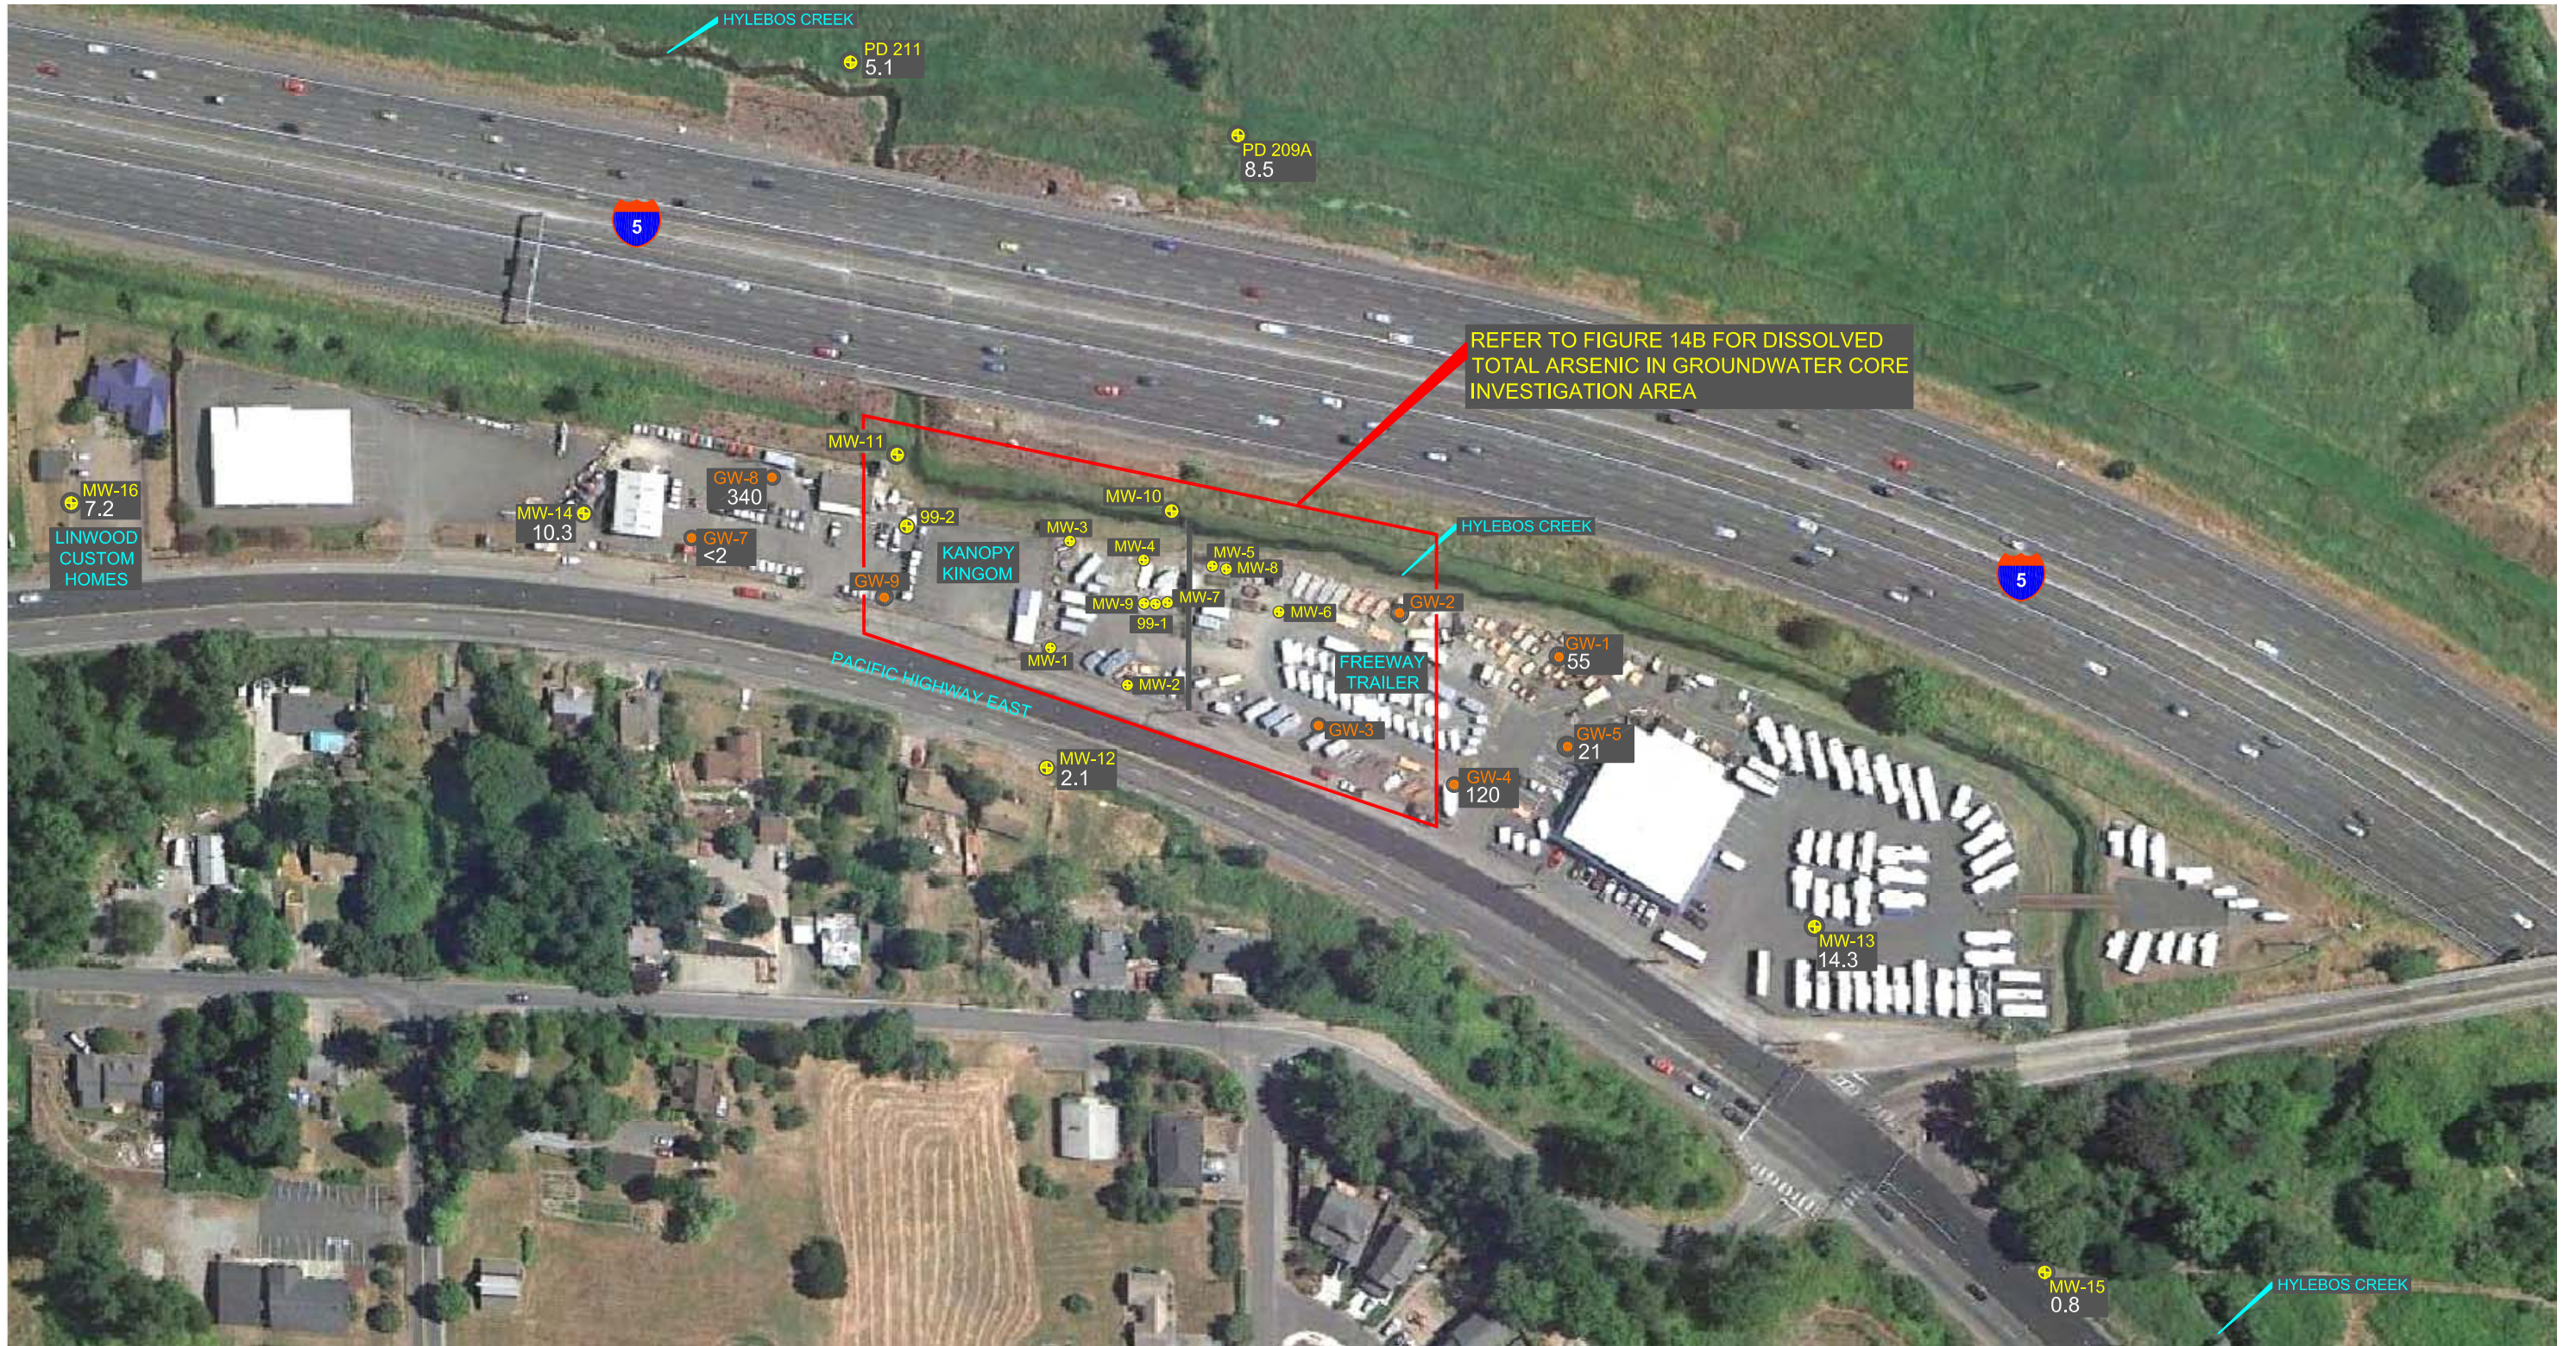
Figure 14A shows total dissolved arsenic concentration outside the core investigation area, including the results of samples collected in November 2012. **Figure 14B** is an isoconcentration map that shows the distribution of total dissolved arsenic in groundwater in the core investigation area. **Figures 15 through 19** are isoconcentration maps showing dissolved iron, arsenic (+3), arsenic (+5), and ORP in groundwater.
