# SITE MANAGEMENT PLAN

YAKIMA VALLEY TRANSPORTATION CO. TROLLEY BARN SITE  
404 SOUTH 3rd AVENUE  
YAKIMA, WASHINGTON

*Prepared for*  
**CITY OF YAKIMA**  
YAKIMA, WA  
*July 1, 2015*  
*Project No. 0818.03.01*

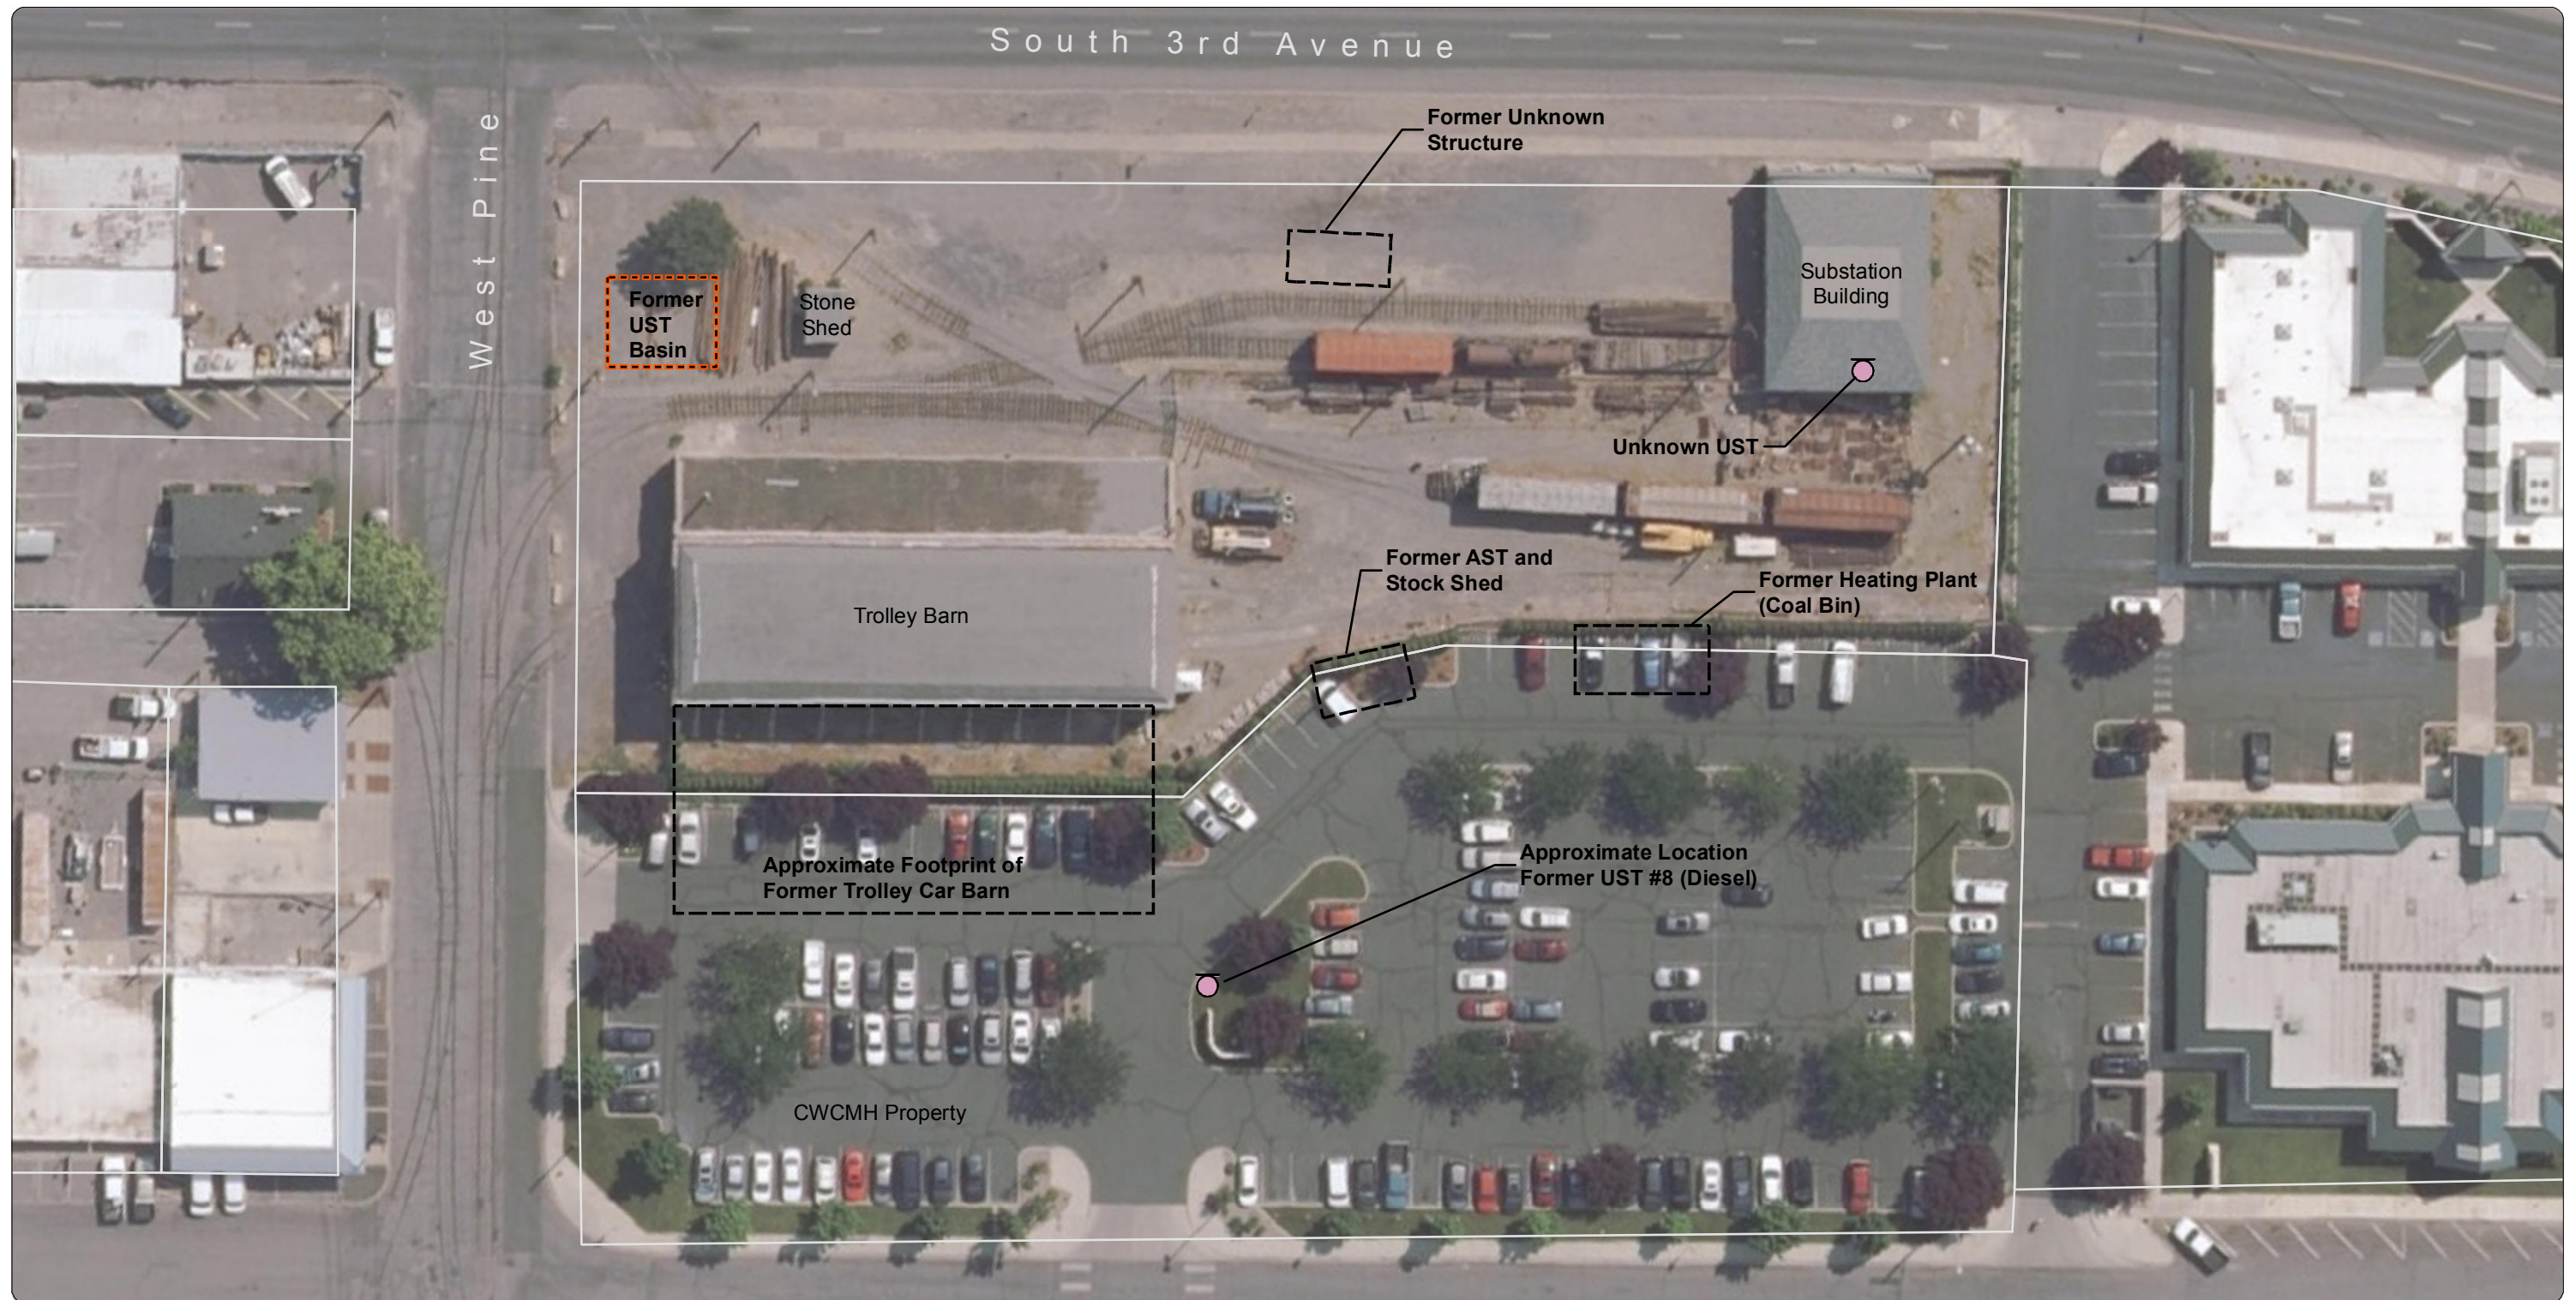
Notes:  
AST = aboveground storage tank  
UST = underground storage tank
