APPENDIX A
SEPA Environmental Checklist

ENVIRONMENTAL CHECKLIST

EXISTING CONDITIONS REPORT

Figure 1
Vicinity Map
West Bay Park Phase I Project
Natural Resources Existing Conditions Report

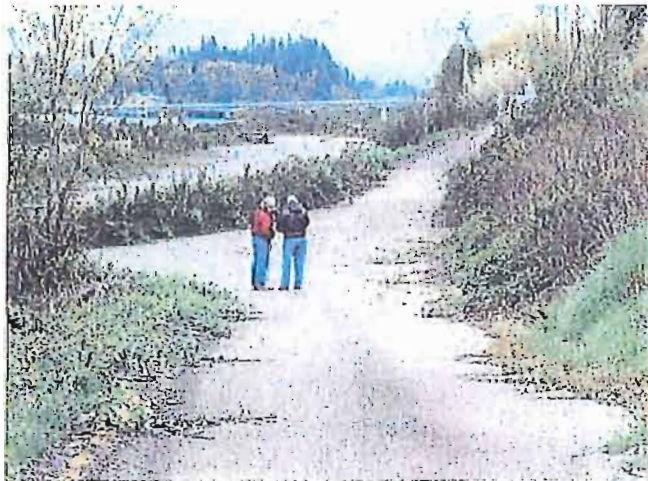
Photo 1

Overview of upland area, looking south; invasive vegetation and concrete roads/pads are visible in the foreground and upper left

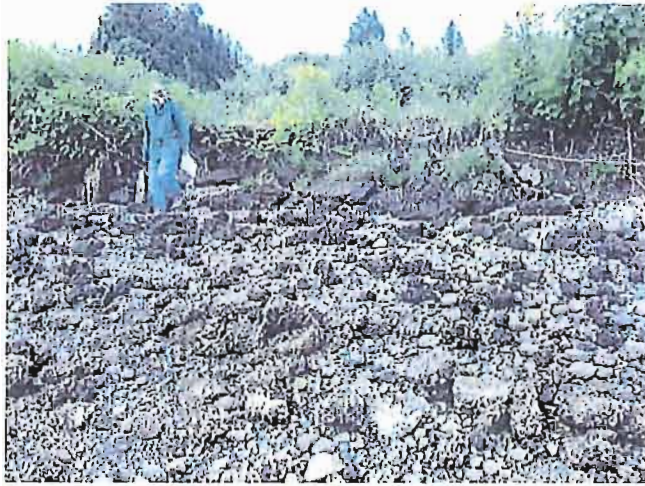
Photo 2
Beach and intertidal substrate sizes and scattered debris,
looking west

The shoreline consists of a cobble beach but contains areas of concrete, asphalt, metal, and brick debris, as well as derelict piling from past industrial uses (Figure 2). The shoreline vegetation is a mix of native and non-native species. Downtown Olympia and the State Capitol building can be viewed from many locations within the property.

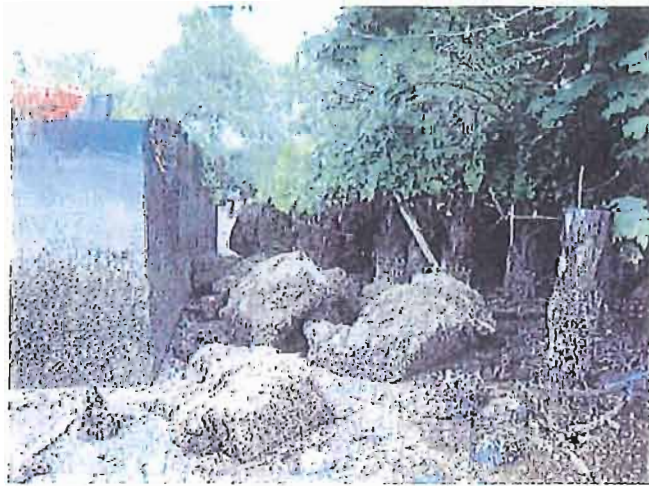
Photo 3
Beach substrate, concrete debris, and derelict piling,
looking south

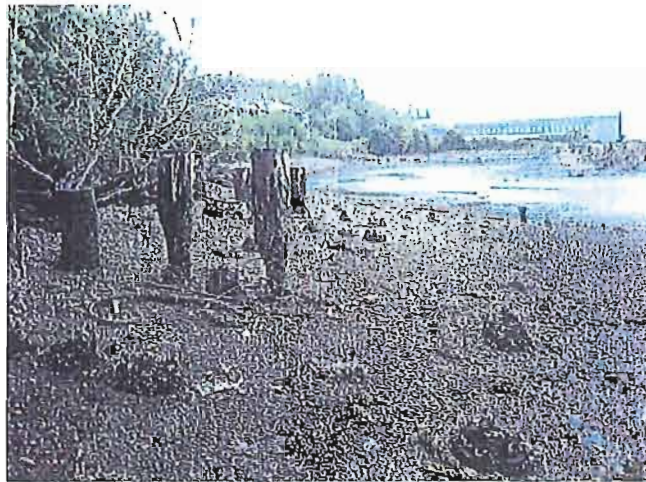
Photo 4
Derelict pilings in shoreline area, looking north

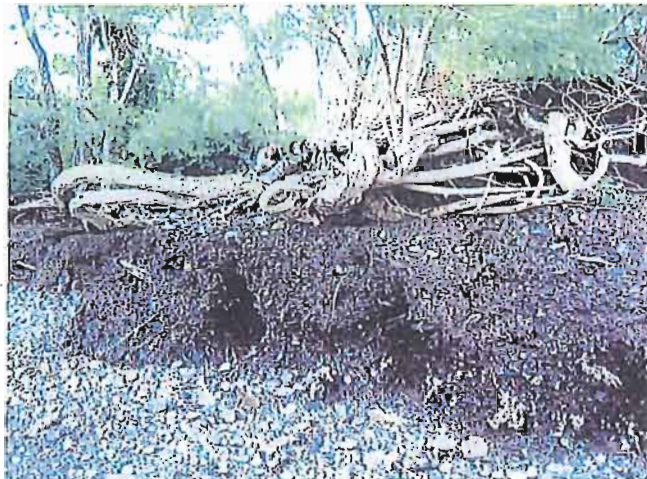
Photo 5
Shoreline erosion

There is no known history of unstable soils, nor are there surface indications of any stability problem. The site is not designated as a landslide hazard area on the Thurston County Sensitive Areas Ordinance map. There are some areas of moderate to severe shoreline erosion.

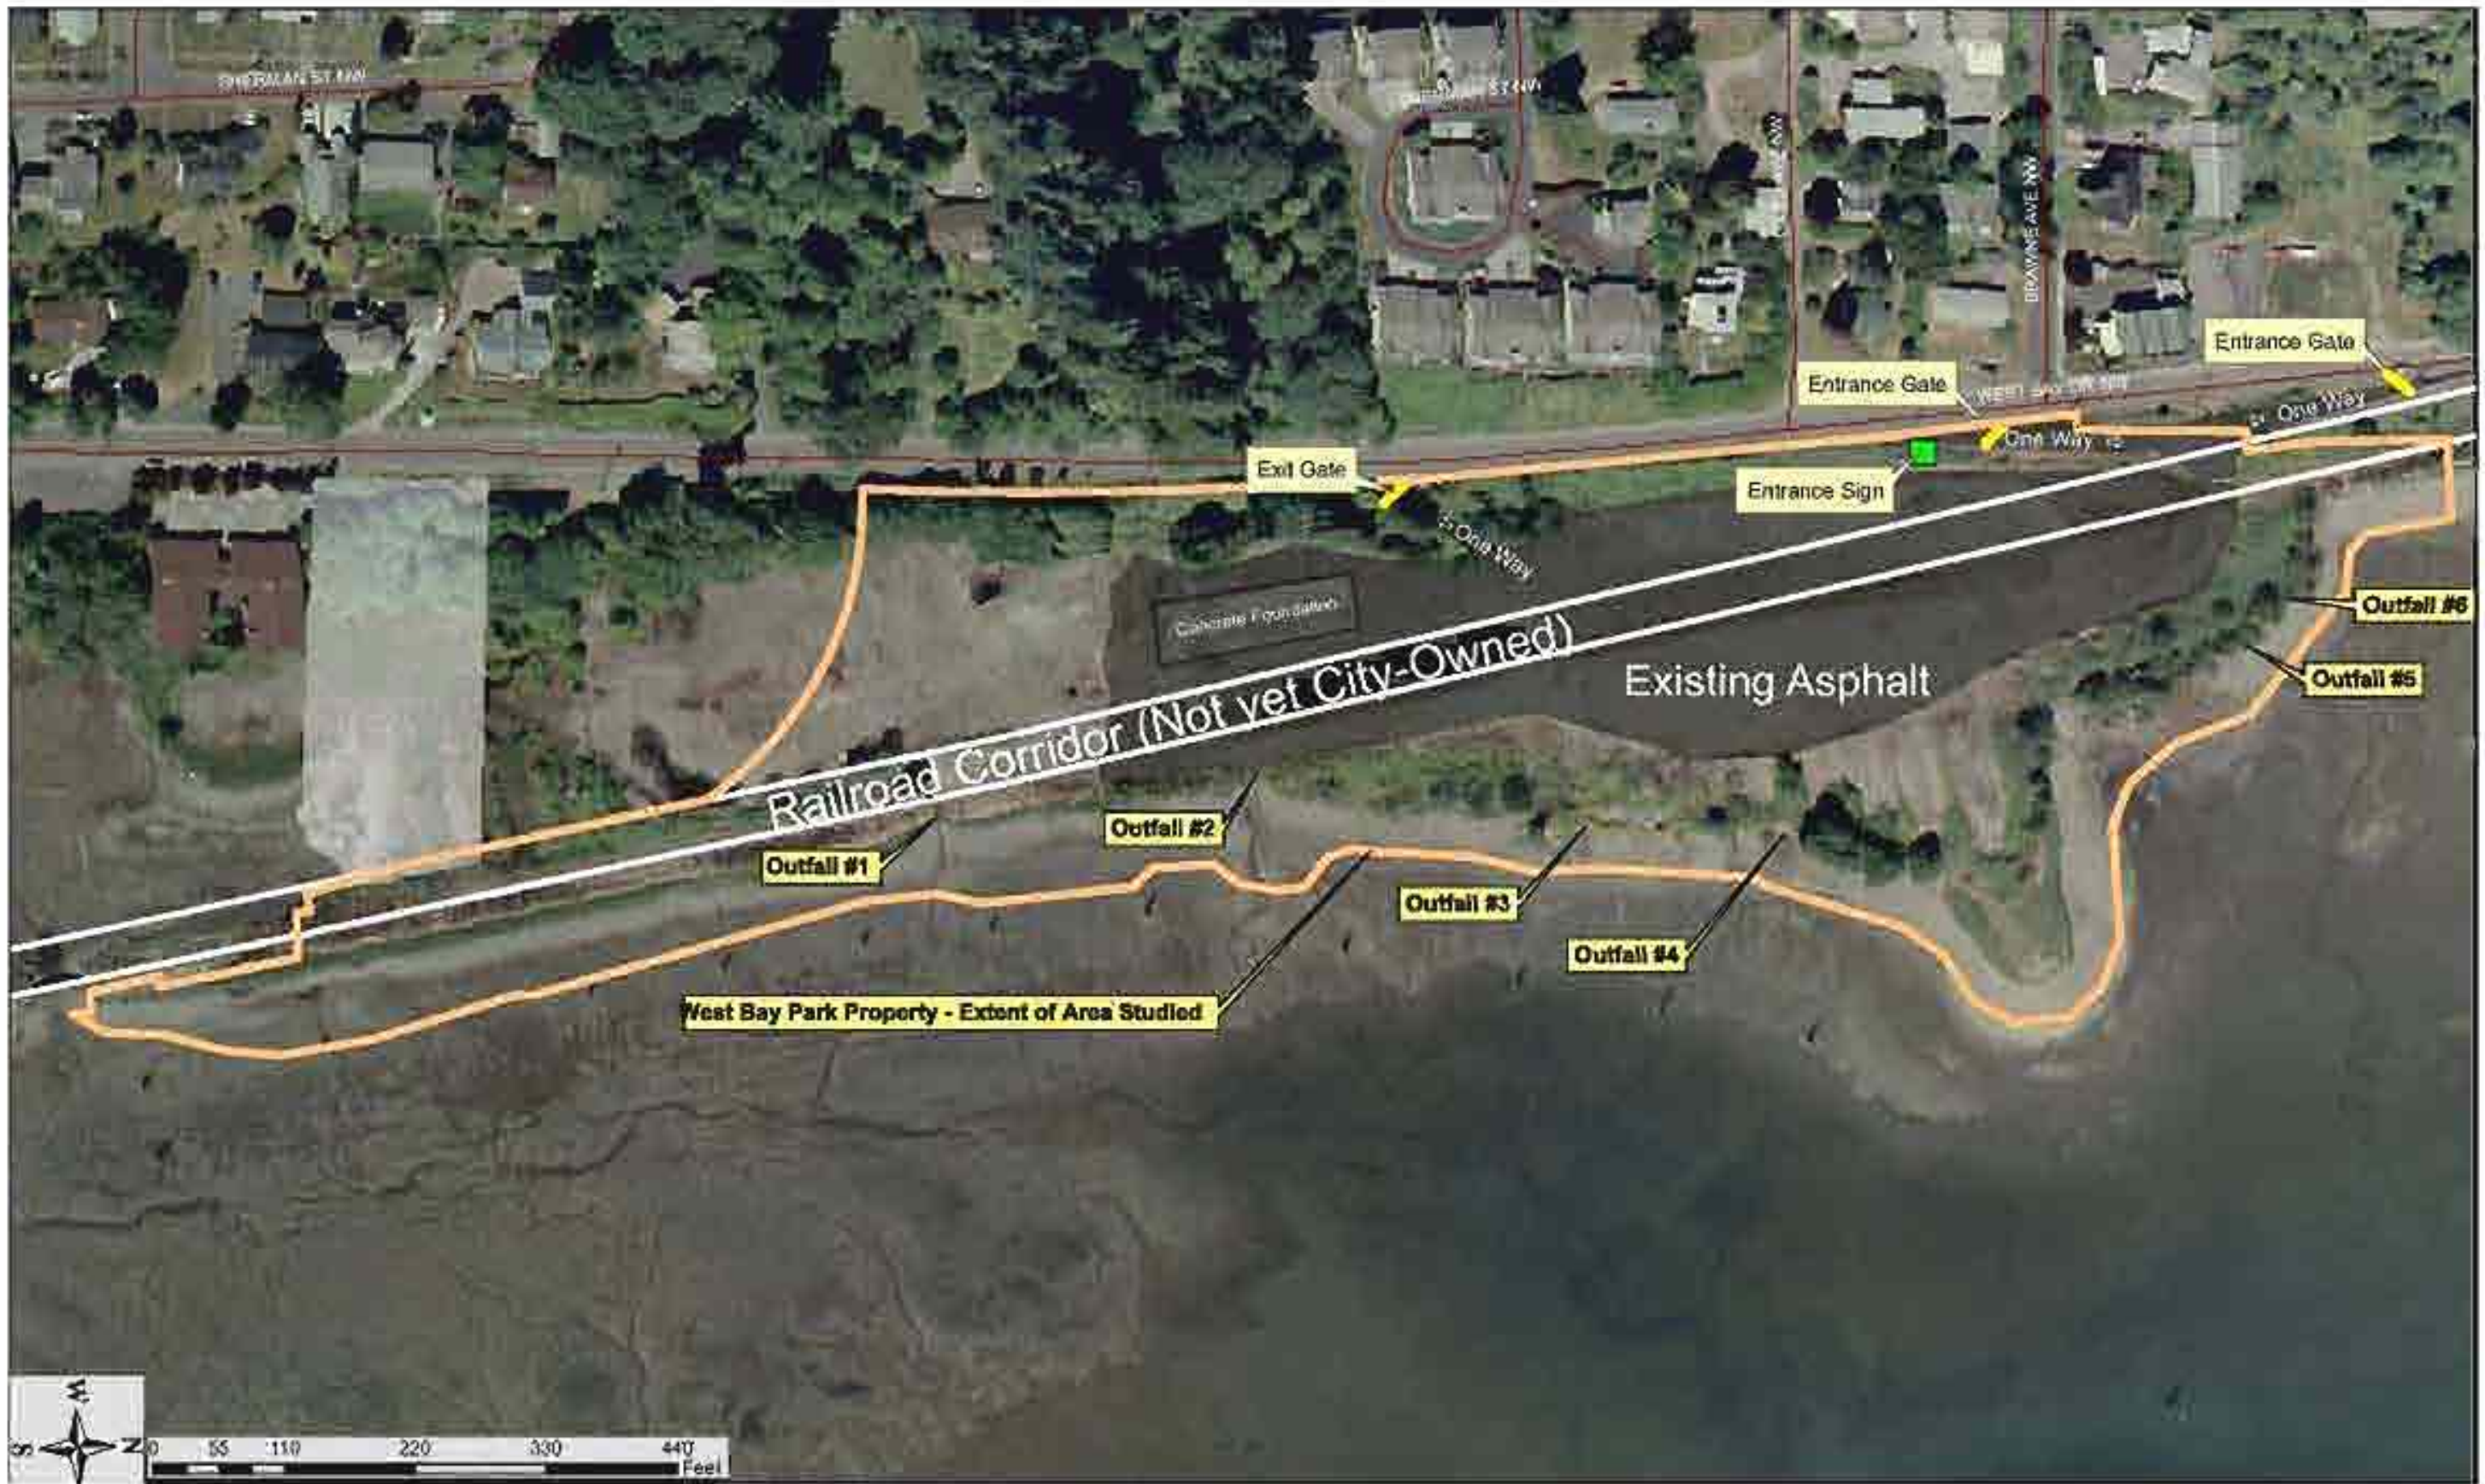
Jul 02, 2007 1:51pm c:\dev\p001\K:\U:\doc\070324-West Bay Park\07032401\07032401-000.dwg FIG. 3

In general, West Bay Drive NW is built into and paralleling a sloping hillside above the Property. Most of the Property is dominated by a degraded asphalt surface that is relatively level. Relatively steep slopes 15 to 20 feet high occur along the west side of the property between the asphalt areas and West Bay Drive NW. A steep slope 4 to 6 feet high also occurs from the east end of the asphalt down the beach along the shoreline of Puget Sound (Figures 2 and 3). For more detailed information on topography, see Section 2, Landslide Hazard Areas.

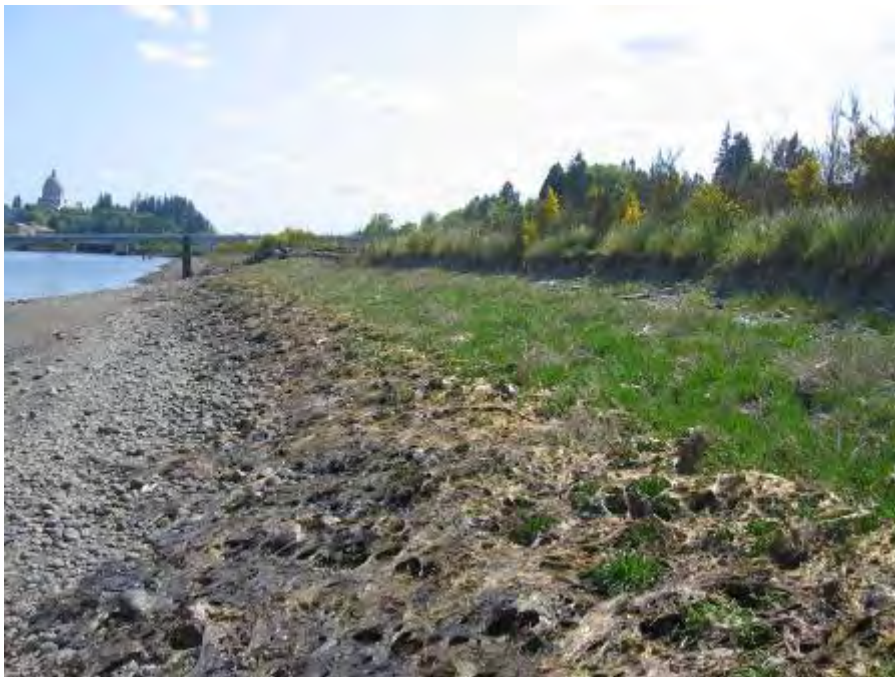
Photograph 4. Wetland A

Wetland A is a 0.26-acre (approximate), regularly exposed E2US wetland system associated with the marine environment of Puget Sound (Figure 3). Wetland A is the largest wetland in the Project area, covering an approximately 300 foot length of beach in the south portion of the Property (see Photograph 4). The inland boundary of Wetland A corresponds with the OHW line (Figure 3). Wetland A is dominated by the salt tolerant emergent species sea plantain, with pickleweed and fat-hen saltbush (*Atriplex patula*) also occurring. Dominant buffer vegetation of Wetland A includes Scot's broom, Himalayan blackberry, red fescue (*Festuca rubra*), and common dandelion.

The soils are common beach substrate consisting of brown (10YR 4/3) to dark grayish brown (10YR 4/2) sand to loamy sand with a high density of gravel and cobbles to more than 18 inches in depth. Soils in the upland plot were dark yellowish brown (10YR 4/4) loamy sand with a lower concentration of gravel and cobbles than the beach habitat.

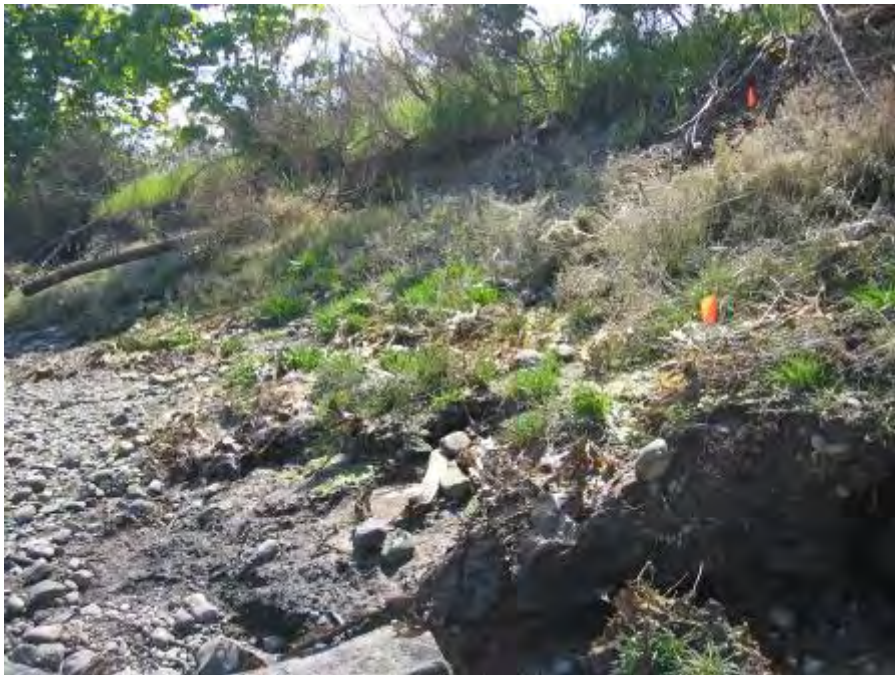
Photograph 5. Wetland B

Wetland B is a 0.004-acre (approximate), regularly exposed E2US wetland system associated with the marine environment of Puget Sound (Figure 3). Wetland B is a small patch of vegetation located north of Wetland A (see Photograph 5). The inland boundary of Wetland B corresponds with the OHW line (Figure 3). Wetland B is dominated by the salt tolerant emergent species sea plantain, with pickleweed and fat-hen saltbush also occurring. Dominant buffer vegetation of Wetland B includes black locust, Scot's broom, Himalayan blackberry, and common velvet-grass.

The soils are common beach substrate consisting of brown (10YR 4/3) to dark grayish brown (10YR 4/2) sand to loamy sand with a high density of gravel and cobbles to more than 18 inches in depth. Soils in the upland plot were dark yellowish brown (10YR 4/4) loamy sand with a lower concentration of gravel and cobbles than the beach habitat.

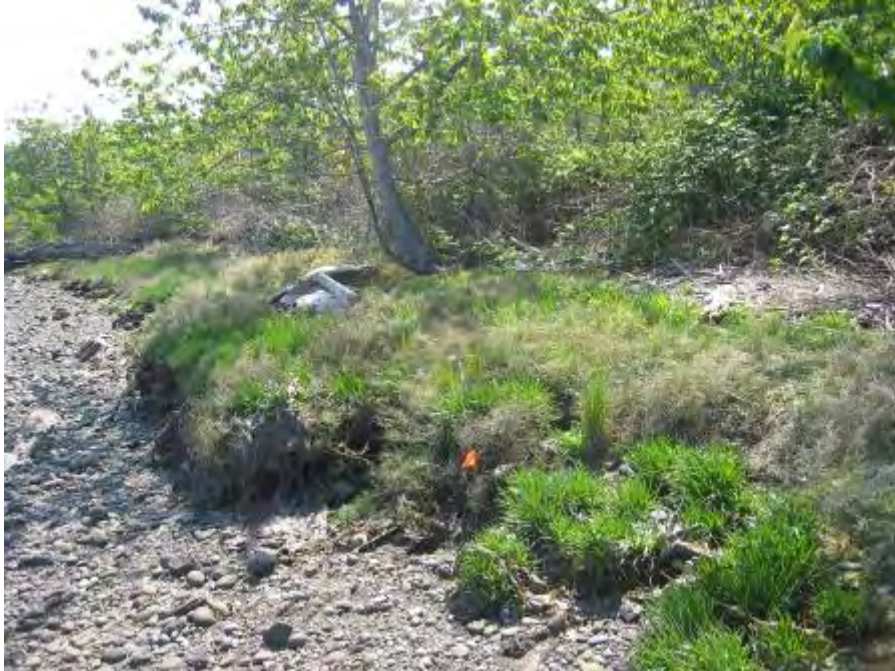
Photograph 6. Wetland C

Wetland C is a 0.03-acre (approximate), regularly exposed E2US wetland system associated with the marine environment of Puget Sound (Figure 3). Wetland C is a small patch of vegetation located north of Wetland B (see Photograph 6). The inland boundary of Wetland C corresponds with the OHW line (Figure 3). Wetland C is dominated by the salt tolerant emergent species sea plantain, with pickleweed and fat-hen saltbush also occurring. Dominant buffer vegetation of Wetland C includes black locust and Himalayan blackberry.

The soils are common beach substrate consisting of dark grayish brown (10YR 4/2) sand to loamy sand with a high density of gravel and cobbles to more than 18 inches in depth. Soils in the upland plot were dark yellowish brown (10YR 4/4) loamy sand with a lower concentration of gravel and cobbles than the beach habitat. Small pieces of broken asphalt were also present within the upland soil plot.

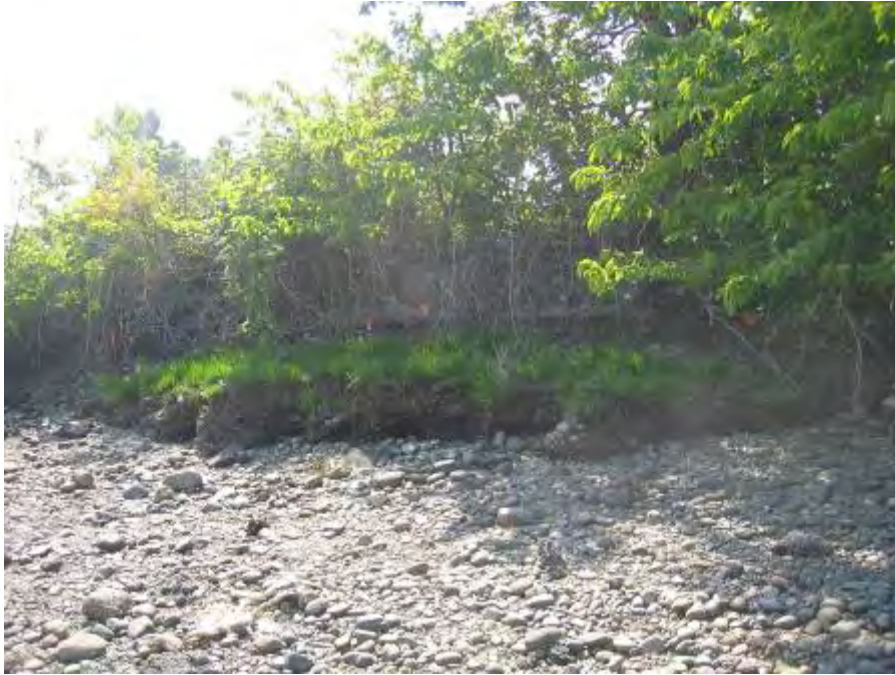
Photograph 7. Wetland E

Wetland E is a 0.0008-acre (approximate), regularly exposed E2US wetland system associated with the marine environment of Puget Sound (Figure 3). Wetland E is a small patch of vegetation located north of Wetland D (see Photograph 7). The inland boundary of Wetland E corresponds with the OHW line (Figure 3). Wetland E is dominated by the salt tolerant emergent species sea plantain. Dominant buffer vegetation of Wetland E includes black locust and Himalayan blackberry.

The soils are common beach substrate consisting of dark grayish brown (10YR 4/2) sand to loamy sand with a high density of gravel and cobbles to more than 18 inches in depth. Soils in the upland plot were dark yellowish brown (10YR 4/4) loamy sand with a lower concentration of gravel and cobbles than the beach habitat. Small pieces of broken asphalt were also present within the upland soil plot.

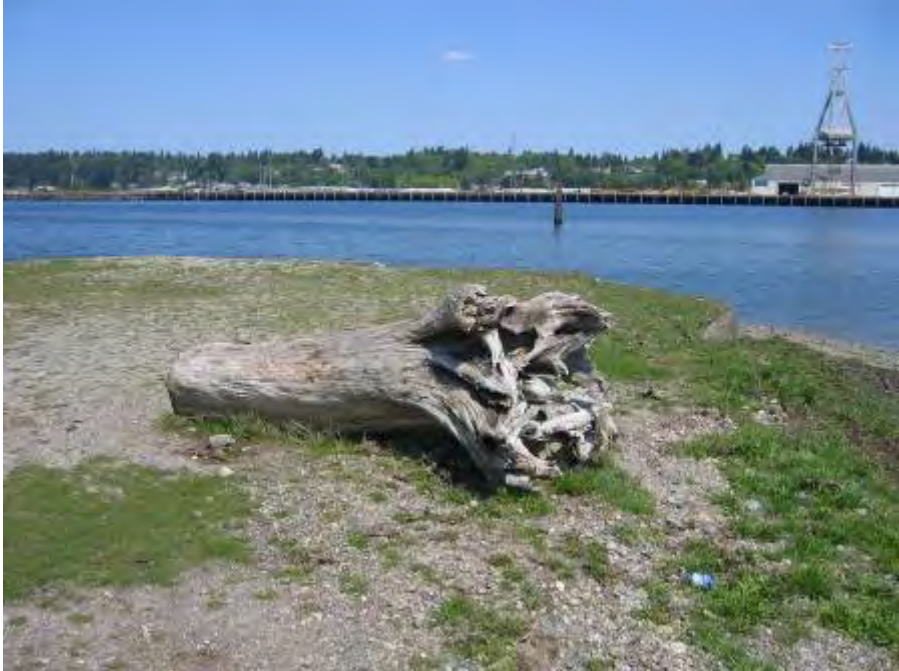
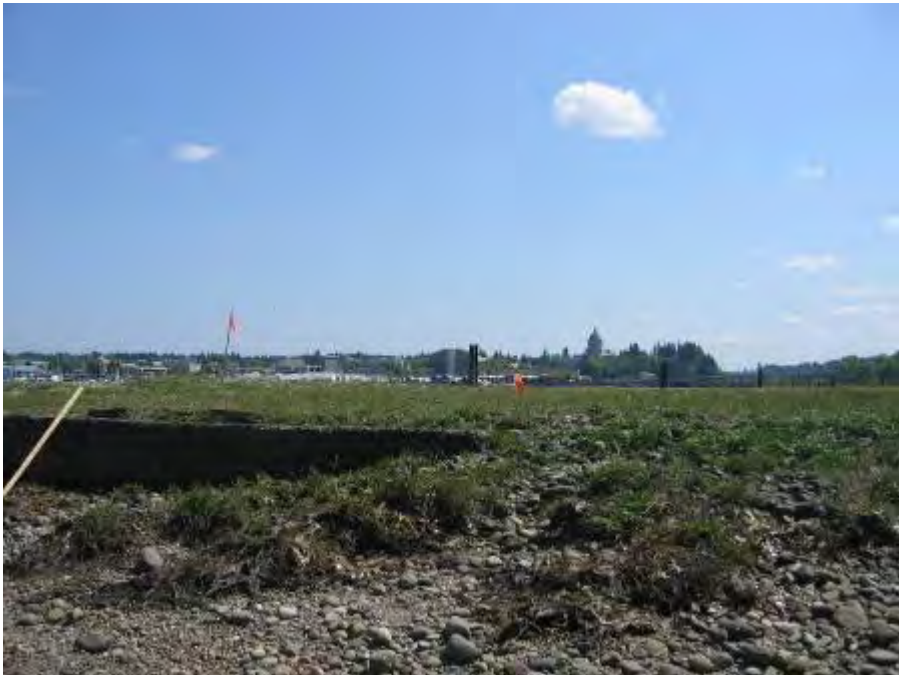
A prominent feature of the Property is a piece of land that extends out into Puget Sound farther than the rest of the beach (Figures 2 and 3) and is referred to by the City as "Rotary Point." On this point of land is an approximately 2-foot-tall semi-circular concrete wall from past wood products manufacturing operations. Salt tolerant vegetation, identified as Aquatic Vegetation Patch F, does not appear to meet the criteria for estuary wetland habitat. The top of the concrete wall is above or very near the OHW line. Salt tolerant vegetation in this area (pickleweed and sea plantain) occurs in small patches intermixed with bare ground. The vegetation appears stressed and the growth is stunted compared to aquatic vegetation in Wetlands A through E. Plant species associated with upland habitat in the Project, area such as common dandelion and various grass species, were also observed growing amongst the salt tolerant vegetation. Soils in the majority of this area resemble compact fill material with the surface impenetrable for more than a few inches with a shovel. Accessed soils are brown (10YR 4/3) to dark yellowish brown (10YR 4/4) loamy sand with gravel and cobbles. No saturation in the soil material was observed. Inland of the bulkhead there are sparse patches of pickleweed and sea plantain mixed with patches of bare ground, sloping down toward the upper intertidal habitat that bear a resemblance to Wetlands A through E. The entire boundary of Aquatic Vegetation Patch F was flagged and surveyed if the City chooses to recognize all aquatic vegetation in the Project area in the same manner. Conditions of Aquatic Vegetation Patch F are shown on Photographs 8 and 9.
