WETLAND BUFFER  
ENHANCEMENT/RESTORATION  
YEAR 3 FINAL MONITORING REPORT  
SLAG DISPOSAL, BECKWITH PROPERTY  
SITE  
SOUTH 218TH STREET AND 90TH  
AVENUE SOUTH  
KENT, WASHINGTON

Anchor QEA, LLC  
720 Olive Way, Suite 1900  
Seattle, Washington 98101

**October 2014**

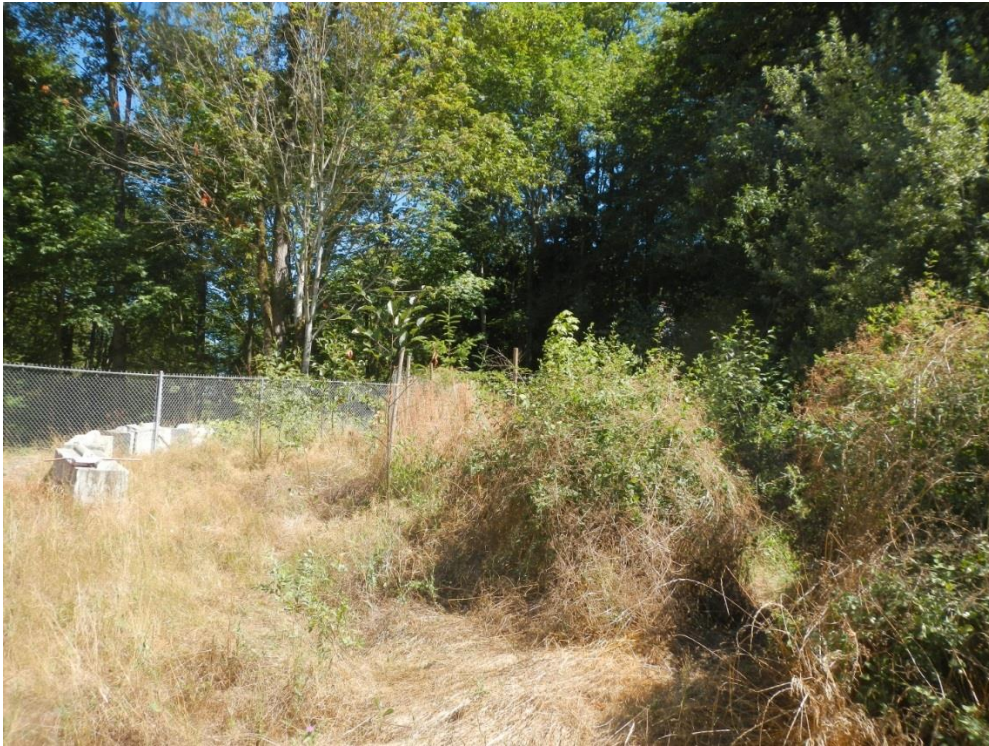
**Photograph 1. Photo Point 1: Wetland I Buffer Facing North from West Side of Buffer**

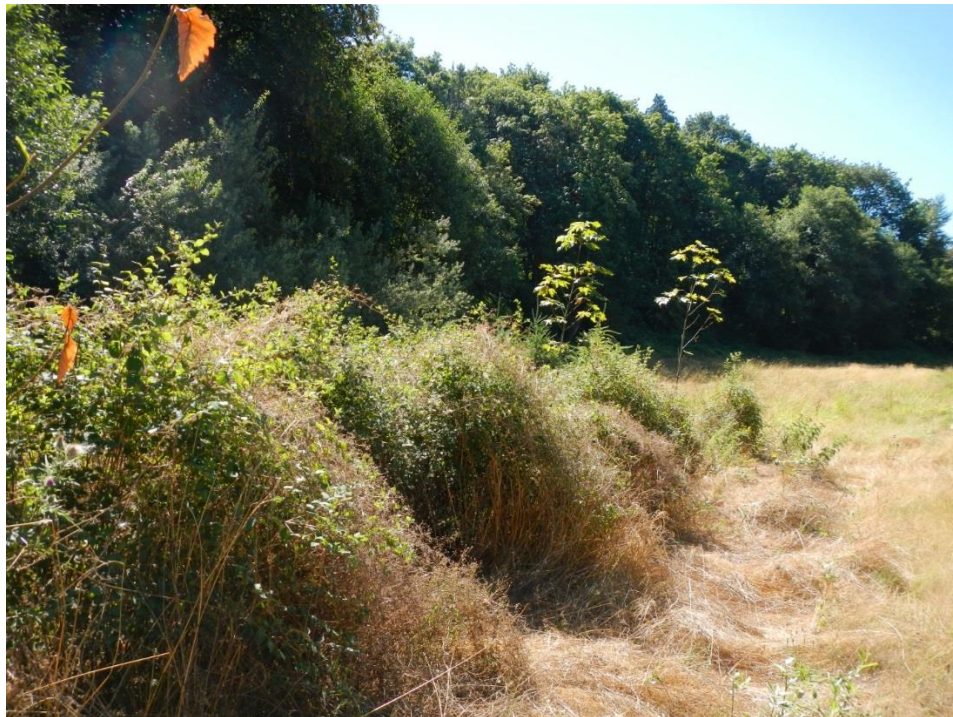
**Photograph 2. Photo Point 2: Wetland I Buffer Facing South from West Side of Buffer**

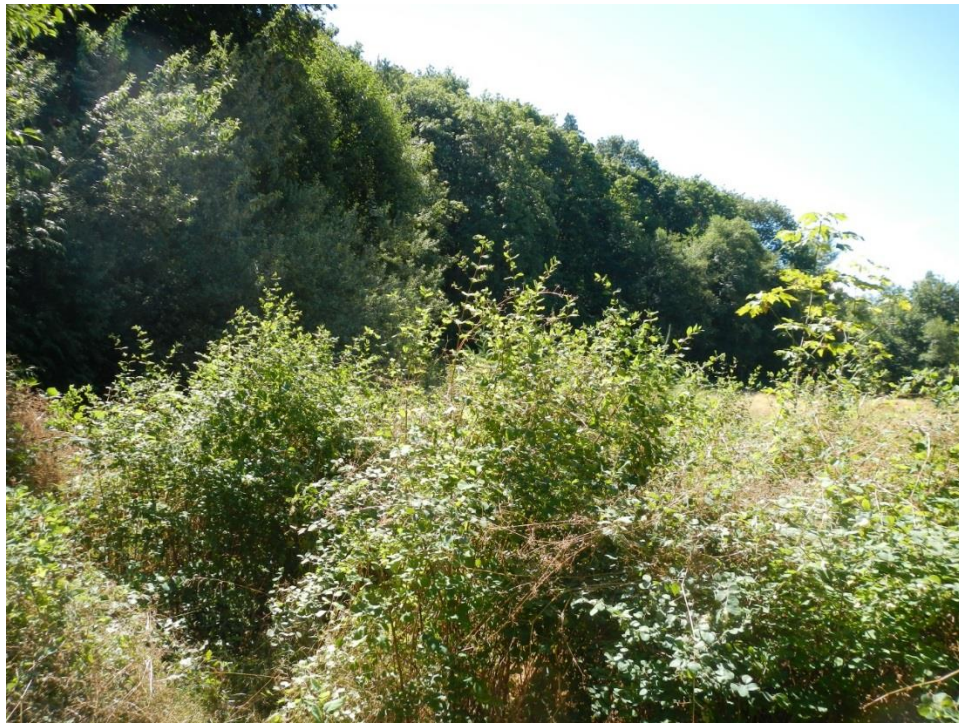
**Photograph 3. Photo Point 3: Wetland I Buffer Facing South from Middle of Buffer**

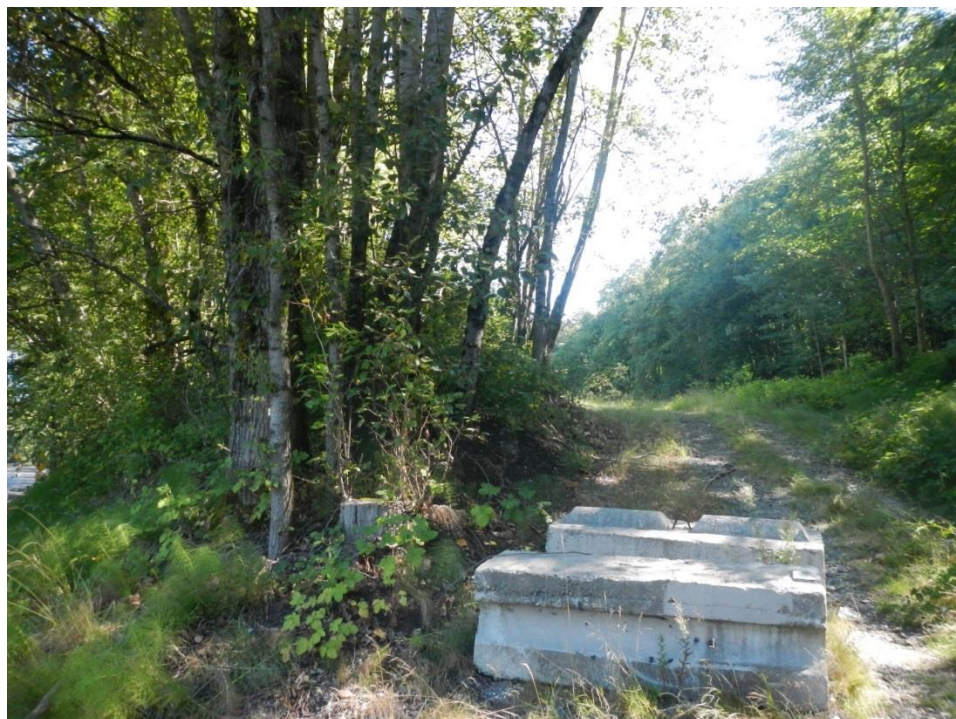
The Wetland M buffer area was dominated by bare ground, and field horsetail (*Equisetum arvense*) was the only herbaceous plant observed. A complete list of colonizing species observed at the site, and the percent areal cover within the buffer restoration areas, is presented in Table 9.

**Photograph 4. Photo Point 4: Wetland M Buffer Facing North from East Side of Buffer**

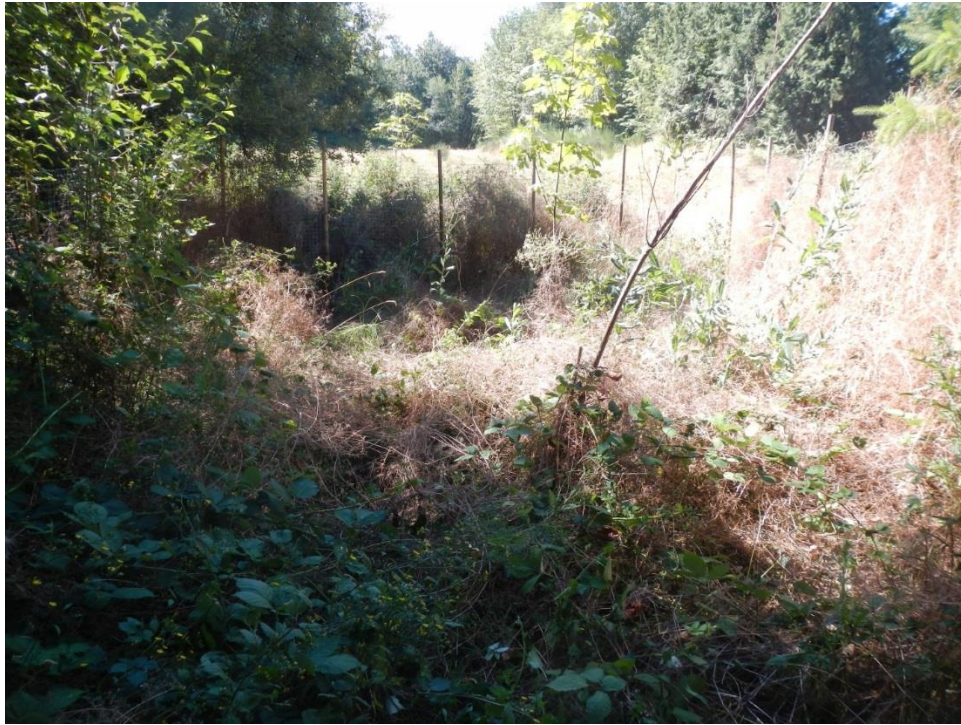
Very few shrubs were alive within the three fenced clusters at the time of the 2014 Year 3 monitoring. Overall, 16 live plants of the 79 planted shrubs were observed during the Year 3 monitoring. Live shrubs observed within the three clusters included four Indian plum, five Nootka rose, five salmonberry, and two snowberry. During the Year 3 monitoring the three clusters were identified as Cluster 1, 2, and 3 based on their north, middle, and south location within the Wetland I buffer area, respectively. Eleven shrubs were observed within Cluster 1. No live shrubs were observed within Cluster 2, and five salmonberry shrubs were observed within Cluster 3. The salmonberry shrubs appeared to be very stressed. The fencing around the shrubs appeared to be intact, and no evidence of deer browsing of vegetation was observed within the fenced areas. The area within the three fenced clusters was also overgrown with dense grass and herbaceous vegetation such as cleavers bedstraw,

fireweed, prickly lettuce, reed canarygrass, and Canada thistle. Young shoots of Himalayan blackberry are also growing within the three fenced clusters. Photographs of the existing conditions within the three fenced clusters are presented in Appendix B. Table 10 lists species composition and cover number of planted vegetation within the three fenced clusters, per cluster.

**Photograph 5. Existing Conditions within the Supplemental Planting Area Cluster 1 (North), Facing North**

Factors that may have contributed to the significant plant mortality of the 2014 supplemental planting could include a lack of irrigation, exposure to sun, dense herbaceous growth over the plants, and the time of year that the supplemental planting occurred. Lack of irrigation and exposure to the sun is often a contributing factor for plant mortality in restoration sites and appears to be associated with the high plant mortality observed during the Year 1 and Year 2 monitoring. The establishment of dense herbaceous cover that grows over the planted vegetation can shade the plants and prevent effective photosynthesis from occurring. Finally, the supplemental planting occurred on March 24. Restoration plantings typically occur during the late fall or winter, when plants are dormant and weather conditions are more favorable for new plantings, cooler temperatures, and higher precipitation. Deer browsing does not appear to be a factor in the high mortality of supplemental planting, since the areas were fenced off from wildlife access, and no evidence of deer browsing was observed.

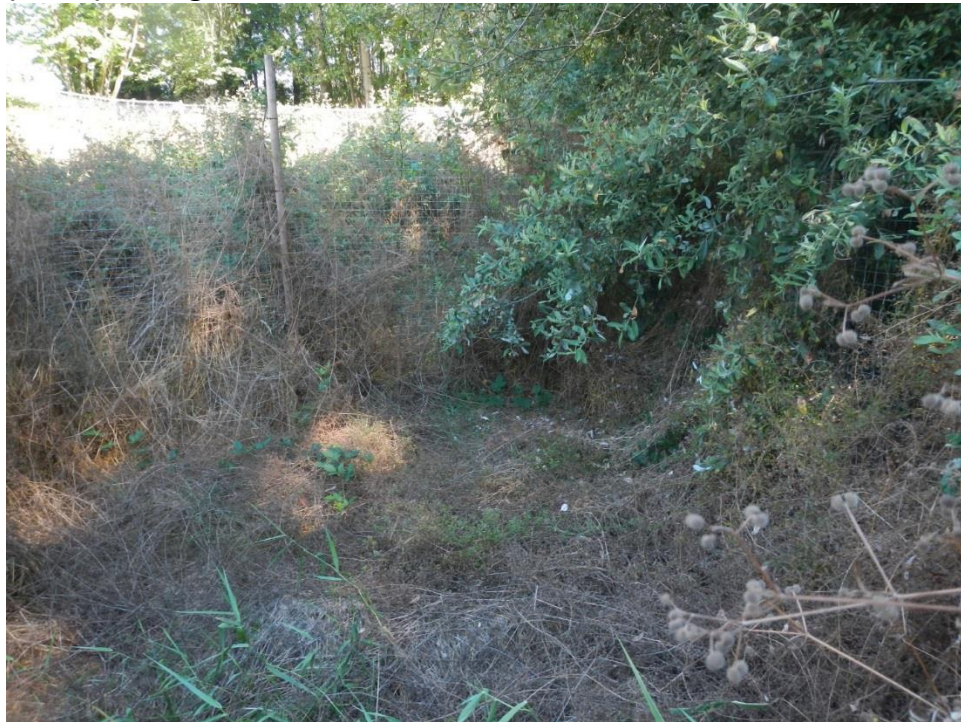
**Photograph 6. Existing Conditions within the Supplemental Planting Area Cluster 2 (Middle), Facing North**

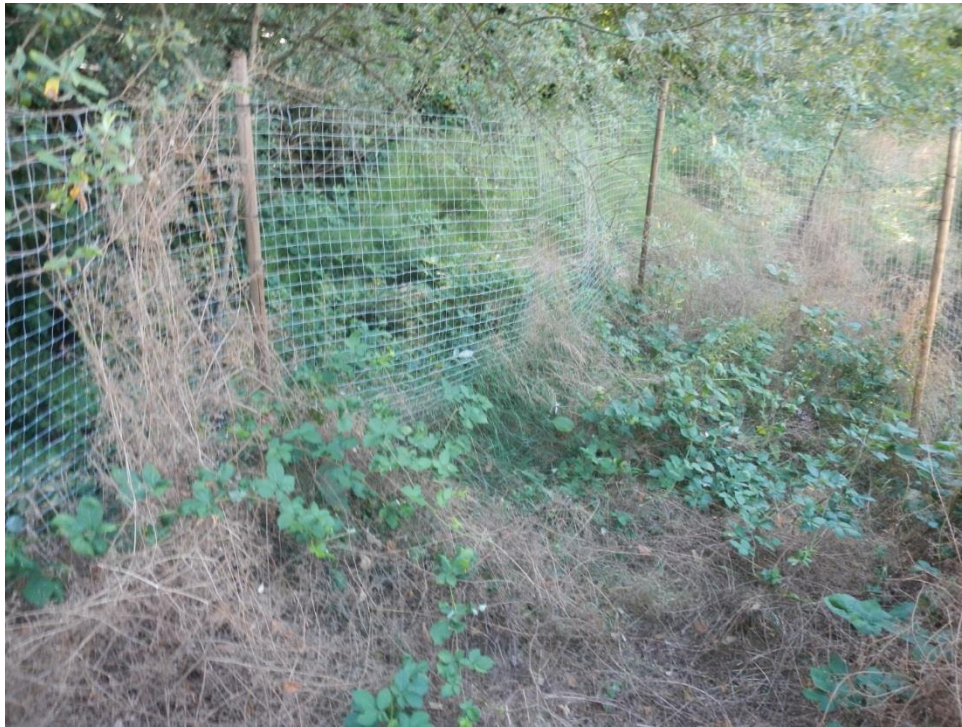
**Photograph 7. Existing Conditions within the Supplemental Planting Area Cluster 2 (South), Facing South**

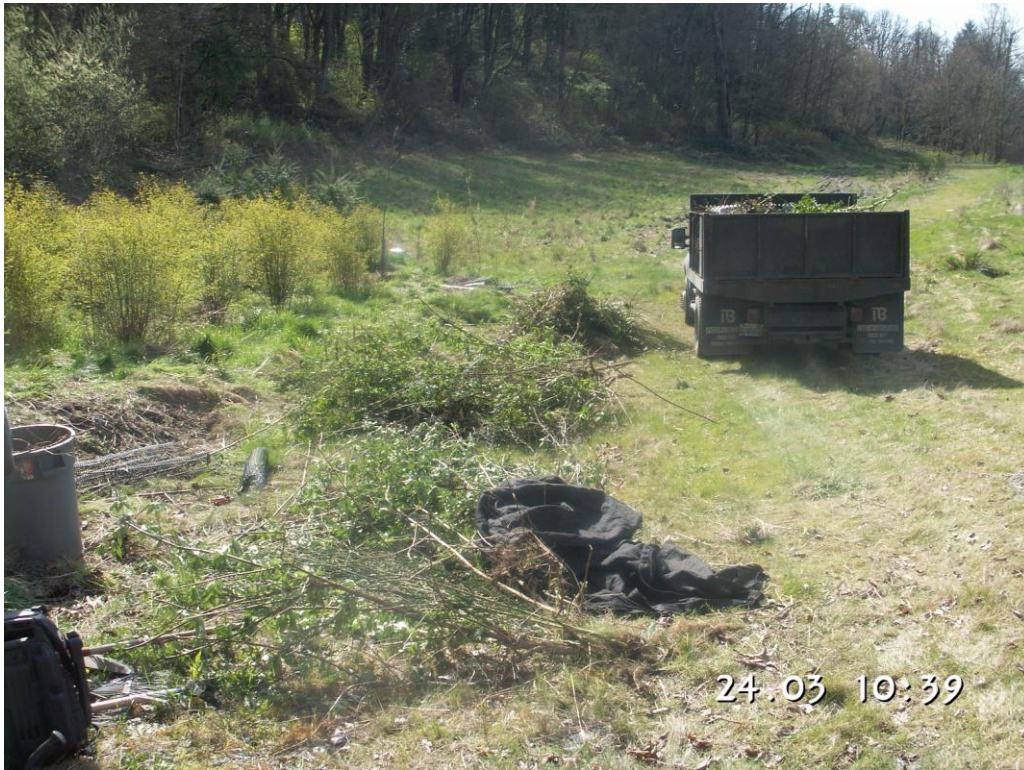
**Photograph 1:** Invasive species removal in Wetland I Buffer Area, looking southeast.

Double Eagle removed non-native invasive species from the Wetland I Buffer Area, as defined in the Restoration Plan, on March 24, 2014. Species removed included Himalayan Blackberry, Scot's Broom, Butterfly Bush, Canada Thistle, Prickly Lettuce, and Reed Canary Grass. Farallon observed two large dead leaf maples and one dead alder, which were removed from the

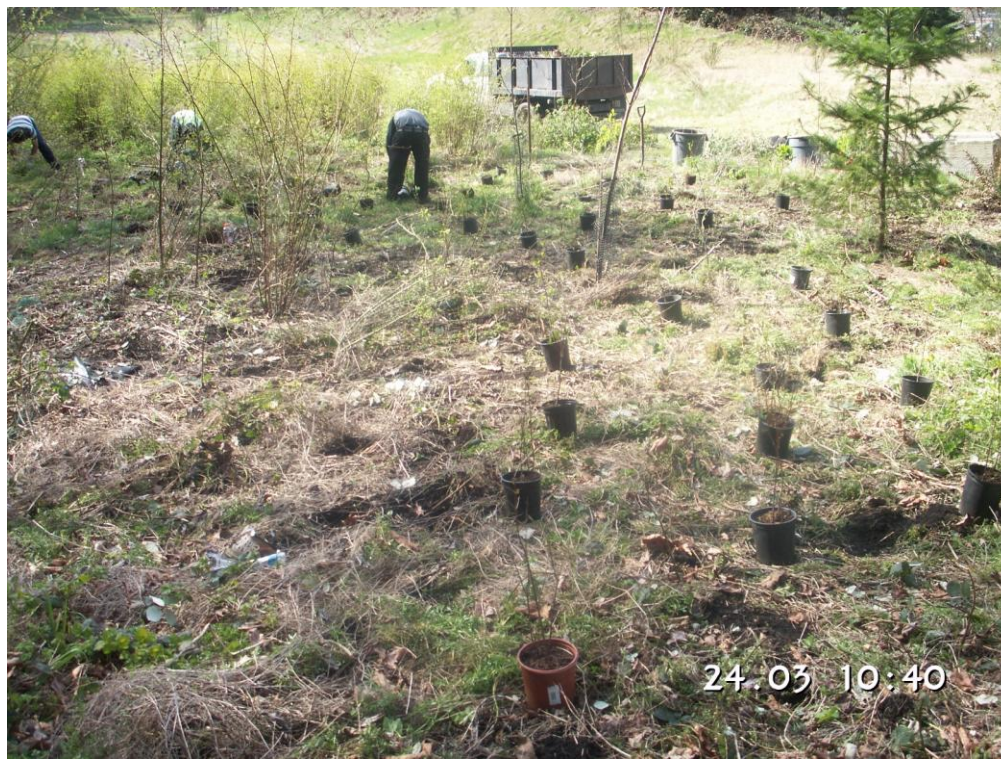
**Photograph 3:** Planting in north end of Wetland I Buffer Area, looking southwest.

Double Eagle planted 79 shrubs on March 25, 2014 in accordance with the Restoration Plan. The shrubs planted included 32 Indian Plum, 11 Nootka rose, 31 Salmonberry, and 5 Snowberry shrubs, which were installed to replace shrubs installed in February 2011 that did not survive. To protect the shrubs from deer browsing, chicken wire fencing was installed around all of the newly installed shrubs. The shrubs were planted in three separate clusters, all located within the Wetland I Buffer Area (Sheet W2). Photograph 2 shows the new shrubs prior to planting. Two of the shrub clusters were located at the southern end of the Wetland I Buffer Area, and the third, larger, cluster was located at the northern end of the Wetland I Buffer Area, as shown in Photograph 3 and on Sheet W2. Six-foot-high chicken wire fencing was installed around each of the three clusters for protection from deer browsing, as shown in Photographs 4 and 5.

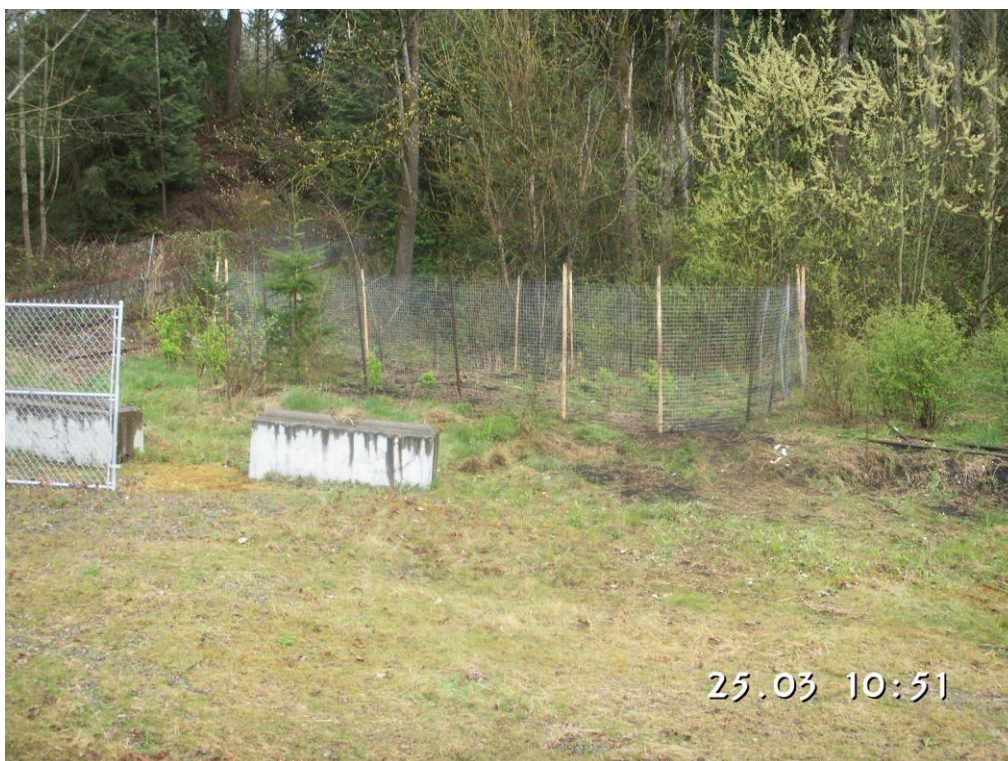
**Photograph 4:** Wetland I Buffer Area following completion of species removal, shrub planting, and installation of plant guards, looking east.

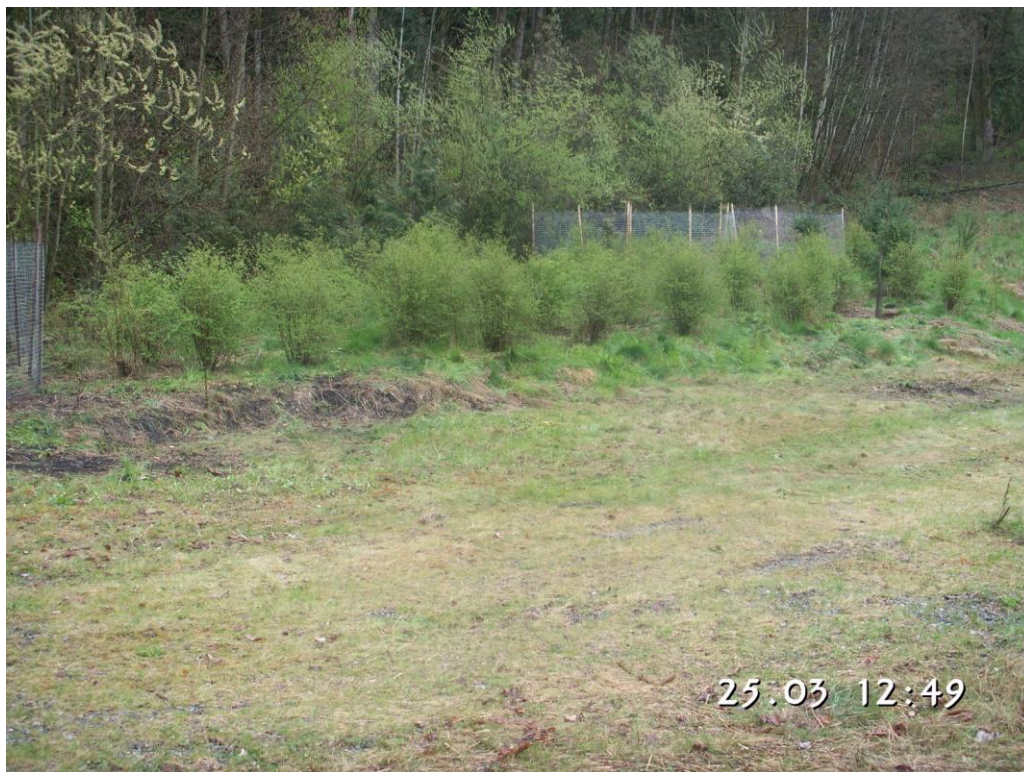
**Photograph 5:** Wetland I Buffer Area following completion of invasive species removal, shrub planting, and installation of plant guards, looking southeast.
