SEATTLE-KING COUNTY ABANDONED LANDFILL
TOXICITY/HAZARD ASSESSMENT PROJECT

DECEMBER 31, 1986

PREPARED BY WAYNE L. TURNBERG
SEATTLE-KING COUNTY DEPARTMENT OF PUBLIC HEALTH

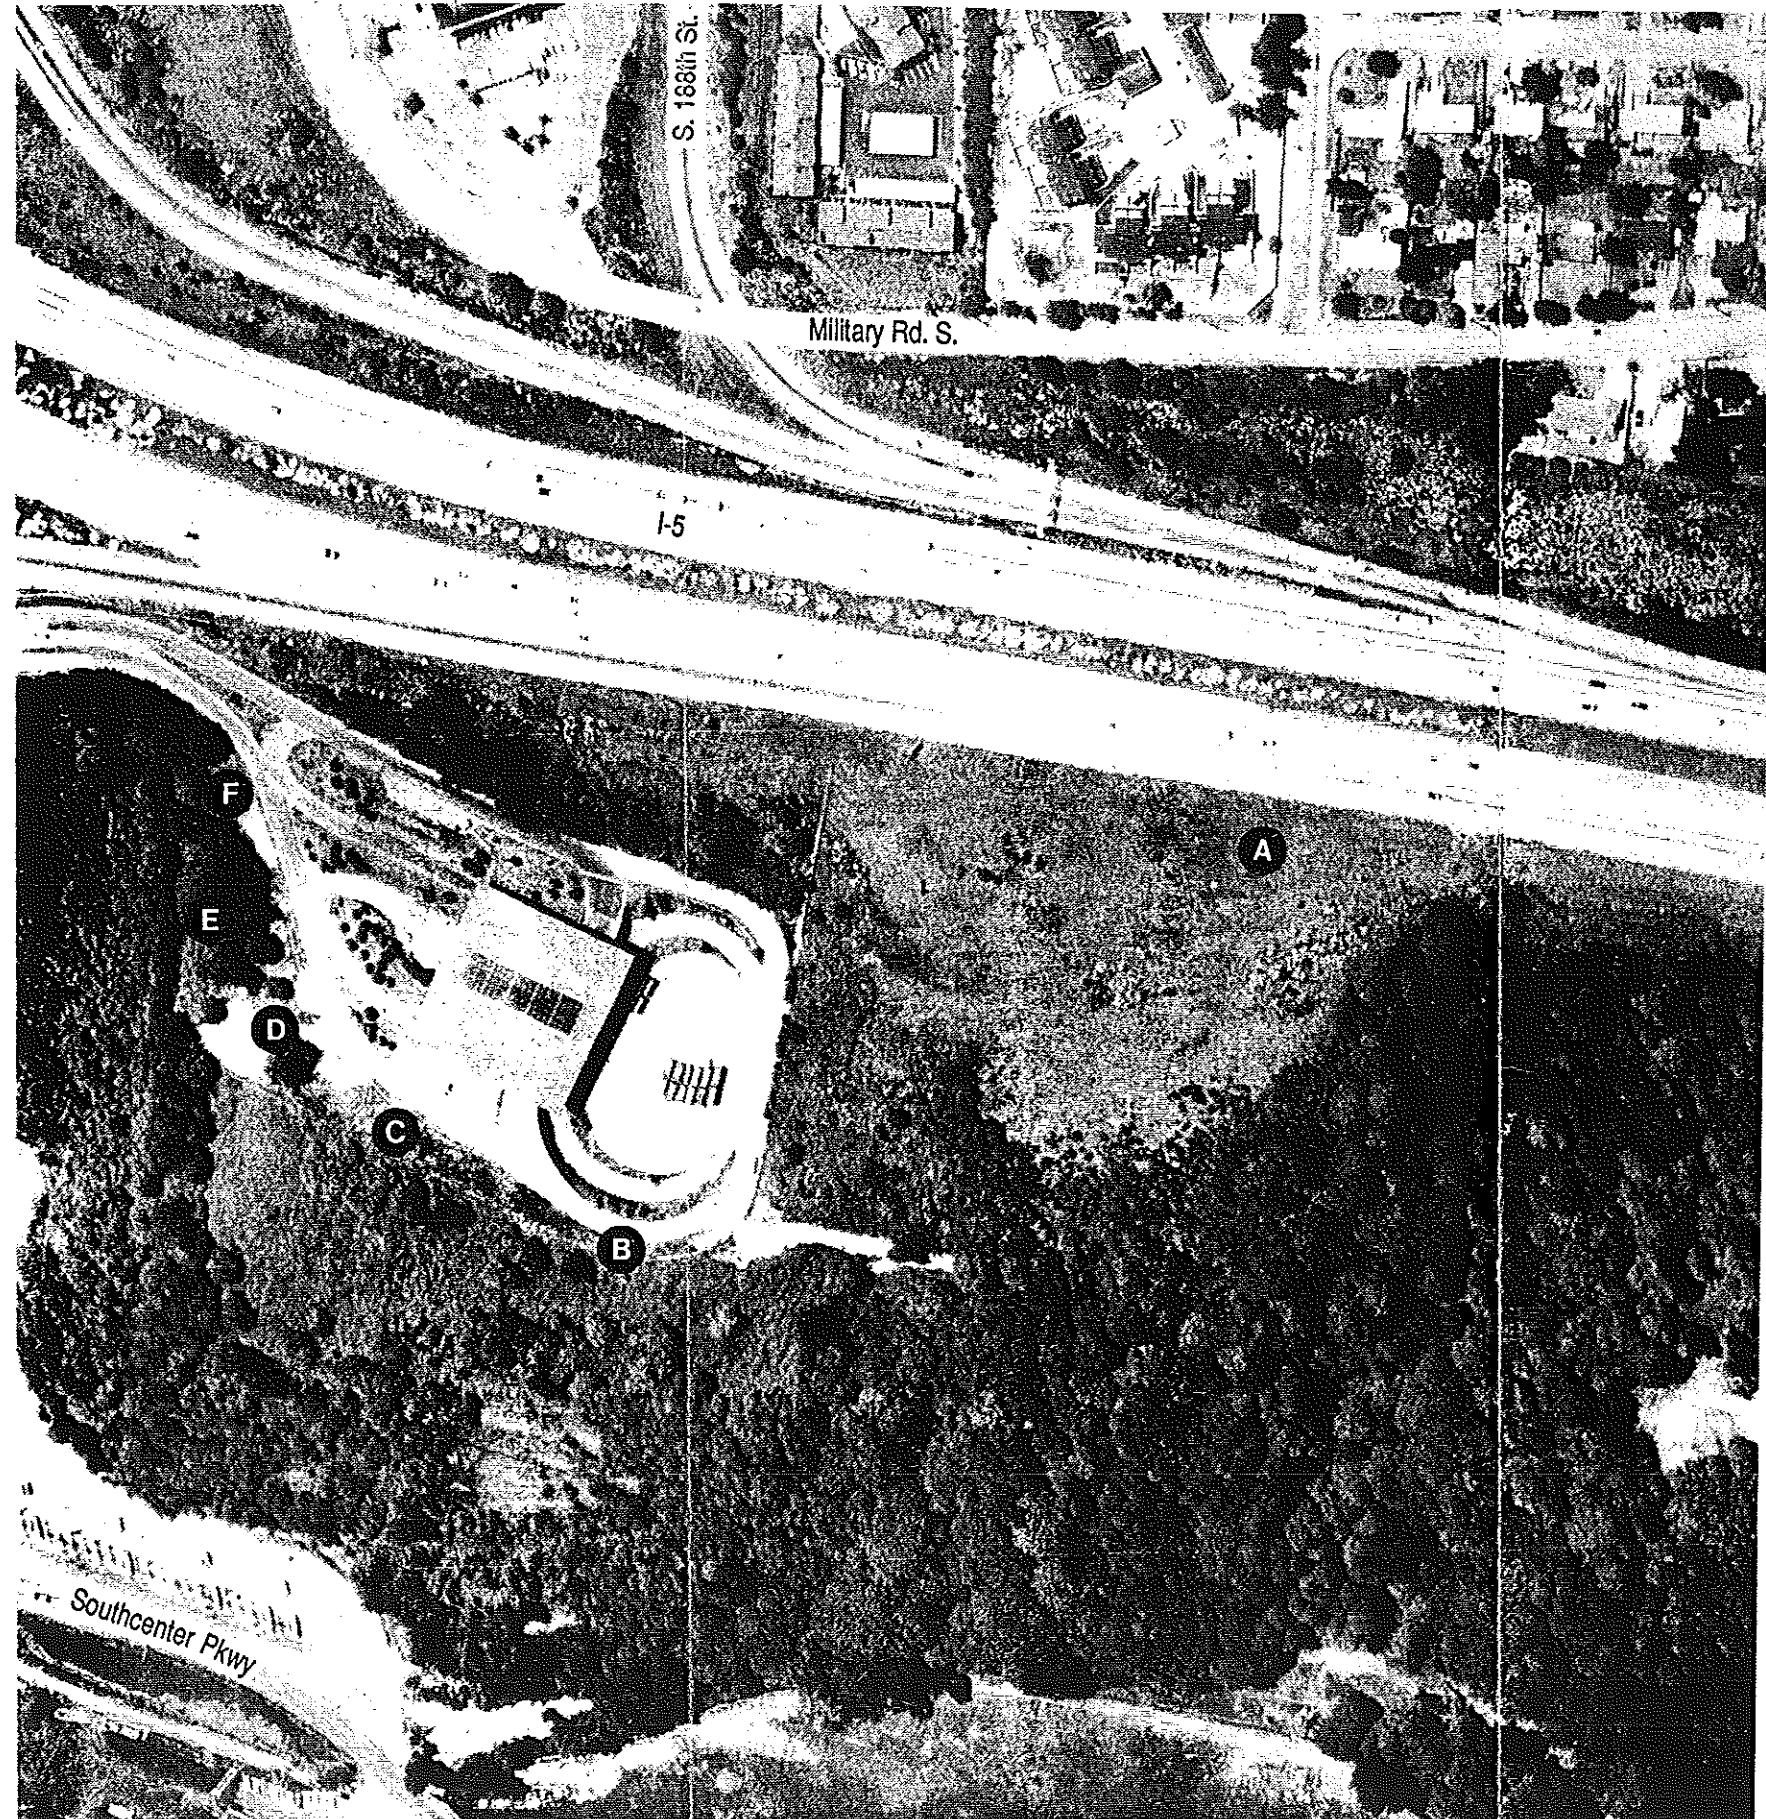
FIGURE 2

A subsequent survey was conducted during the soil sampling program on July 25, 1986. At that time, a slow surface water stream containing an oily sheen was observed from Site F of Figure 2. This surface water source has been described by the King County Solid Waste Division as an outfall point for surface runoff from the transfer station. A sediment sample was retrieved for analysis from this source.

During the Health Department's 1984 study of this site, a leachate seep was observed from Site D of Figure 2. There was no evidence of this during the recent surveys. The King County Solid Waste Division indicated that this had been controlled by adding to the landfill cap in that area and by diverting water run-off away from that area.

Landfill artifacts were observed within the top four inches of soil from site D and E. These artifacts included rusting cans, broken glass, wire and other metal objects.

Bow Lake Abandoned Landfill

Surface Soil Sampling
Locations

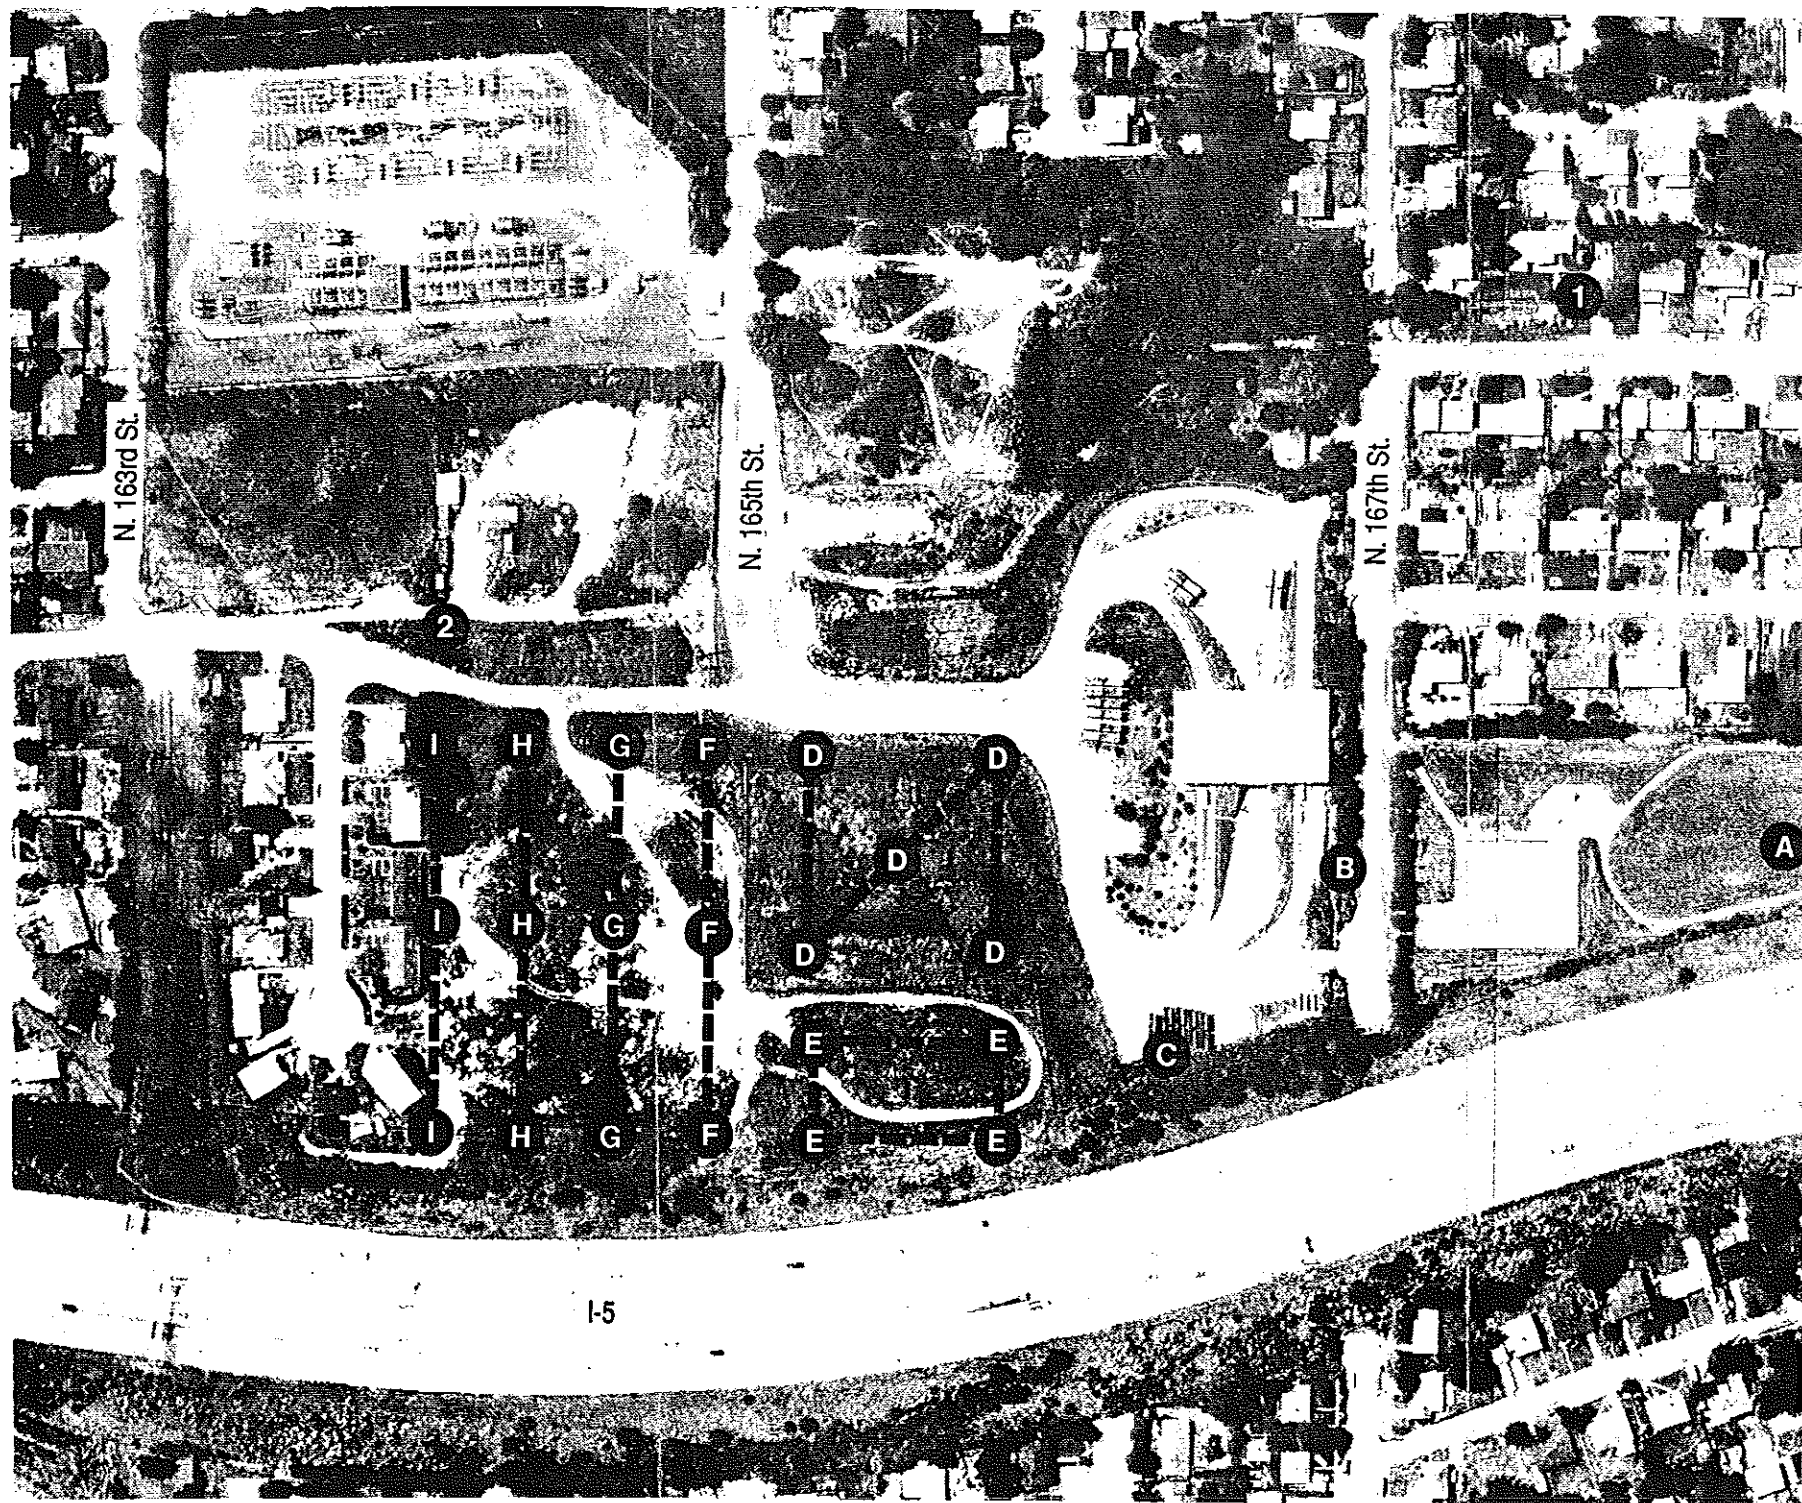
On June 26, 1986 the Corliss Abandoned Landfill was surveyed for the presence of surface water on or adjacent to the fill. No leachate seeps were observed. Thornton Creek which runs to the south from Ronald Bog Park and adjacent to the westerly perimeter of the former fill was sampled at locations upstream (Site 1); and downstream (Site 2) from the fill and analyzed for chemical components and bioassay toxicity. These data appear in Chapter IV and Appendices D and E. Water sampling locations are indicated in Figure 3. The stream was free flowing and signs of contamination were not visually evident.

Artifacts including broken glass, ceramic and brick segments were observed within the top four inches of soil from Composite E and F.

Corliss Abandoned Landfill

Surface Soil and Surface
Water Sampling Locations

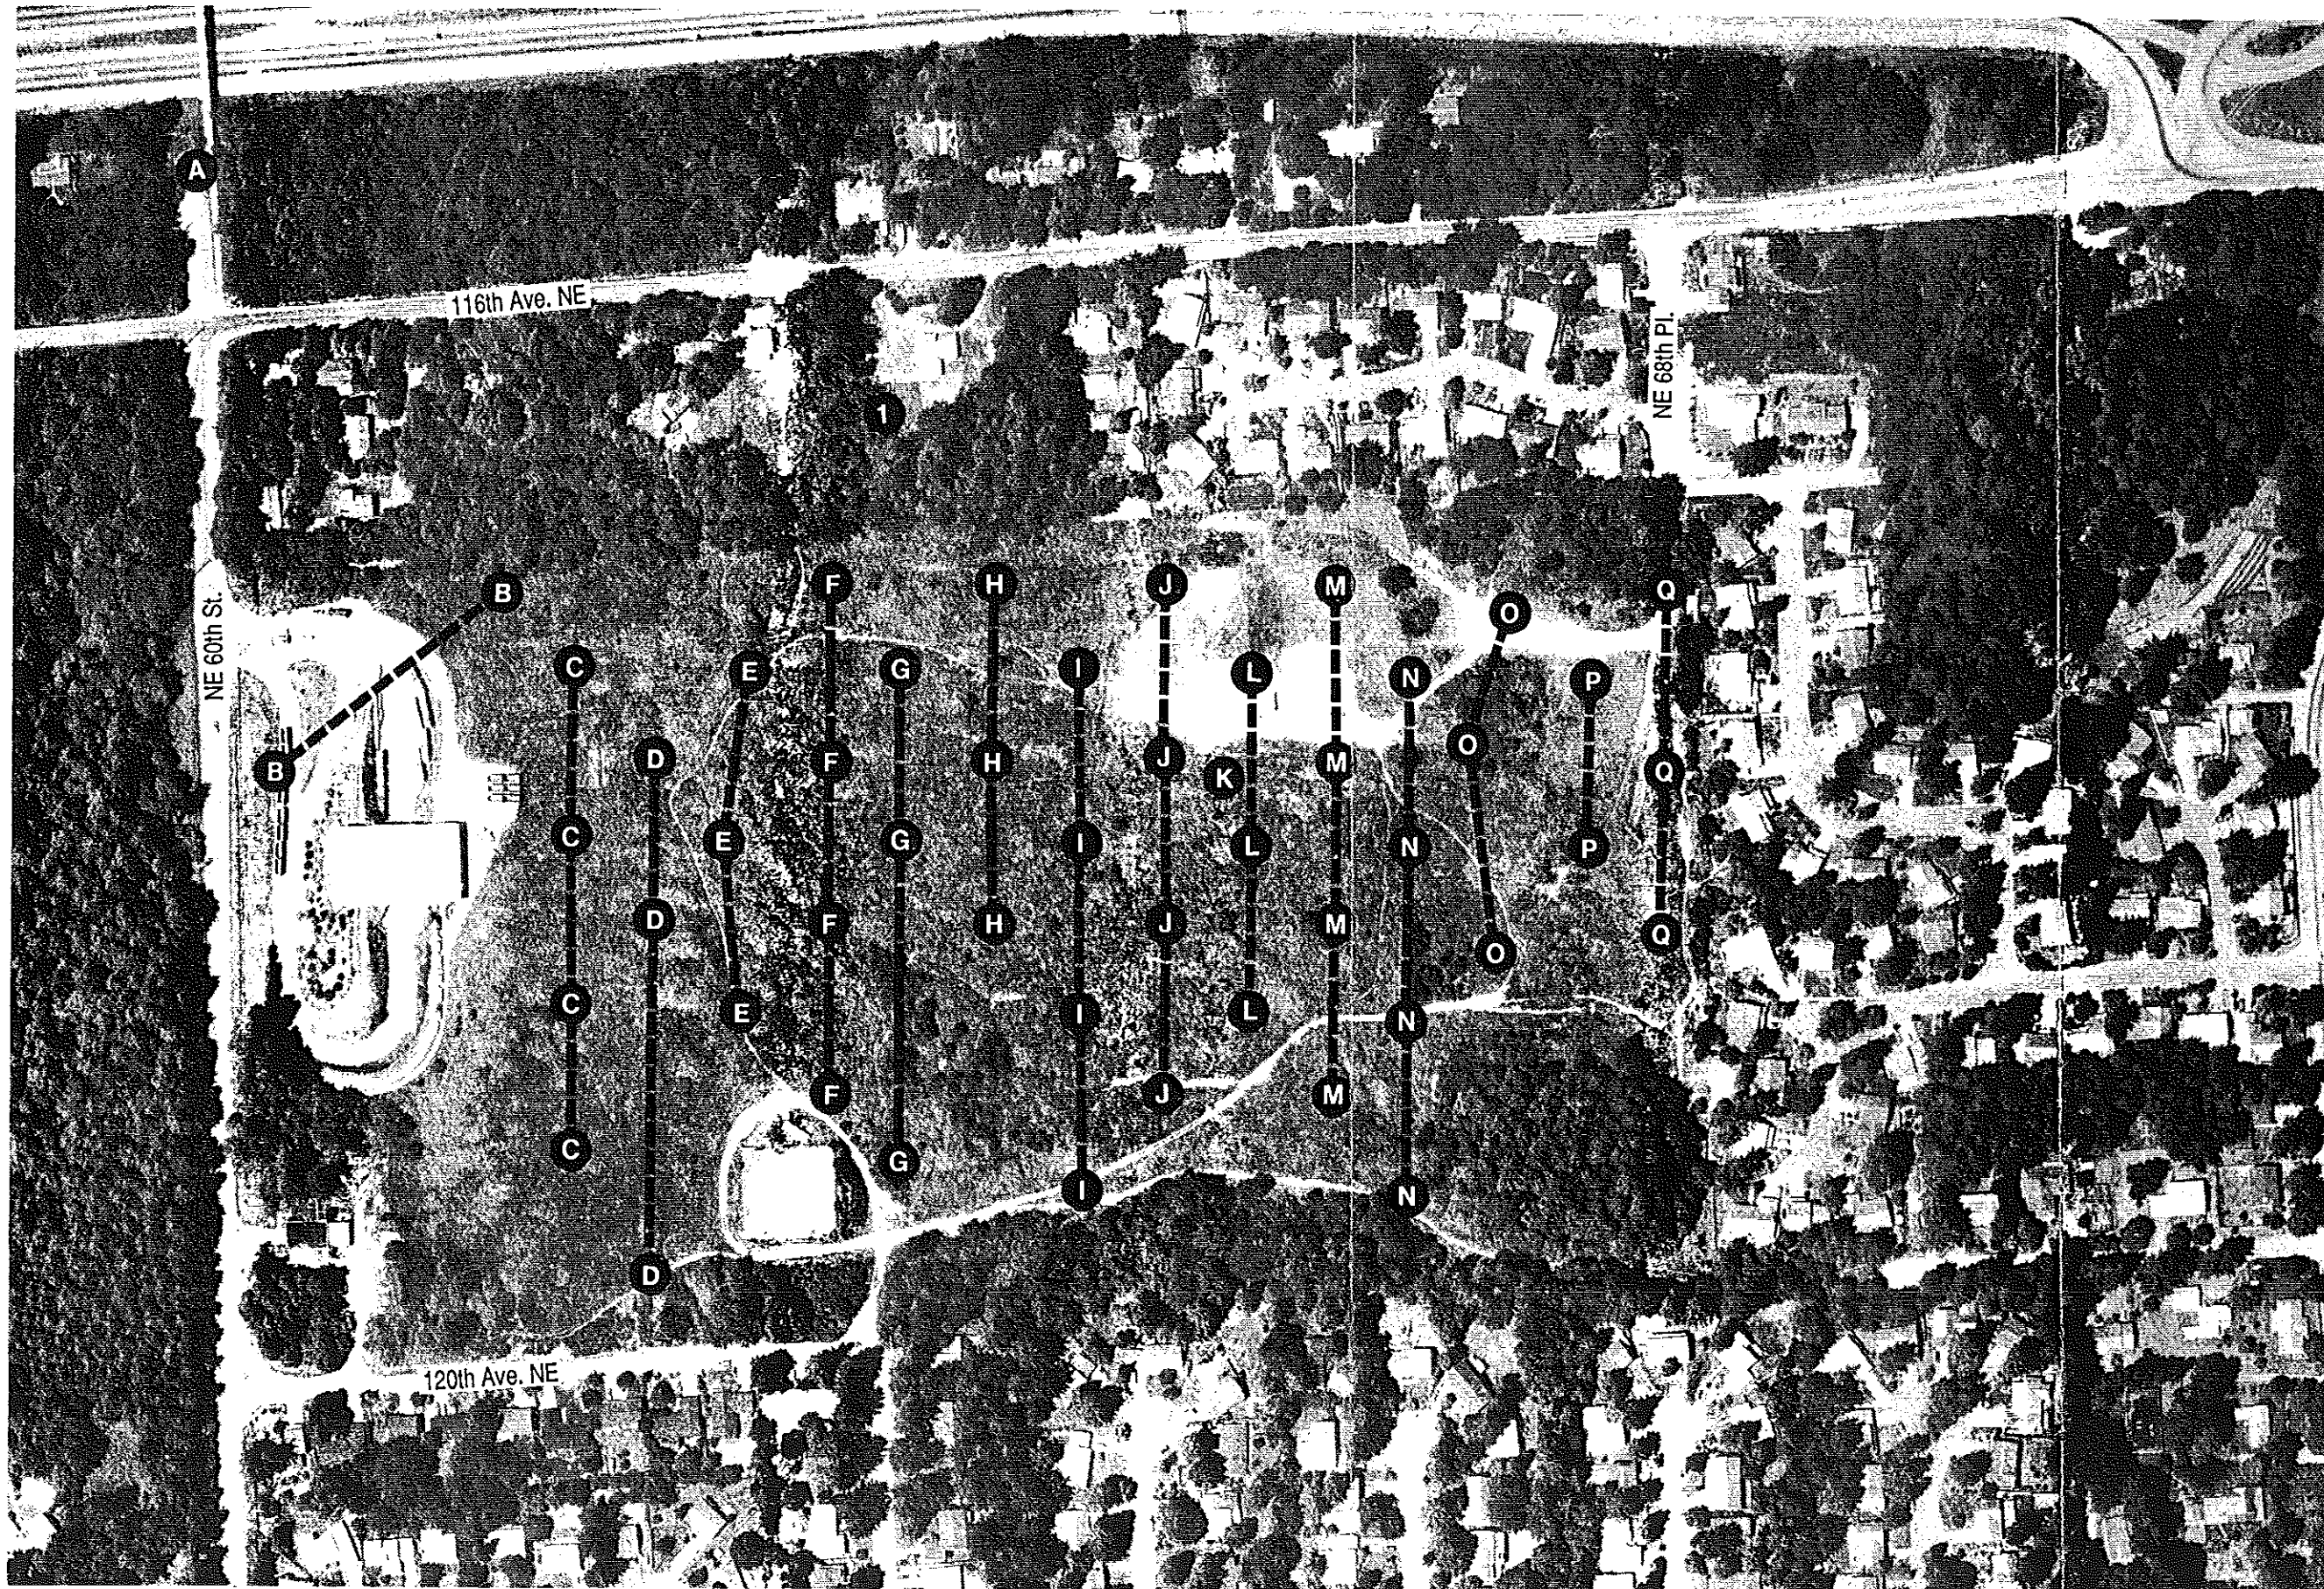
FIGURE 4

Surface fissure due to landfill gas release were observed at various locations on-site. A discrete "hotspot" sample from Site K was collected from a surface fissure. Black stains were observed on the soil. A landfill odor was apparent.

Gas fissures were also sampled as subsamples for Composite I and E. Landfill gas odors were apparent from both.

Artifacts consisting of broken glass fragments were observed within the top four inches of soil from individual subsamples of Sites I, E, D and C. No other artifacts were observed.

Houghton Abandoned Landfill

Surface Soil and Surface Water Sampling Locations

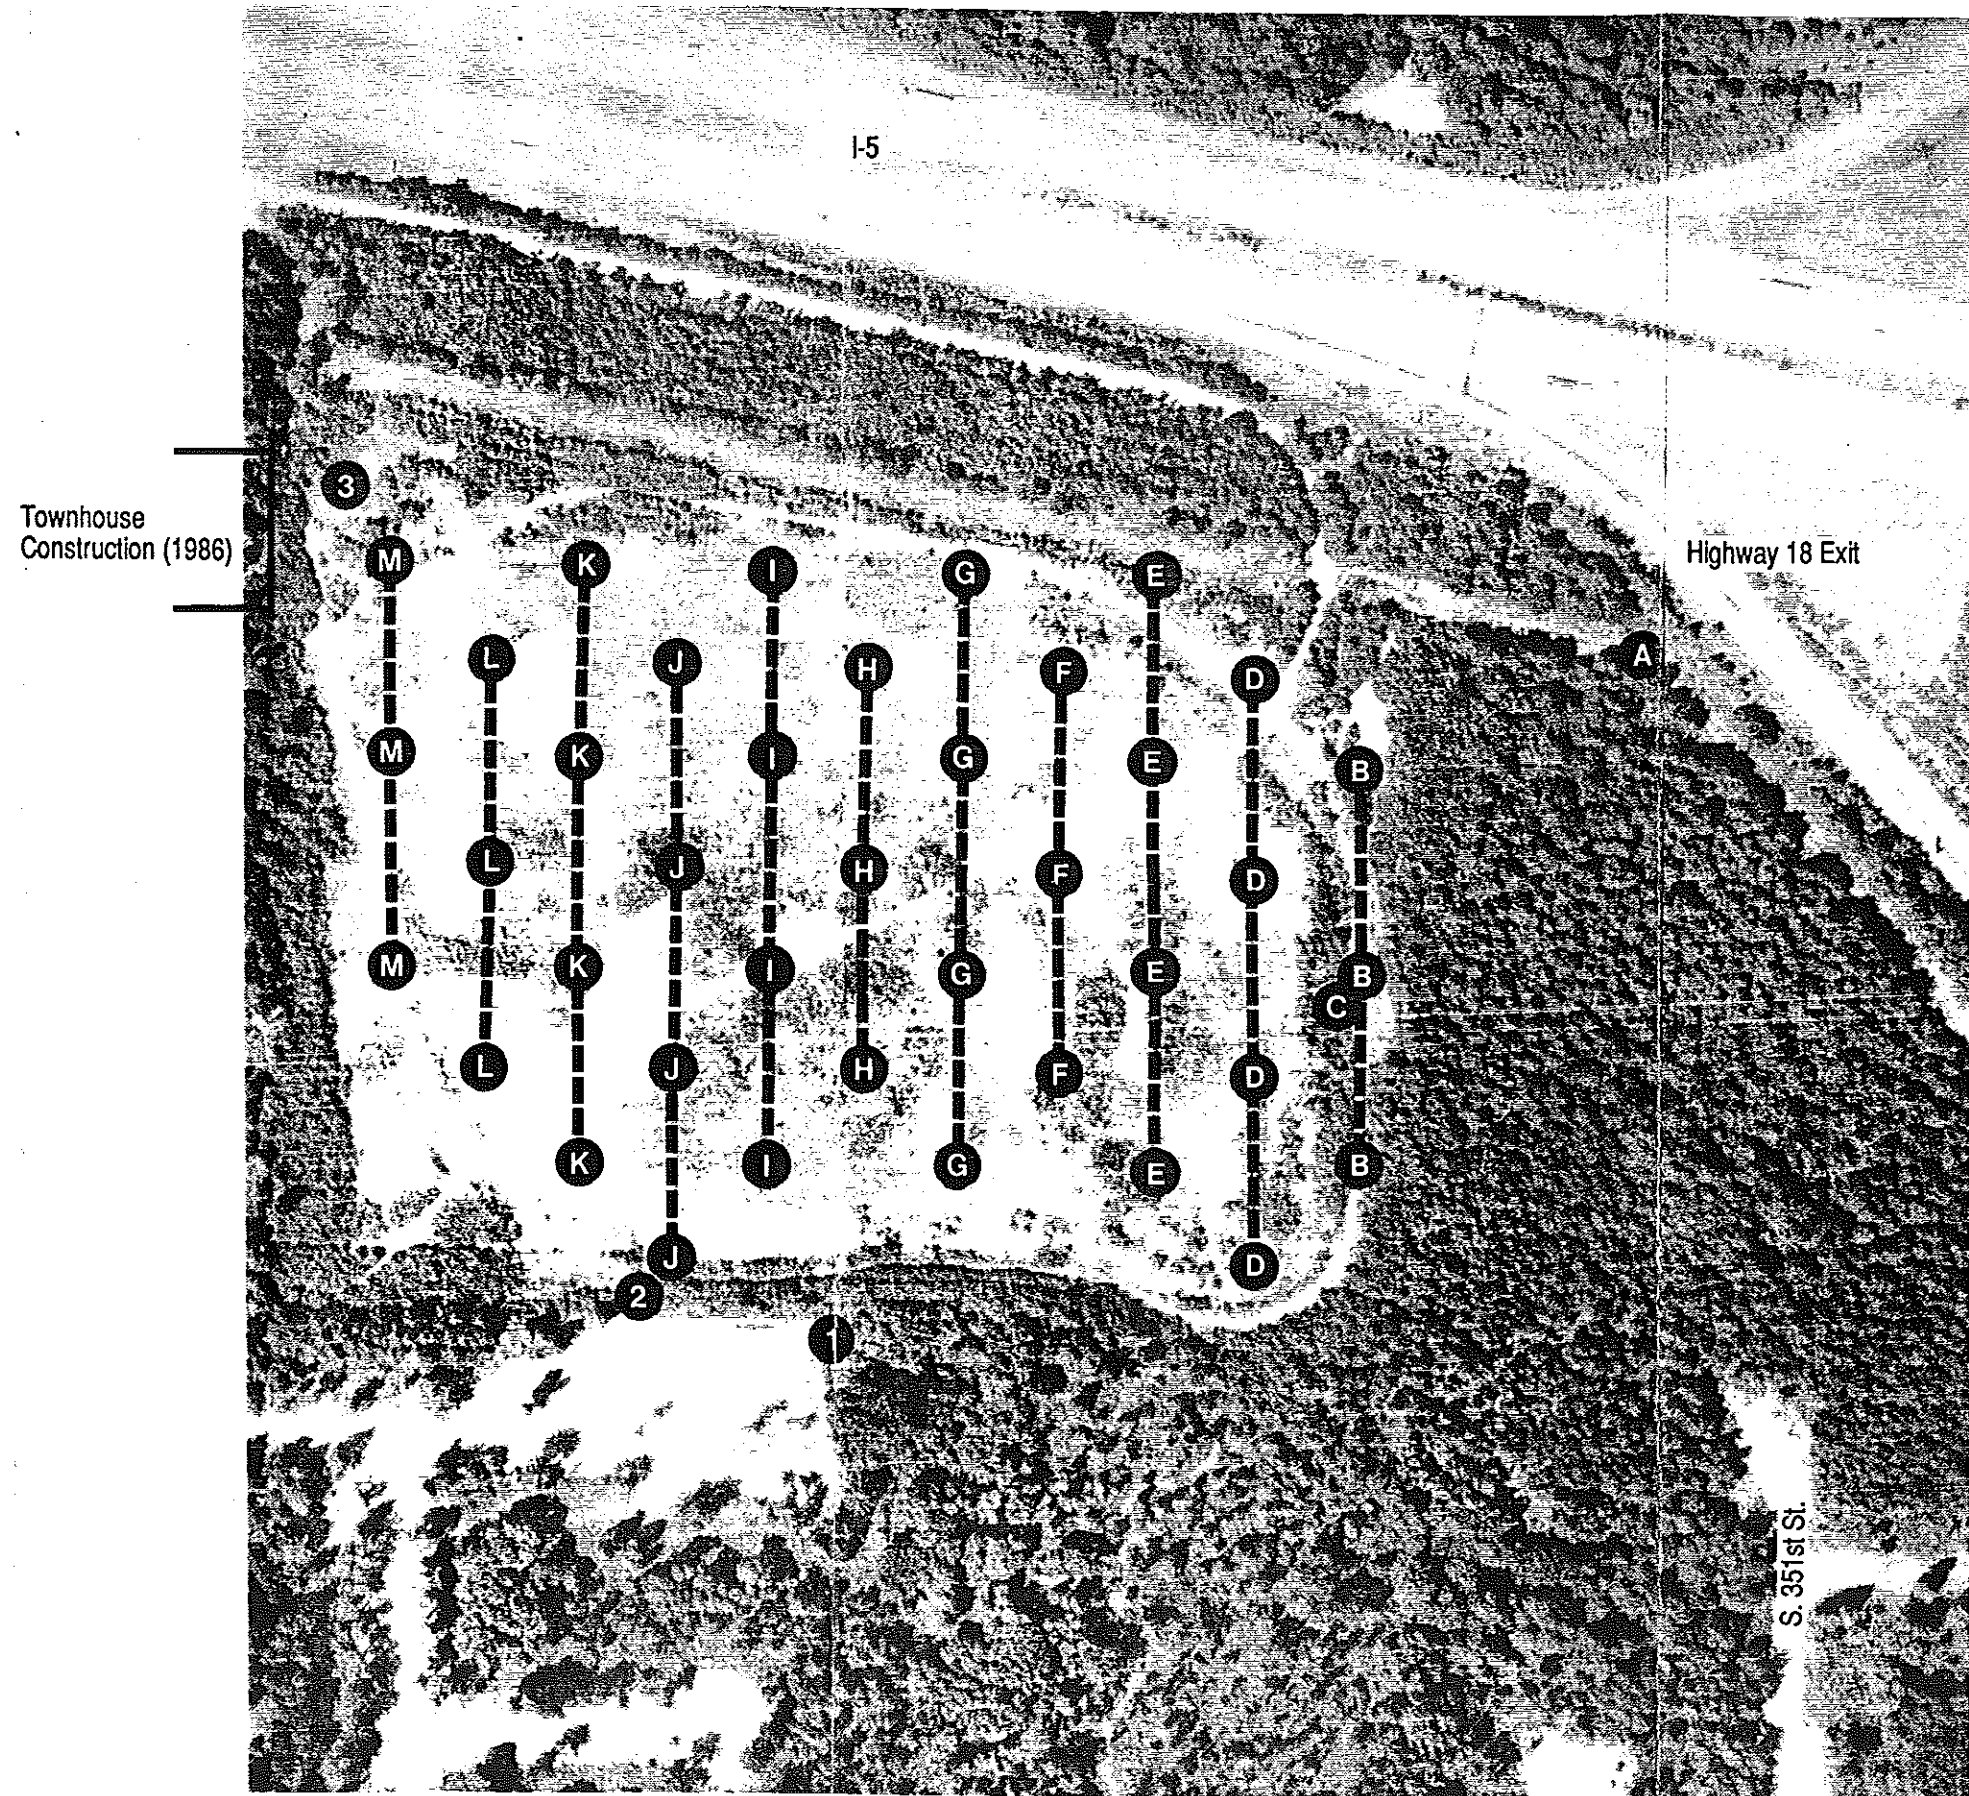
FIGURE 5

A stream flows from the east toward the landfill perimeter (Site 1), diverts to the south along the landfill perimeter and flows into a culvert under the landfill. A culvert outfall (presumably for the same stream) is located to the center of the southern perimeter. Just northeast of the outfall, a large manhole has collapsed measuring approximately eight feet in diameter and 10 feet in depth. Stream water has been observed flowing through this in November 1986.

A stagnant pool of water was sampled at Site 3 within the vicinity of the new townhouse complex. The water exhibited a brown discoloration. Water vegetation (grasses) was observed growing in the pool.

One discrete sample was collected from a run-off ditch at the site's north end (Site C). The ditch soils had a stained rust-colored appearance.

Puyallup/Kit Corner Abandoned Landfill

Surface Soil and Surface Water Sampling Locations

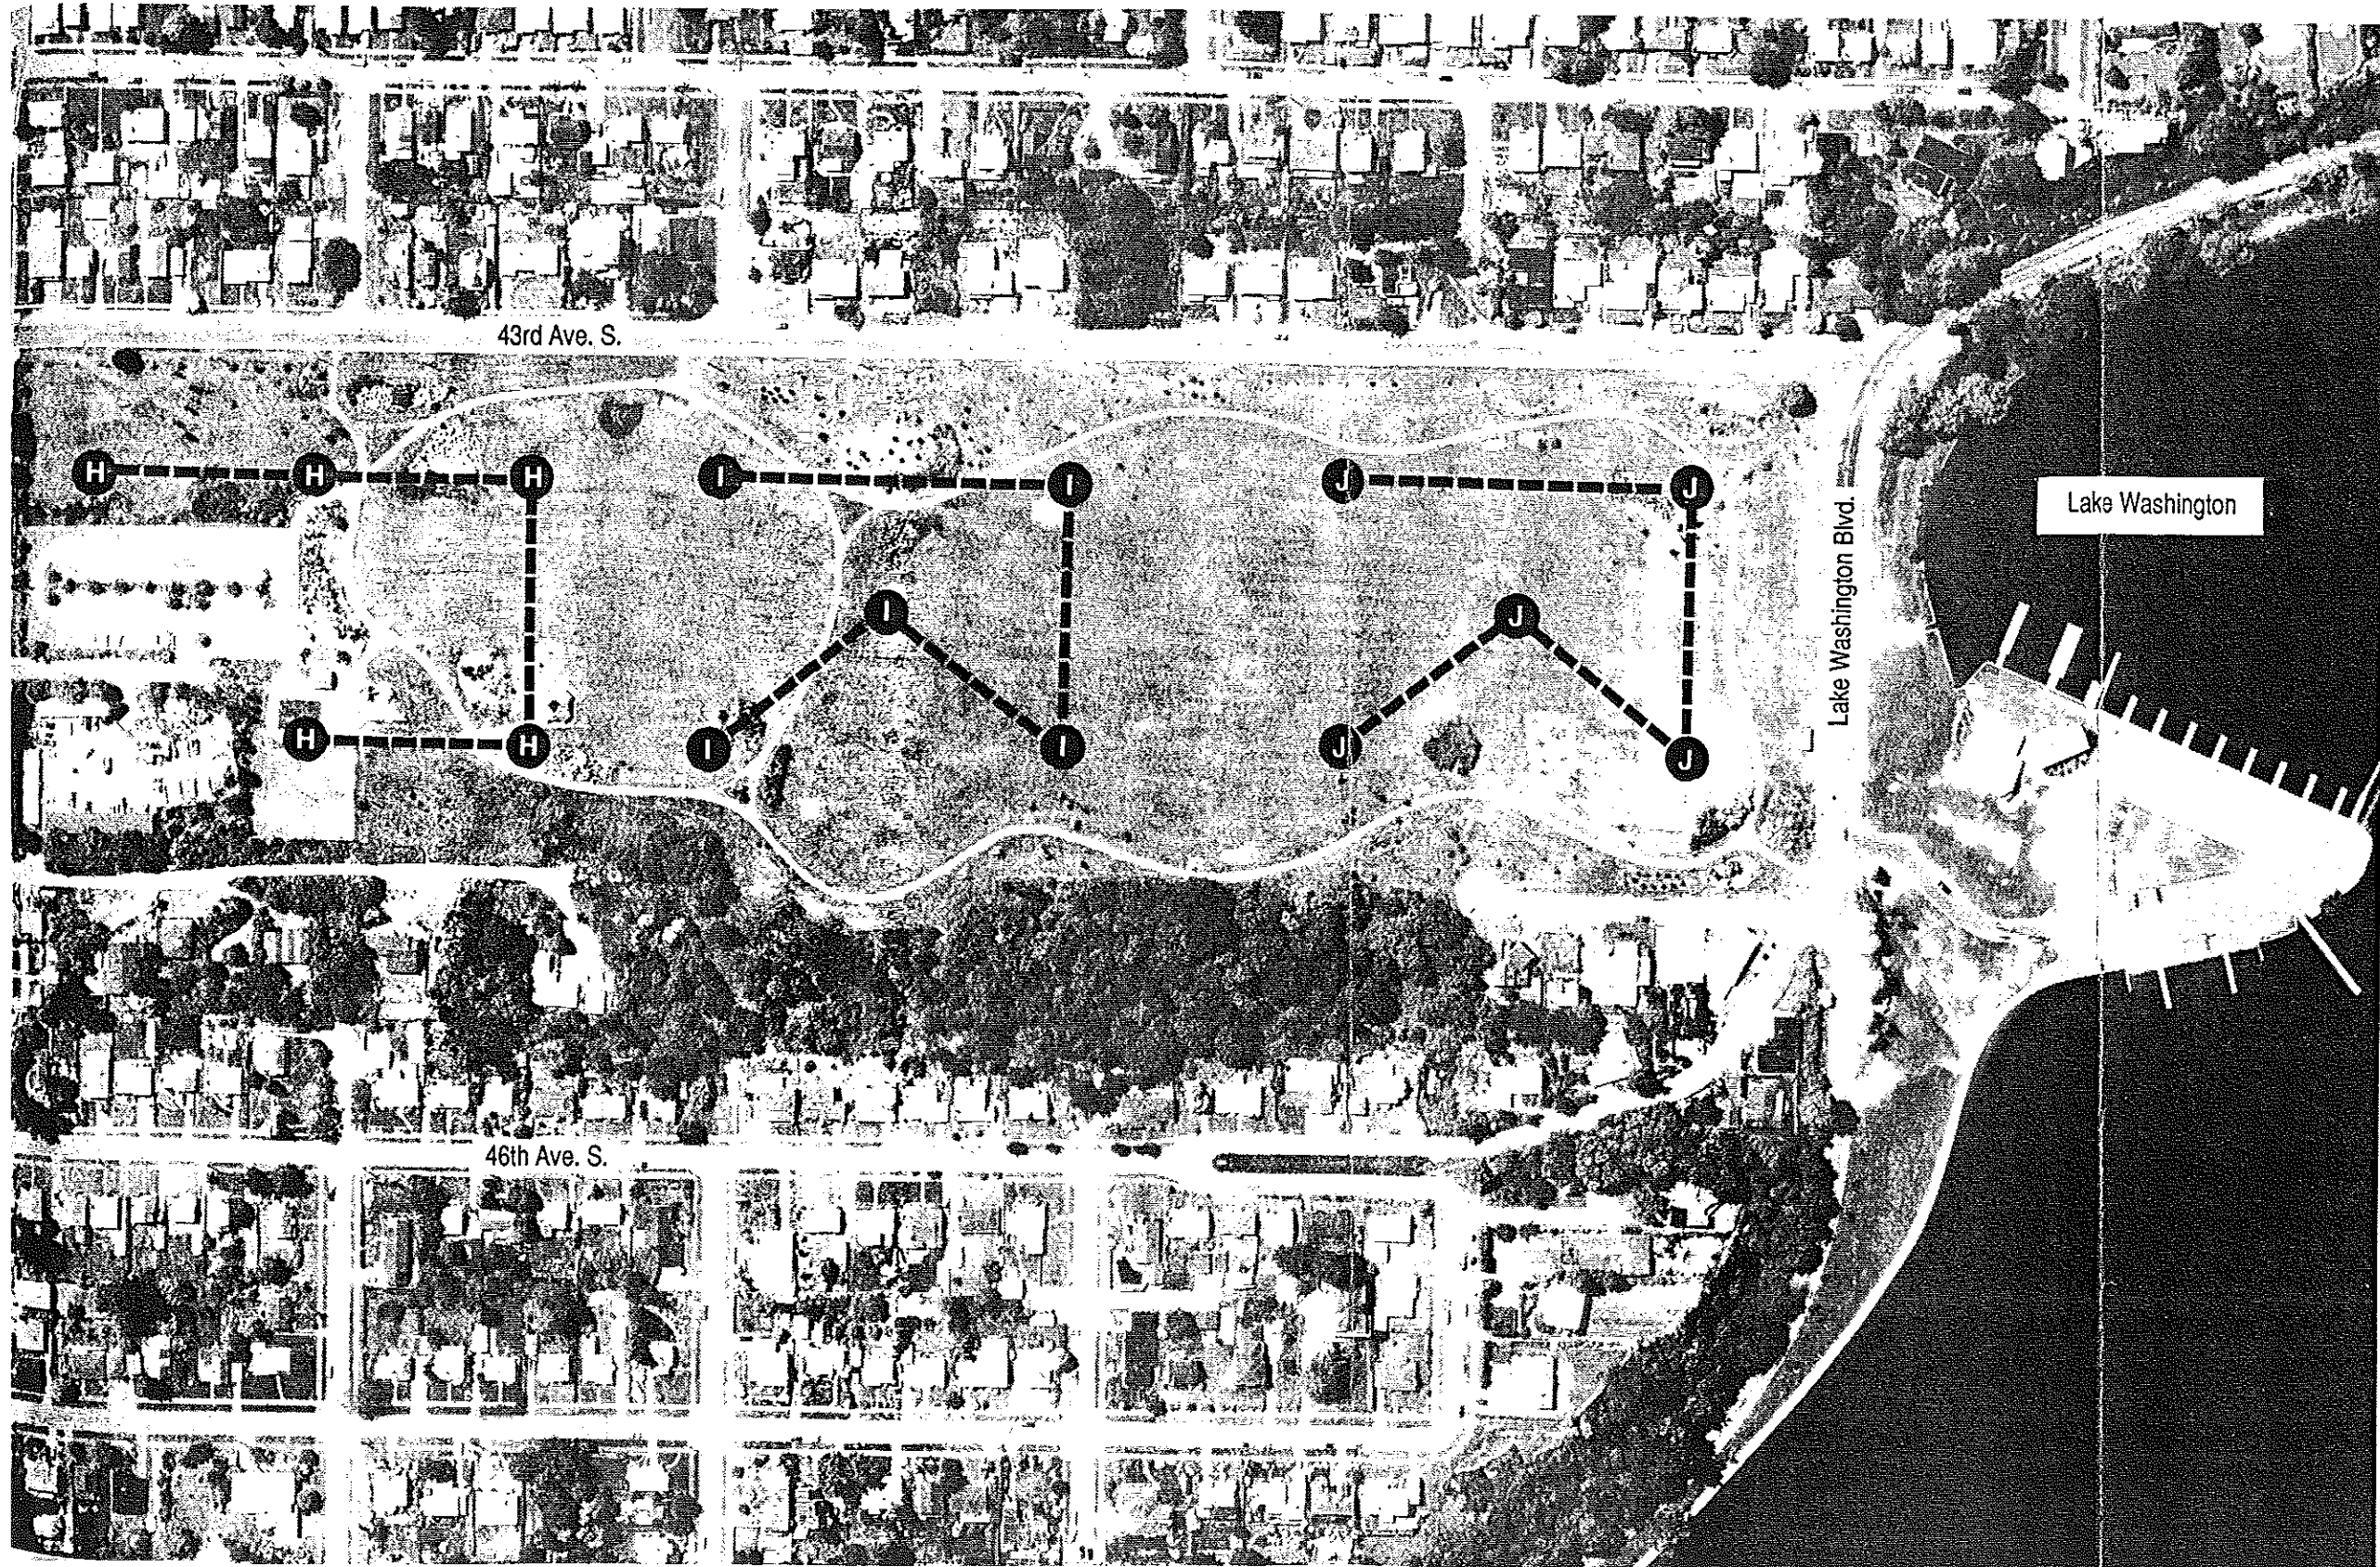
FIGURE 6

Of note, ground fissures and zones of dead vegetation presumably caused by venting landfill gas were observed within the area bordered by 46th Avenue South. One discrete sample (Site G) was retrieved from a fissure for analysis, but did not indicate a toxicity problem. Landfill odors were evident during the sampling at this location.

A strong landfill off-odor was observed within the top two inches of surface soil (gray clay) in the west sub-sample of Site E indicating a poor cover at that point.

A rust colored stain was observed across the paved walkway at Site C. A soil sample was retrieved on the downslope side of the walkway which did not indicate evidence of toxic components or toxicity from the test results.

**Genesee Park
Abandoned
Landfill
(North Section)**

Surface Soil Sampling
Locations

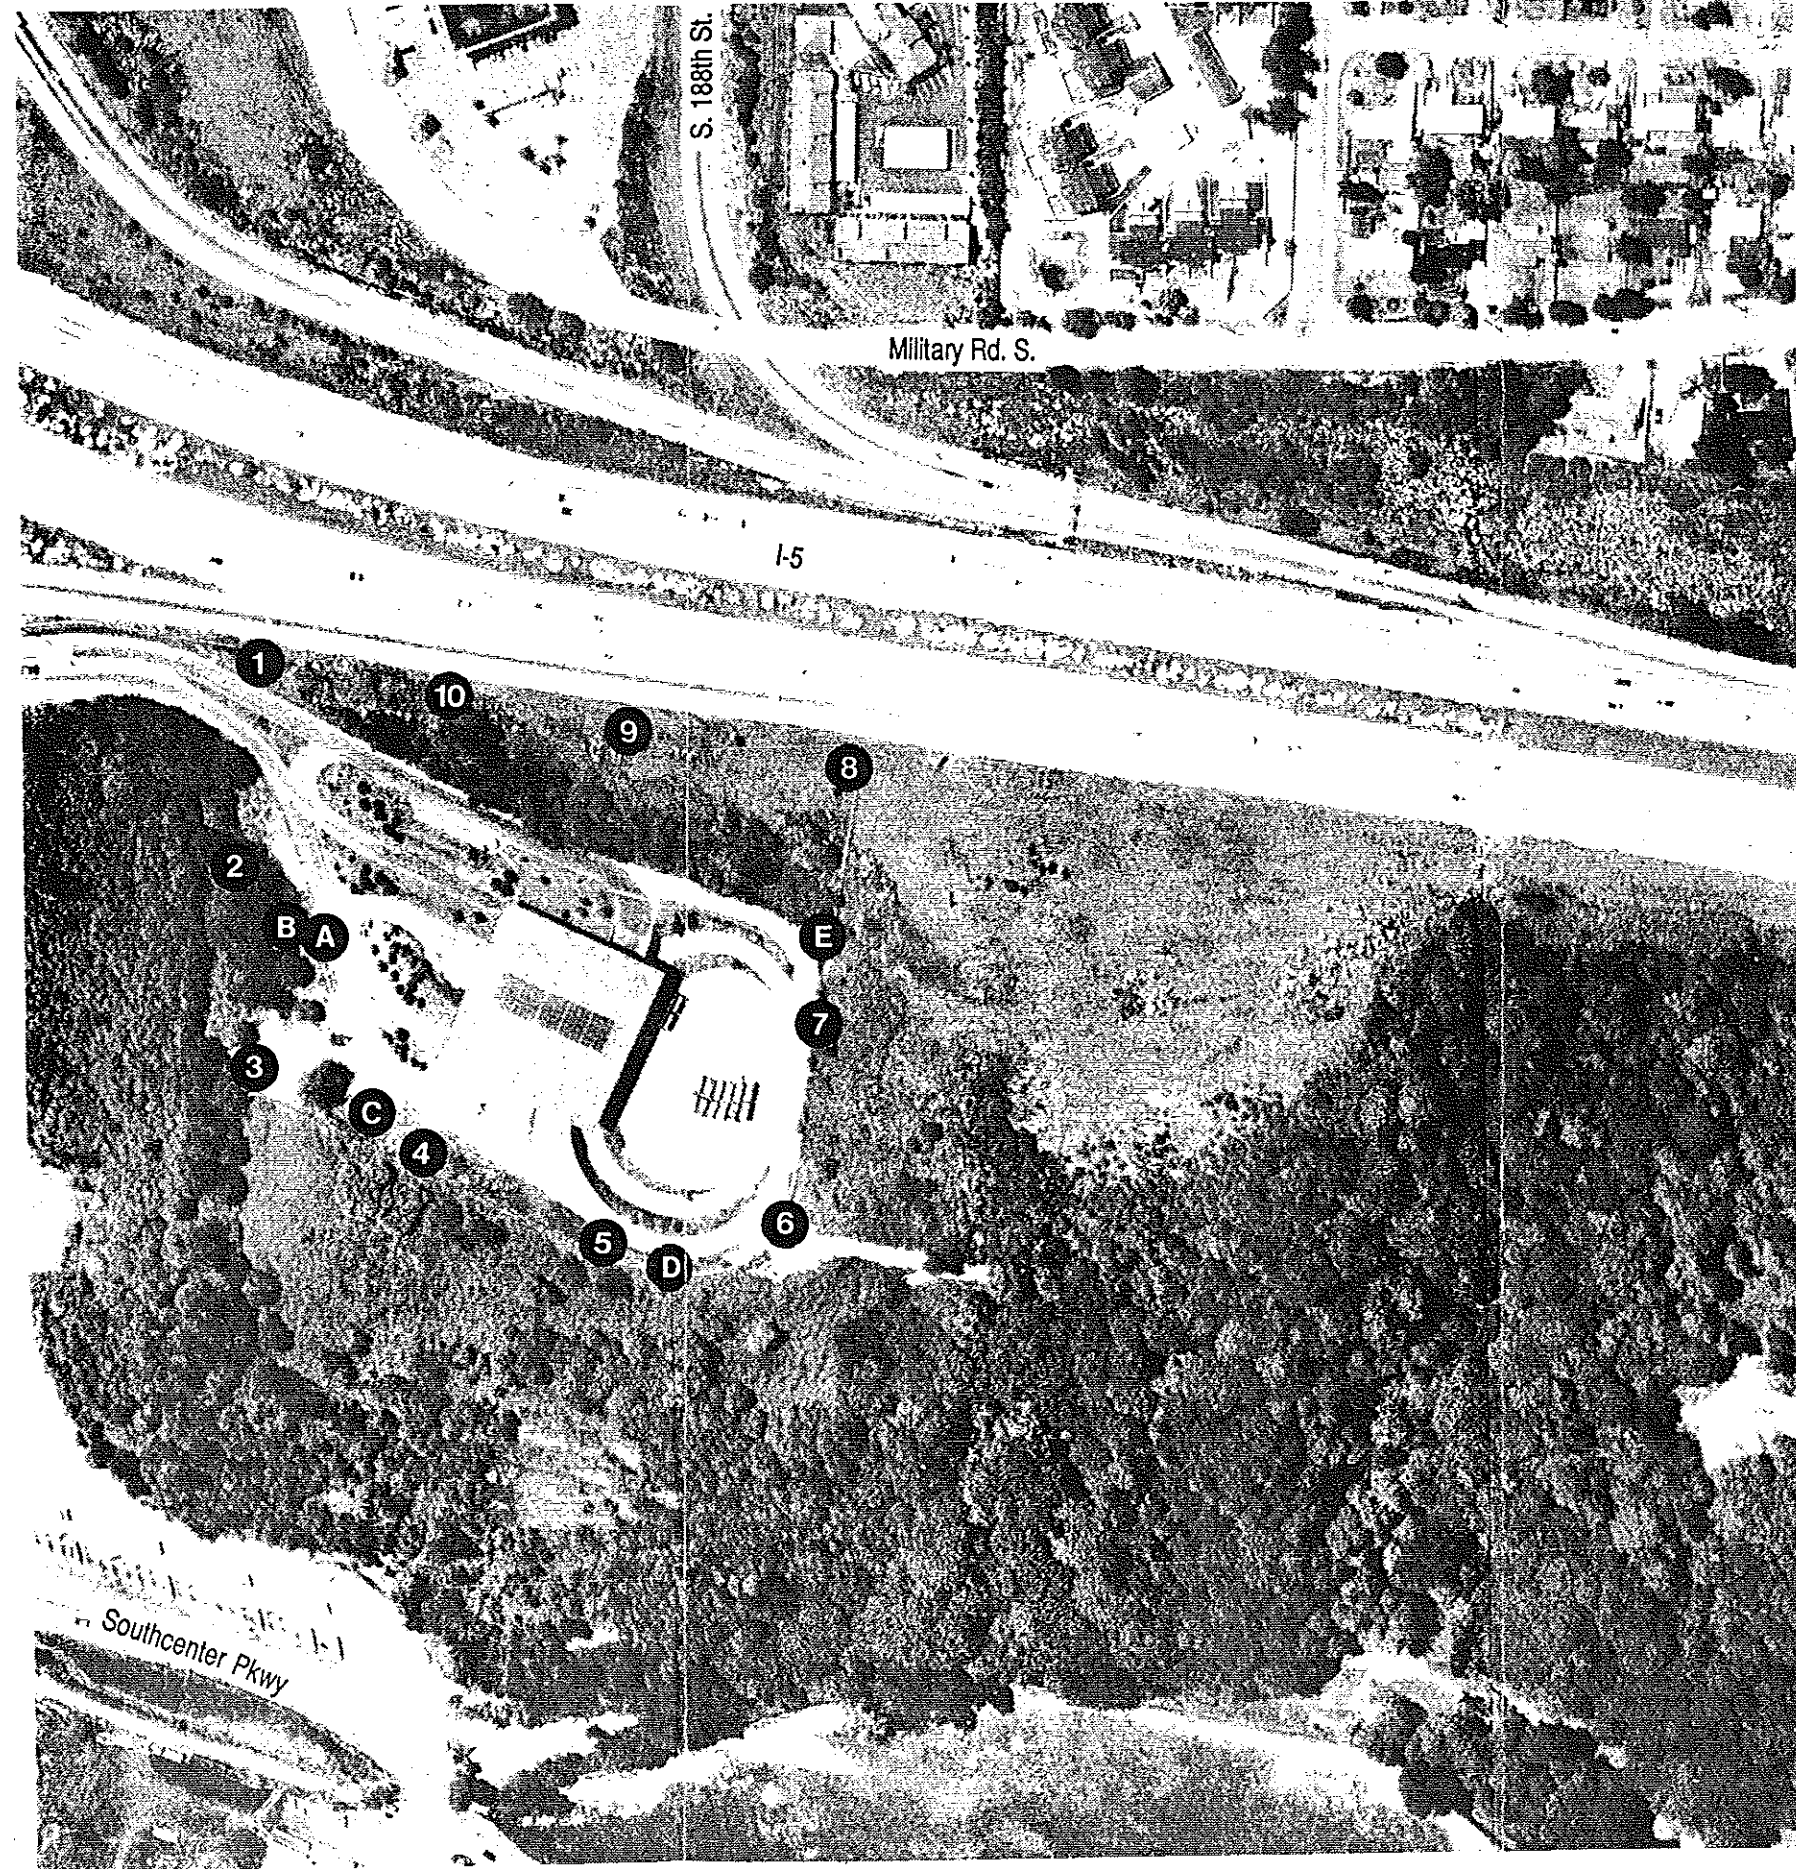
FIGURE 12

-
- (1) Sampled October 5, 1986
(2) Data reported as methane equivalent values
(3) Refer to Figure 12.

Bow Lake Abandoned Landfill

Landfill Gas Sampling
Locations
