SEATTLE-KING COUNTY ABANDONED LANDFILL
TOXICITY/HAZARD ASSESSMENT PROJECT

DECEMBER 31, 1986

PREPARED BY WAYNE L. TURNBERG
SEATTLE-KING COUNTY DEPARTMENT OF PUBLIC HEALTH

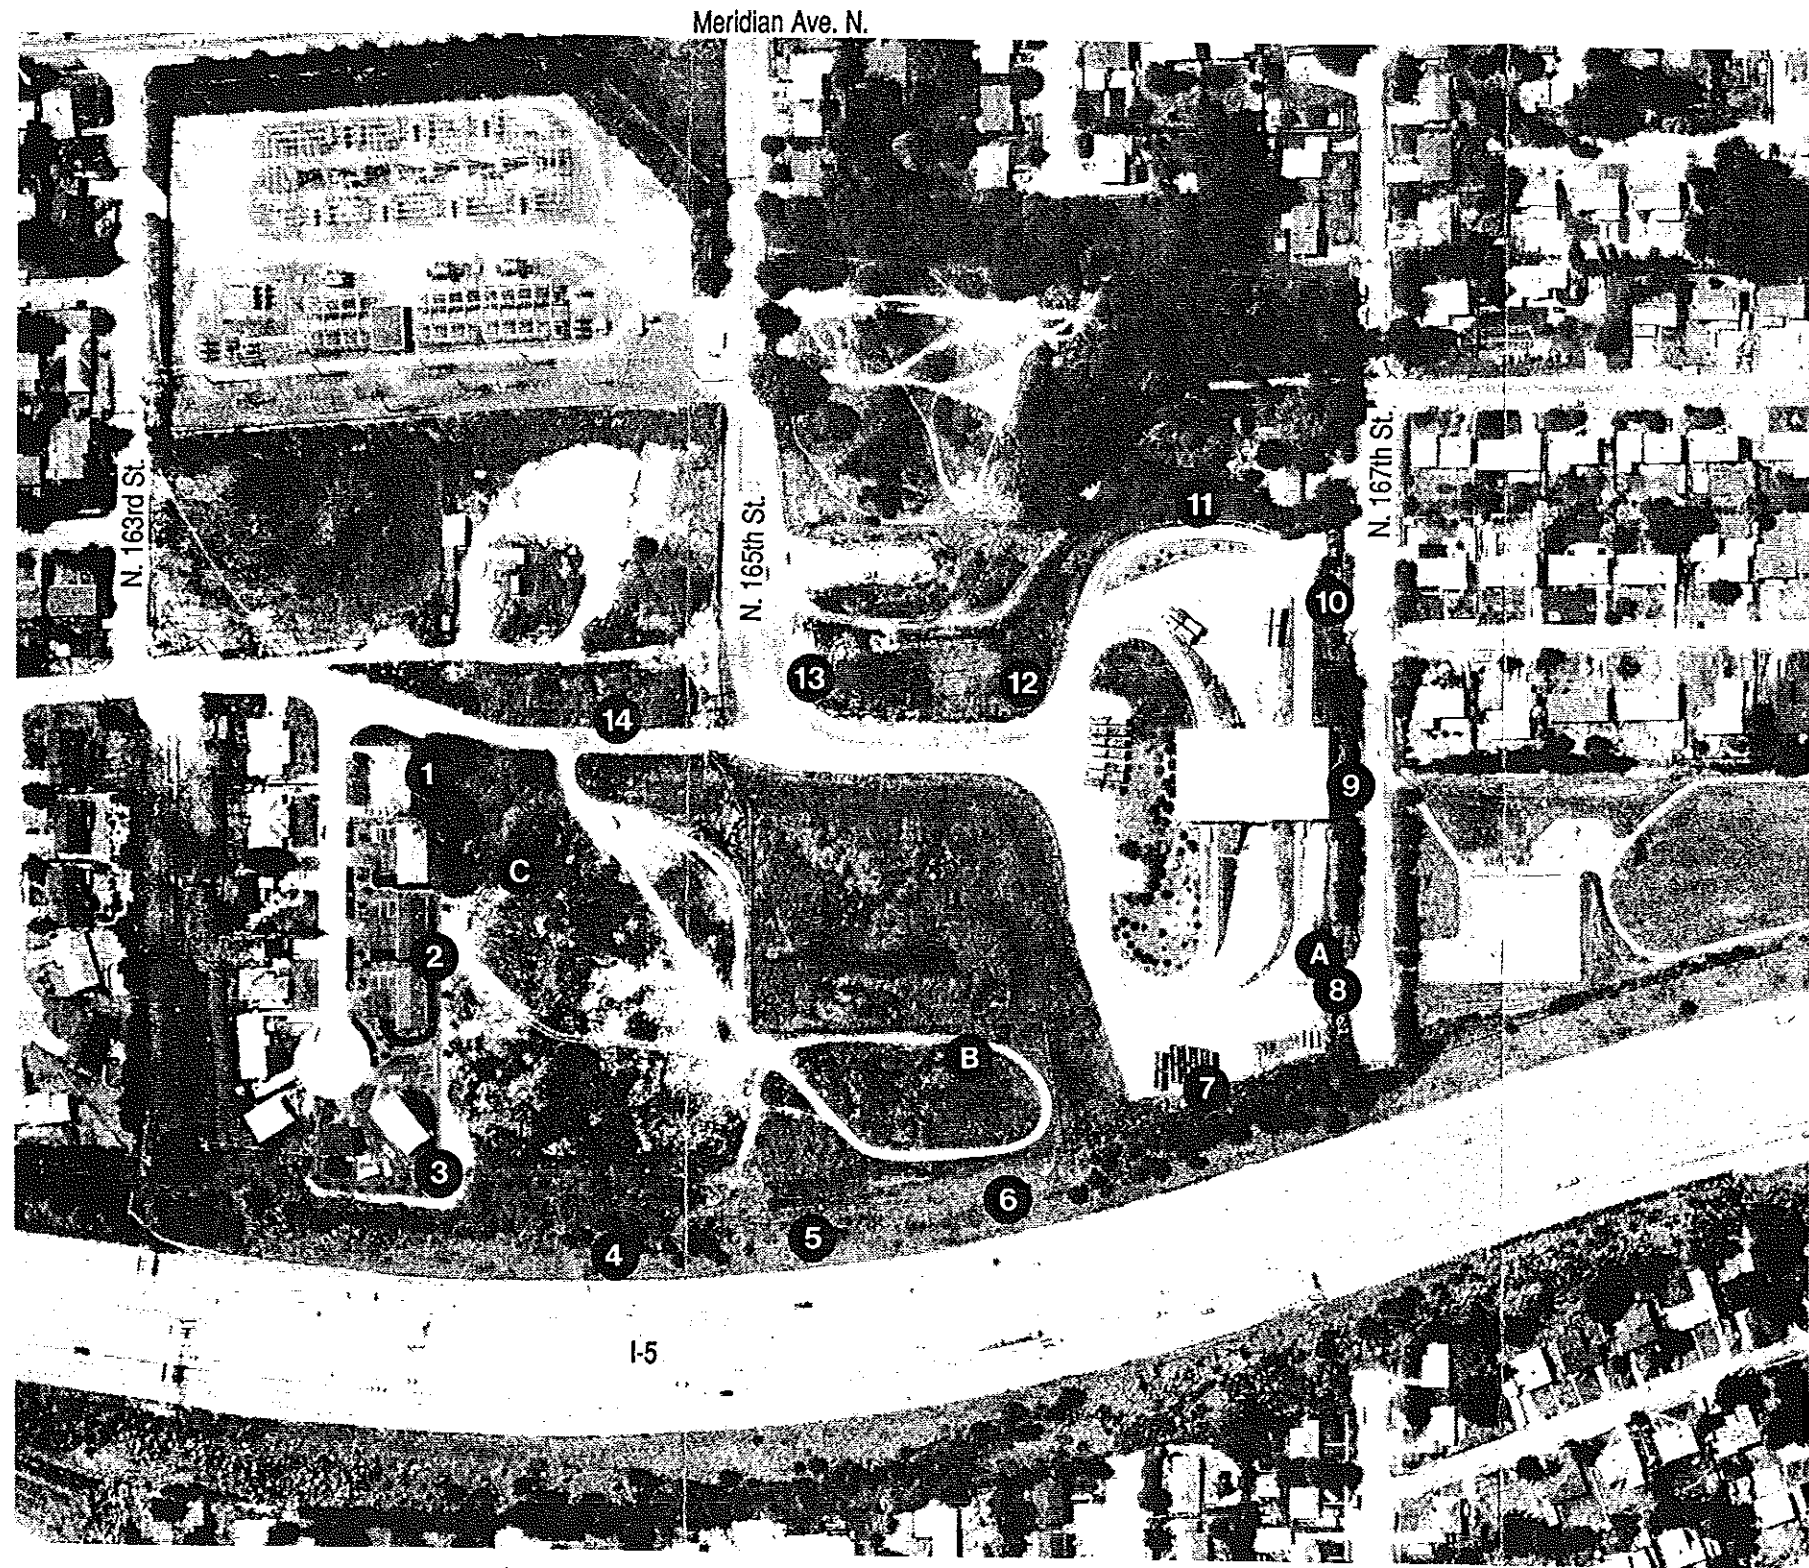
FIGURE 13

- (1) Sampled October 8, 1986.
 (2) Data reported as methane equivalent values.
 (3) Refer to Figure 13.

Corliss Abandoned Landfill

Landfill Gas Sampling Locations

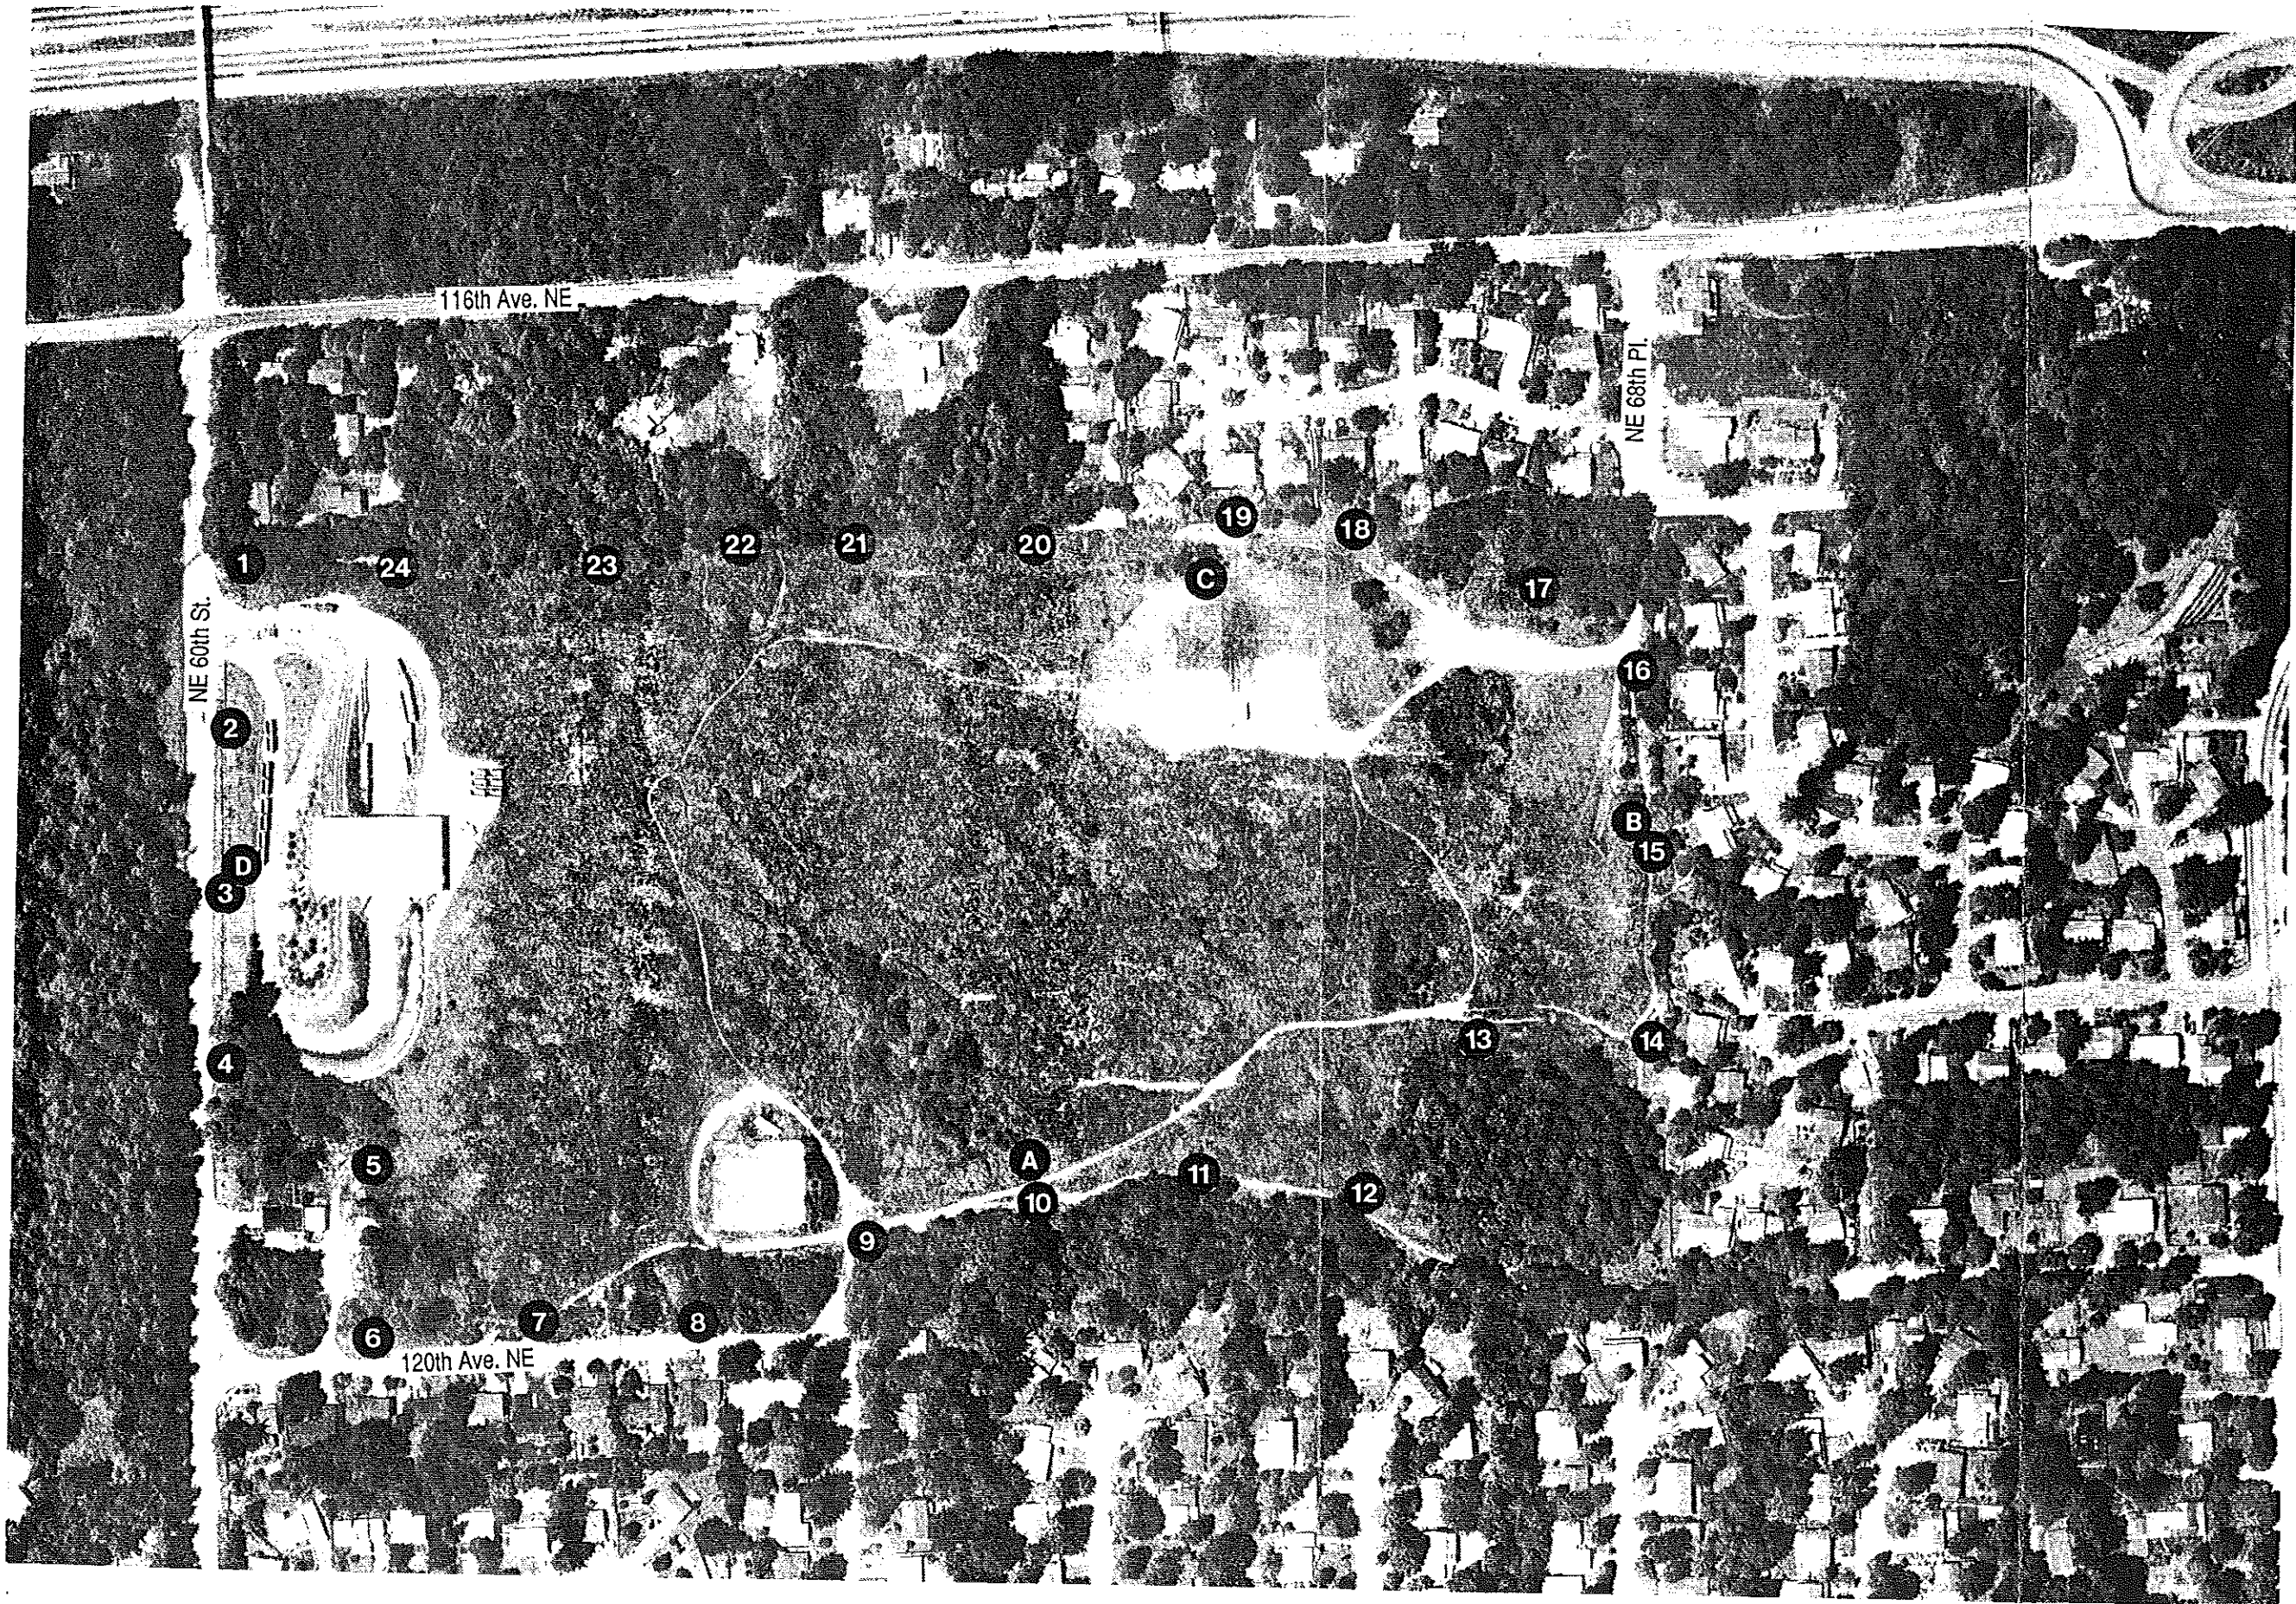
FIGURE 14

- (1) Sampled October 9, 1986.
(2) Data reported as methane equivalent values.
(3) Refer to Figure 14.

Houghton Abandoned Landfill

Landfill Gas Sampling Locations

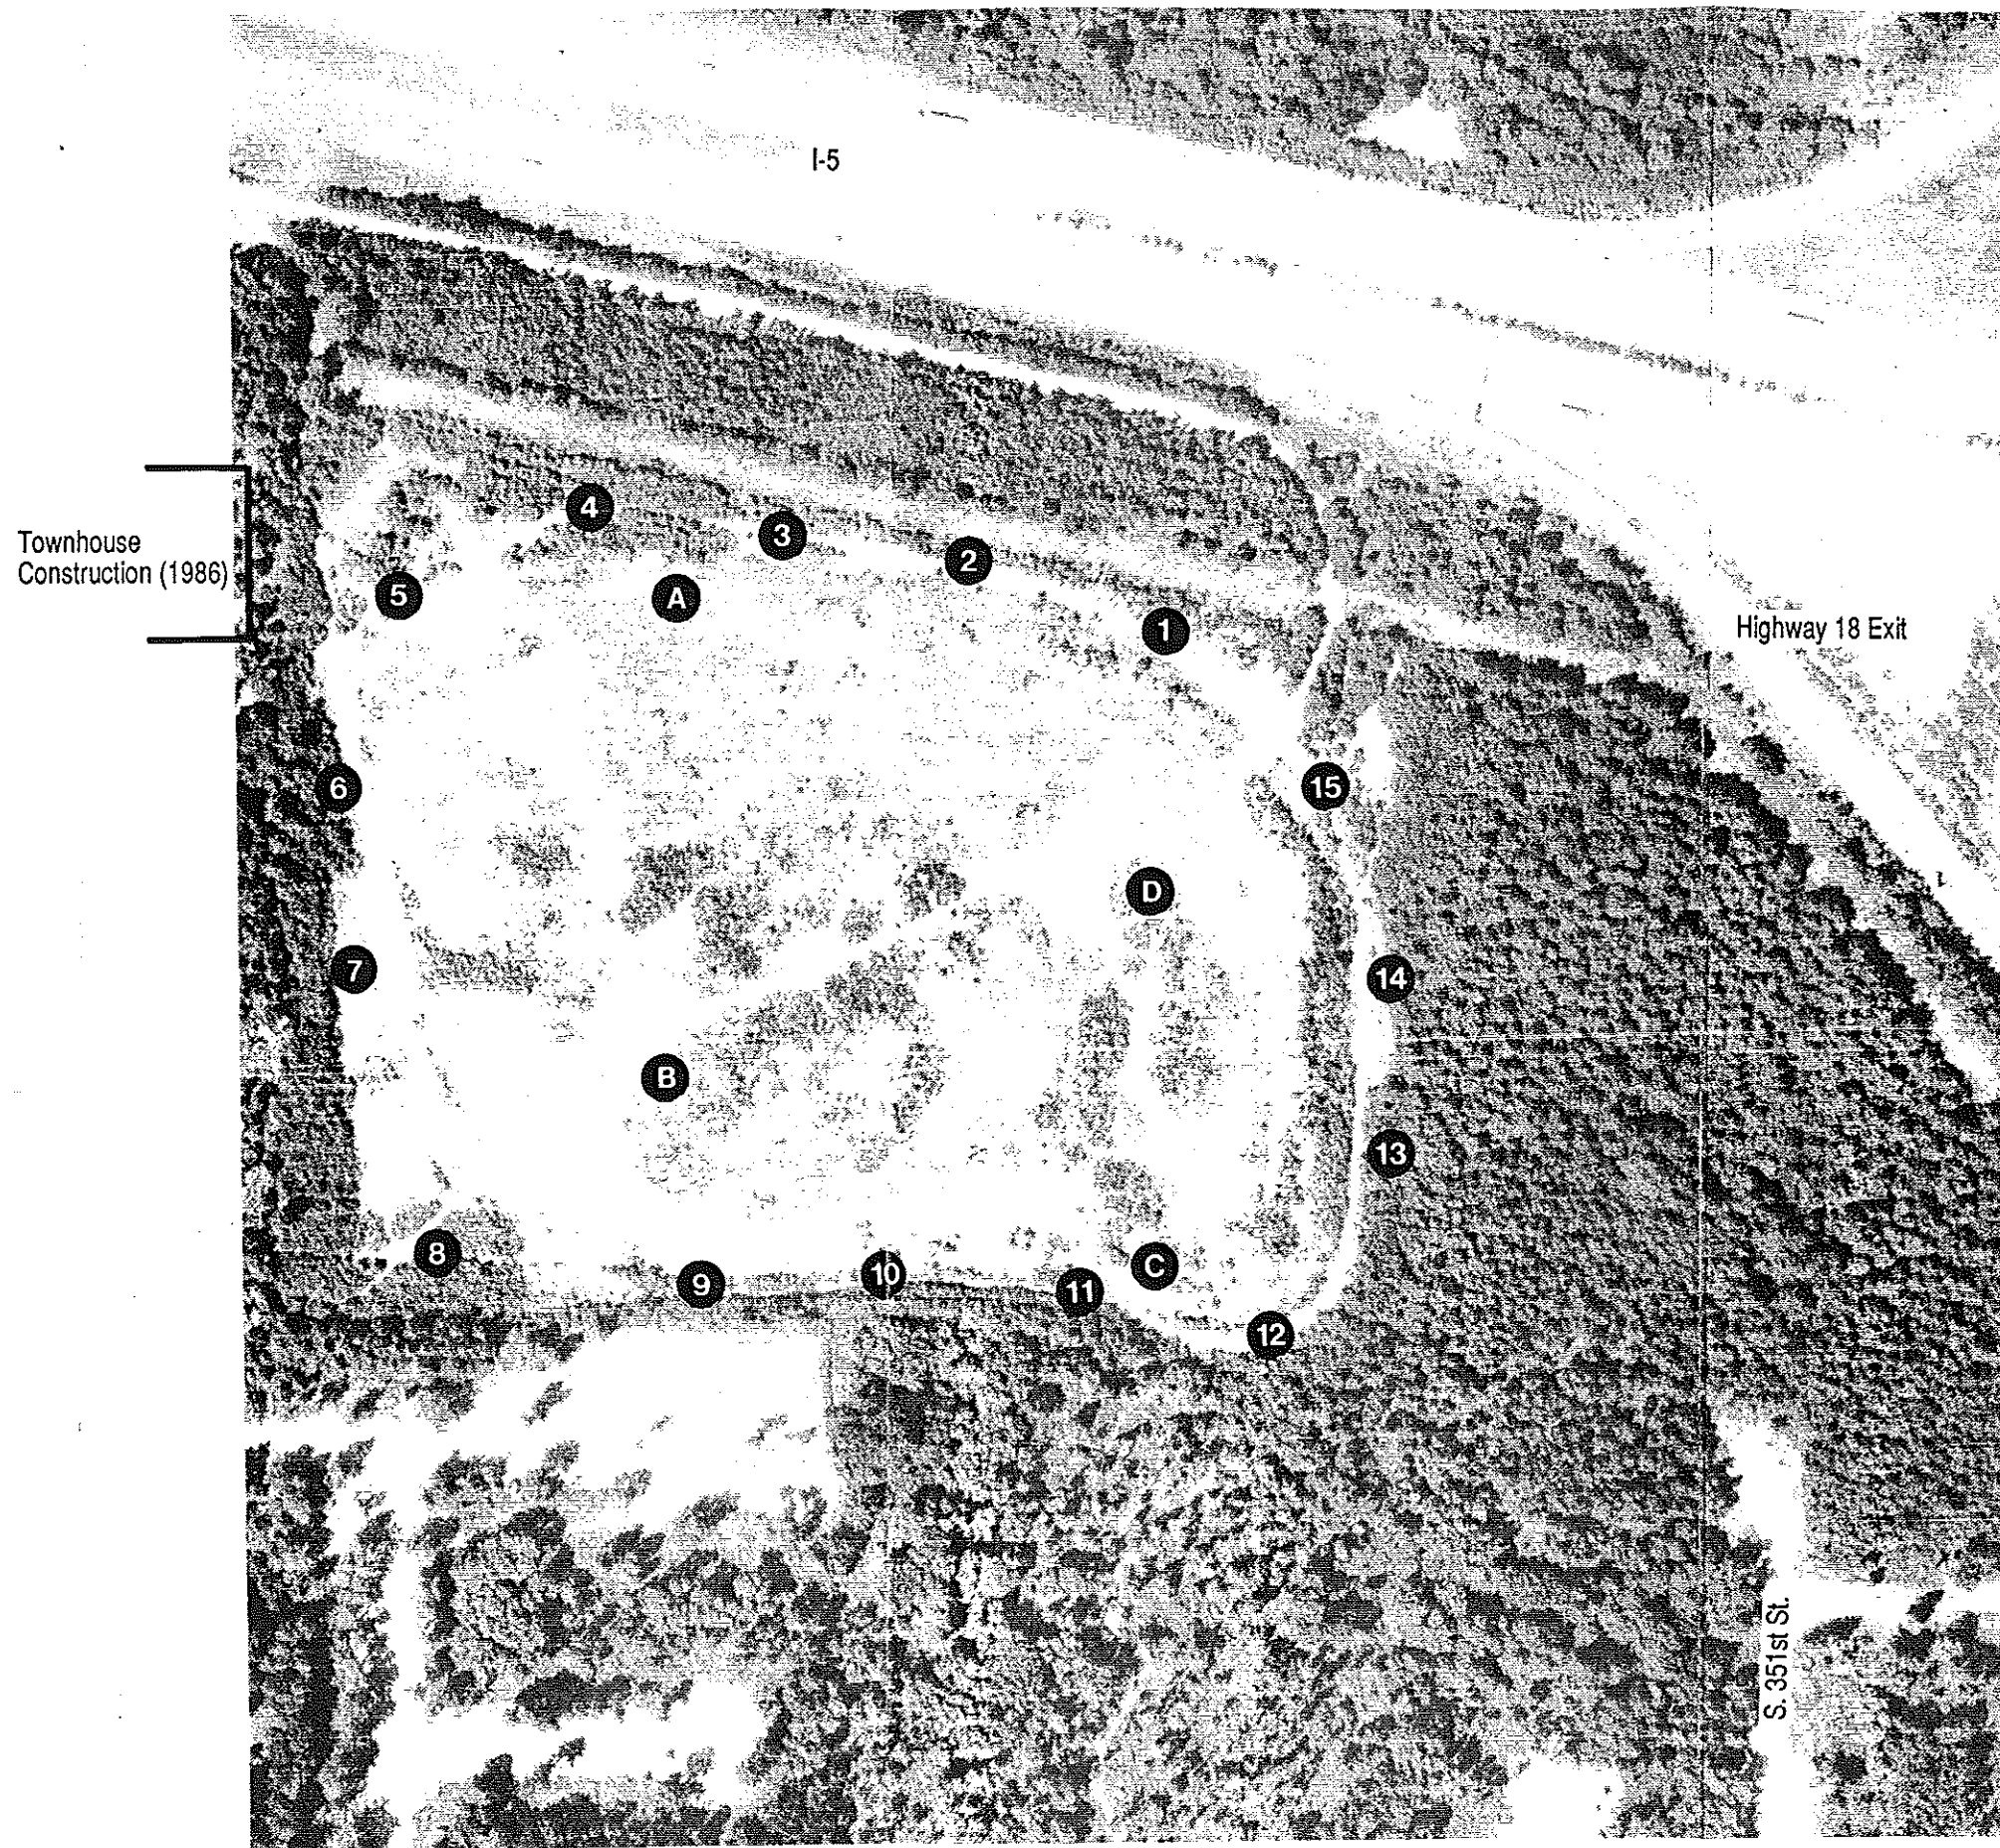
FIGURE 15

- (1) Sampled October 7, 1986.
(2) Data reported as methane equivalent values.
(3) Refer to Figure 15.

Puyallup/Kit Corner Abandoned Landfill

Landfill Gas Sampling Locations

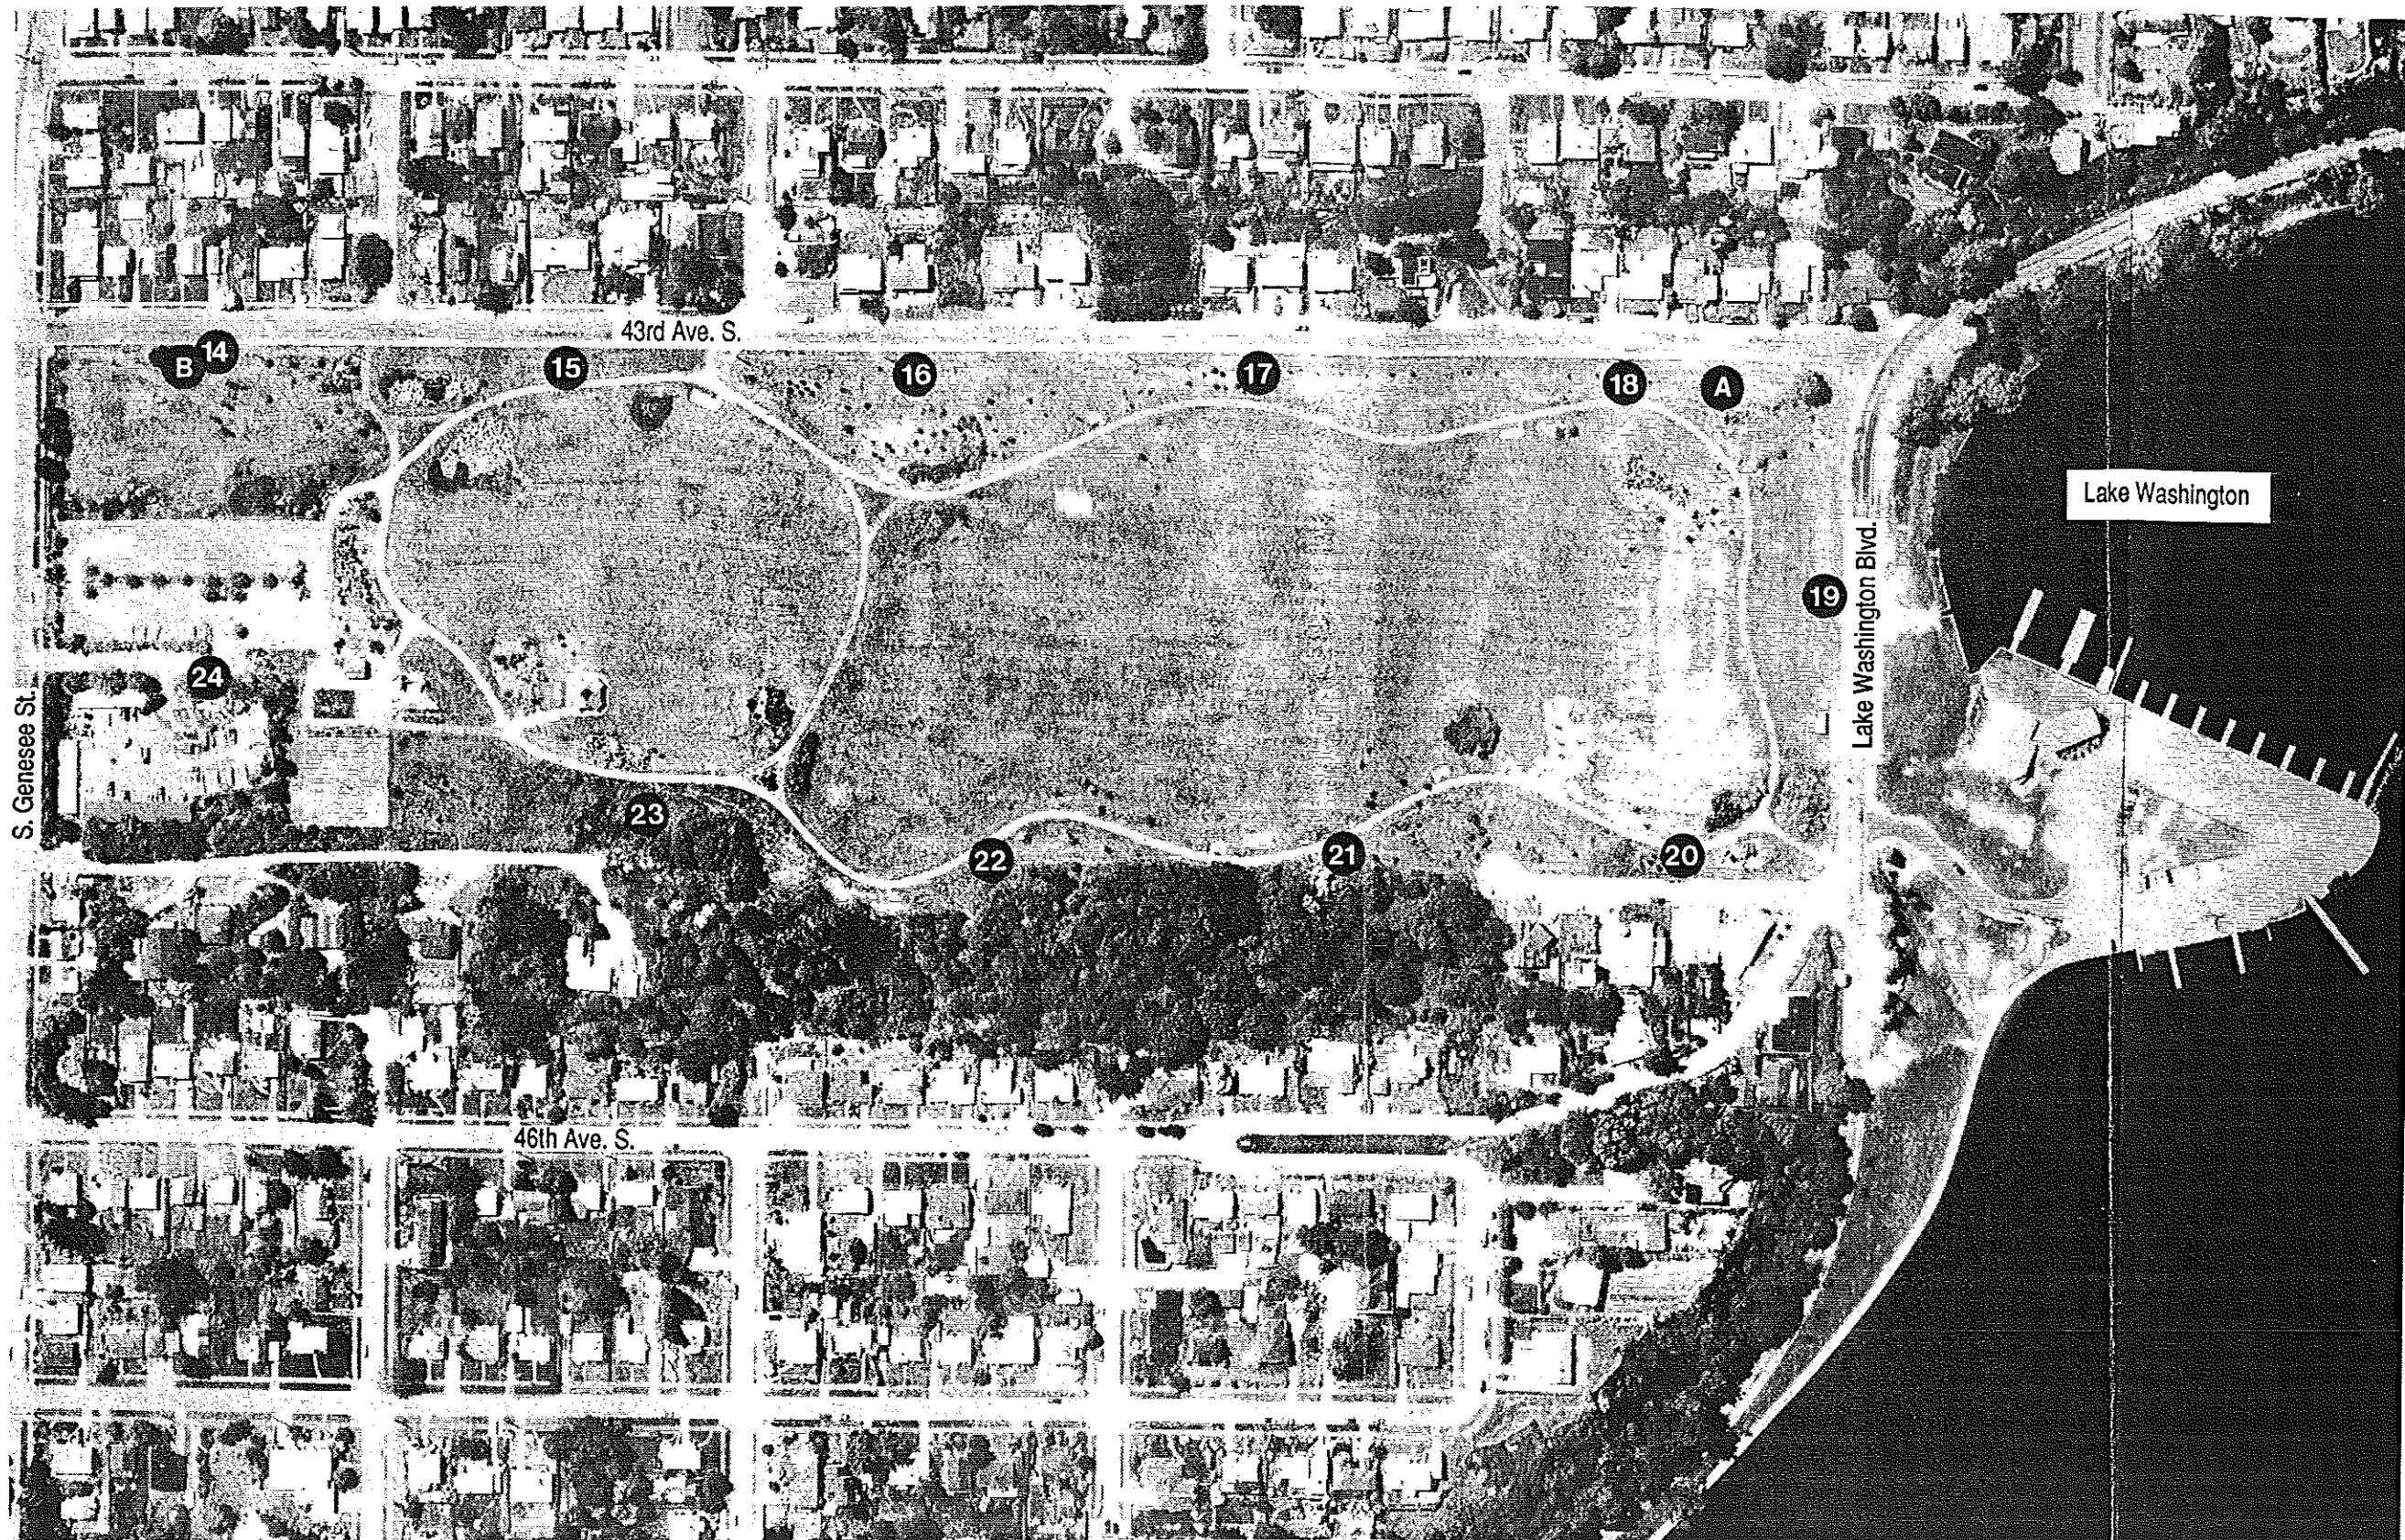
FIGURE 16

-
- (1) Sampled October 14, 1986.
 (2) Data reported as methane equivalent values.
 (3) Refer to Figure 16.
 (4) Refer to Figure 17.

**Genesee Park
Abandoned
Landfill
(North Section)**

Landfill Gas Sampling
Locations

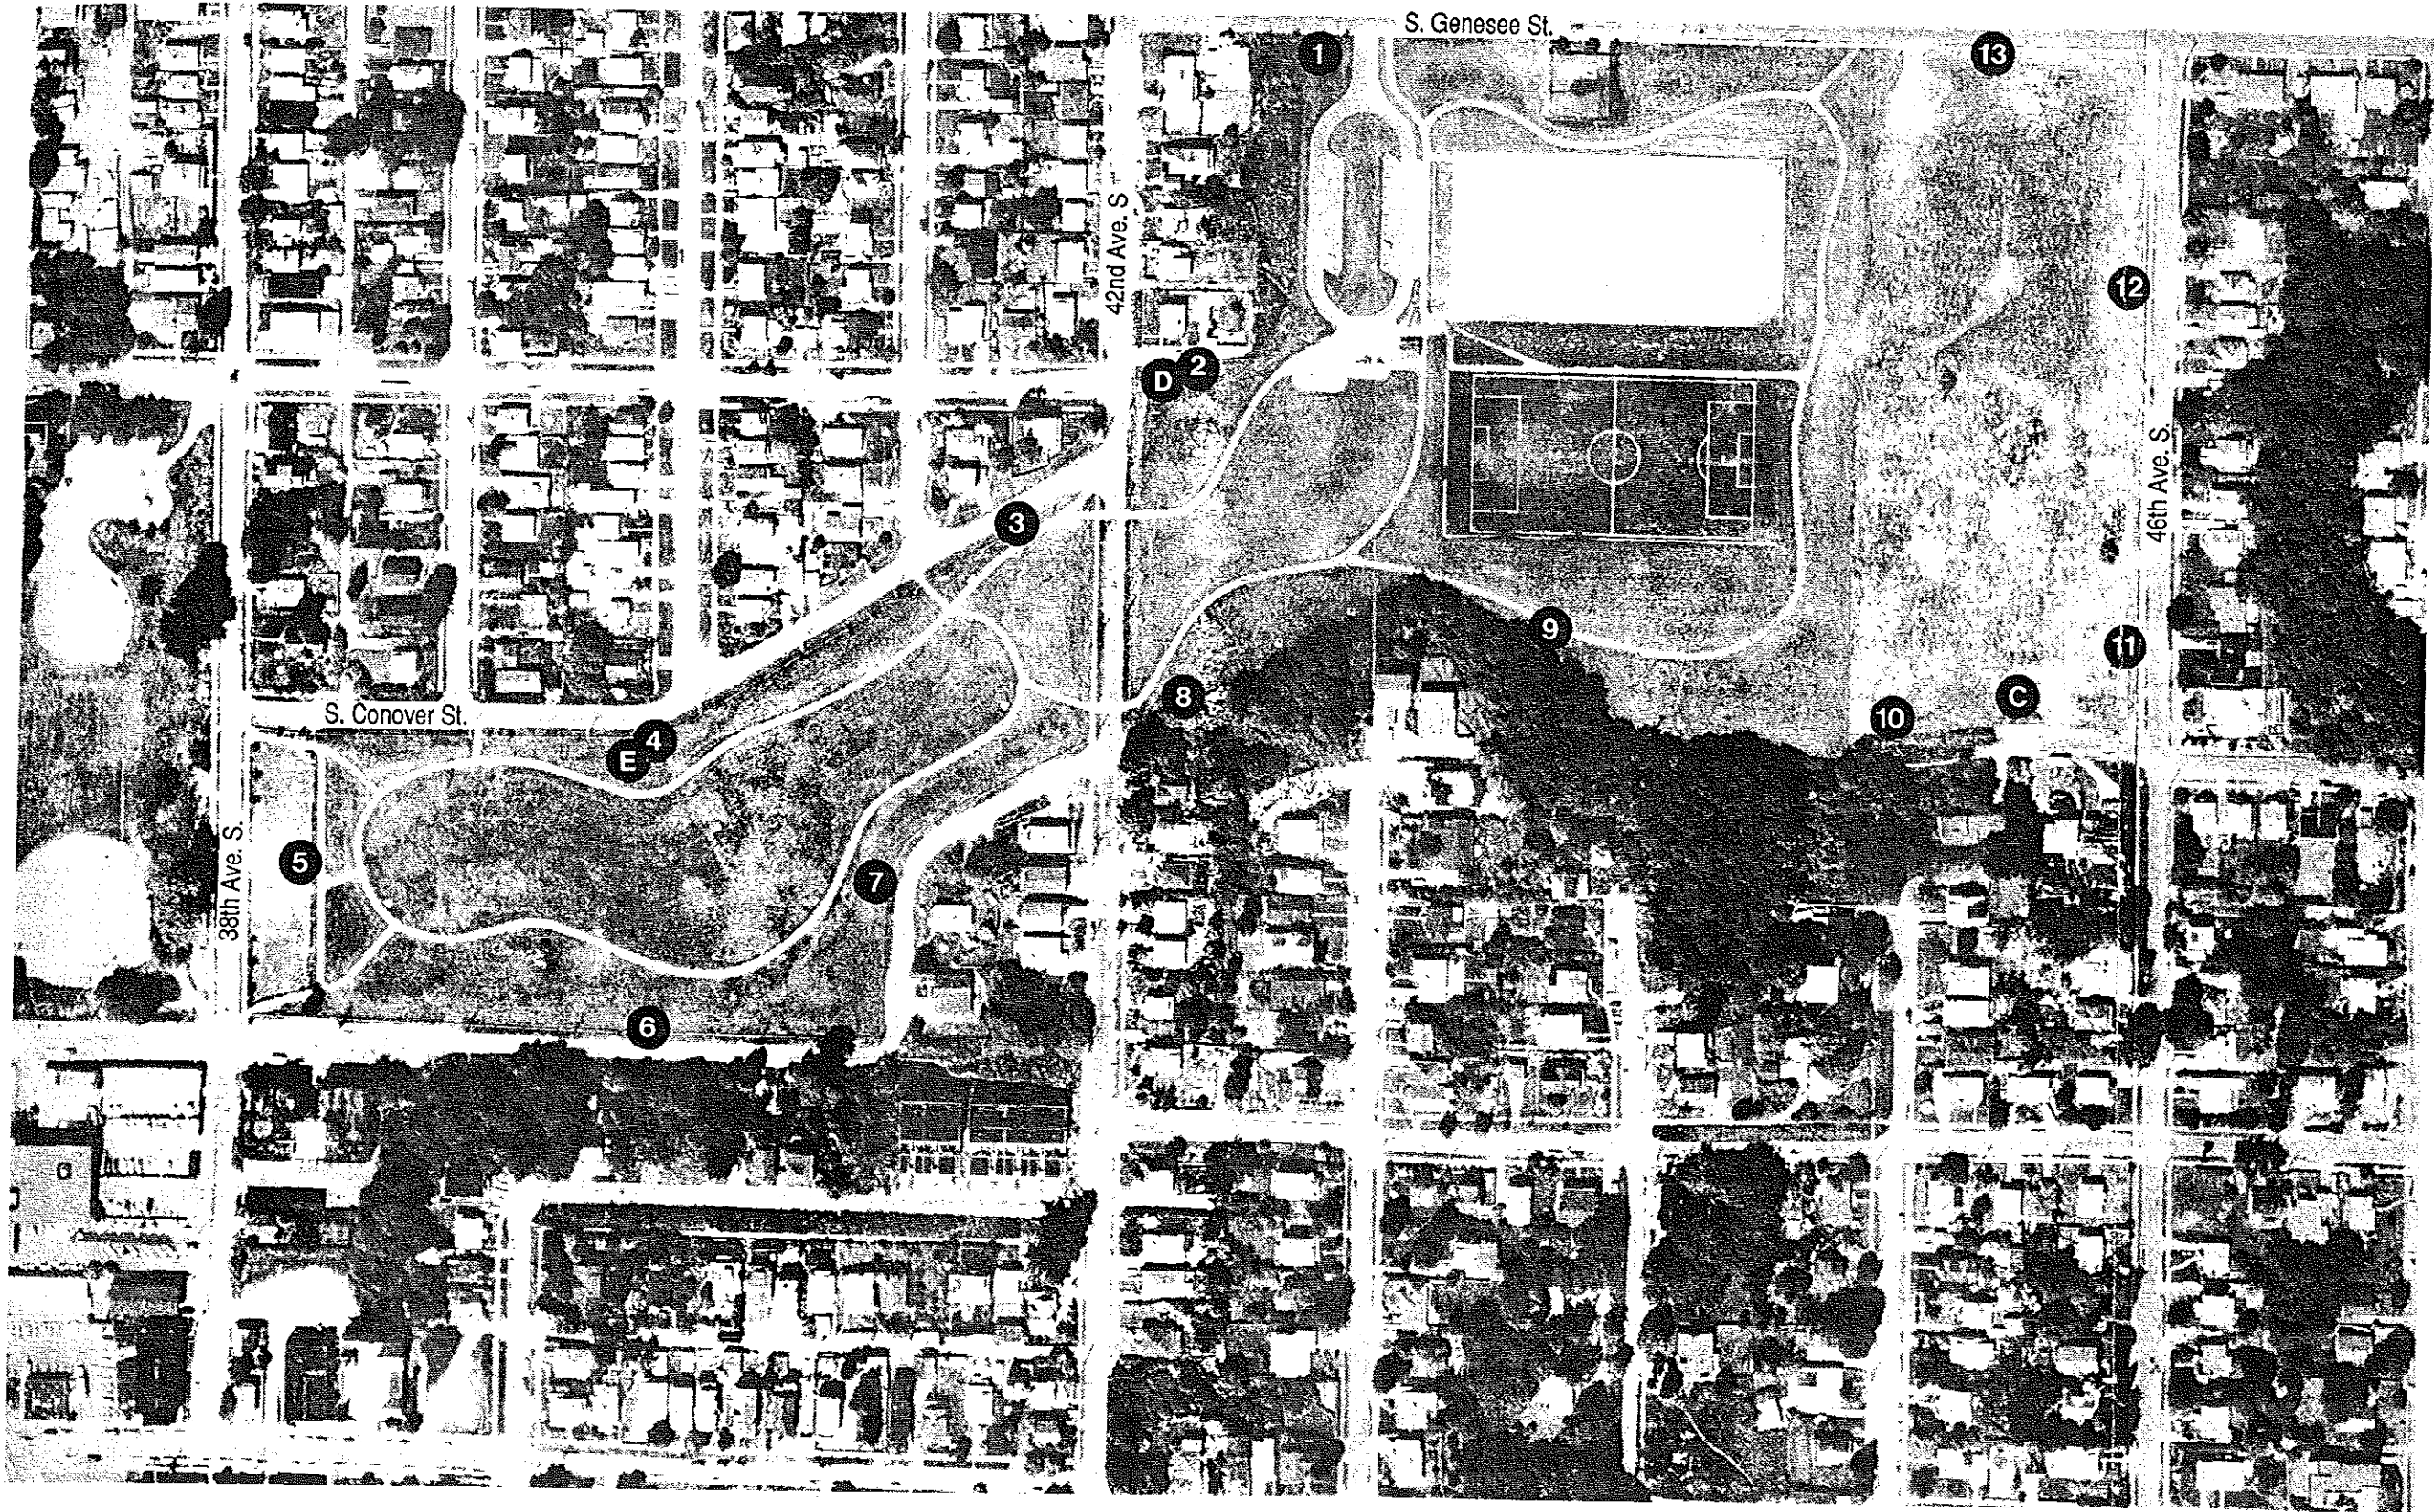
FIGURE 17

**Genesee Park
Abandoned
Landfill
(South Section)**

Landfill Gas Sampling
Locations
