Remedial Action Report Petroleum-Contaminated Soils

**212 South 3rd Street
Renton, Washington**

January 30, 2015

Project Number: 90001

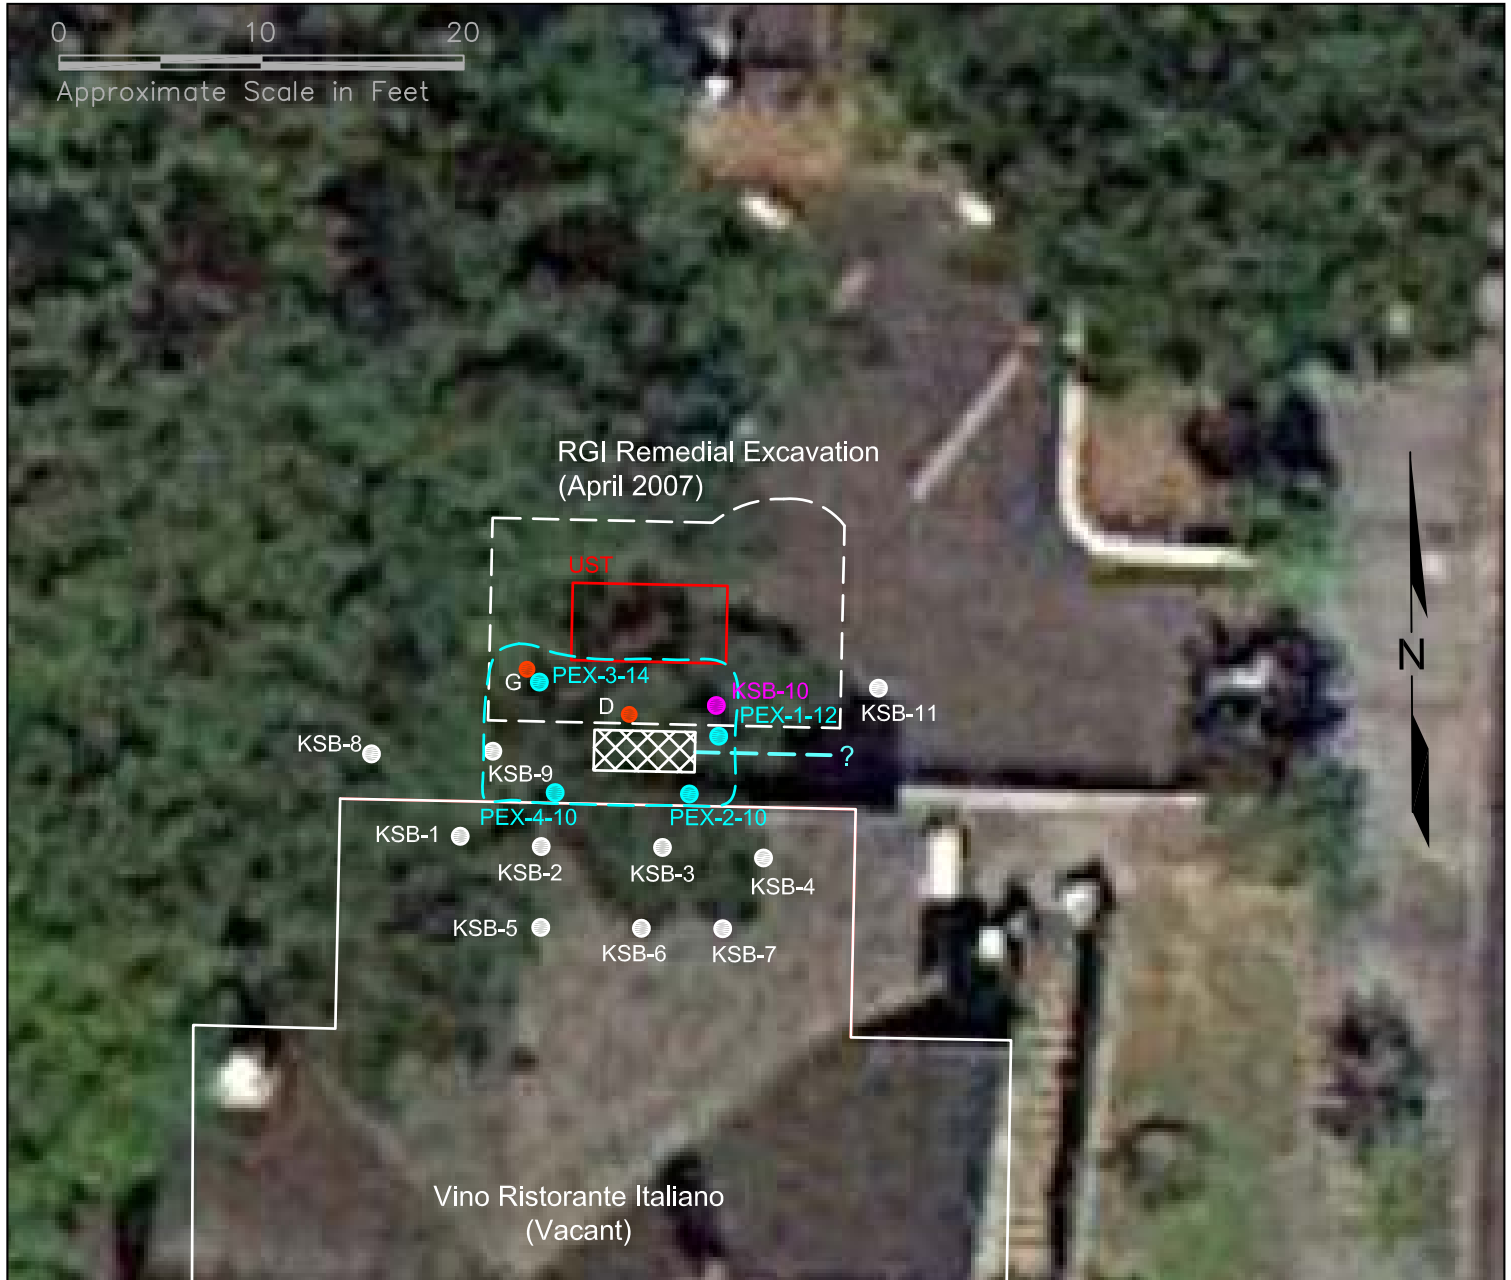
Figure 2
Site Plan and Soil Sampling Locations

Kane Environmental collected four post-excavation soil samples from the excavation sidewall and base (Figure 2). Petroleum hydrocarbons were not detected at laboratory reporting limits in any of the soil samples (Table 1). Laboratory analytical reports are included as Attachment A.

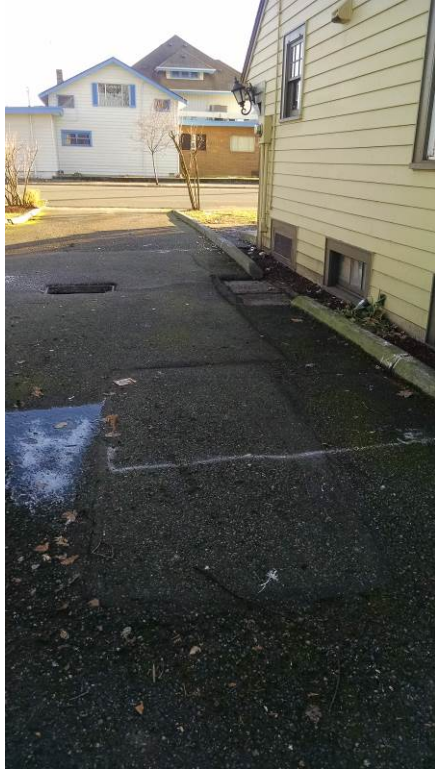
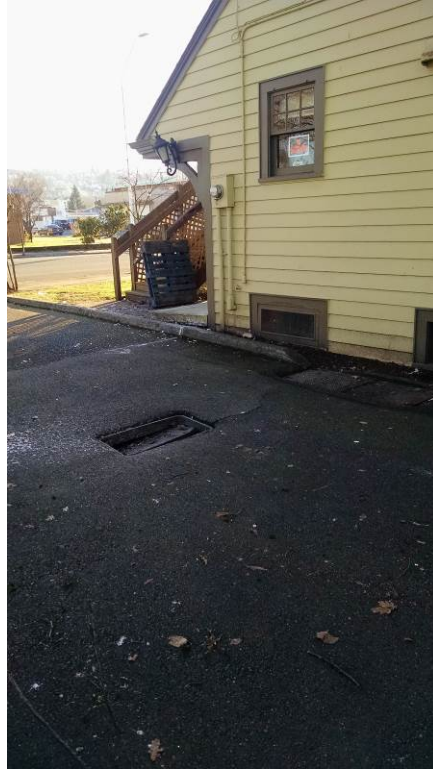
Photographs 1&2 – Area of remedial excavation prior to asphalt removal. Approximate planned extent of excavation marked on pavement. Utility cover protects 4-inch monitoring/dewatering well installed by Riley (2007).

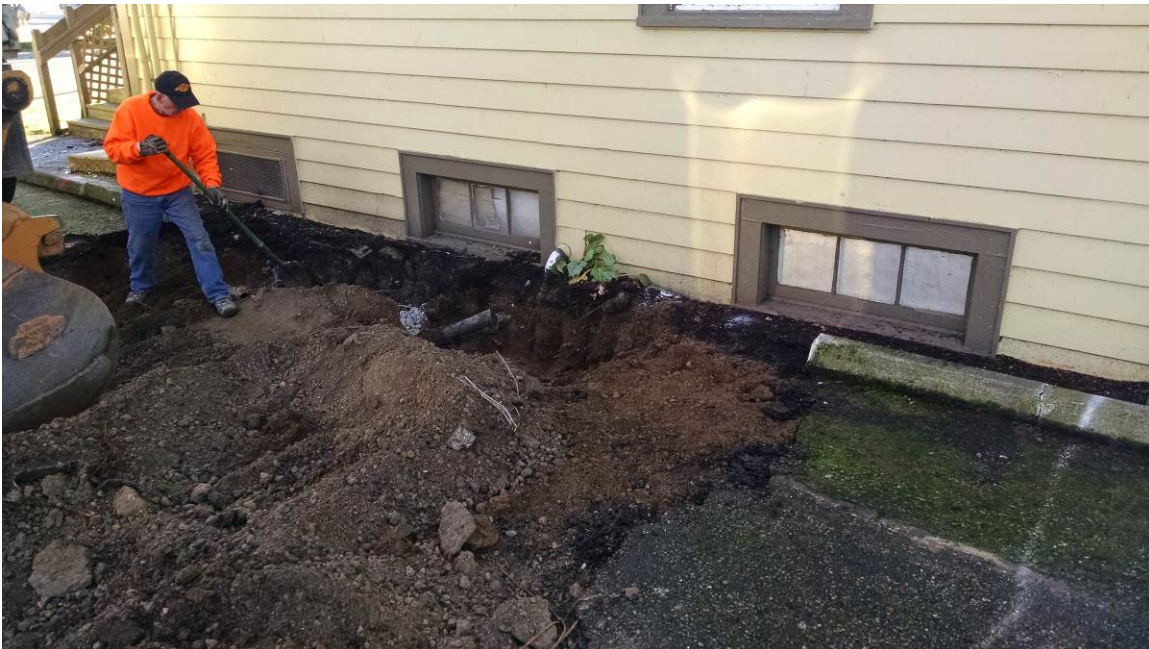
Photograph 3 – Removal of asphalt and grease trap. Grease trap/sewer piping visible by building foundation.

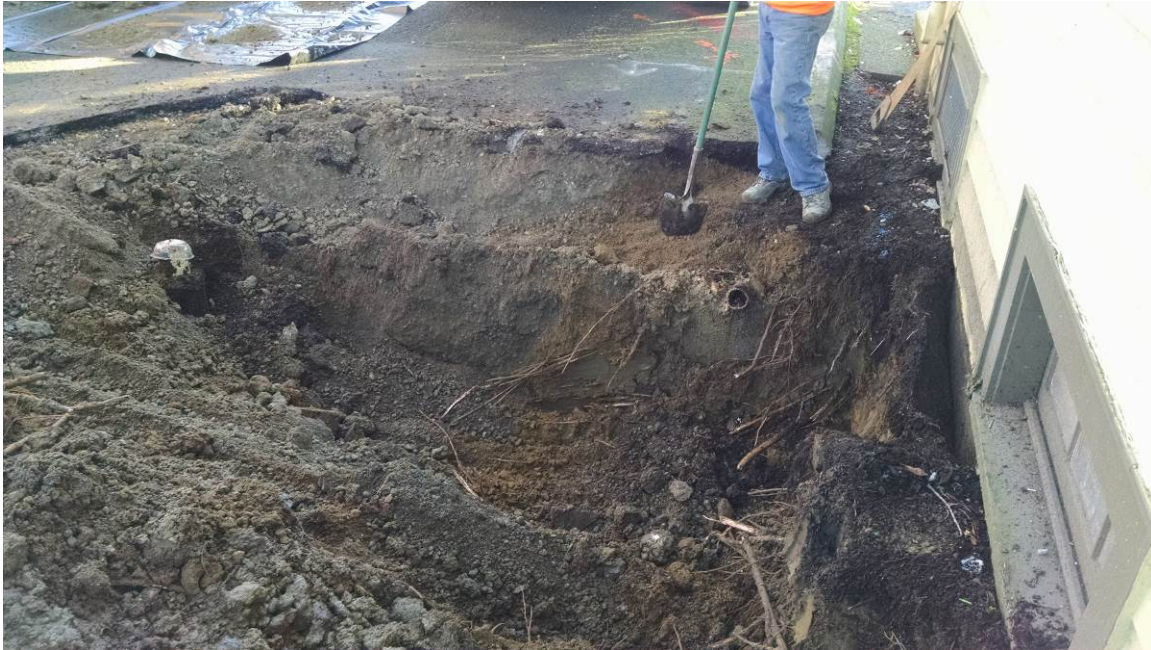
Photograph 4 – Beginning excavation at east 'cell.' Surficial soils and 2007 backfill removed and segregated. 4-inch PVC well casing visible to left of photograph.

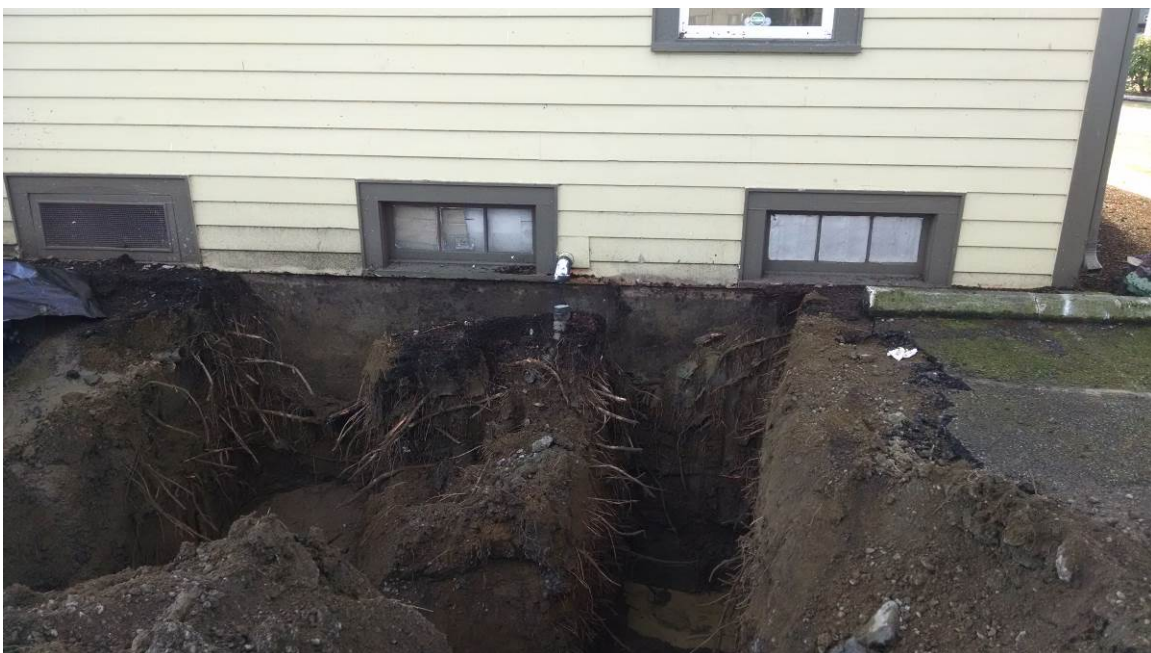
Photograph 5 – East and west 'cells' after soil removal, with remnant center cell in place, January 13, 2015.

Petroleum-contaminated soils were excavated for off-site disposal. The soil excavation extended east-west consistent with the prior UST remedial soil excavation. The soil was removed by excavating two four-foot-wide 'cells' exposing the Property building foundation. After removal of the soils, the excavation was sampled and backfilled with controlled-density fill (CDF) to provide support to the remnant soils and building foundation. After the CDF had cured, the remaining central 'cell' of petroleum-contaminated soil was removed. Soils were excavated to 12 to 13 feet bgs, below observed perched groundwater seepage. The excavation vertical and horizontal extent was based on prior soil boring results and field screening at the time of excavation. The soil excavation removed soils associated with two soil samples exceeding MTCA cleanup levels (Riley, 2007) left in place at the base of the former UST excavation. Photographs of the excavation are included as Attachment B.

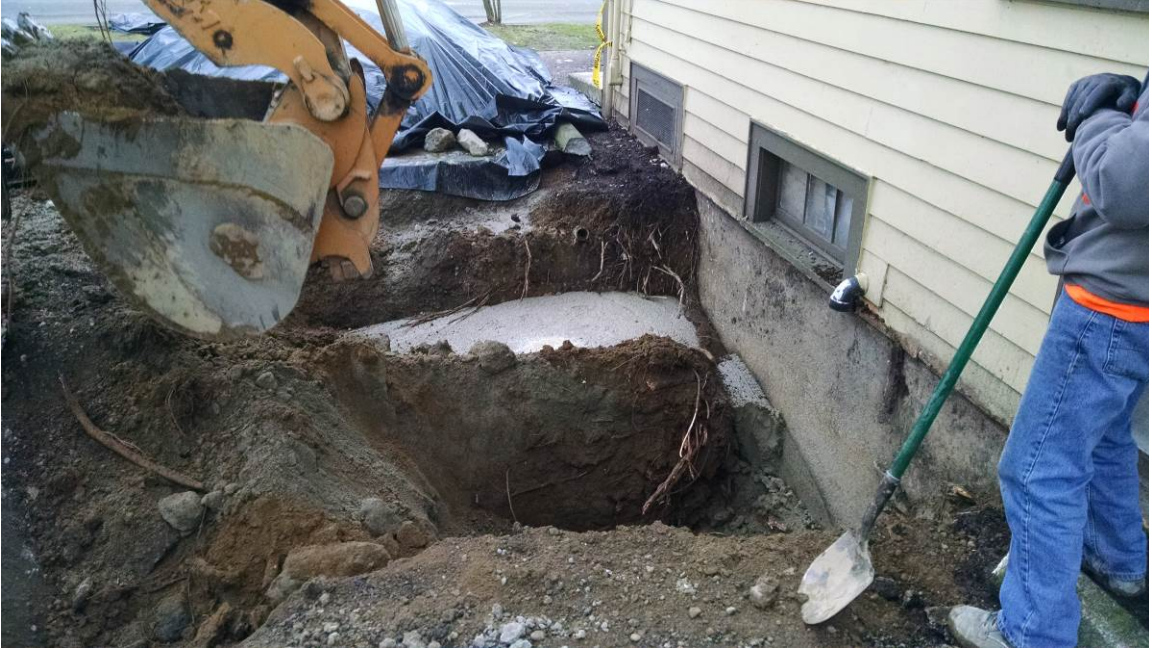
Photograph 6 – East and west 'cells' backfilled with CDF to stabilize excavation, January 13, 2015.

As discussed above, the excavated area was backfilled with CDF to an elevation of the previous approximate ground surface. The excavated area surface was restored with gravel backfill and surfaces with asphalt.

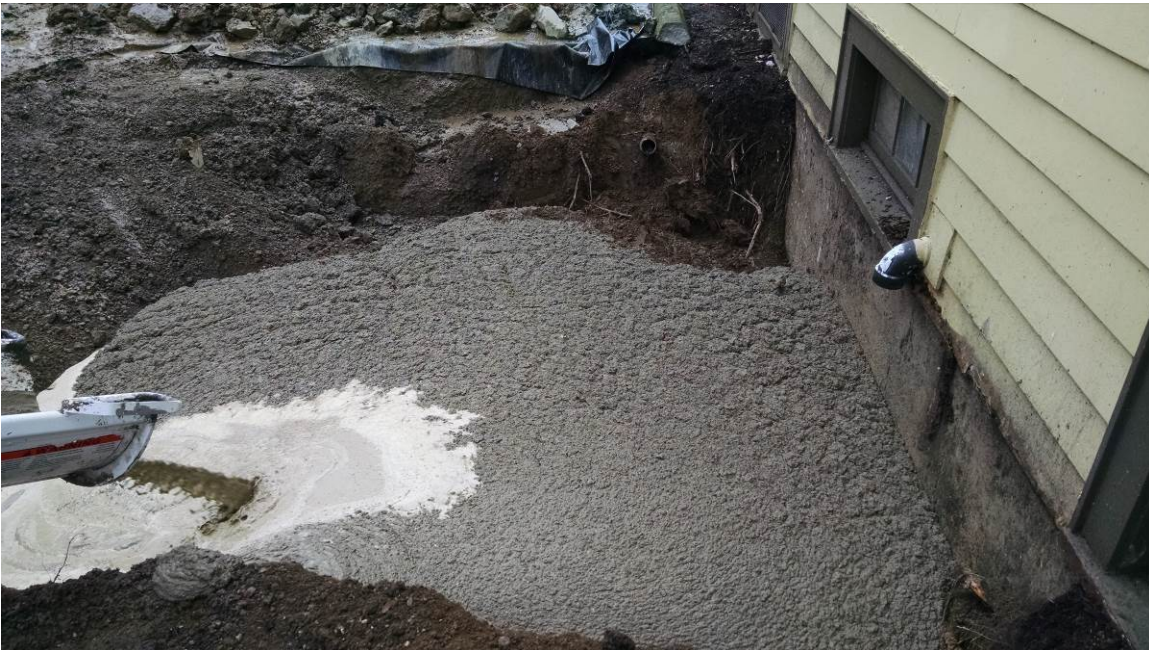
Photograph 7 – Backfilling central 'cell' after completion of remedial excavation on January 15, 2015.

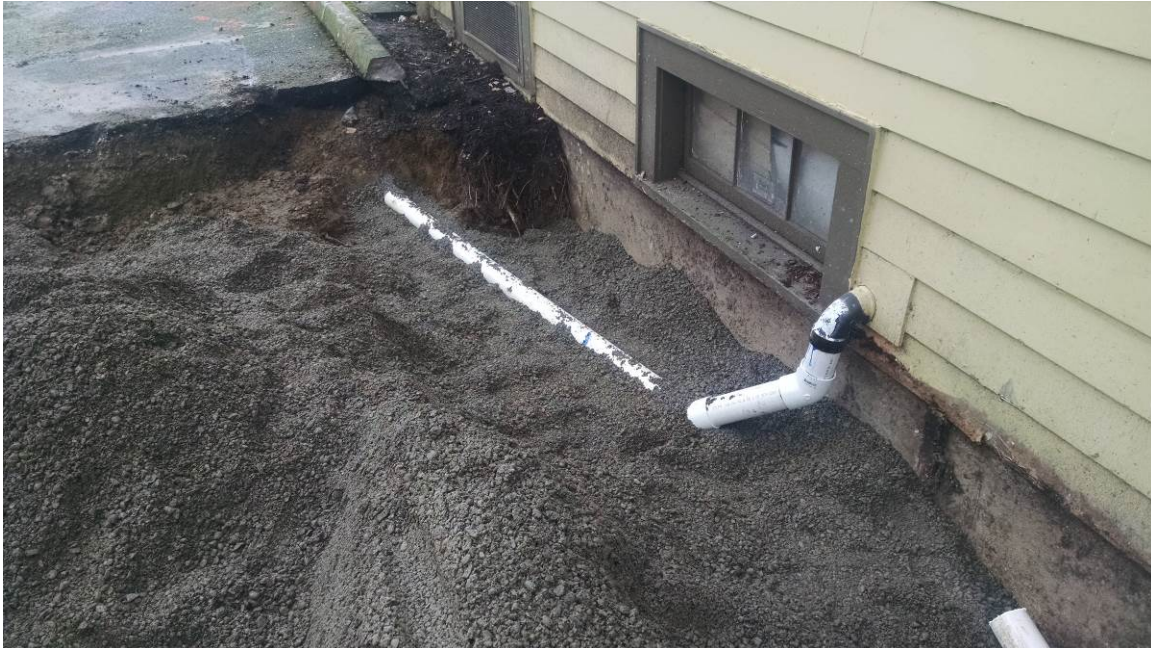
Photograph 8 – Surfacial backfill and sewer line replacement, January 16, 2015

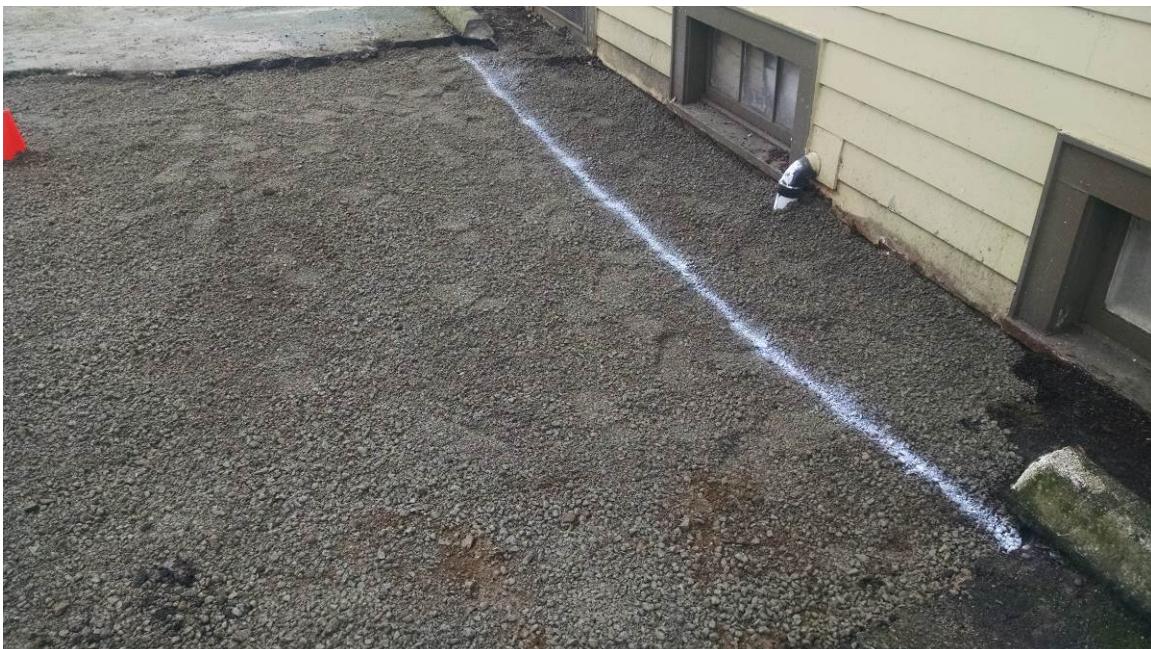
Photograph 9 – Surfacial backfill brought to grade and prepared for asphalt surfacing. 4-inch well location marked with cone. Well monument subsequently replaced prior to asphalt paving.
