# CONSTRUCTION COMPLETION REPORT

FORMER HAMBLETON BROS. LOG YARD—REMEDIAL ACTION

*Prepared for*  
**PORT OF CAMAS-WASHOUGAL**  
*May 13, 2015*  
*Project No. 0229.04.08*

*Prepared by*  
*Maul Foster & Alongi, Inc.*  
*400 E Mill Plain Blvd., Suite 400, Vancouver WA 98660*

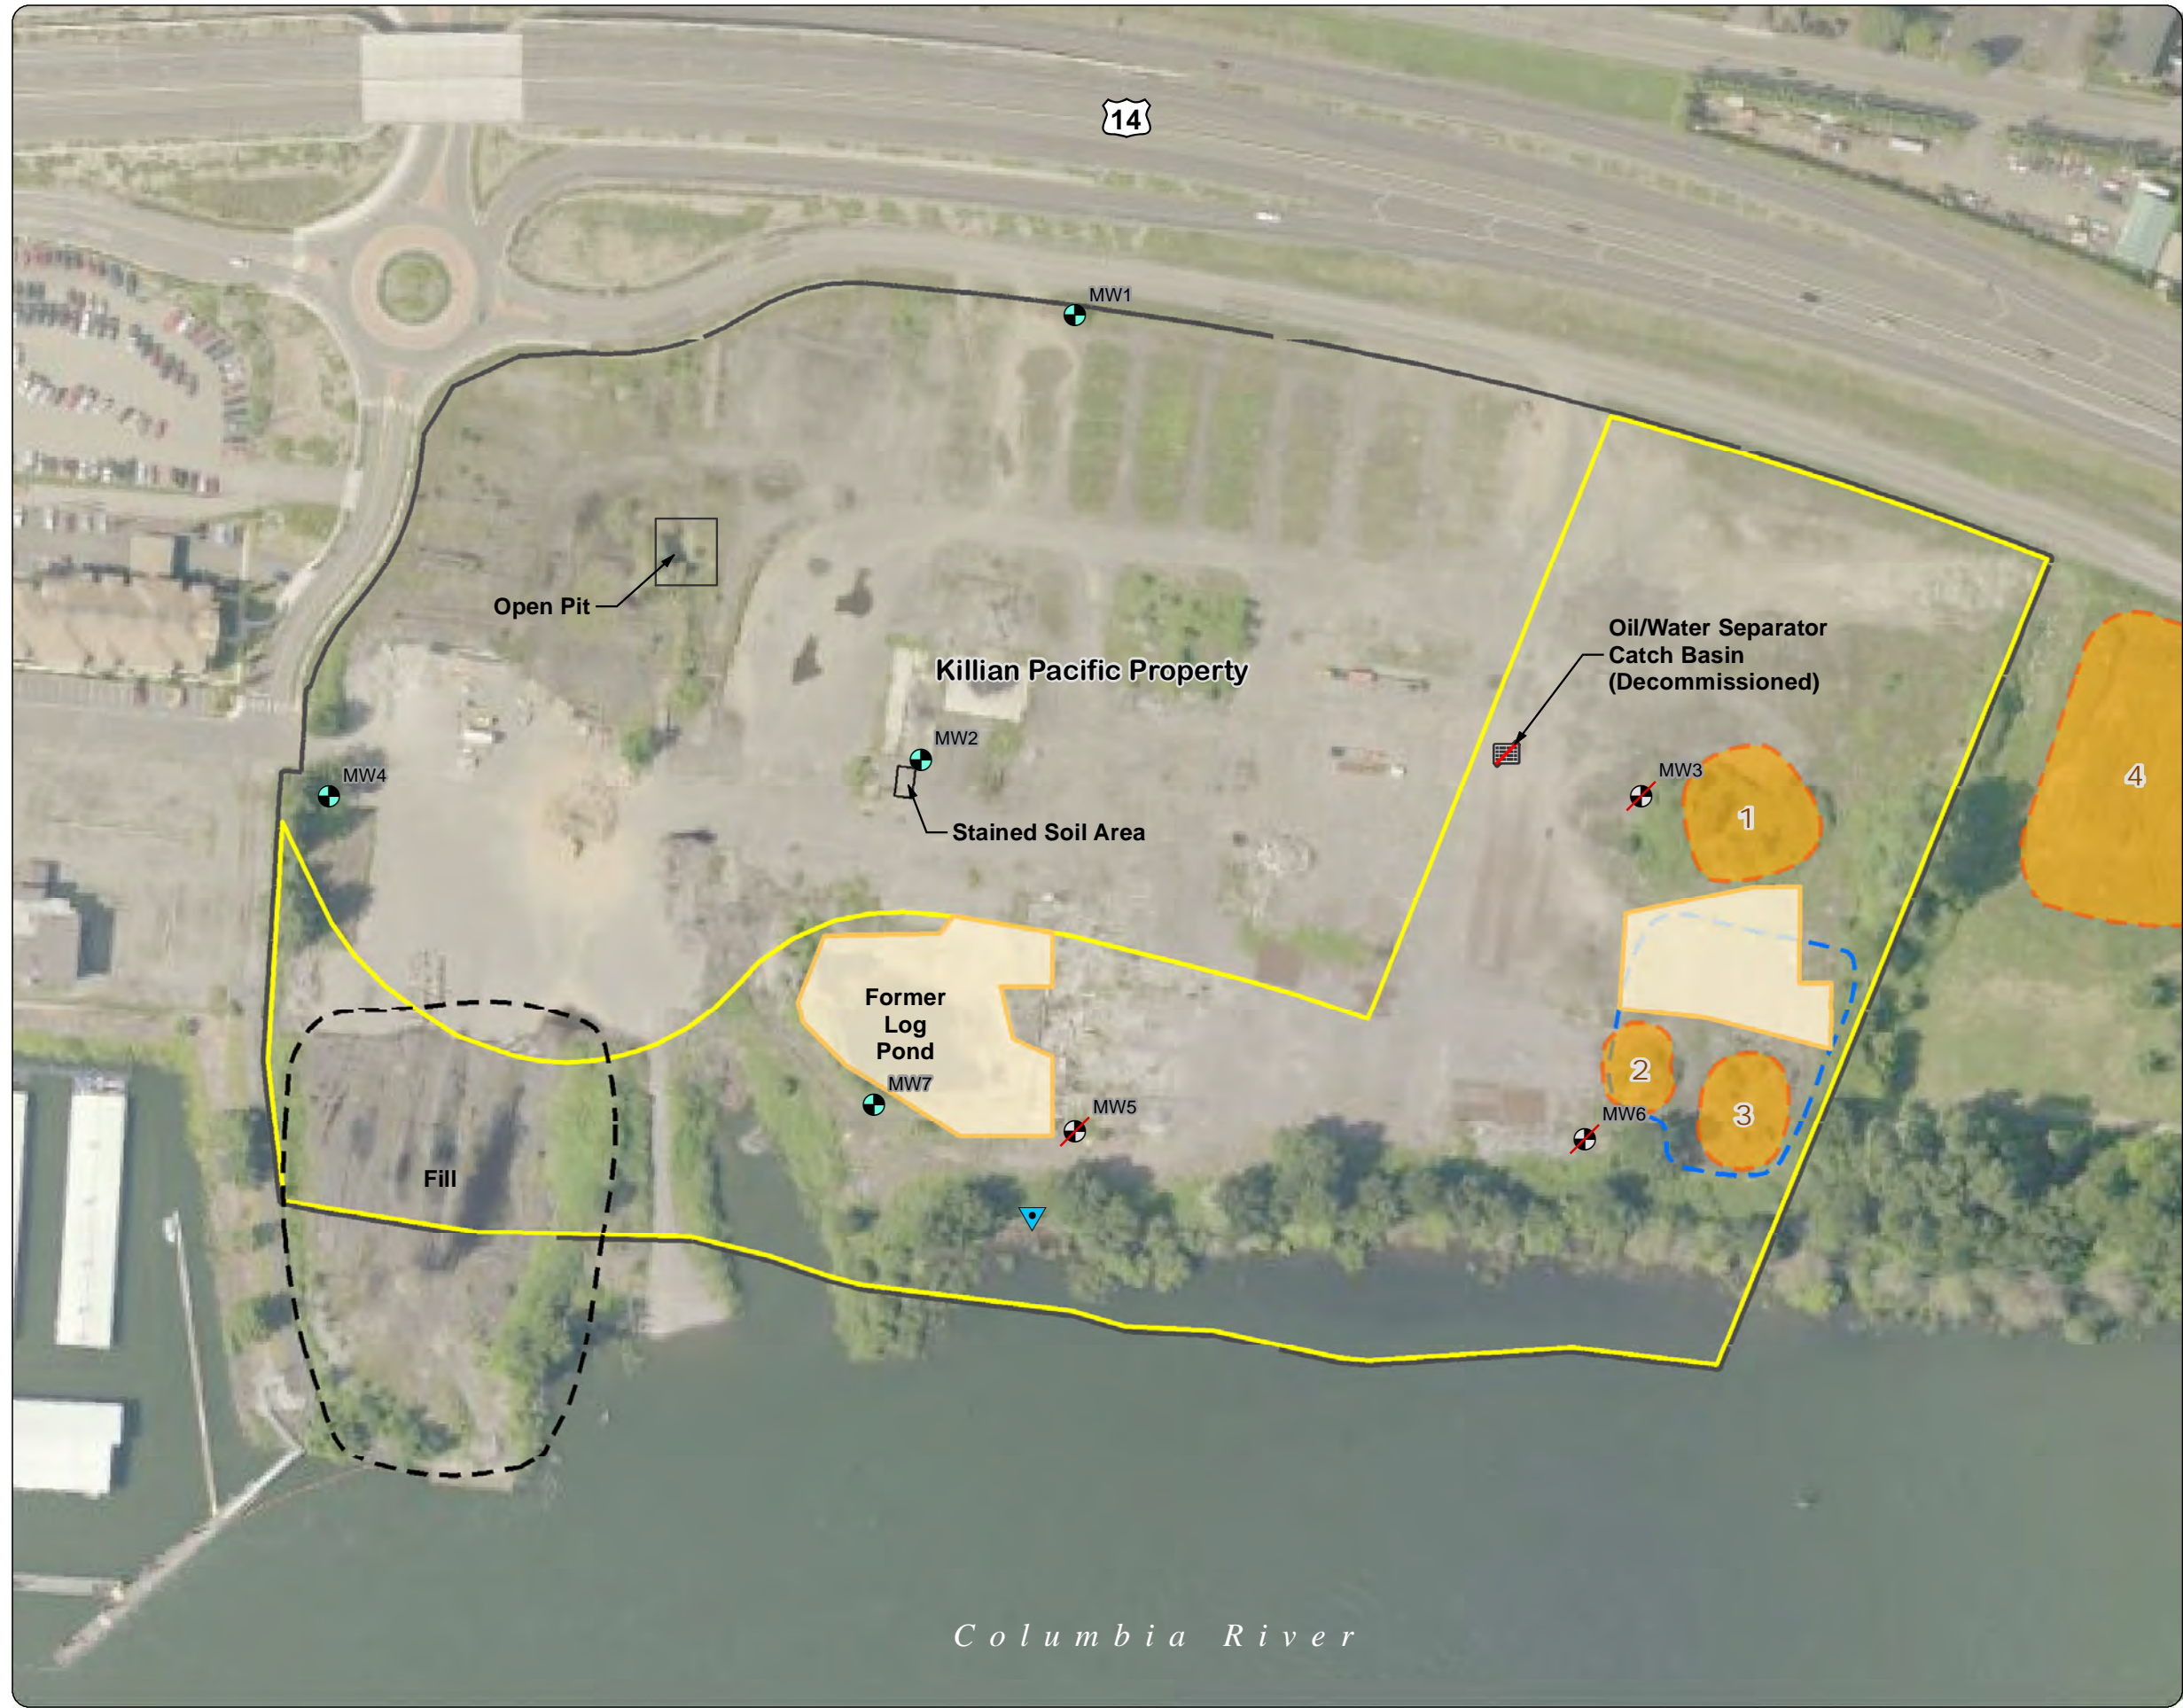
**Figure 2**  
**Site Features**  
Port of Camas-Washougal  
Washougal, Washington

There have been no structures on the Site since demolition of the lumber mill, shop, office, chemical storage shed, and planer building (see Figure 2). Demolition of these structures was generally completed in November 2011. Concrete foundations from the demolished structures remain. The Site is surfaced with asphalt and gravel; however, areas of the Site are covered in woody debris from log storage.

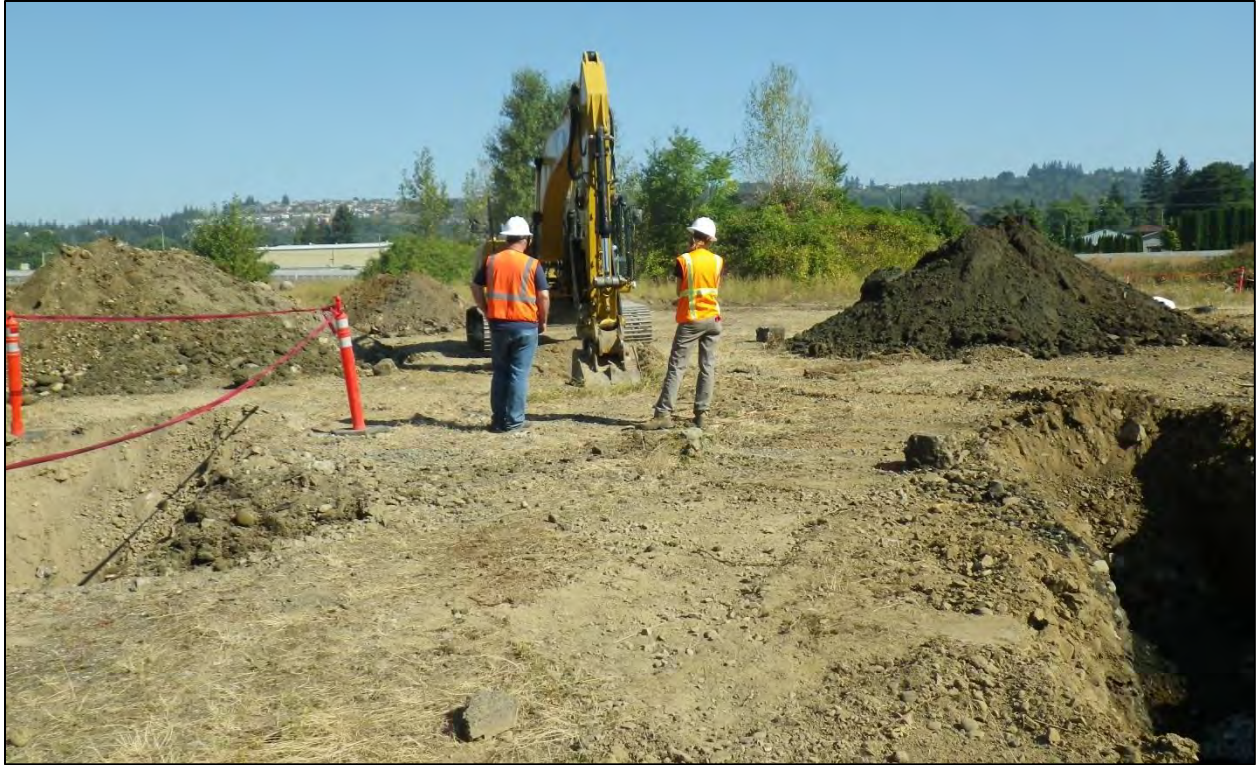
Figure 3. Project area overview, view to north. A-1 in progress, A-2 on left and A-3 on right.

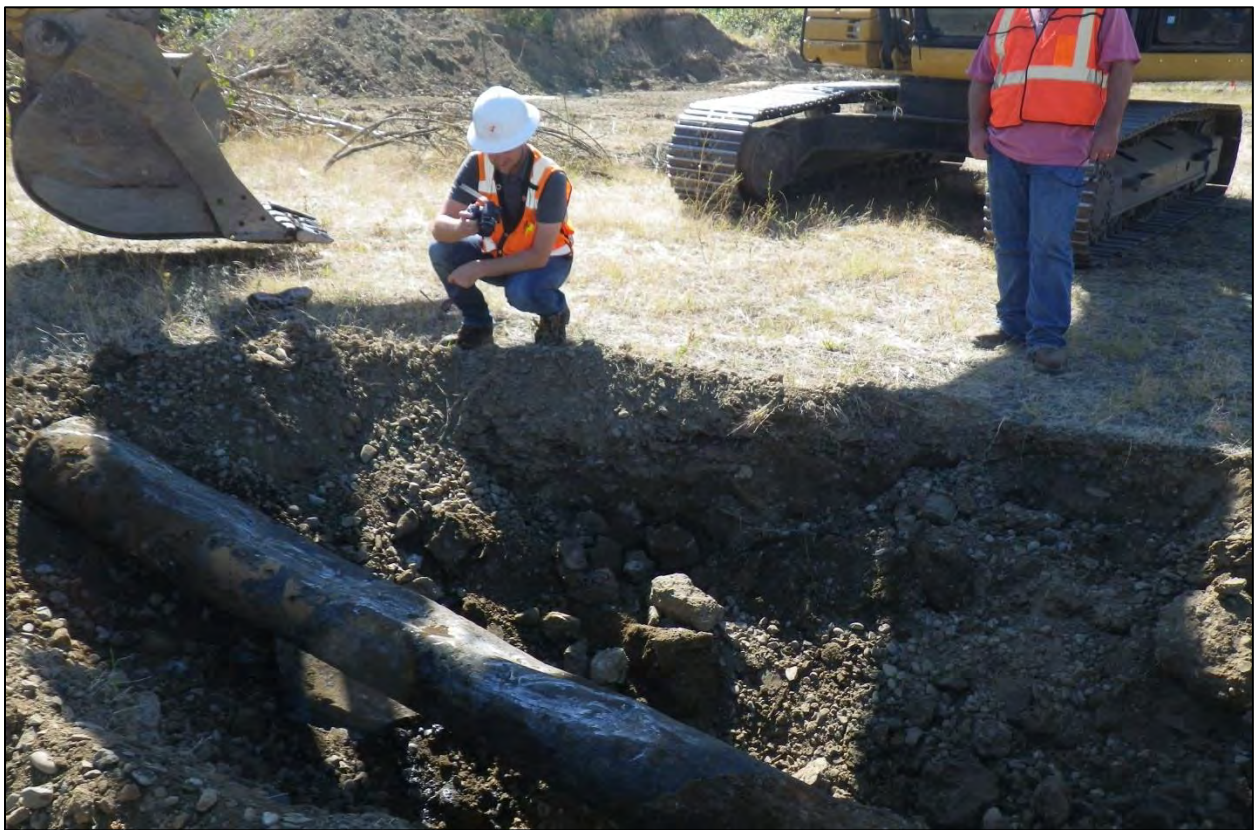
Figure 4. Steel bollard within fill deposits in C-1, view to southeast.

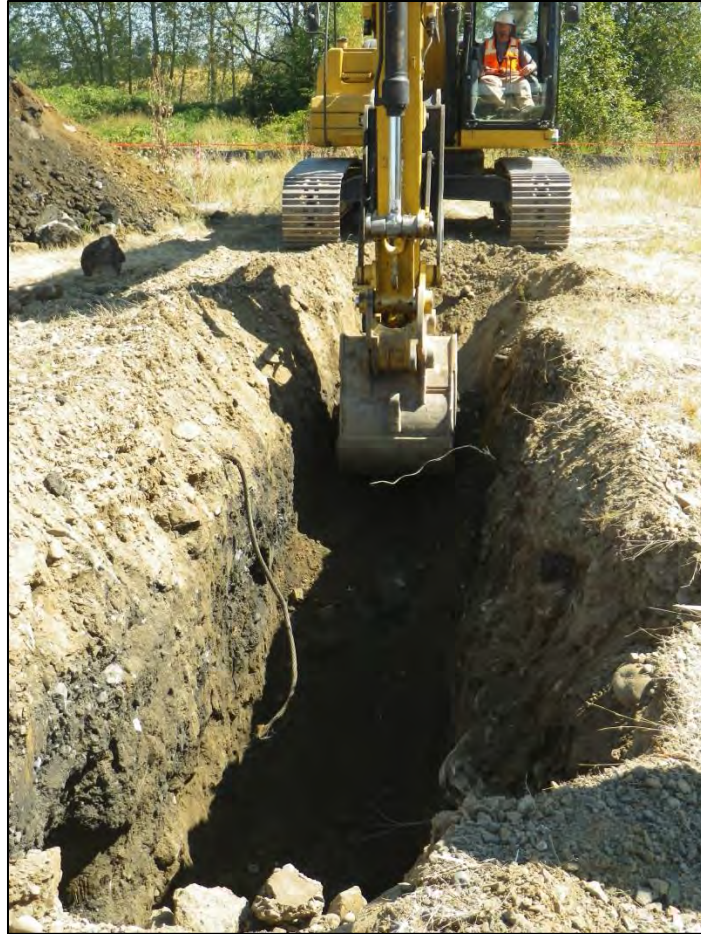
soil varied between 5.5 and 8.5 ft. below ground surface (Figure 5). Native sediment consisted of yellow brown, fine sandy silt loam, with some small-sized water worn pebbles and cobbles throughout. Large rounded boulders were encountered in the bottom portion of all the test pits within native soil (Figure 6).

Figure 5. C-2 in progress, fill deposits and top of native sediment visible in trench wall and base of excavation. View to northeast.

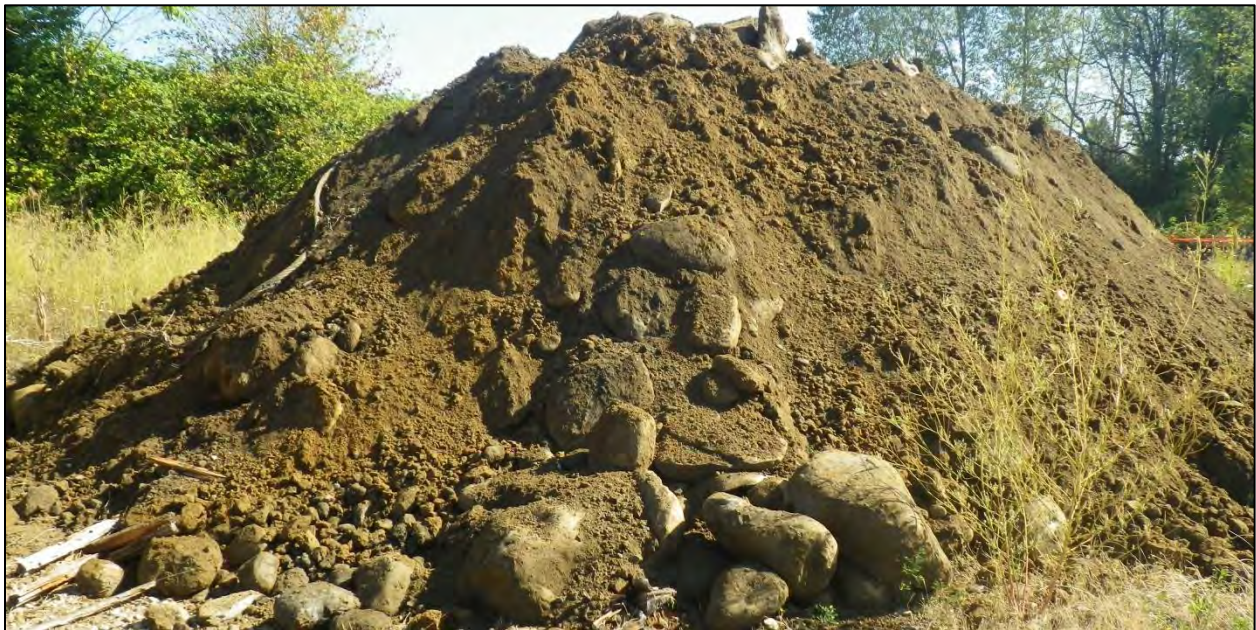
Figure 6. Example of large boulders excavated from native sediment, view to northeast.

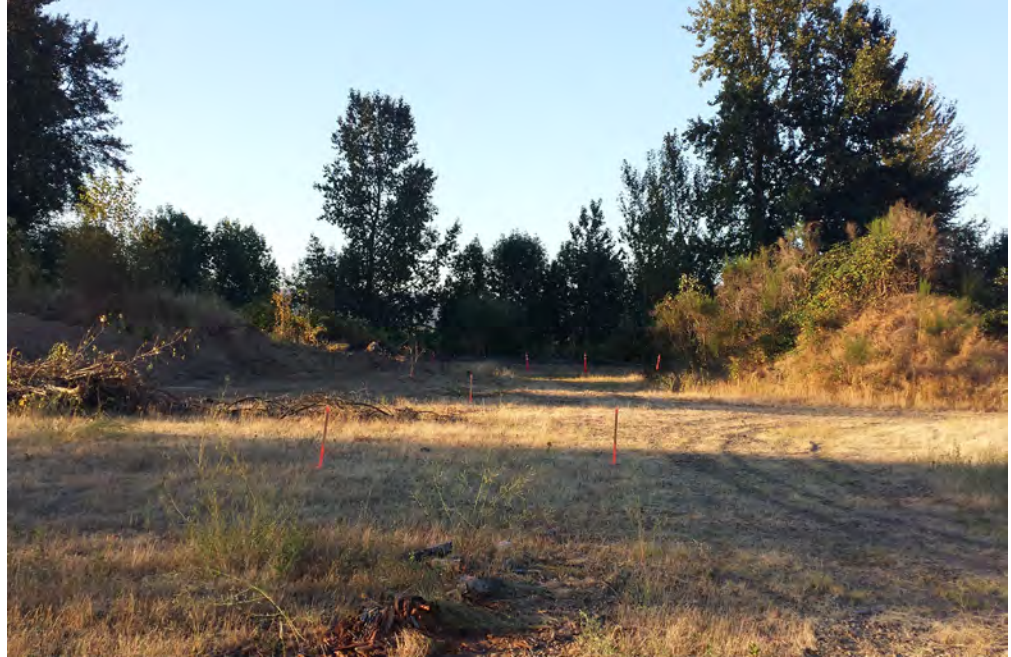
Looking north, metal  
removed from TP-A1

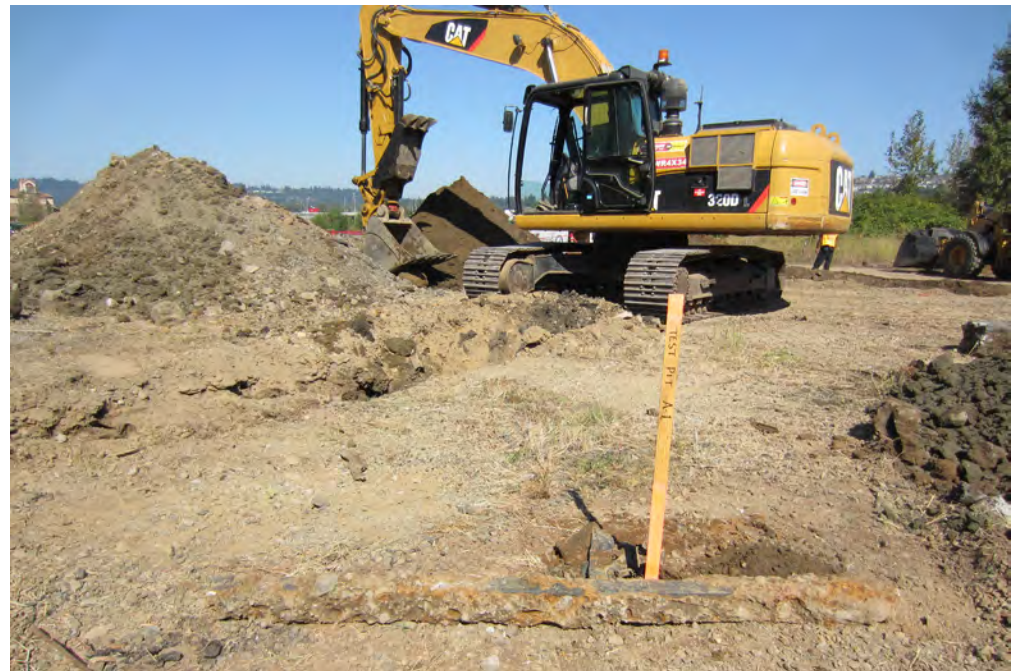
Looking south, metal  
removed from TP-A2

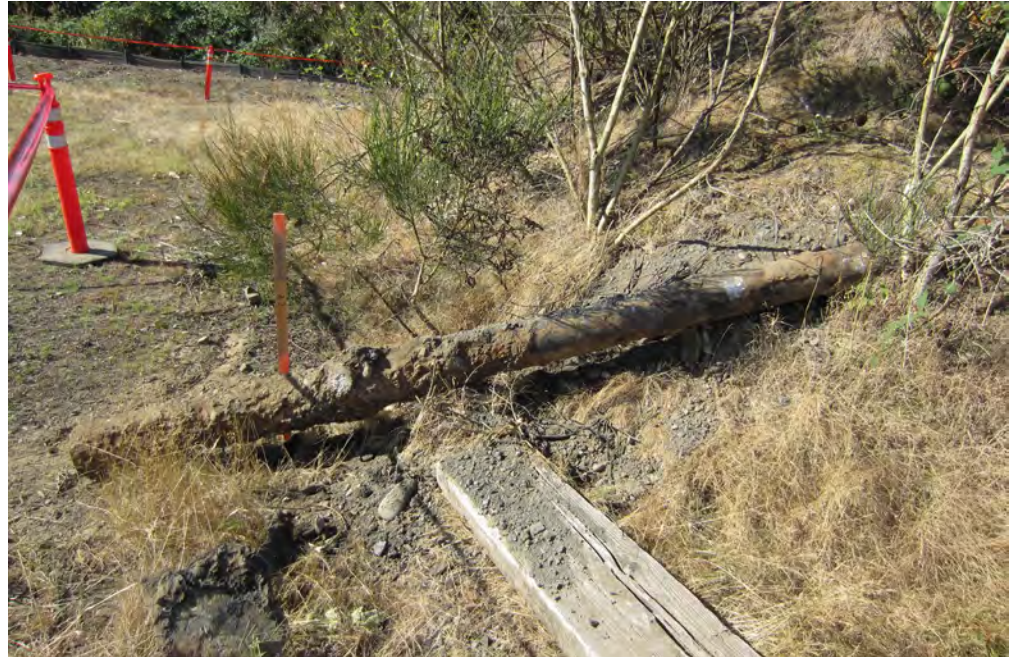
Looking north, metal  
removed from TP-A2

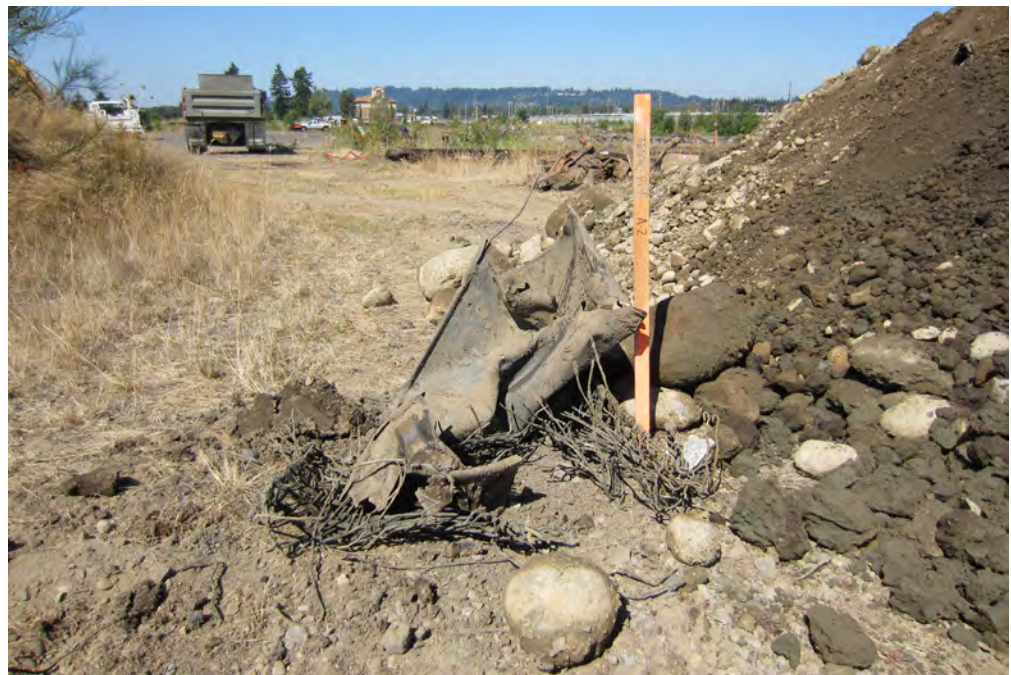
Looking northeast, metal removed from TP-A3

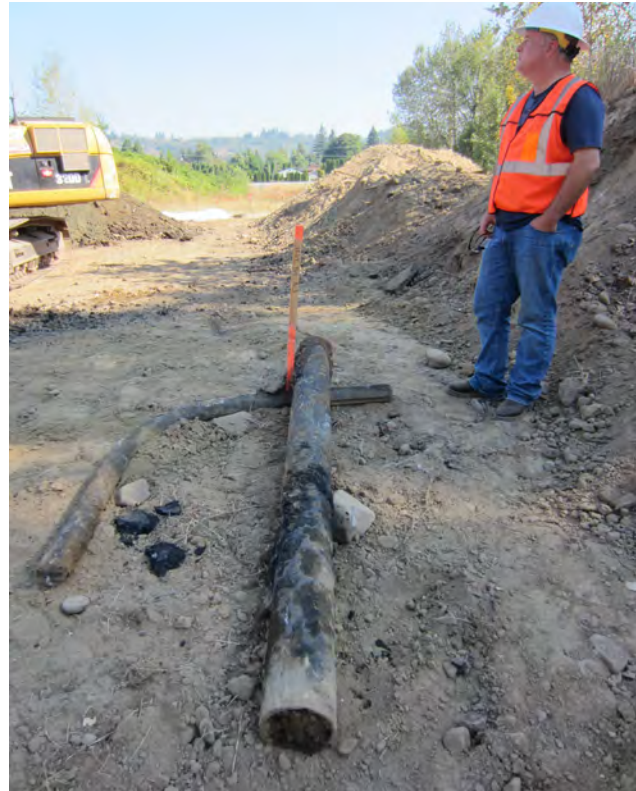
Metal removed from TP-B1

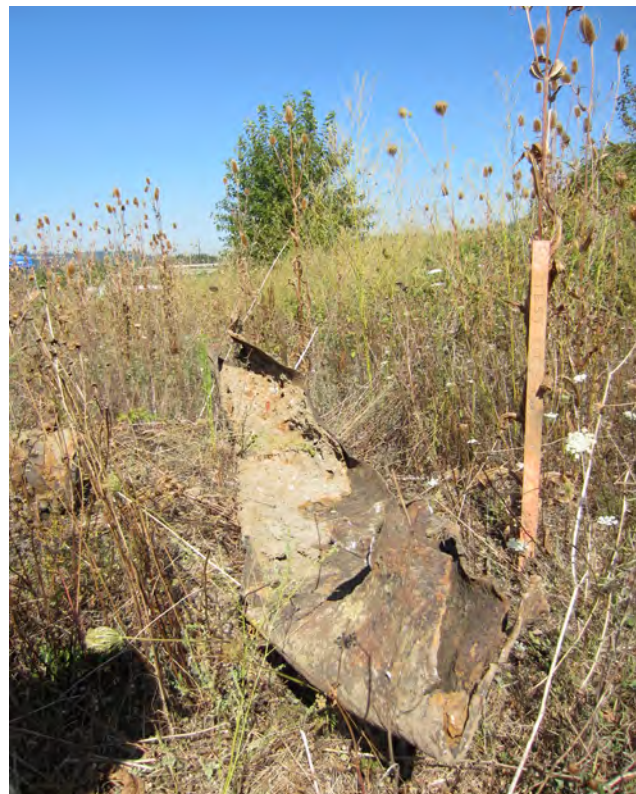
Metal removed from TP-B2

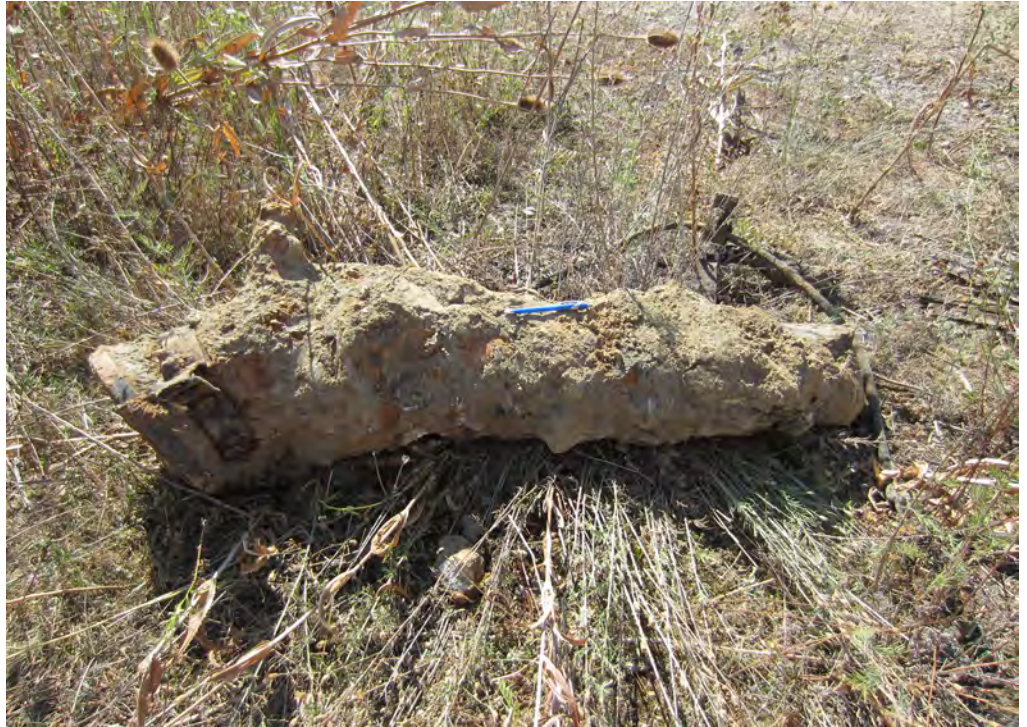
Looking south, metal  
removed from TP-B3

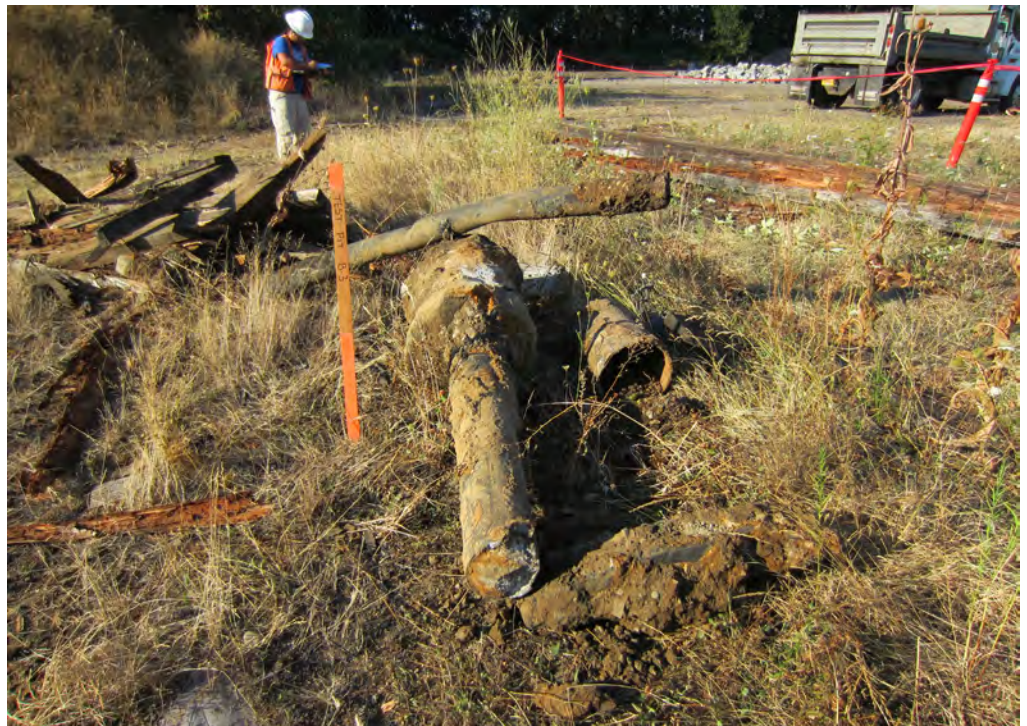
Looking east, metal in TP-C1

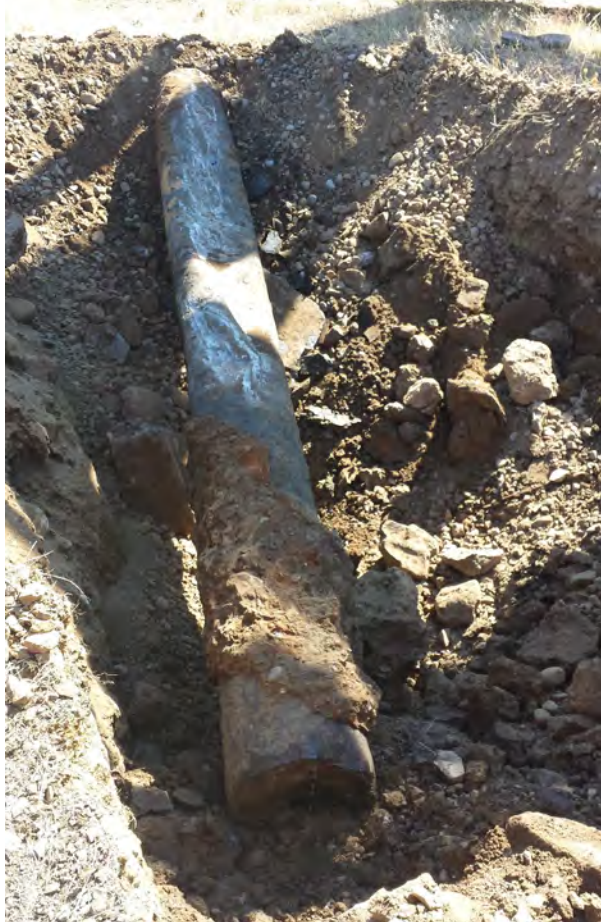
Looking east, metal  
removed from TP-C1

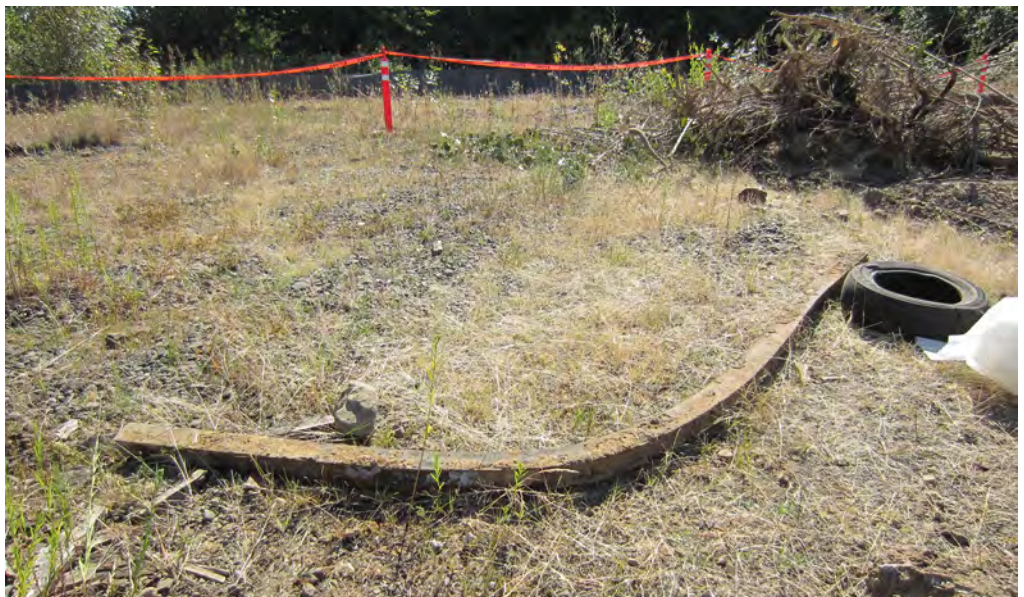
Looking west, metal  
removed from TP-C1

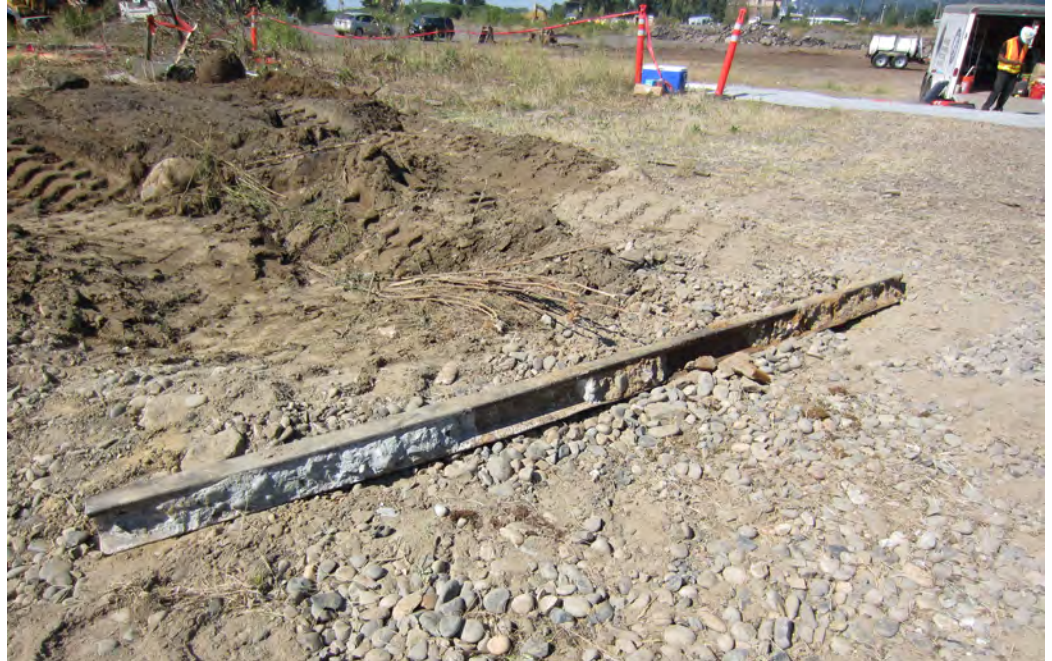
Looking northwest, metal  
removed from TP-C2

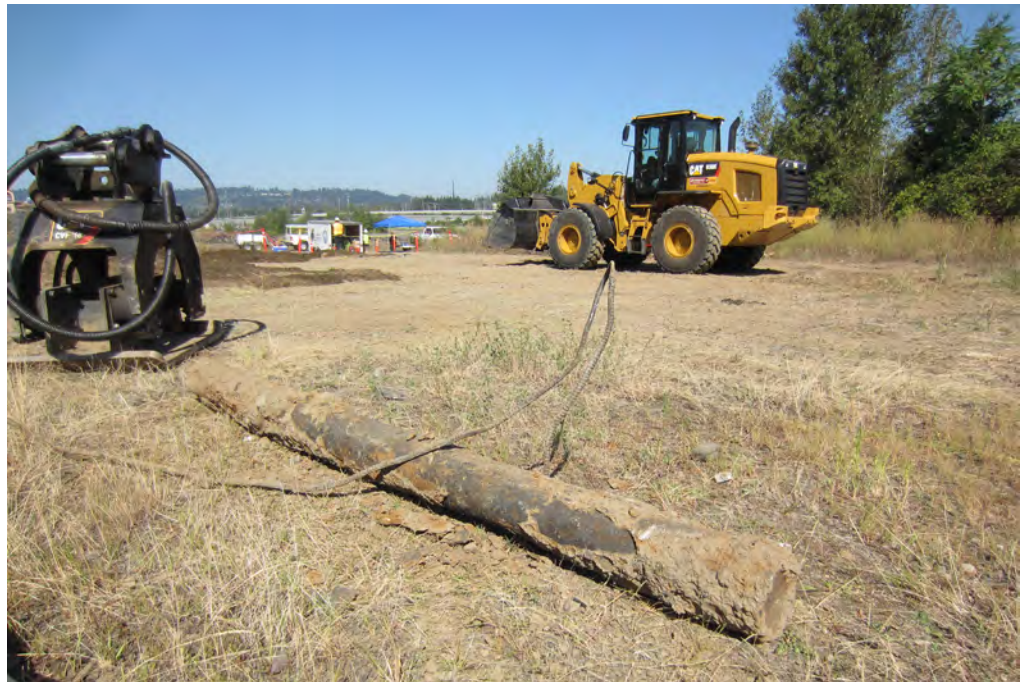
Approximately 120 cy of stained soil on the Killian Pacific property was excavated with a track hoe excavator. The soil was consolidated in the former log pond. The dimensions of the excavation were 21 feet in the north/south dimension by 19 feet in the east/west dimension, with depths ranging

between 2 feet and 8.5 feet below ground surface (bgs). The excavation was advanced to remove visibly stained soil.

Looking northwest,  
excavation of 120 cy of  
impacted soil complete

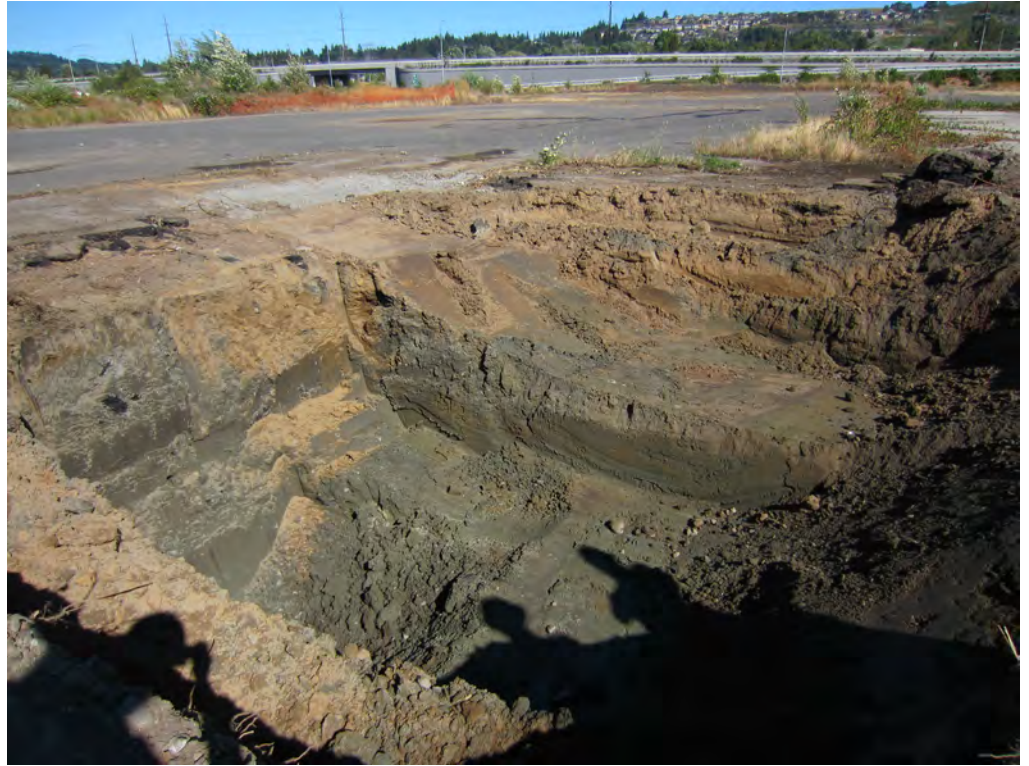
Looking south, backfilling  
excavation with clean fill  
material

Excavations were backfilled with the excavated soil. Soil backfill was placed and compacted in accordance with the project specifications and recommendations in the geotechnical report (Apex, 2014). Backfill was compacted with an excavator-mounted plate compactor at approximately 24-inch lifts. The final grade was placed to match the existing grade. Area B and Area C test pits were also covered with a clean soil cap, as described in Section 4.6.

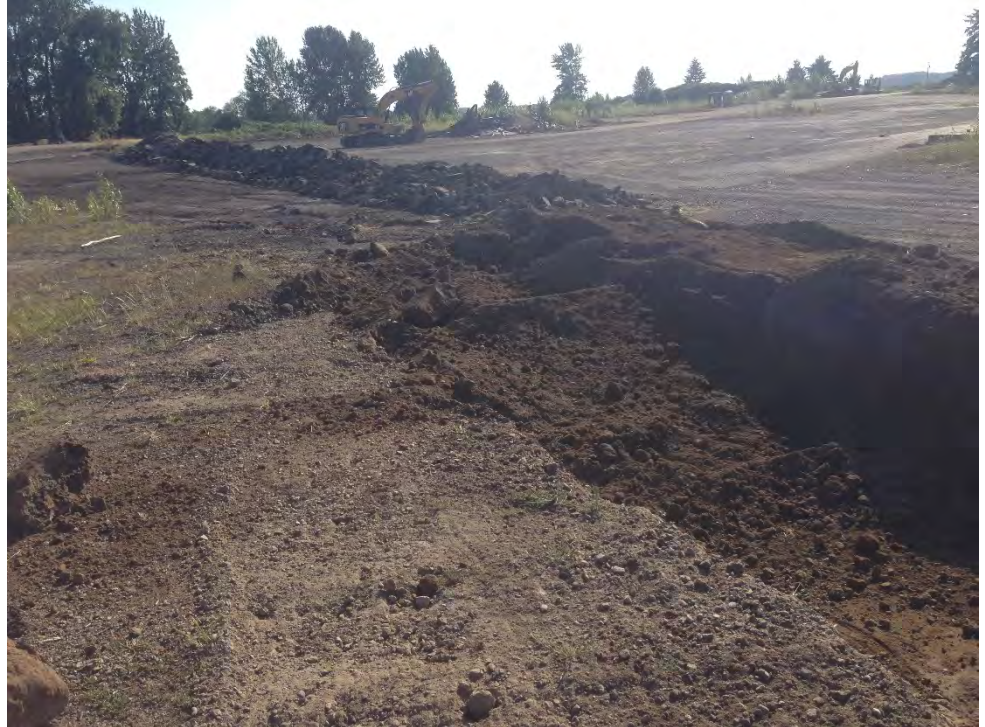
Silt fence on east side of site  
(facing south)

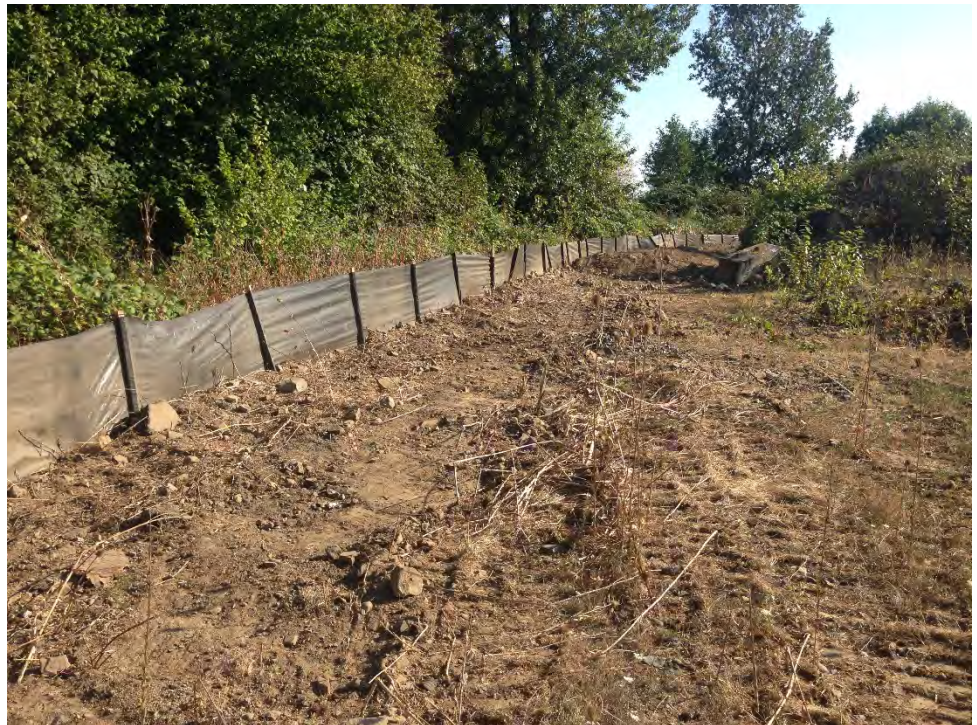
Completed berm and  
sediment along south end  
of site (facing west)

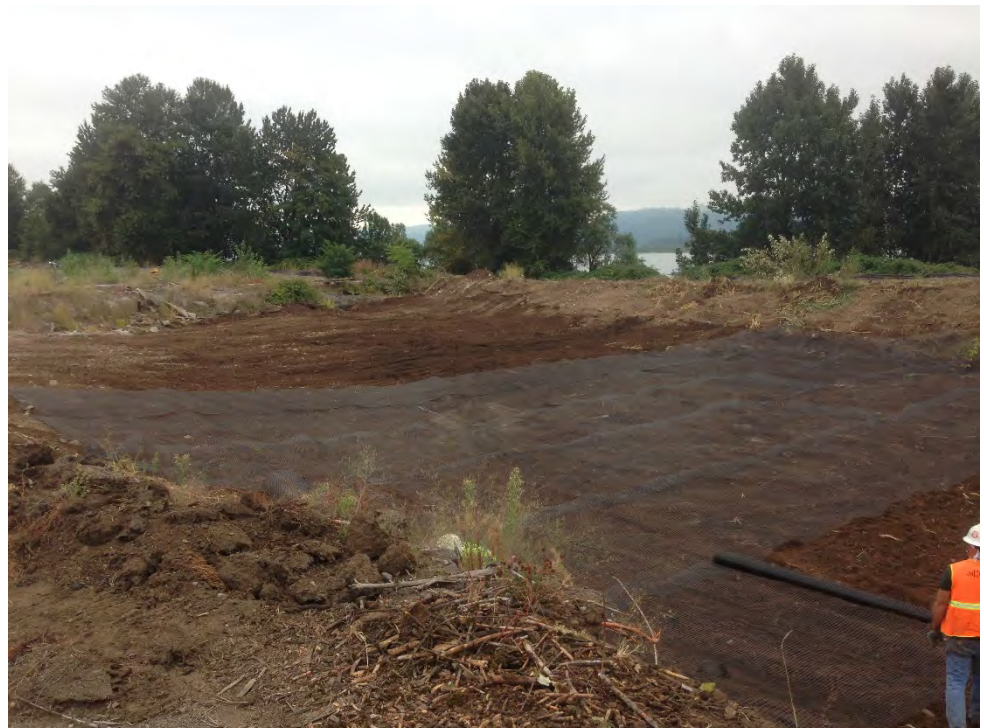
Geogrid nearly complete—one more roll was purchased and gaps and slopes were covered. (northeast)

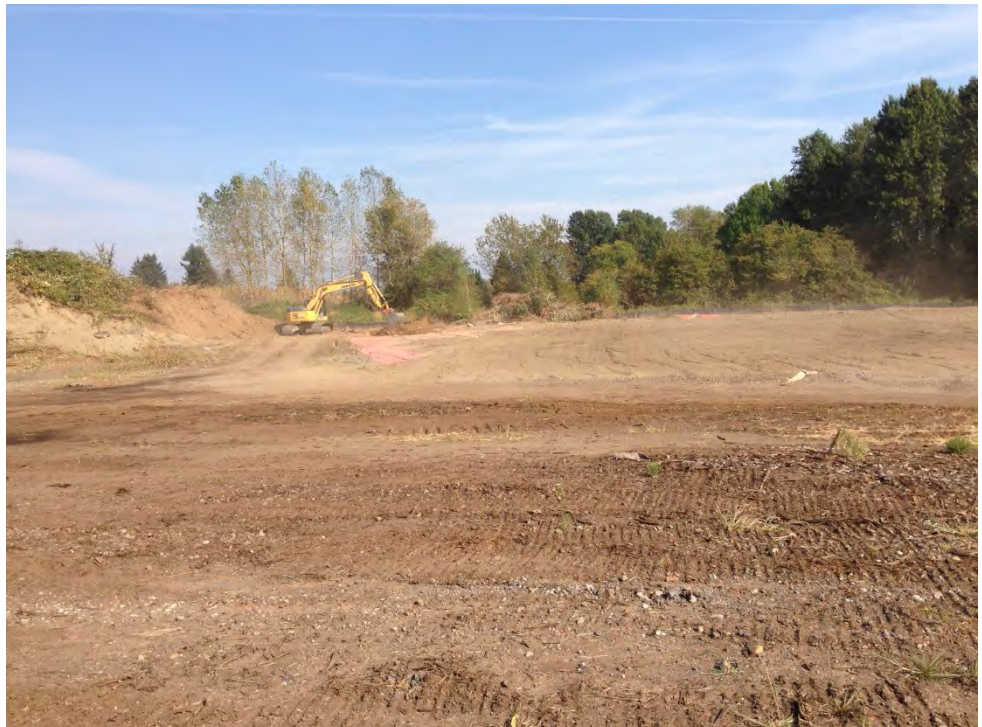
Clean cap rough graded over  
former pond. (facing south)

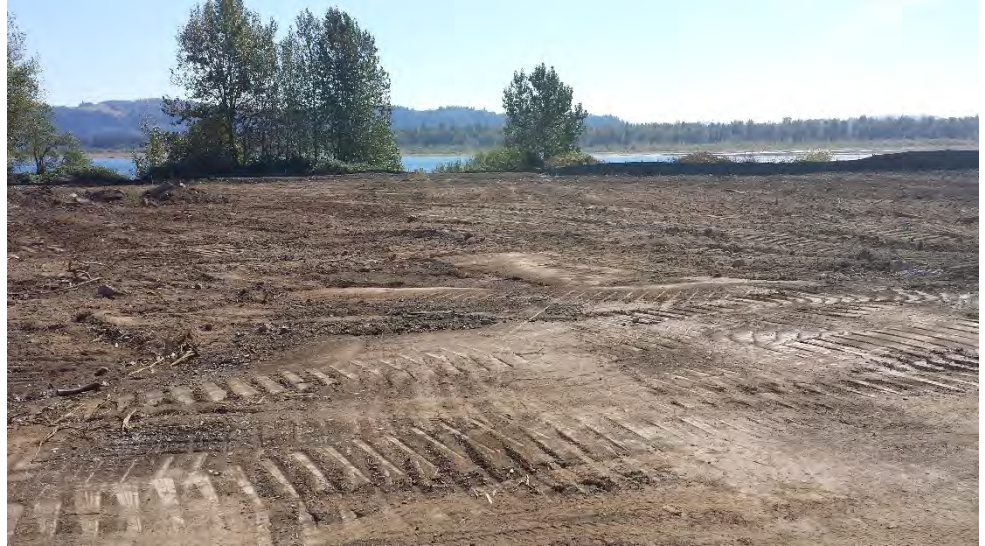
Demarcation fabric installed  
adjacent / northeast of  
former pond. Asphalt was  
removed in this area and  
approximately 1 foot of soil  
excavated. (facing southeast)

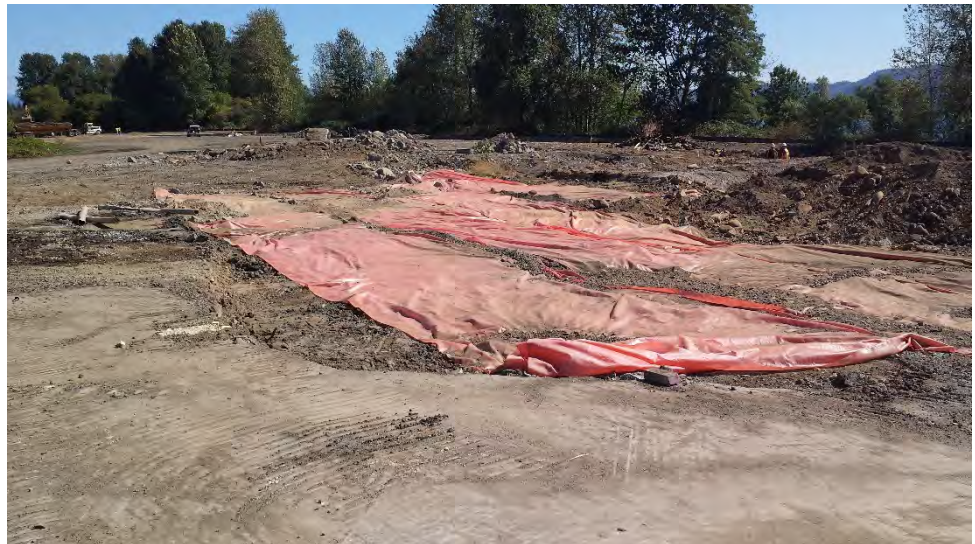
Former pond, now graded and compacted with a roller.  
Surveyor to confirm correct grading and mark final adjustments in coming days.  
(facing southeast)

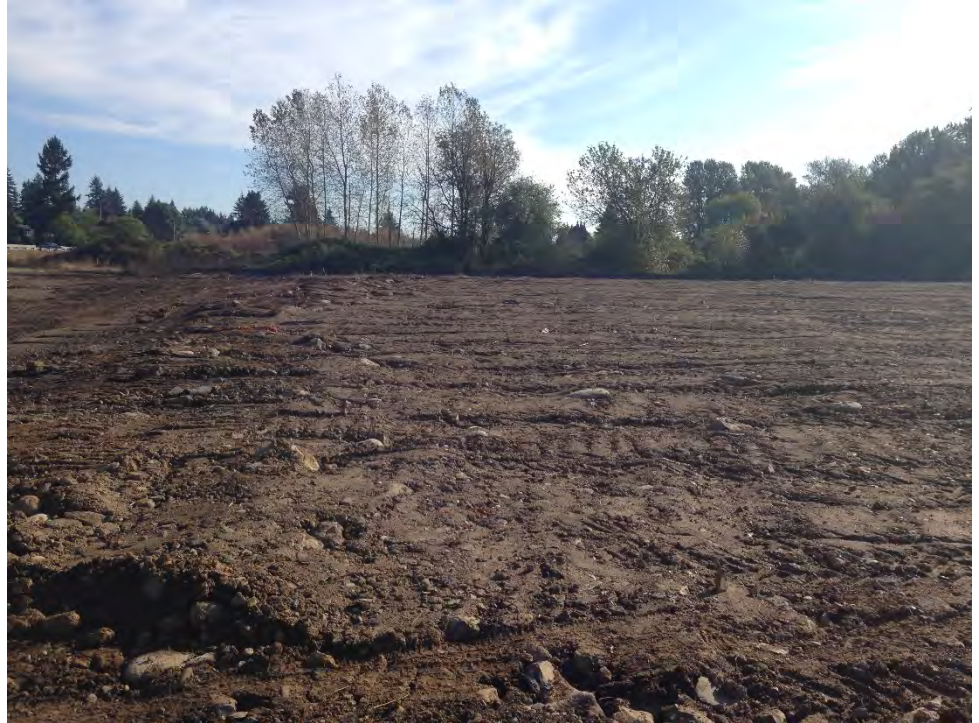
Edge of broken asphalt near south-central portion of site. Waiting to hear from Port how to finish off the gravelly portion of the site. (east)

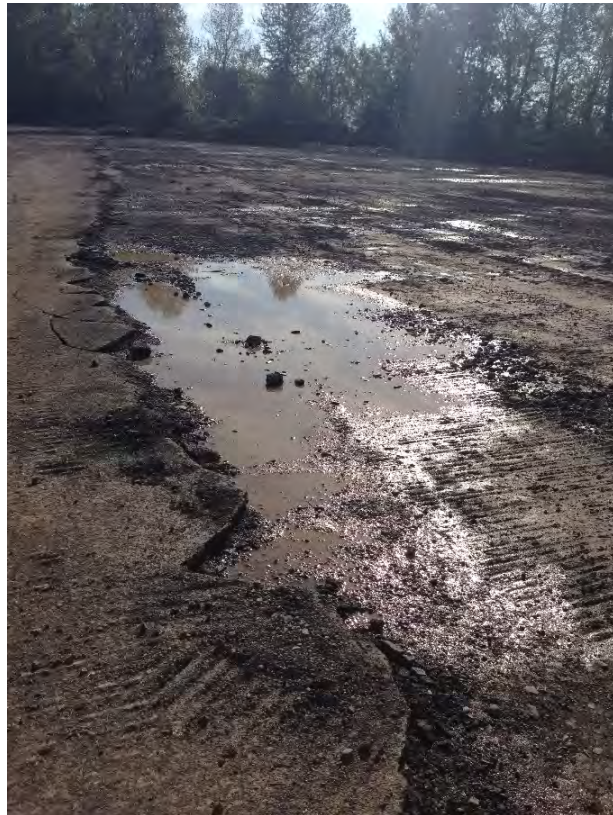
Former pond and surrounding area capped, graded, and hydroseeded. (west)

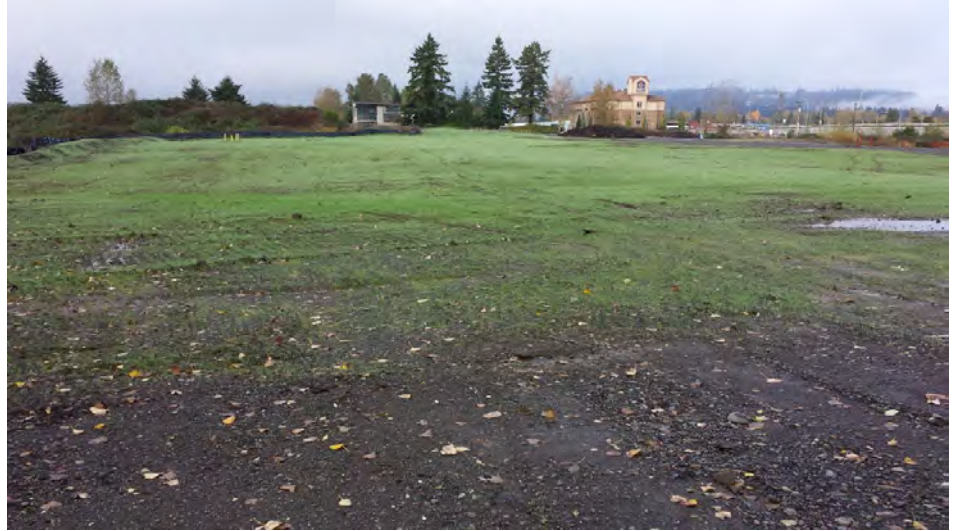
Former stockpile area capped, graded, and hydroseeded. (east)

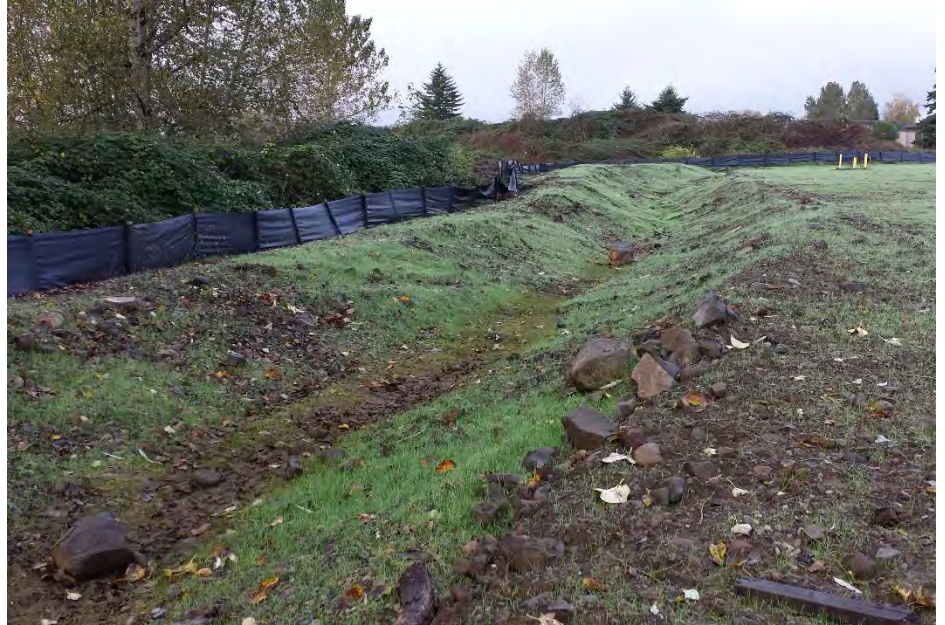
Ponding occurs around the berm that runs North-South along the boundary between the Port's property and Killian. (north)

The final inspection of the remedial action work was completed on November 7, 2014. Work contracted for the project has been completed. While no work remains, there is ponding in an infiltration trench on site. The ponding does not appear to be a threat to the cap, but should be monitored visually to ensure that no design remedy for the ponding is needed before further development.
