WASHINGTON STATE
DEPARTMENT OF ECOLOGY

DRAFT REPORT

PHASE I REMEDIAL INVESTIGATION REPORT
MARALCO SITE
KENT, WASHINGTON
WORK ORDER NO. 2121.05.03.320

MK-ENVIRONMENTAL SERVICES
1300 114th Avenue SE, #112
Bellevue, Washington 98004

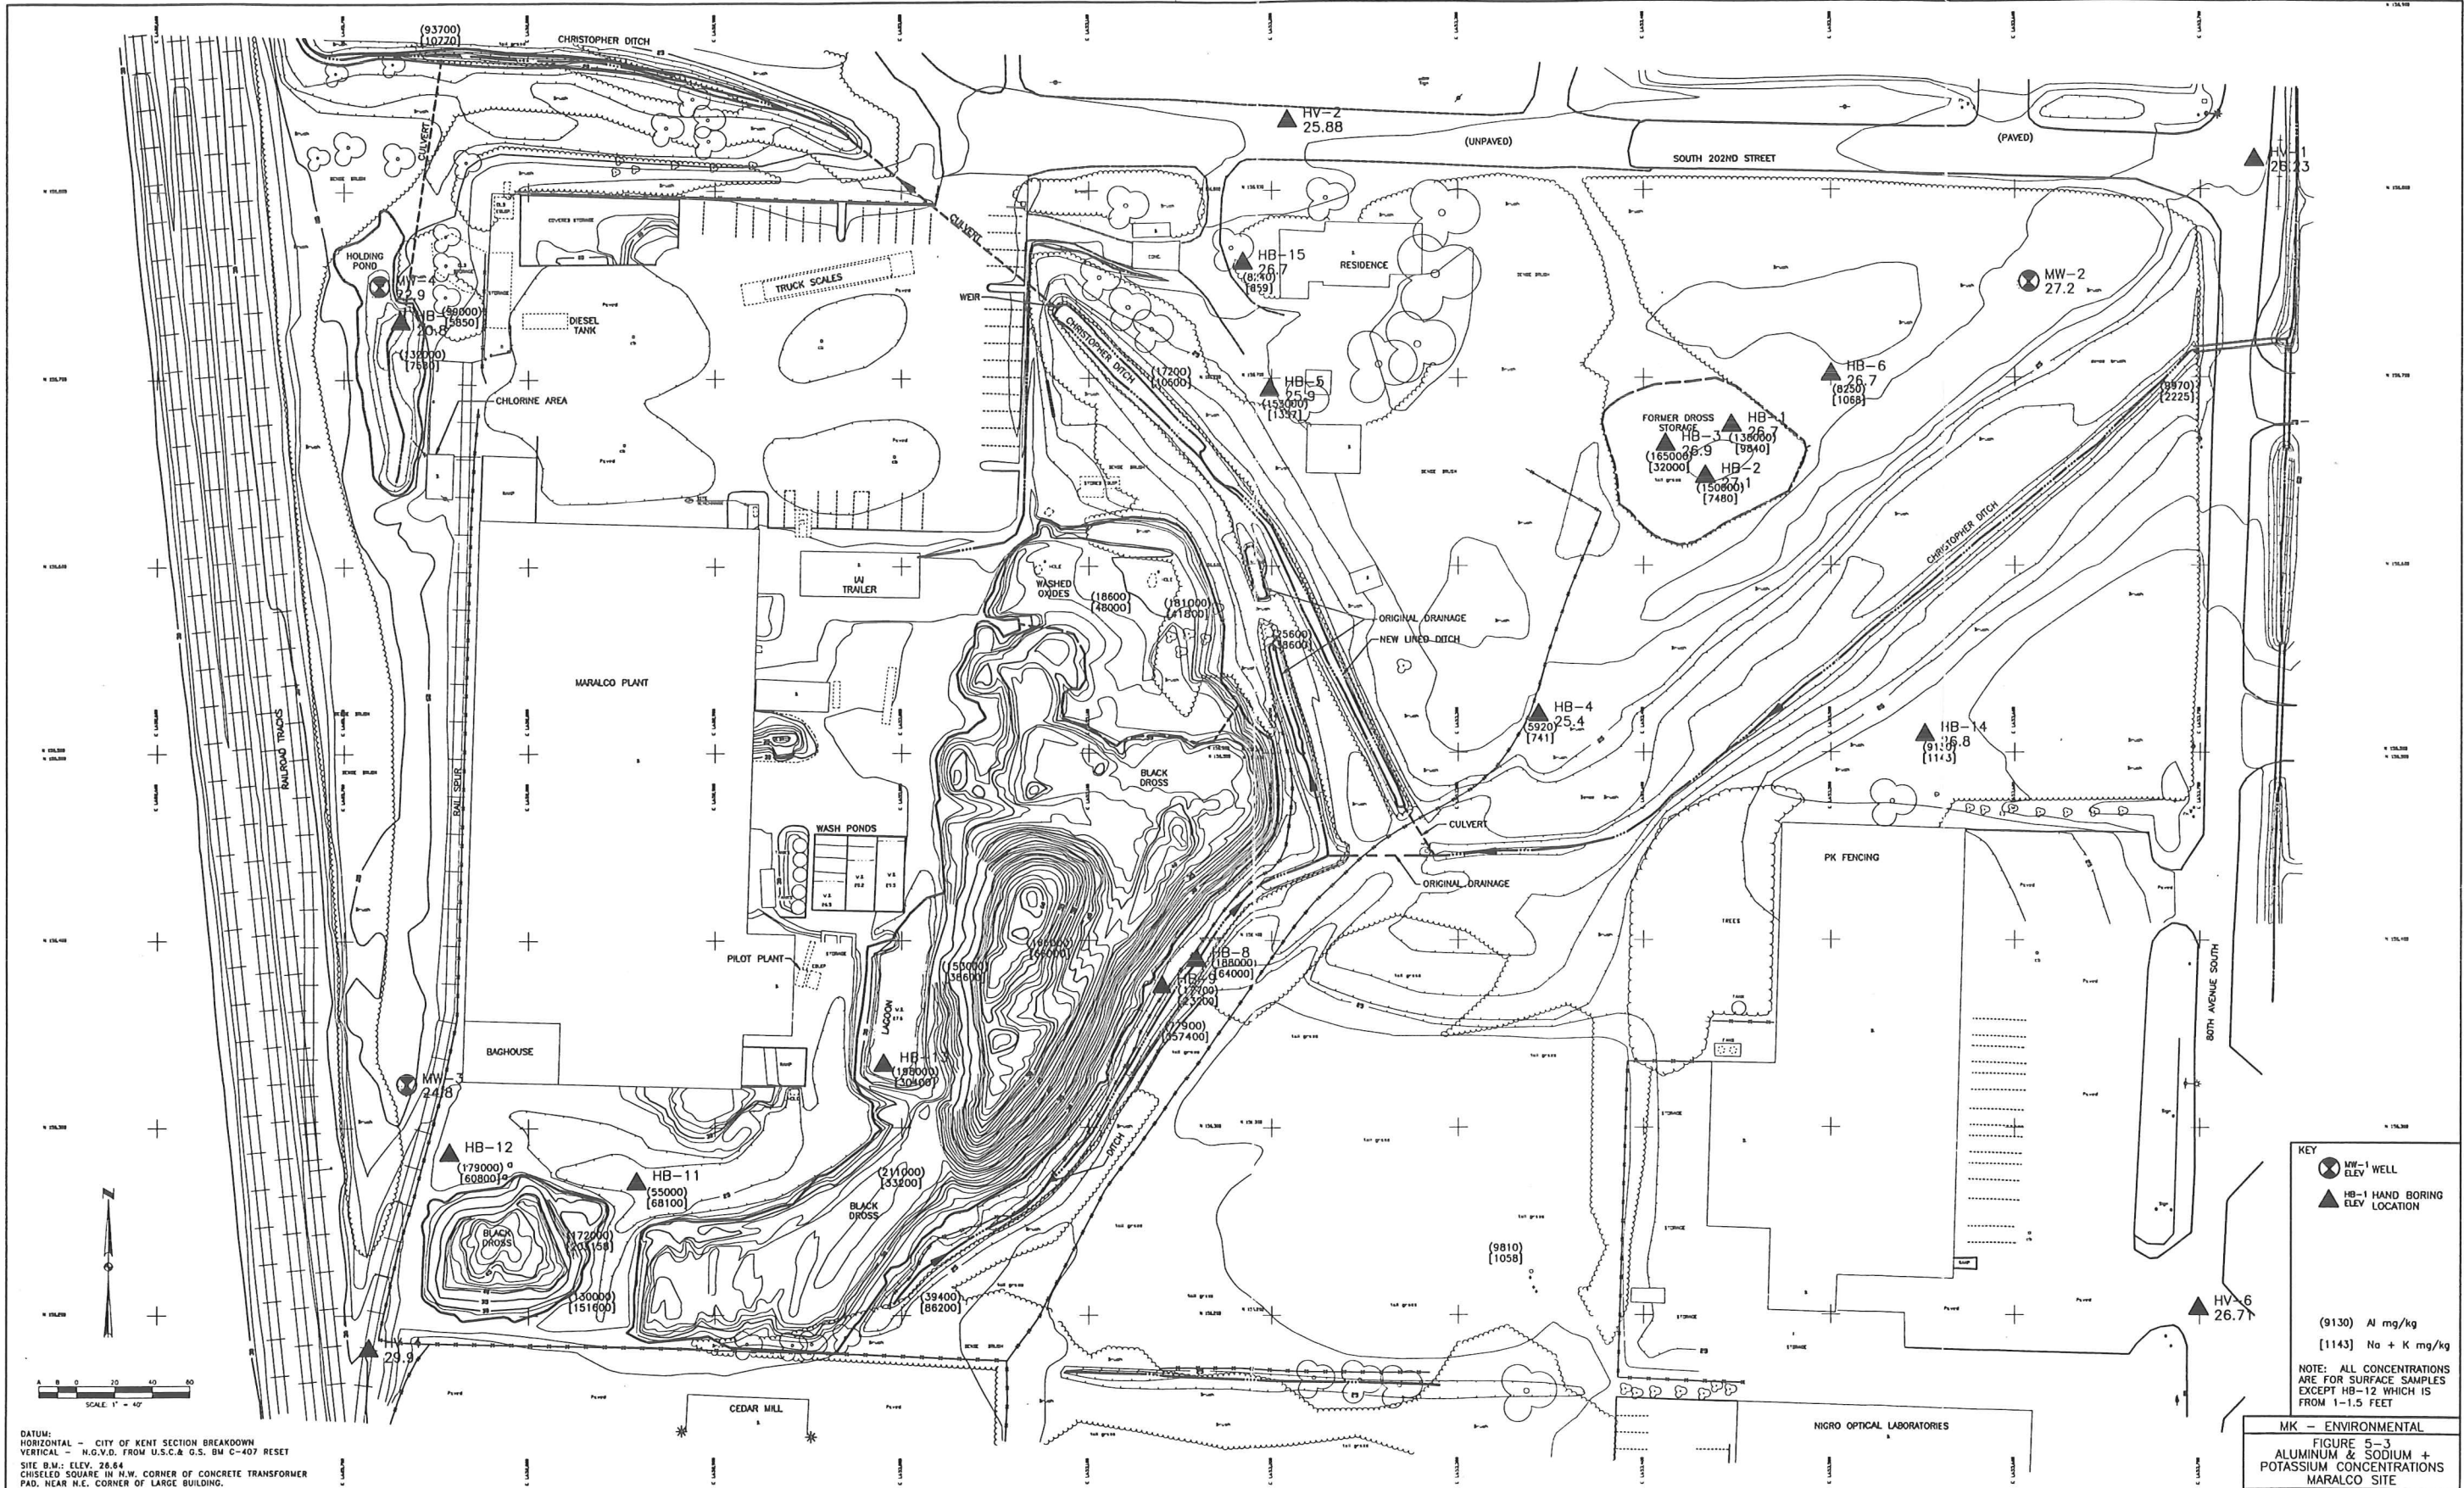
KEY
 MW-1 WELL
 HB-1 HAND BORING
 ELEV LOCATION

(9130) Al mg/kg
 [1143] Na + K mg/kg

Sediment samples from the drainage ditch southeast and east of the Maralco black dross pile contained elevated total metal concentrations (Table 5.2). Total metal results from these samples indicate aluminum concentrations up to 77,900 mg/Kg (SW-6), barium to 130 mg/Kg (SW-6), chromium to 87.5 mg/Kg (SW-6), copper to 883 mg/Kg (SW-6), lead to 89 mg/Kg (SW-4), zinc to 1200 mg/Kg (SW-4), potassium to 4,900 mg/Kg (SW-1), and sodium to 330,000 mg/Kg (SW-6). Very high metals were also observed in sediments from a shallow seasonal pond in the area of a former holding pond, near SW-7, and in the ditch to the north of the Maralco plant. SW-8 was located in this ditch by the outfall of a small culvert that appeared to serve as drainage for the pond by SW-7. Aluminum concentrations were reported to 132,000 mg/Kg (SW-7), barium to 188 mg/Kg (SW-8), chromium to 150 mg/Kg (SW-7), copper to 1330 mg/Kg (SW-7), lead to 261 mg/Kg (SW-8), zinc to 1150 mg/Kg (SW-7), potassium to 4500 mg/Kg (SW-8), and sodium to 6270 mg/Kg (SW-8). Sediments collected from site SW-2 are upstream of the present and former black dross piles. Metals concentrations from SW-2 were considerably lower; aluminum concentrations were 9,970 mg/Kg, potassium 525 mg/Kg, and sodium 1700 mg/Kg.
