STATE OF WASHINGTON
DEPARTMENT OF ECOLOGY

DRAFT REPORT

PHASE I FEASIBILITY STUDY REPORT
MARALCO SITE
KENT, WASHINGTON

MARCH 1991

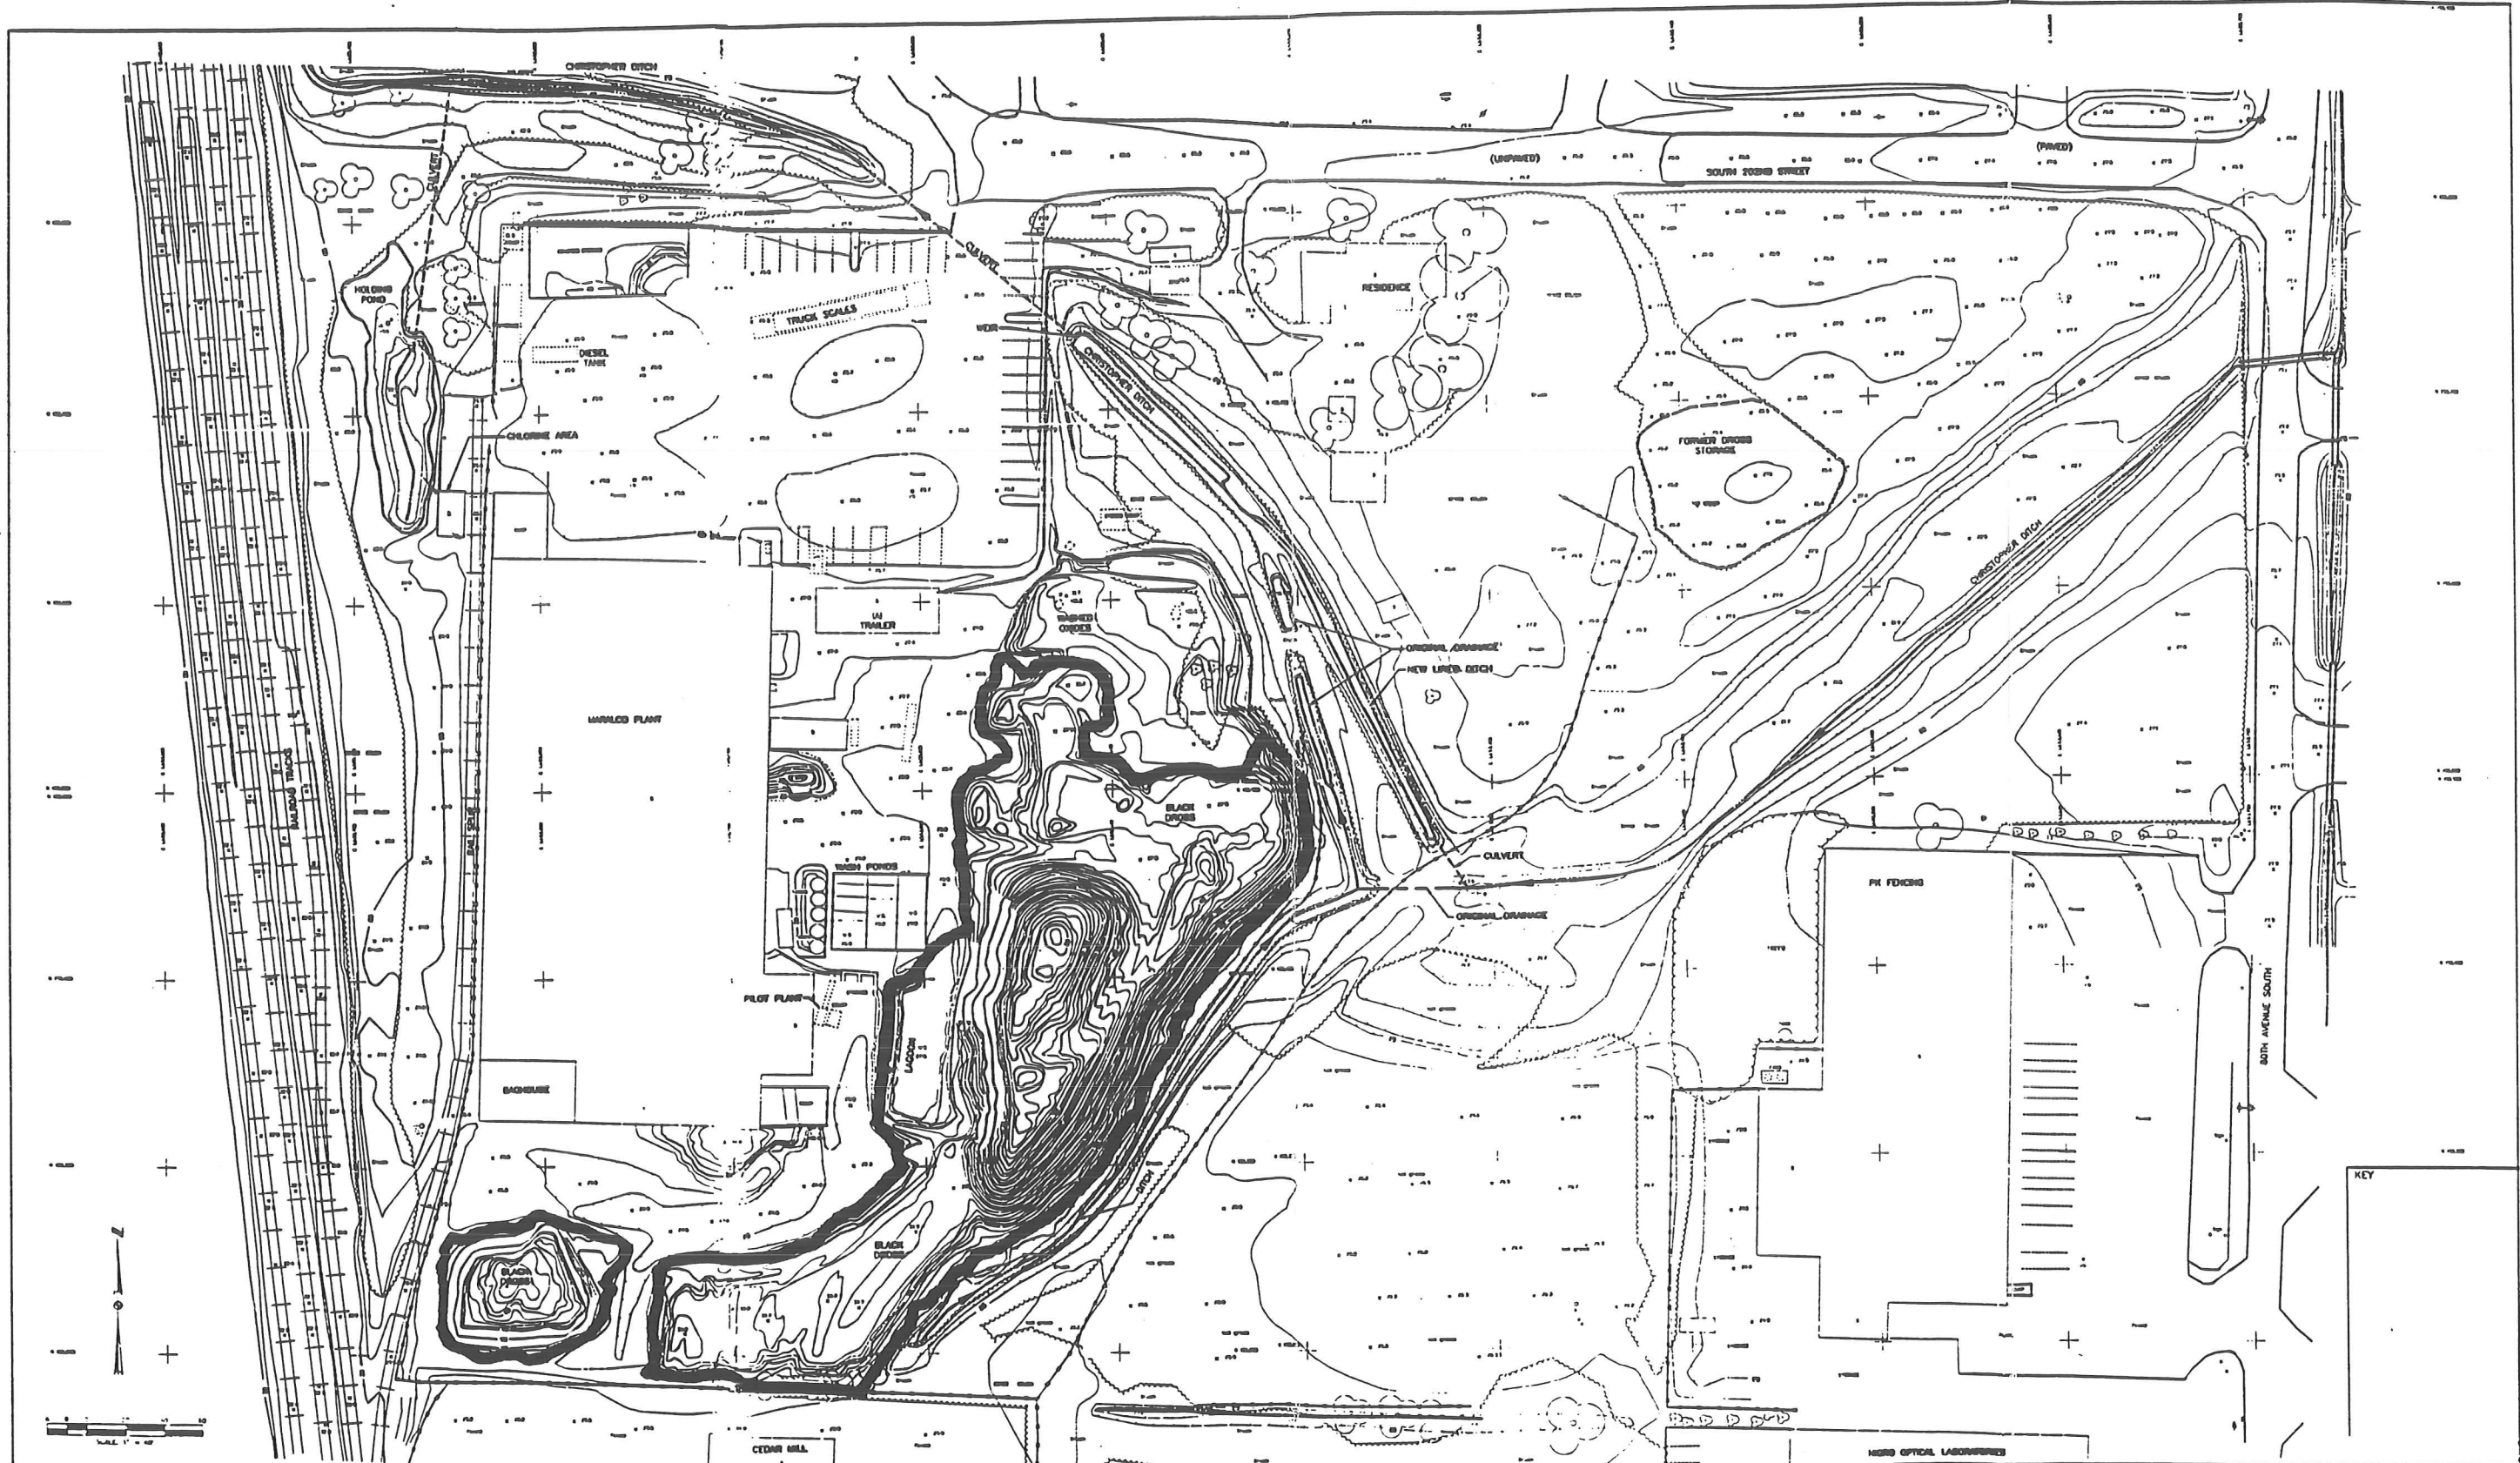
BLACK DROSS PILE MARALCO SITE Kent, WA	
Figure No: 3-15	File Name:

The total volume of the black dross pile was calculated to be 19,325 cubic yards with an accuracy of $\pm 10\%$. Using a density factor for the dross of 2,700 pounds per cubic yard, the total tonnage of black dross is 26,089 tons. This figure includes an estimated moisture content of 20% which is equivalent to 5,218 tons of water. On a dry basis, the weight of the black dross pile is 20,870 tons.

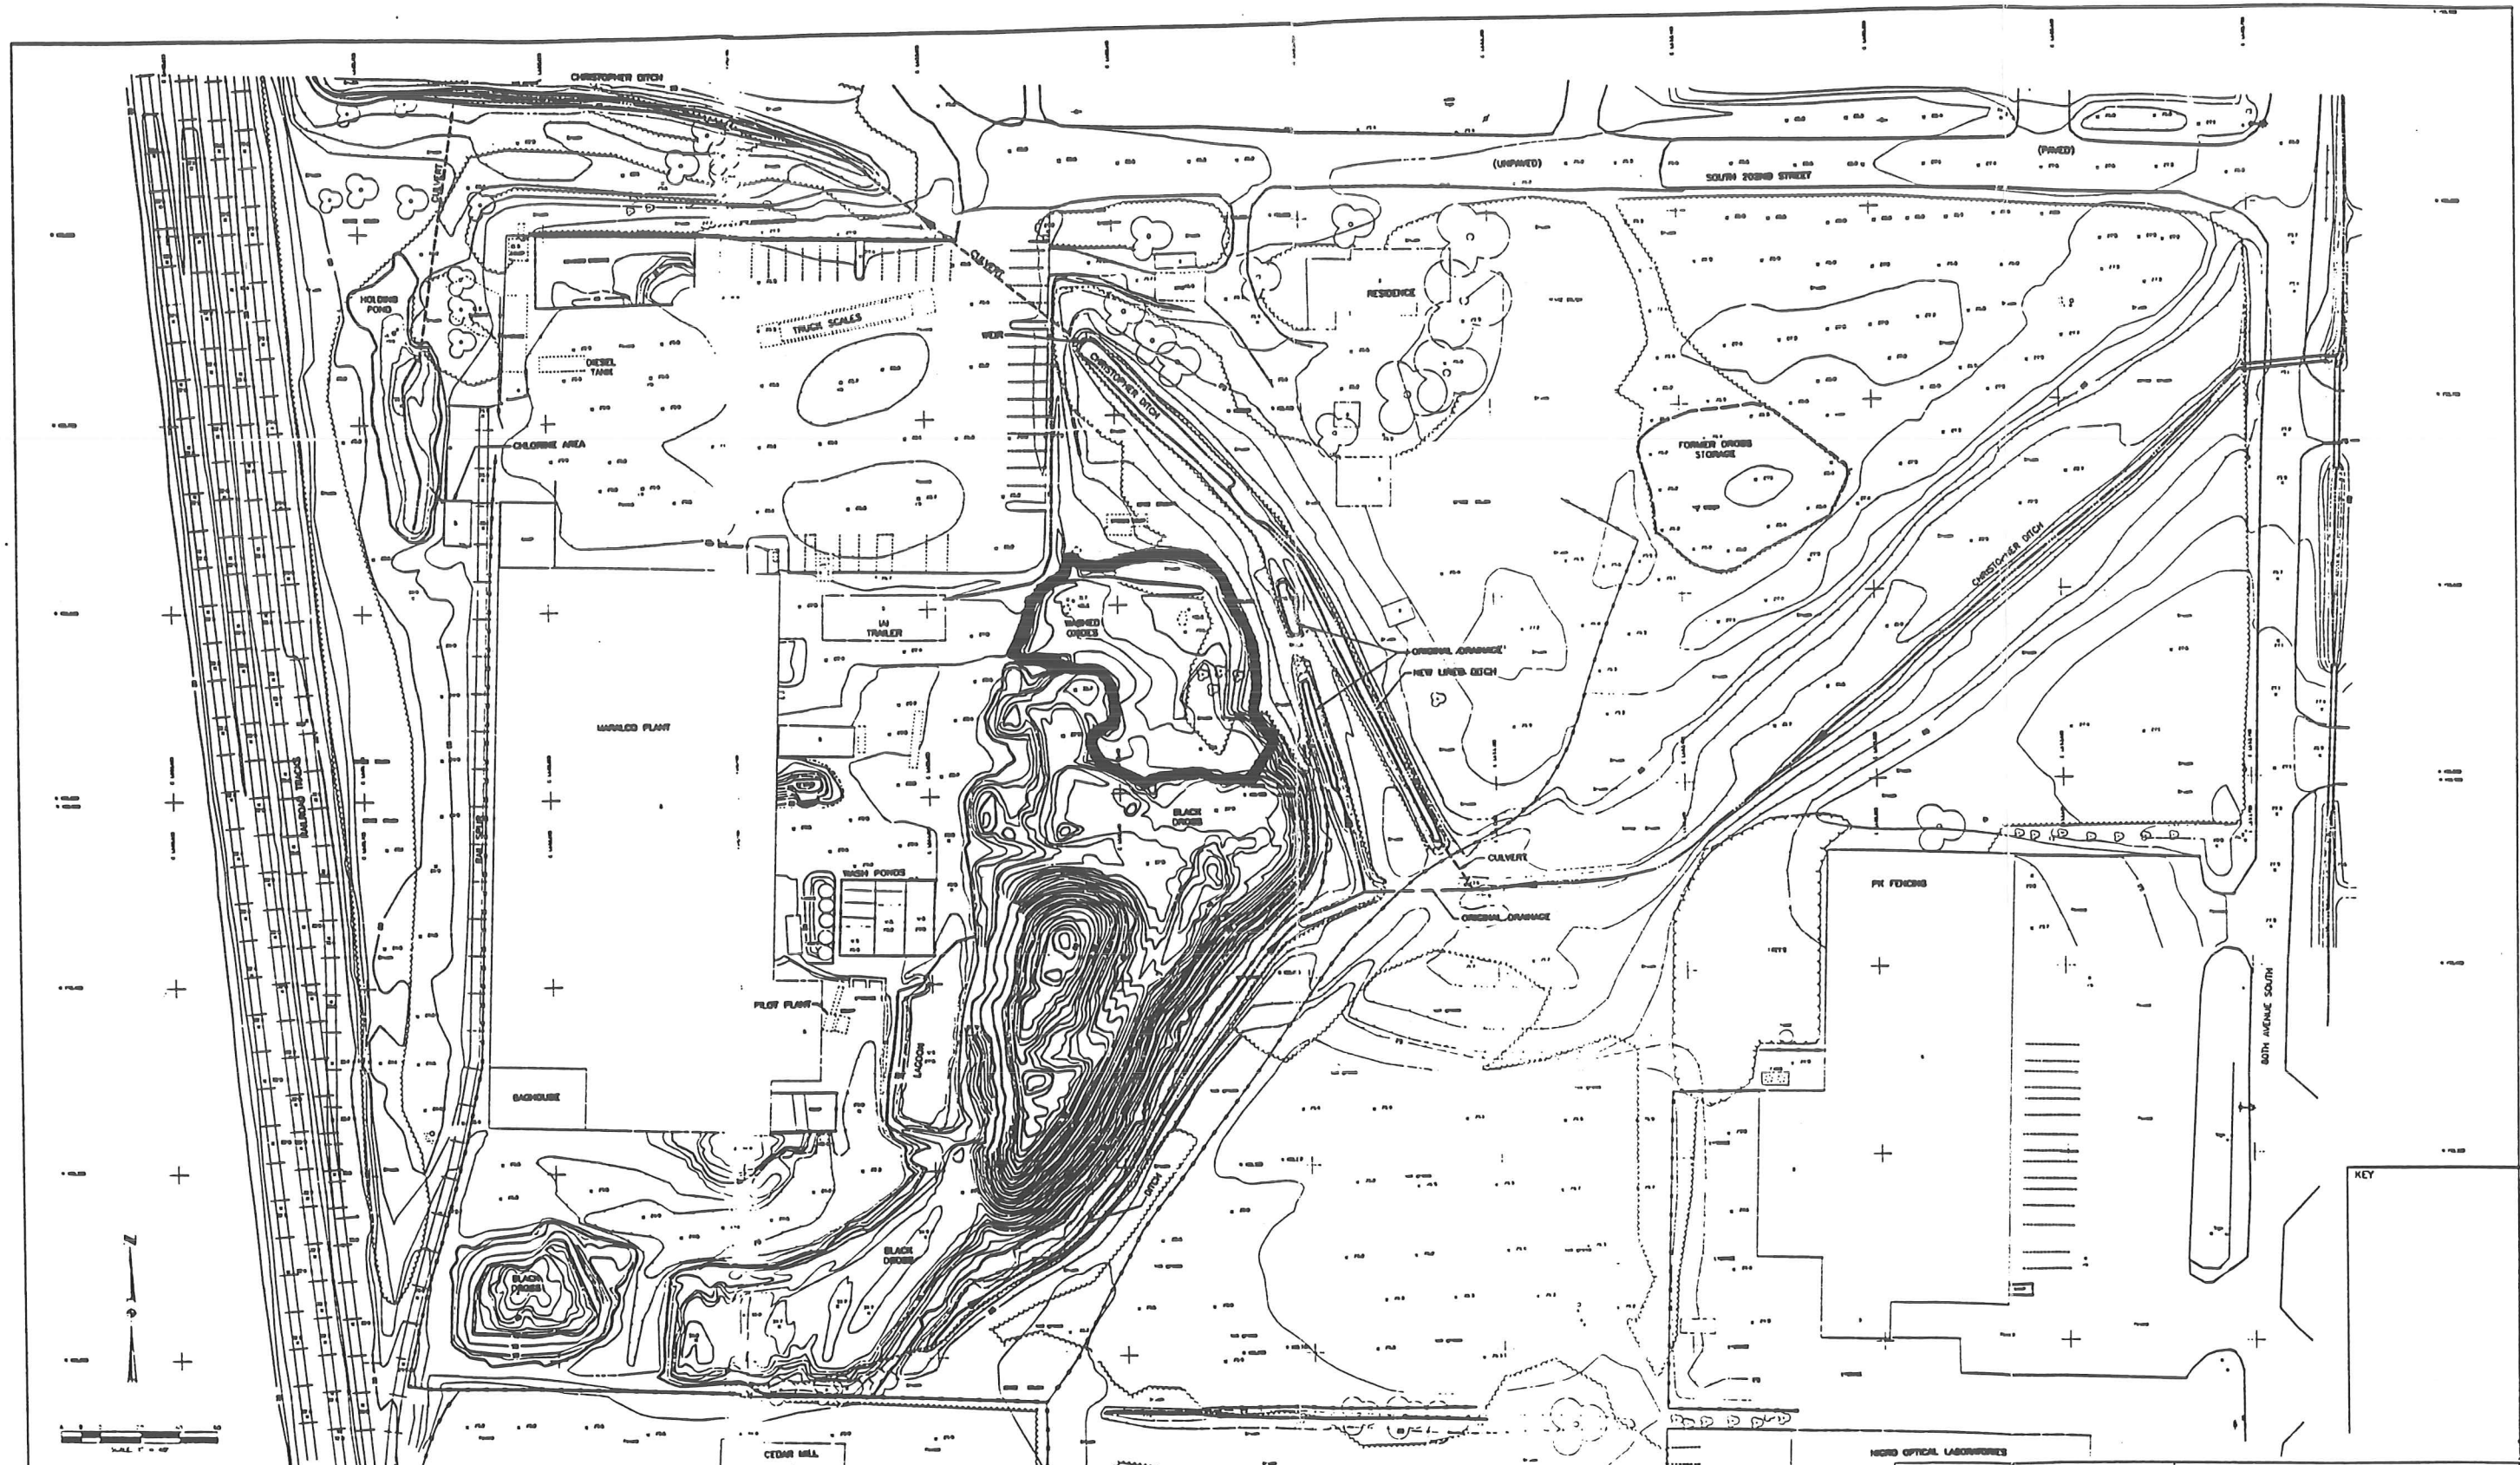
The washed oxide pile, located at the north end of the black dross pile, was also surveyed (see Figure 3-16). Using the same factors, the tonnage of washed oxide is estimated to be 1,450 tons. On a dry basis the weight is 1,160 tons.
