Subject: Northeast Heating Oil UST Removal and Site Assessment Report  
9<sup>th</sup> and Lenora Development Project  
Seattle, Washington  
GeoEngineers File No. 21138-001-03

This report presents the results of the heating oil underground storage tank (UST) system removal monitoring and site assessment activities completed in June 2015 at the 9<sup>th</sup> and Lenora development property (Subject Property). The Subject Property (approximately 0.49-acres) comprises two King County tax parcels (0660000540 and 0660000545) located at 2118 Westlake Avenue and 2101 9<sup>th</sup> Avenue, respectively, in Seattle, Washington. Ninth and Lenora LLC owns the Subject Property which is currently a construction site. The Subject Property is bounded to the north by a retail building, Lenora Street to the south, 9<sup>th</sup> Avenue to the east, and a public alley to the west. The Subject Property is shown relative to surrounding physical features on the Vicinity Map, Figure 1.

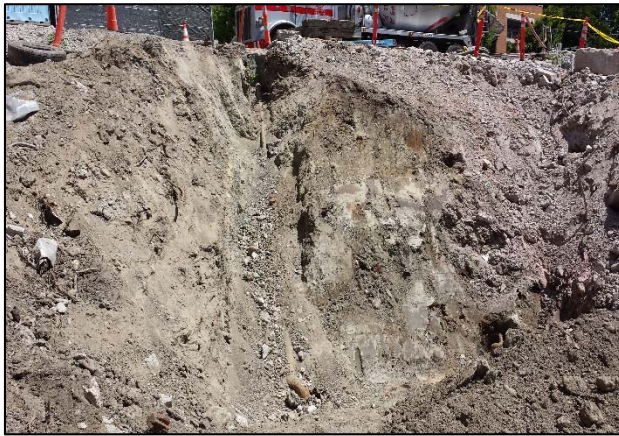
Preparing to remove the fill port (uphill), fuel supply line, and UST (downhill) in northeast portion of the Subject Property – looking east

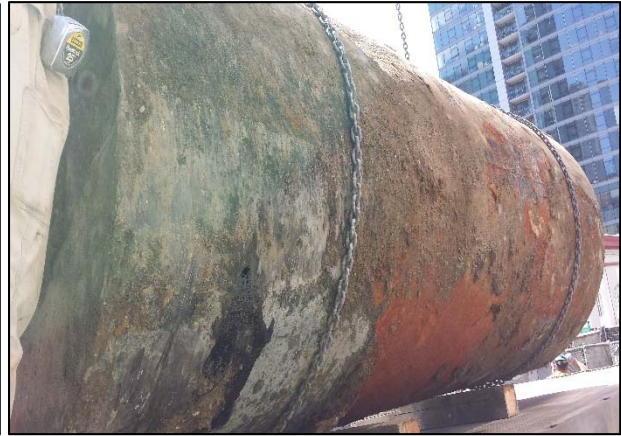
- The top of the UST was observed at an approximate depth of 2 feet (estimated elevation 67 feet) below the existing concrete slab (remnant from former Subject Property improvements). The steel tank measured approximately 12 feet in length and 5 feet in diameter (approximately 1,750 gallons). The tank appeared to be in good physical condition except for one 3/4-inch diameter hole in its side near the bottom of the tank (see photos).

Removal of 1,750 gallon diesel UST. A hole is visible near the tank bottom – looking north

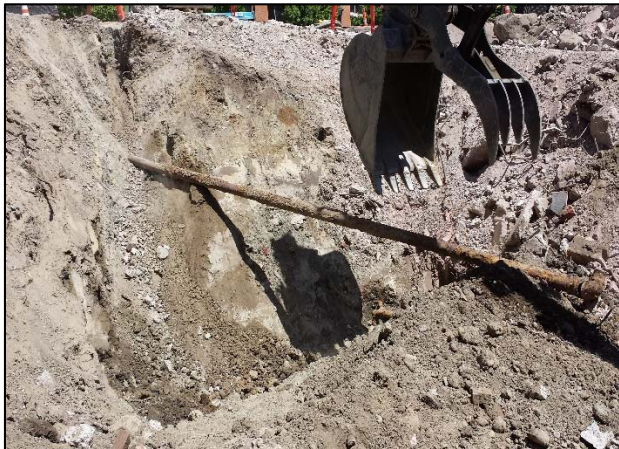
Excavation and removal of fuel supply line east of UST – looking southeast

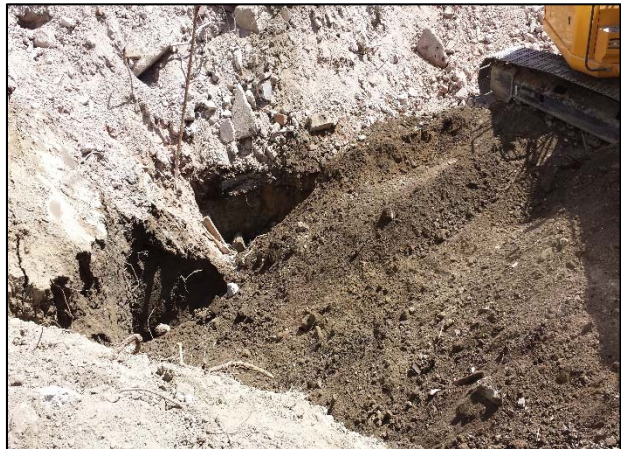
- CTI backfilled the UST excavation using the stockpiled overburden soil.

Petroleum-impacted overburden soil stockpile backfilled in UST excavation – looking southeast

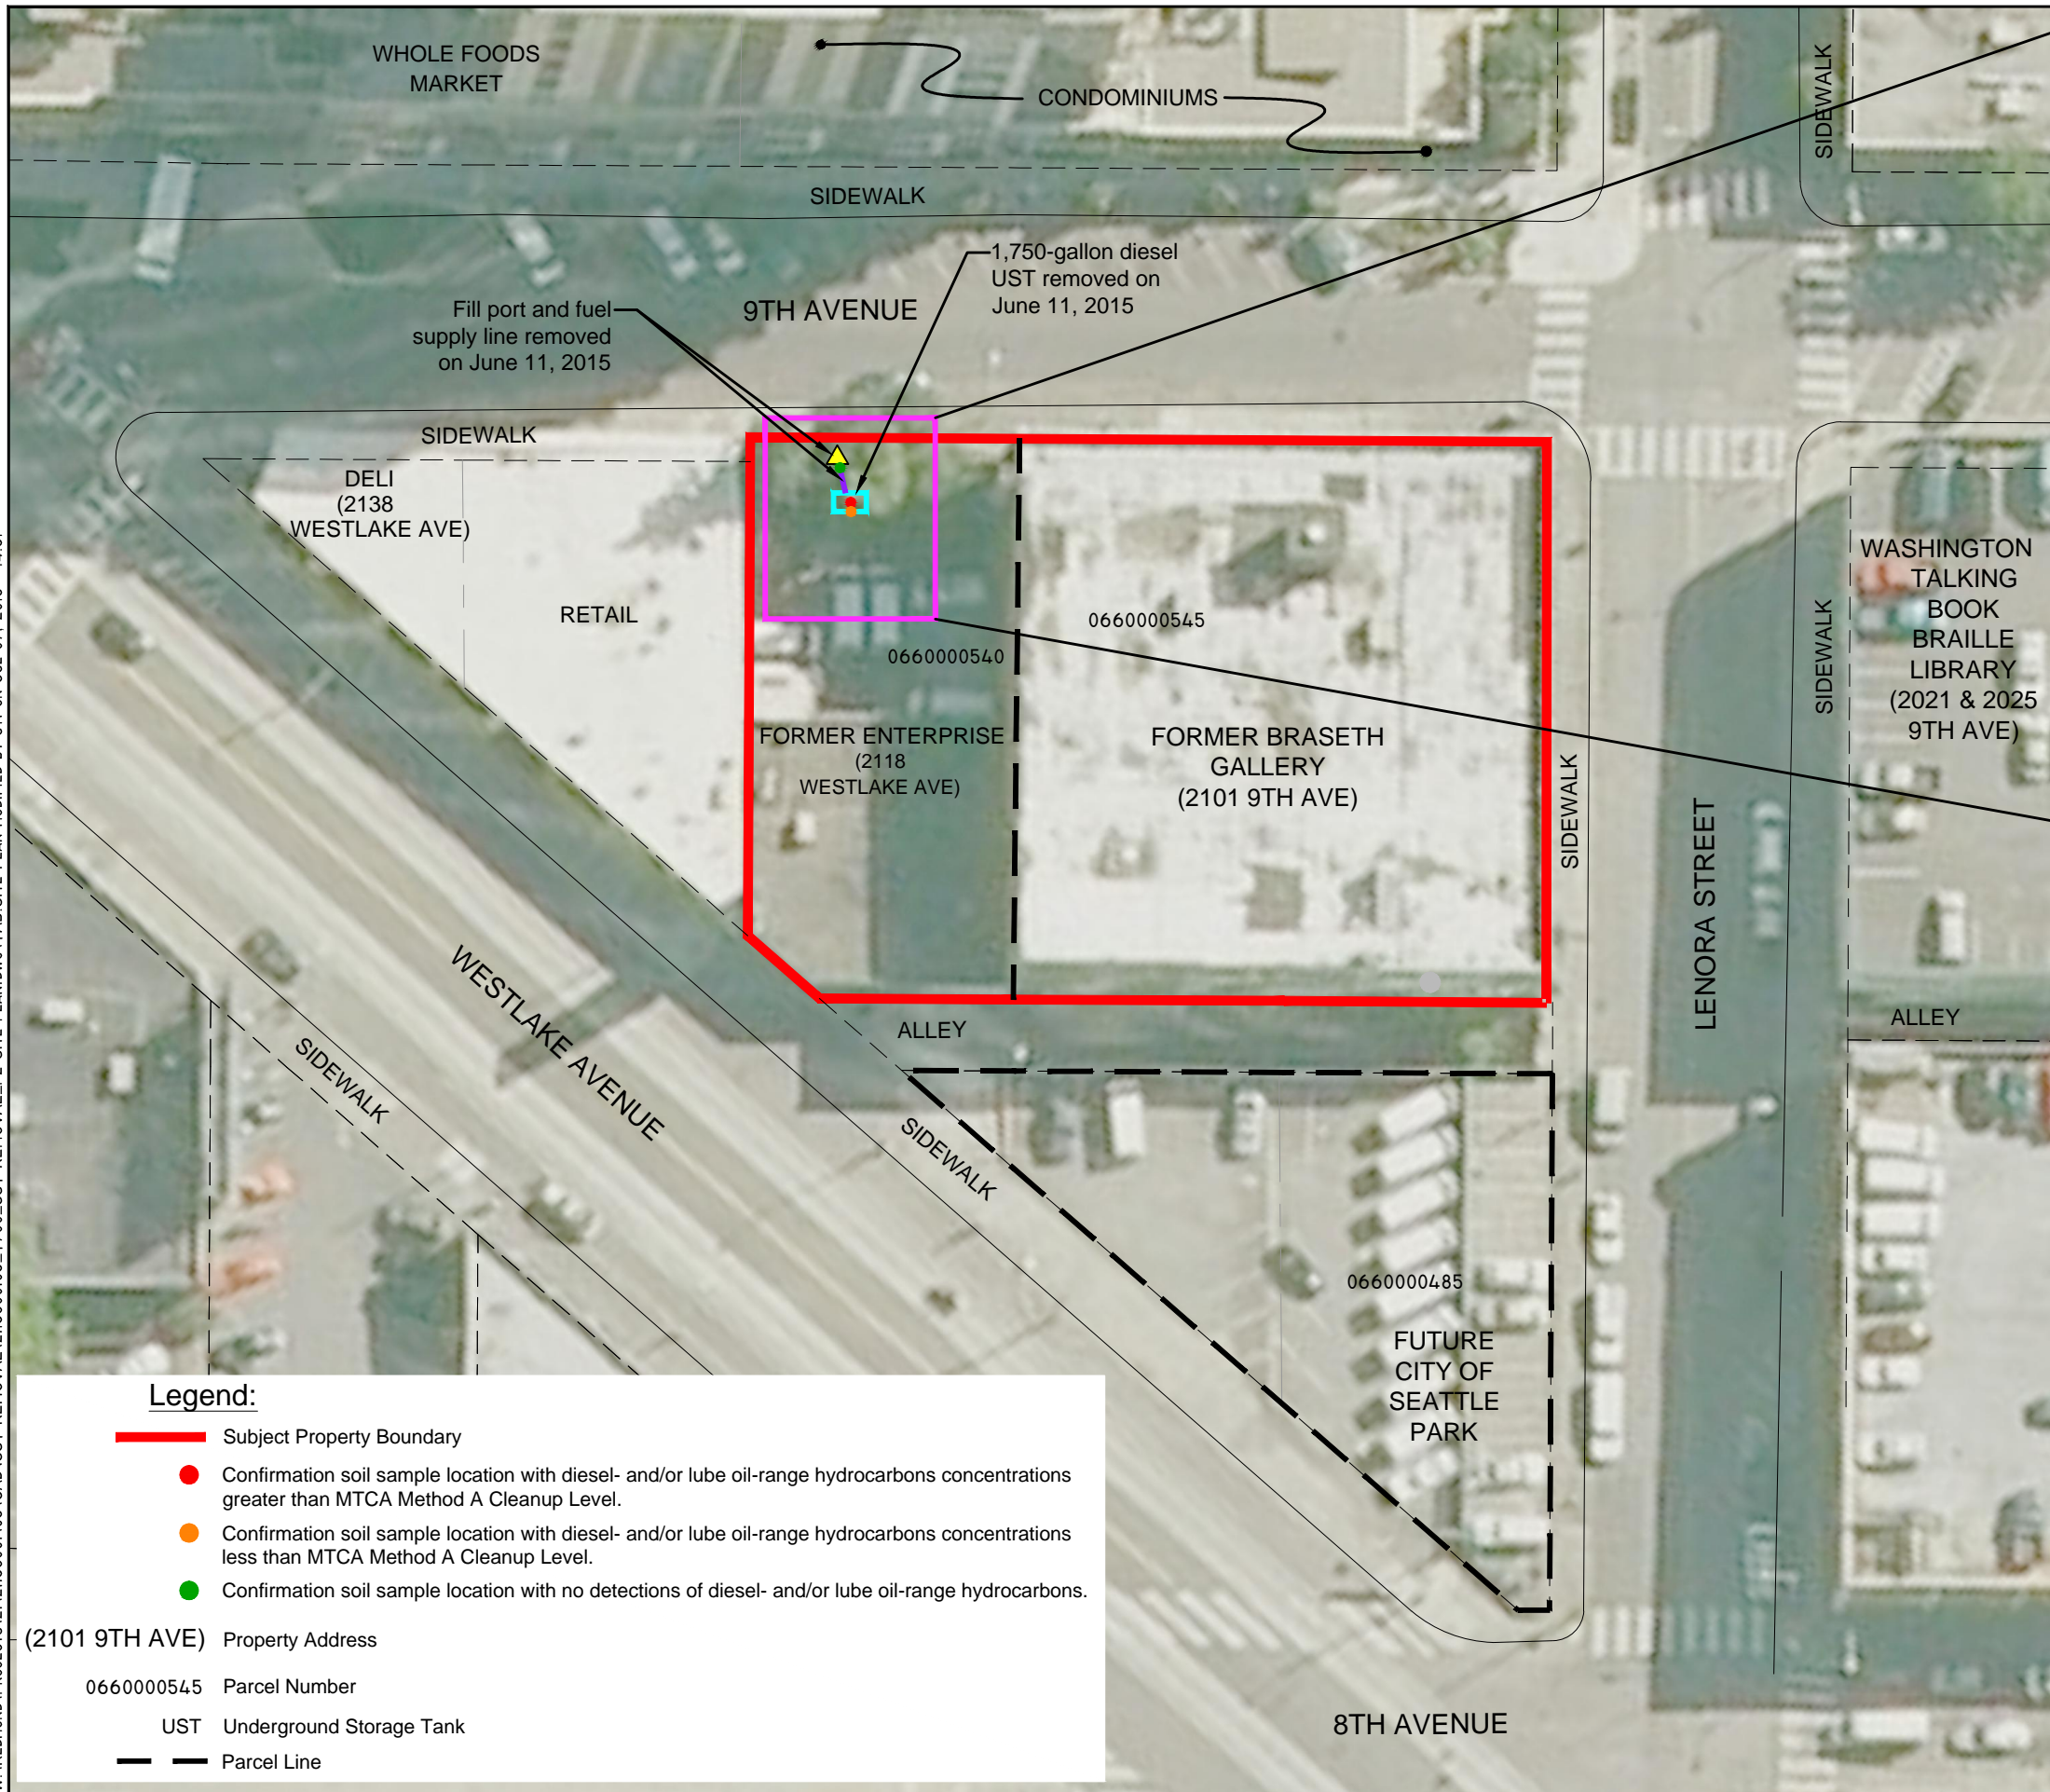
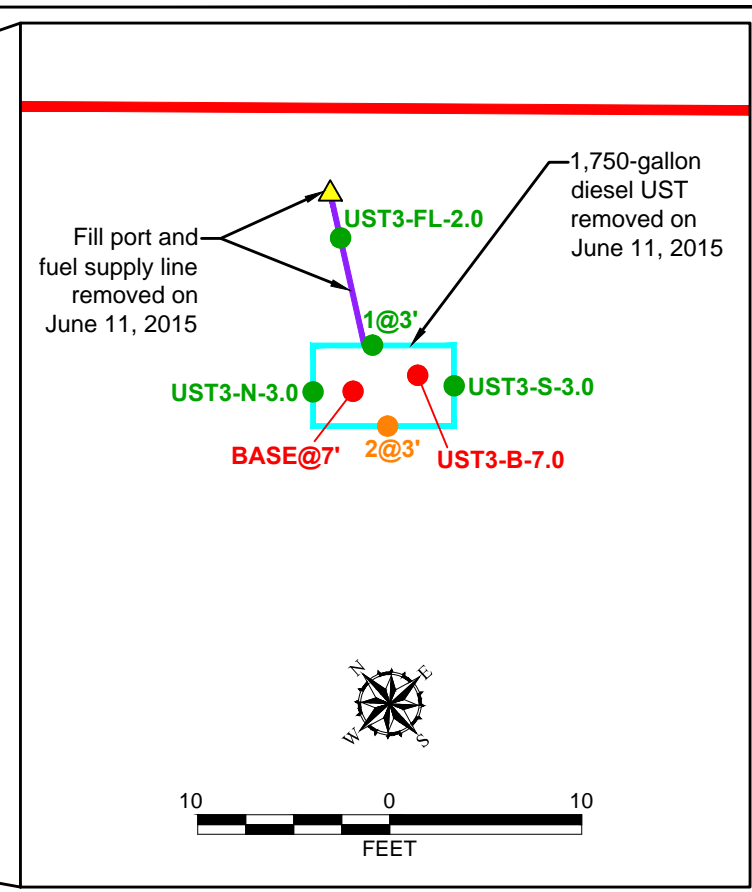
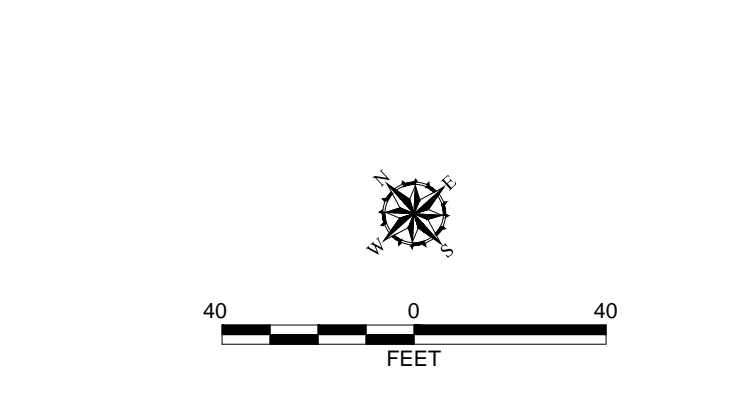
**Figure 2**

The UST system consisting of a fill port, fuel supply line, and a steel diesel tank (approximately 1,750 gallons) was discovered at the 2118 Westlake Avenue property (parcel 0660000540) in June 2015 during construction activities associated with the Subject Property redevelopment. The UST and associated components were located in the northeast portion of the Subject Property close to 9<sup>th</sup> Avenue. Approximate locations of the UST and associated components relative to Subject Property layout are shown on the Site Plan, Figure 2.

**UST Removal Site Plan**
