***Remedial Investigation  
Westbay Marina  
2100 West Bay Drive NW  
Olympia, Washington***

***Prepared for  
Washington State  
Department of Ecology***

***June 30, 2011  
17330-35***

Prepared by  
**Hart Crowser, Inc.**

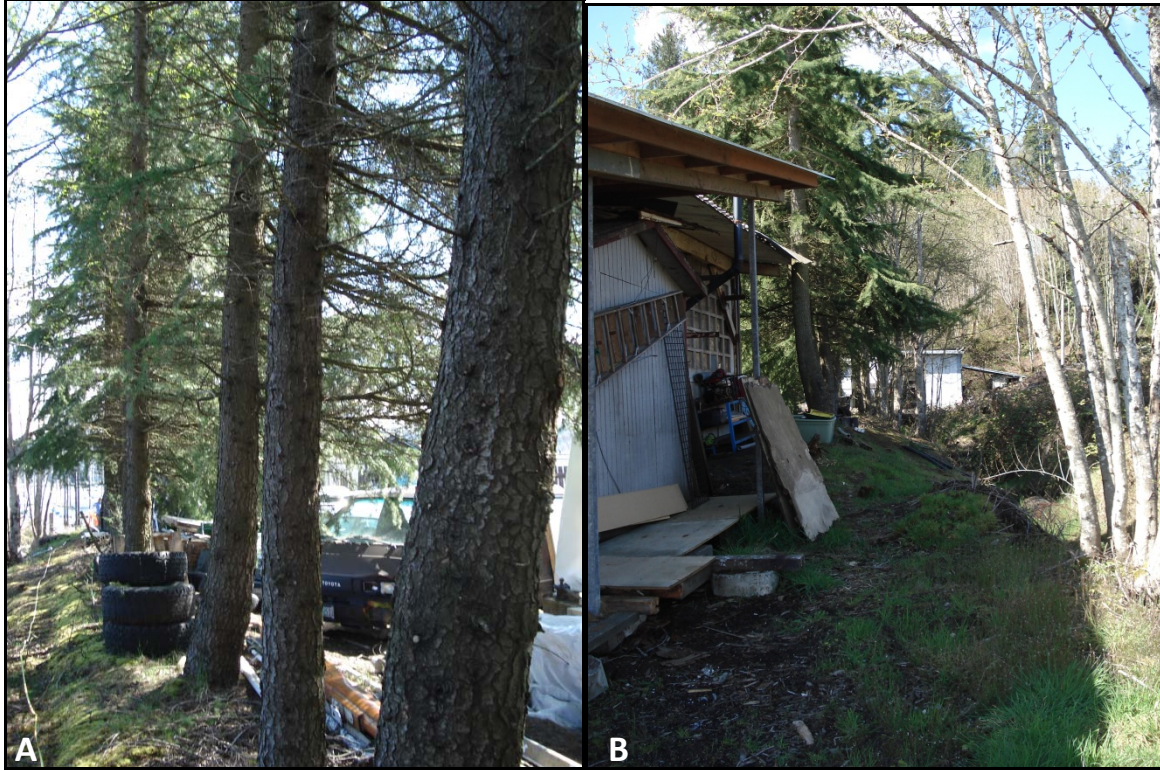
Figure C-5. Northern Strip (Area 1) [A is looking east toward Budd Inlet and B is looking west toward West Bay Drive NW. Birch and cedar trees growing over weedy groundcover. There is no fence separating the Site from the Dunlap Towing Company, but a ditch (containing water at the time of the field survey in April 2011) runs along the boundary and empties into Budd Inlet.]

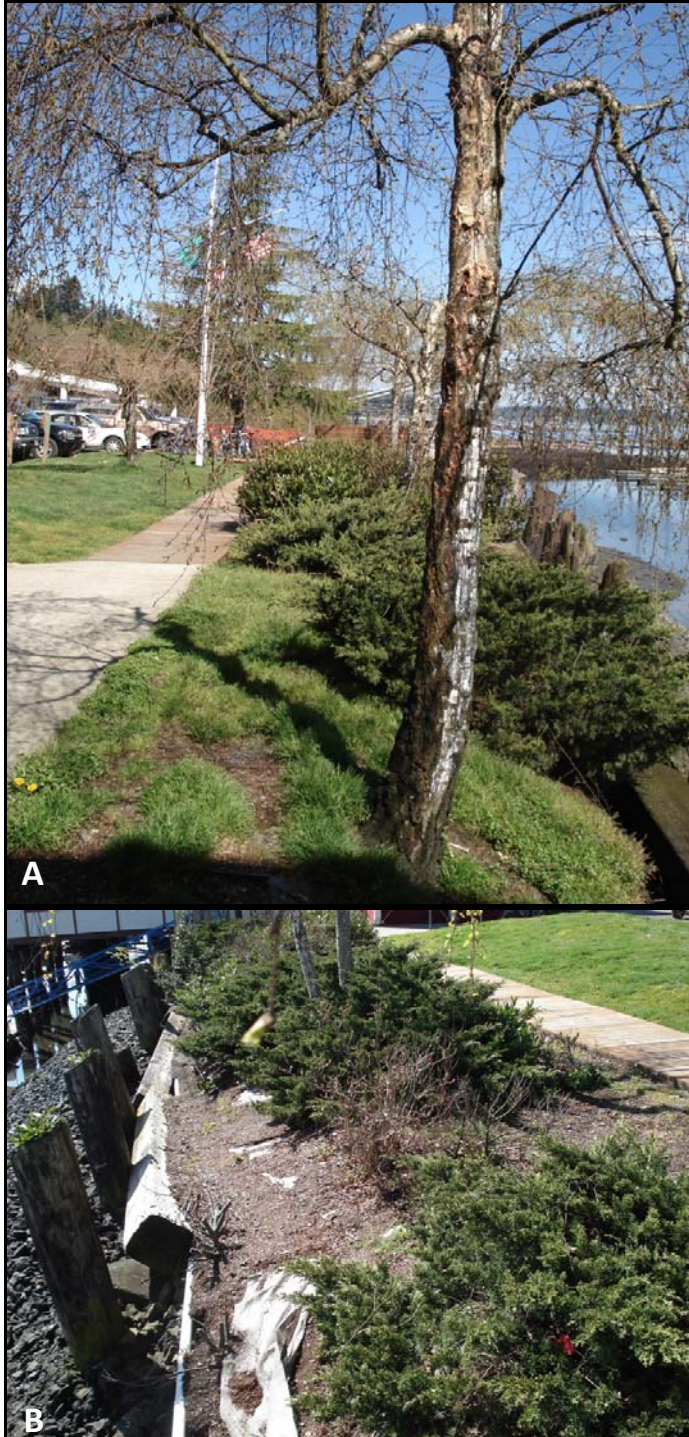
Figure C-6. Northeast Strip (Area 2) [A is looking north toward Dunlap Towing Company and B is looking south toward Tugboat Annie's Restaurant. Turf grass with birch and flowering plum trees covers some areas, while juniper shrubs with wood/bark mulch covers the shoreline. Area 2 drops off onto a relatively steep cobble beach.]

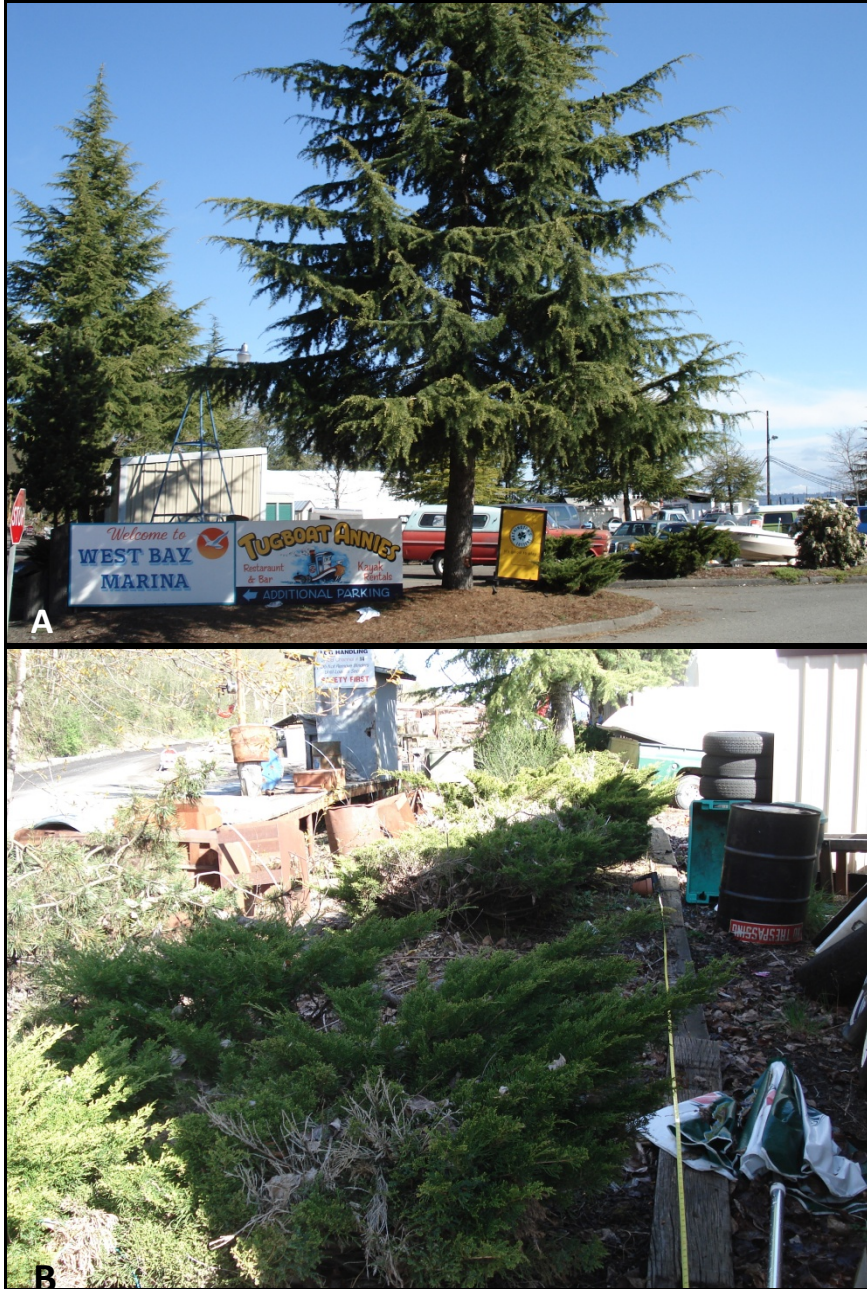
Figure C-7. Northwest Strip (Area 3) [A is looking southeast toward the Site entrance and B is looking north toward Dunlap Towing Company. Juniper shrubs with mulch cover part of the area and several cedrus trees line this strip. Although no fencing is present, storage sheds act as a buffer between West Bay Drive NW and the Site. ]

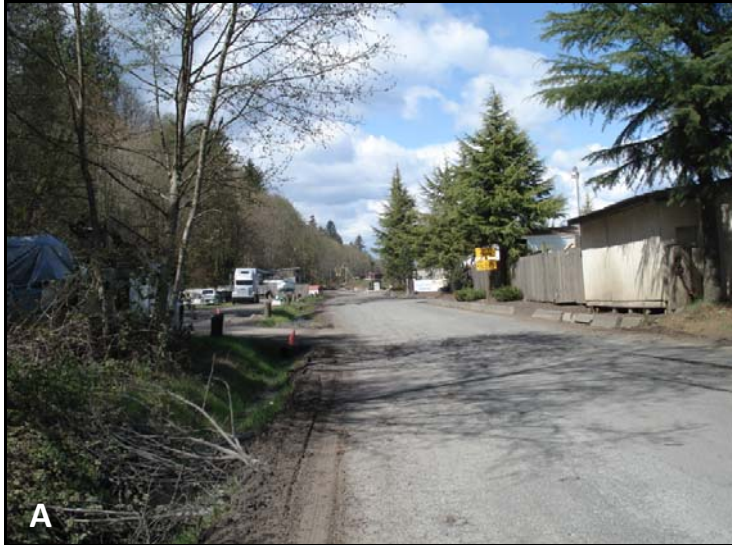
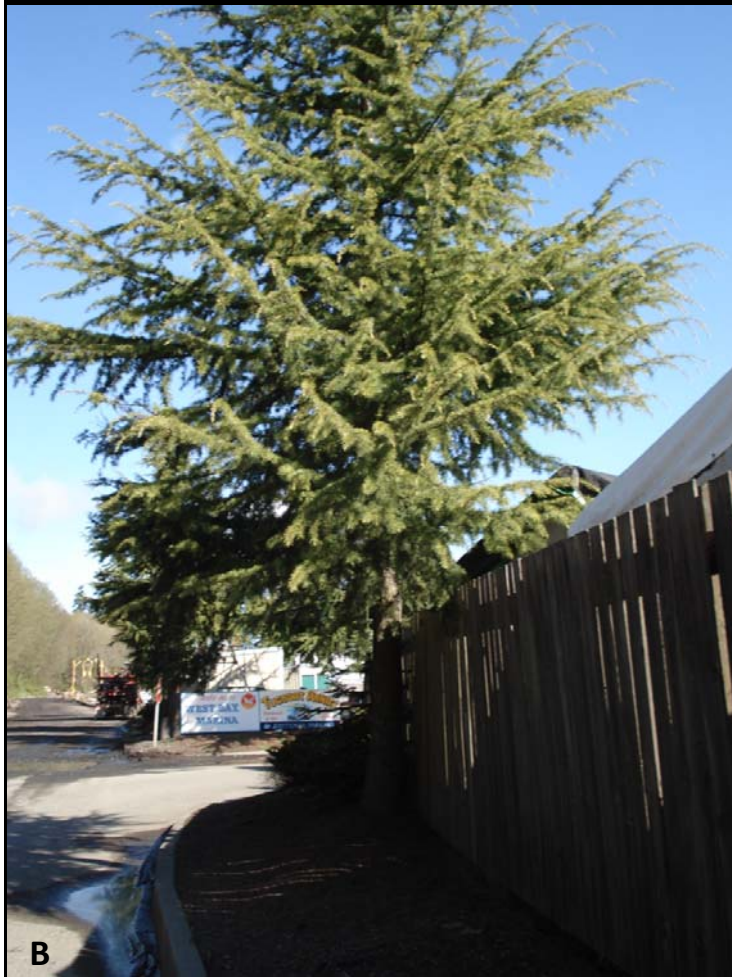
Figure C-8. Southwest Strip (Area 4) [A is looking north toward the Site entrance and B is a close-up of the Site entrance. The area is largely open ground with a few cedar and small oak trees.]

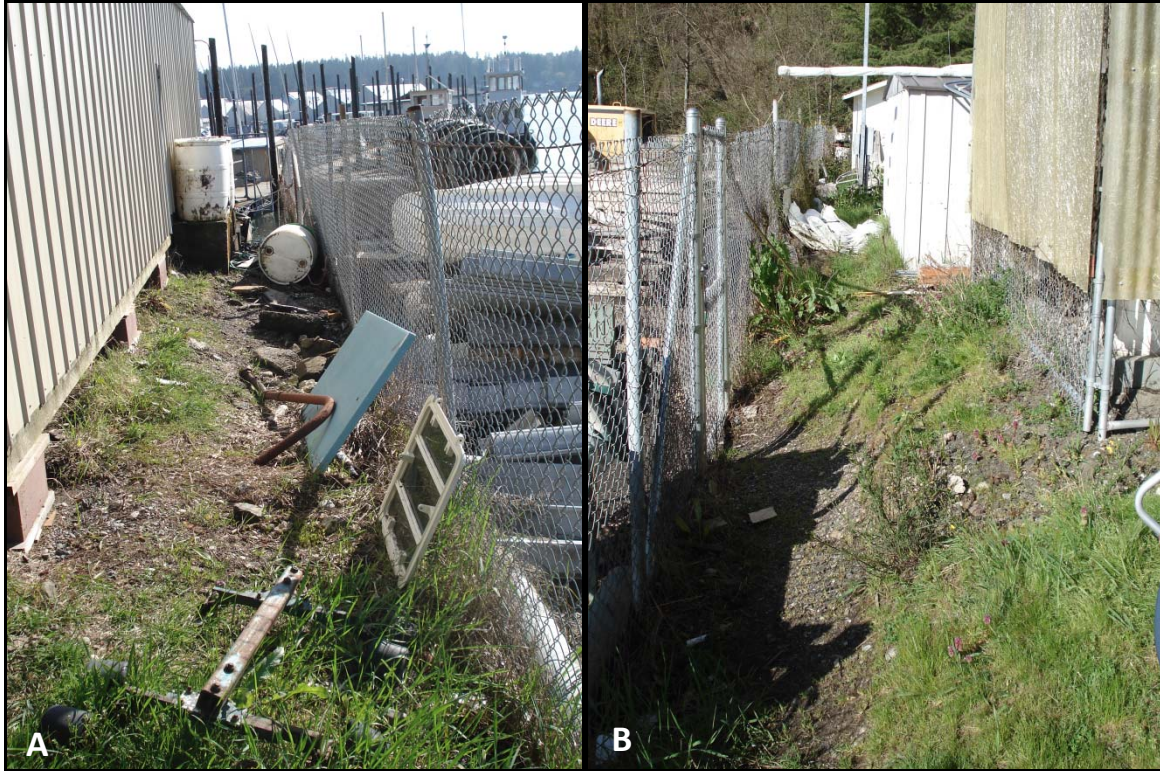
Figure C-9. Southern Ditch (Area 5) [A is looking east toward Budd Inlet and B is looking west toward West Bay Drive NW. The area is largely open ground with weedy grasses and forbs. There is a chain-link fence separating the Site and the Delson Lumber Company property.]

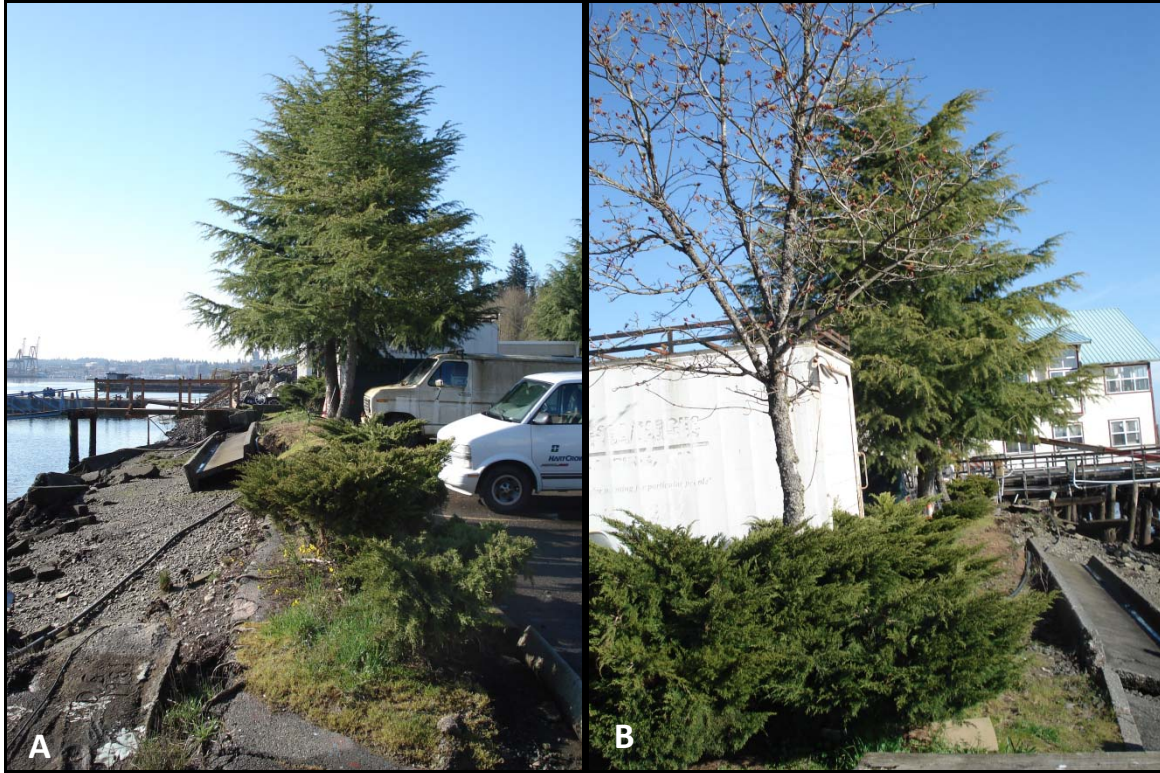
Figure C-10. Southeast Strip (Area 6) [A is looking south toward Delson Lumber Company property and B is looking north toward Tugboat Annie's Restaurant. Cedar and maple trees growing over juniper shrubs with little groundcover. This narrow strip of landscaping drops off onto a relatively steep cobble beach.]

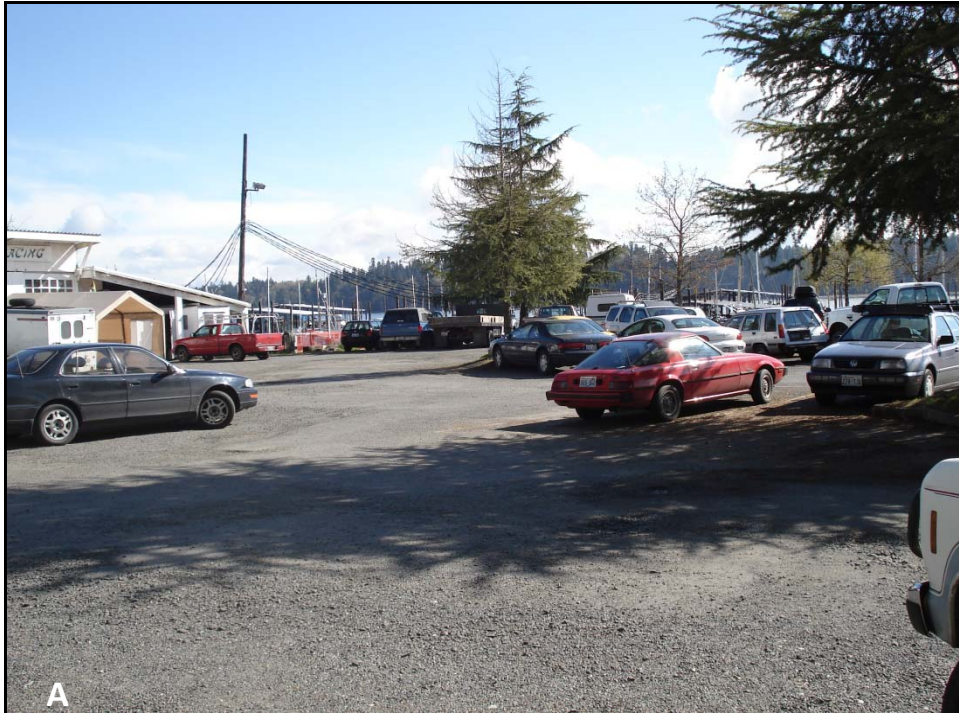
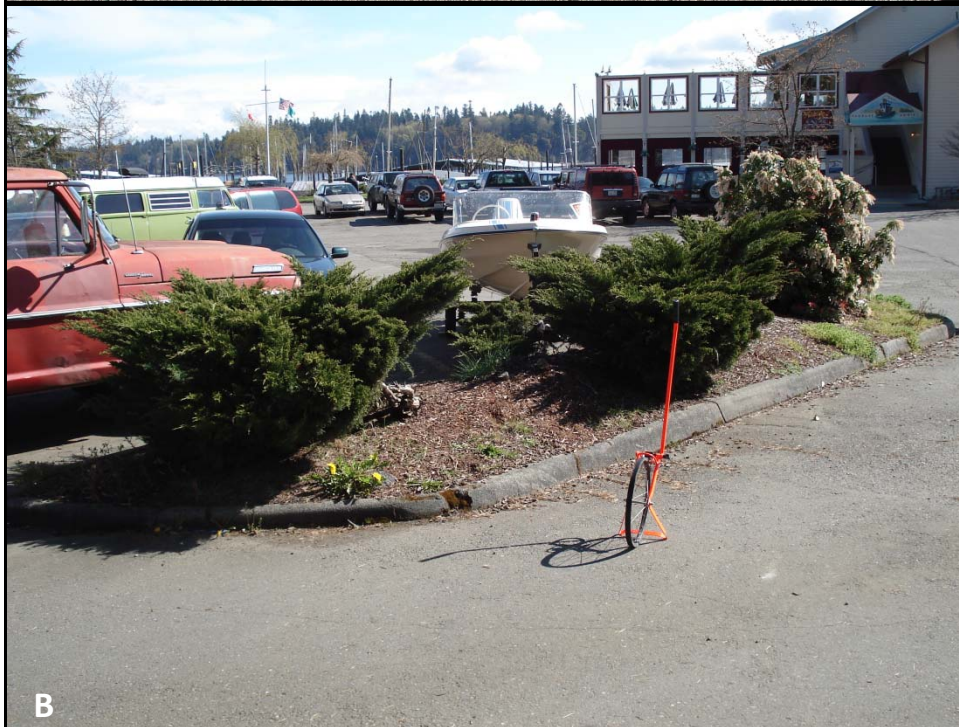
Figure C-11. Parking Lot Islands (Area 7) [A is looking northeast toward Budd Inlet and B is looking east toward Tugboat Annie's Restaurant. Plants include cedar trees and juniper and Japanese Andromeda shrubs. Note that some islands have curbed borders, while others do not.]

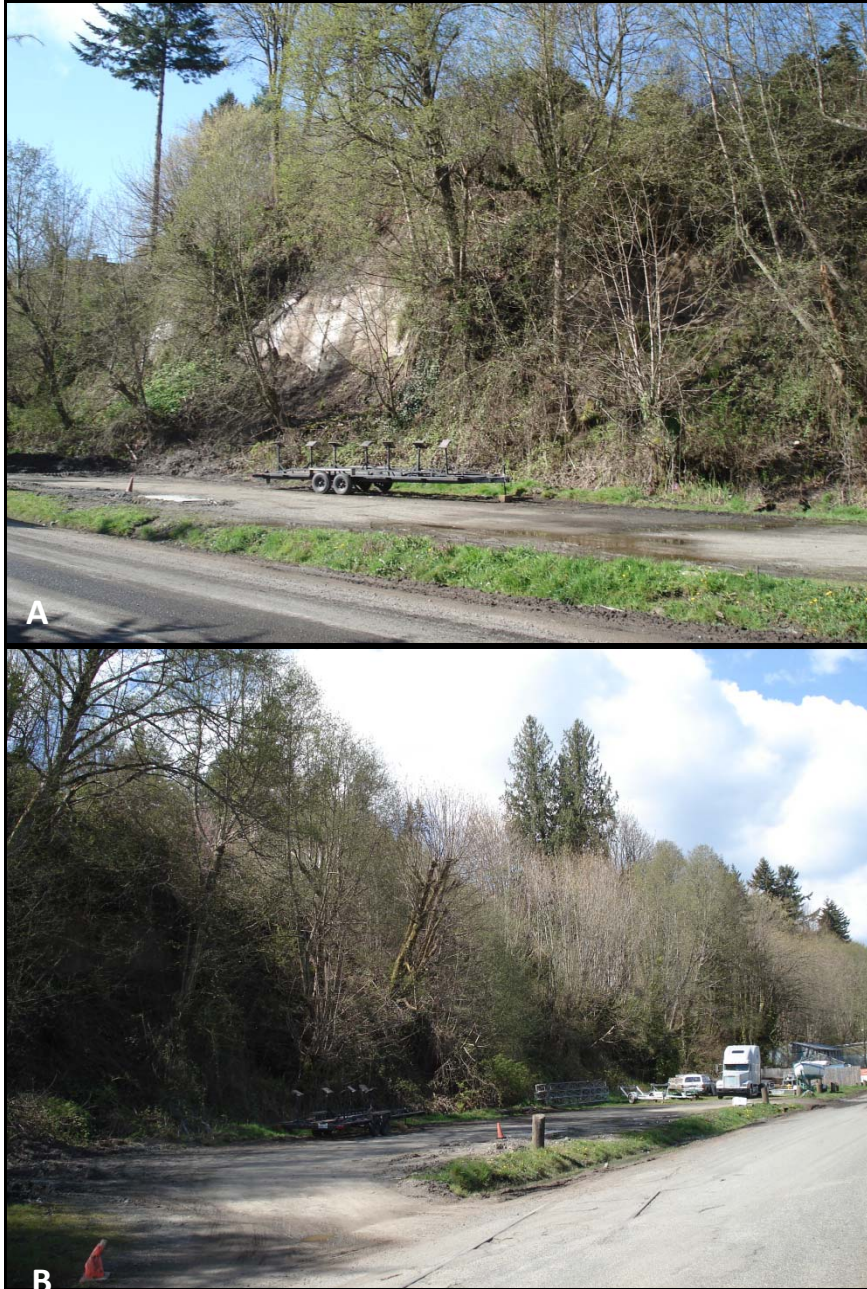
Figure C-12. Hillside located west of the Site across West Bay Drive NW. [A is looking southwest from the Site and B is looking northwest from the Site. A parking/storage area is located at the base of the hillside and a shallow ditch (containing water at the time of the field survey in April 2011) occurs between the base of the hillside and the parking area. Trees include Douglas fir, bigleaf maple, and red alder. Grasses, blackberry, ferns, rush, and English ivy dominates the understory. The hillside extends over much of the western shoreline of Budd Inlet and provides a corridor for wildlife moving between forested areas on the top of the hillside.]

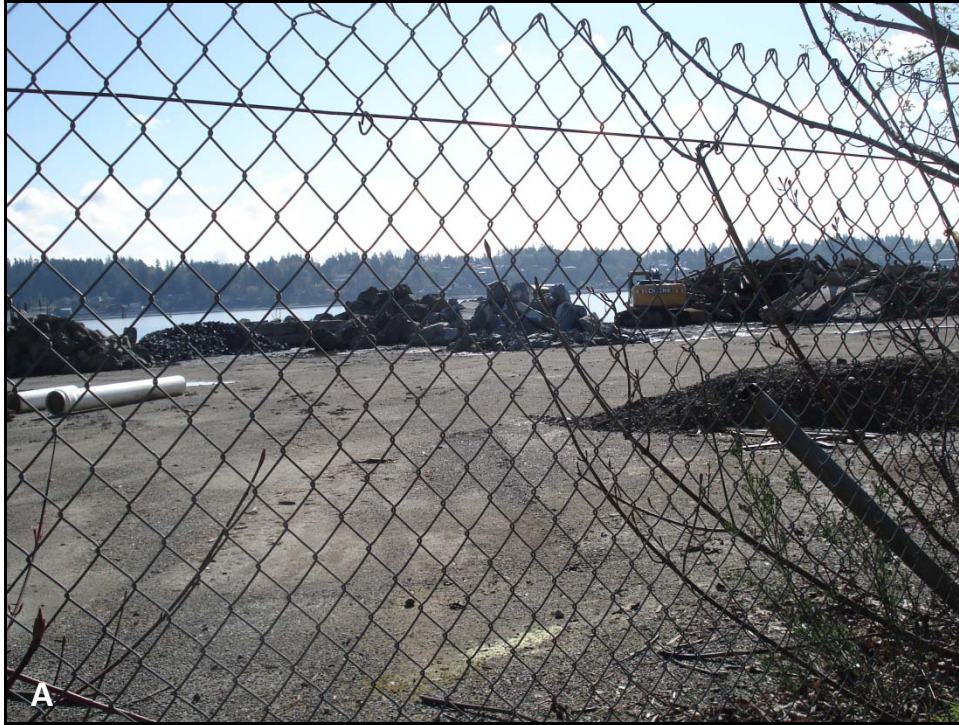
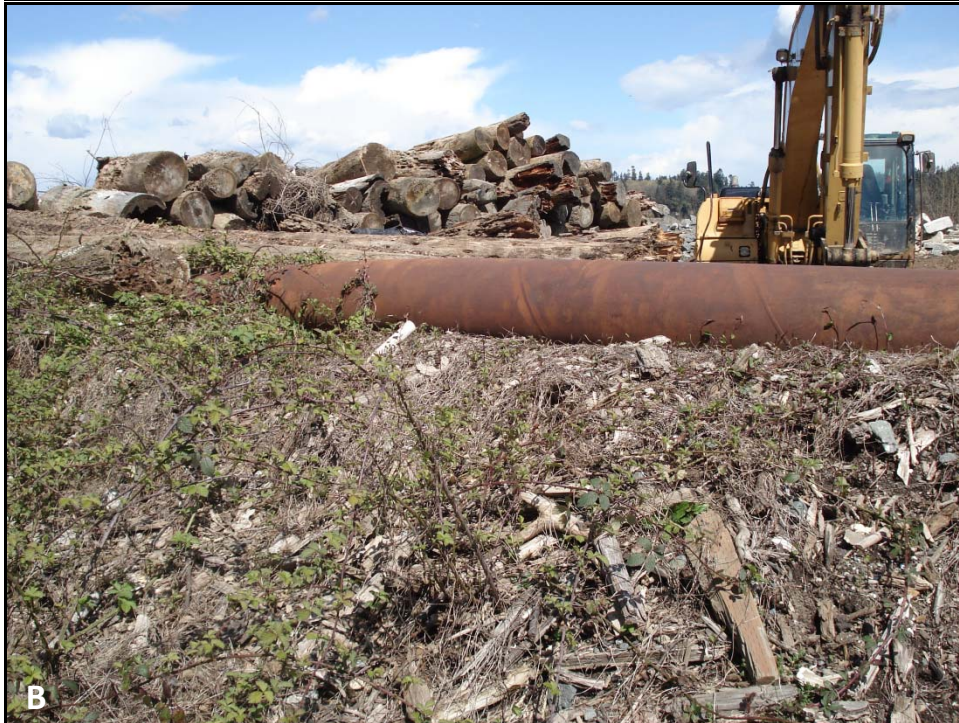
Figure C-13. Delson Lumber Company property located south of the Site. [A is looking southeast toward Budd Inlet and B is looking northeast toward Budd Inlet. This vacant property is a mixture of open ground and wood debris piles. Although some weedy vegetation is present along the perimeter of the property, the property provides limited habitat for wildlife.]

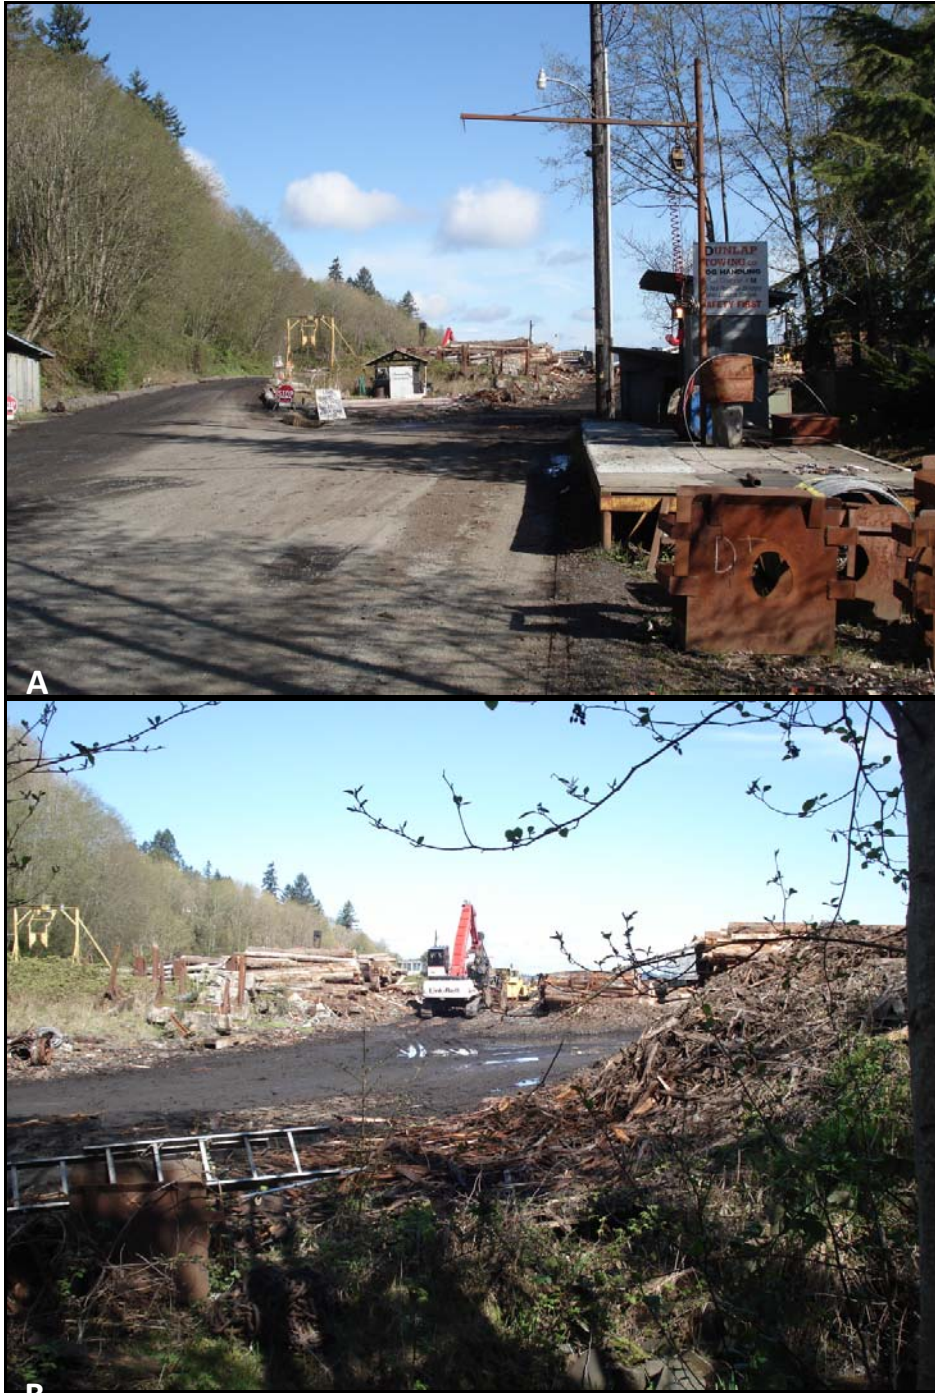
Figure C-14. Dunlap Towing Company property located north of the Site. [A is looking north toward entrance of Dunlap Towing Company and B is looking north from the Site. This operational facility consists of a mixture of open ground and log piles. Although some weedy vegetation is found along the perimeter of the property, it provides limited habitat for wildlife.]

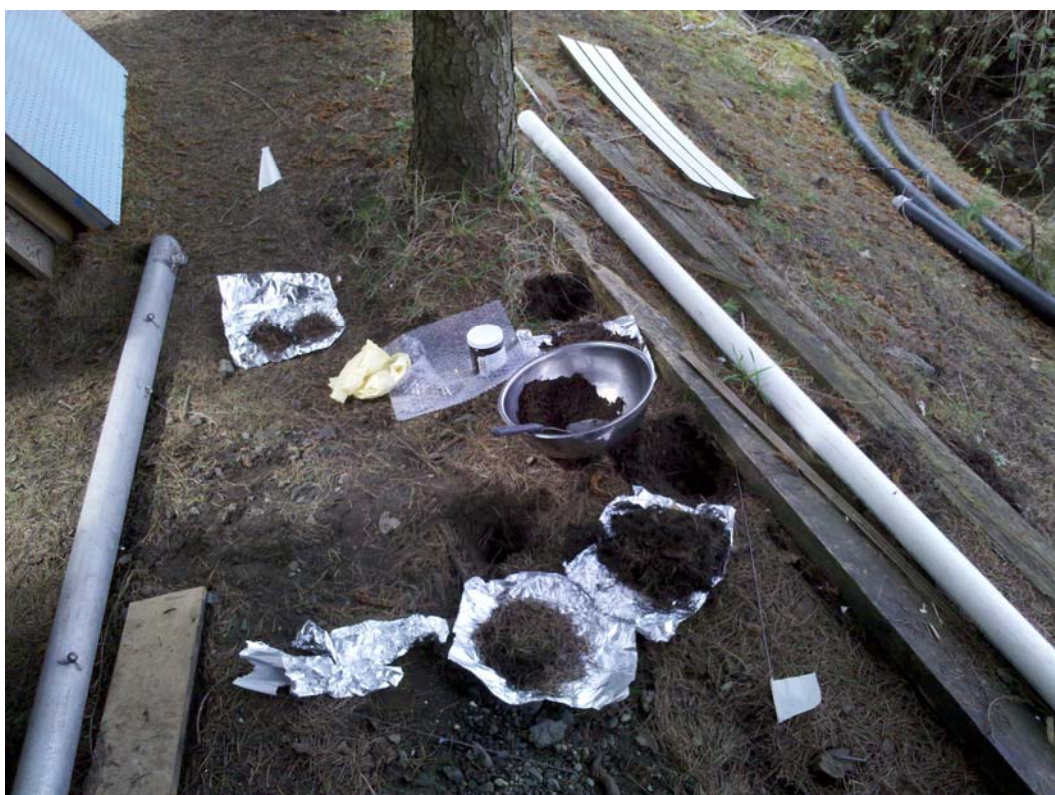
Dioxin/furan concentrations were compared to MTCA Method B criteria of 11 pg/g. Two samples, HC-WB-US-001 and HC-WB-US-002, located closest to the historic hog fuel burner, exceeded this criterion. It should be noted that sample HC-WB-US-001 had a significantly lower total solids result, compared to the other upland soil samples (45.4 percent compared to approximately 70 percent). When dioxins/furans extract results are dry-weight normalized, this low total solids value contributes to a higher sample result.

Photograph 1 - Upland soil sample location HC-WB-US-002.

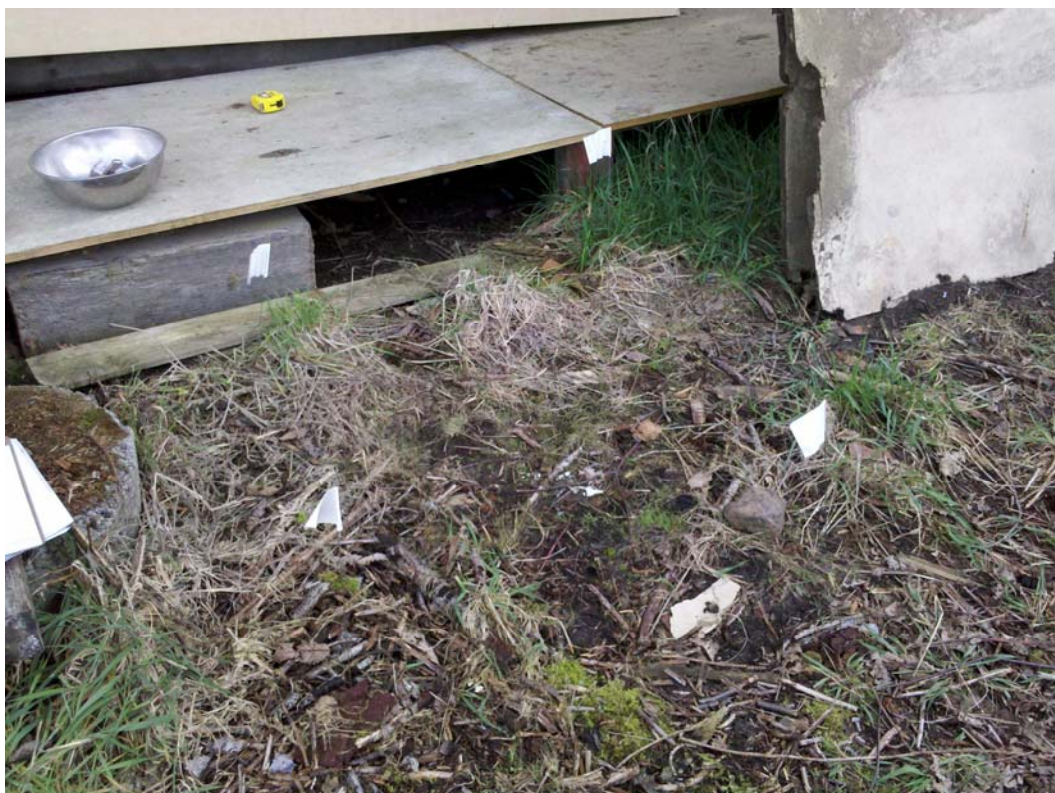
Dioxin/furan congeners were detected in all samples. The total TEQ concentrations ranged from 5.99 to 87.06 pg/g (picograms/gram or parts per trillion). The highest concentration was in sample HC-WB-US-001, located close to the historic hog fuel burner (Figure 2).

Photograph 2 - Upland soil sample location HC-WB-US-001.

The results of this RI indicate that the only constituents of potential concern in Westbay Marina warranting additional action under the MTCA are dioxins/furans in the upland soil in the vicinity of the former hog fuel burner. Dioxins/furans in this area is of potential concern with respect to both direct and

indirect human health exposures. It is recommended that the upland soil with dioxins/furans exceedances be further evaluated for cleanup action in accordance with the MTCA process.

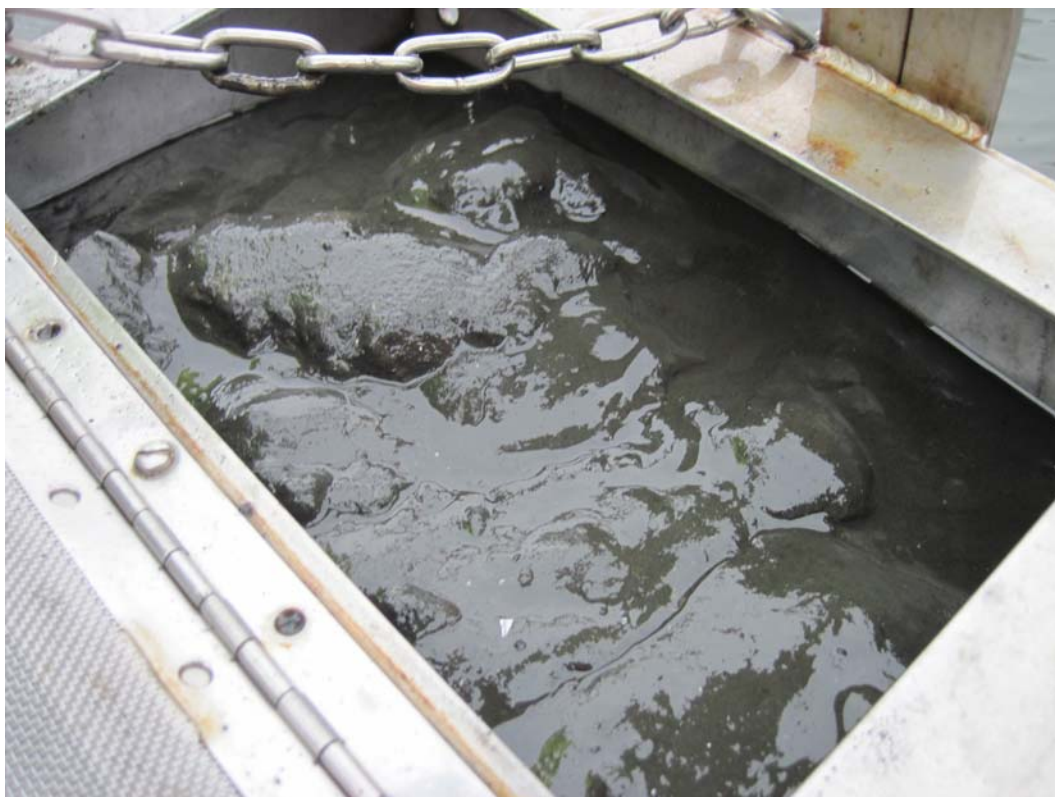
Photograph 6 - Subtidal surface sediment grab sample.

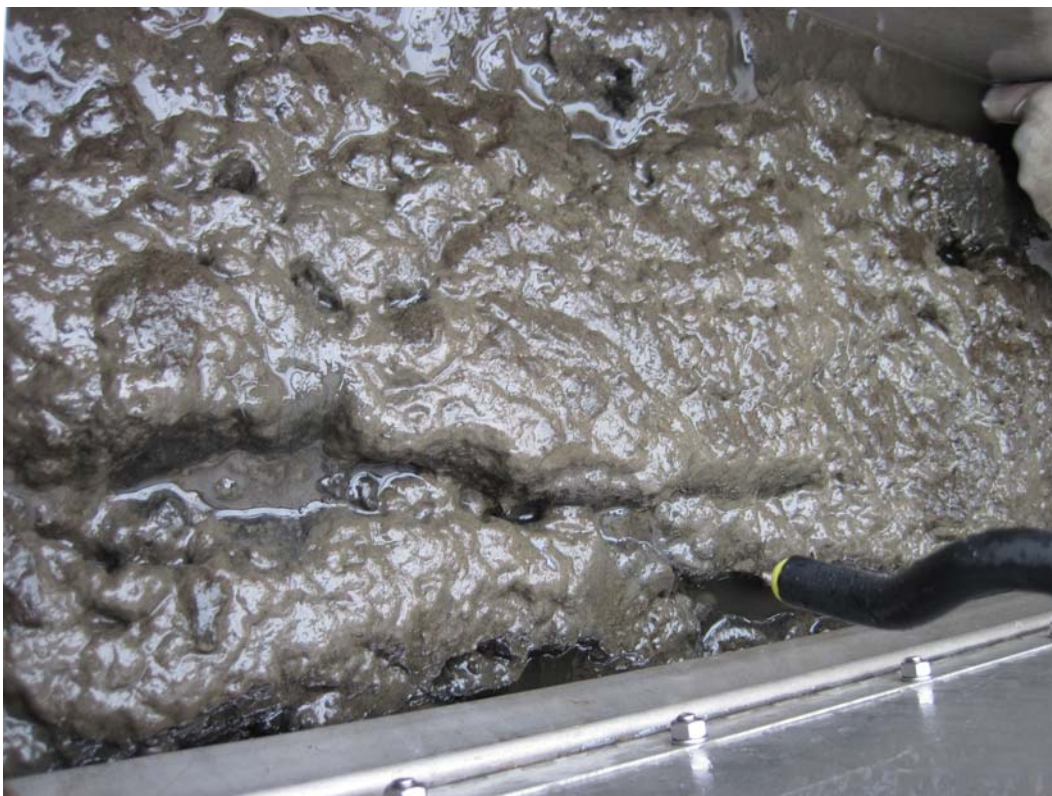
At sample locations HC-WB-SS-005, HC-WB-SS-006, and HC-WB-SS-007, the power grab was used for sample collection. Due to the soft sediment, all weights were removed from the sampler but, mounding was observed during sample collection. As no more weight could be removed, it was decided to accept the sample and collect sediment from the areas in the grab that were least disturbed

Photograph 7 - Example of an over penetrated surface sediment grab sample.

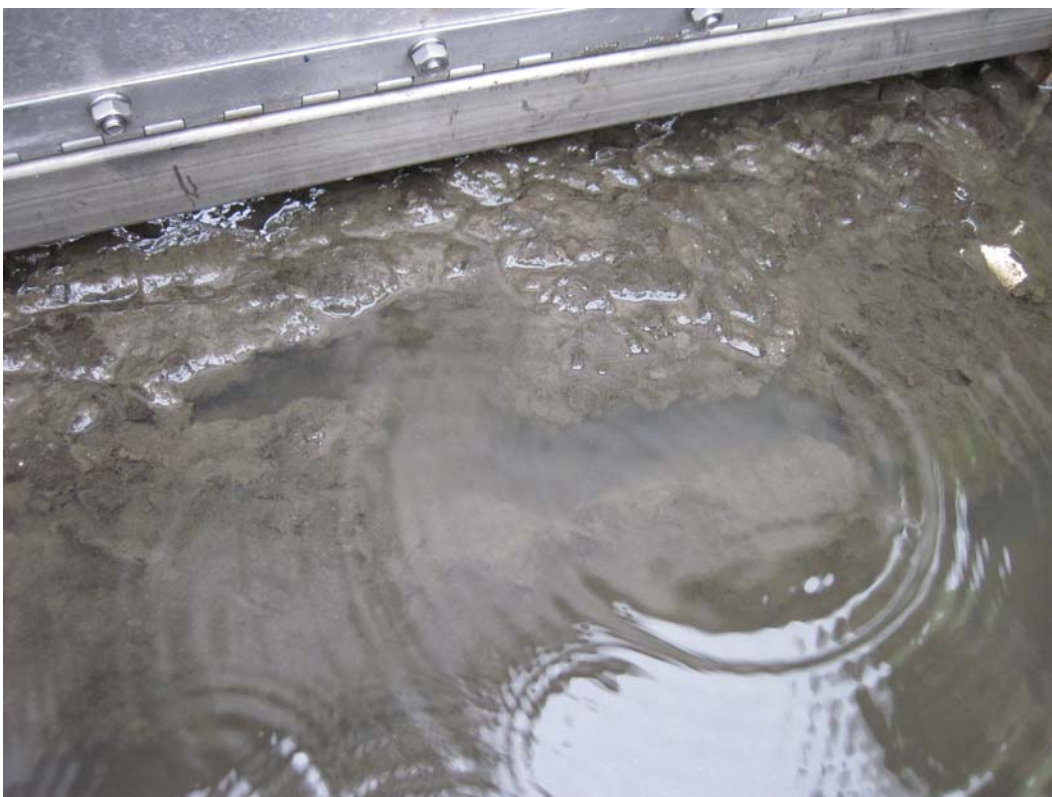
Photograph 8 - Example of a subtidal surface sediment grab sample with overlying water.

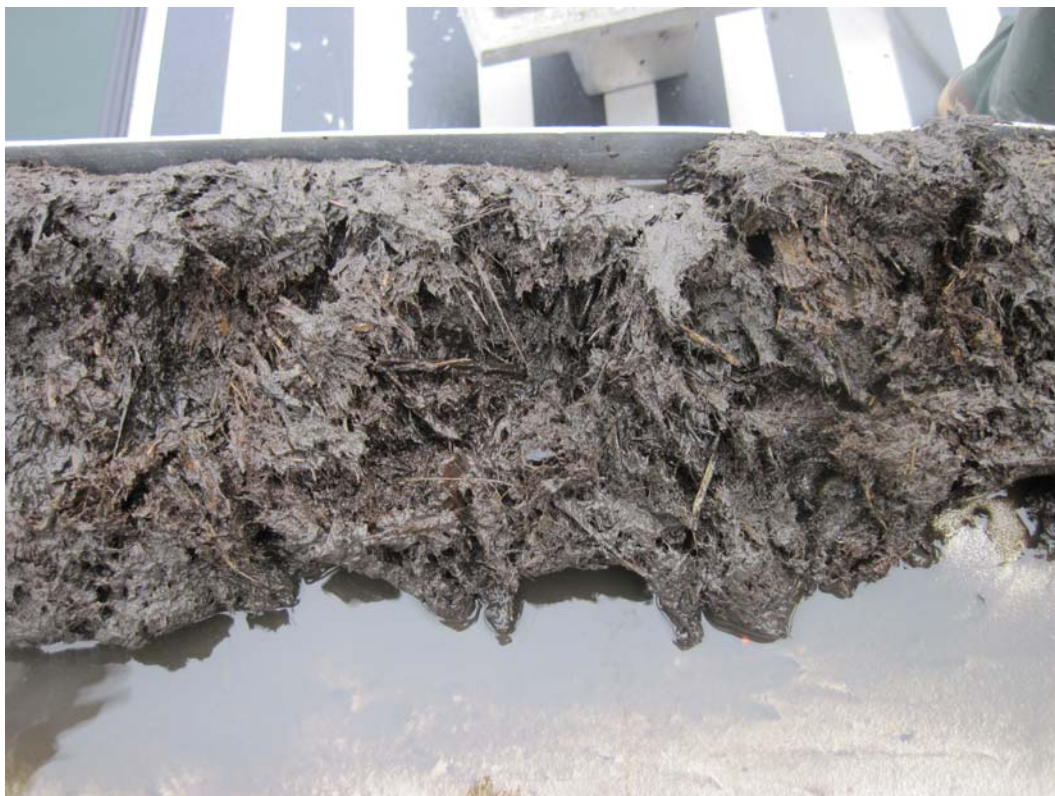
Wood debris was observed in 100 percent of the sediment core samples taken to quantify the extent of wood debris. In addition, large wood fragments and wood debris were found in all subtidal sediment samples. All intertidal sediment samples had small amounts of woody organic debris (less than 10 percent). The highest accumulations of wood waste were observed near the northwest boundary of the Westbay Marina DNR lease with adjacent property owned by Dunlap Towing Company (greater than 25 percent wood waste).

Photograph 9 - Example of wood debris found in a vibracore tube sample. Note the large wood fibers seen in this sample.

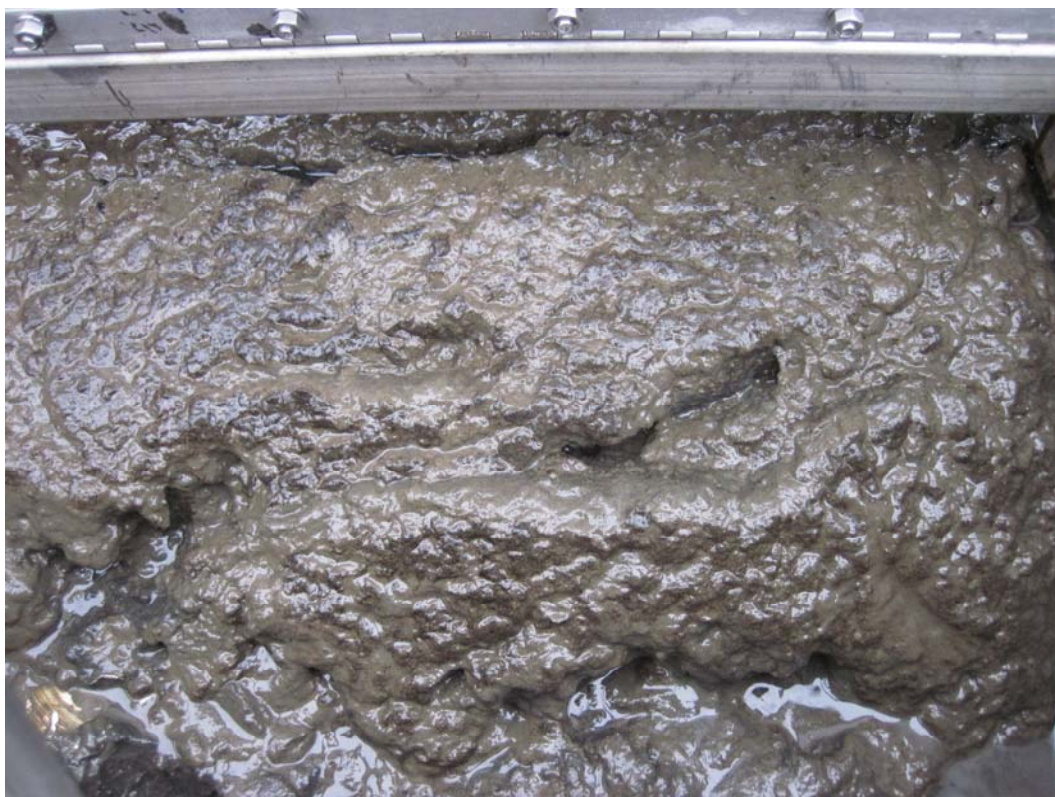
Photograph 10 - Wood debris found in a surface sediment grab sample.

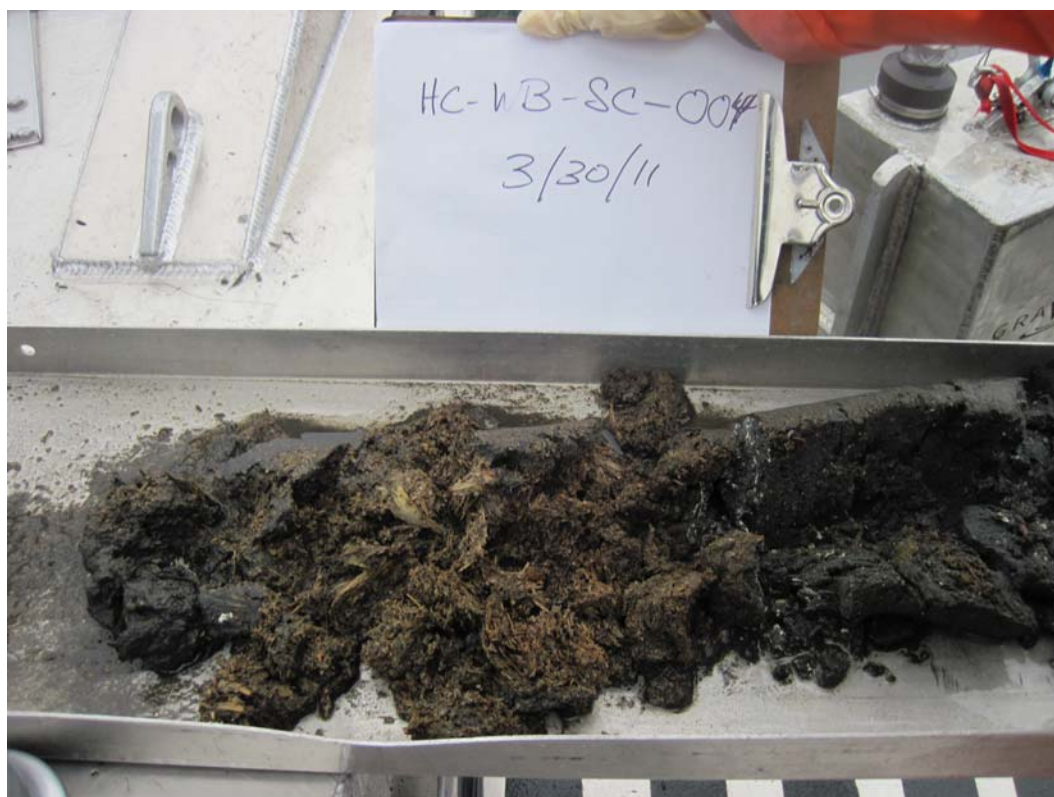
Photograph 11 - Example of wood debris found in a vibracore tube sample. Note the smaller wood fibers seen in this sample.

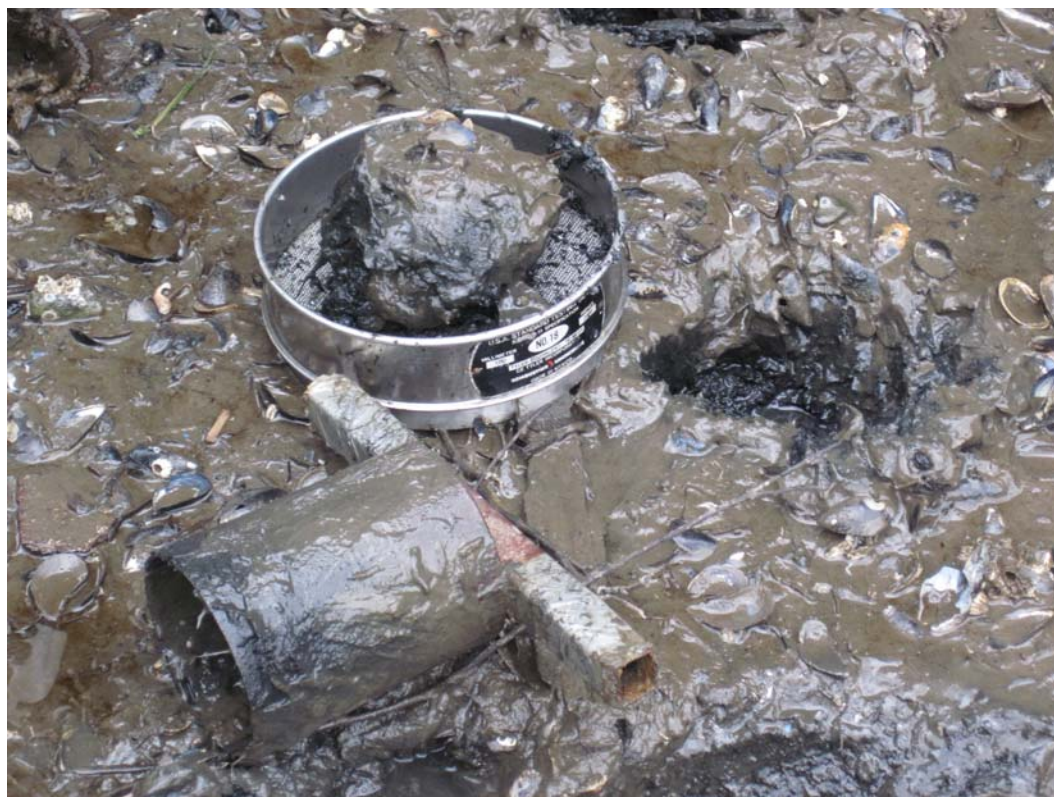
All sediment samples collected for benthic infauna evaluation contained invertebrates. The benthic infauna samples contained a variety of organisms that can be found in both aerobic and anaerobic environments including nematodes, polychaetes, oligochaetes, bivalves, gastropods, and arthropods. The subtidal benthic infauna samples had less than one-third the number of organisms observed in the intertidal samples. The lack of diversity in the subtidal samples may be due to the abundance of fine sediment compared to the more sandy intertidal samples. Alternately, it may be indicative of an anaerobic environment due to abundant wood debris in the subtidal areas.

Photograph 12 - Benthic infauna corer and core sample in sieve.

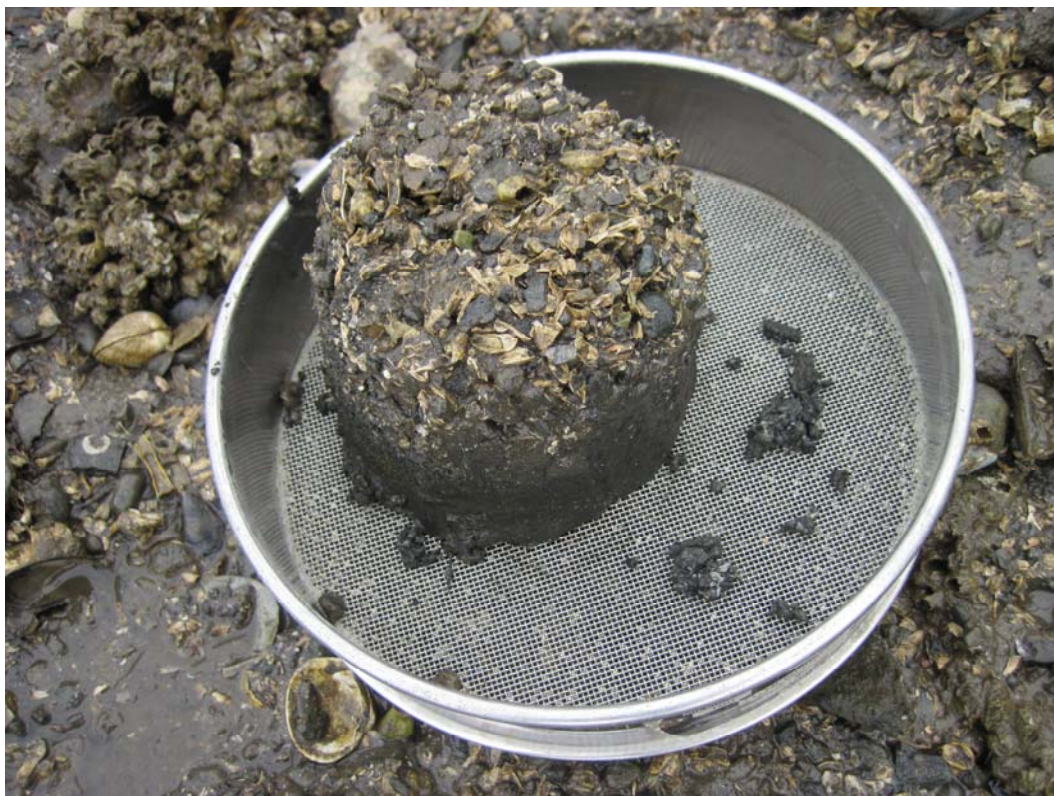
Photograph 13 - Intertidal benthic infauna core sample before being sieved.
