**Focused Feasibility Study**

Southeast Portion of the  
318 State Avenue NE Property  
Olympia, Washington

*for*  
**City of Olympia**

August 26, 2015

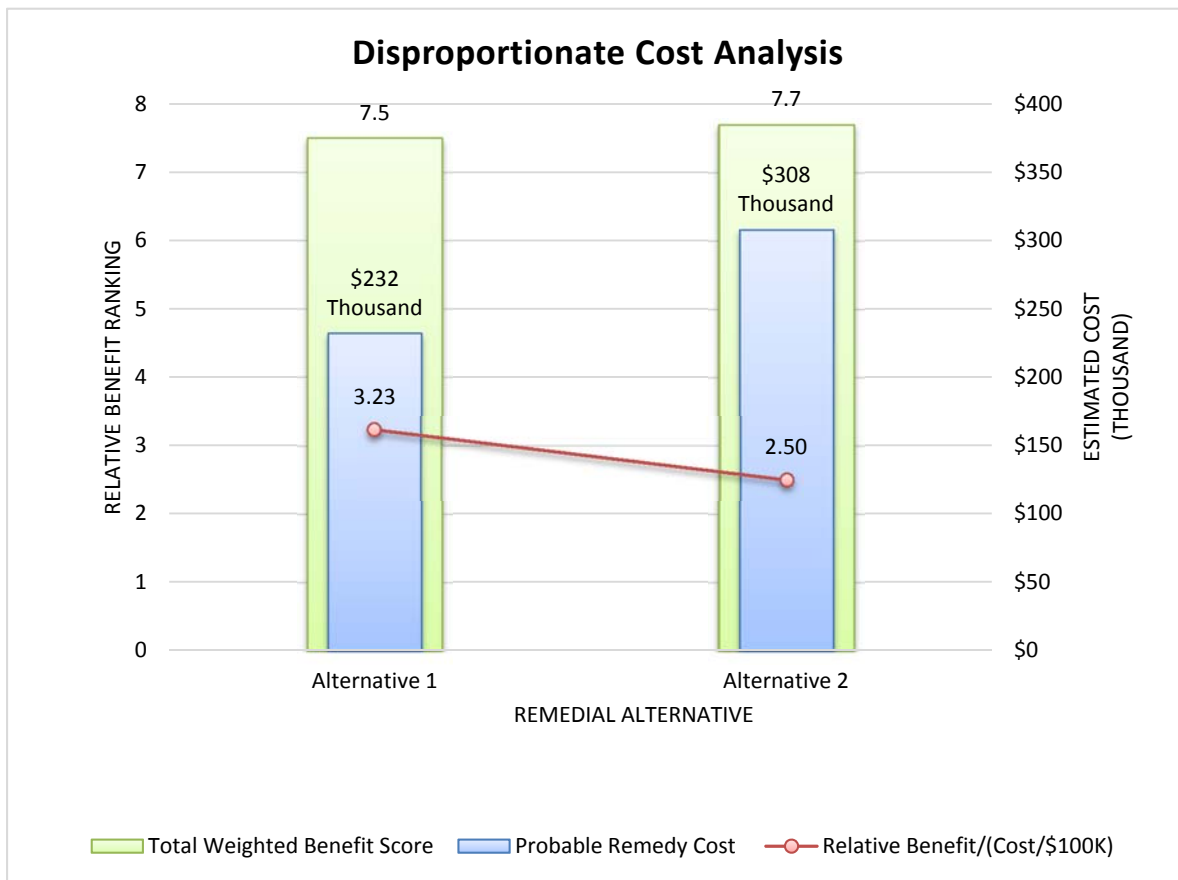
The MTCA DCA analysis uses a relative benefit/cost ratio to compare each of the remedial alternatives developed and is used to determine whether overall remedy cost is disproportionate to the relative benefit when compared to other alternatives. Using the summation of the weighted benefit scores described in Section 11.2.1 and the estimated remedy cost described in Section 11.2.2, a relative benefit/cost ratio was calculated for each remedial alternative. The benefit/cost ratio was calculated by dividing the total weighted benefit score by the total cost for each alternative. The resulting relative benefit/cost ratio for each remedial alternative is plotted relative to the overall benefit score and probable remedy cost below. To facilitate graphical presentation of the relative benefit/cost shown below, the total cost of each remedial alternative was divided by \$100,000.

The individual DCA criterion benefit scores (Section 11.2.1), weighting factors, weighted scores and total weighted benefit score and probable remedy cost for each of the remedial alternatives used to generate the DCA graphic above are presented in Table 5.

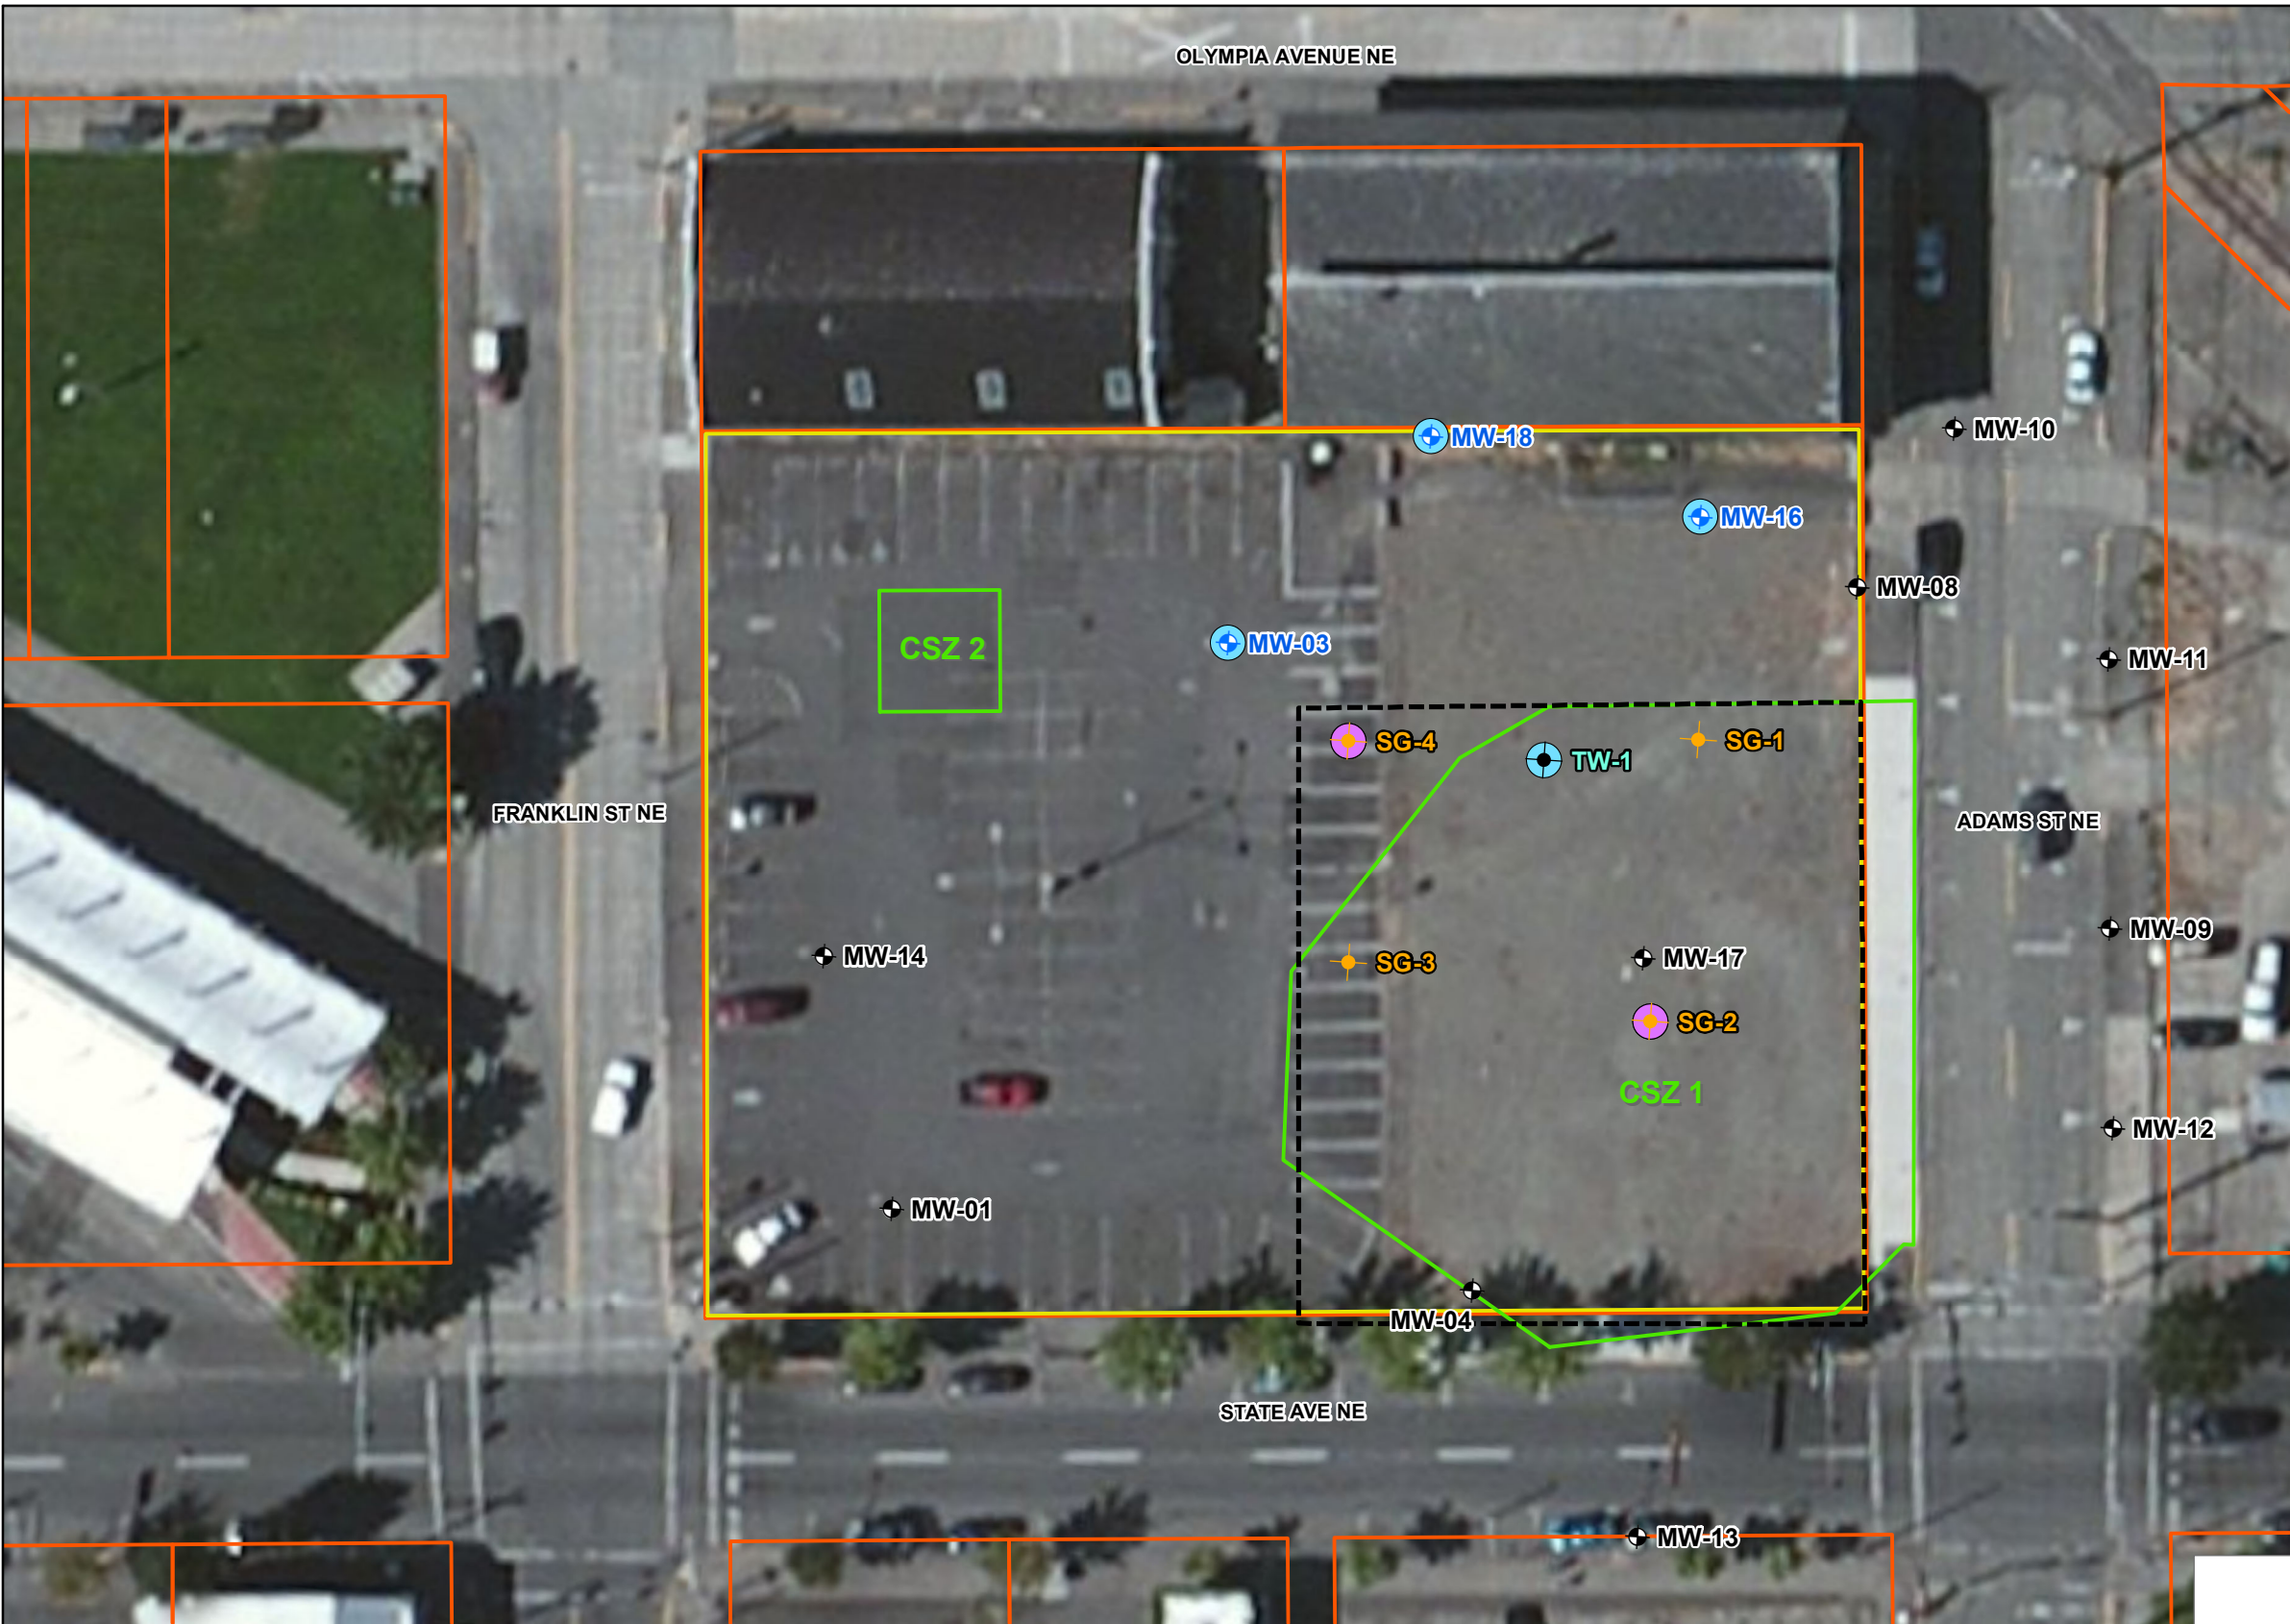
- Legend**
- Approximate Property Boundary
  - Southeast portion of property proposed for redevelopment
  - Parcel Boundary
  - Contaminated Soil Zones (CSZ) Remediated in September-October 2009
  - MW-03: Monitoring well currently being monitored as part of semi-annual monitoring events
  - MW-01: Monitoring well that was previously monitoring as part of quarterly or semi-annual monitoring events
  - SG-4: Soil Gas Exploration Location
  - TW-1: Temporary Groundwater Monitoring Well Location
  - Vinyl Chloride at concentrations greater than MTCA groundwater cleanup level
  - Trichloroethene (TCE) at concentrations greater than MTCA soil gas screening limit

Groundwater compliance monitoring performed between May 2010 and August 2013 included collection and analysis of groundwater from monitoring well MW-17 located within the southeast portion of the property (Figure 2). Sampling and analysis of groundwater from MW-17 was performed during 12 monitoring events. Chlorinated compounds were either not detected or were detected at concentrations less than groundwater cleanup levels during all 12 events. No chlorinated organic compounds or degradation products were detected in the groundwater samples collected from MW-17 during the last two monitoring events (Table 1 in Appendix D). Groundwater compliance monitoring at MW-17 was discontinued based on the results.

In April 2015, a temporary monitoring well (i.e., TW-1) was installed and sampled at the request of Ecology to support evaluation of groundwater on the northern portion of the area to be redeveloped (Figure 2). Temporary monitoring well TW-1 was located adjacent to monitoring wells MW-03, MW-16 and MW-18. The groundwater sample from TW-1 was analyzed for chlorinated solvents and associated degradation products. The results of the groundwater sample obtained from TW-1 are presented in Supplemental Site Investigation Report (GeoEngineers, 2015b) provided in Appendix E.

In April 2015, soil gas sampling was performed in the southeast portion of the property at the request of Ecology to further evaluate the area to be redeveloped. Soil gas samples were collected from four locations, SG-1 through SG-4 (Figure 2), and were analyzed for chlorinated solvents and associated degradation products including PCE, TCE, 1,1-DCE, cis-1,2-DCE, trans-1,2-DCE and VC. The results of the soil gas sampling and analysis were compared to soil gas screening level criteria, which is protective of indoor air, provided in Ecology's Draft Guidance for Evaluating Soil Vapor Intrusion in Washington State (Ecology, 2009) as updated in April 2015 to revise the soil gas screening levels provided in Appendix B of the guidance document (Ecology, 2015). The results of the soil gas samples obtained from the southeast portion of the property are presented in Supplemental Site Investigation Report (GeoEngineers, 2015b) provided in Appendix E.

The concentrations of TCE in soil gas samples collected from SG-2 and SG-4 were greater than the MTCA Method B soil gas screening level for TCE (Table 1 in Appendix E). All other chlorinated solvents and associated degradation products were either not detected or detected at concentrations less than MTCA Method B soil gas screening level in SG-2 and SG-4. Each of the contaminants analyzed in samples collected from SG-1 and SG-4 were either not detected or detected at concentrations less than MTCA soil gas screening level. Approximate locations of soil gas sampling locations SG-1 through SG-4 are shown on Figure 2.

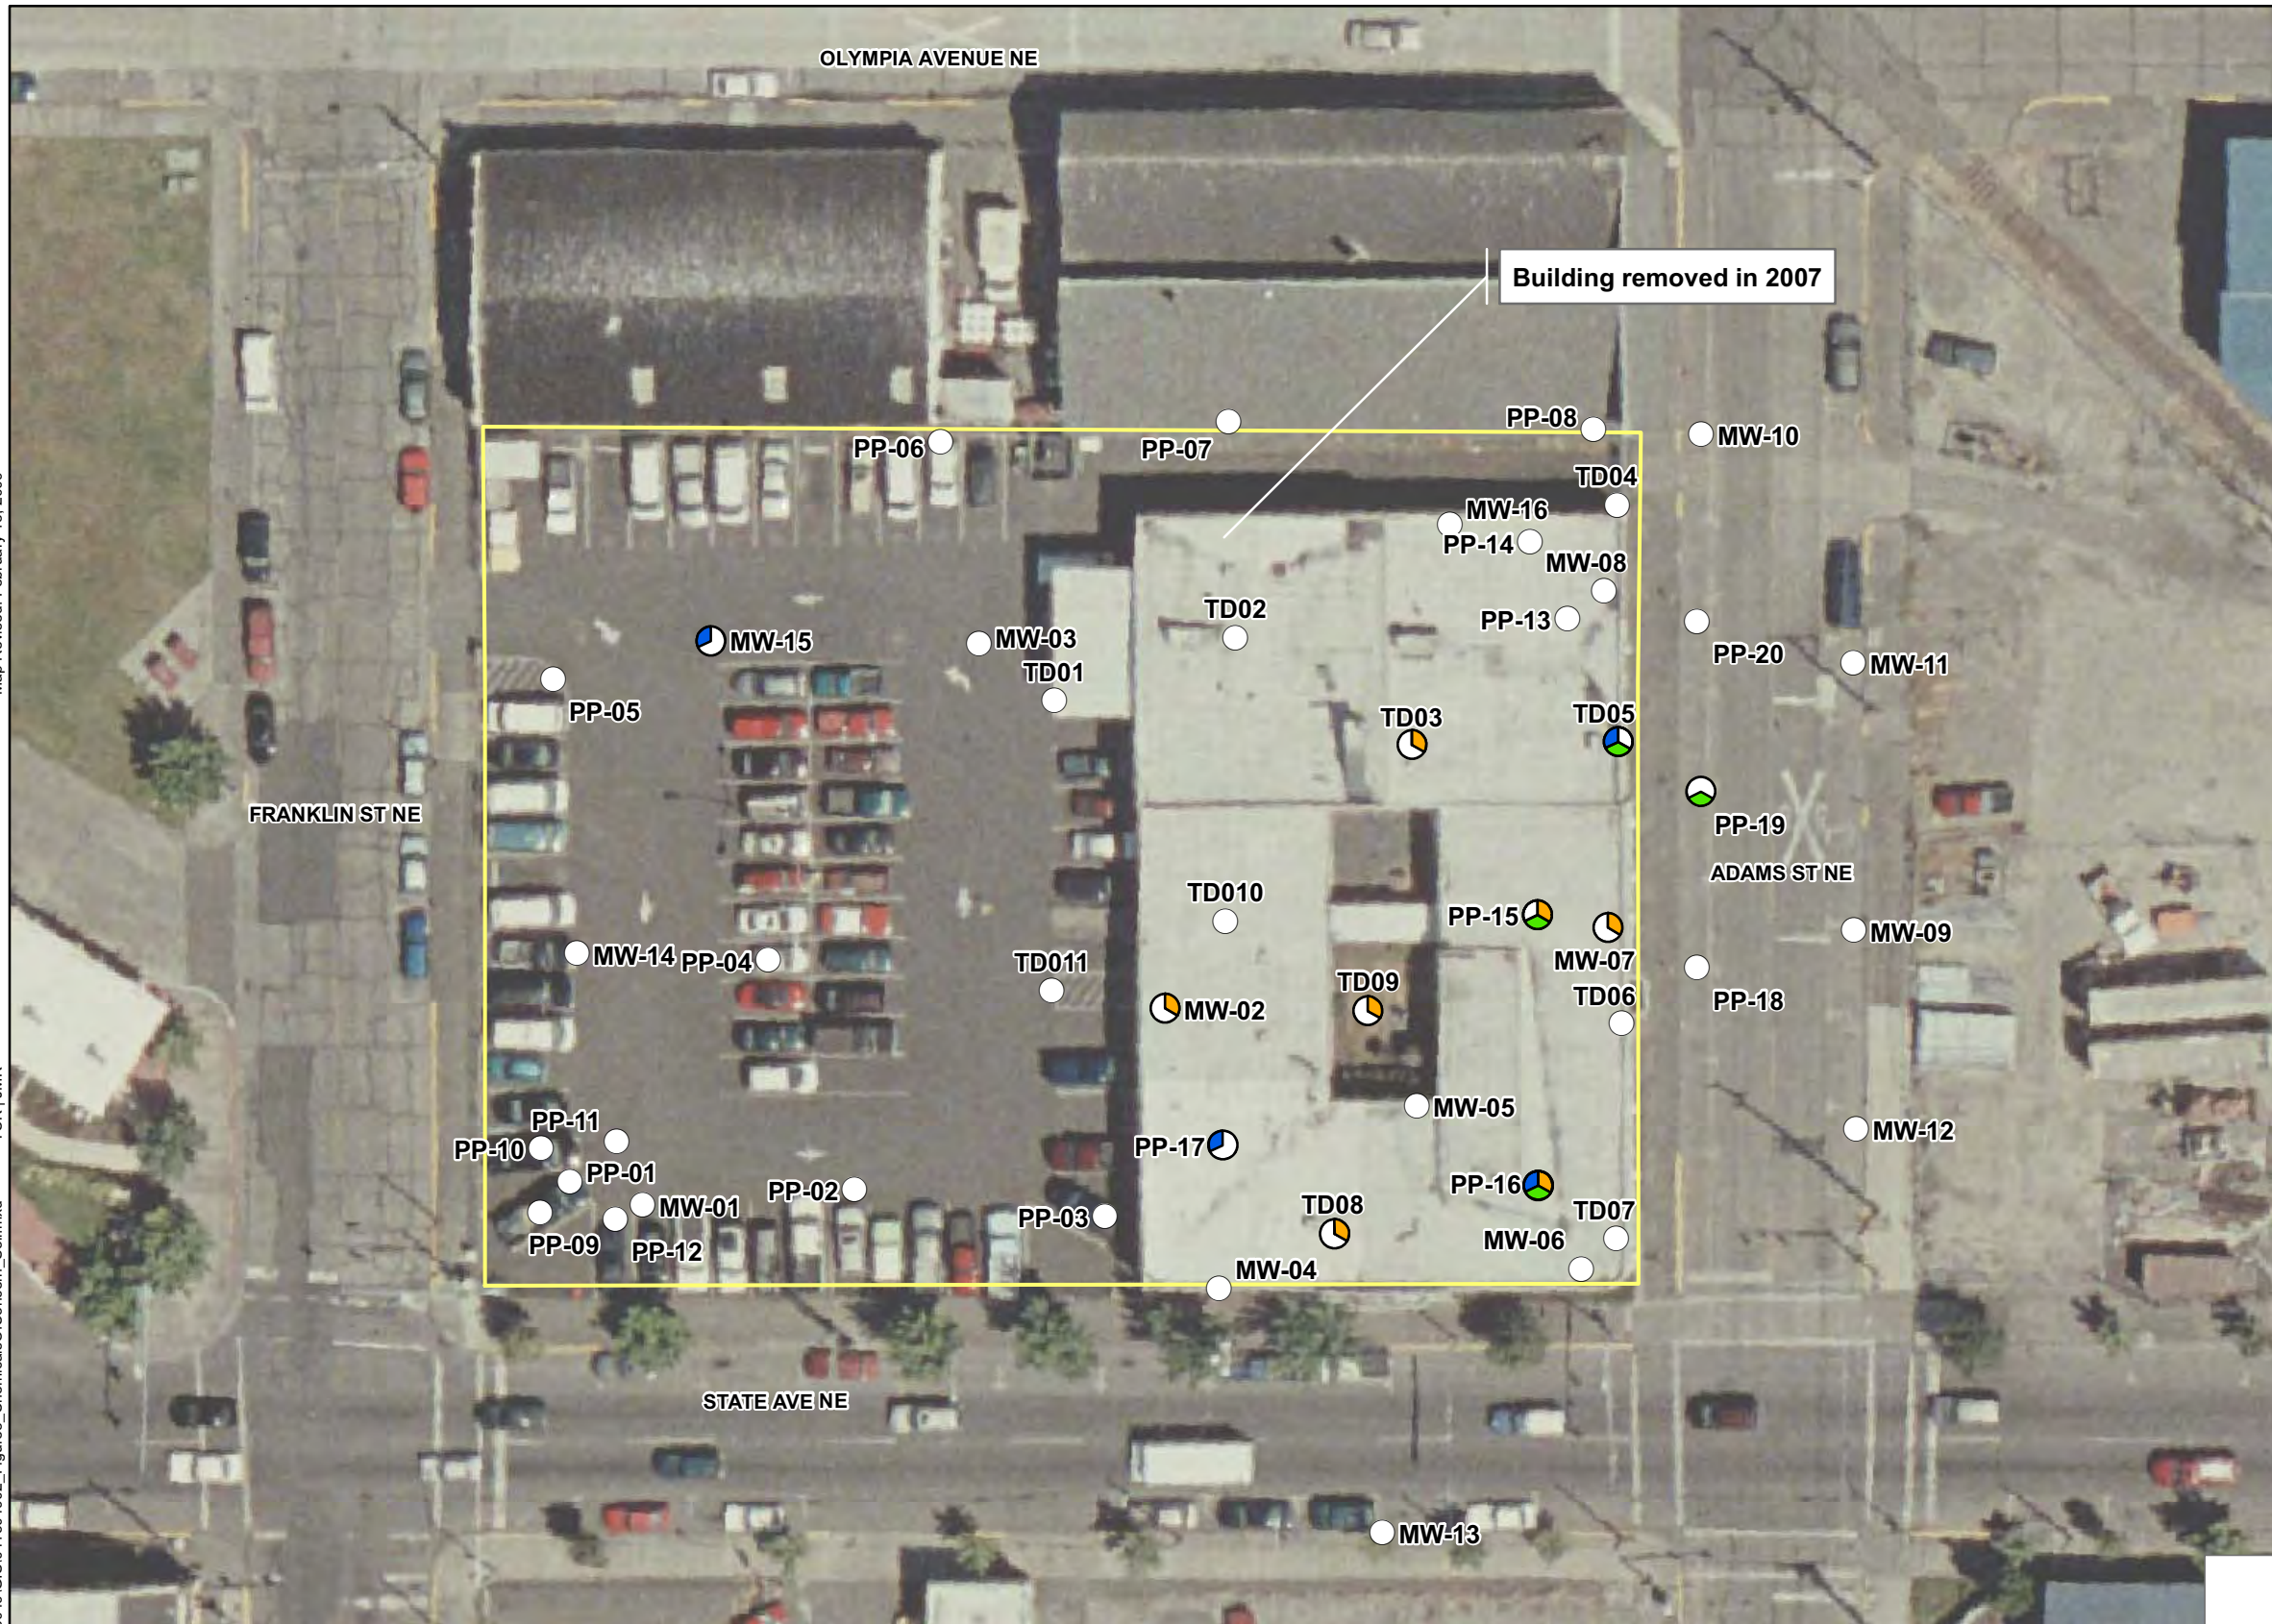
Location	Depth (ft bgs)	Result
<b>PP15</b>		
TCE	2-4	2,300 ug/kg
cPAH	2-4	678.3 ug/kg
<b>PP16</b>		
Lead	2-4	350 mg/kg
TCE	2-4	46 ug/kg
cPAH	2-4	1270.7 ug/kg
TCE	6-8	55 ug/kg
<b>PP17</b>		
Arsenic	2-4	23 mg/kg
Lead	2-4	840 mg/kg
<b>TD03</b>		
TCE	4-4.5	230 ug/kg
<b>TD05</b>		
Arsenic	2-2.5	40 mg/kg
cPAH	2-2.5	1,715.6 ug/kg
<b>TD08</b>		
TCE	4-4.5	82 ug/kg
<b>TD09</b>		
TCE	4-4.5	600 ug/kg
<b>MW02</b>		
TCE	7-7.5	900 ug/kg
<b>MW07</b>		
TCE	7-7.5	45 ug/kg
<b>MW-15</b>		
Lead	3-3.5	510 mg/kg
<b>PP19</b>		
cPAH	3-3.5	4,860 ug/kg

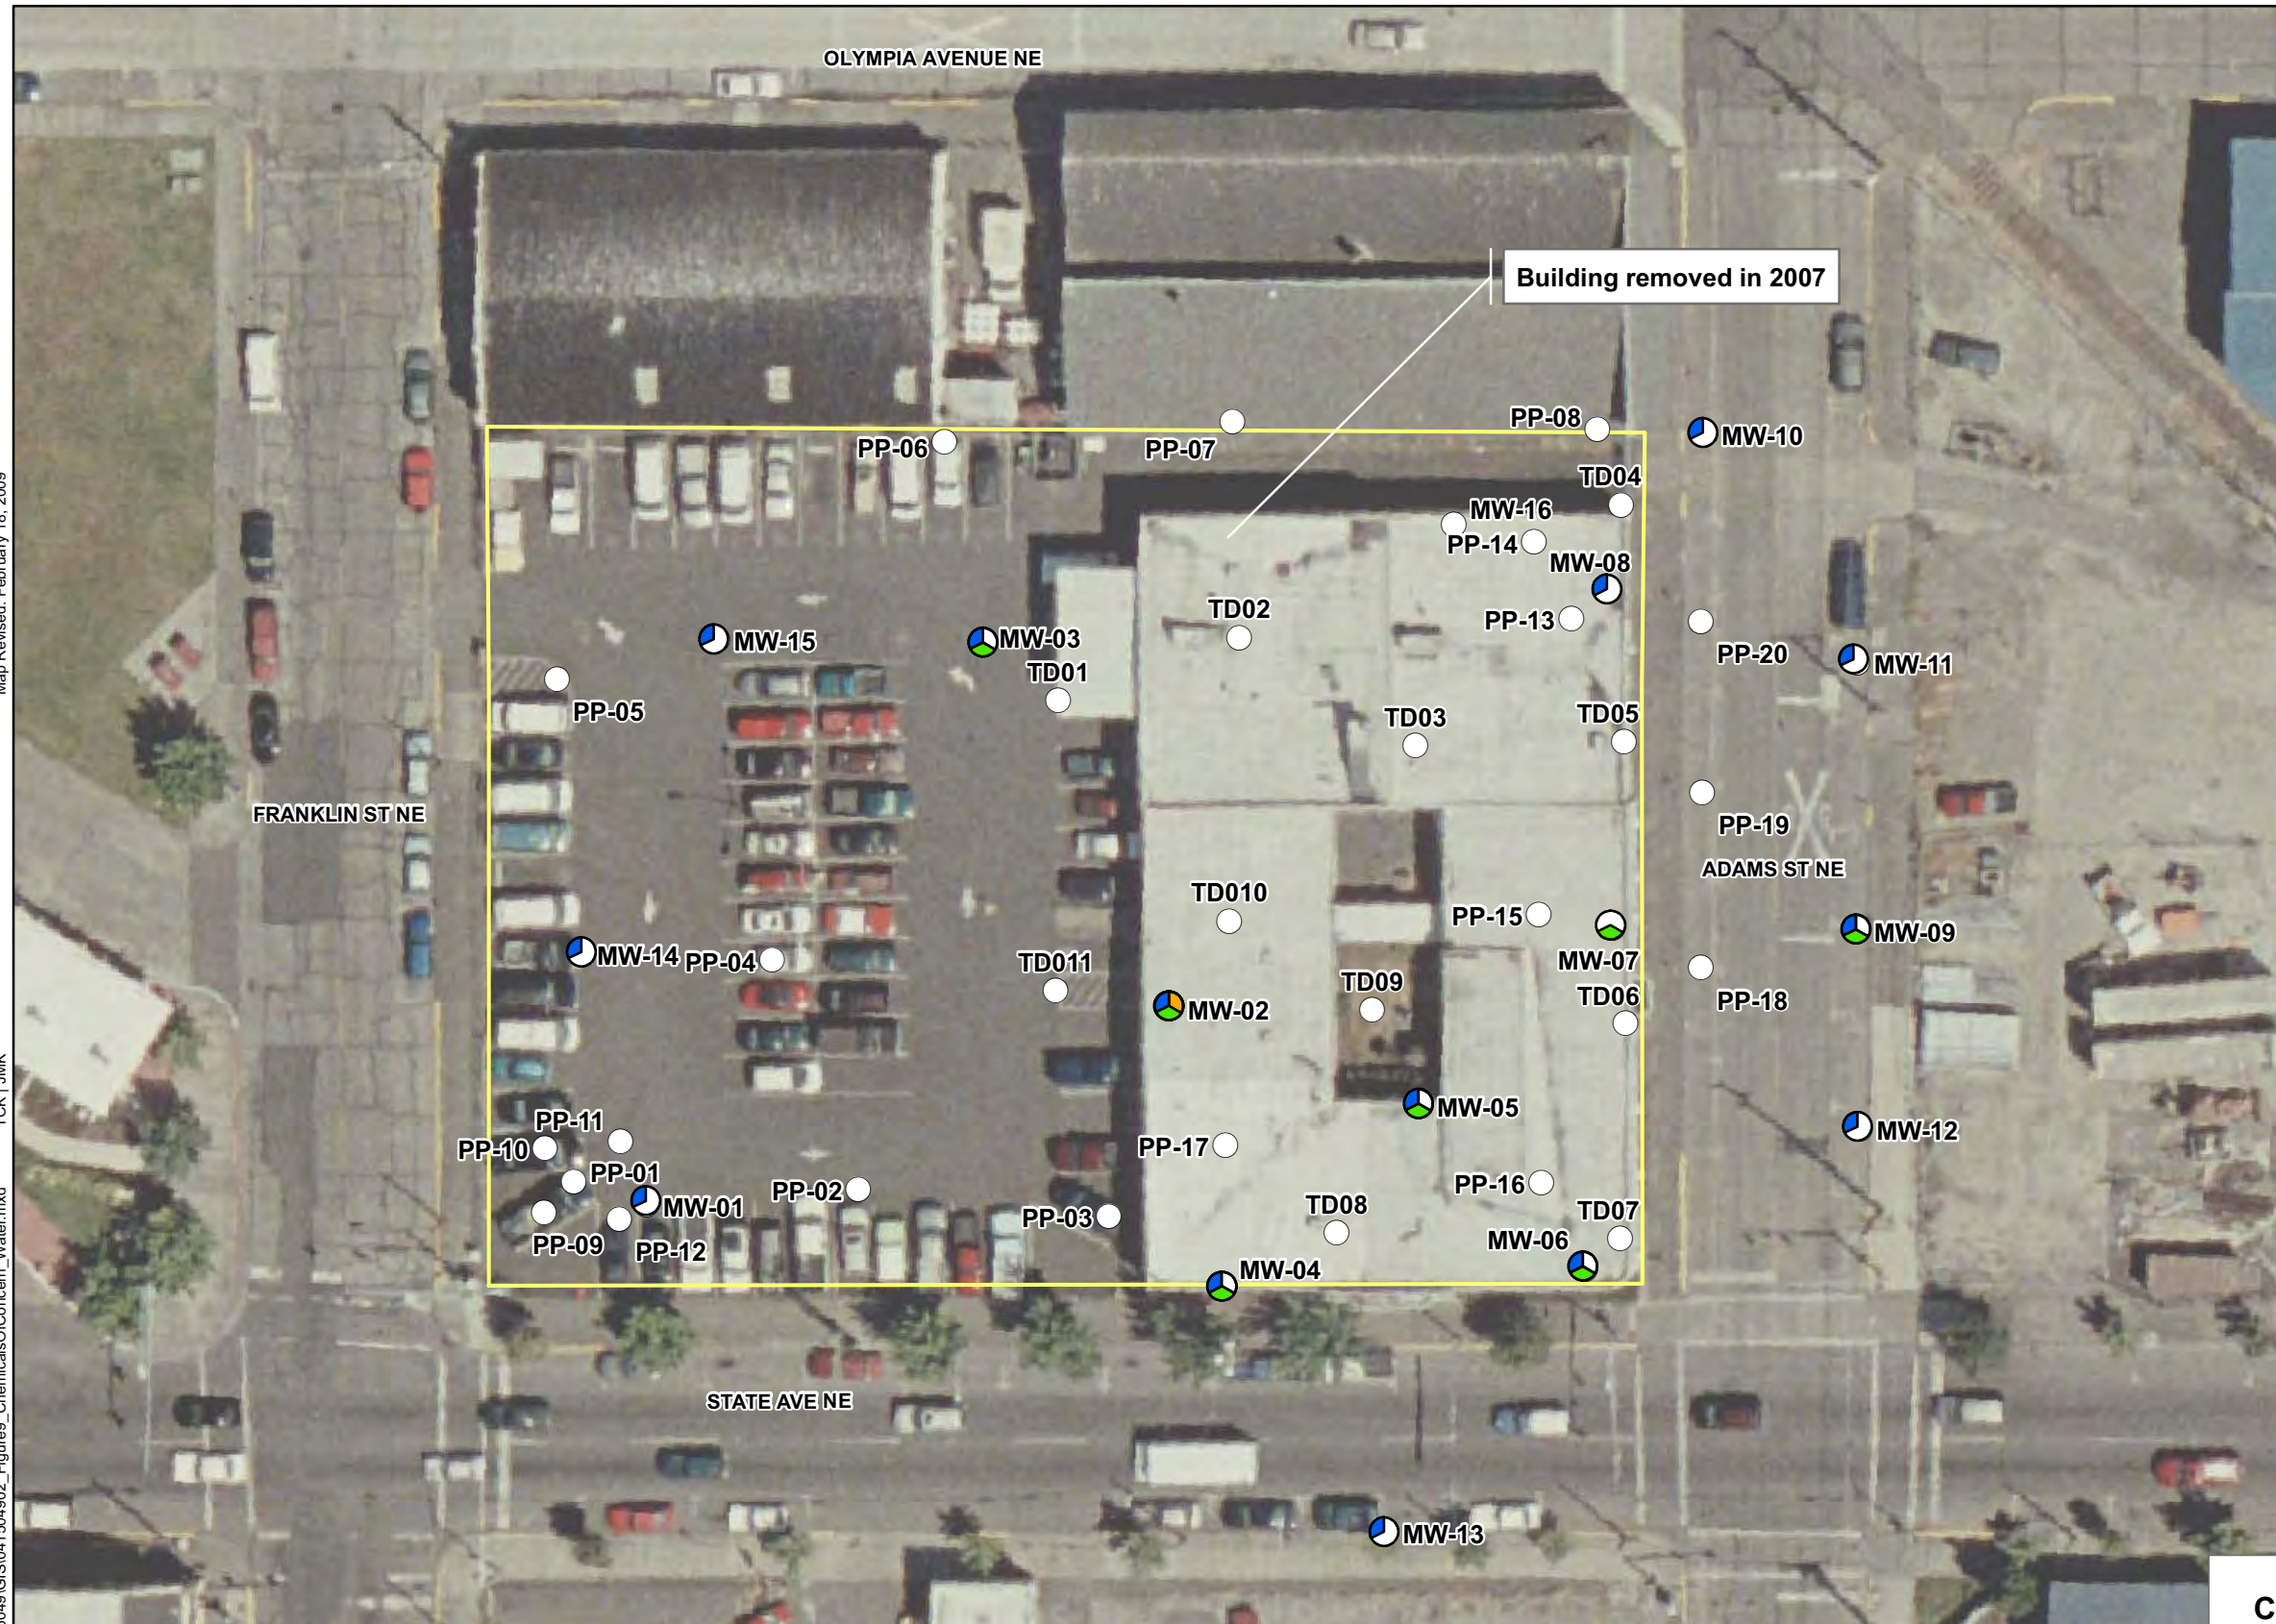
Well	Event	Result*
MW-01	Arsenic Mar/Apr	0.0079 / 0.0053 mg/l
	Arsenic Oct/Nov	0.013 / 0.014 mg/l
MW-02	TCE Mar/Apr	5.3 ug/l
	VC Mar/Apr	0.45 ug/l
	Arsenic Oct/Nov	0.0093 / 0.0095 mg/l
MW-03	VC Mar/Apr	1.7 ug/l
	Arsenic Oct/Nov	0.0059 / 0.0058 mg/l
MW-04	VC Mar/Apr	0.35 ug/l
	Arsenic Oct/Nov	0.012 / 0.017 mg/l
MW-05	Arsenic Mar/Apr	0.0061 / (<MTCA) mg/l
	Arsenic Oct/Nov	0.014 / 0.015 mg/l
	VC Mar/Apr	1.5 ug/l
MW-06	VC Mar/Apr	0.27 ug/l
	Arsenic Oct/Nov	0.0065 / 0.0074 mg/l
MW-07	VC Mar/Apr	3.5 ug/l
MW-08	Arsenic Oct/Nov	0.0062 / 0.0058 mg/l
	VC Mar/Apr	0.8 ug/l
MW-09	Arsenic Oct/Nov	0.0093 / 0.0097 mg/l
	VC Mar/Apr	0.8 ug/l
MW-10	Arsenic Oct/Nov	(<MTCA) / 0.0059 mg/l
	Arsenic Oct/Nov	0.016 / 0.017 mg/l
MW-11	Arsenic Oct/Nov	0.0064 / 0.0093 mg/l
	Arsenic Oct/Nov	0.063 / 0.062 mg/l
MW-12	Arsenic Oct/Nov	(<MTCA) / 0.0056 mg/l
	Arsenic Oct/Nov	0.012 / 0.013 mg/l
MW-13	Arsenic Oct/Nov	0.012 / 0.013 mg/l
	Arsenic Oct/Nov	0.012 / 0.013 mg/l

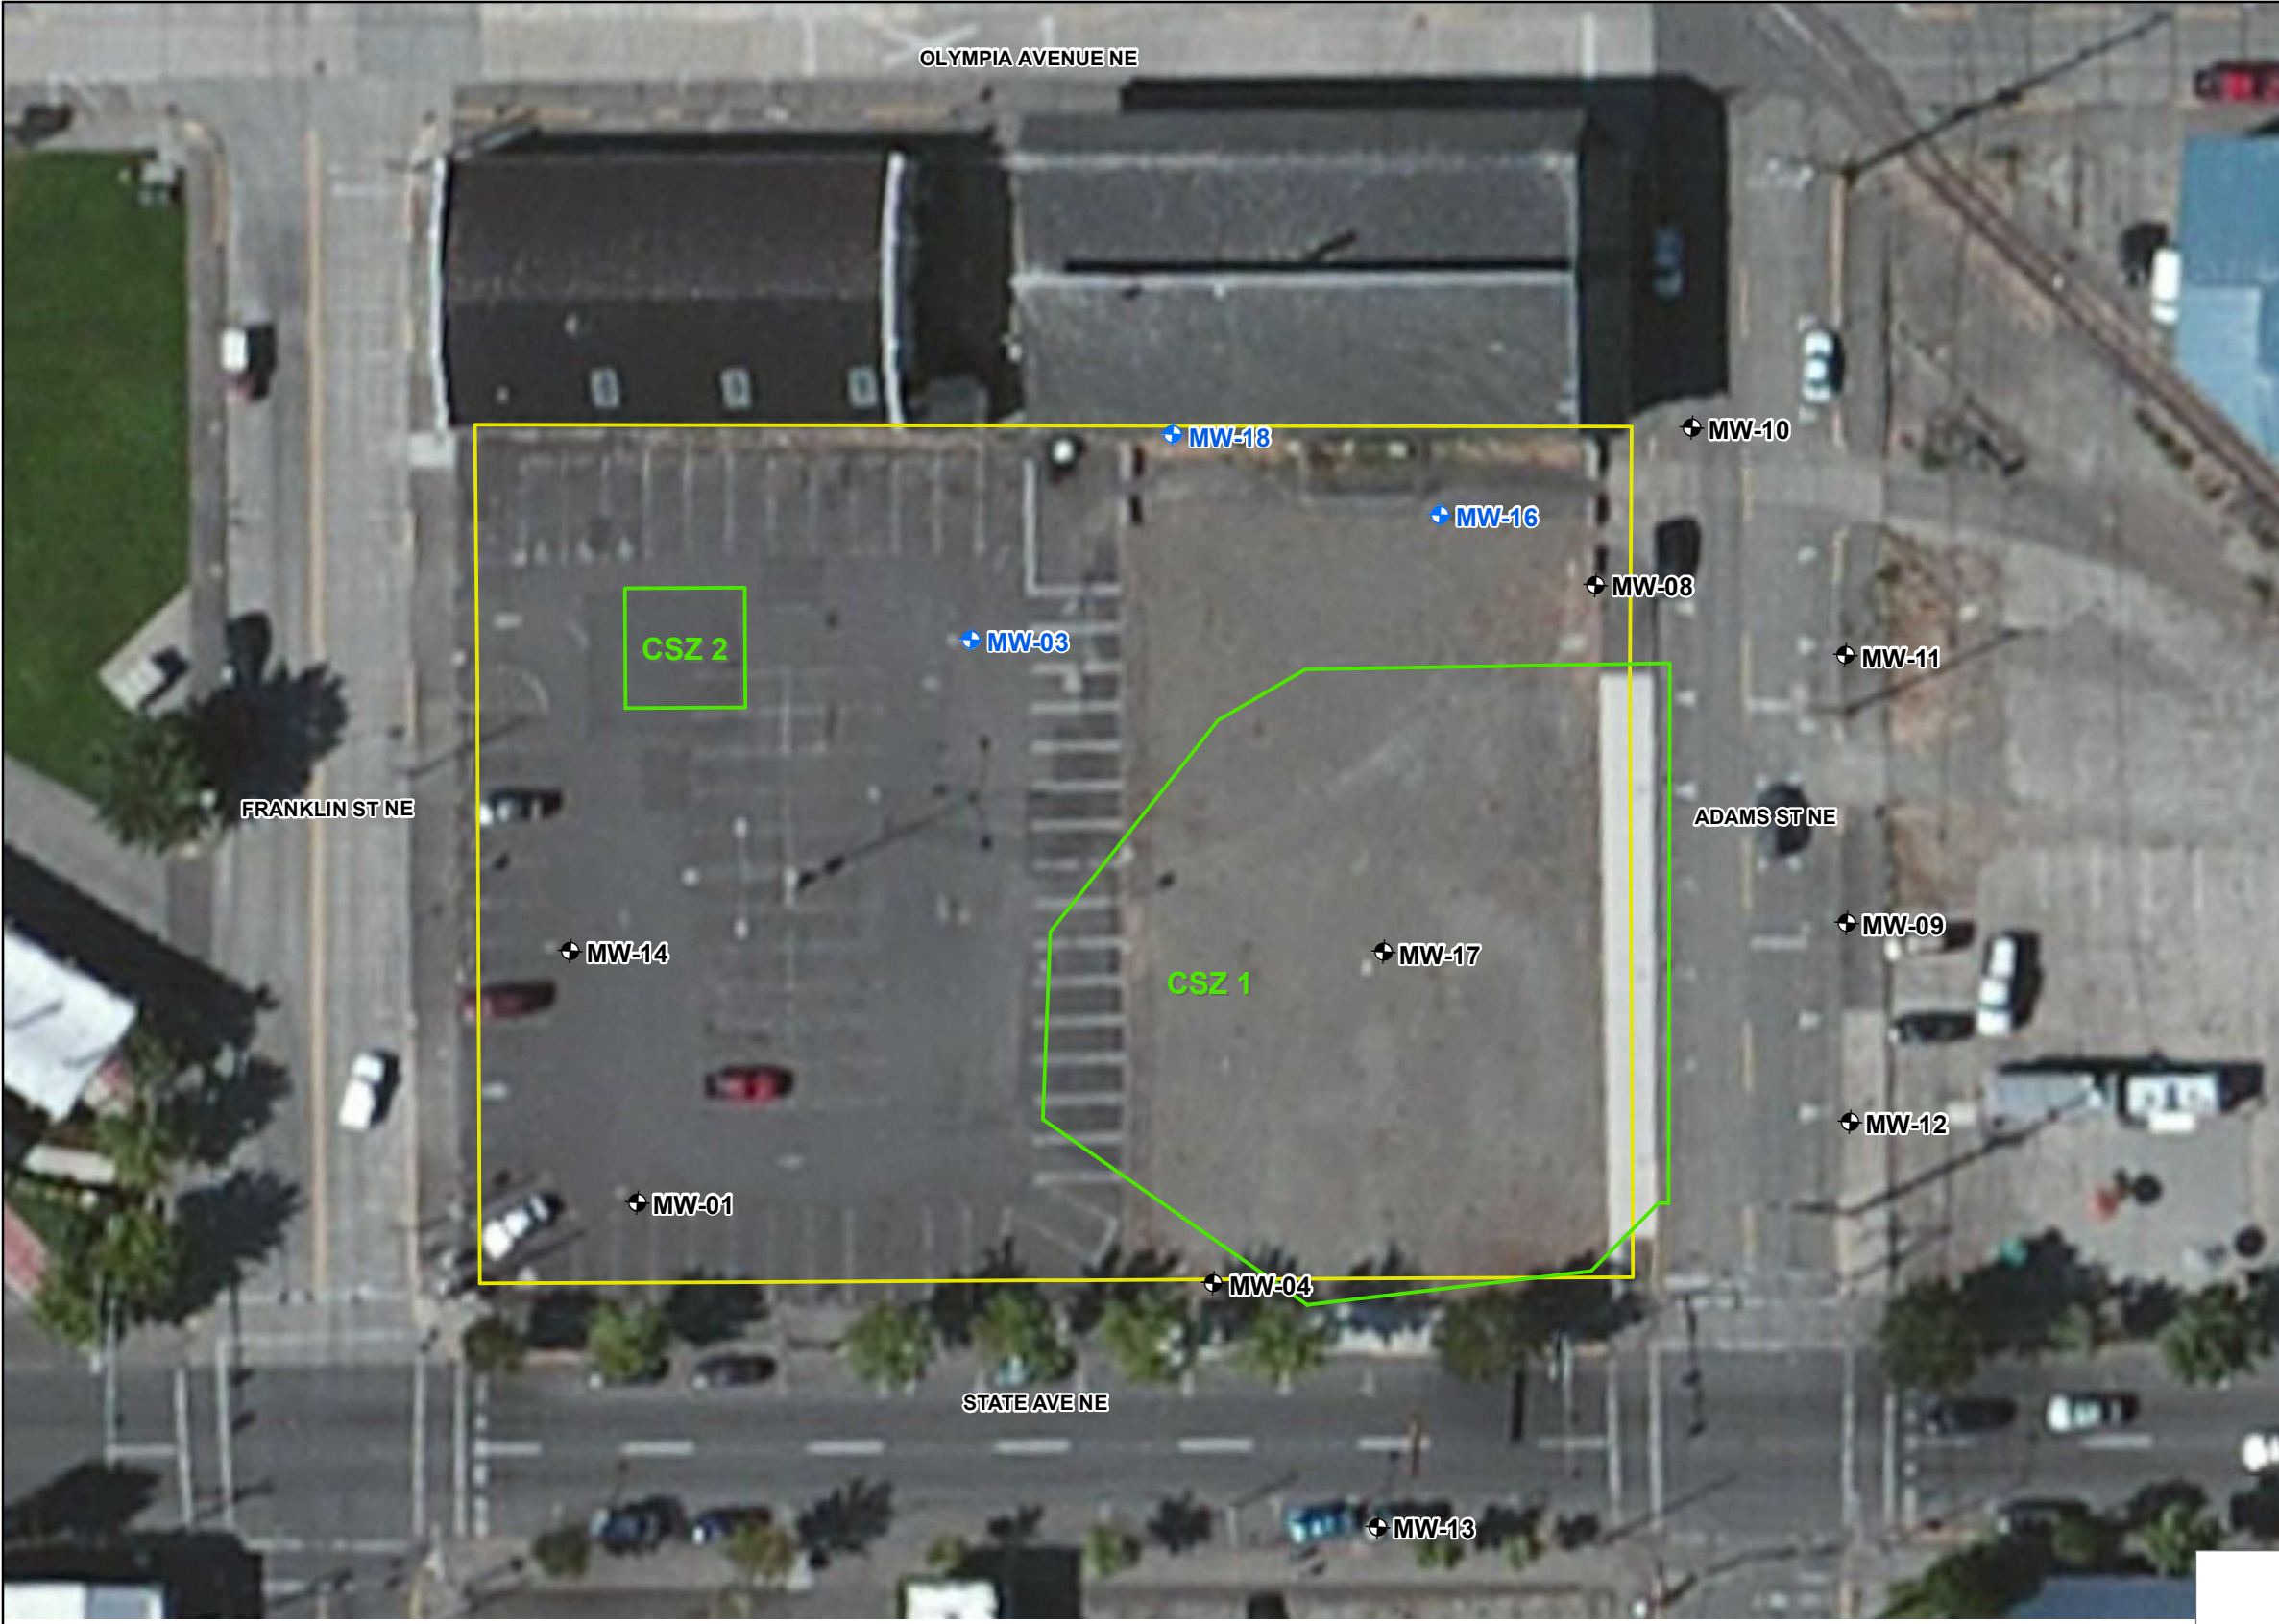
- Legend**
- MW-03 Existing Monitoring Well Sampled for Groundwater Analysis and used to monitor Groundwater Gradients
  - MW-01 Existing Monitoring Well Previously Sampled for Groundwater Analysis and to Monitor Groundwater Gradients
  - CSZ 1 Contaminated Soil Zones (CSZ) Remediated in September-October 2009
  - Approximate Property Boundary

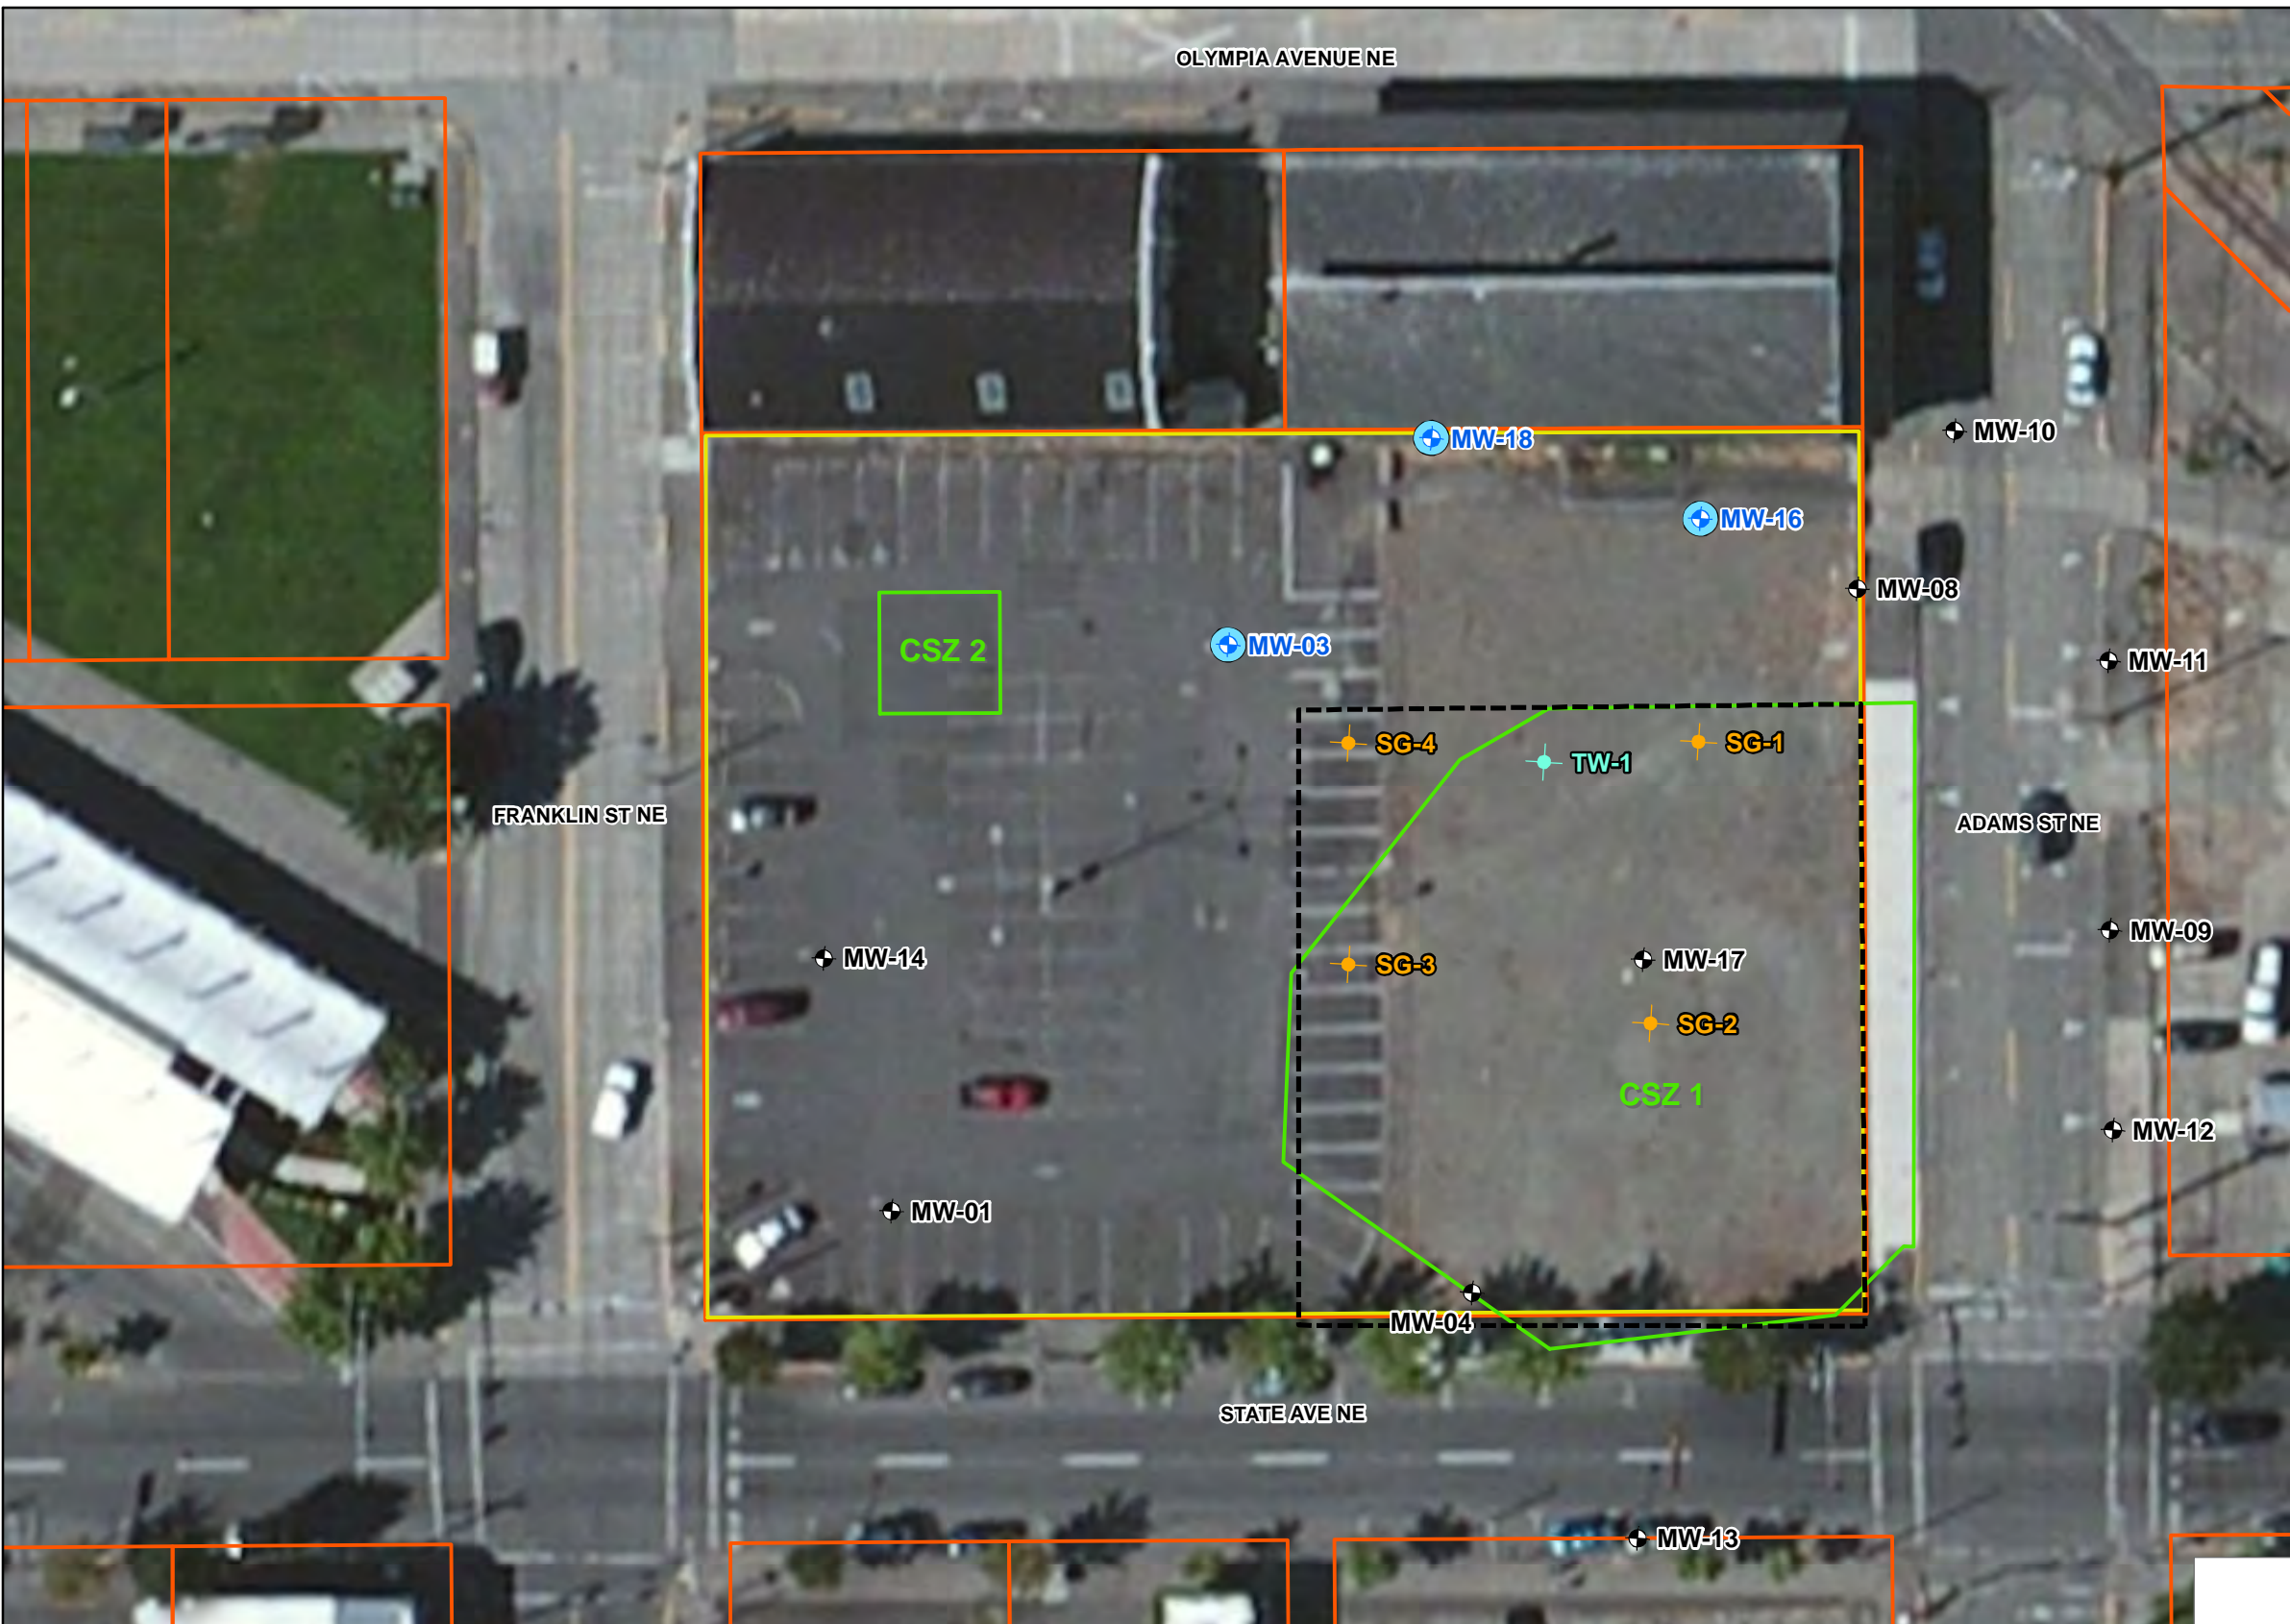
- Soil Gas Exploration Location
- Temporary Groundwater Monitoring Well Location
- Monitoring Well Sampled for Groundwater Analysis and used to Monitor Groundwater levels
- Existing Monitoring Well Previously Sampled for Groundwater Analysis and to Monitor Groundwater levels
- Vinyl Chloride at concentrations greater than MTCA Method A (0.2 ug/l)
- Contaminated Soil Zones (CSZ) Remediated in September-October 2009
- Approximate Property Boundary
- Parcel Boundary
- Approximate Limits of Proposed Property Redevelopment
