**Focused Feasibility Study**

Southeast Portion of the  
318 State Avenue NE Property  
Olympia, Washington

*for*  
**City of Olympia**

August 26, 2015

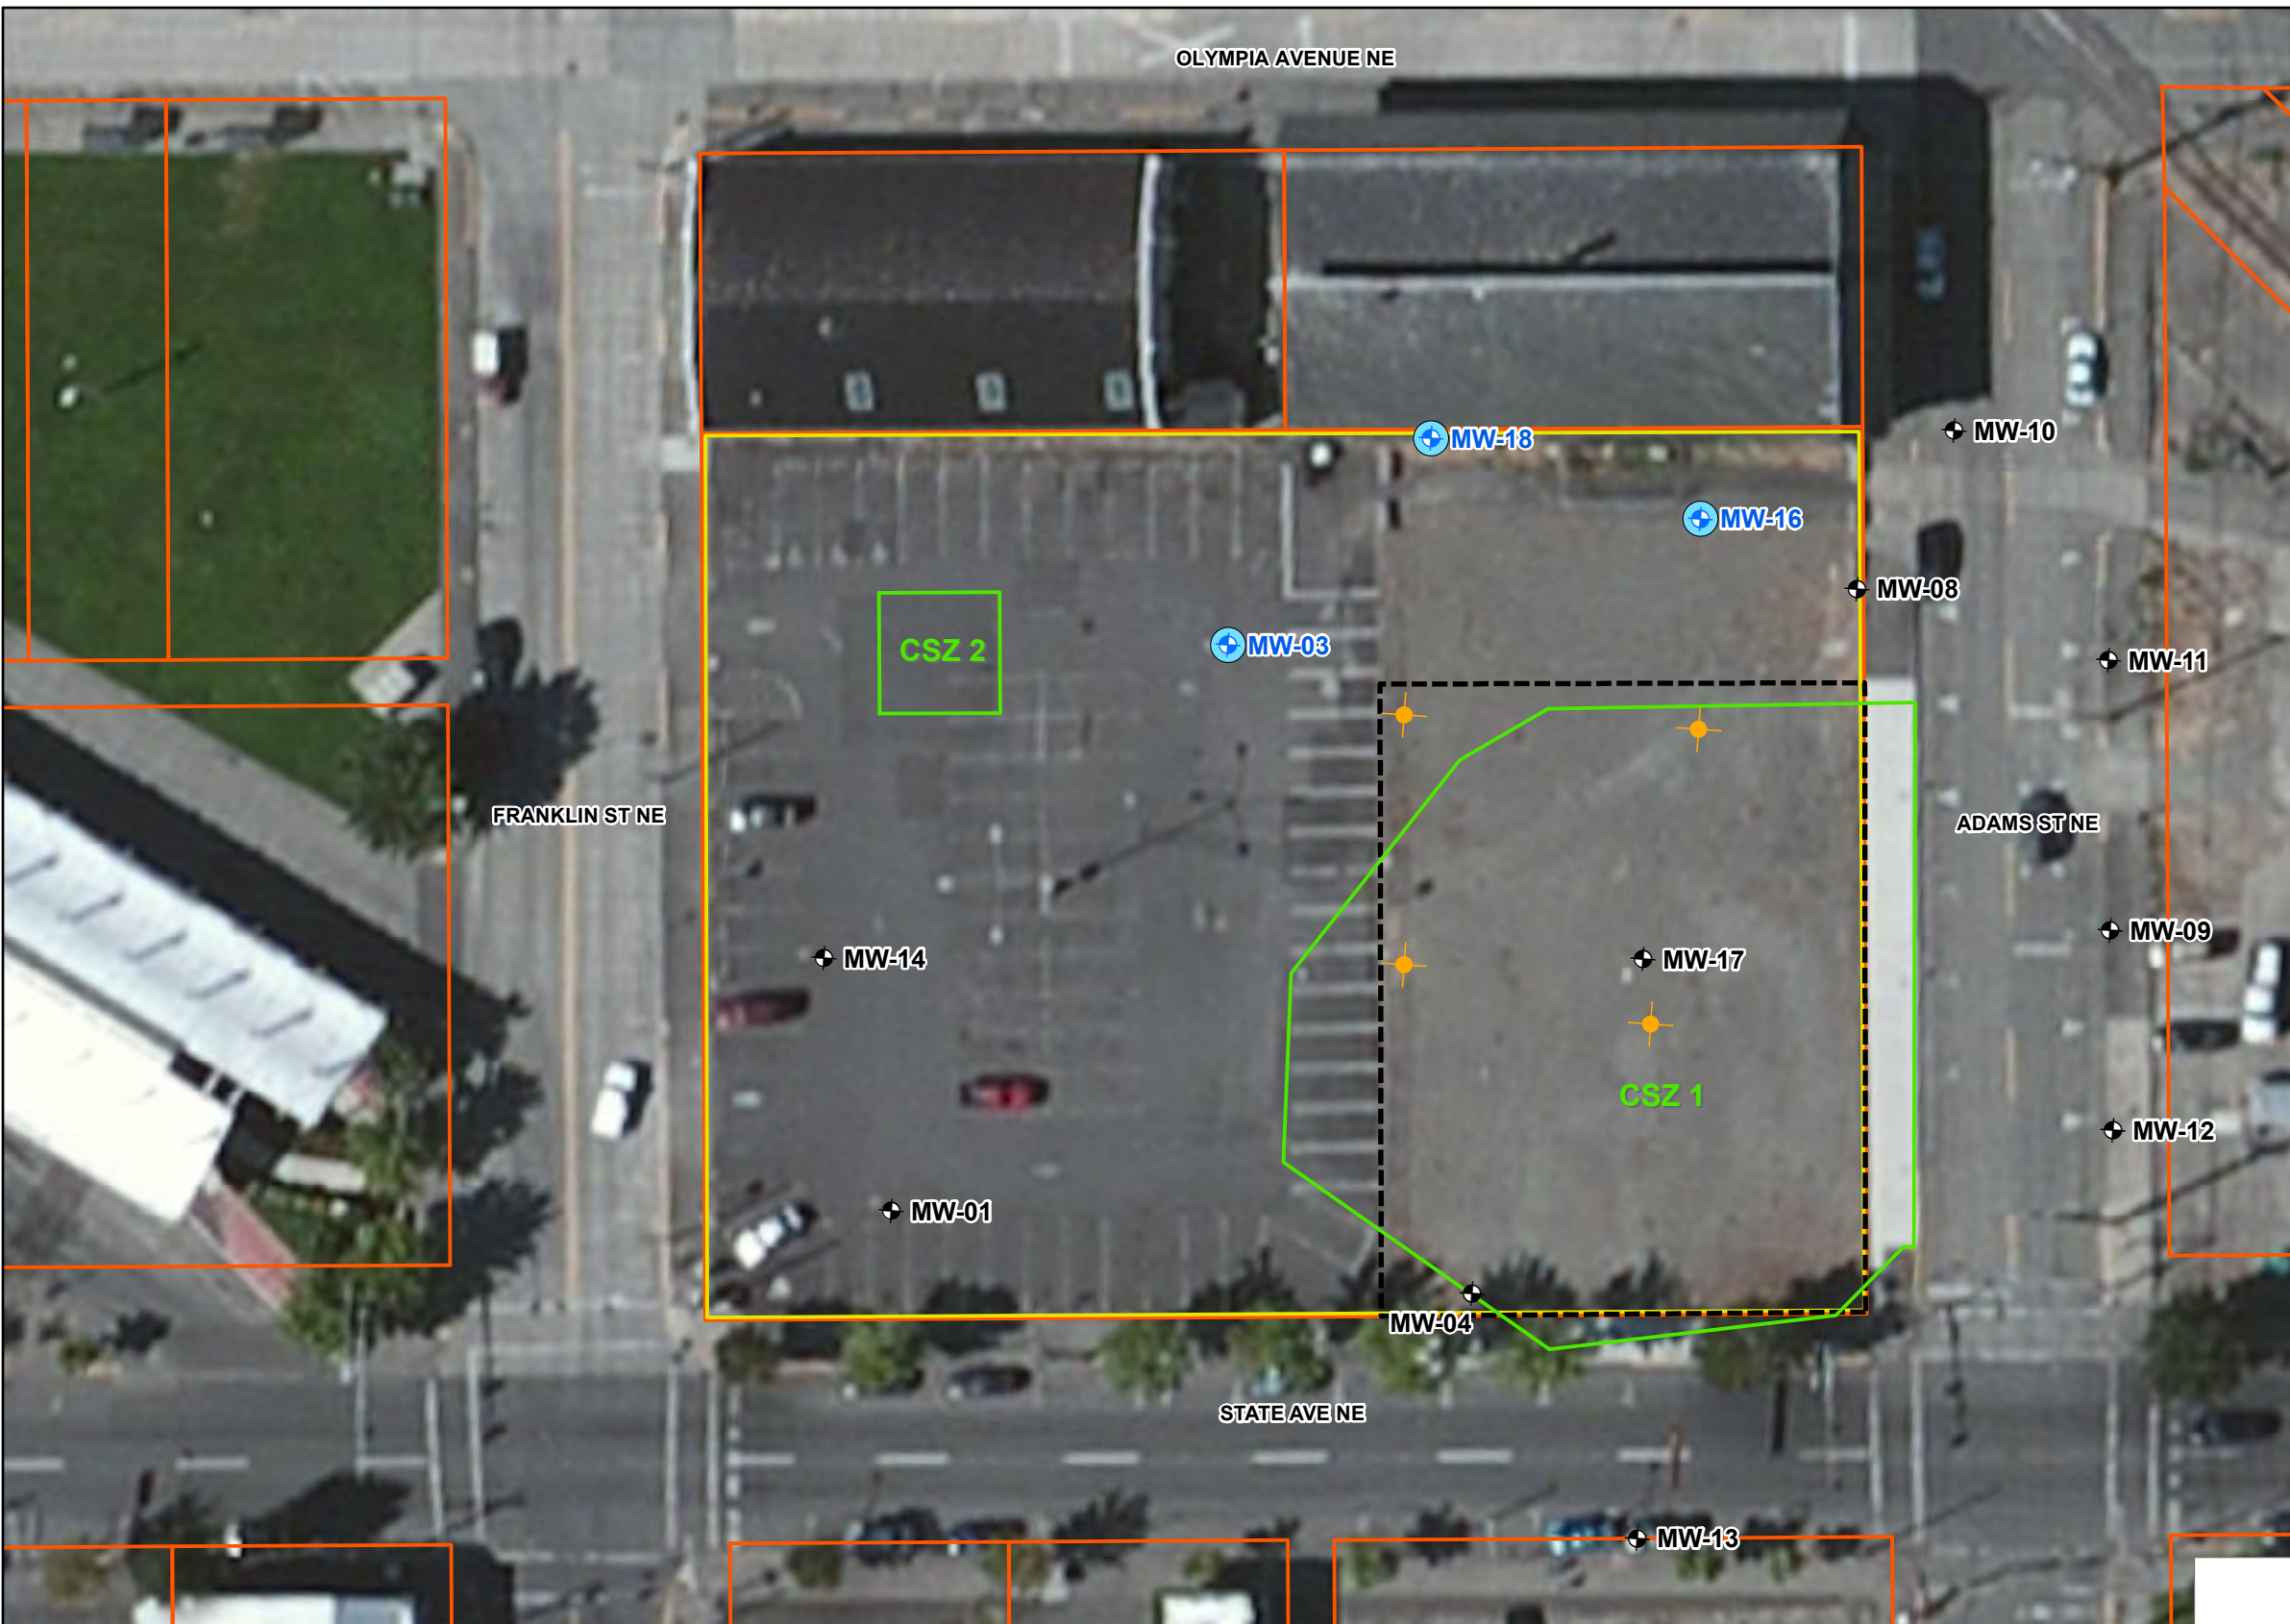
- Proposed Soil Gas Exploration Location
- MW-03 Monitoring Well Sampled for Groundwater Analysis and used to Monitor Groundwater levels
- MW-01 Existing Monitoring Well Previously Sampled for Groundwater Analysis and to Monitor Groundwater levels
- Vinyl Chloride at concentrations greater than MTCA Method A (0.2 ug/l)
- CSZ 1 Contaminated Soil Zones (CSZ) Remediated in September-October 2009
- Approximate Property Boundary
- Parcel Boundary
- Approximate Limits of Proposed Property Redevelopment
