# **PHASE II ENVIRONMENTAL SITE ASSESSMENT HAZEN HIGH SCHOOL FINAL REPORT**

1101 Hoquiam Avenue NE  
Renton, WA

**December 9, 2011**

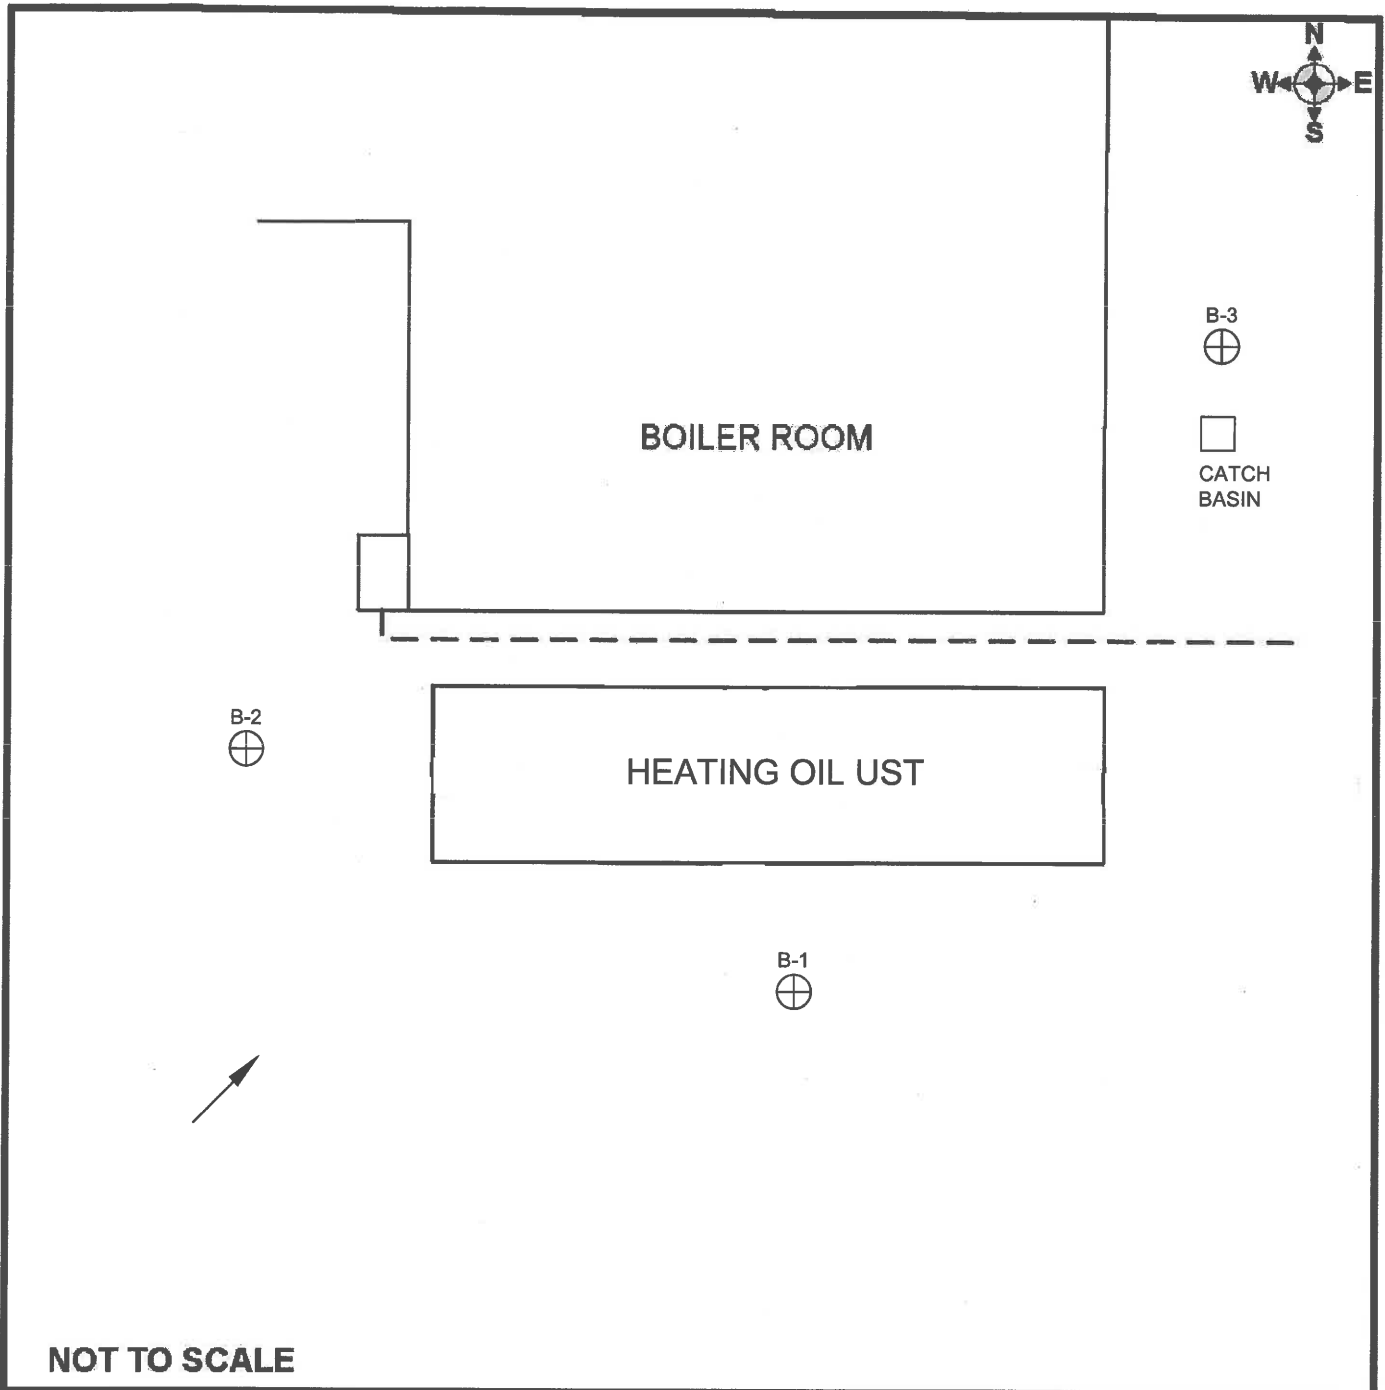
#### FIGURE 3

EHSI placed three soil borings in the following Site property locations described below and as depicted on Figure 2:

- Boring B-1 was drilled at the closest practical approach to the south side of the former heating oil UST removal excavation;
- Boring B-2 was positioned at the closest practical approach to the west of the former UST removal excavation;
- Boring B-3 was drilled at the closest practical approach to the northeast of the heating oil UST removal excavation;

SITE SAMPLE PLOT PLAN
