**New Soccer Fields  
Cleanup Action Report  
Brewster School District, Brewster WA**

**Prepared by  
Brewster School District**

**August 10, 2004**

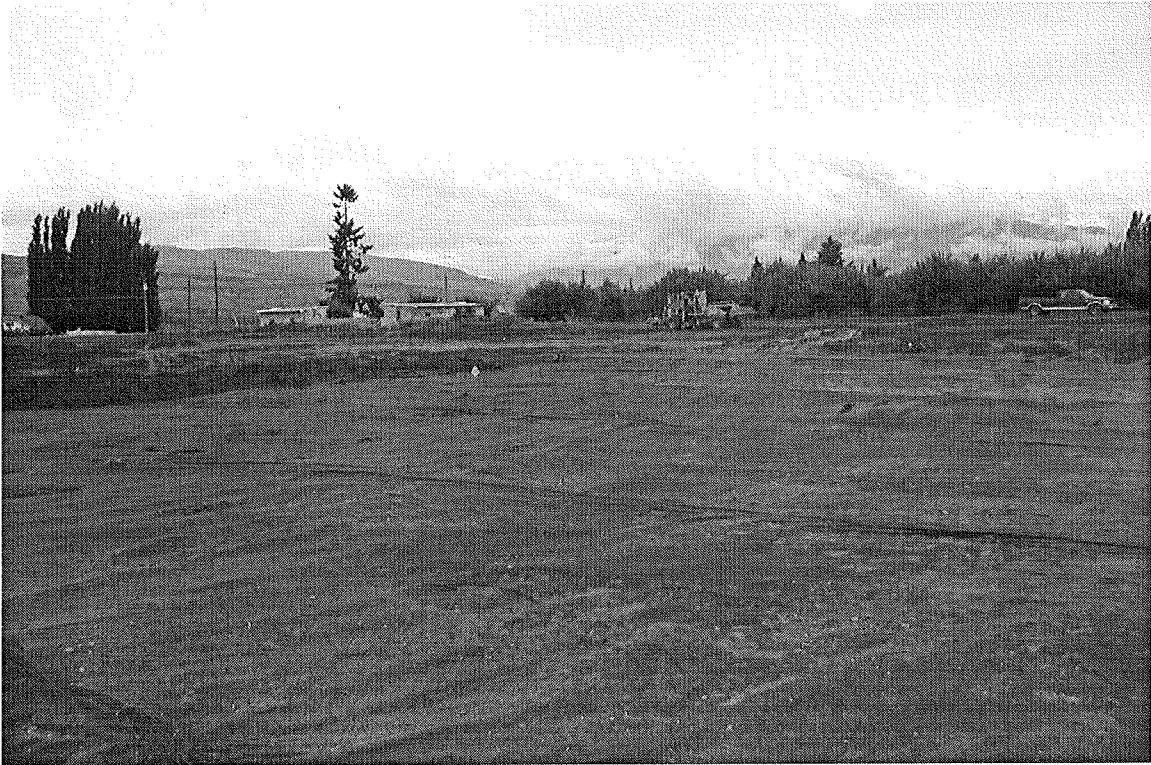
View of Geotextile fabric placed over contaminated soil in New Soccer Field

The final cap construction included installing the irrigation system, preparing the subgrade, laying the geotextile fabric, placing clean soil and sod. The photo journal, Attachment 1, shows the construction process and the completed work. A restrictive covenant, Attachment 1, has been placed on the property to restrict activities that have the potential to jeopardize the protectiveness of the cover system.

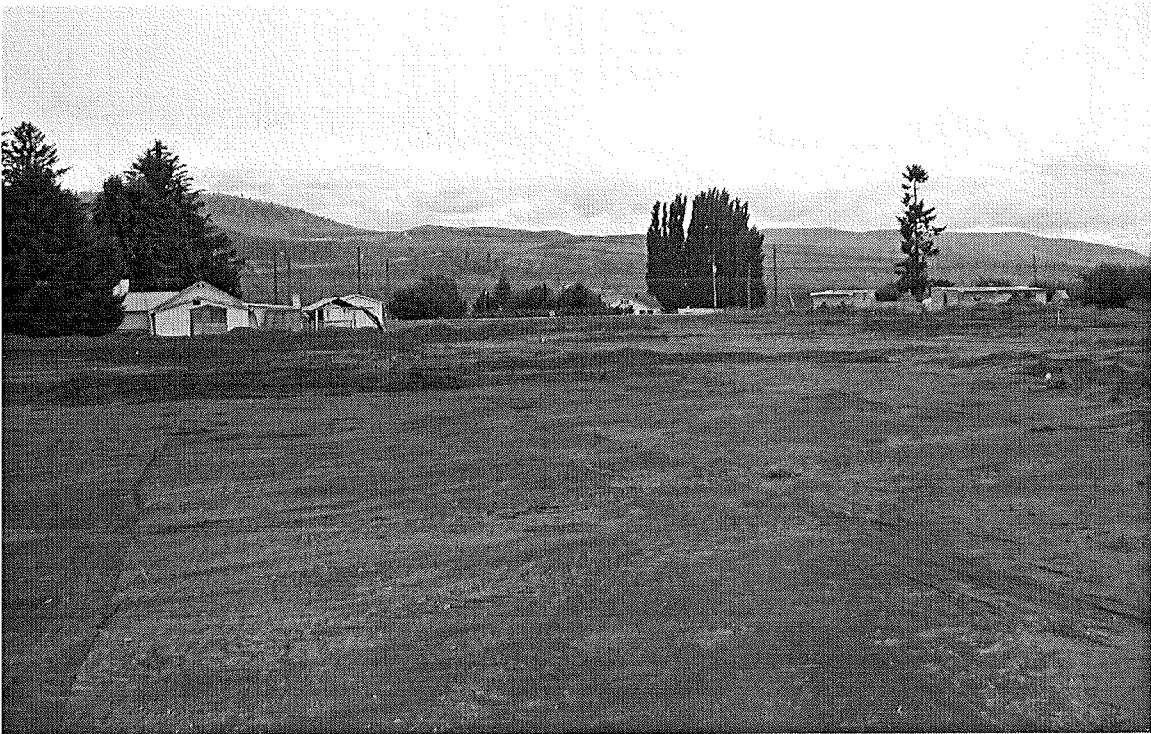
Another View of Geotextile fabric placed over the contaminated soil in New Soccer Field

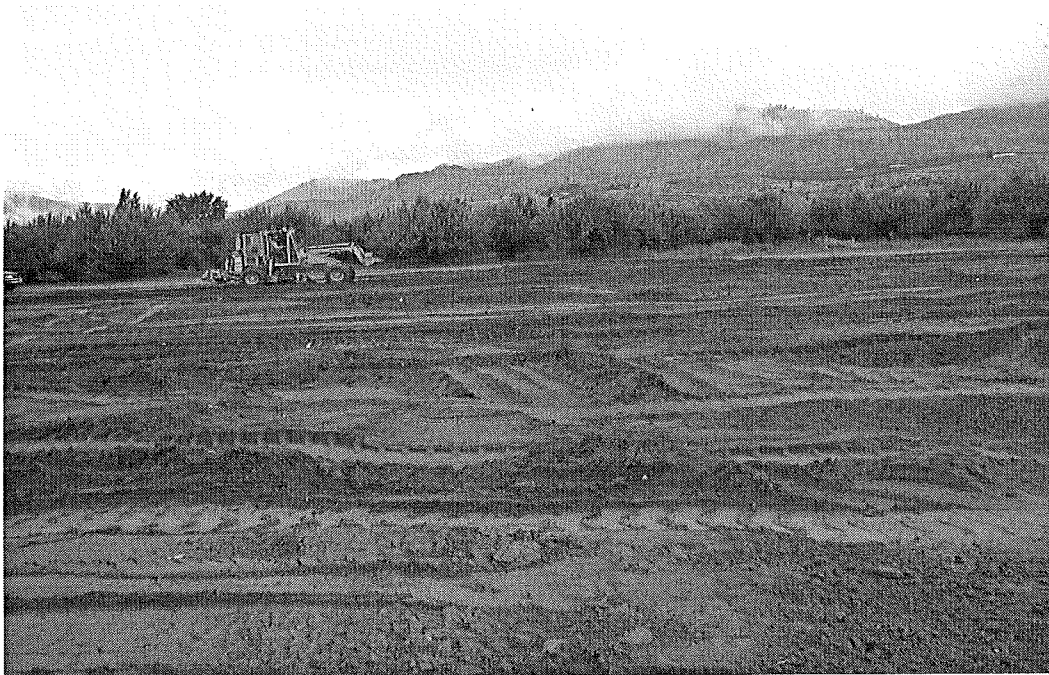
Clean soil being spread over the geotextile fabric in the New Soccer field

The clean cover soil was imported from a native, undisturbed soil source located at the Godbey Redi-Mix Pit Site, Route 97, outside Pateros, WA. For quality control, three samples from the soil source were taken on August 5, 2004 to ensure that the soil met MTCA cleanup standards. The samples results are shown below in Table 2.

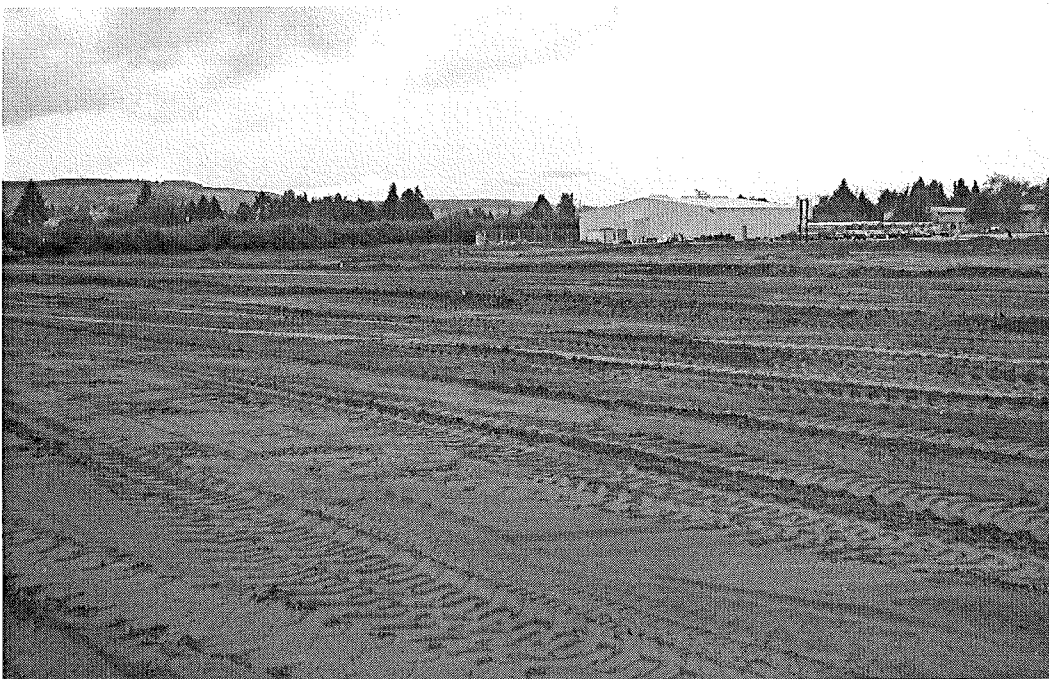
Clean soil cap placed above the geotextile fabric

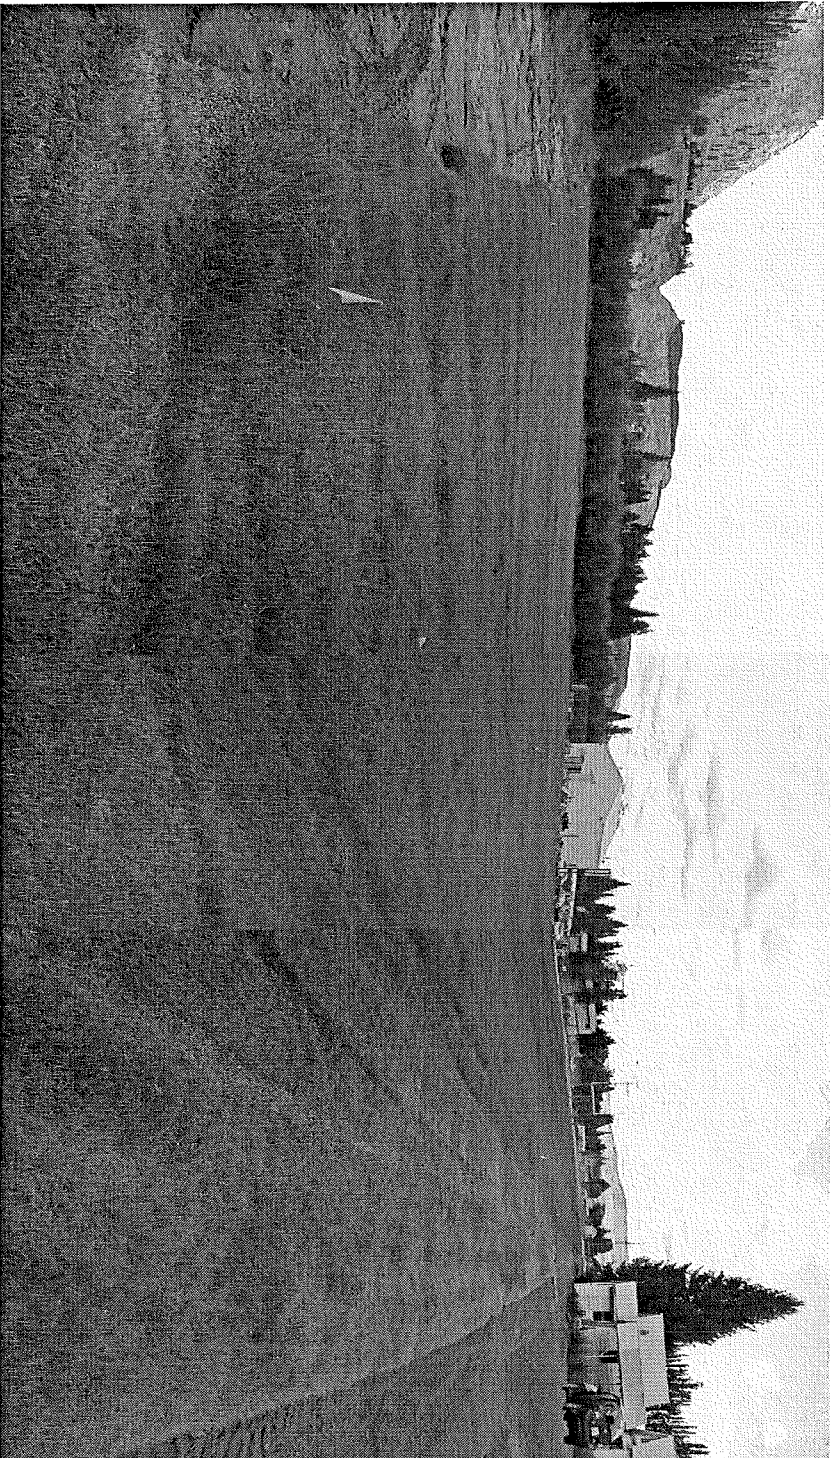
View of the clean soil cap and sod in the New Soccer Field  
(Photo has been edited to provide panoramic view of field.)

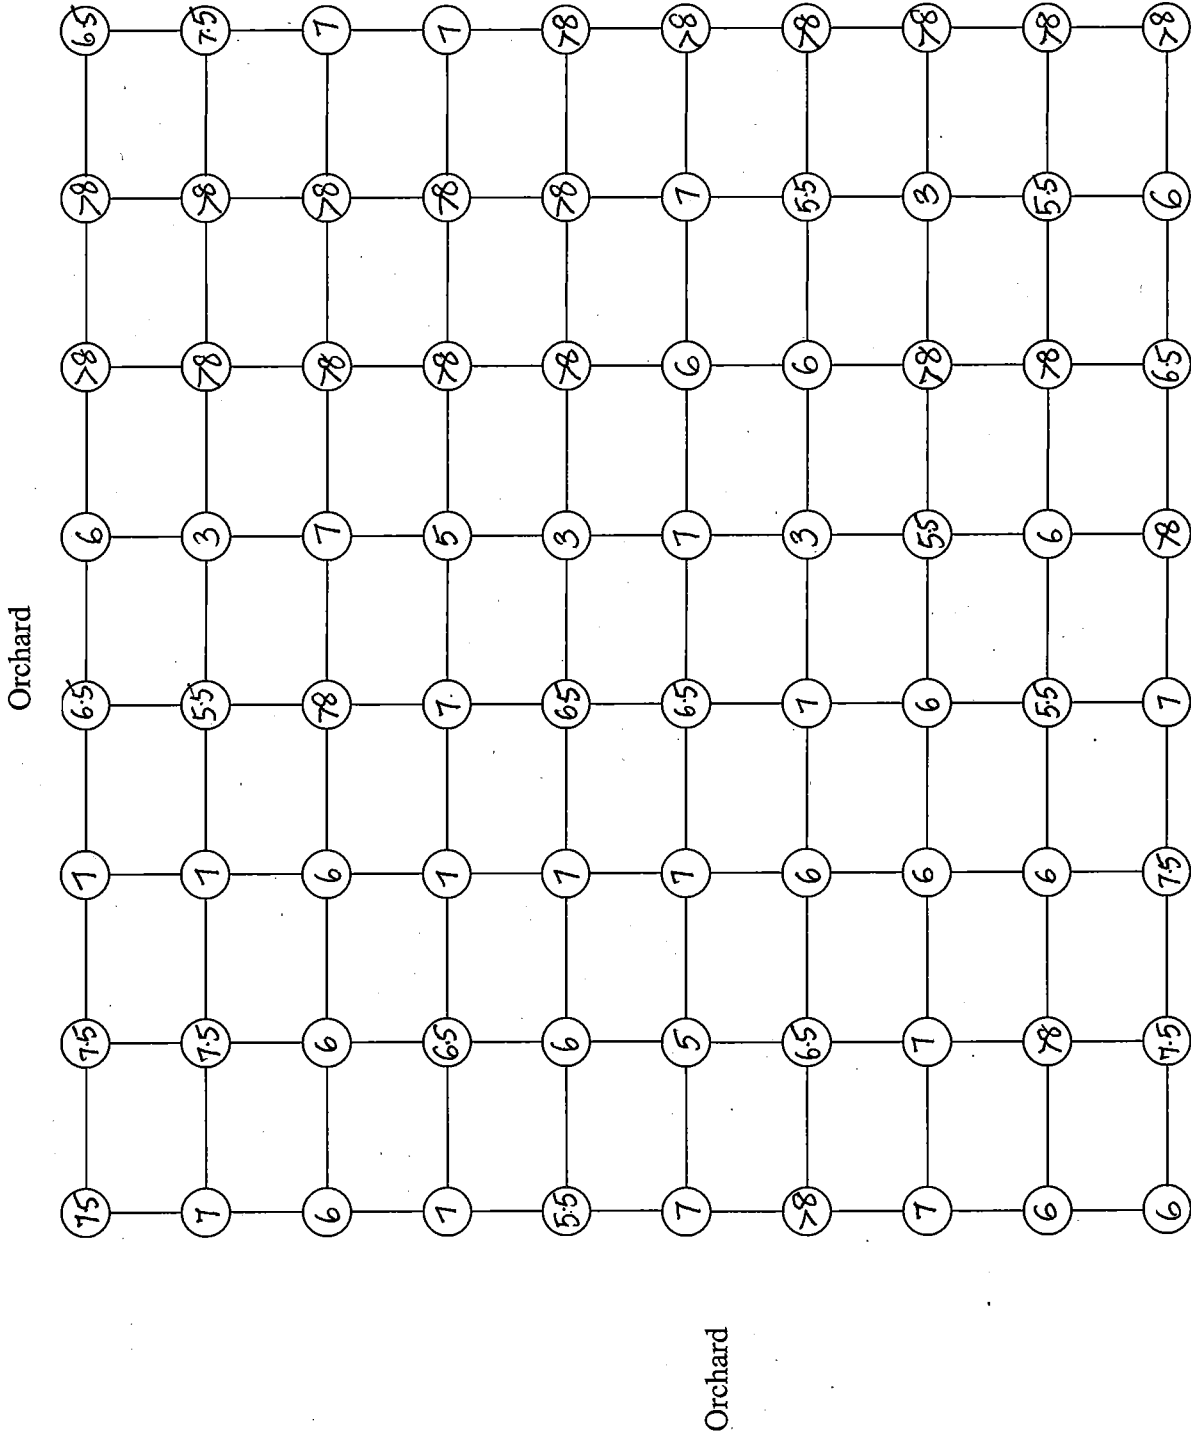
Brewster School District New Soccer Field Soil Cap Depth Measurement  
 Aug 5, 2004 by WA State Dept. of Ecology

Confirmational monitoring of the installed cap consisted of taking depth measurements of the constructed cover and ensuring cover soil meets MTCA cleanup levels. The sample sites were selected using a predetermined grid sampling pattern based on sprinkler head spacing. Depth of soil to the geotextile barrier were taken on August 5, 2004 at each sprinkler head and averaged 7" with a minimum of 3" at the 80 sites sampled as shown in Attachment 2. The 3" depth measurements near the sprinkler heads are likely the result

of raising the sprinkler heads and the fabric pulled up to access them. It is not likely indicative of a large area of low soil depth cover.
