SITE SOILS CHARACTERIZATION AND CLEANUP REPORT

SMITH BROTHERS FARM  
27441 68<sup>th</sup> Ave. S  
KENT, WA 98032

Blue Sage Environmental, Inc.  
P.O. Box 6738  
Kennewick, WA 99336

August 27, 2013

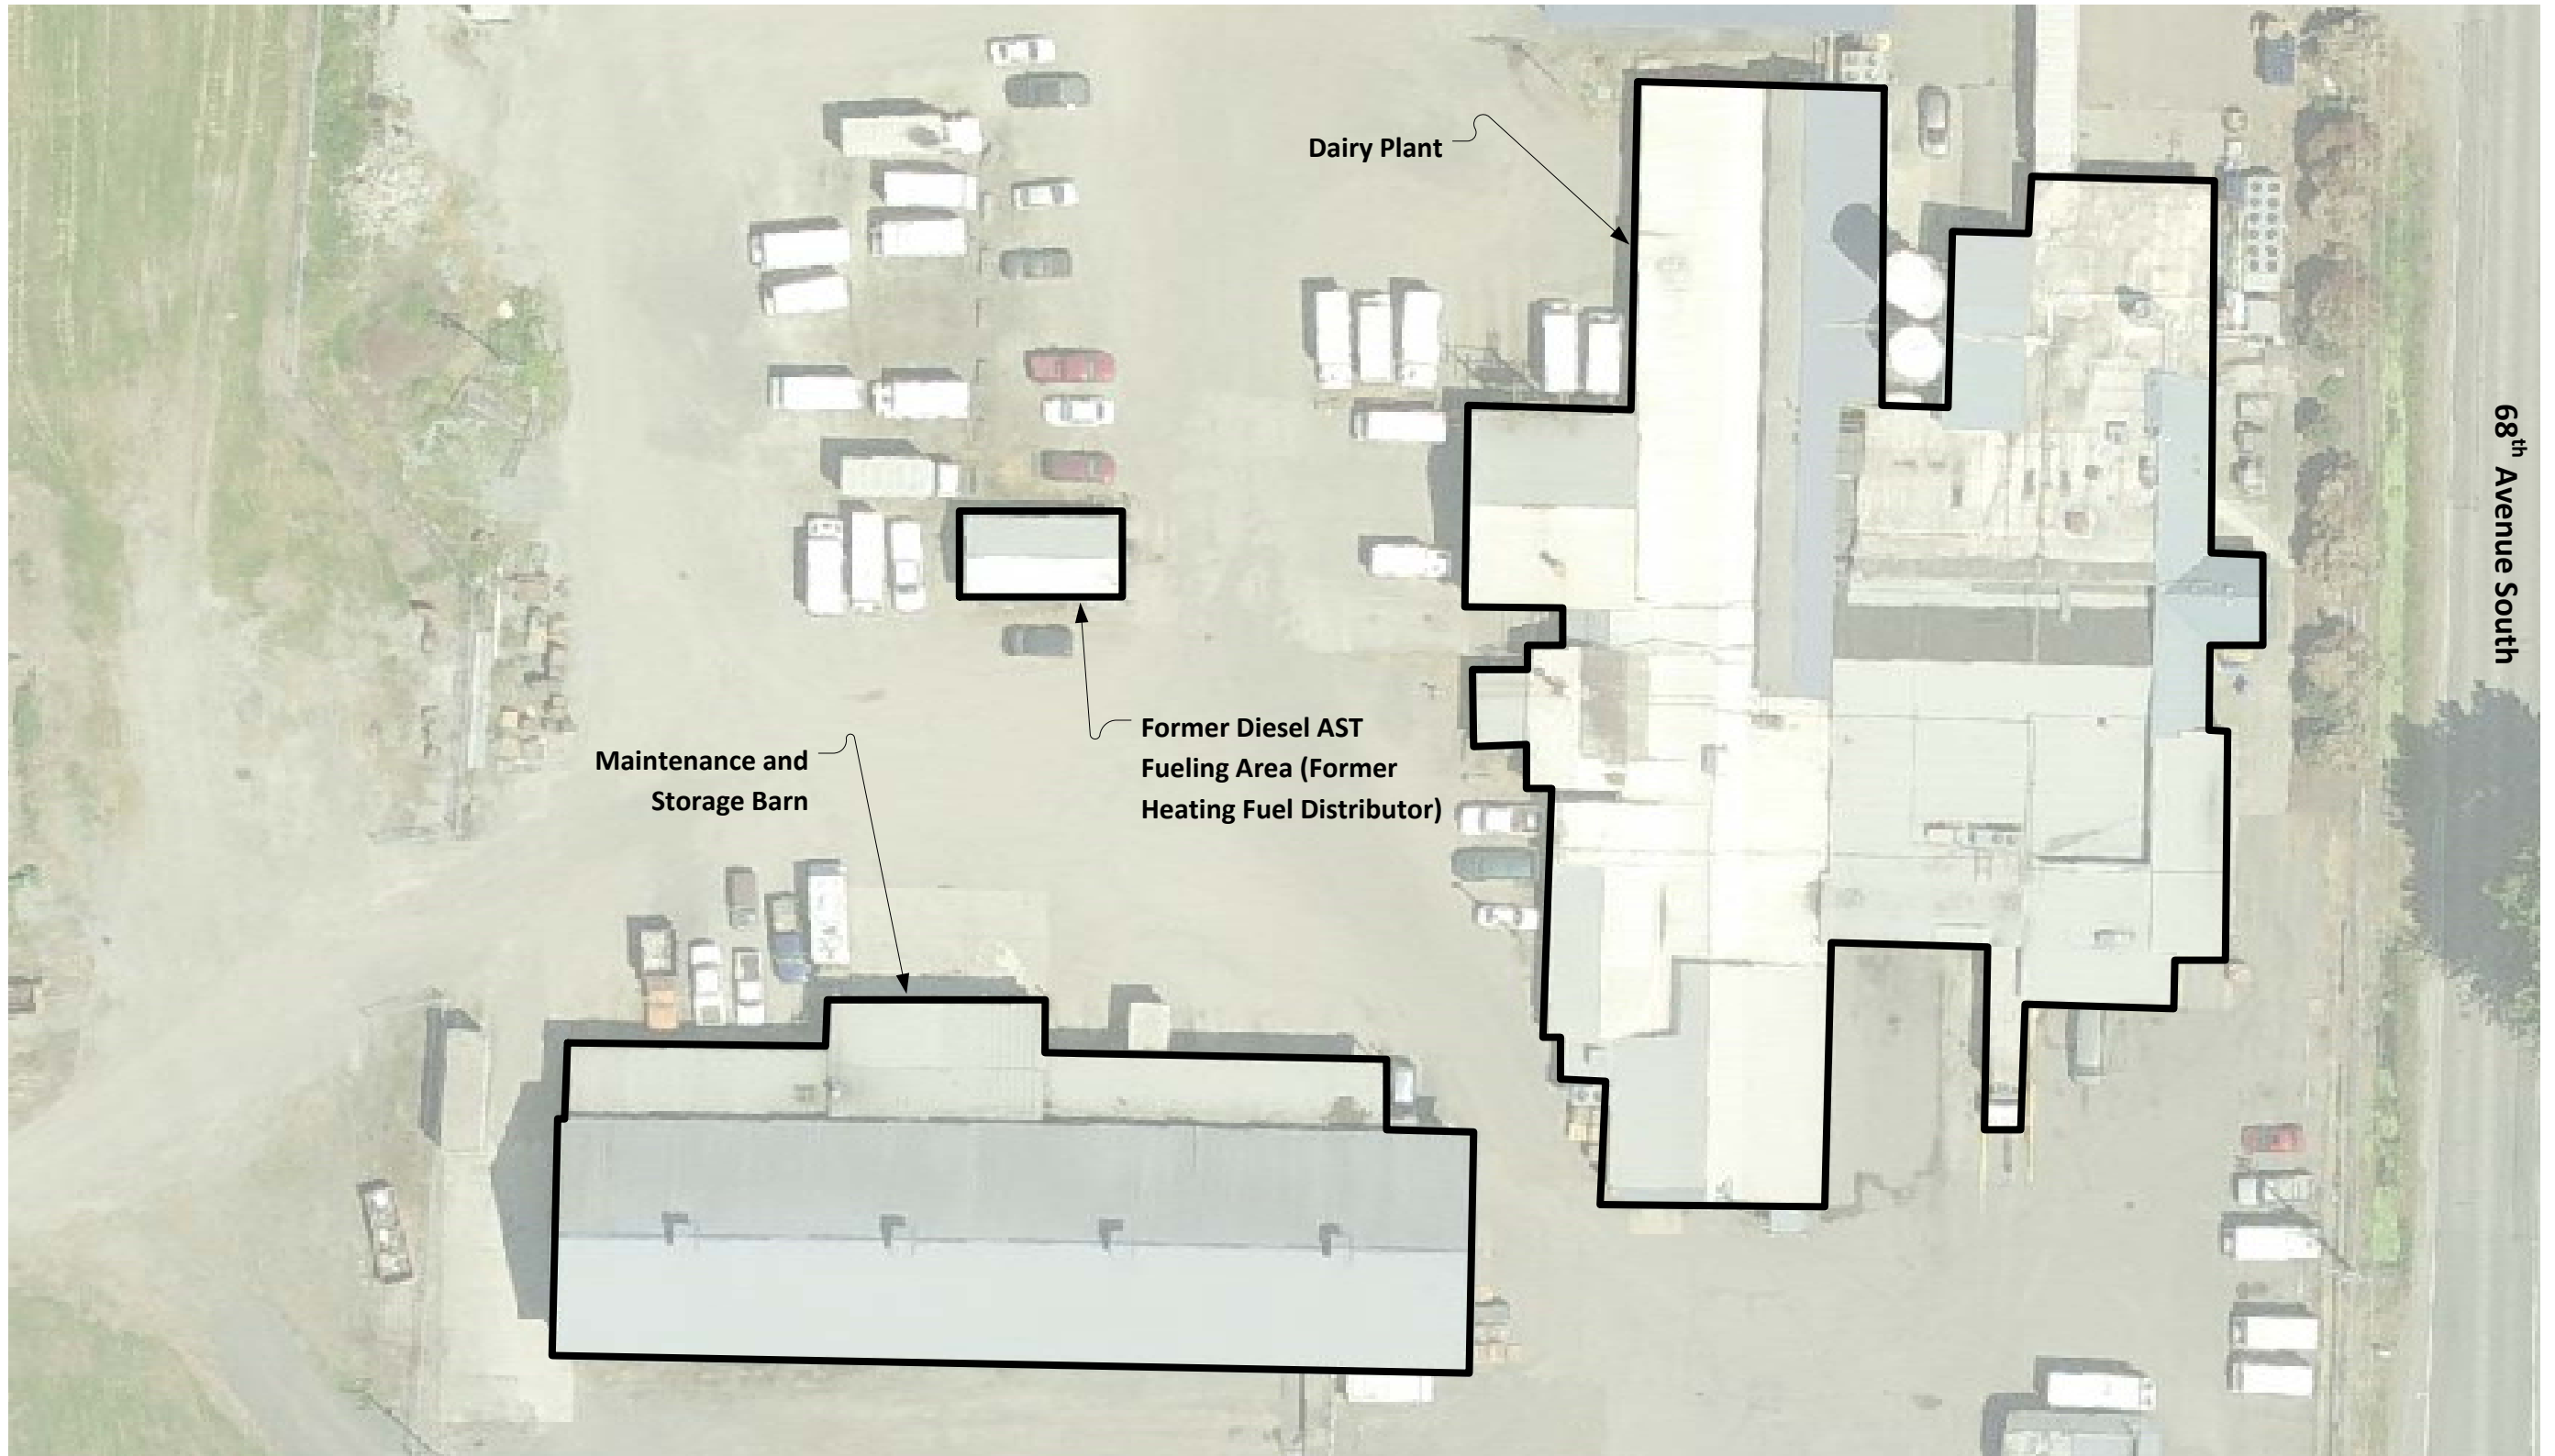
**Figure  
2A**

**Site Diagram  
Smith Brothers Farms  
27441 68<sup>th</sup> Avenue South  
Kent, WA 98032**

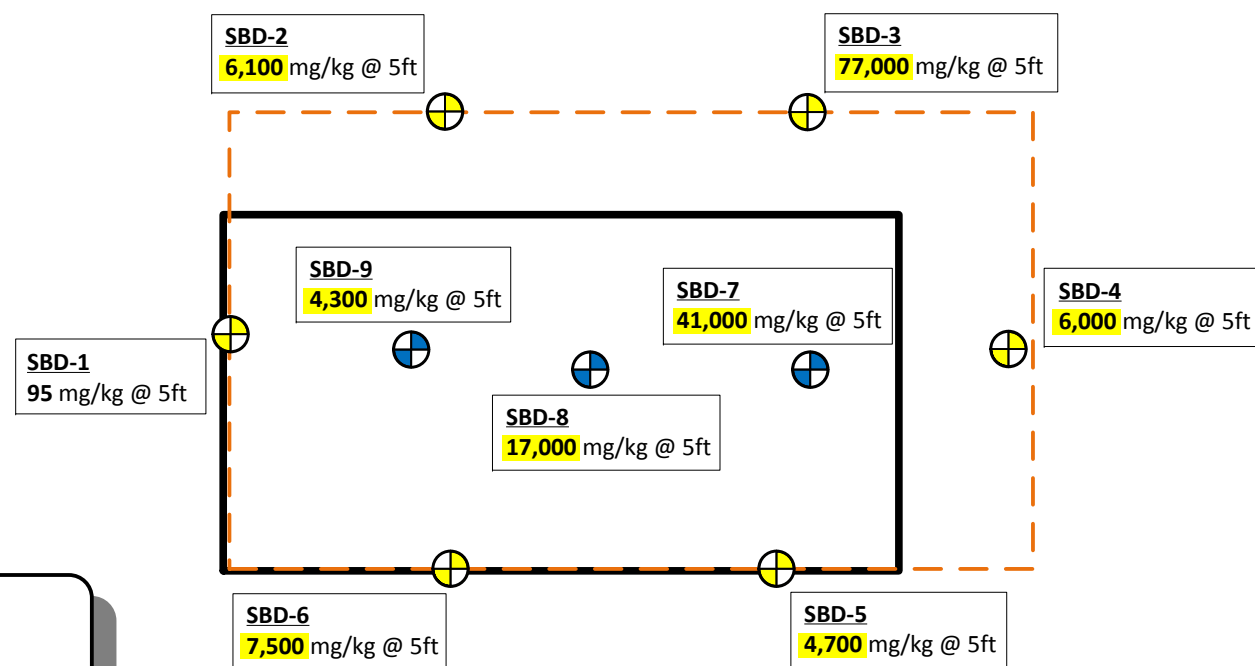
Figure  
3A

Soil samples were obtained from the sidewalls and floor of the excavation (**Figure 3a**). Petroleum odor and sheen testing were used to identify areas of potential contamination from the release.

Sample Number	Depth (ft)	Location
SBD 1	5	W sidewall
SBD 2	5	N sidewall, east end
SBD 3	5	N sidewall, west end
SBD 4	5	E sidewall, center
SBD 5	5	S sidewall, east end
SBD 6	5	S sidewall, west end
SBD 7	5	Floor, east end
SBD 8	5	Floor, center
SBD 9	5	Floor, west end

Concentrations of diesel were elevated above the MTCA Method A cleanup level for soil in all samples except for SBD 1. Additional excavation was required after review of the analytical results.

**BSE Excavation (6/5/2013)**  
Smith Brothers Farms  
27441 68<sup>th</sup> Avenue South  
Kent, WA 98032

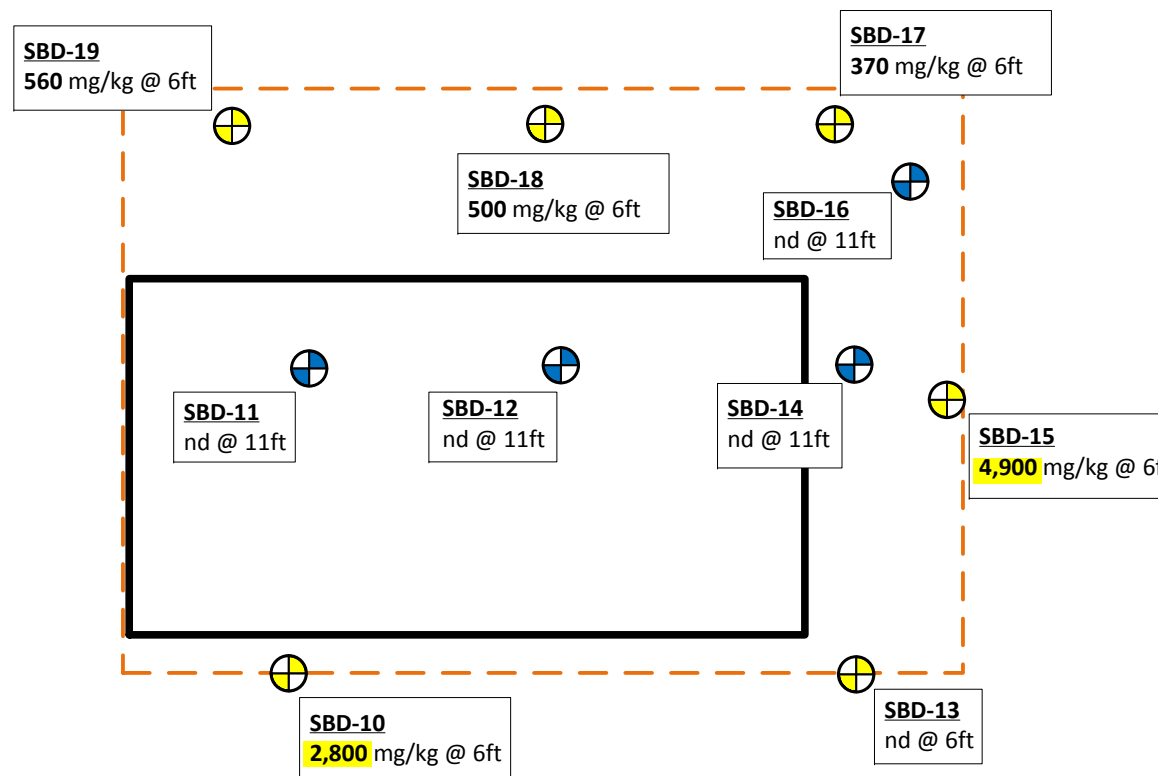
Figure  
3B

Soil samples were obtained from the sidewalls and floor of the excavation (**Figure 3b**).

Sample Number	Depth (ft)	Location
SBD 10	6	S sidewall, west end
SBD 11	11	Floor, west end
SBD 12	11	Floor, center
SBD 13	6	S sidewall, east end
SBD 14	11	Floor, east end
SBD 15	6	E sidewall, center
SBD 16	11	Floor, northeast corner
SBD 17	6	N sidewall, east end
SBD 18	6	N sidewall, center
SBD 19	6	N sidewall, west end

Elevated concentrations of diesel were present in the west end of the south sidewall, and in the center of the east sidewall.

**BSE Excavation (6/8/2013)**  
Smith Brothers Farms  
27441 68<sup>th</sup> Avenue South  
Kent, WA 98032

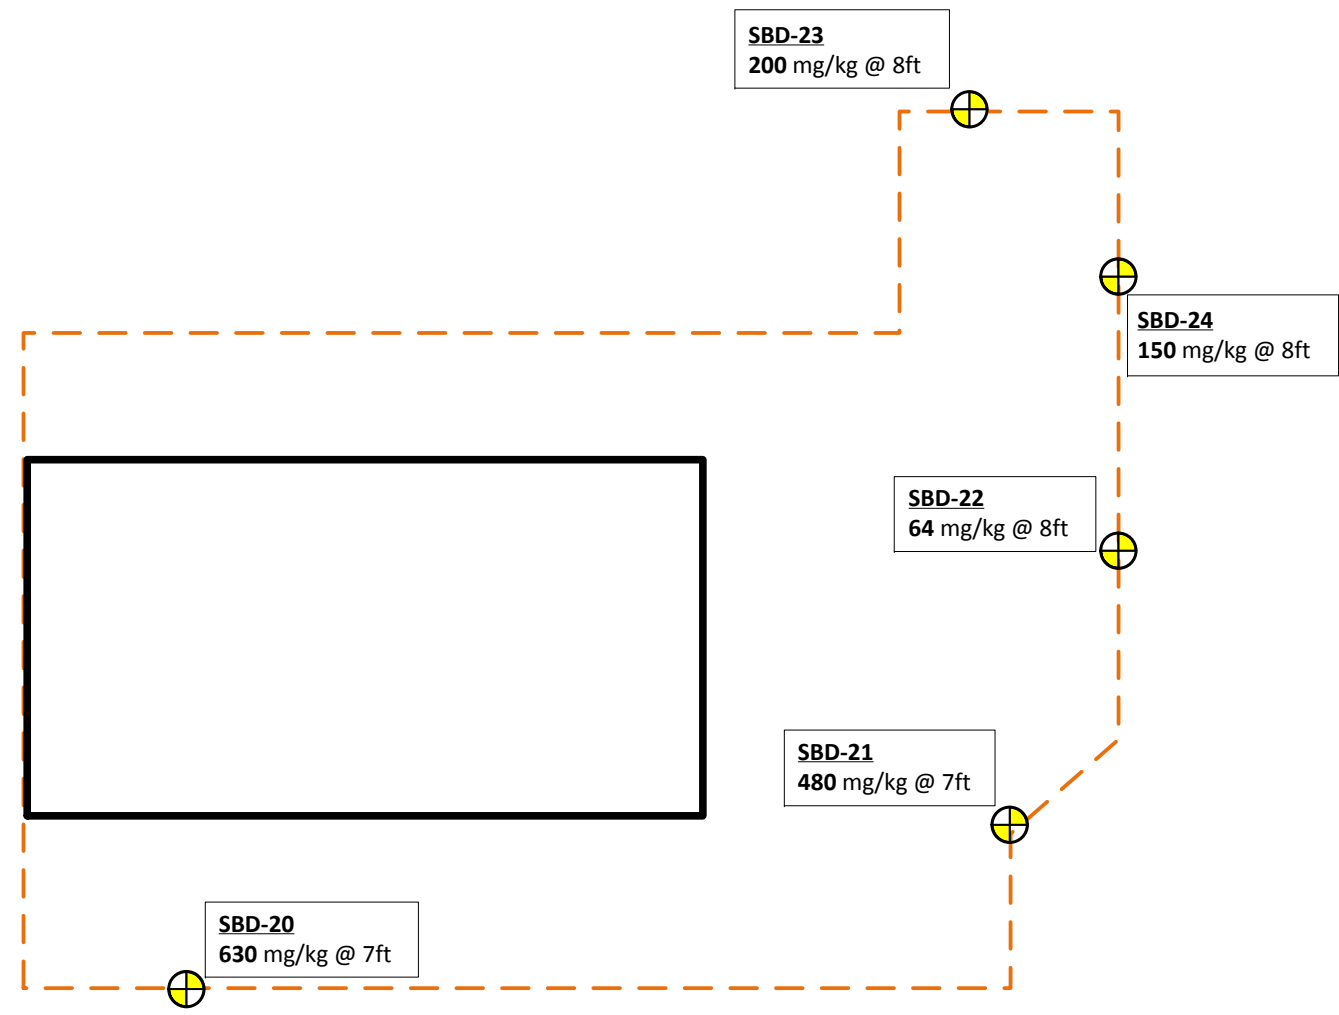
Figure  
 3C

Soil samples were obtained from the south sidewall near its west end, along the east sidewall, and in the northeast corner where the sidewall wall was expanded further to the north (**Figure 3c**).

Sample Number	Depth (ft)	Location
SBD 20	7	S sidewall, SE corner
SBD 21	7	E sidewall, south end
SBD 22	8	E sidewall, center
SBD 23	8	N sidewall, east end
SBD 24	8	E sidewall, north corner

All samples reported diesel concentrations below MTCA Method A cleanup levels for soil.

**BSE Excavation (6/15/2013)**  
**Smith Brothers Farms**  
 27441 68<sup>th</sup> Avenue South  
 Kent, WA 98032

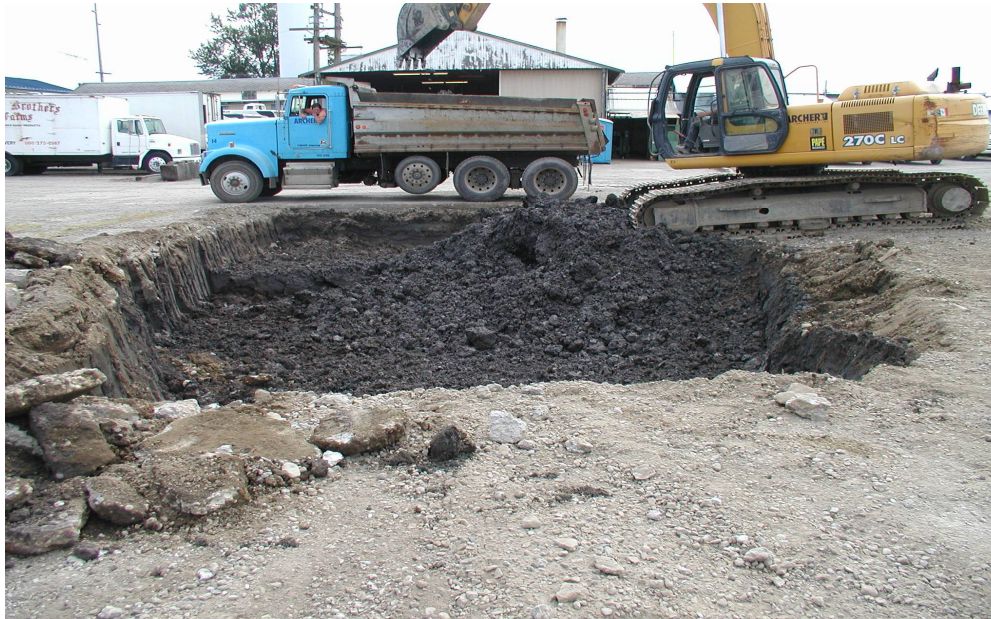
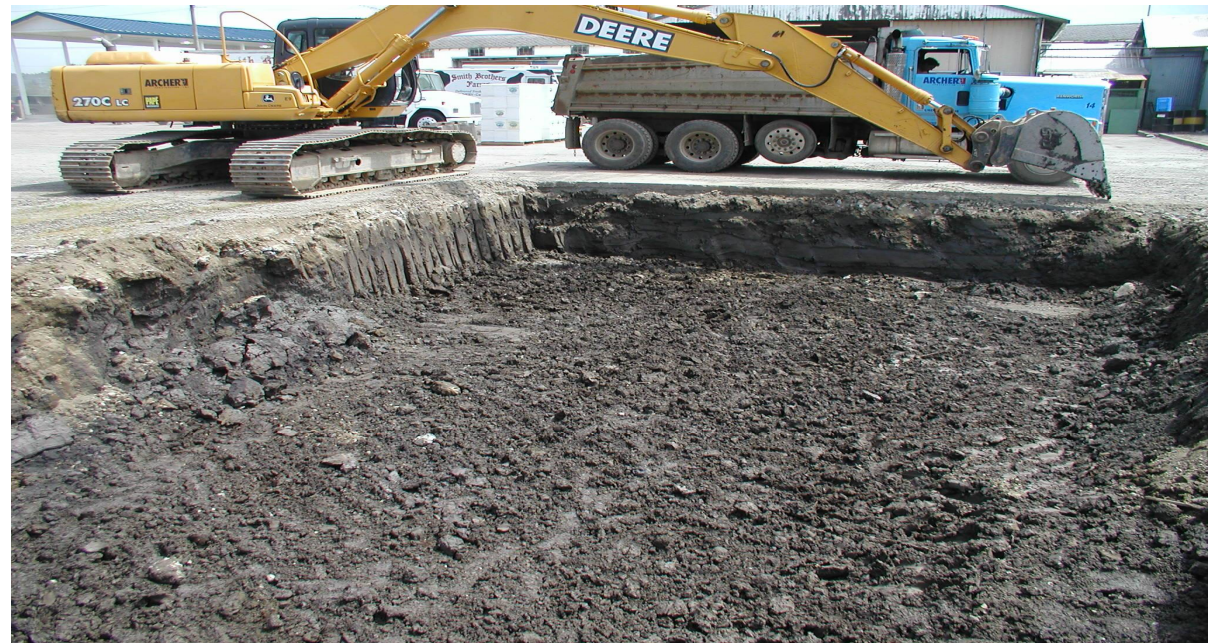
DWG. NO.  
**Photos**

On June 5, the area immediately around and below the containment structure was excavated down to a depth of 5 feet. It was noted that a strong odor of diesel was present in both the excavated soils and the open excavation. Groundwater was present in several

areas across the floor of the excavation at that depth. A treatment cell was constructed with a 6 mil visqueen liner and straw bales at the northeast corner of the fence line. All excavated soils were placed in the cell (**Photos**).

TITLE Smith Brothers Farm  
Excavation Arera  
June 5, 2013

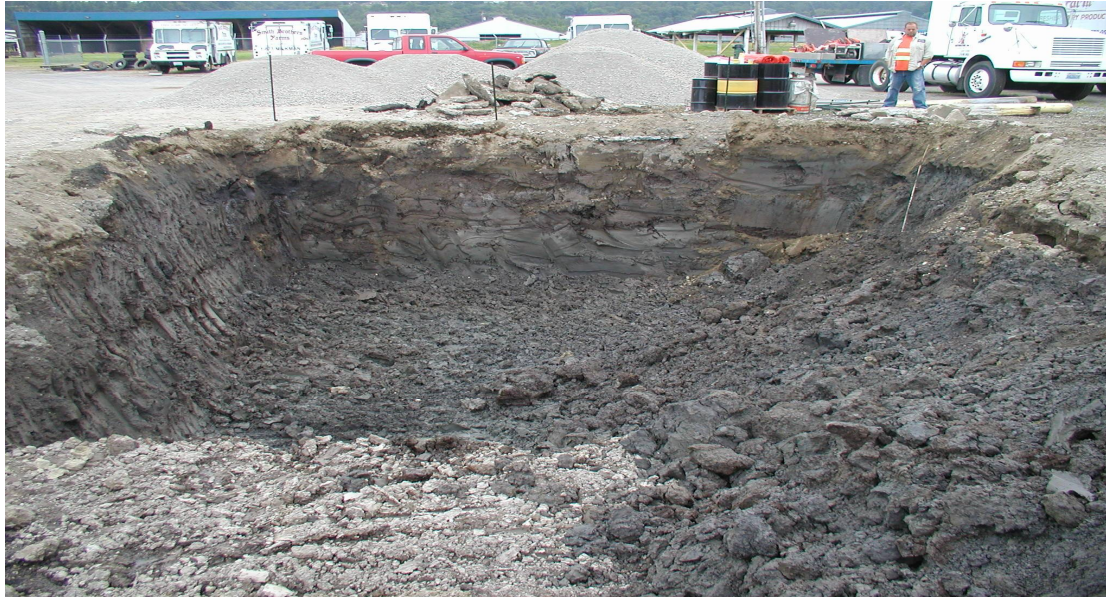
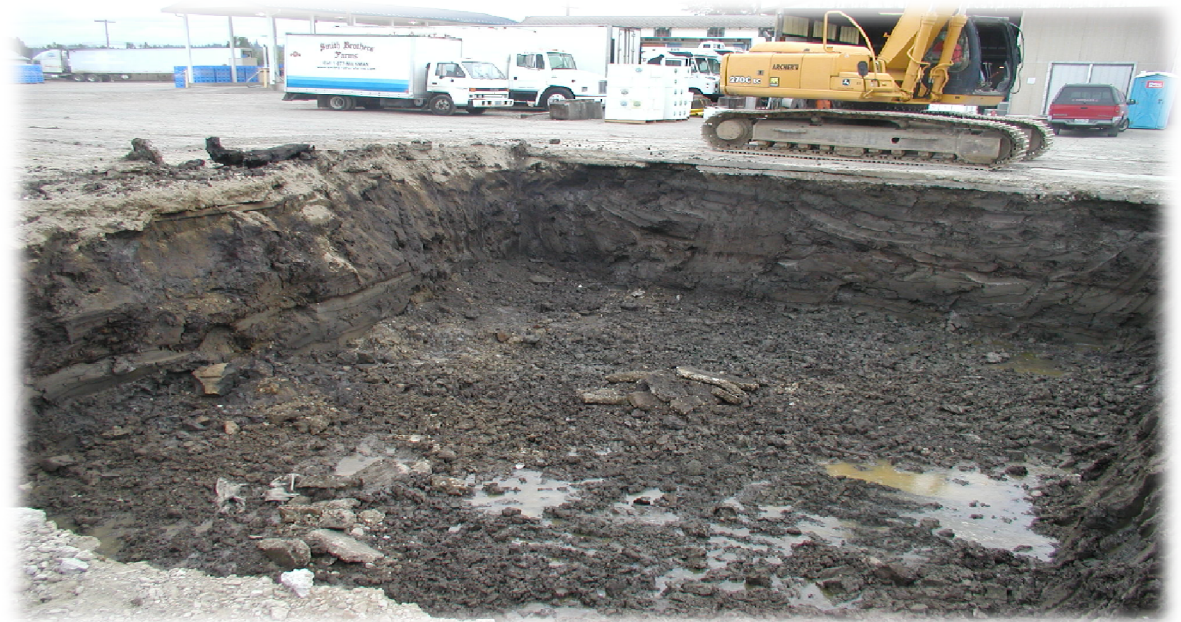
DWG. NO.  
**Photos**

Removal of soil was done along the south, east and north sidewalls. The floor of the excavation was lowered from 5 to 10 feet. Groundwater was noted in several areas across the floor of the excavation (**Photos**).

TITLE Smith Brothers Farm  
Excavation Arera  
June 8, 2013

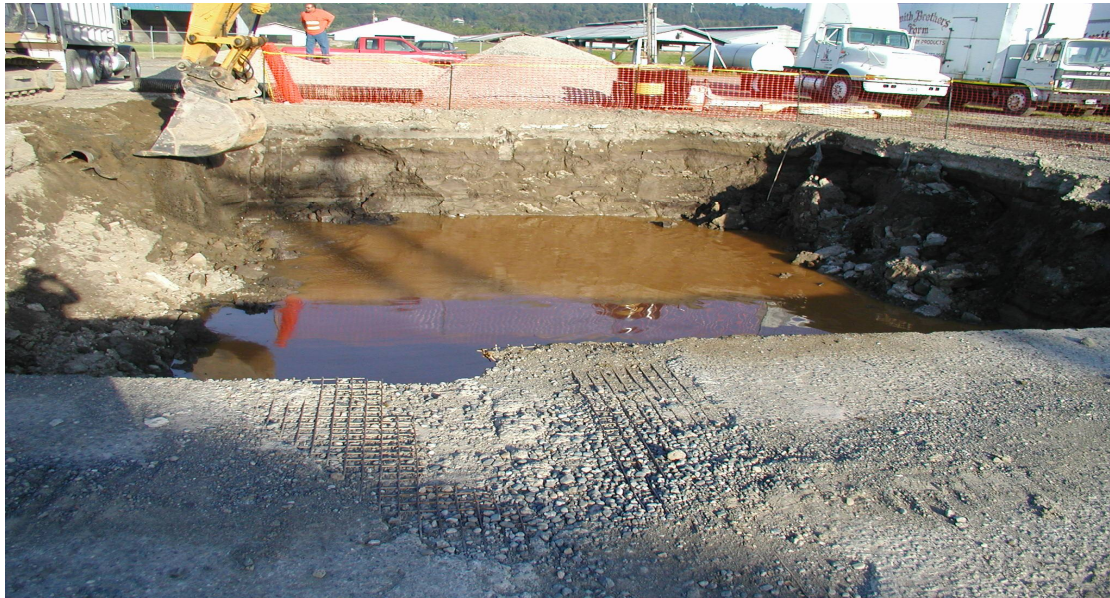
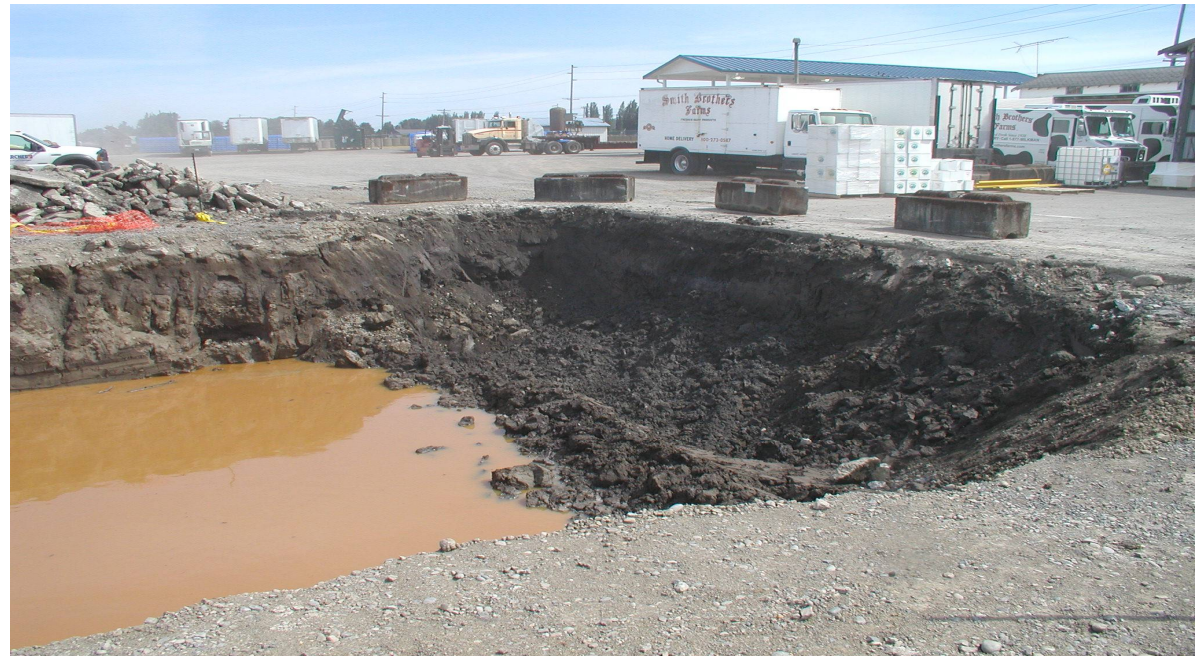
DWG. NO.  
**Photos**

Additional removal of soil was done several areas. On the south sidewall along the west end, and on the east sidewall continuing along the center of the wall up to the north end. Contamination was also found at the northeast corner of the excavation that extended approximately twelve feet to the north. The floor of the excavation was covered in water prior to excavation activities being undertaken. A temporary soil wall was used to keep existing water out of the east end of the excavation (**Photos**).

TITLE    Smith Brothers Farm  
Excavation Arera  
June 15, 2013

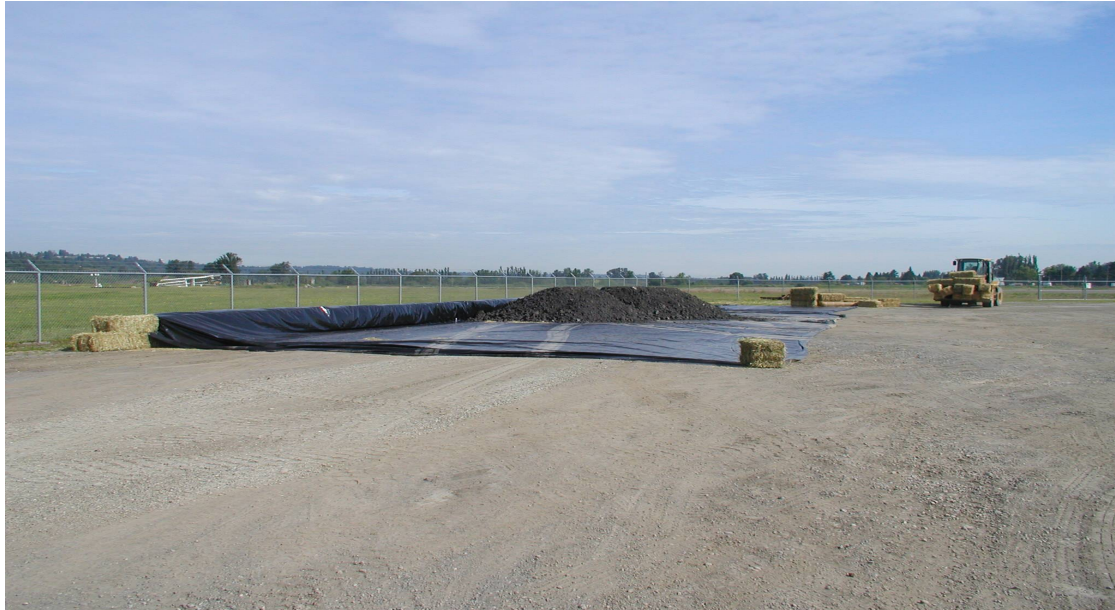
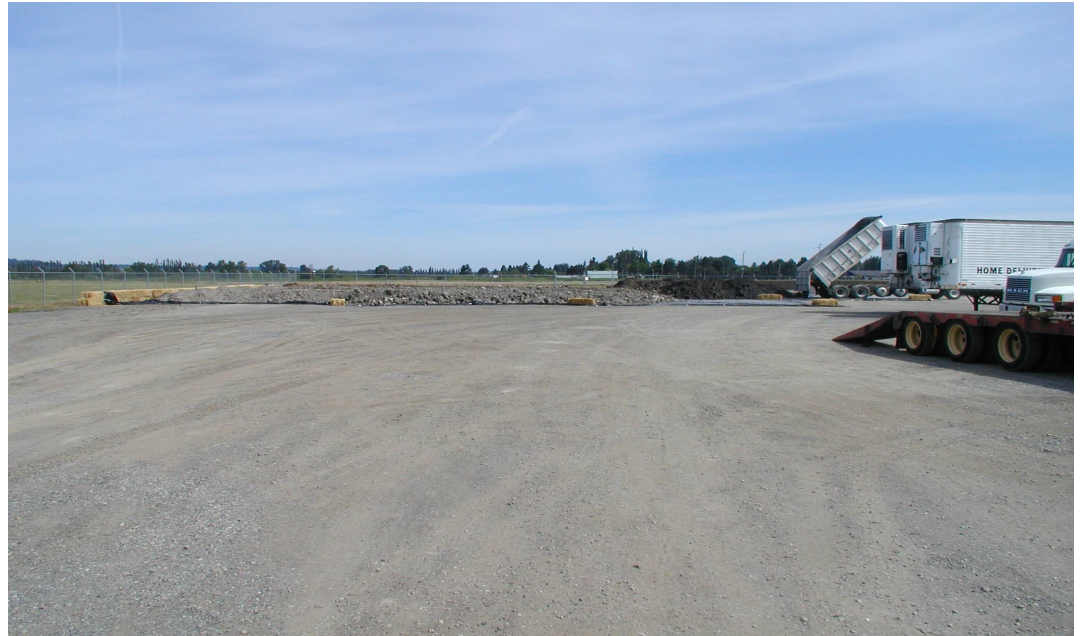
DWG. NO.  
**Photos**

All excavated material has been stored in a treatment cell located on the property. A nitrogen source has been added into the soil. The treatment cell is being aerated by turning the soil every 7 to 10 days. Samples will be taken at the end of summer to measure the progress in the bioremediation of this material.

TITLE Smith Brothers Farm  
Bioremediation Cell

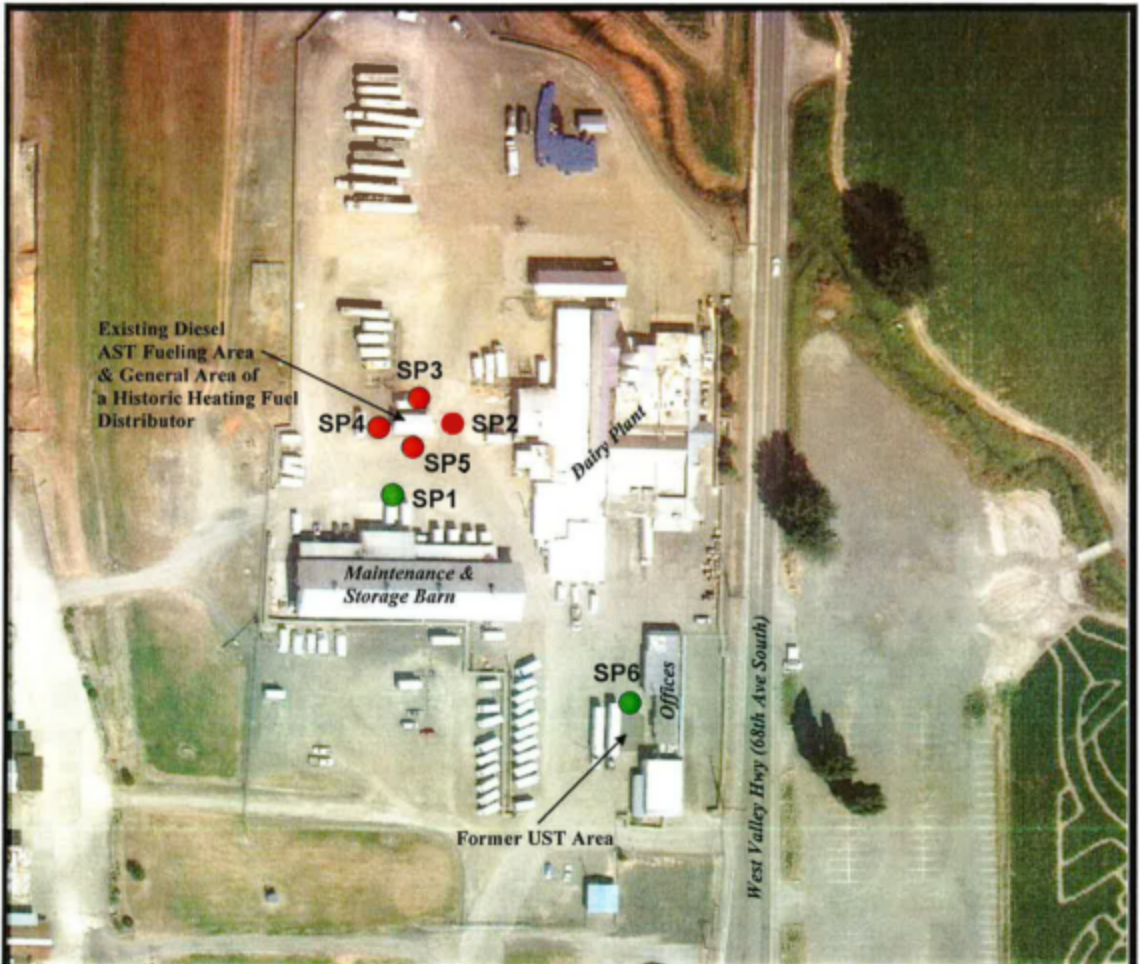
Job Number:	Date:	Plate:
JN 32115-1	October 2012	2

- Approximate location of soil borings made by EAI in October 2012
- Red denotes locations where soil and/or groundwater contained diesel at concentrations above the WDOE's target compliance levels for unrestricted land use.

**SITE PLAN OVERVIEW**

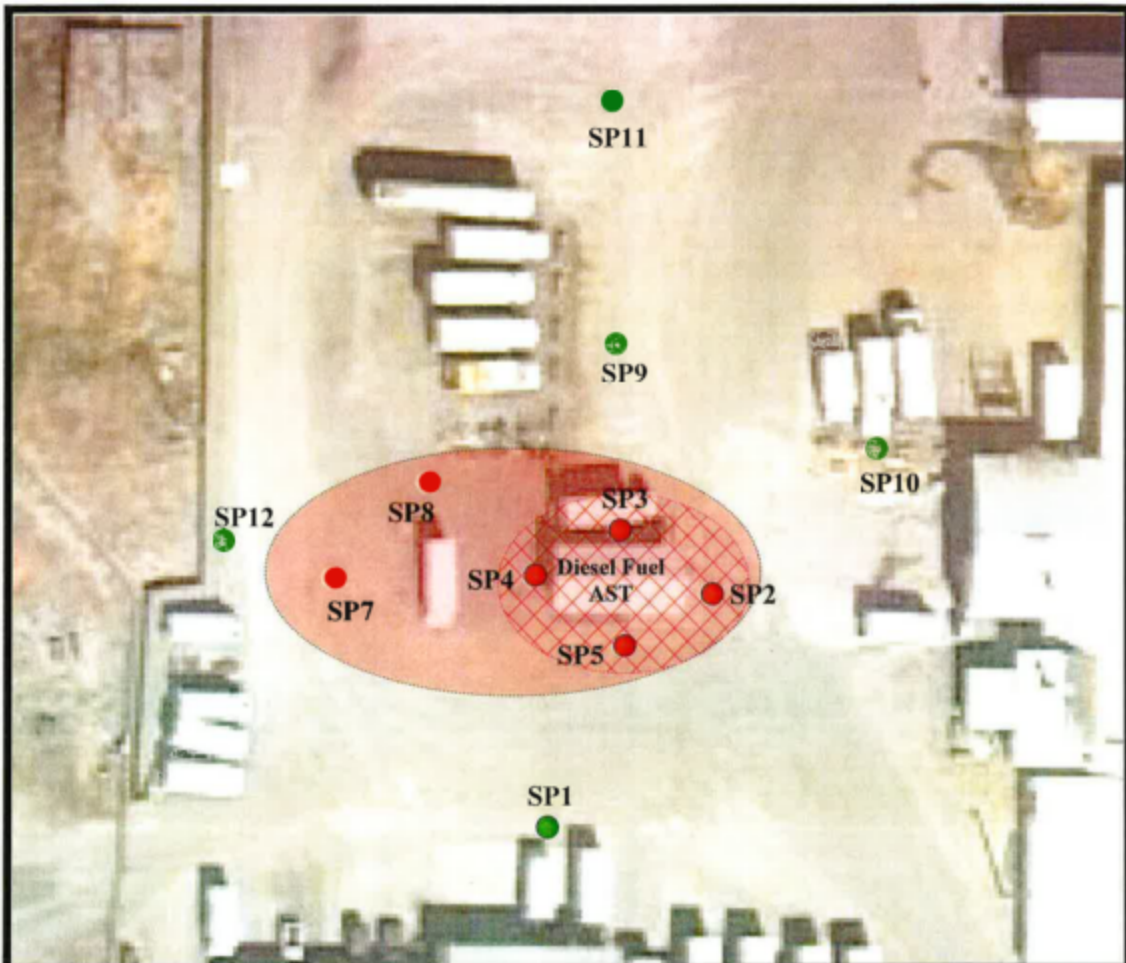
Job Number:	Date:	Scale:	Plate:
JN-32115-2	November 2012	1"=40'	3

Conceptualization of diesel contamination plume. Cross-hatch area represents approximate area where petroleum-impacted soil may be present above the water table and impacting groundwater. Remaining area represents areas where the contaminant mass appears to be primarily dissolved into the groundwater, down gradient from the soil source area.

**DETAILED EXPLORATION PLAN**
