## Technical Memorandum

**Subject: Remedial Investigation Supplemental Work Plan**  
Plaid Pantries Store #112  
1002 West Fourth Plain Boulevard  
Vancouver, Washington  
Ecology VCP File #SW1314  
EES Project #1179

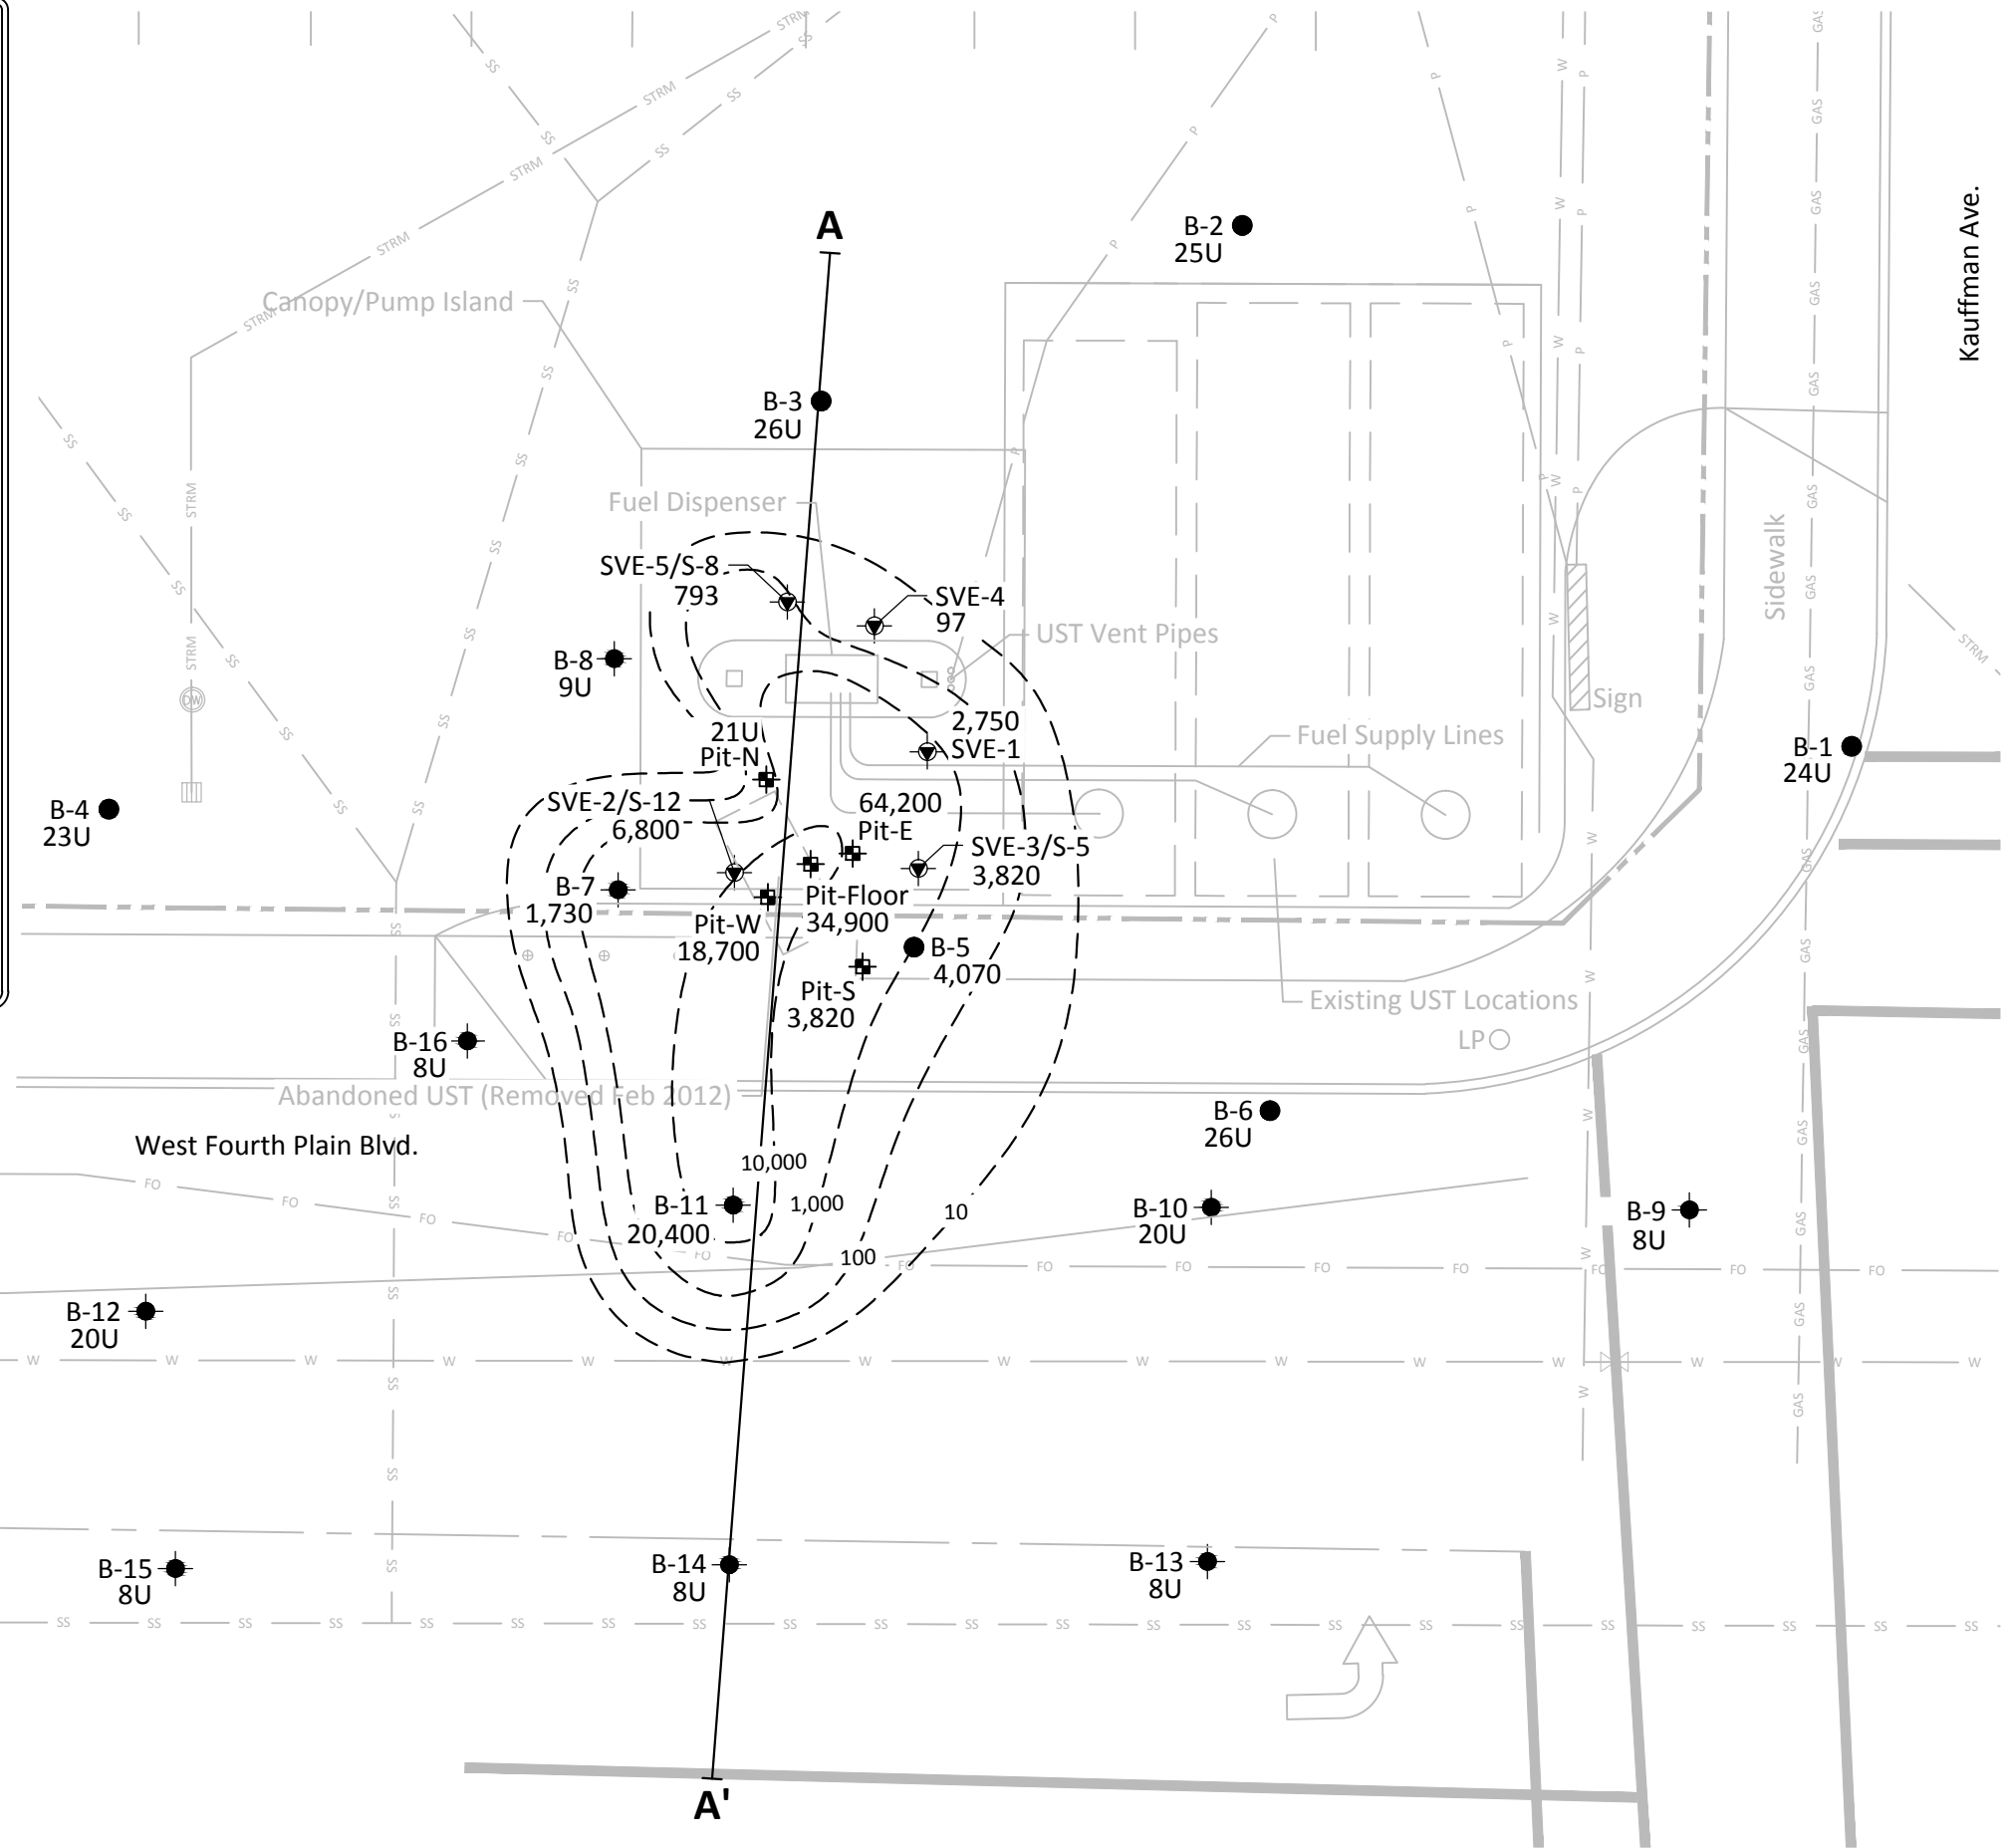
DATE:	7-6-15	PROJECT NO.	1179-01
FILE:	1179-01	FIGURE NO.	4
DRAWN:	JJT		
APPROVED:	CR

MAXIMUM GASOLINE  
CONCENTRATIONS IN SOIL

- Gasoline contamination appears to be associated with historical fueling infrastructure, including an abandoned underground tank unrelated to Plaid's operations that Plaid discovered and removed in early 2012. Fuel/petroleum releases may have occurred on the Property prior to Plaid's operations, during its long period of use as a gasoline service station dating back to the 1950s or before. Gasoline-contaminated soils exceeding regulatory cleanup levels have been identified in the fuel pump island area where the abandoned tank was discovered, and extending beyond the southern Property boundary beneath a portion of the sidewalk and Fourth Plain Boulevard (Table 1; Figures 4 through 6).

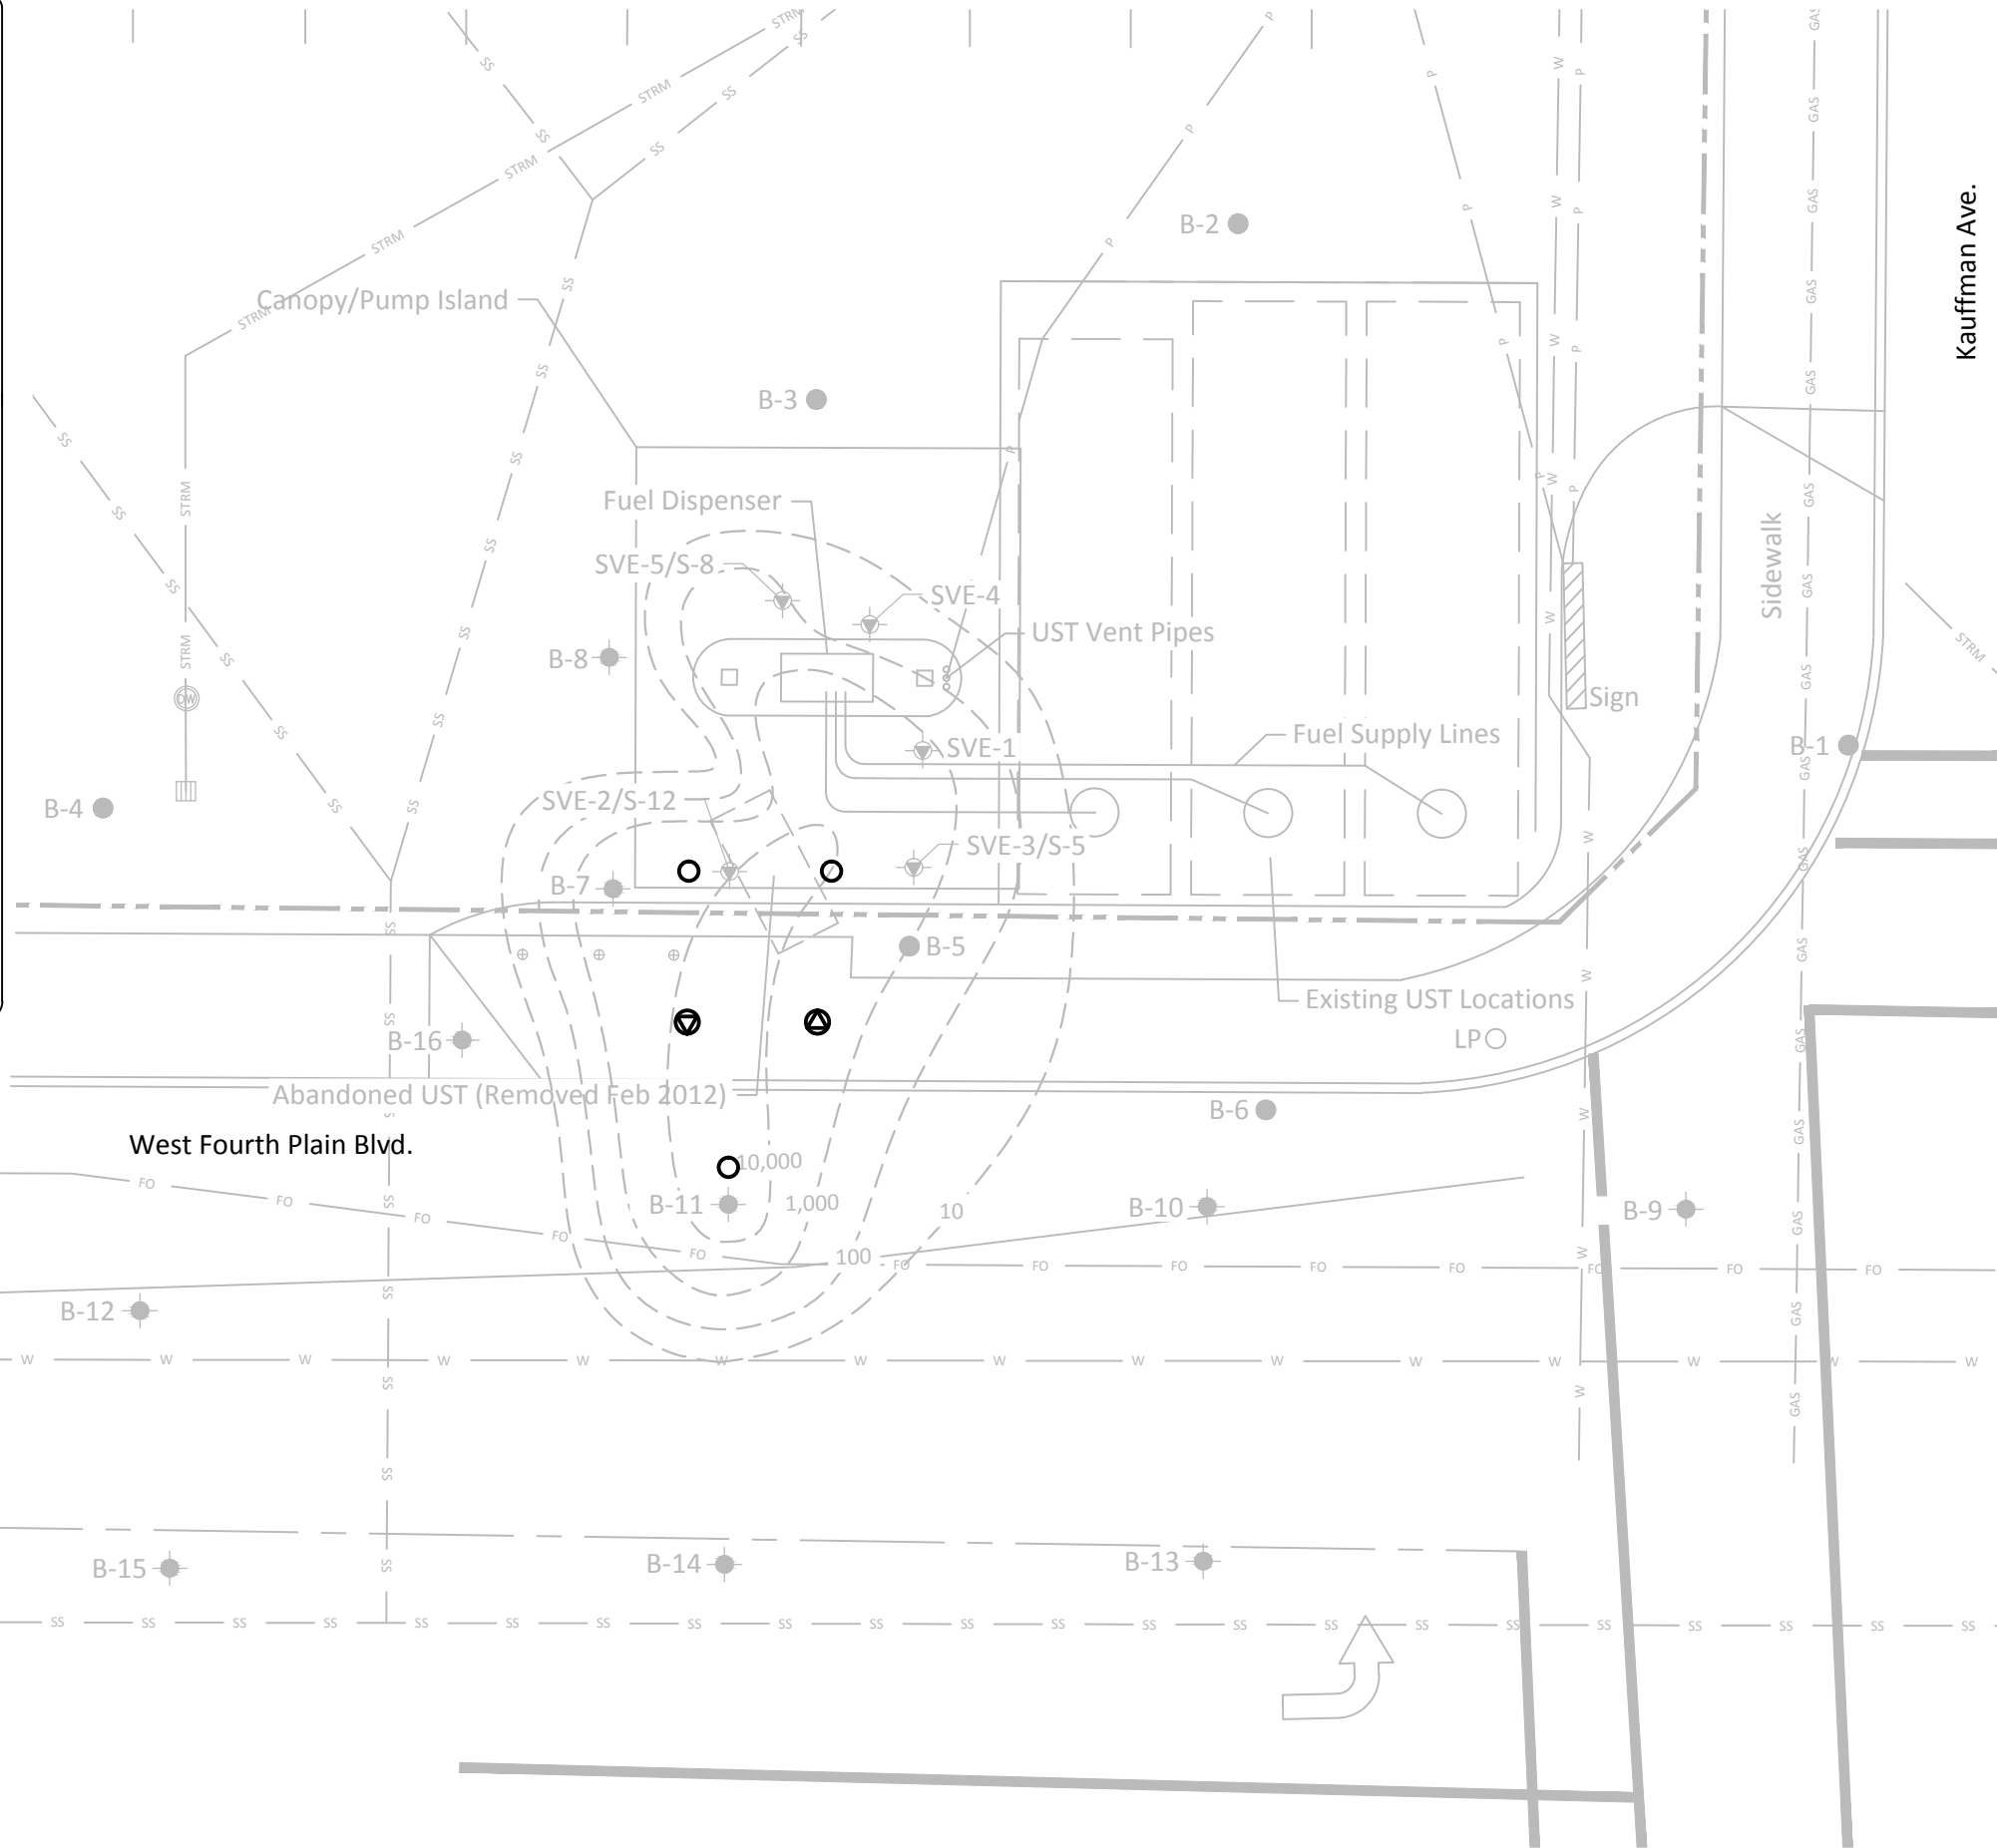
DATE:	7-20-15	PROJECT NO.	1179-01
FILE:	1179-01	FIGURE NO.	7
DRAWN:	JJT		
APPROVED:	CR

PROPOSED SOIL SAMPLE LOCATIONS

Advance five direct-push soil borings at the Site's most contaminated locations (Figure 7). Soil data collected from this area will be used for quantitative VPH analysis and calculation of Site-specific Method B cleanup levels in accordance with Ecology guidance (2011). Borings will be advanced to terminal depths of up to 20 feet below ground surface (bgs) as described below. After sampling, two of

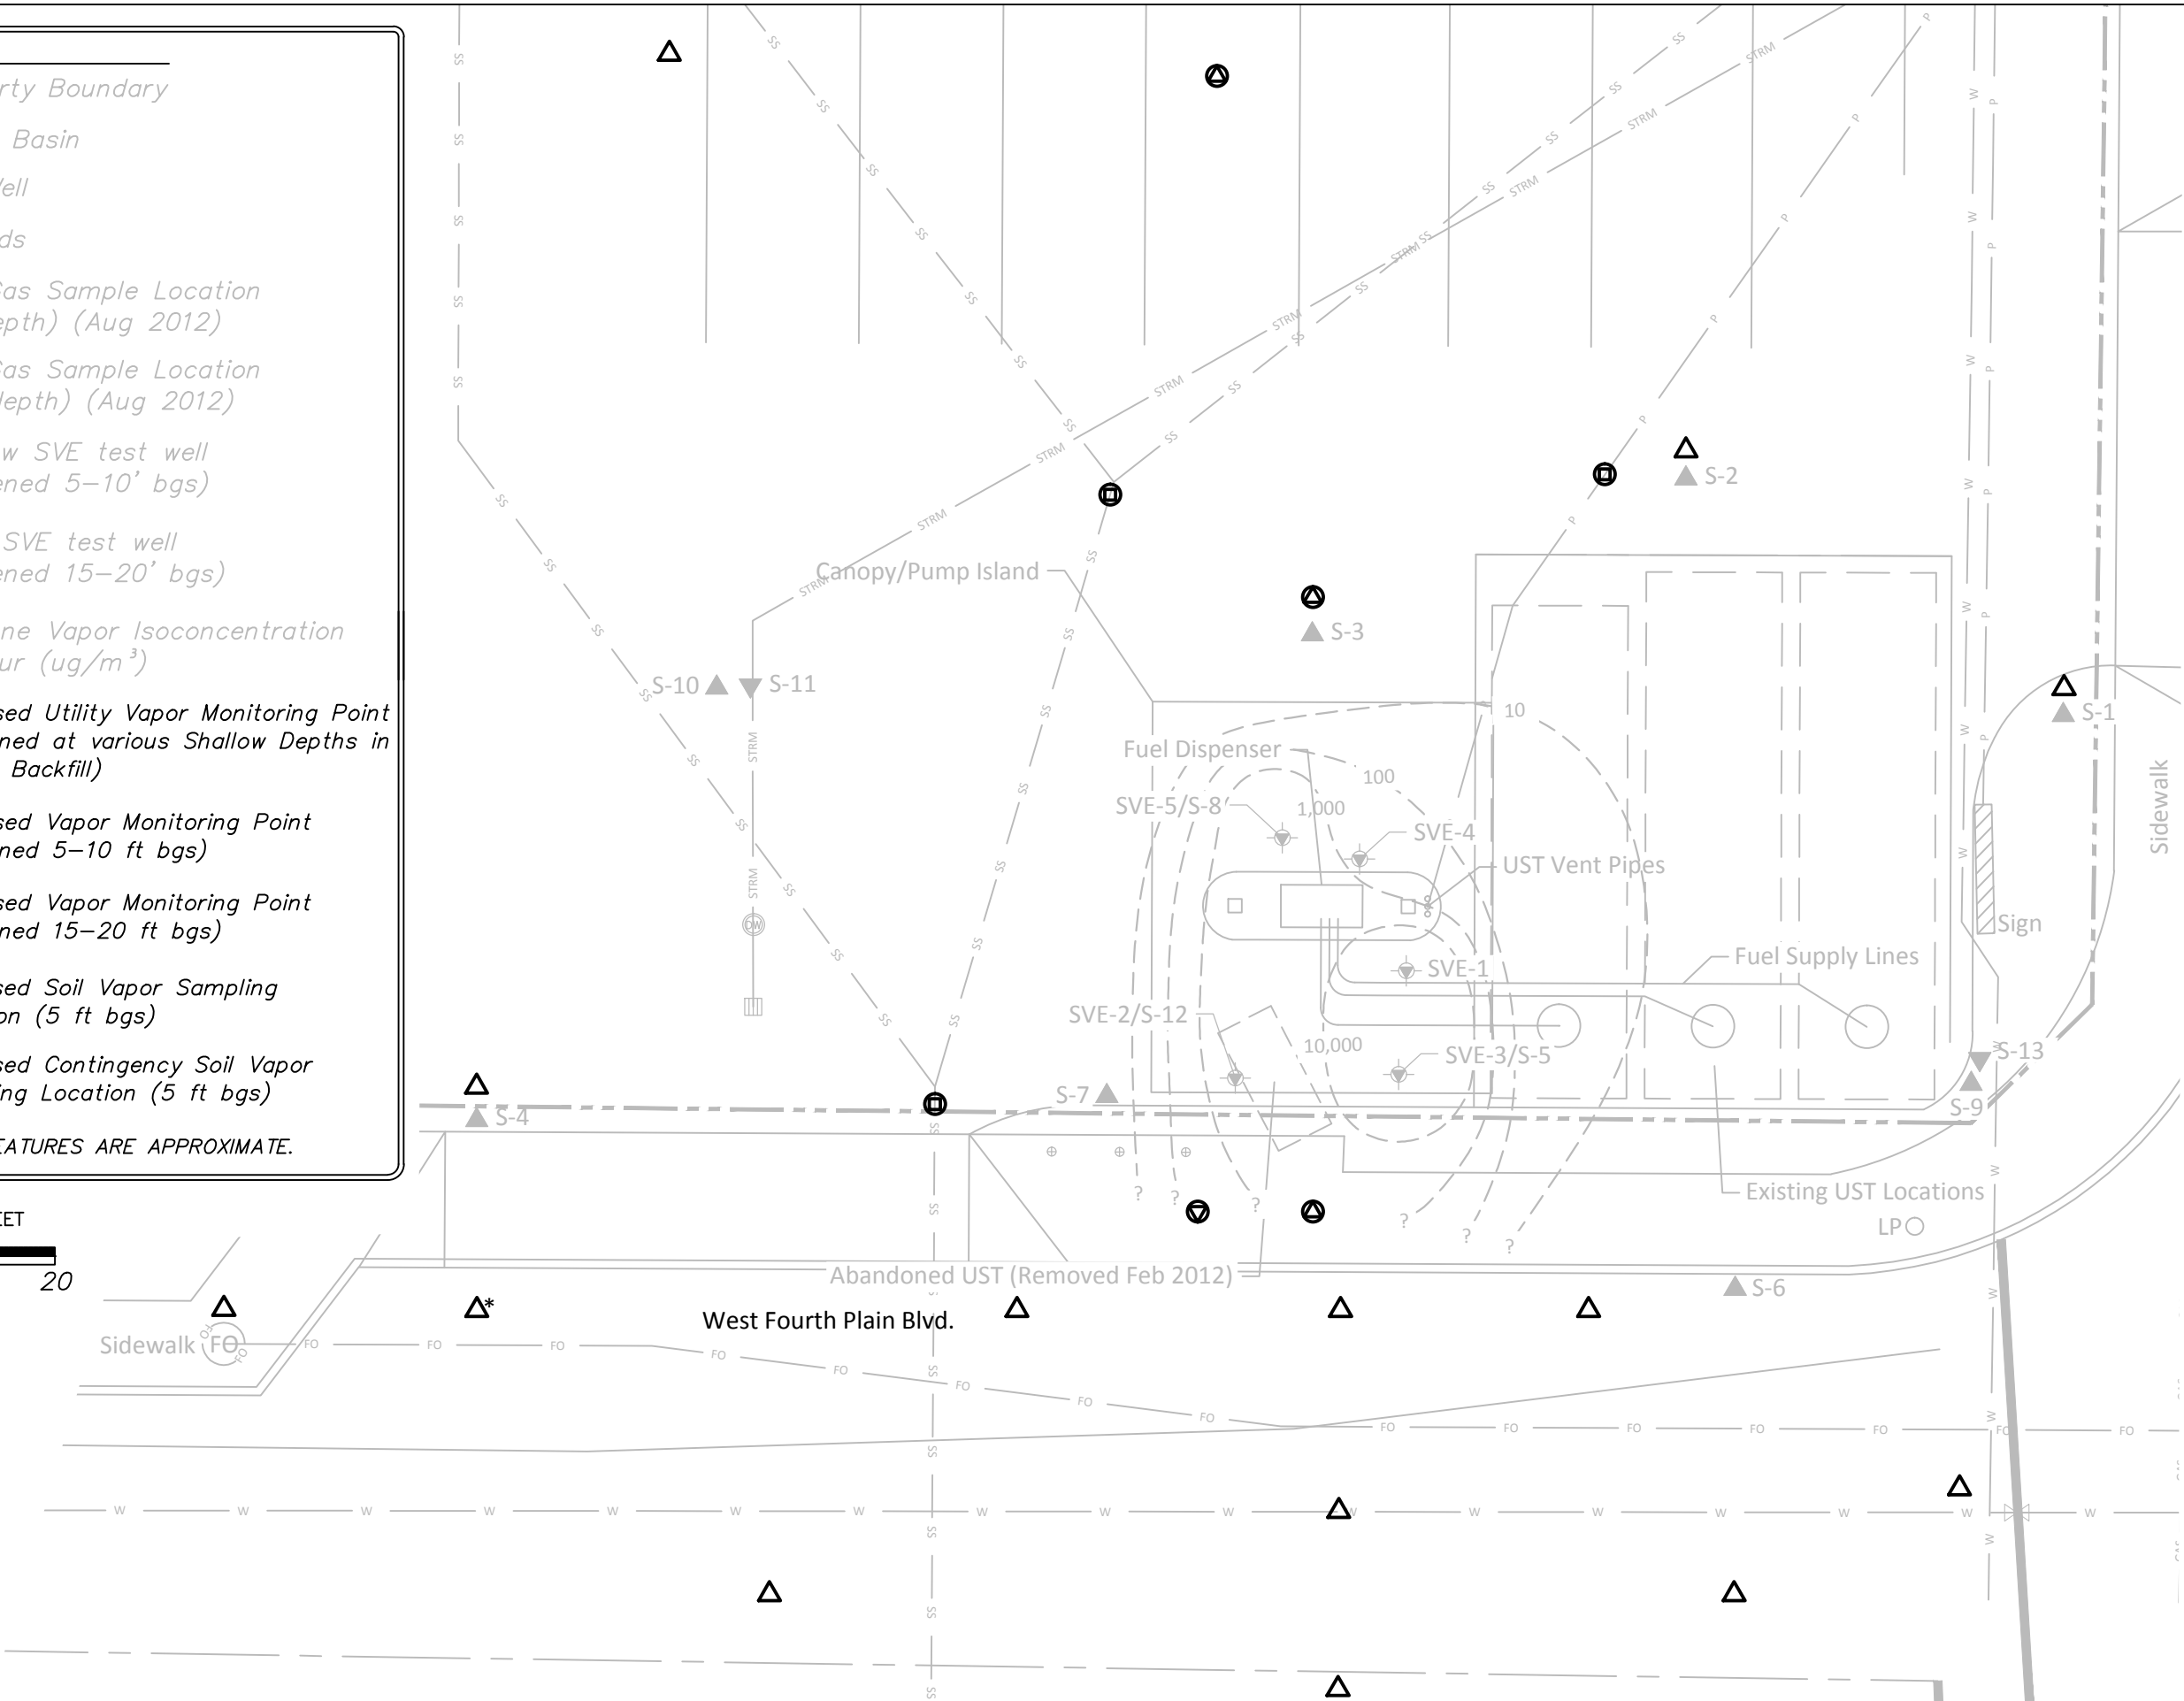
DATE:	7-21-15	PROJECT NO.	
FILE:	1179-01	1179-01	
DRAWN:	JJT	FIGURE NO.	8
APPROVED:	CR

PROPOSED SOIL VAPOR  
SAMPLING LOCATIONS

Advance shallow soil gas borings to provide vapor intrusion and vapor migration assessment, particularly with regard to existing underground utility infrastructure located in close proximity to known soil impacts at the Site. Typical soil gas samples will be collected at depths of 5 feet bgs, while vapor samples from utility corridor backfill materials may range in depth between approximately 3 and 10 feet bgs. Targeted sample locations are described below, and shown on Figure 8.

- Two soil gas borings are proposed in the asphalt parking area immediately south of the existing Plaid/Domino's store building to delineate gasoline vapors north of the source-area and to evaluate potential vapor intrusion into the building. In view of continuing SVE operations and ongoing vapor data needs, one of these sampling points will be converted to a re-useable vapor monitoring well, screened between 5 and 10 feet bgs.

- Four soil gas borings are proposed near previous soil gas sampling locations S-1 through S-4 for comparison to elevated vapor concentrations identified during the 2013 investigation (originally sampled prior to beginning SVE operations). The sampling point advanced at S-3 (slightly north of the source area) will be converted to a re-useable vapor monitoring well, screened between 5 and 10 feet bgs.

- Re-useable vapor monitoring well points will be installed if possible at three Property locations within trench bedding materials in locations traversing or near the soil gasoline source area. Gasoline vapors, if present in these bedding materials, could migrate towards the Property building or (within the sewer line trench) away from the Property into the Fourth Plain public right-of-way where the sanitary sewer main line is present.

- In addition to the two sidewalk soil gas sampling and well installation locations described above, up to 10 soil gas borings are proposed within the Fourth Plain ROW in an effort to delineate gasoline vapors extending south of the Property and potentially migrating into utility corridors in this area. Underground utility bedding materials will be accessed if possible (after securing permission from utility owners) by careful use of an air knife/hand auger system to minimize the risk of infrastructure damage. EES will attempt to identify backfill material and collect vapor samples from various utility trench locations to evaluate these possible preferential vapor migration pathways where they are located in close proximity to soil impacts. Ideal sampling locations are noted below, subject to confirming
