# **Pope & Talbot Mill Site and Leased Area Port Gamble Bay**

**Open House and Public Meeting**

**March 9, 2011**

WASHINGTON STATE  
Department of Ecology

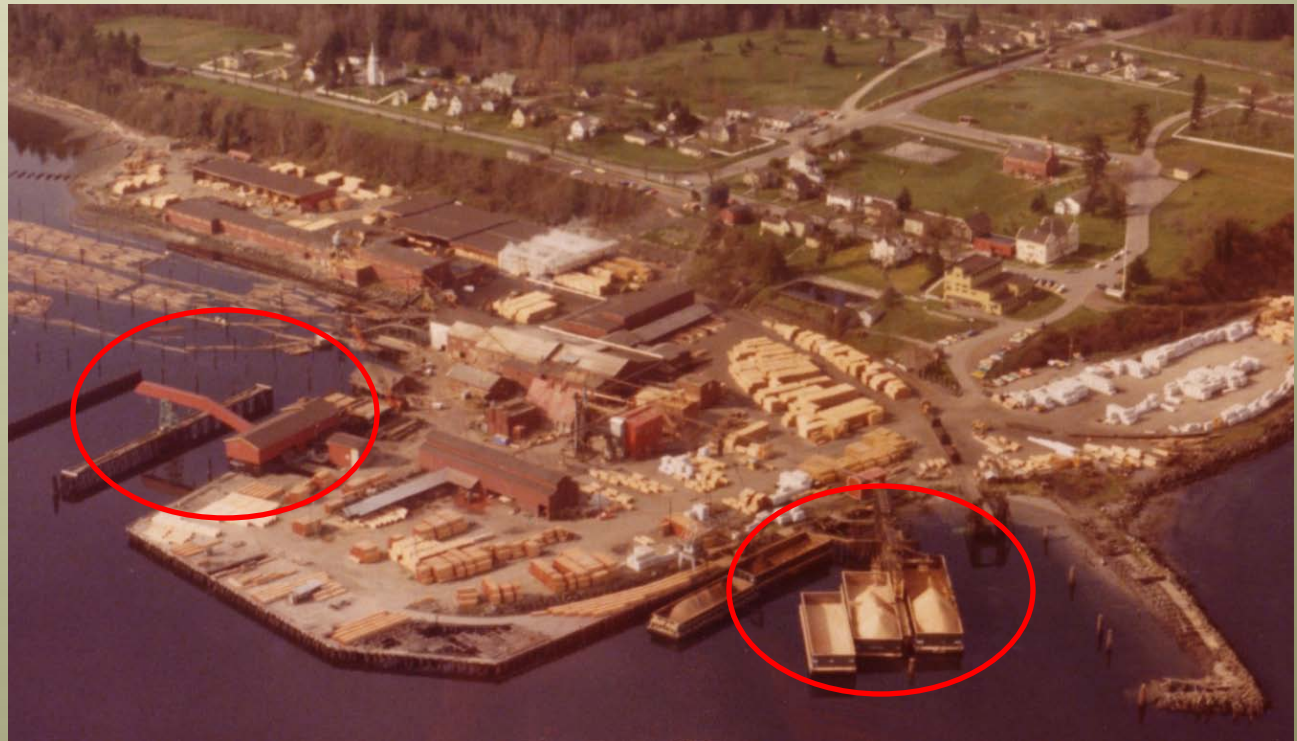
- Northern Chip Mill active 1928 – 1995
- Southern Chip Mill active 1974 – 1995

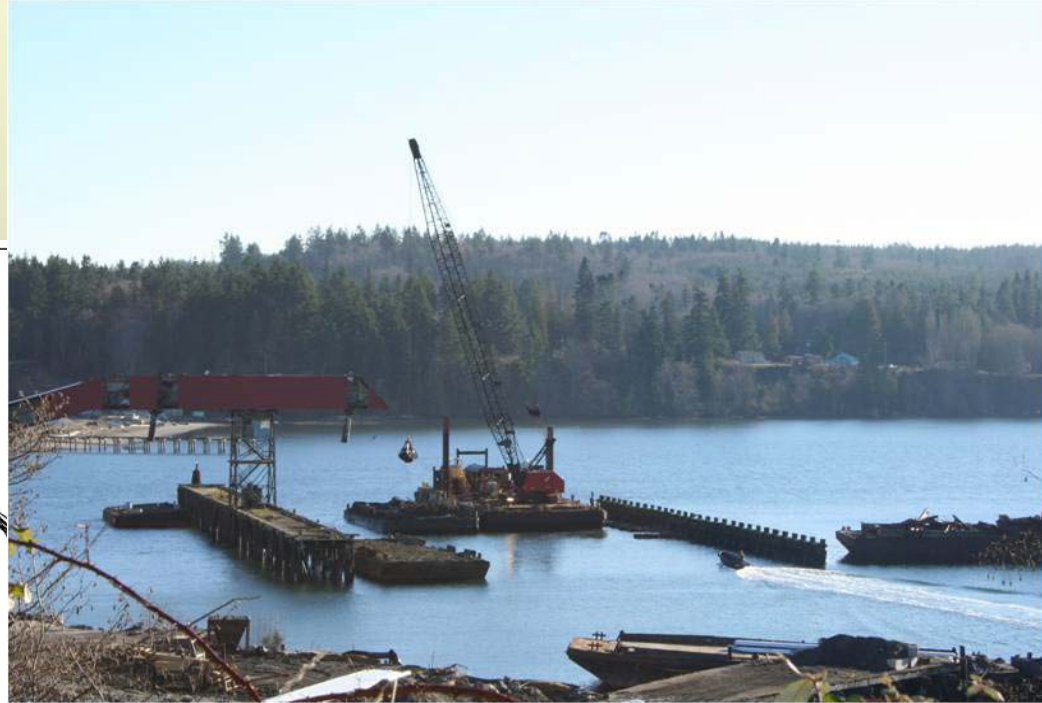
- 27,000 tons of soil removed.
- 30,000 cubic yards of wood waste dredged 2003/2007
- Off Site 4 landfills along the west shore.

\* Landfills are not part of the Mill Site
