**Phase II Environmental Site Assessment**

Former Dry Cleaner Lynnwood Public Facilities  
District Property  
3815 196<sup>th</sup> Street SW  
Lynnwood, Washington

# Phase II Environmental Site Assessment

## Former Dry Cleaner Lynnwood Public Facilities District Property 3815 196<sup>th</sup> Street SW Lynnwood, Washington

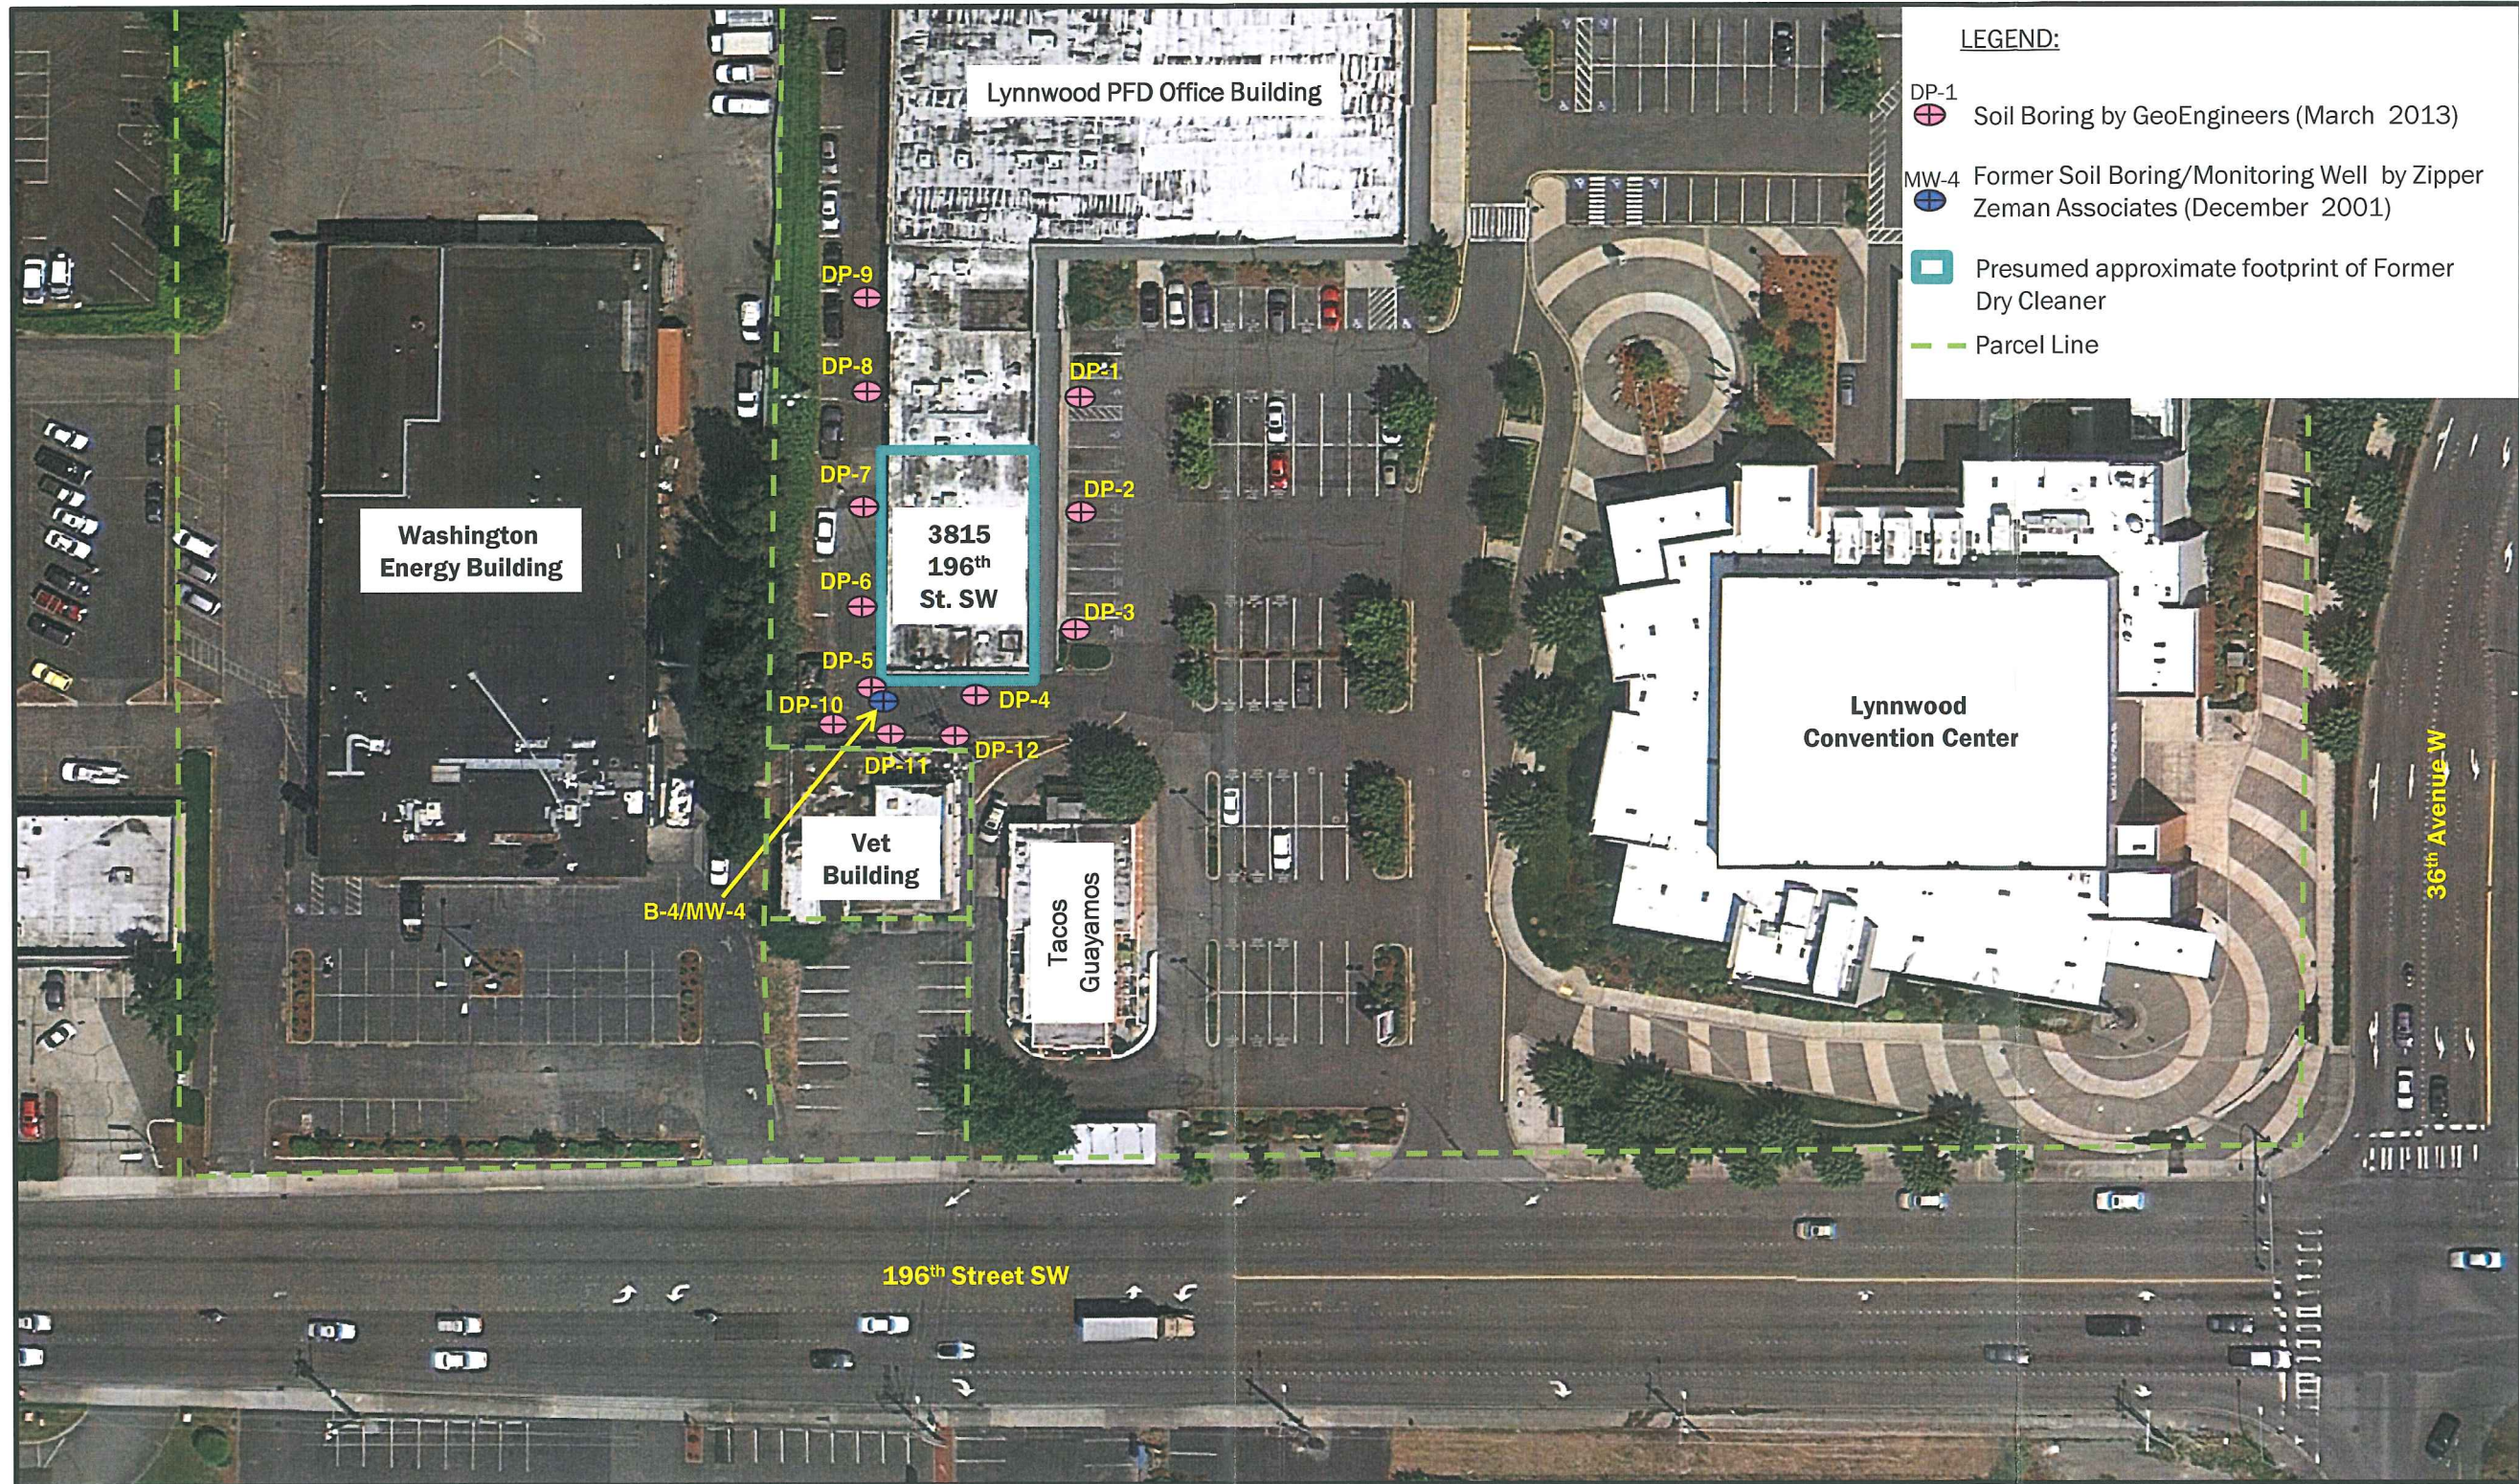
**Figure 2**

Twelve direct-push soil boring explorations (DP-1 through DP-12) were completed on March 28 and 29, 2013 at the approximate locations shown in Figure 2. The exploration locations were selected based on results of previous environmental investigation studies, the results of the November 2012 soil vapor survey, the presumed footprint of the former dry cleaner, and the locations of underground utilities. To minimize disruption to current business operations and due to practical limitations of building footprint and layout, exploratory borings were not completed inside existing buildings. Field procedures and the exploration logs are included in Appendix A. Field screening results of soil samples from the borings are included in the exploration logs and in Table 1 for soil samples submitted for chemical analysis. The Phase II ESA soil and groundwater sample chemical analytical data are summarized in Tables 1 and 2. The chemical analytical laboratory reports and our review of the laboratory quality assurance/quality control (QA/QC) information are included in Appendix D.

**Site Plan - Exploration Locations**

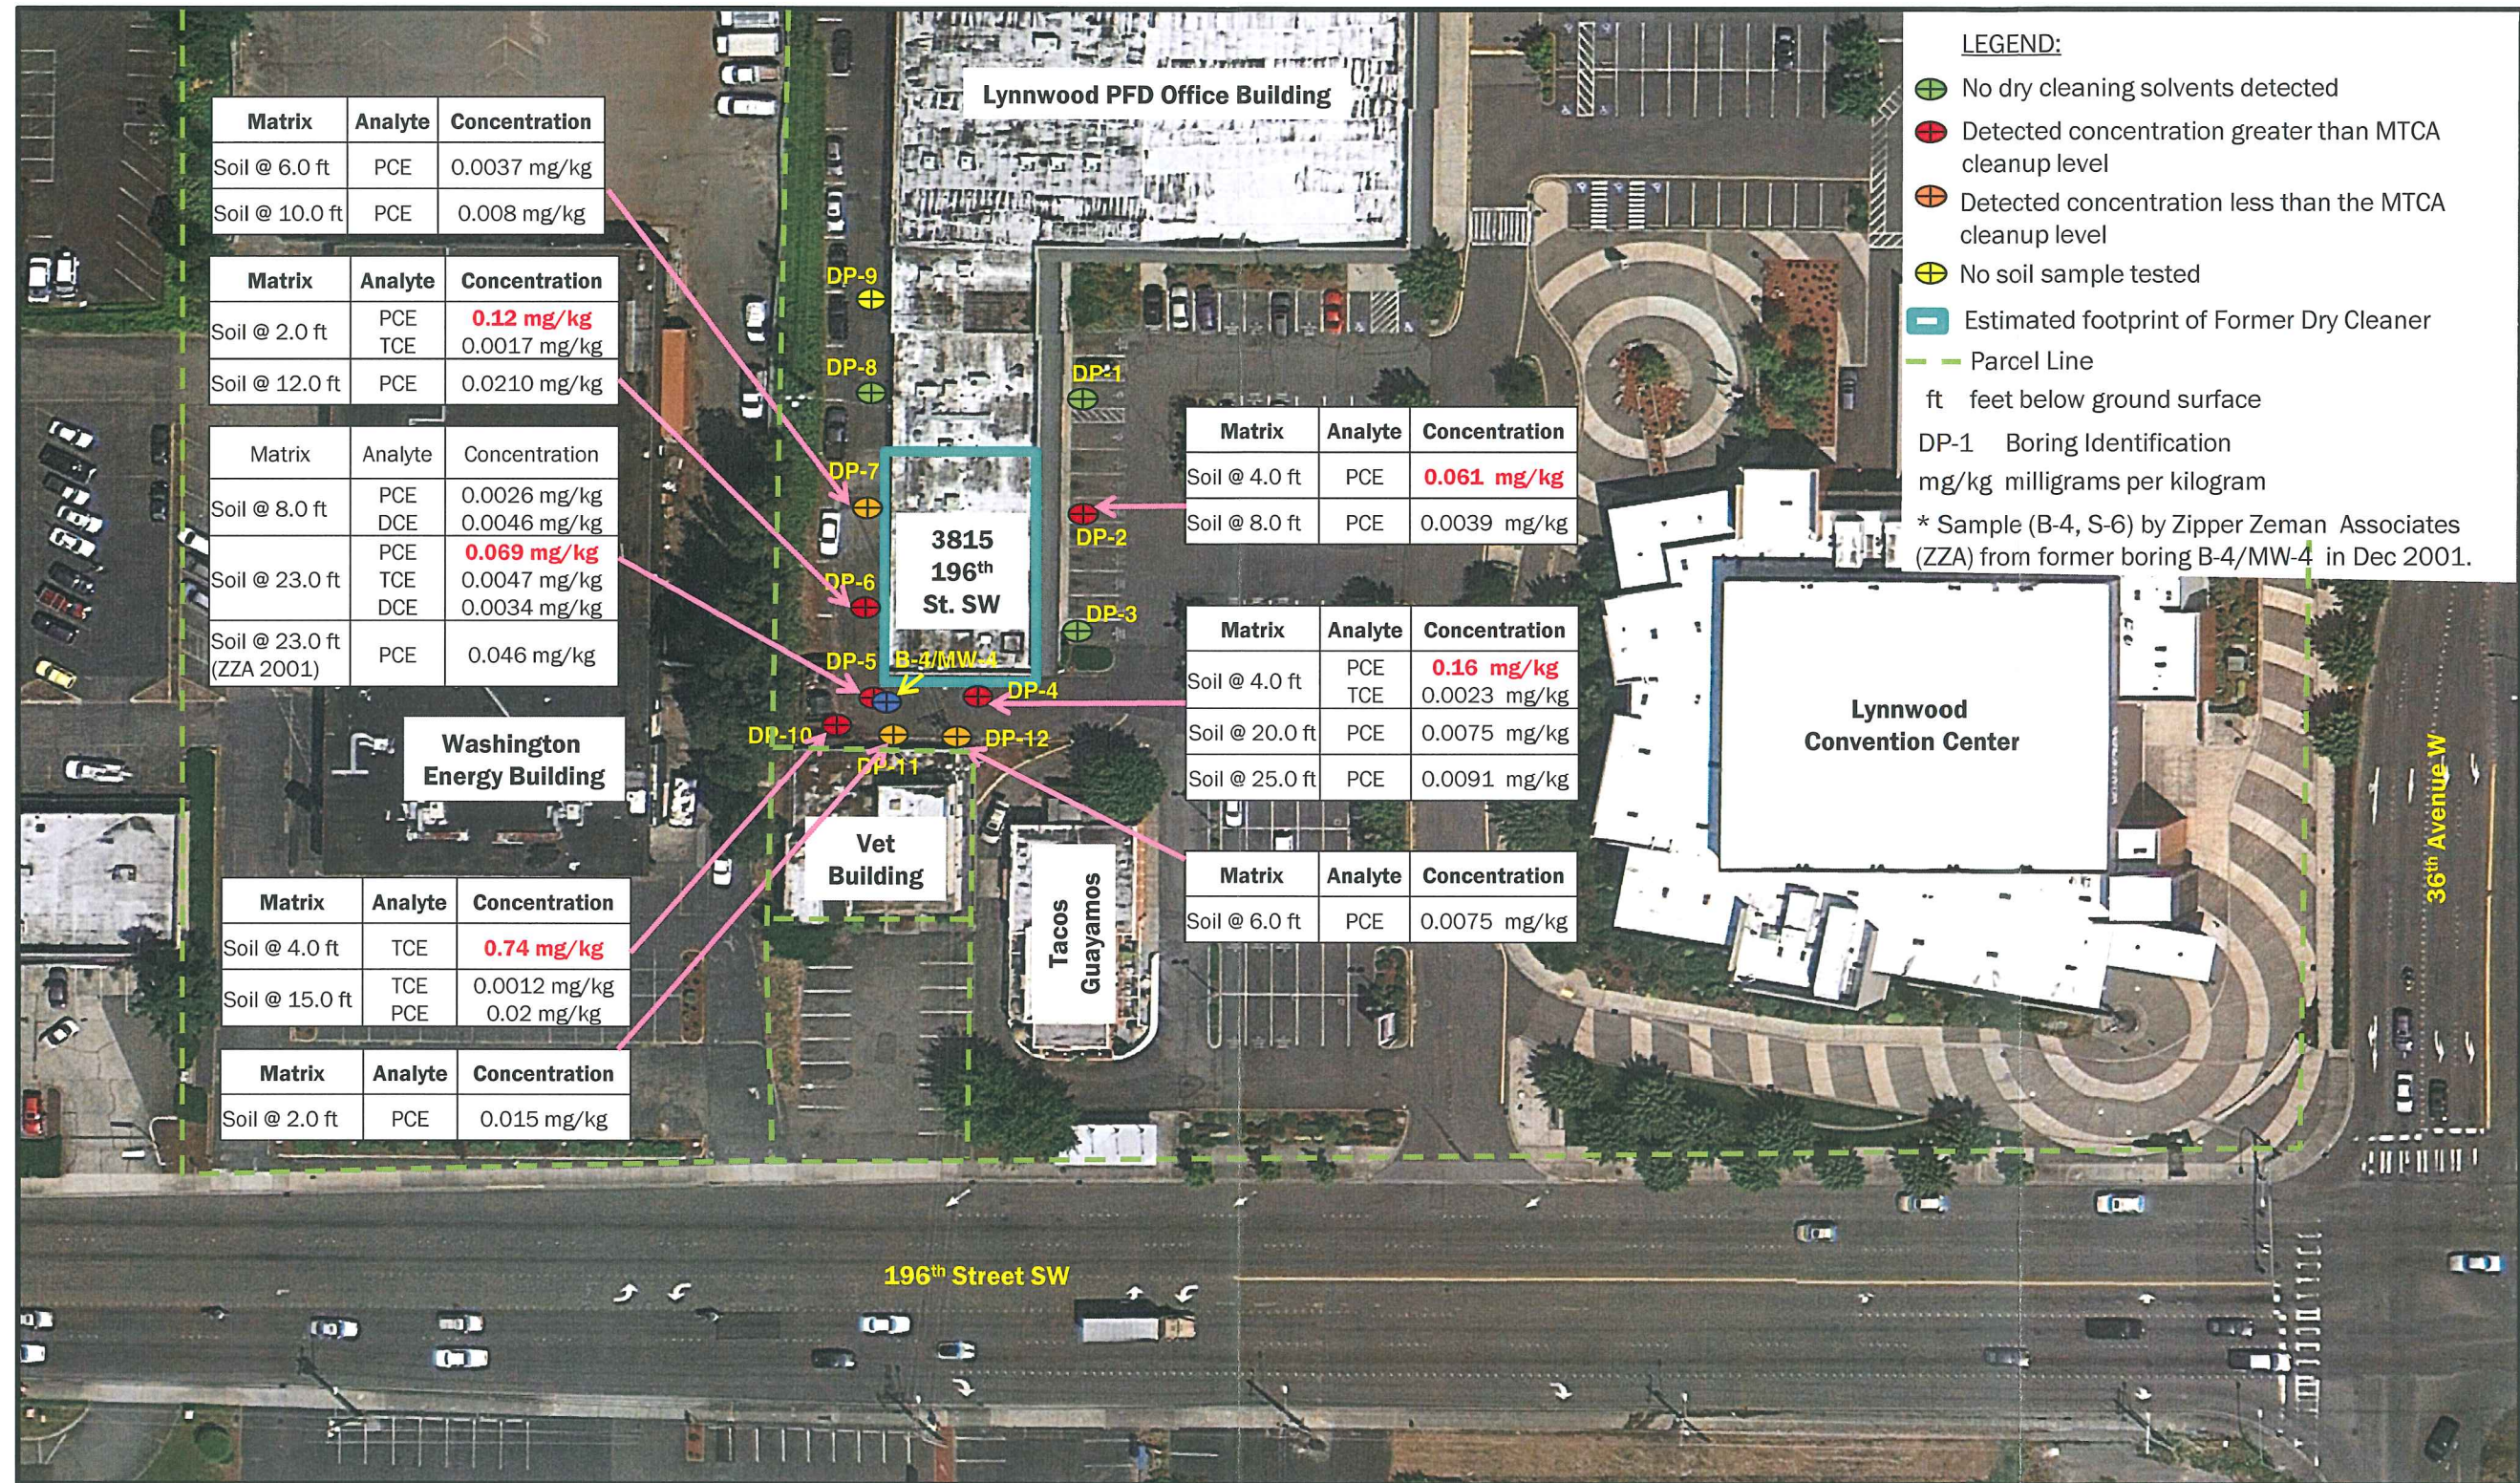
**Figure 3**

Matrix	Analyte	Concentration
Soil @ 6.0 ft	PCE	0.0037 mg/kg
Soil @ 10.0 ft	PCE	0.008 mg/kg

Matrix	Analyte	Concentration
Soil @ 2.0 ft	PCE	<b>0.12 mg/kg</b>
	TCE	0.0017 mg/kg
Soil @ 12.0 ft	PCE	0.0210 mg/kg

Matrix	Analyte	Concentration
Soil @ 8.0 ft	PCE	0.0026 mg/kg
	DCE	0.0046 mg/kg
Soil @ 23.0 ft	PCE	<b>0.069 mg/kg</b>
	TCE	0.0047 mg/kg
	DCE	0.0034 mg/kg
Soil @ 23.0 ft (ZZA 2001)	PCE	0.046 mg/kg

Matrix	Analyte	Concentration
Soil @ 4.0 ft	PCE	<b>0.061 mg/kg</b>
Soil @ 8.0 ft	PCE	0.0039 mg/kg

Matrix	Analyte	Concentration
Soil @ 4.0 ft	PCE	<b>0.16 mg/kg</b>
	TCE	0.0023 mg/kg
Soil @ 20.0 ft	PCE	0.0075 mg/kg
Soil @ 25.0 ft	PCE	0.0091 mg/kg

Matrix	Analyte	Concentration
Soil @ 4.0 ft	TCE	<b>0.74 mg/kg</b>
Soil @ 15.0 ft	TCE	0.0012 mg/kg
	PCE	0.02 mg/kg

Matrix	Analyte	Concentration
Soil @ 2.0 ft	PCE	0.015 mg/kg

Matrix	Analyte	Concentration
Soil @ 6.0 ft	PCE	0.0075 mg/kg

**Dry Cleaning Solvent Detections in Soil**

Twenty soil samples, one or two from each boring, were selected for chemical analysis from the March 2013 explorations. The selection of samples from DP-1 through DP-10 was based on the sample depths in relation to the former dry cleaner location and underground utilities as well as depth of apparent perched groundwater. Two shallow soil samples were selected from DP-11 and DP-12 based in part on foundation depths of the Vet building. Selected soil samples were submitted to OnSite Environmental Laboratory (OnSite) in Redmond, Washington for chemical analysis of HVOCs by EPA Method 8260C. The soil chemical analytical data are summarized in Table 1 and analytical data for contaminants of concern are presented on Figure 3.

- Tetrachloroethene (PCE) was detected at concentrations greater than the MTCA Method A Cleanup Level in samples DP-2-4.0, DP-4-4.0, DP-5-23.0, and DP-6-2.0. PCE either was not detected or was detected at concentrations less than the MTCA Method A Cleanup Level in the remaining samples submitted for chemical analysis. The detected concentrations of PCE in the March 2013 soil samples ranged from 0.0037 to 0.16 mg/kg.

- Trichloroethene (TCE) was detected at a concentration greater than the MTCA Method A Cleanup Level in sample DP-10-4.0. TCE either was not detected or was detected at concentrations less than the MTCA cleanup level in the remaining samples submitted for chemical analysis. The detected concentrations of TCE in the March 2013 soil samples ranged from 0.0012 to 0.74 mg/kg.

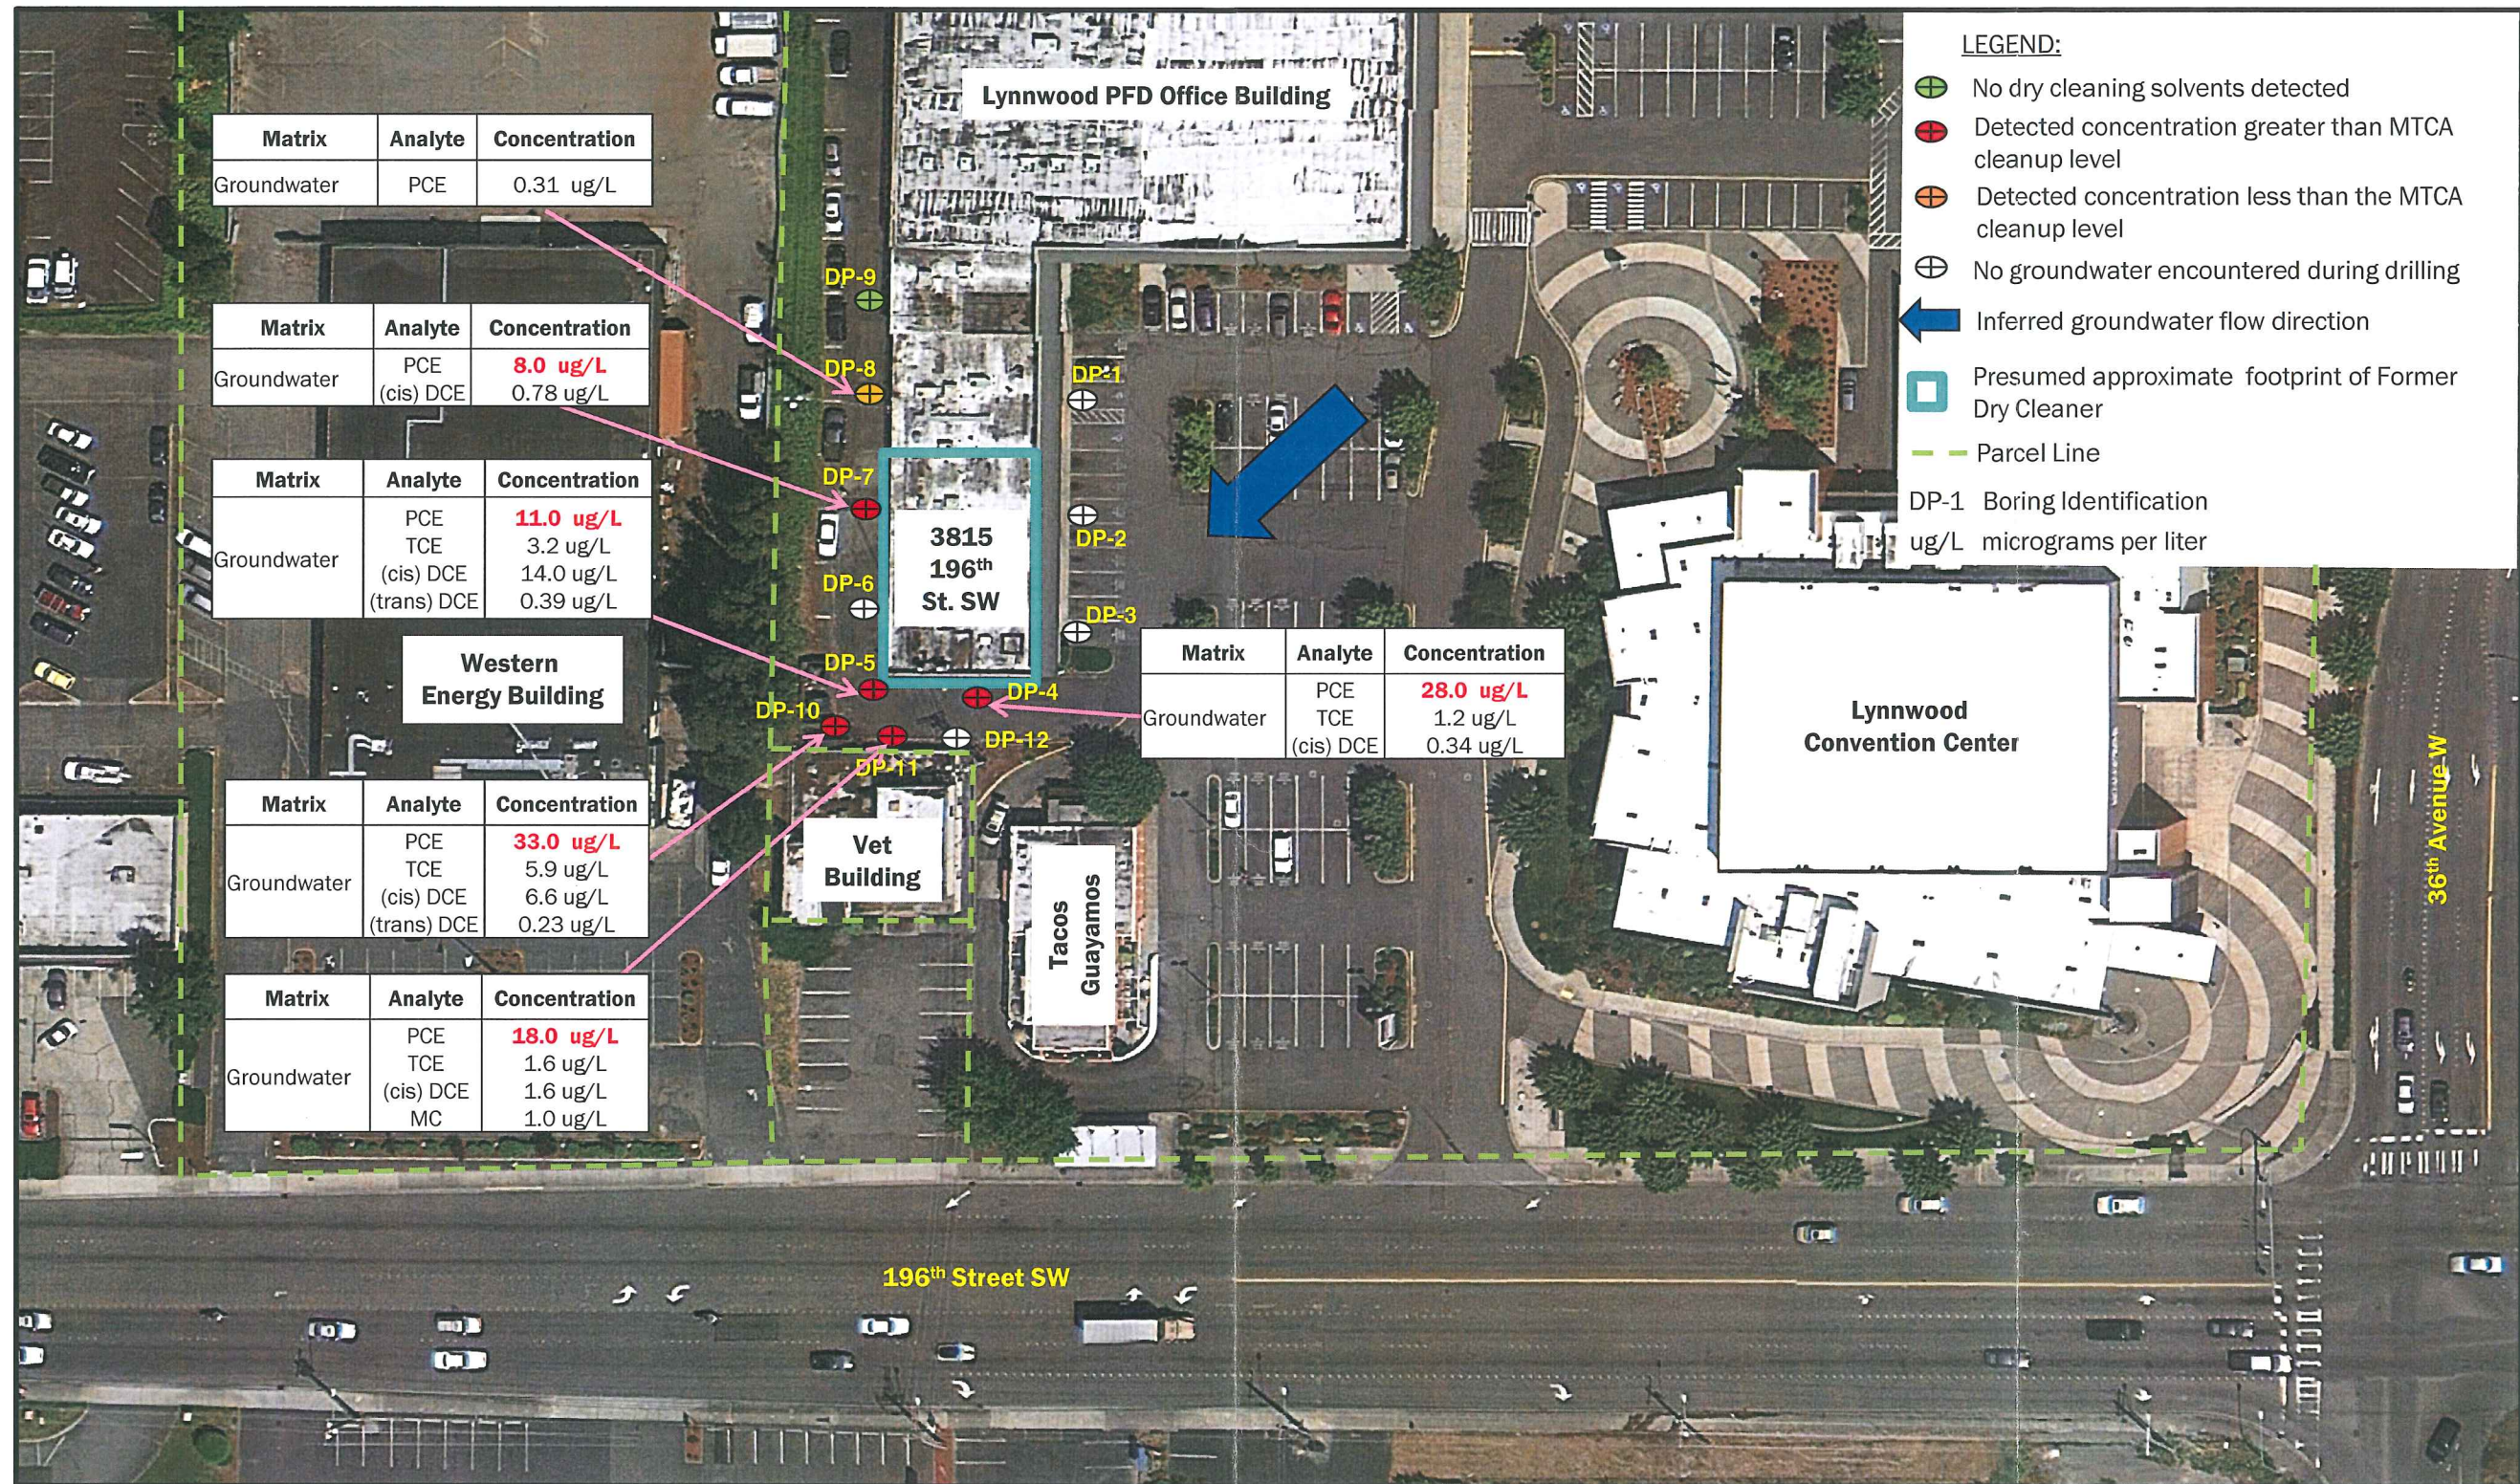
**Figure 4**

Matrix	Analyte	Concentration
Groundwater	PCE	0.31 ug/L

Matrix	Analyte	Concentration
Groundwater	PCE	<b>8.0 ug/L</b>
	(cis) DCE	0.78 ug/L

Matrix	Analyte	Concentration
Groundwater	PCE	<b>11.0 ug/L</b>
	TCE	3.2 ug/L
	(cis) DCE	14.0 ug/L
	(trans) DCE	0.39 ug/L

Matrix	Analyte	Concentration
Groundwater	PCE	<b>33.0 ug/L</b>
	TCE	5.9 ug/L
	(cis) DCE	6.6 ug/L
	(trans) DCE	0.23 ug/L

Matrix	Analyte	Concentration
Groundwater	PCE	<b>18.0 ug/L</b>
	TCE	1.6 ug/L
	(cis) DCE	1.6 ug/L
	MC	1.0 ug/L

Matrix	Analyte	Concentration
Groundwater	PCE	<b>28.0 ug/L</b>
	TCE	1.2 ug/L
	(cis) DCE	0.34 ug/L

**Dry Cleaning Solvent Detections in Groundwater**

Groundwater quality was evaluated by collecting grab groundwater samples from the explorations. Groundwater samples were obtained from DP-4, DP-5, and DP-7 through DP-11. Groundwater was not encountered in remaining borings to the maximum depth explored. The groundwater samples were submitted for chemical analysis of HVOCs by EPA Method 8260C. Field procedures for groundwater sampling are described in Appendix A. Groundwater chemical analytical data are summarized in Table 2 and analytical data for contaminants of concern are presented on Figure 4.

- PCE was detected at concentrations greater than the MTCA Method A Cleanup Level in five (DP-4, DP-5, DP-7, DP-10 and DP-11) of the seven groundwater samples. PCE was detected at a concentration less than the MTCA cleanup level in DP-8, and PCE was not detected in DP-9. The detected concentrations of PCE in the March 2013 groundwater samples ranged from 8 to 33 µg/l.
- TCE was detected at a concentration greater than the MTCA Method A Cleanup Level in the groundwater sample from DP-10. TCE either was not detected or was detected at concentrations less than the MTCA cleanup level in the remaining groundwater samples. The detected concentrations of TCE in the March 2013 groundwater samples ranged from 1.2 to 5.9 µg/l.

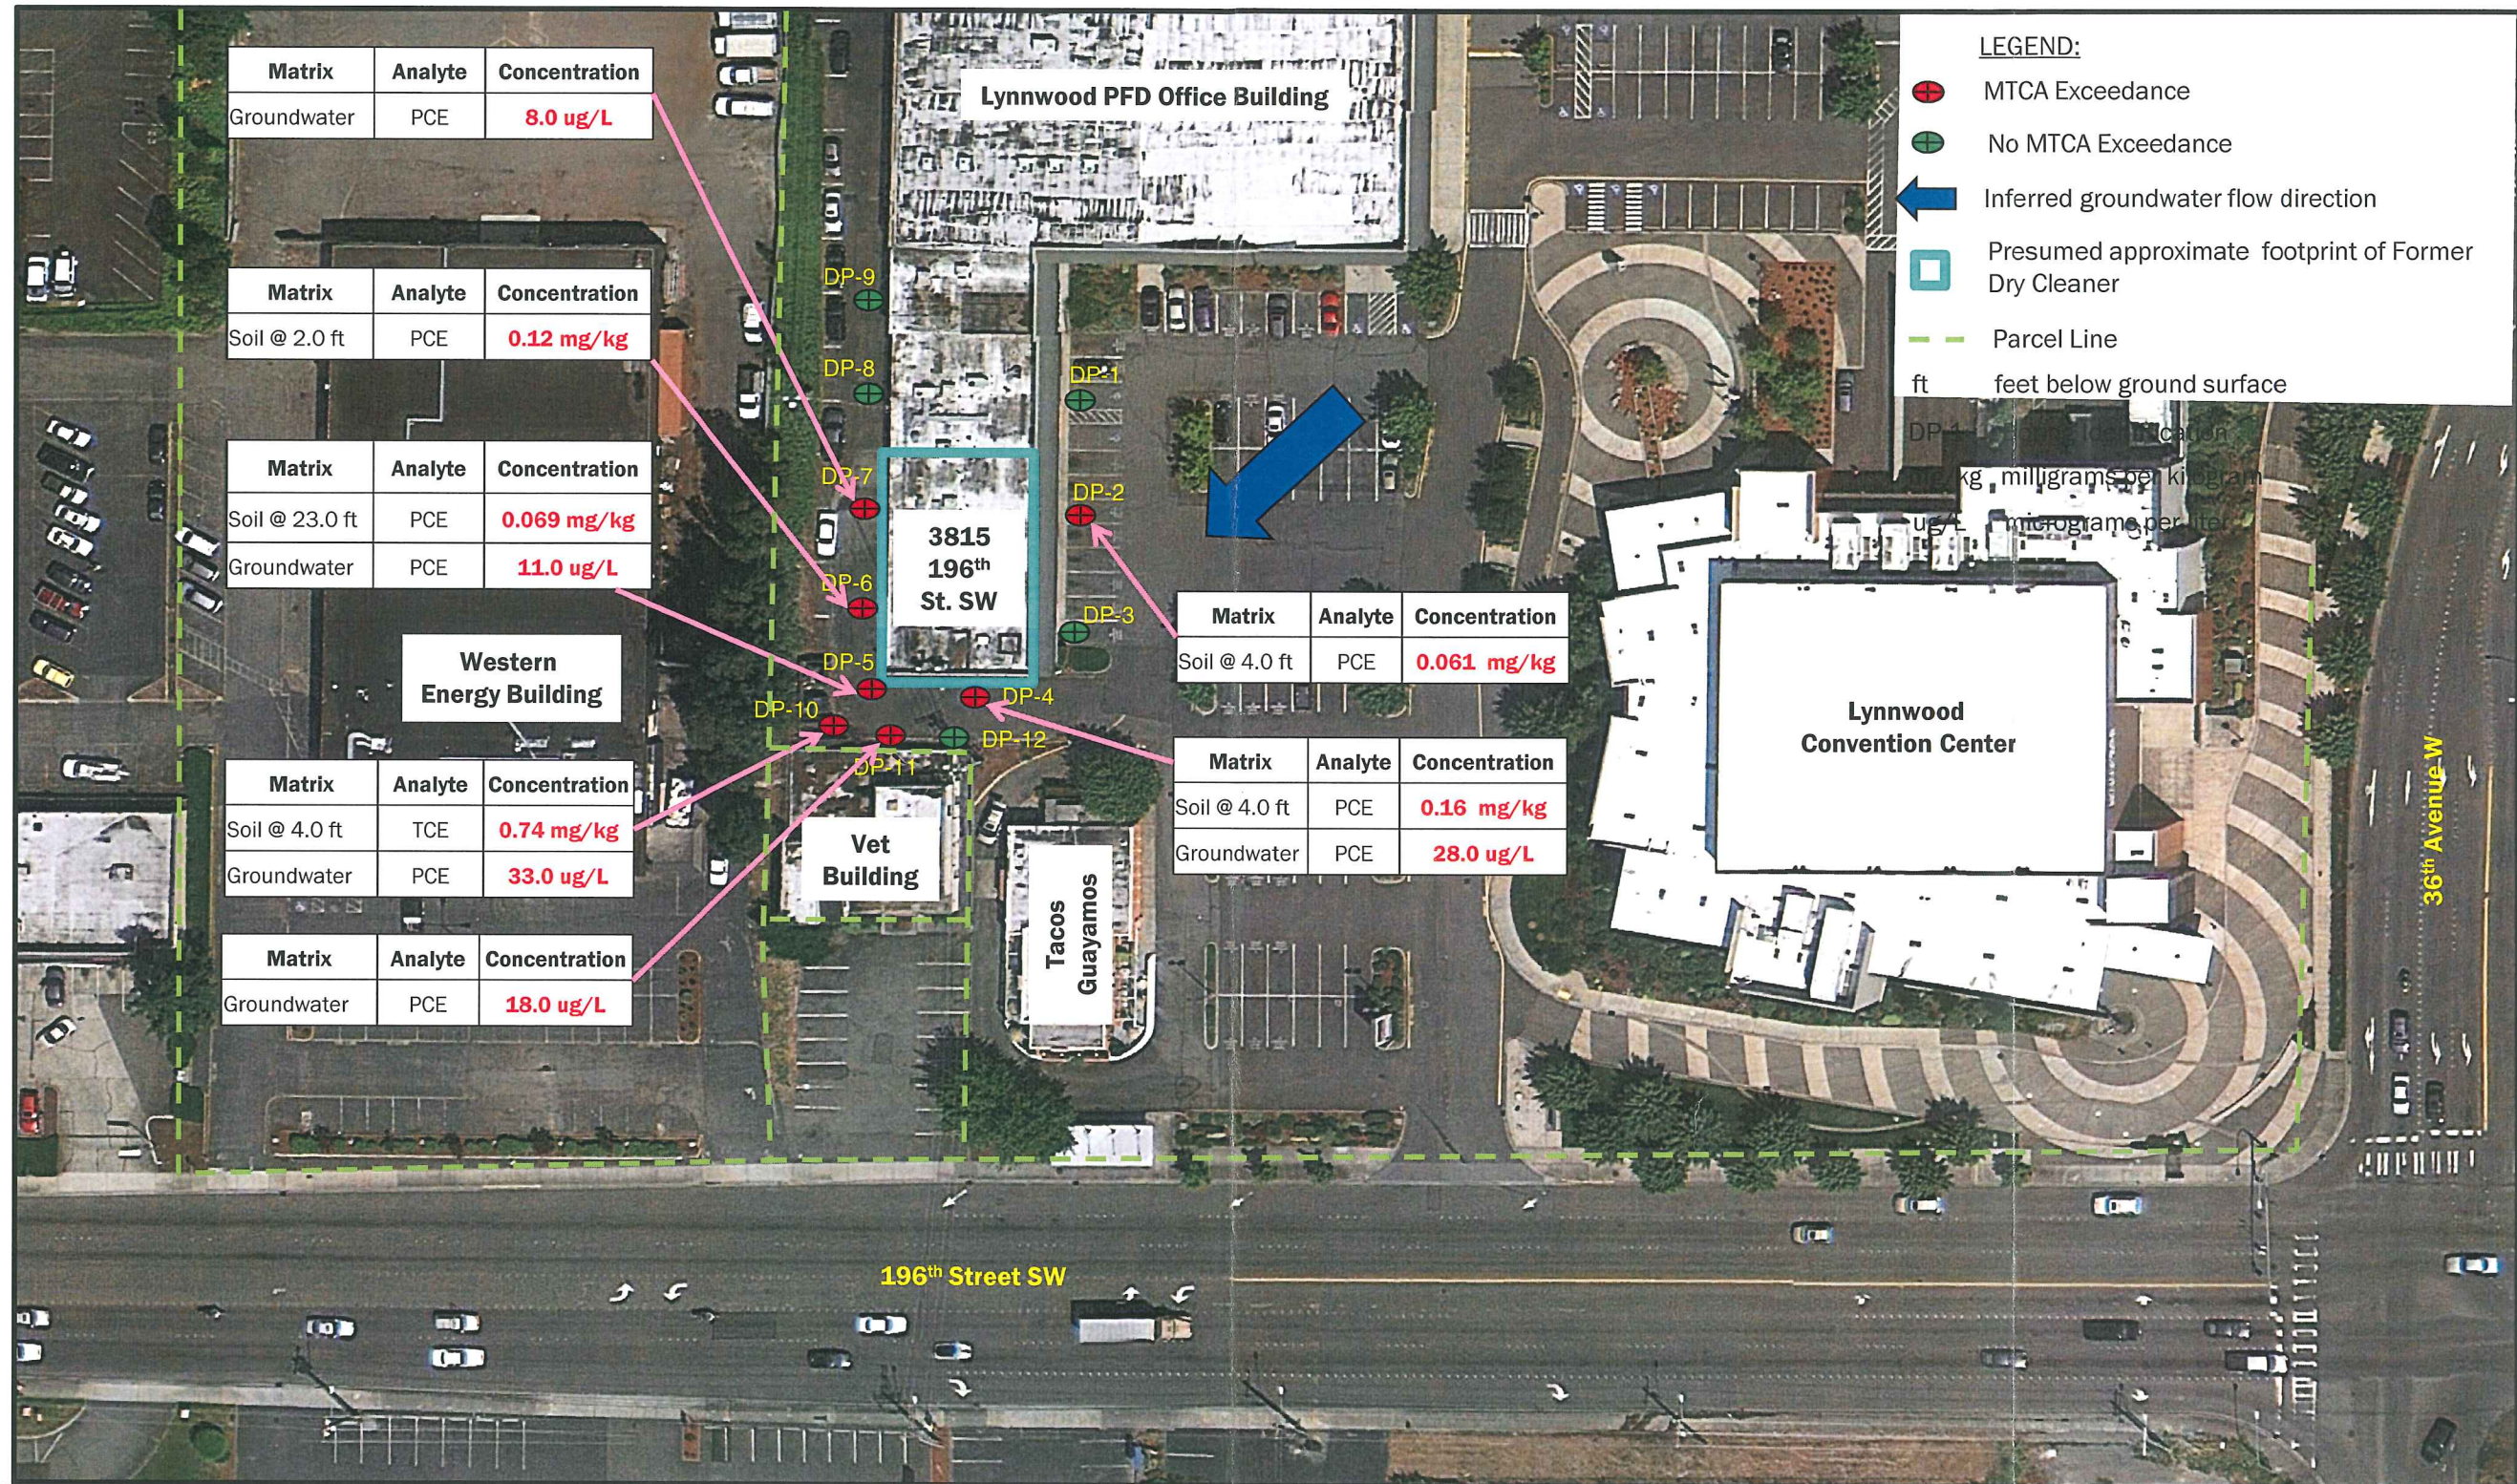
**Figure 5**

Matrix	Analyte	Concentration
Groundwater	PCE	8.0 ug/L

Matrix	Analyte	Concentration
Soil @ 2.0 ft	PCE	0.12 mg/kg

Matrix	Analyte	Concentration
Soil @ 23.0 ft	PCE	0.069 mg/kg
Groundwater	PCE	11.0 ug/L

Matrix	Analyte	Concentration
Soil @ 4.0 ft	TCE	0.74 mg/kg
Groundwater	PCE	33.0 ug/L

Matrix	Analyte	Concentration
Groundwater	PCE	18.0 ug/L

Matrix	Analyte	Concentration
Soil @ 4.0 ft	PCE	0.061 mg/kg

Matrix	Analyte	Concentration
Soil @ 4.0 ft	PCE	0.16 mg/kg
Groundwater	PCE	28.0 ug/L

**MTCA Exceedances in Soil and Groundwater**

- The soil vapor survey and the results of soil and groundwater sampling indicate evidence of a release of PCE and TCE, likely associated with the former dry cleaner on the property.

- The highest detected concentrations of PCE or TCE were in shallow soil samples at 2 or 4 feet bgs. However, the three samples with the highest detected concentrations of PCE or TCE are widely distributed: directly south of the building (DP-4 at 4 feet bgs), directly west of the presumed dry cleaner space (DP-6 at 2 feet bgs) and southwest of the building near several underground utilities (DP-10 at 4 feet bgs).

- The groundwater samples with the highest concentrations of PCE were at DP-4, DP-10 and DP-11, south and southwest of the building and in downgradient locations in relation to the former dry cleaner space. Groundwater encountered in the borings appeared to be perched and may be present in this area of the property at varying depths in discontinuous lenses of more permeable soil.
