Independent Remedial Action Report

Facility/Site: 2821735
Wyman's Marina and Wholesale Supply
202 U Avenue
Anacortes, Washington

**Washington State Department of Ecology
on Behalf of Port of Anacortes**

January 6, 2015

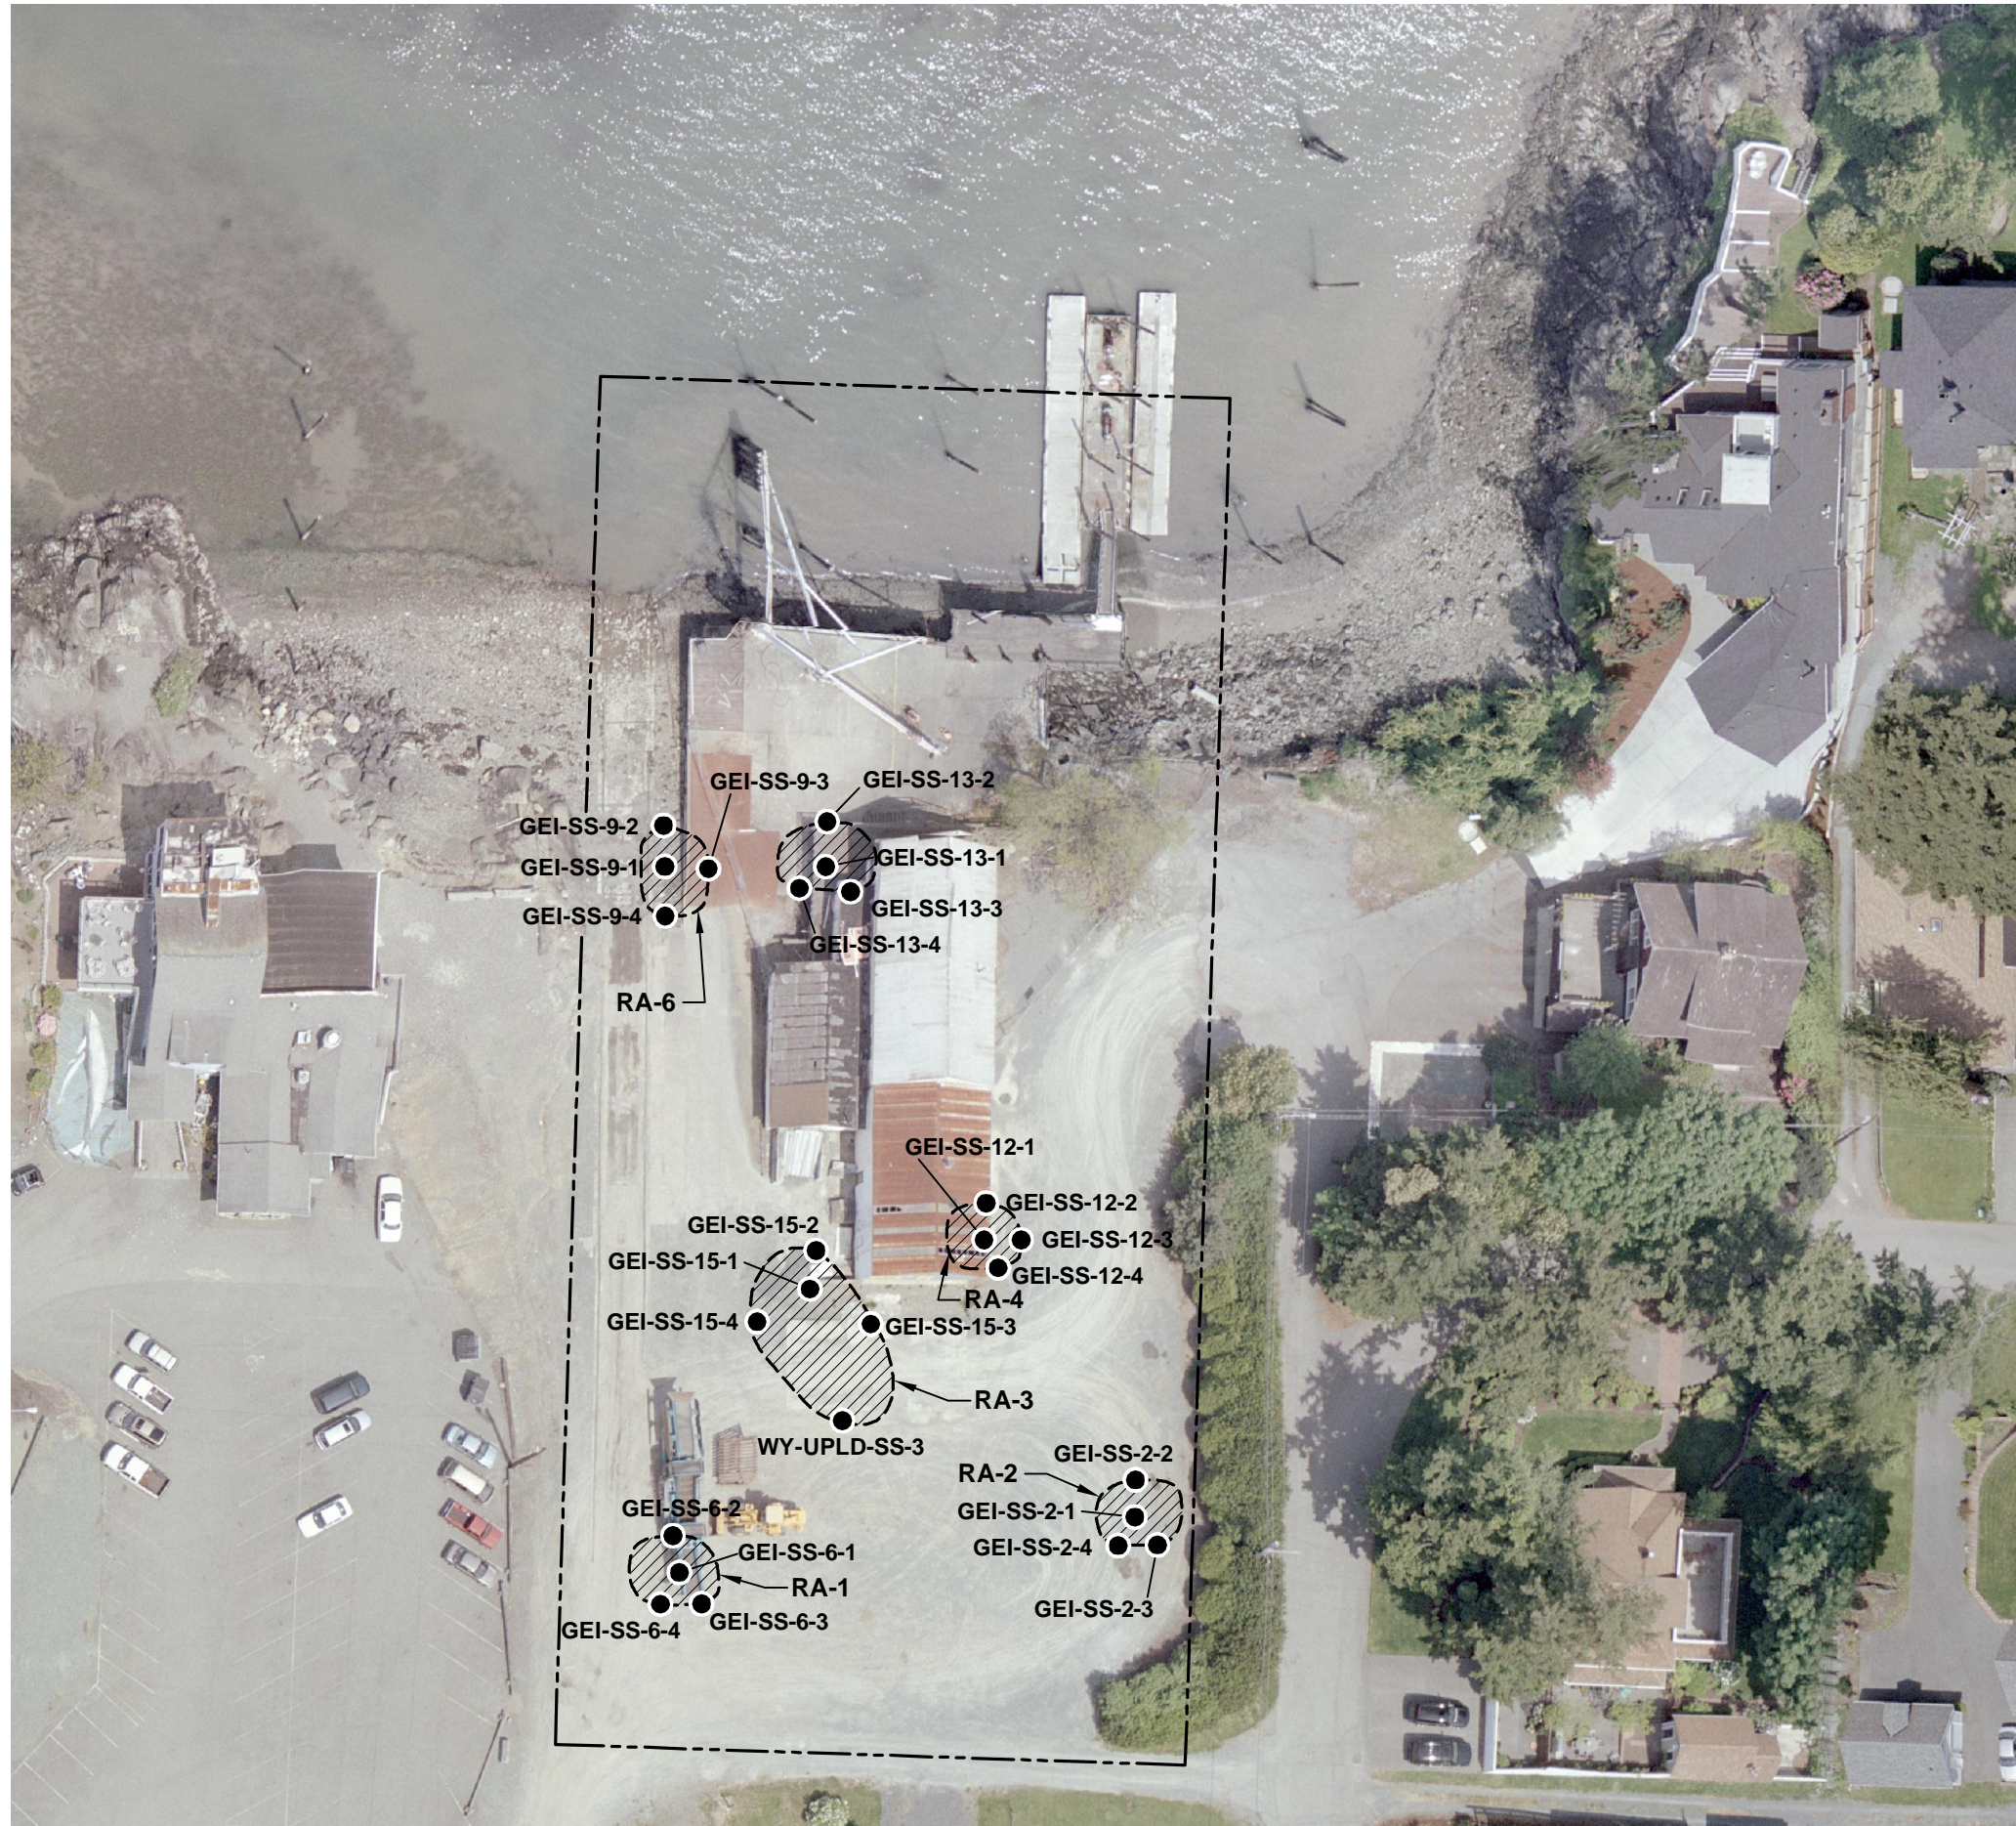
Remedial Excavation Areas	
Wyman's Marina Site Anacortes, Washington	
GEOENGINEERS	Figure 5

- **Remedial Excavation Area RA-1:** Based on GeoEngineers construction observations, field screening results and chemical analytical results of verification soil samples, approximately 23 cubic yards of gasoline-, diesel- and heavy oil-range petroleum hydrocarbon contaminated soil was excavated from RA-1 to complete the cleanup action at this location. A total of four verification soil samples (GEI-SS-6-1-1.5 through GEI-SS-6-4-0.5) represent soil conditions from the final RA-1 excavation limit.

- **Remedial Excavation Area RA-2:** Based on GeoEngineers construction observations, field screening results and chemical analytical results of verification soil samples obtained, approximately 20 cubic yards of diesel- and heavy oil-range petroleum hydrocarbon contaminated soil was excavated from RA-2 to complete the cleanup action at this location. A total of four verification soil samples (GEI-SS-2-1-1.5 through GEI-SS-2-4-0.5) represent soil conditions from the final RA-2 excavation limit.

- **Remedial Excavation Area RA-3:** Based on GeoEngineers construction observations, field screening results and chemical analytical results of verification soil samples obtained, approximately 6 cubic yards of diesel- and heavy oil-range petroleum hydrocarbon, cadmium, lead and mercury contaminated soil was excavated from RA-3 to complete the cleanup action at this location. A total of five verification soil samples (GEI-SS-14/15-1-1.5 through GEI-SS-14/15-4-0.5 and WY-UPLD-SS-3) represent soil conditions from the final RA-3 excavation limit.

- **Remedial Excavation Area RA-4:** Based on GeoEngineers construction observations, field screening results and chemical analytical results of verification soil samples obtained, approximately 3 cubic yards of diesel- and heavy oil-range petroleum hydrocarbon contaminated soil was excavated from RA-4 to complete the cleanup action at this location. A total of four verification soil samples (GEI-SS-12-1-1.5 through GEI-SS-12-4-0.5) represent soil conditions from the final RA-4 excavation limit.

- **Remedial Excavation Area RA-5:** Based on GeoEngineers construction observations, field screening results and chemical analytical results of verification soil samples obtained, approximately 4 cubic yards of cadmium, lead, mercury and organochlorine pesticide contaminated soil was excavated from RA-5 to complete the cleanup action at this location. A total of four verification soil samples (GEI-SS-13-1-1.5 through GEI-SS-13-4-0.5) represent soil conditions from the final RA-5 excavation limit.

- **Remedial Excavation Area RA-6:** Based on GeoEngineers construction observations, field screening results and chemical analytical results of verification soil samples obtained, approximately 1.5 cubic yards of arsenic and copper contaminated soil was excavated from RA-6 to complete the cleanup action at this location. A total of four verification soil samples (GEI-SS-9-1-1.5 through GEI-SS-9-4-0.5) represent soil conditions from the final RA-6 excavation limit.
