UST CLOSURE REPORT

Benton County Area I yard - Prosser

9th Street & Sheridan Avenue
Prosser, Washington

WSI Job No. - 198-091-01

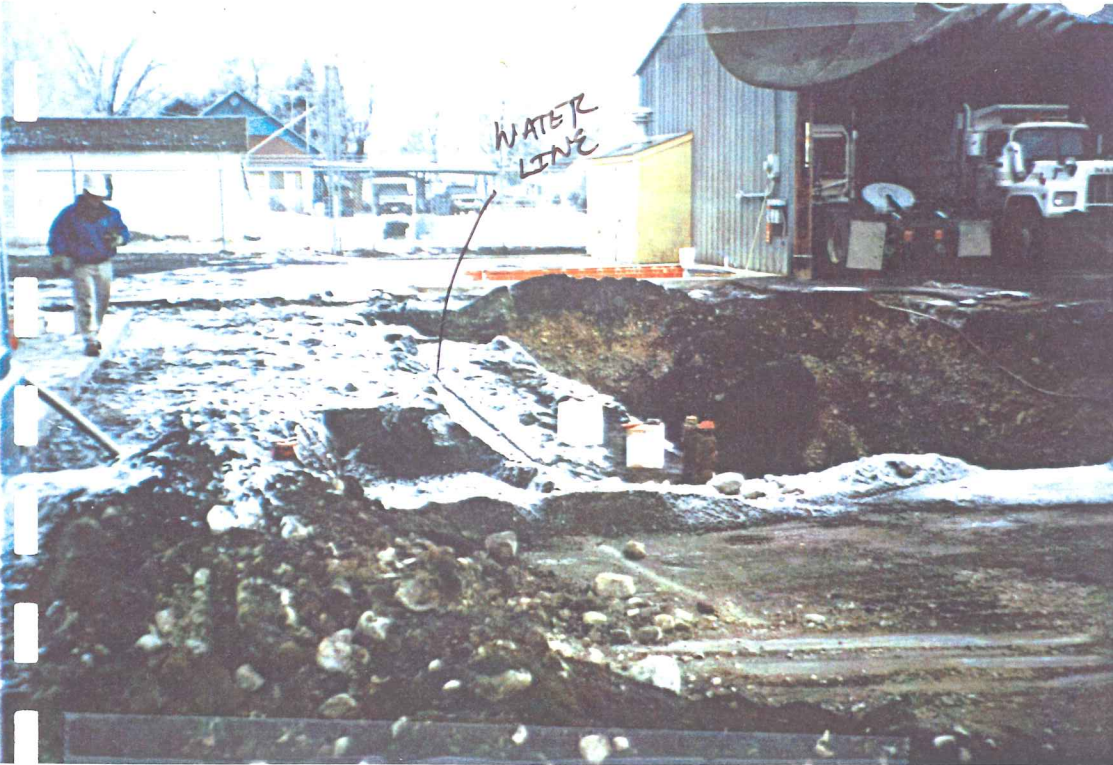
Photograph No: 1
UST excavation upon arrival.
The diesel fuel UST had been
removed prior to approval.

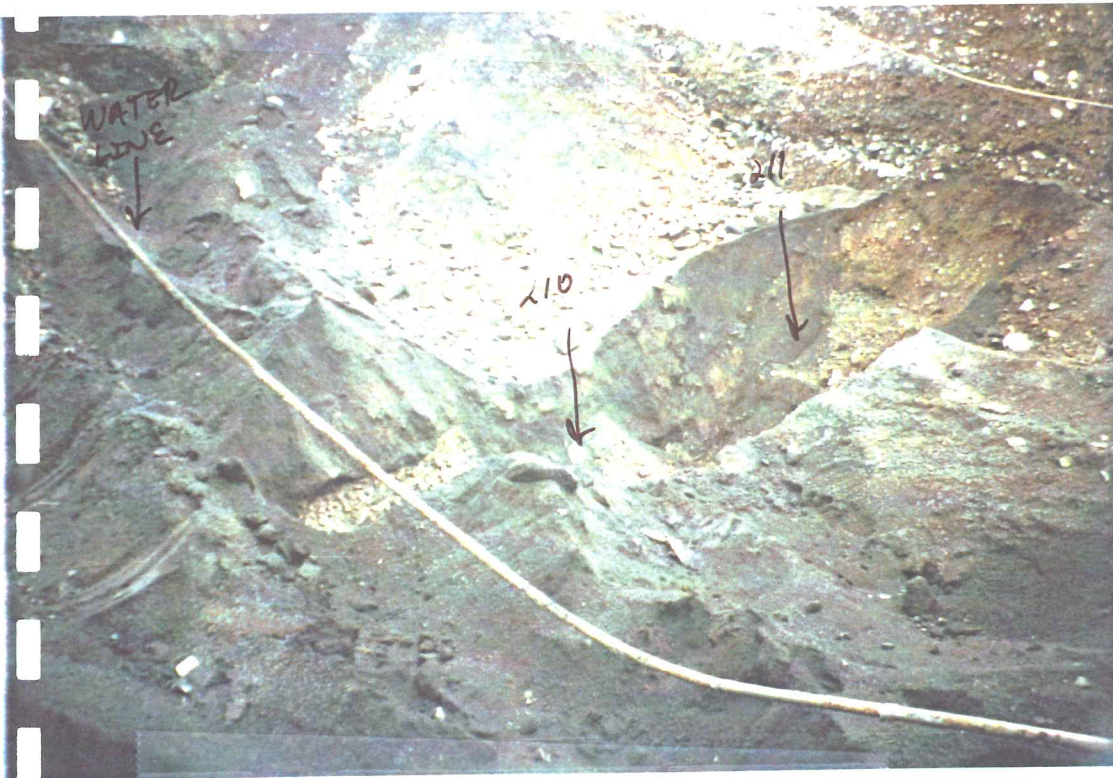
Photograph No. 2: Bottom of
UST excavation. Sample
locations for #PPC-3198-210 and
211. Bottom of diesel fuel UST
and gasoline UST #2.

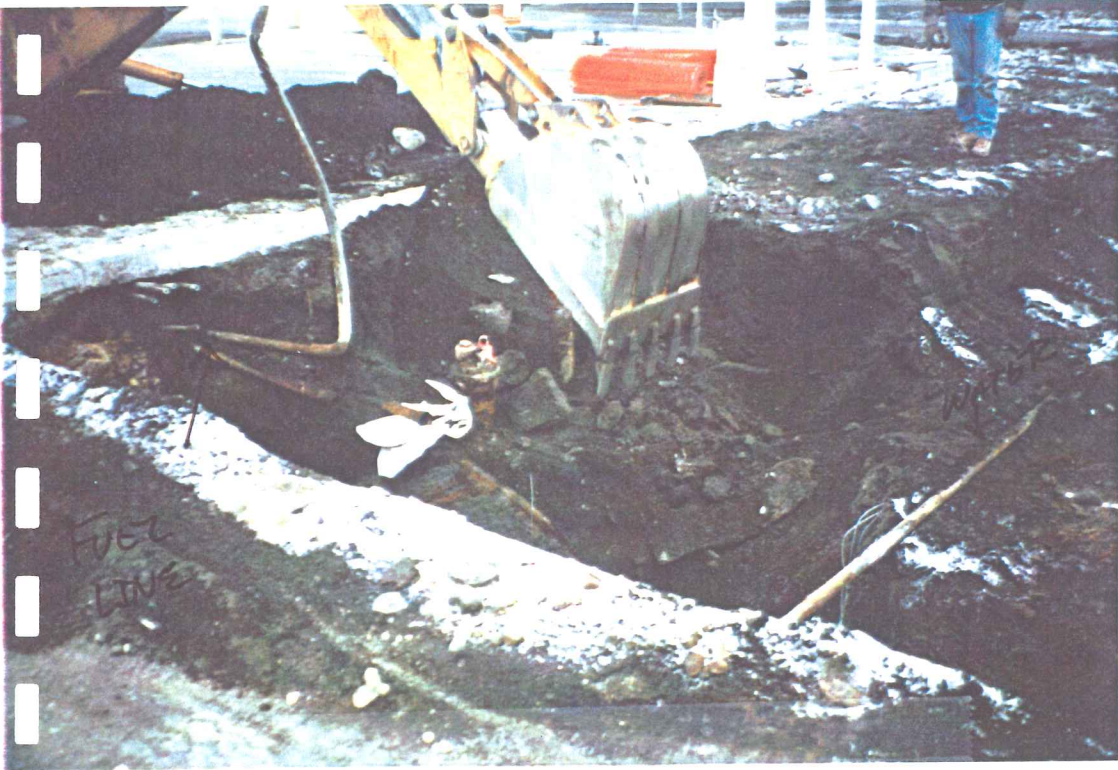
Minor staining was observed along the fuel lines next to the gasoline UST #1. A total of approximately 8 yards of soil was excavated and stockpiled.

Photograph No. 3: Gasoline UST #1 and fuel lines being exposed.
