**UNDERGROUND STORAGE TANK SITE  
ASSESSMENT AND PETROLEUM  
CONTAMINATED SOIL REMOVAL ACTION  
117 ANTHES AVENUE  
LANGLEY, WASHINGTON**

**April 30, 2015**

Whatcom Environmental Services  
228 East Champion Street #101  
Bellingham, Washington 98225

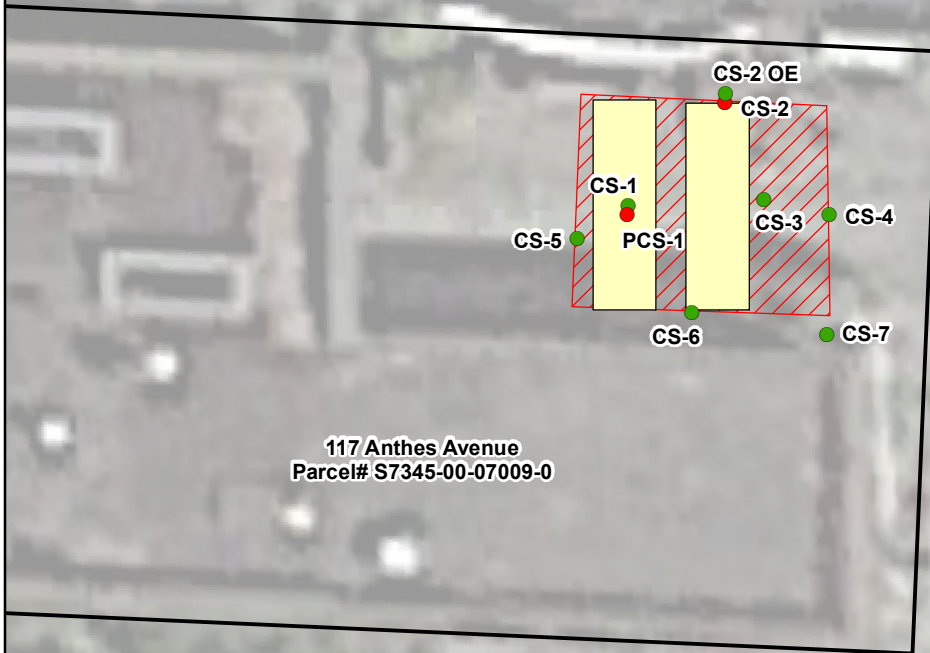
**Figure 2**

**Soil Samples**

**Subject Property Site Map**

Two USTs were decommissioned and removed from the ground on April 21, 2015. The two 500 gallon tanks were previously used to store gasoline for a former fueling station which operated at the property. The tanks were located in the courtyard of the Langley Whale Center. A map showing the location of the removed tanks and other pertinent site features is provided as Figure 2.

soil. The soil sample descriptions including locations, depths of collection, and field screening results are included in Table 1. The soil sample locations are shown on Figure 2.

The excavation extent to the southeast was limited due to the presence of the building foundation. A sample was collected via hand auger approximately 2 feet under the building foundation to ensure no PCS was left under the foundation. The final excavation was approximately 14 feet long by 11 feet wide by an average of 9 feet deep. The excavation location is shown on Figure 2.

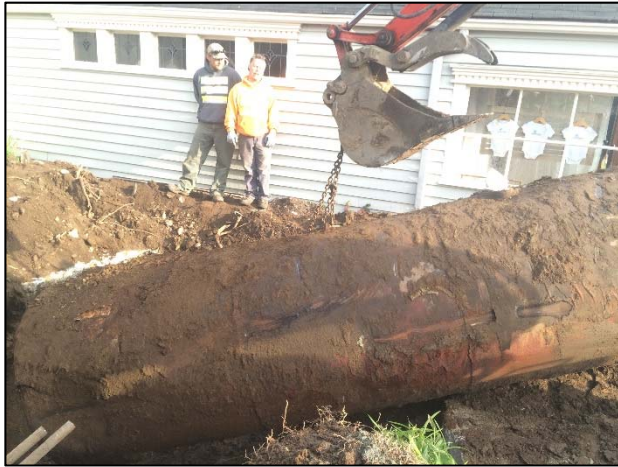
**Photo 1.** A view looking north at the removal of the eastern tank from the tank pit.

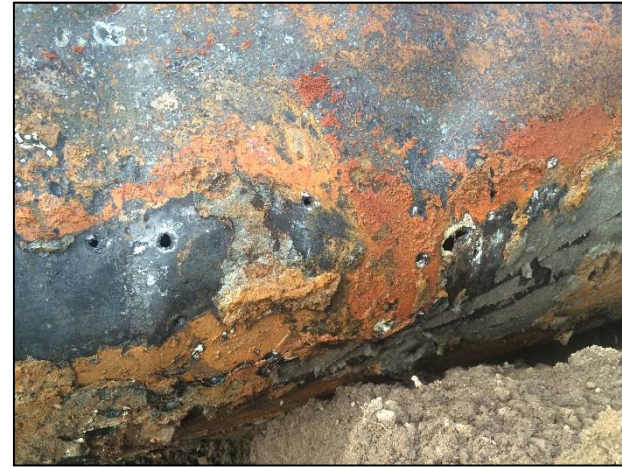
Both USTs were single-walled, steel tanks measuring approximately 3.5 feet in diameter and 12 feet in length. The tanks were uncovered after removing approximately 2.5 feet of overburden. No cathodic protection system was observed during tank removal. No product piping was observed at the site. Upon inspection after being removed from the ground, the tanks were determined to be in poor condition with heavy corrosion and numerous holes were observed in each tank. Photographs of the tank removal are included in the Photographic Log.

**Photo 2.** A view of the eastern tank showing the quarter sized holes as well as corrosion along the bottom of the tank.

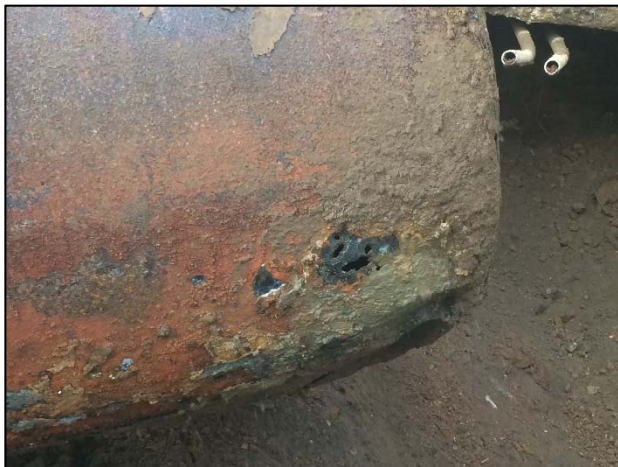
**Photo 3.** A view to the south of the bottom of the western tank along its southern end. Note the corrosion and several holes.

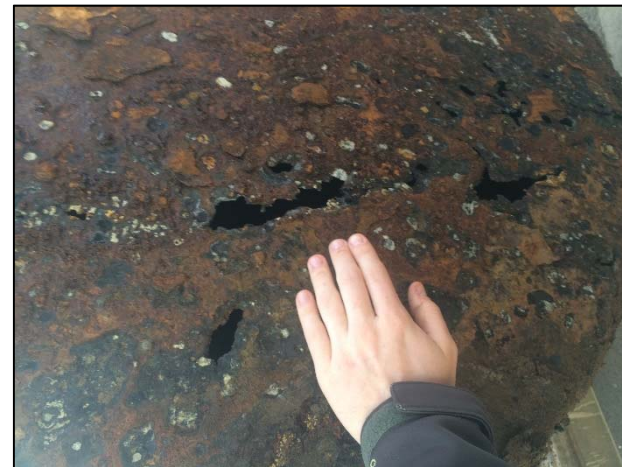
**Photo 4.** A close up view showing the poor condition of the bottom of the western tank's northern end.

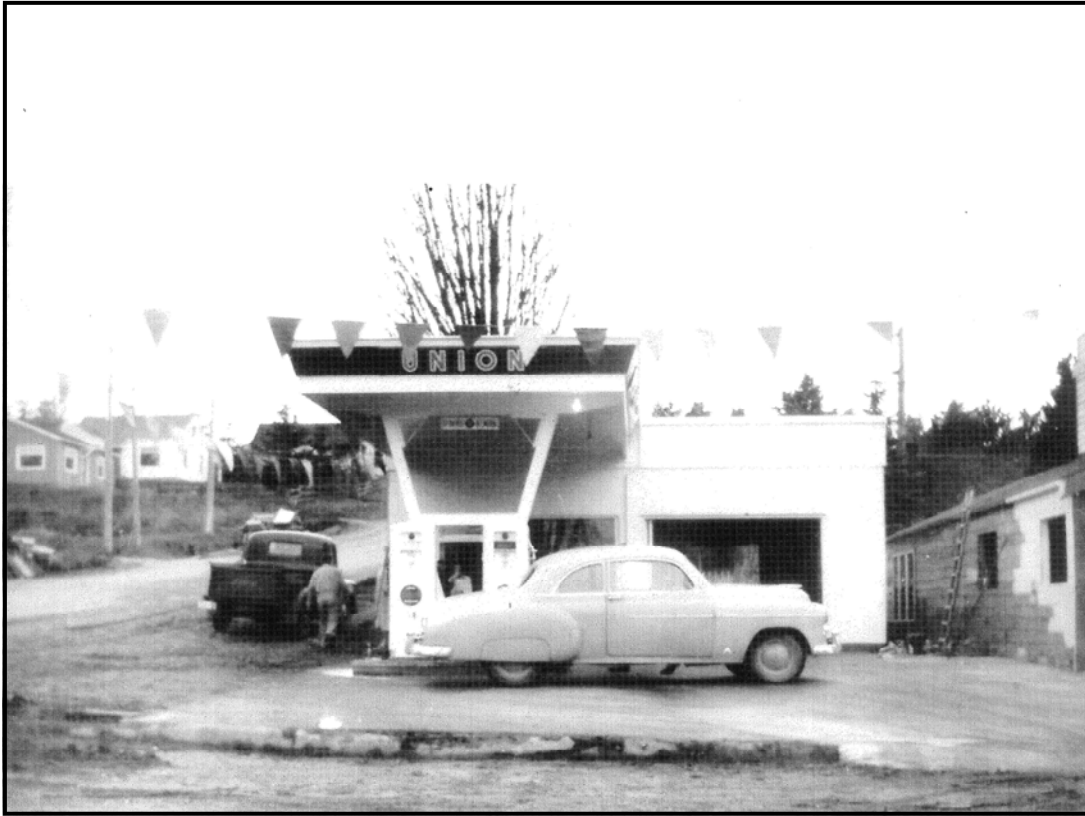
**Photograph 1.** Photo date unknown. Photo provider states that the gas station was a Union gas station constructed in 1951/1952 next to the auto body shop that was constructed in 1950.
