# **INITIAL INVESTIGATION FIELD REPORT**

**ERTS Number:** 658182 & 658827

Site Address (including City, State and Zip): 2826 NW Market St	Phone/email:			
Seattle, WA 98107				
Site Contact Address (including City, State and Zip):	Phone/email: (206) 386-9168			
Site Owner Address (including City, State and Zip): 700 5TH Ave, Ste 3200-AP PO Box 34023 Seattle, WA 98124	Phone/email:			
Site Owner Contact Address (including City, State and Zip):	Phone/email:			
Additional Info:				
Degrees): -122.39405	announced			
No ⊠ Photos are available in report				
No   Data are available in construction completion rep	oort			
pes not pose a threat	med and Suspected Sites List:			
	Site Contact Address (including City, State and Zip):  Site Owner Address (including City, State and Zip): 700 5TH Ave, Ste 3200-AP PO Box 34023 Seattle, WA 98124  Site Owner Contact Address (including City, State and Zip):  Additional Info:  Degrees): 47.66892 ID Degrees): -122.39405  Ime: Entry Notice: Announced Unated Info:  No Photos are available in report No Data are available in construction completion registate box below):  Description of the Contaminated Info:  LIST on Confirmation Contaminated Info:  LIST on

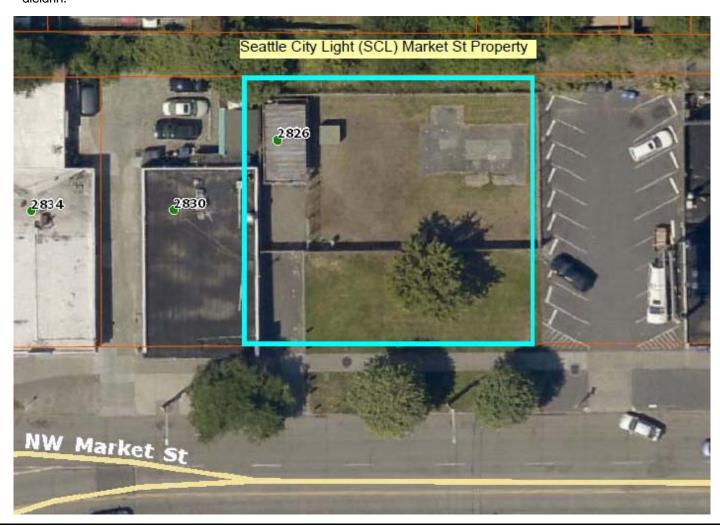
- The northeast corner of the property, where cadmium was found to exceed MTCA, was excavated to 12 inches below ground surface (bgs). Verification samples showed that all remaining soil was below the cleanup level for cadmium.

- The area inside the south former transformer yard fence, where lead was found to exceed MTCA, was excavated to 12 inches bgs. Verification samples showed that all remaining soil was below the cleanup level for lead.

- The grass landscaped area, where dieldrin was found to exceed MTCA, was excavated to 12 inches bgs. Verification samples showed that there was still remaining dieldrin above the cleanup level, so further excavation was done. Ultimately, the impacted area was excavated down to 36 inches bgs in the northwest corner, 30 inches bgs in the north and northeast, and 24 inches bgs in the south portion. Confirmation samples verified that all remaining soil was below the cleanup level for dieldrin.
