**Silverdale Dump Site
Removal Site Assessment
Trip Report
TDD: 97-06-0009**

TRIP REPORT

Removal site assessment for alleged buried drums and cylinders.

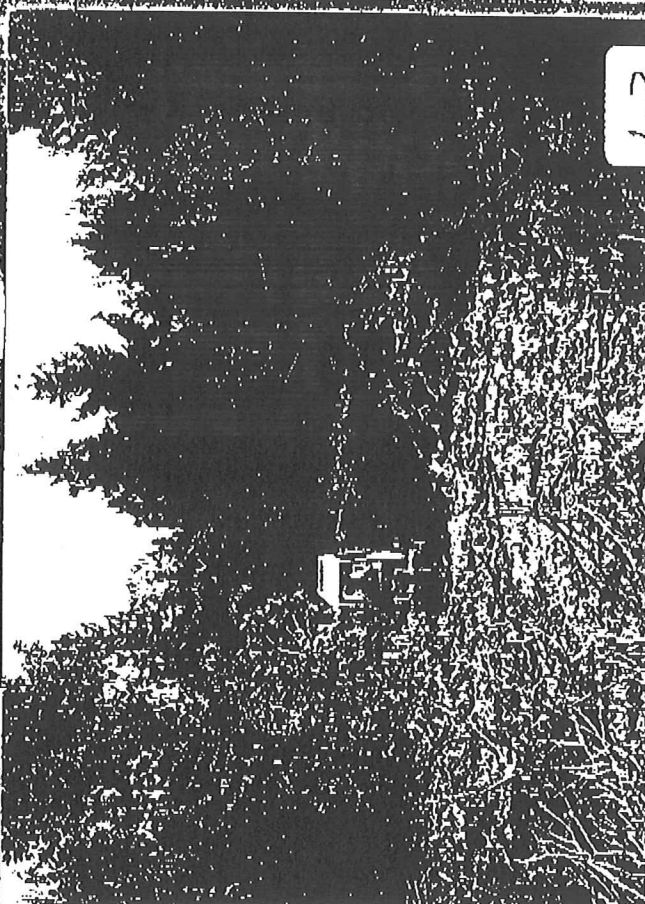
Photo No.	Date	By	Description
1-1	8/13/97	AN	55-gallon drum approximately 1/4 full found while clearing brush and debris from site. Facing East.
1-2	8/13/97	AN	Bulldozer clearing the site. Facing South.
1-3	8/13/97	LD	Bulldozer piling debris. Facing South.
1-4	8/13/97	LD	Scattered surface debris. Facing South.
1-5	8/13/97	LD	Unidentified object with US Government stenciled on it. Facing East.
1-6	8/13/97	LD	Unidentified object with US Government stenciled on it. Facing East.
1-7	8/13/97	LD	Unidentified object with US Government stenciled on it. Facing East.
1-8	8/13/97	LD	Abandoned house with propane tank (foreground). Facing Southwest.
1-9	8/13/97	LD	View of bulldozing progress. Facing South.
1-10	8/13/97	AN	View of cleared area. Facing South.
1-11	8/13/97	AN	START conducting electromagnetic survey using EM-31 device. Facing West.
1-12	8/13/97	LD	START conducting electromagnetic survey using EM-31 device. Facing West.

A sample was collected from the drum found during clearing activities. A chemist performed hazardous categorization of the unknown and the sample results were consistent with a diesel or heating oil type of product. The drum was recycled by Spencer Environmental of Sumner, Washington.

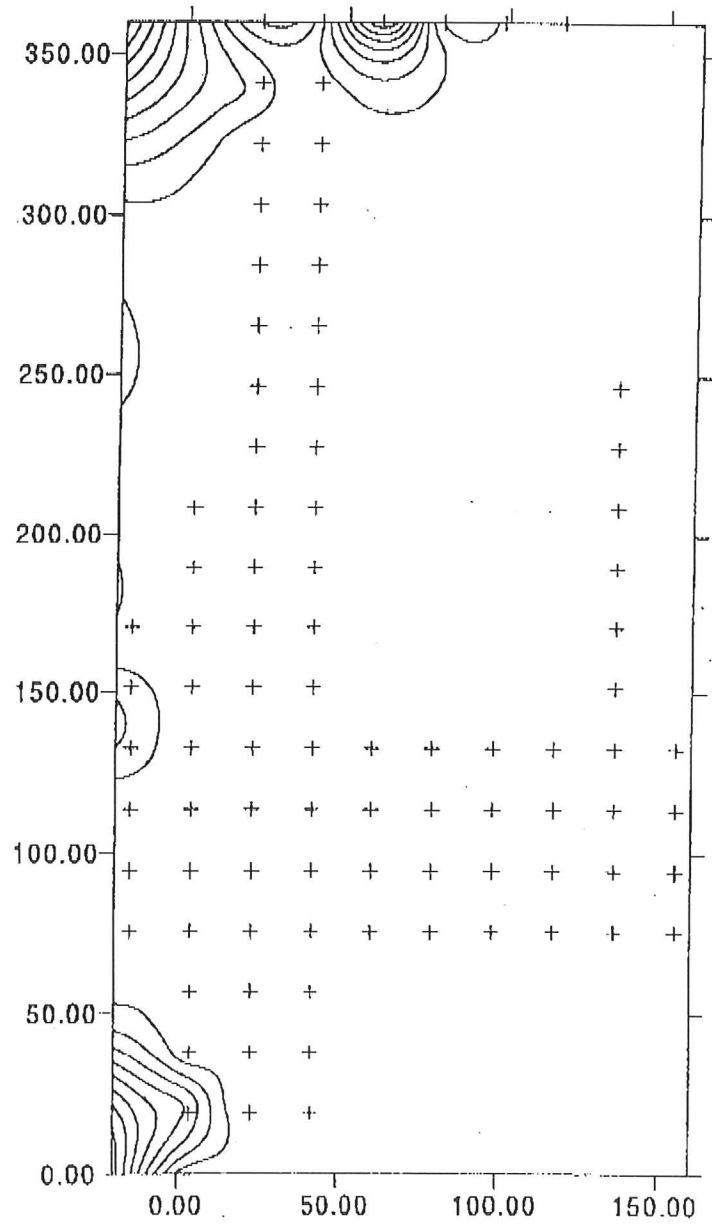
Silverdale EM-31 Results
Horizontal Dipole (North)

Prior to conducting the electromagnetic survey, the field team established a grid at 20 foot node spacings throughout the cleared area. The field team then conducted an electromagnetic conductivity geophysical investigation throughout the property using an EM-31 device. At each node, four readings were collected from two vertical dipole positions and two horizontal dipole positions. The orientations completed at each node were approximated to north-south and east-west positions. The depth range for the EM-31 is typically 6 meters in the horizontal dipole position and 3 meters in the vertical dipole position. Included with the readings is an in-phase reading that provides an indication of metallic objects. Appendix B provides contoured plots of the conductivity values and in-phase readings for the cleared area. A careful review of the conductivity readings indicates the lack of any disturbances or buried objects throughout the area investigated, except for metal debris on the ground surface (e.g., Bus Seats).
