# **Delineation of Subsurface Petroleum Hydrocarbon Contamination**

**Horse Heaven Hills Travel Plaza  
101 Merlot Drive  
Prosser, Washington 99350**

Blue Mountain Environmental And Consulting Co., Inc.  
PO Box 545/125 Main St.  
Waitsburg, Washington 99361  
(360) 666-1465

May 5, 2014

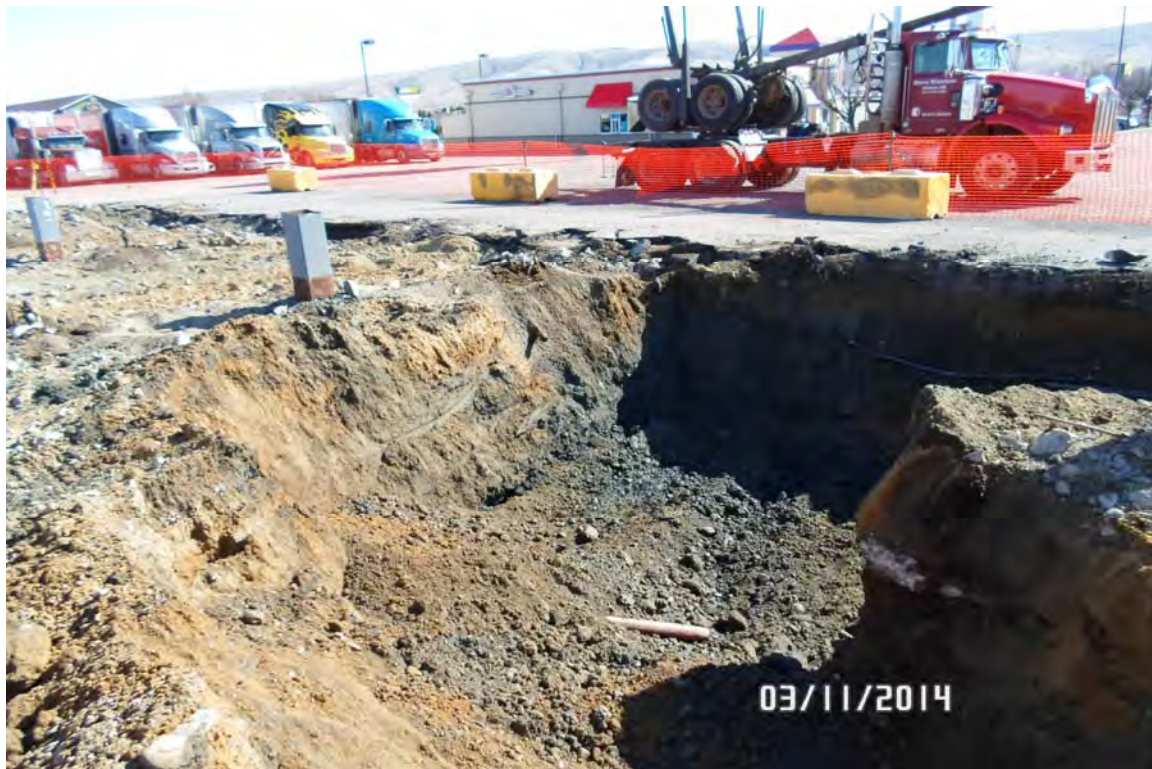
During the March 12, 2014 field activities, soil discolored dark gray and displaying a strong diesel odor was noted near the base of the diesel fuel dispenser excavation pit at an approximate depth of 7.5 to 8 feet bsg (see photograph - **Appendix B**). The diesel fuel-contaminated soil was noted in the vicinity of soil sample 03-19-TP-5 (**Figure 2**). At this stage of the project, discussion was initiated with the current owner, Christensen-Powell Inc., regarding the necessity to remove the former USTs to further delineate the diesel fuel contaminated soils.

IMPACTED SOIL

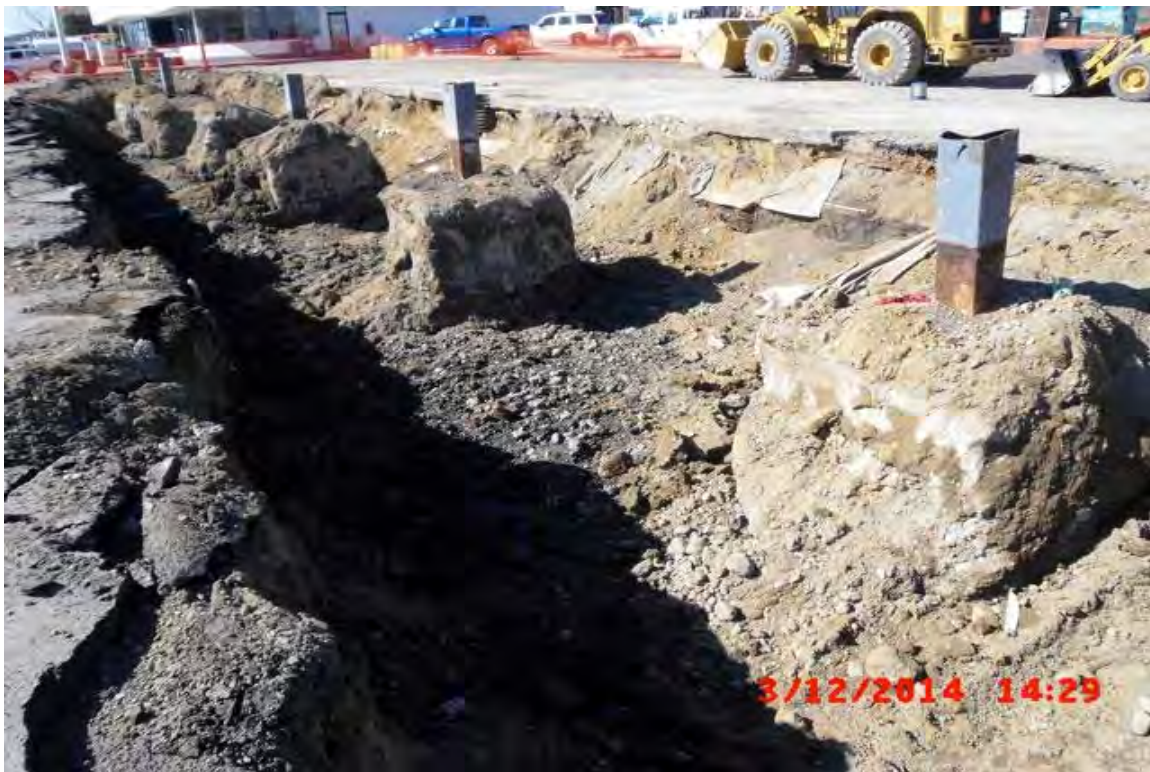
The soil staining on the south sidewall of the trench was very evident at an approximate depth of 2 feet bsg and extended to the base of the excavation at 8 feet bsg. This solid line of discoloration and petroleum odor from 2 to 8+ feet bsg strongly suggests that the groundwater surface has fluctuated to as high as 2 feet bsg in the past and created a diesel fuel “smear zone” that was evident during the site assessment from approximately 2 to 8 feet bsg.

IMPACTED (GREY) SOIL IN FOREGROUND

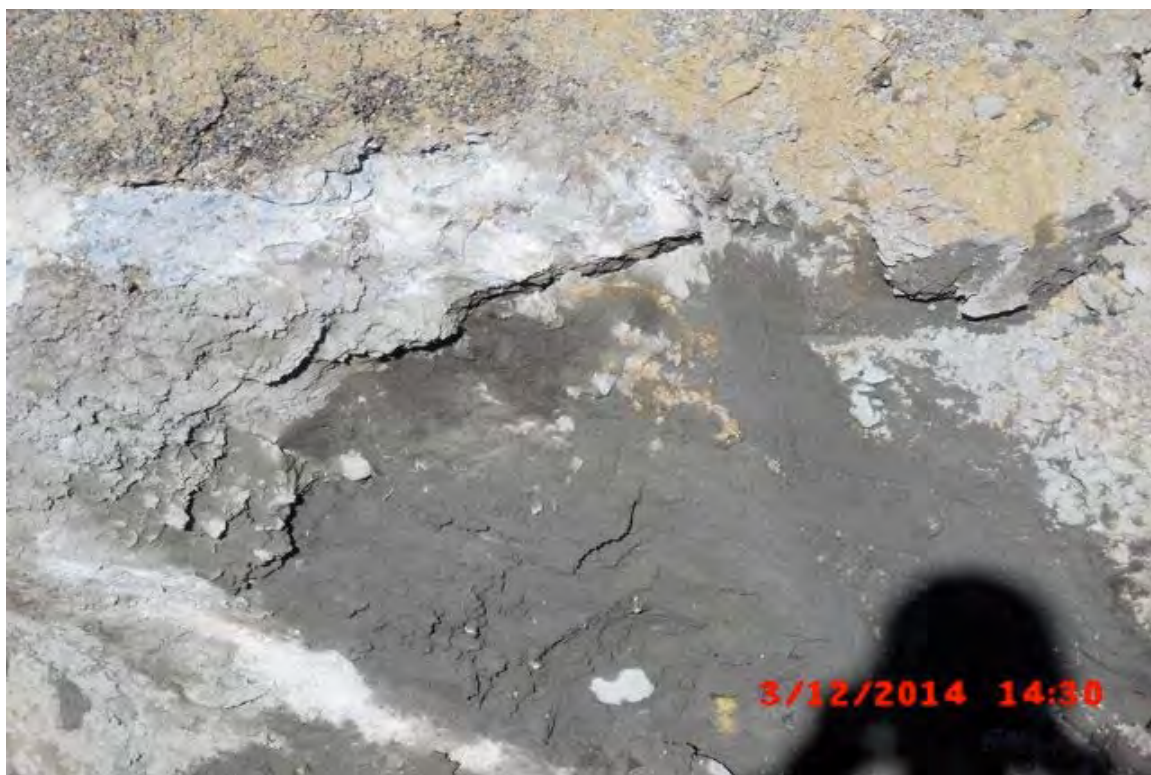
During the March 13 and 14, 2014 field activities, the dimensions of the excavation pit created by removal of the diesel fuel dispenser pump islands and canopy foundations were approximately 130 feet by 28 feet by 8 feet deep. The soil on the south side of the trench and southeast corner of the trench was stained dark brown to gray and had a strong diesel fuel odor from 2 to 8 feet bsg. Aside from the vicinity of soil sample 03-19-TP-5, no staining was noted in the soil on the north or west sides of the trench. Dark gray to black soil staining was noted throughout the base of the trench at an approximate depth of 8 feet bsg. Pooled groundwater was noted at the base of the excavation at an approximate depth of 8 to 8.5 feet bsg. The groundwater had an oily sheen on the surface.

VIEW AT CONTAMINATION SEEPING FROM THE TANK PIT

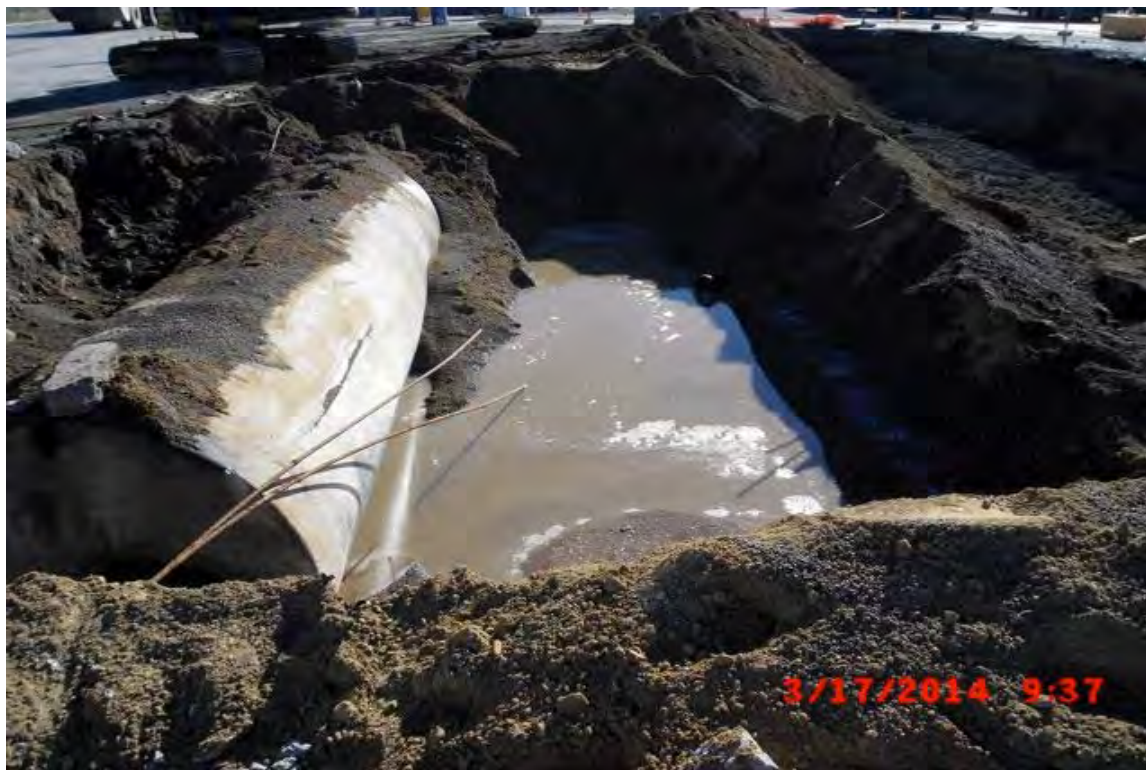
Four of the six soil samples obtained from the bottom of the UST excavation pit (03-19-TP-1 through 03-19-TP-6) yielded PHC concentrations (TPH-D) that exceeded MTCA Method A Cleanup Levels. All four of these soil samples were obtained from an approximate depth of 8 feet bsg. Thus, since groundwater was observed to be at an approximate depth of 8 to 8.5 feet bsg during the day of collection of these samples on March 19, 2014, the MTCA Method A Cleanup Level exceedances in soil attributed to these four samples should technically be considered a potential groundwater issue moving forward.

TANK PIT AFTER UST REMOVAL
