**WORKSHEET 1
SUMMARY SCORE SHEET**

PSE Blumaer Substation
N. Hodgedon St. & SE Garfield Ave.
Tenino, WA 98589

Remedial Action Summary
Puget Sound Energy – Mineral Oil Release
Blumaer Substation
N. Hodgeden St. & Garfield Ave. SE
Tenino, Washington
File No. 0186-482-01, Task 46

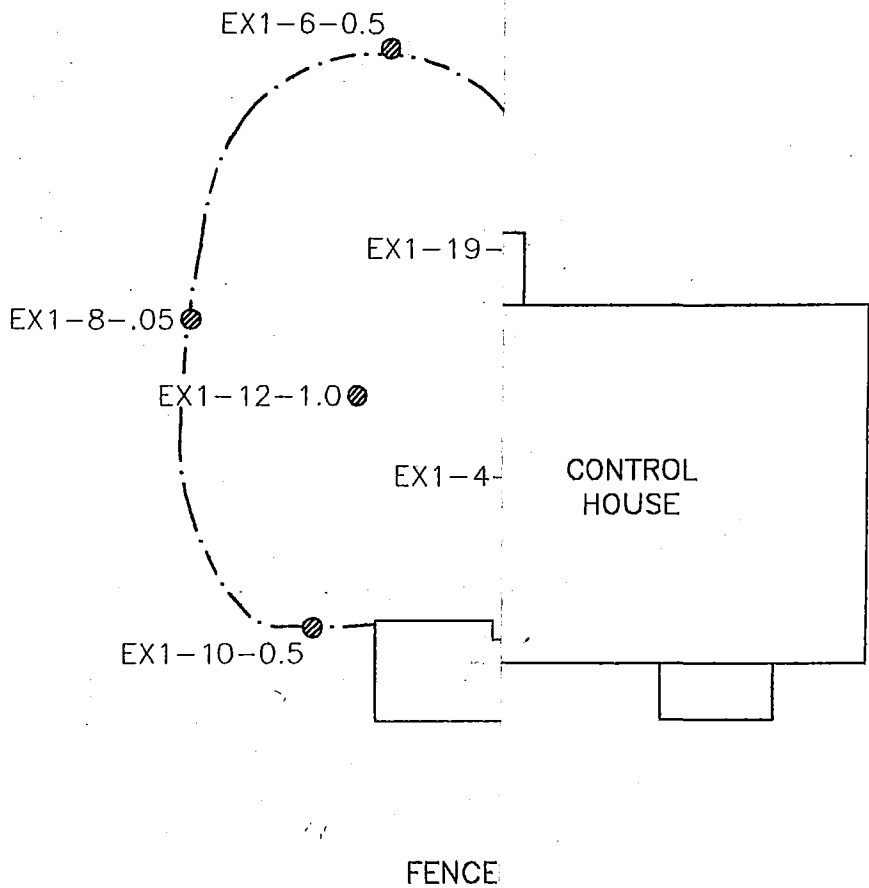
FIGURE 2

SITE PLAN

Field screening of soil at the final limits of the remedial excavation yielded moderate to no sheen, indicating that soil with significant concentrations of mineral oil had been removed from the release area, with three exceptions. Soil yielding a heavy sheen remained in-place on the north, east and west sides of the excavation beneath the concrete pad associated with the damaged regulator. Due to stability issues concerning the electrical equipment located on the concrete pad, this contaminated soil located beneath the regulator's concrete pad was not excavated.

A localized lens of mineral oil-contamination, approximately 1-foot thick, remains in place beneath the concrete pad associated with the damaged regulator at the site. This small volume of remaining soil with elevated mineral oil concentrations is effectively capped by the concrete pad that prevented further remedial excavation. Based on the inaccessibility of this soil and its shallow and limited extent, it is our opinion that the soil does not represent a threat to human health or the environment. Additionally, the soil (located between 0.5- and 1.5 feet bgs) does not appear to present a threat to groundwater beneath the site, which is located approximately 8 feet bgs, as observed in PSE's monitoring well TMW-7 located approximately 125 feet to the northwest. Nevertheless, groundwater in the TMW-7 will be sampled in the summer of 2002 and will be evaluated for potential impacts relative to the remaining contaminated soil beneath the concrete pad. We recommend that when, and if, the soil becomes accessible for remedial excavation in the future, that PSE remove it at that time. The residual mineral oil-impacted soil beneath the concrete cap will be noted in PSE's Spill Prevention Control and Countermeasure (SPCC) plan.
