SITE HAZARD ASSESSMENT
WORKSHEET 1
Summary Score Sheet

Gorst Gas Mart
4121 W. State Hwy 16
Bremerton, WA 98312

*Site scored/ranked for the August 20th 2008, update
July 16, 2008*

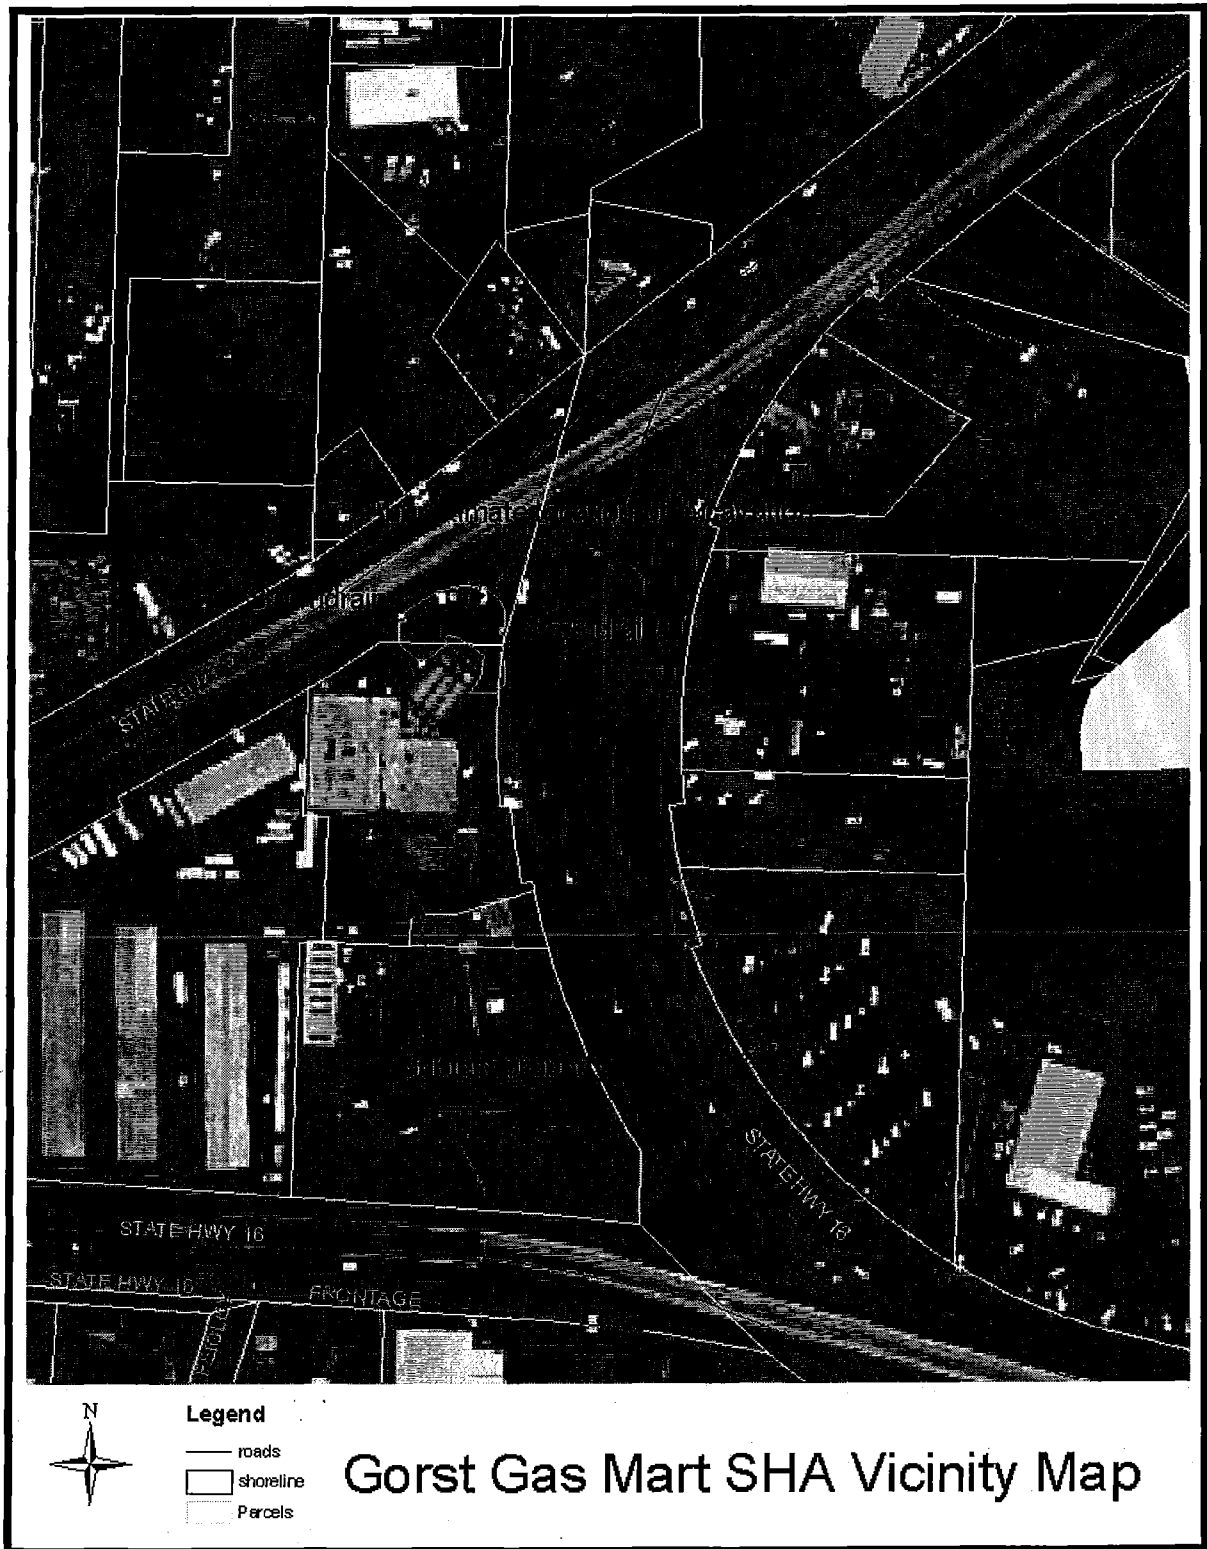
Figure 1. Gorst Gas Mart Vicinity Map

On July 10, 2008, Health District staff conducted a site visit. During the site visit the figures in the Radix Ortega Reports were found to be in error. The north directional arrow, the outline of the buildings in the figures, and the relationship of the two bordering properties are incorrect. The footprint of the excavated area does not match observations from the site visit. Cuts in the asphalt were observed indicating where the excavation most likely occurred. Figure 1 is an aerial photo with

notations showing the probable area of excavation. A copy of one of the figures from the final report is attached for comparison purposes.
