***Final Feasibility Study Report  
for Interim Action Work Plan  
Custom Plywood Site  
Anacortes, Washington***

***Prepared by Hart Crowser  
under Direction and Contract with  
Washington State  
Department of Ecology  
under Agreement with  
GBH Investments, LLC***

***September 2011  
17330-27***

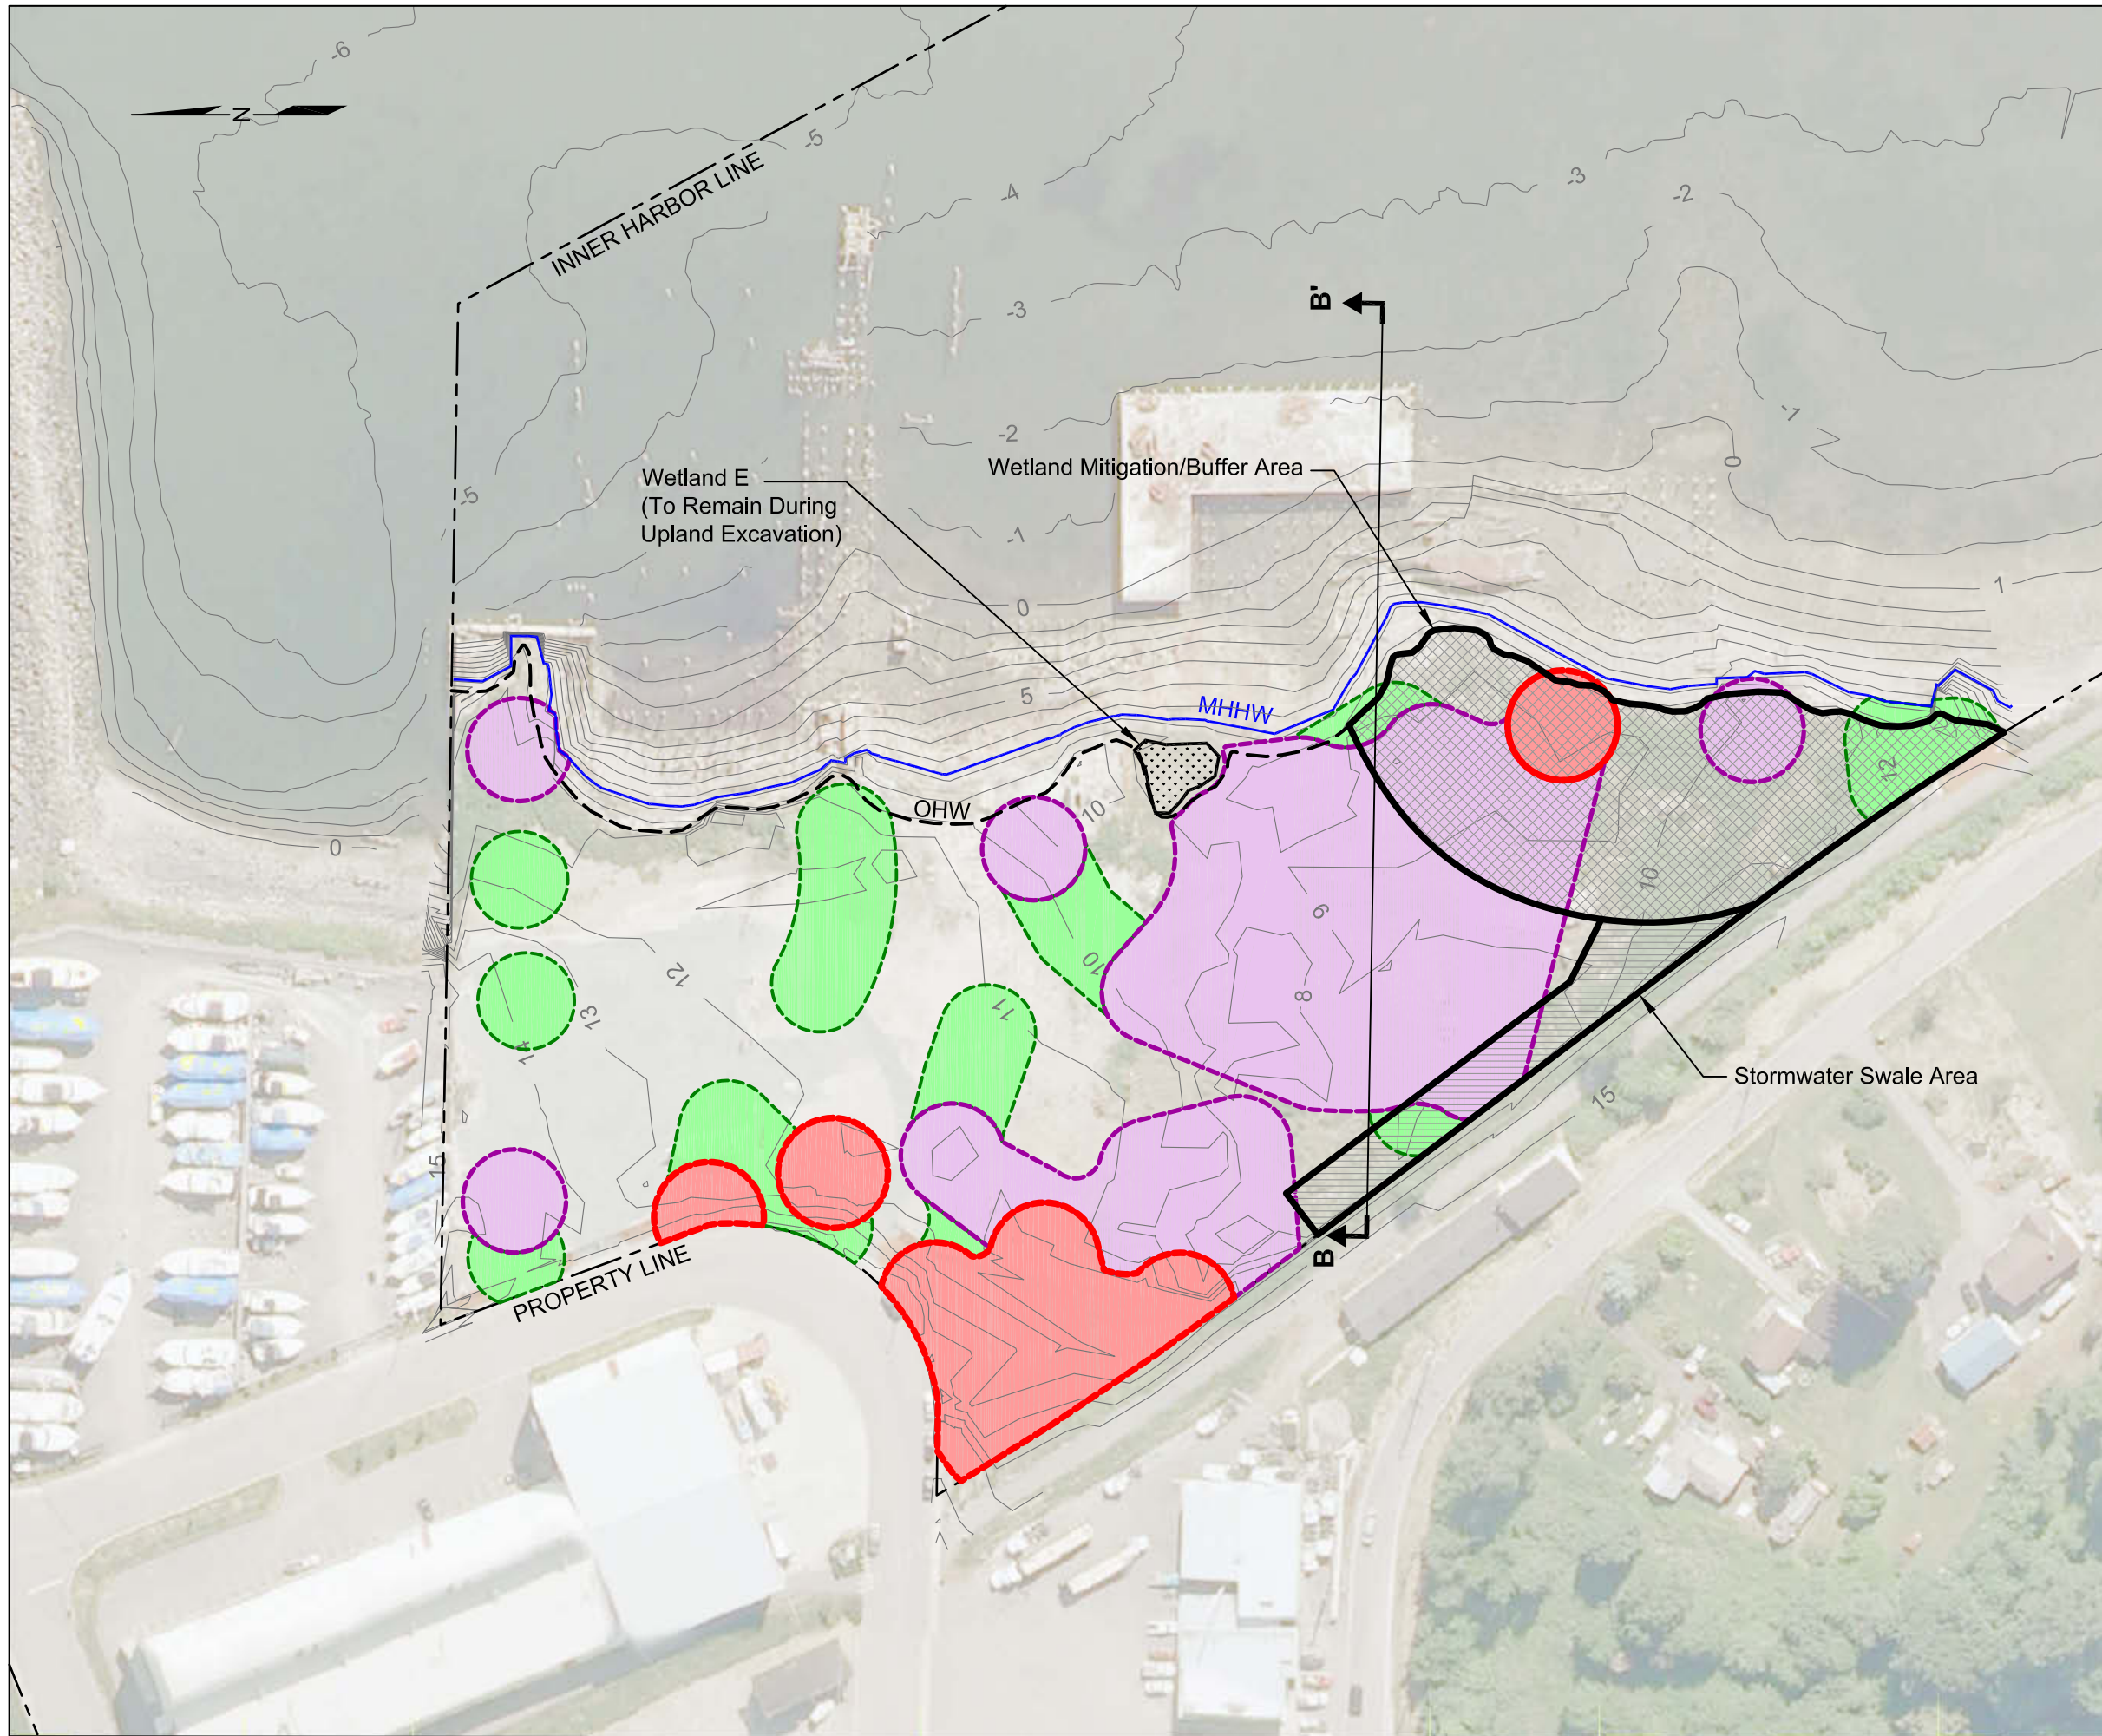
Figure  
**8-1**

Target Excavation Area and Depth in Feet Below Grade

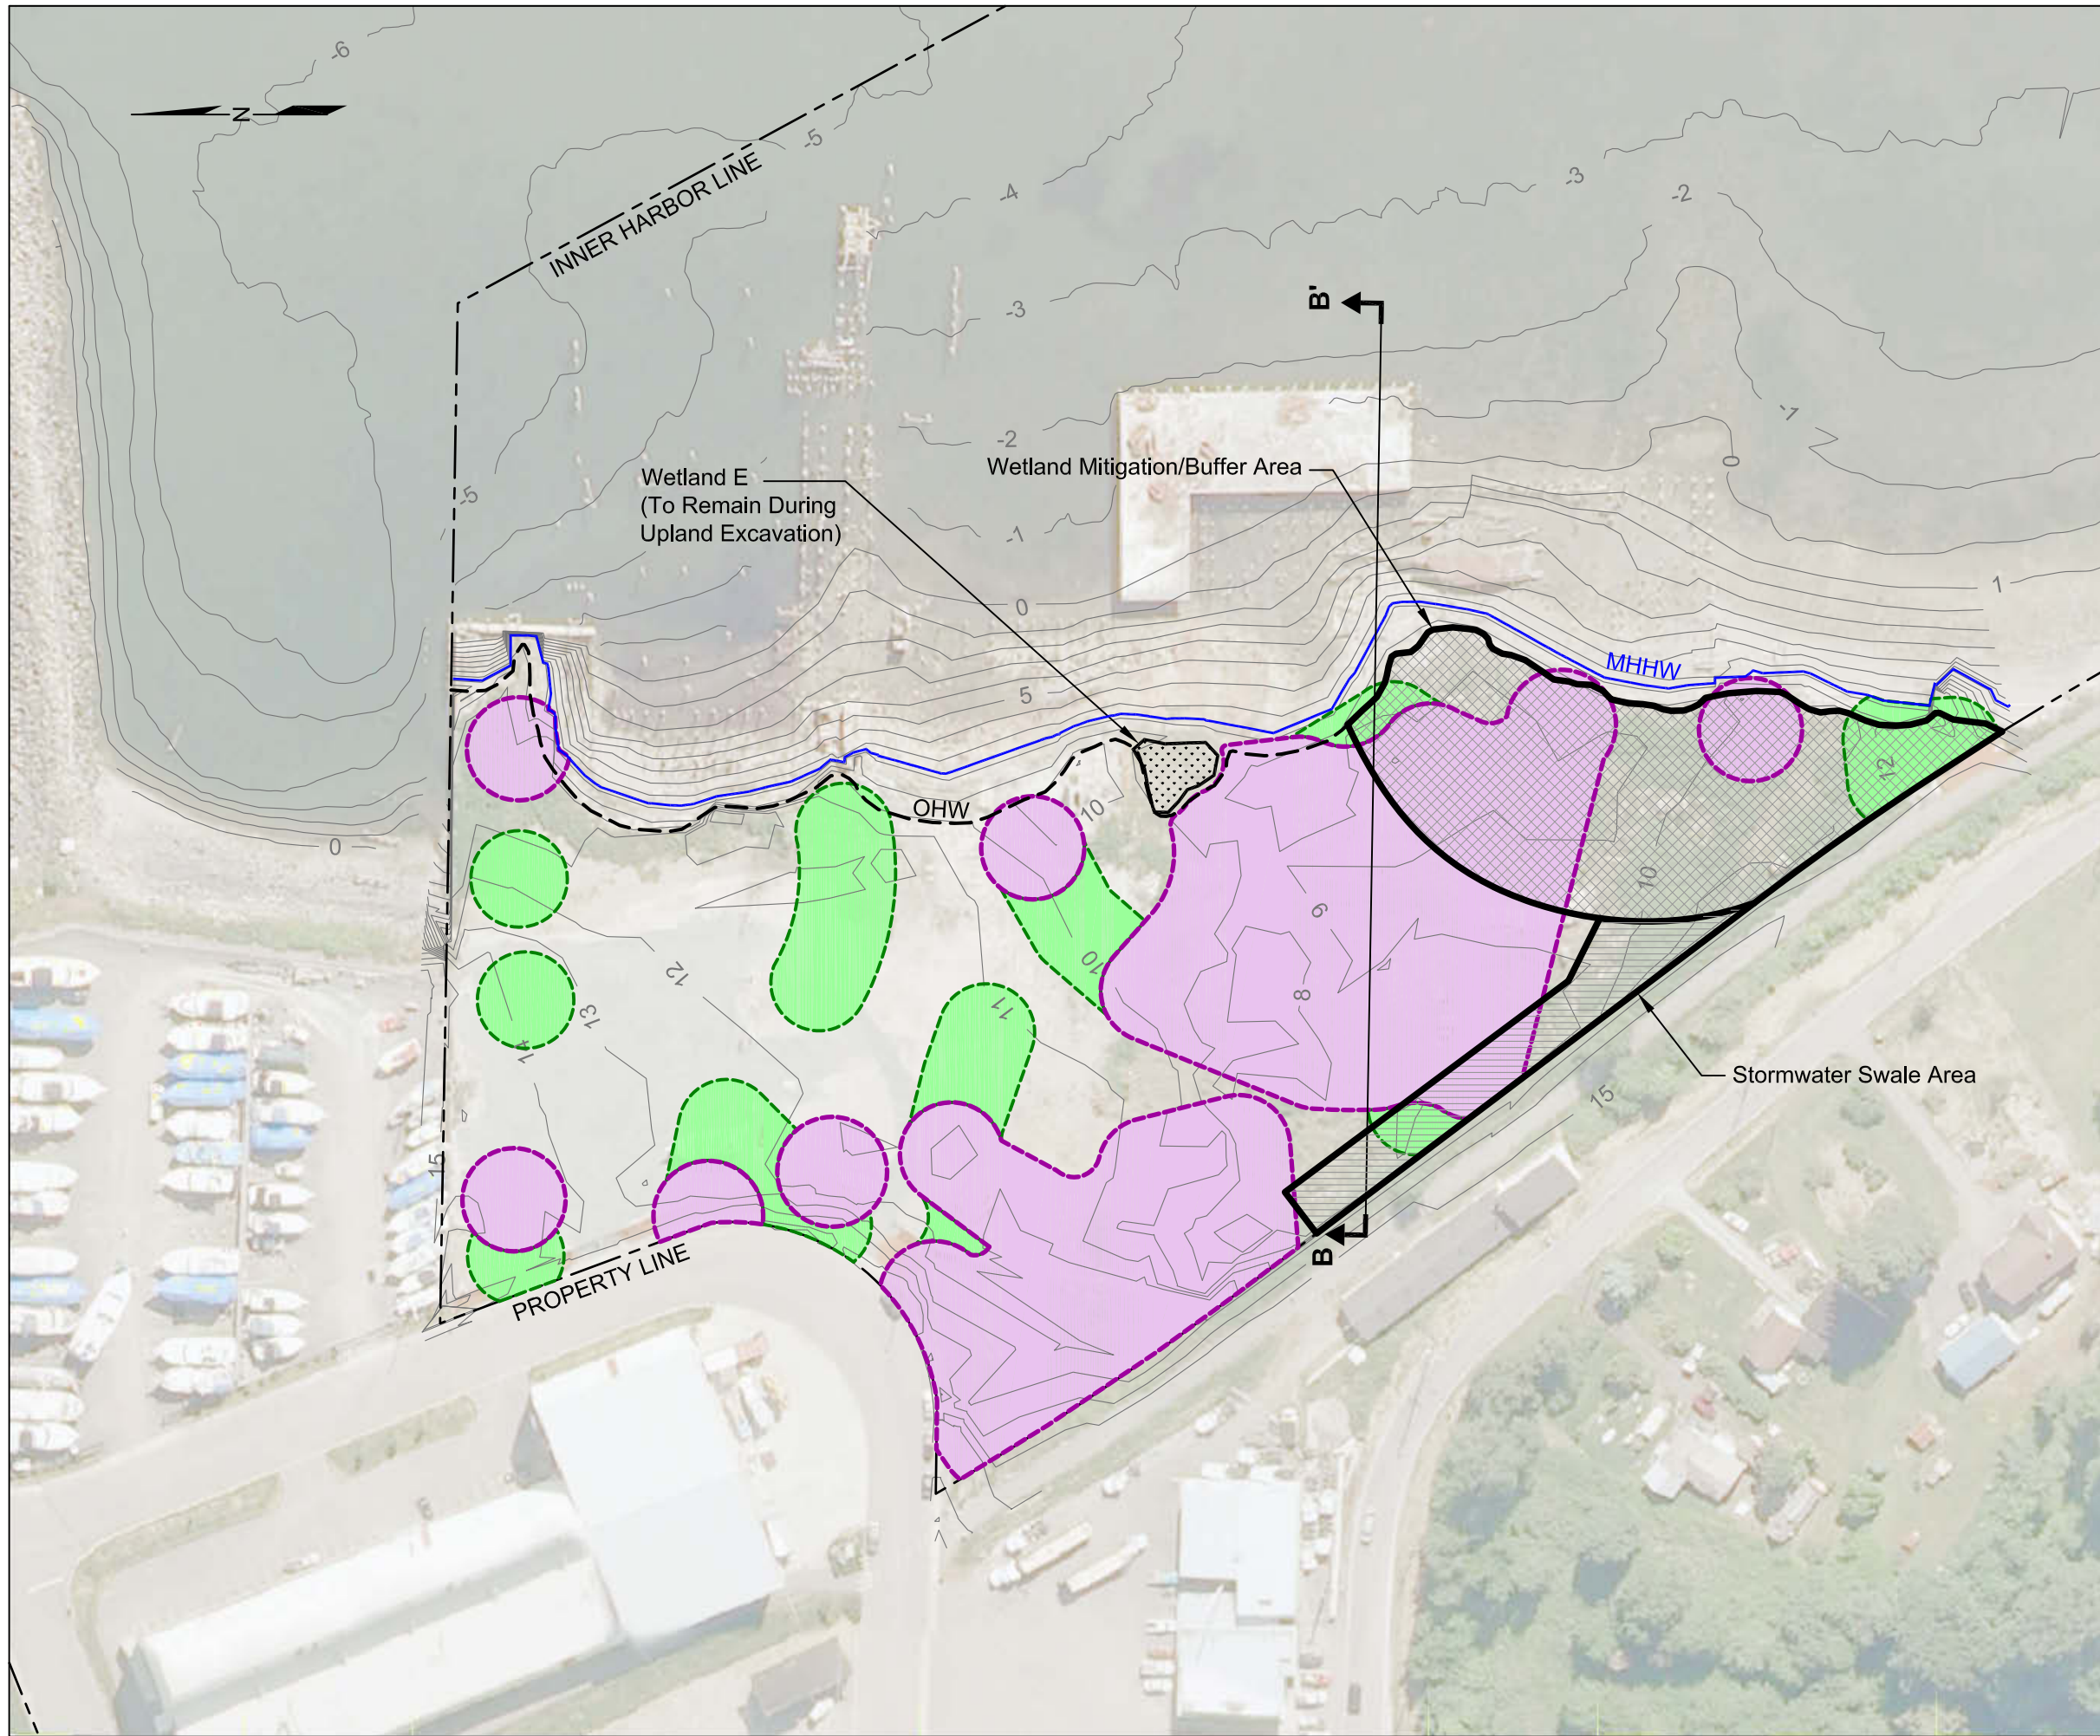
**8-2**

**Target Excavation Area and Depth in Feet Below Grade**

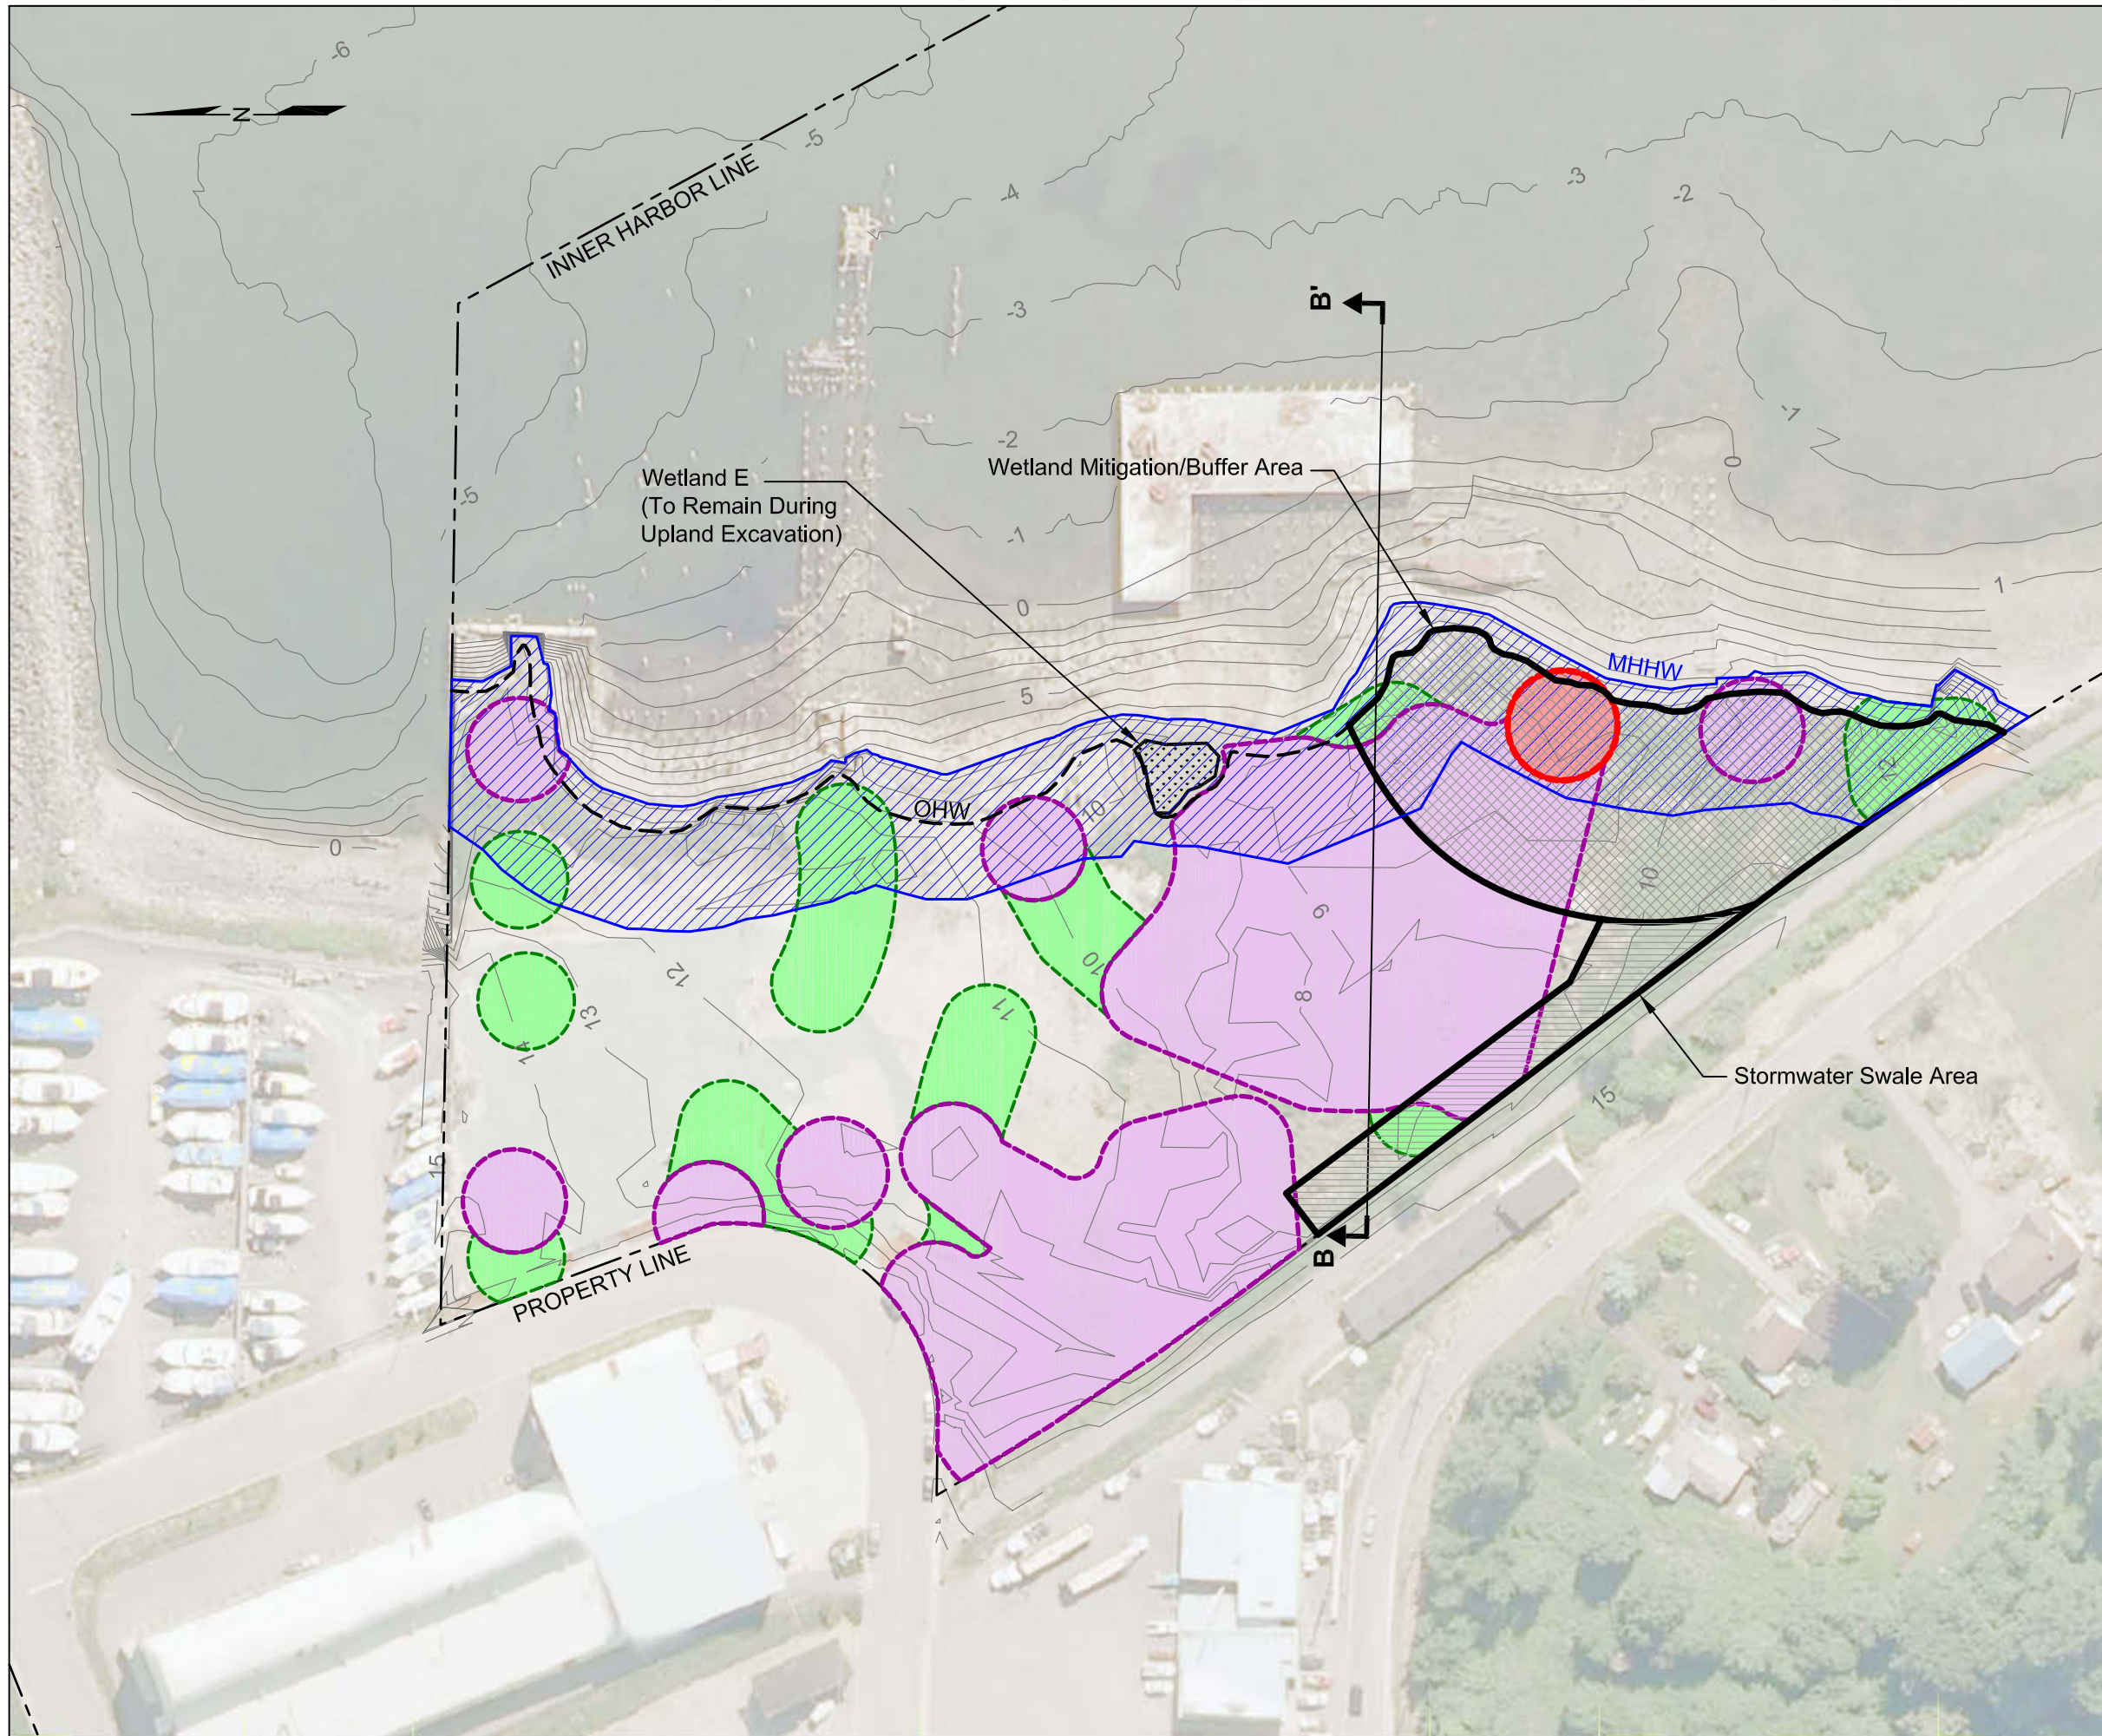
**8-3**

Target Excavation Area and Depth in Feet Below Grade

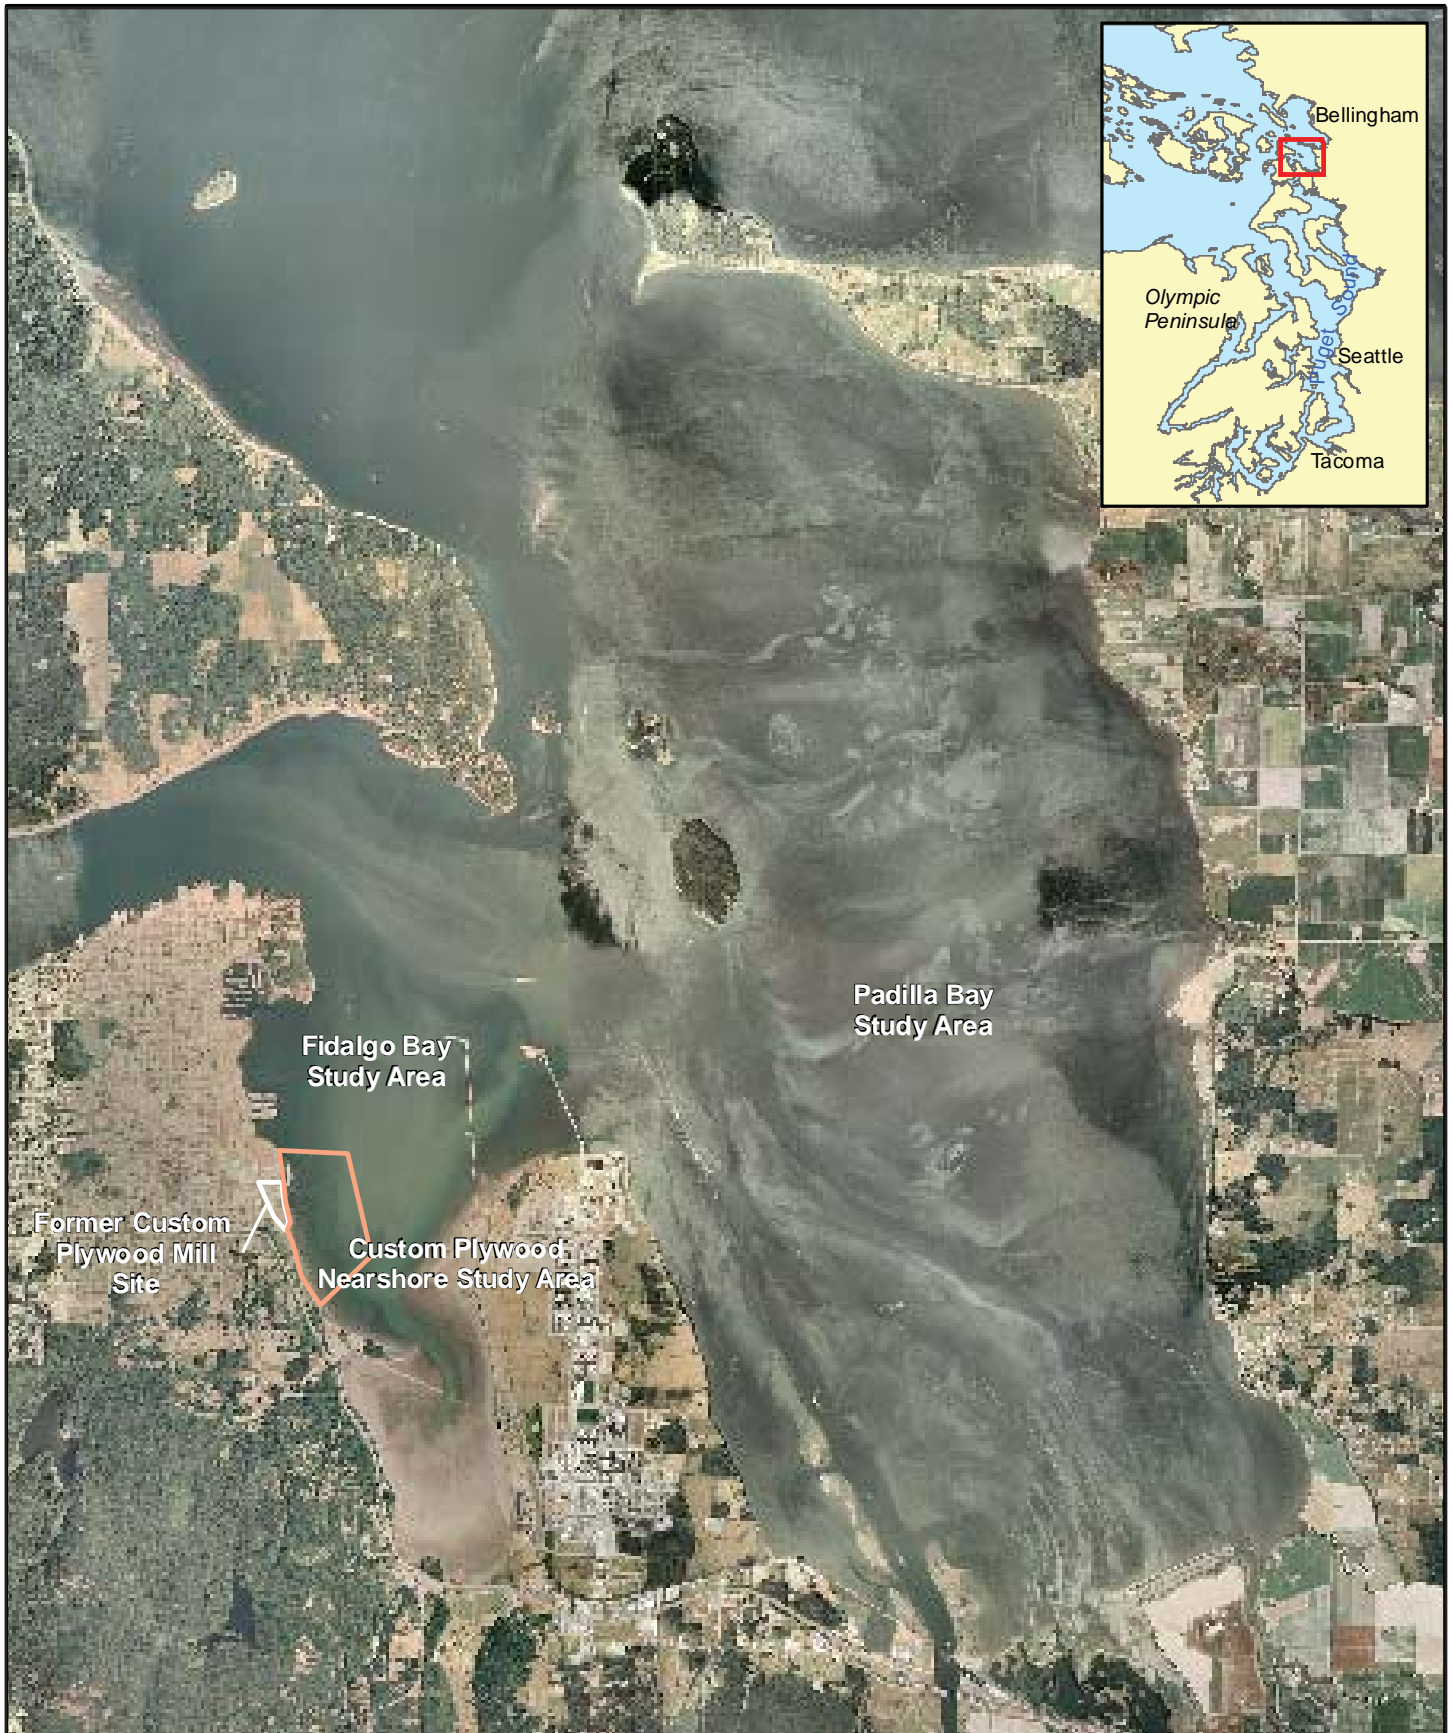
**Figure 1-1. Study Location: Fidalgo and Padilla Bay Bay-wide Study Areas and Custom Plywood Mill Nearshore Study Area**

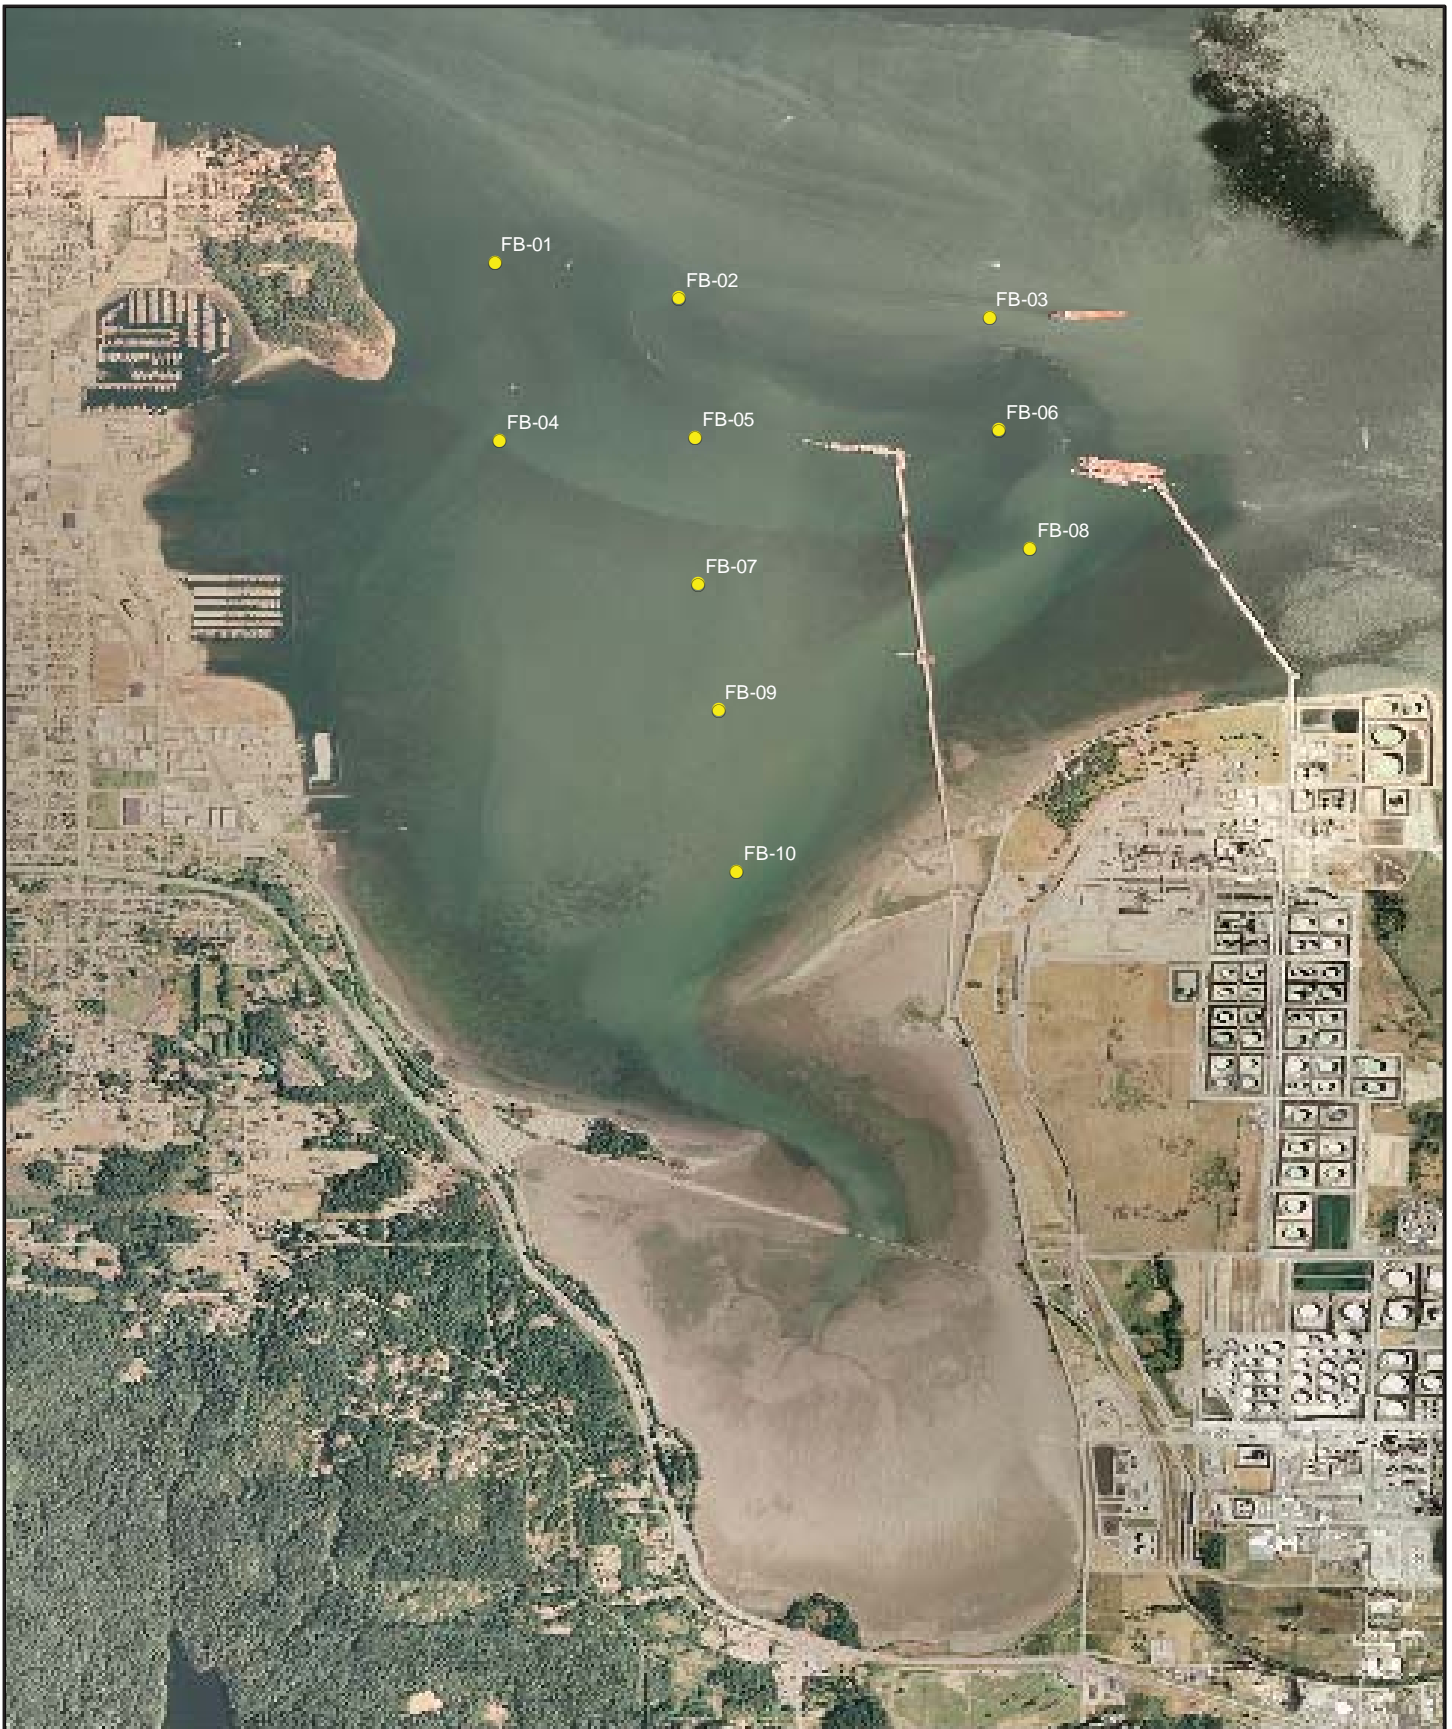
**Figure 2–1. Sediment Sampling Locations for Fidalgo Bay Background Dioxin**

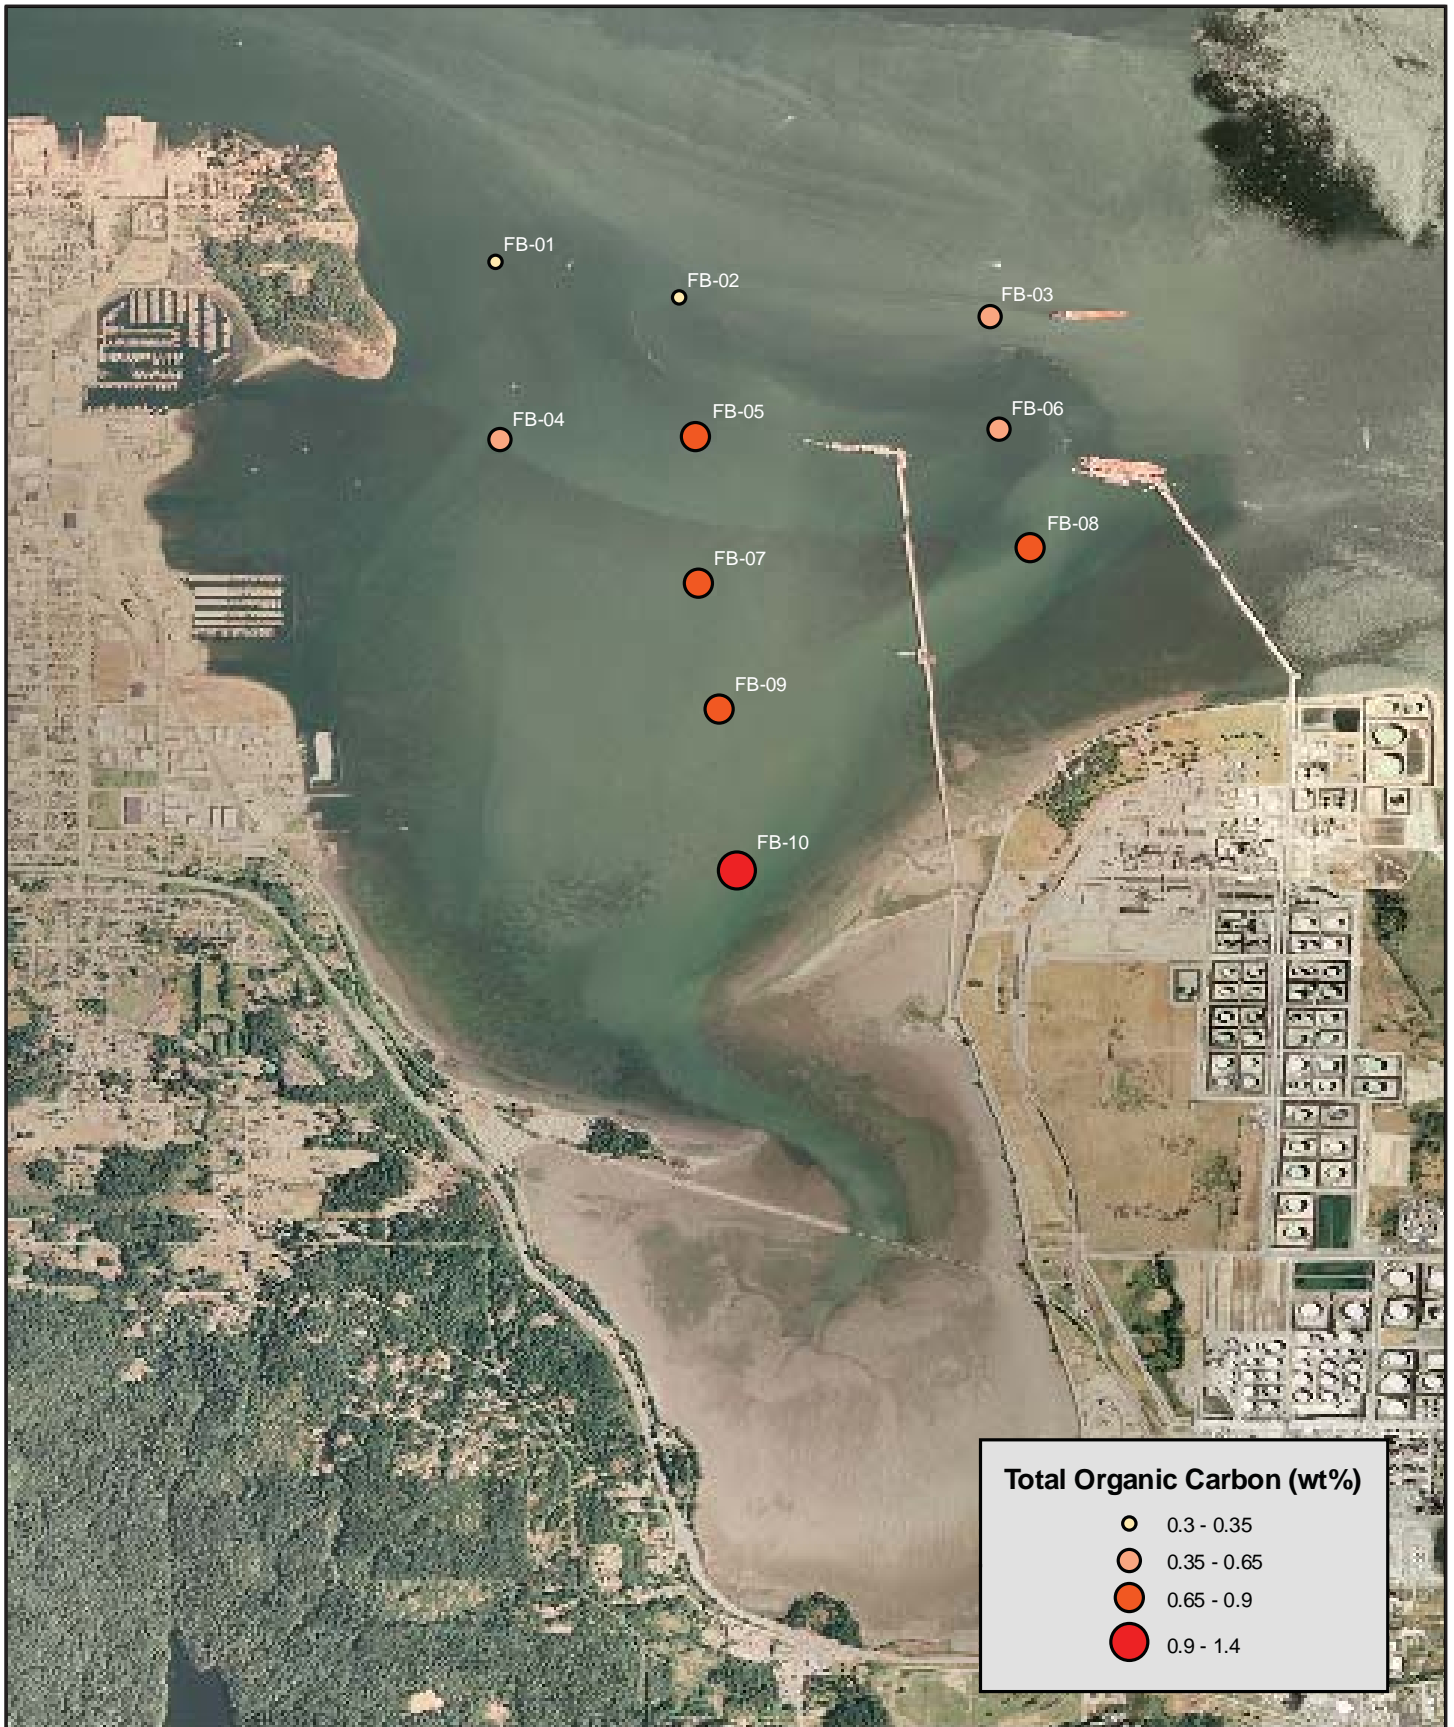
**Figure 3–2. Total Organic Carbon of Fidalgo Bay Background Locations**

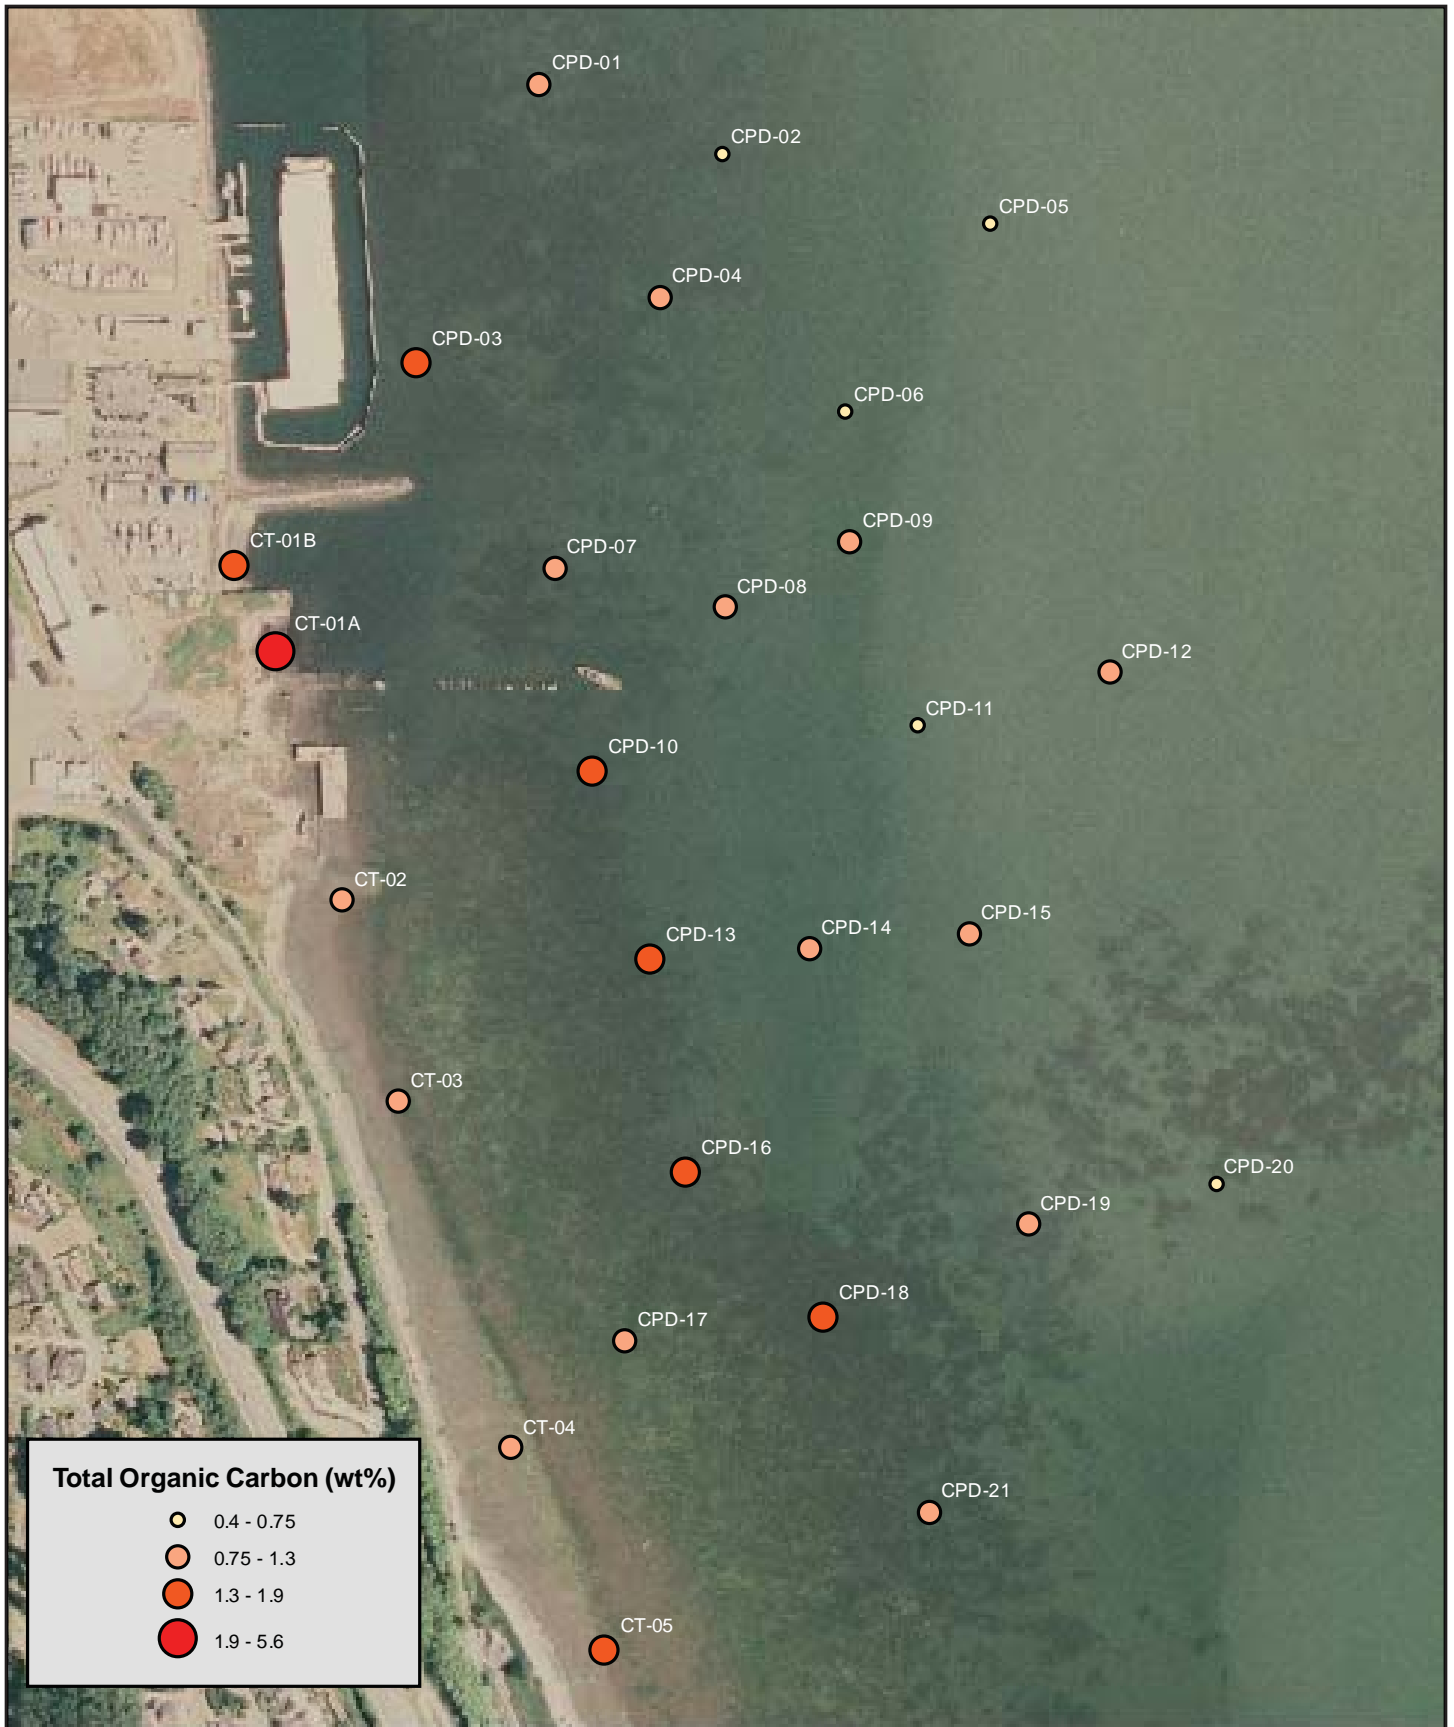
**Figure 3–6. Total Organic Carbon of Former Custom Plywood Mill Nearshore Locations**
